Identification of the Effects of Fire-Wave Propagation through the Power Unit's Boiler Island

Michał Paduchowicz * and Artur Górski

Department of Machine and Vehicle Design and Research, Faculty of Mechanical Engineering, Wrocław University of Science and Technology, 27 Wybrzeże Wyspiańskiego, 50-370 Wrocław, Poland; artur.gorski@pwr.edu.pl

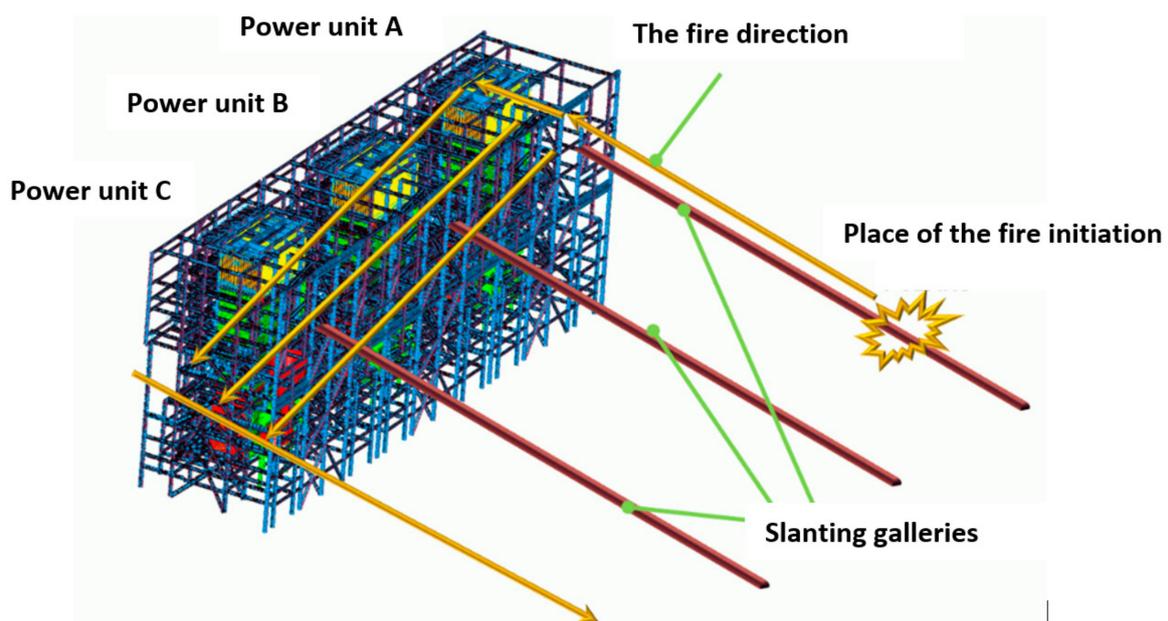
The fire was initiated in the conveyor belt gallery situated in the coal and biomass supply line of power unit A. The fire wave later traveled through communication lines located between the power units and approached further generating units. The propagation of the fire wave necessitated evaluation of the degradation and damage caused to particular elements of the power units. The tests and measurements in this case were complex and consisted of [6]:

Figure 1. The fire's point of origin and way through the power units.

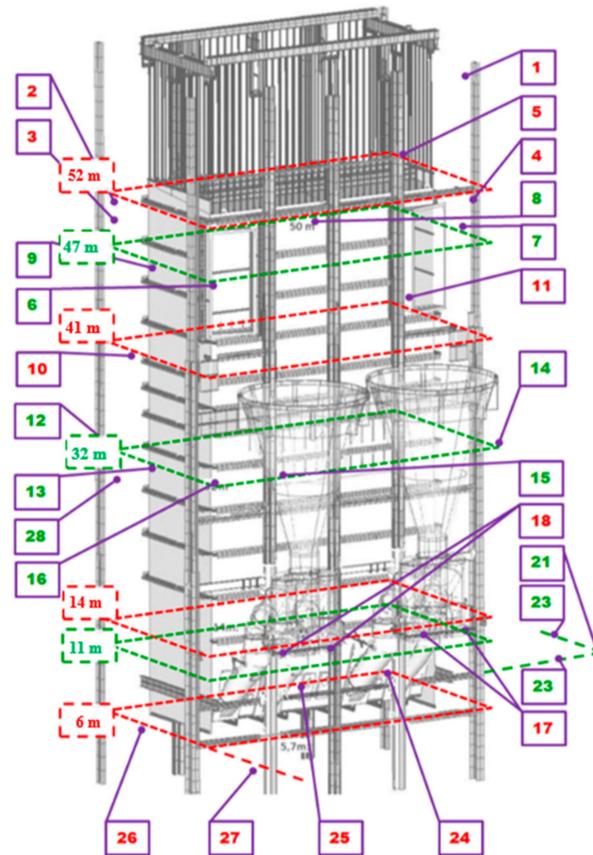
Figure 4. Diagram of the power unit showing the place and labels for inconsistencies found.

The inspected areas of the power unit were shown in Figure 4 and marked with schematic labels.

structure were performed on seven height levels (6, 11, 12, 32, 41, 47, and 52 m) indicated in Figure 4. The inspections covered welded joints and weld quality, as well as bolted joints and plastic strain of both beams and casing. The obtained results allowed to make the following observations [11]:

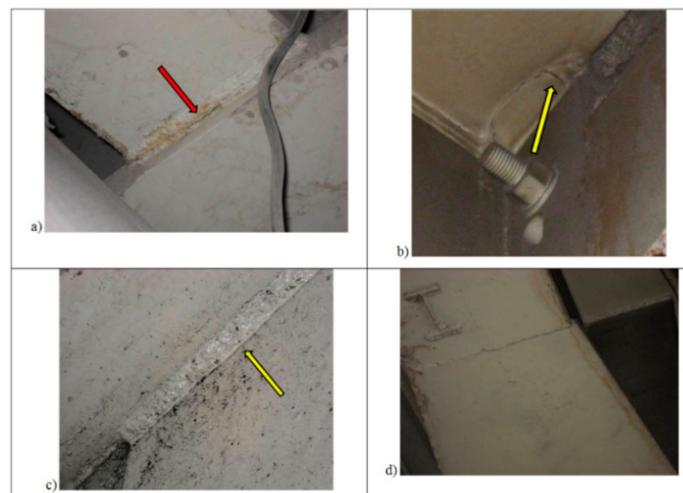
Figure 5. Weld cracks in the girders of the unit's load-bearing structure: (a) weld discontinuity between the face and the heat-affected zone (HAZ); (b) weld crack; (c) subsurface crack of the girder's weld; (d) weld crack at the connection point between load-bearing girders.

- Cracks of weld line in many places (Figure 5);
- Insufficient quality of welding and weld repairs, welded joints made in inappropriate places;
- Elastic buckling of lattice work in the load bearing structure;
- Repairs done during power unit's operation were not protected against corrosion;
- Inappropriate bracing, which may cause stress concentration in the areas of their construction;
- Additionally, a great number of welded joints is accumulated on a small area, which leads to the change in material structure, as a lot of heat is supplied and, therefore, the material loses its strength characteristics;
- Deplanation (warping) of flanges and webs in support beams, as well as deformation of reinforcing ribs in I-beam girders;
- Forbidden process holes (mount holes) in load-bearing girders and posts.

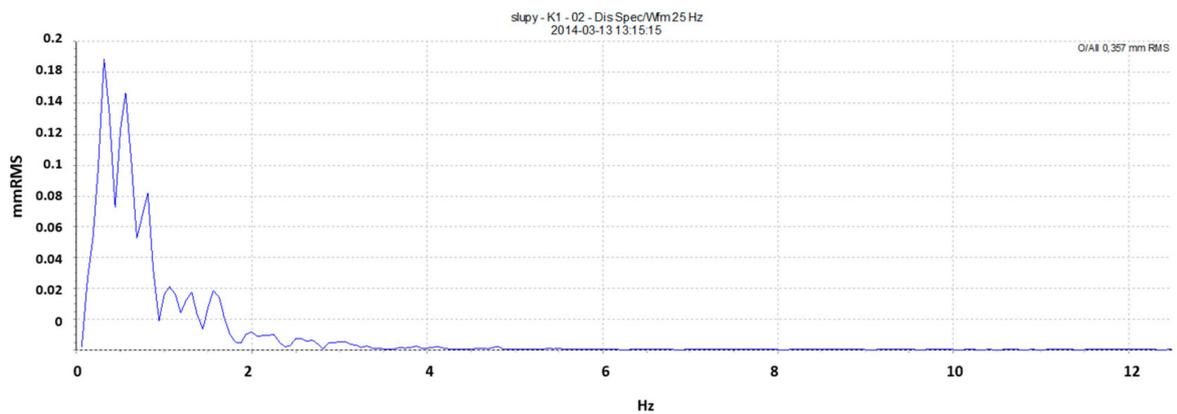
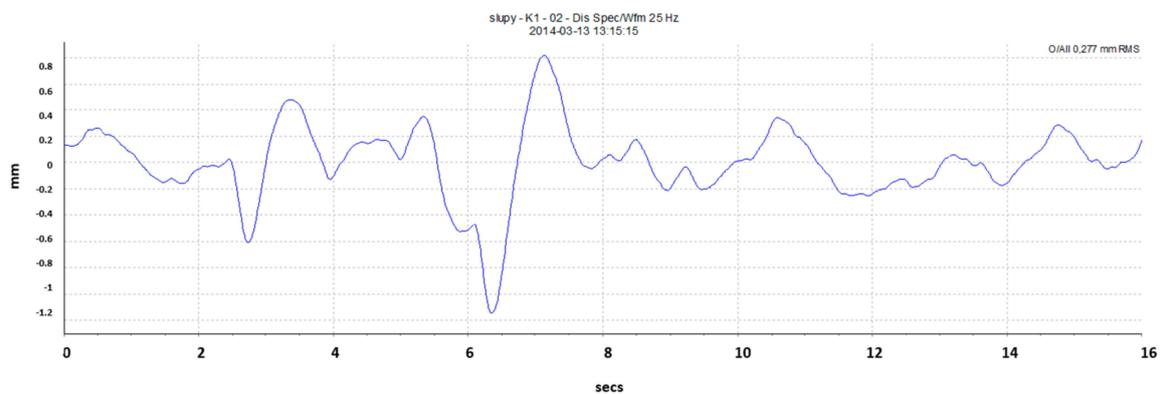
Figure 7. Diagrams of accelerations and displacements in a sample point 2, where vibration amplitudes for the measuring range are inter alia (a) $0.815 \div 0.191$ mmRMS, (b) $-1.146 \div 1.961$ mm.

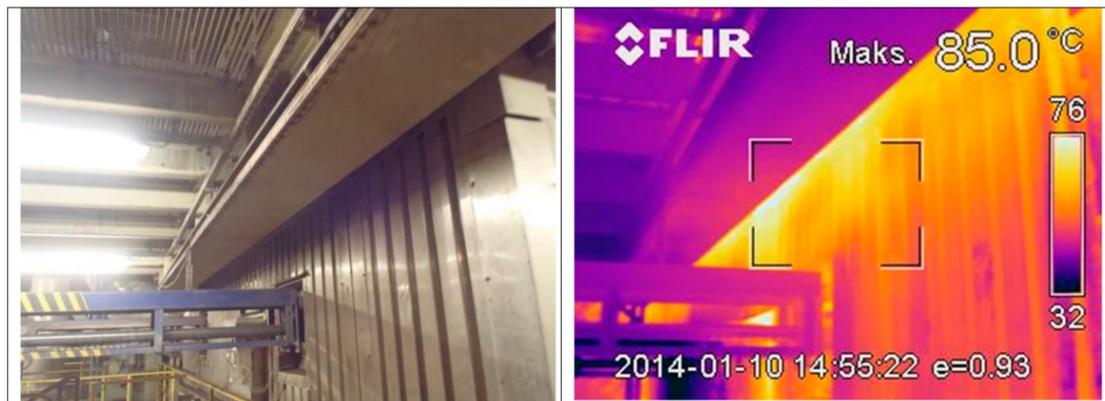
Figure 8. Temperature distribution at the soot blower entrance point into the furnace chamber.

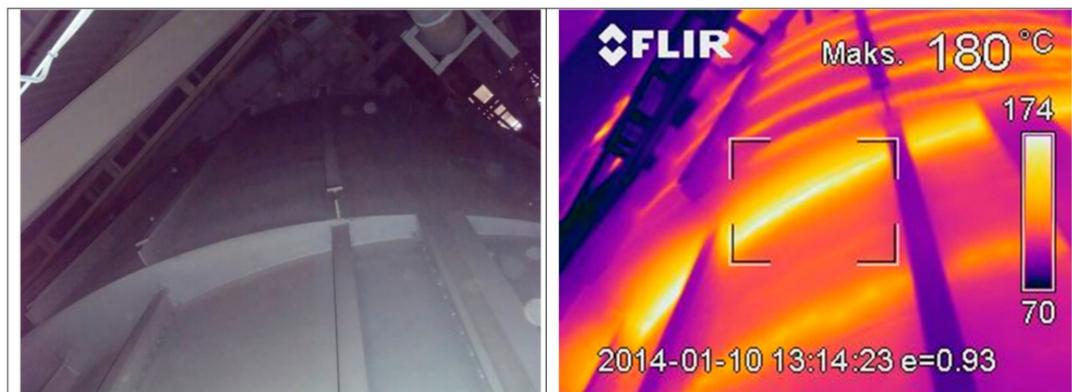
Figure 9. View of temperature distribution on the external casing of flue gas cyclone—clearly visible thermal bridges in the cyclone's upper part.

Thermal imaging inspection of temperature distribution was performed for the power unit's height levels in the range between 0 and 56 m. In addition, the obtained thermal images allowed us to estimate the quality of thermal insulation used in the furnace chamber's external casing and other boiler equipment. This allowed us to find areas with damaged thermal insulation and the resulting thermal bridges, especially those located on the connecting points of the machines working with furnace chamber and other elements. The damage of external insulation layers was closely connected to the propagation of the fire wave in the vicinity of the power units [16].

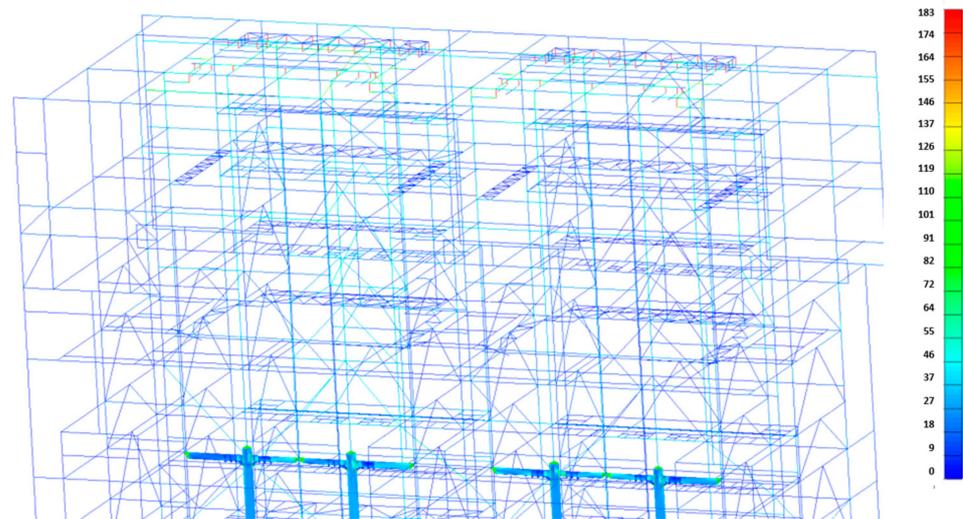
Figure 12. Huber–Mises reduced stress contour lines for the load-bearing structure of the power unit [MPa]—view of the upper grate area.

FEM strength calculations of the load-bearing structure showed among other things that greatest reduced stress equal to 183 MPa could be observed in the area of the posts supporting return lines to the furnace chamber. These values are lower than the yield strength (235 MPa) of the construction material used to build the load-bearing structure of the power units. In the remaining parts of the units' load-bearing structures, the majority of reduced stresses were approximately 50 MPa. The above data prove that the fire in the boiler hall did not cause any damage to the support structure of the power unit. FEM strength calculations were also performed for the container, by building both geometric (Figure 13) and discrete models. The container is supported in four points located in its upper part, as can be seen from the model shown in Figure 13. The colors in the model correspond to metal sheets of different thicknesses [20].

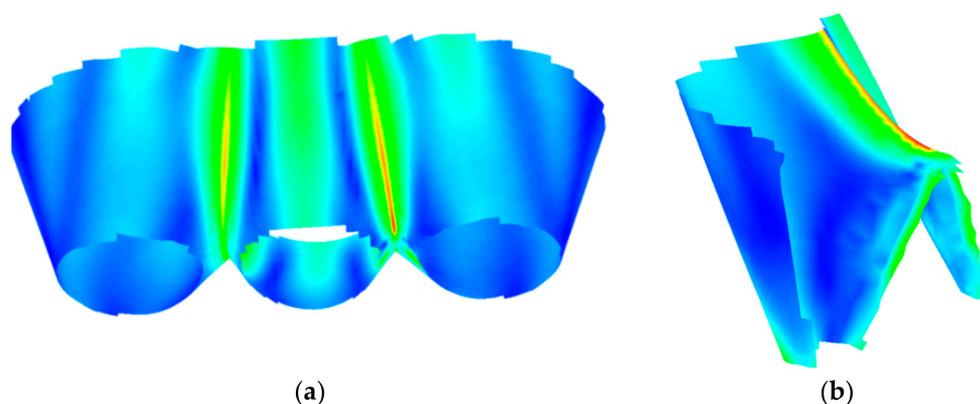
In order to determine the reasons for the container's damage, a series of strength analyses was performed, with consideration paid to several factors that accompanied the fire and could cause a crack in the area of dumping hoppers and complete damage of the container's upper part. The rising temperature inside the boiler hall, which was the result of the fire, led to uneven heating of the boiler's surface. The thermal gradient of the boiler's casing that occurred in consequence, as well as the rise in air temperature inside the container—which translated into the rise in air pressure—both contributed to the emergence of cracks in the area of weld lines on the fuel hopper and sudden damage of its upper part that followed. Strength analysis was performed for the following air pressure values: 5 kPa, 10 kPa, 15 kPa, . . . , 50 kPa (values increased by 5 kPa). Impact strength of approximately 200 MPa was assumed for the observed low quality of weld lines on the fuel hoppers. The strength analysis showed that at air pressure inside the container equal to 50 kPa and at uneven thermal impact that occurred simultaneously, reduced stress in the area of hopper weld lines reached approximately 270 MPa (Figure 14). This contributed to the breaking of the discussed area of the container 8z.

Figure 14. Reduced stress contour lines in the lower part of the container, according to Huber and Mises hypothesis [MPa] (a) hopper area of the fluidized bed material tank; (b) the hopper weld area of the fluidized bed material reservoir where the crack has occurred

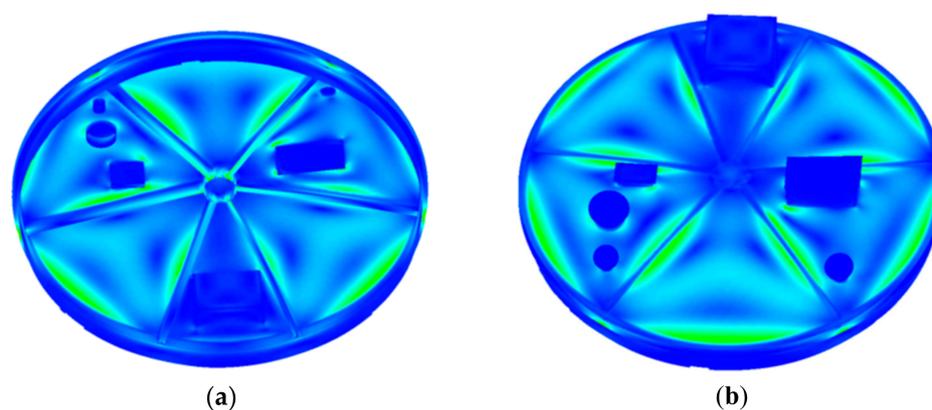
At the same time, reduced stress in the container's upper part was observed at approximately 870 MPa (Figure 15). The latter observation, along with the fact that the tests performed prove the ultimate strength of steel S235 to be at the level of 315 MPa, means that this area experienced a sudden discontinuity of the investigated object's casing [20].

The strength analysis also showed clearly that as the air pressure inside the container rose to approximately 50 kPa and the casing heated unevenly, the casing broke in its both upper and lower parts.

Figure 15. Reduced stress contour lines in the upper part of the container, according to Huber and Mises hypothesis [MPa]: (a) Calculation results of the upper cover of the bed material tank from the outside, (b) Calculation results of the upper cover of the bed material tank from the inside.
