# Partial Discharge Detection and Defect Location Method in GIS Cable Terminal

**Abstract:** The complex structure of gas-insulated switchgear (GIS) cable terminals leads to serious electric field concentration, which is a frequent fault position of a high-voltage cable system. At present, due to the differences in the frequency bands of sensors, various partial discharge detection technologies have certain differences in their scope of application and anti-interference performance, resulting in a low defect detection rate in GIS cable terminals. In this paper, a comprehensive diagnosis scheme is proposed, which integrates transient earth voltage (TEV), ultra-high frequency (UHF), high frequency (HF), and ultrasonic methods. Two abnormal discharge defects of GIS terminals in two 220 kV substations in Tianjin were tracked and monitored, and the joint diagnosis was carried out using the proposed scheme; the type of discharge defect and the phase sequence of the defect were determined, and the UHF was employed to precisely locate and analyze the defect source. Finally, through the disassembly analysis and electric field simulation of the GIS cable terminal, the accuracy and effective

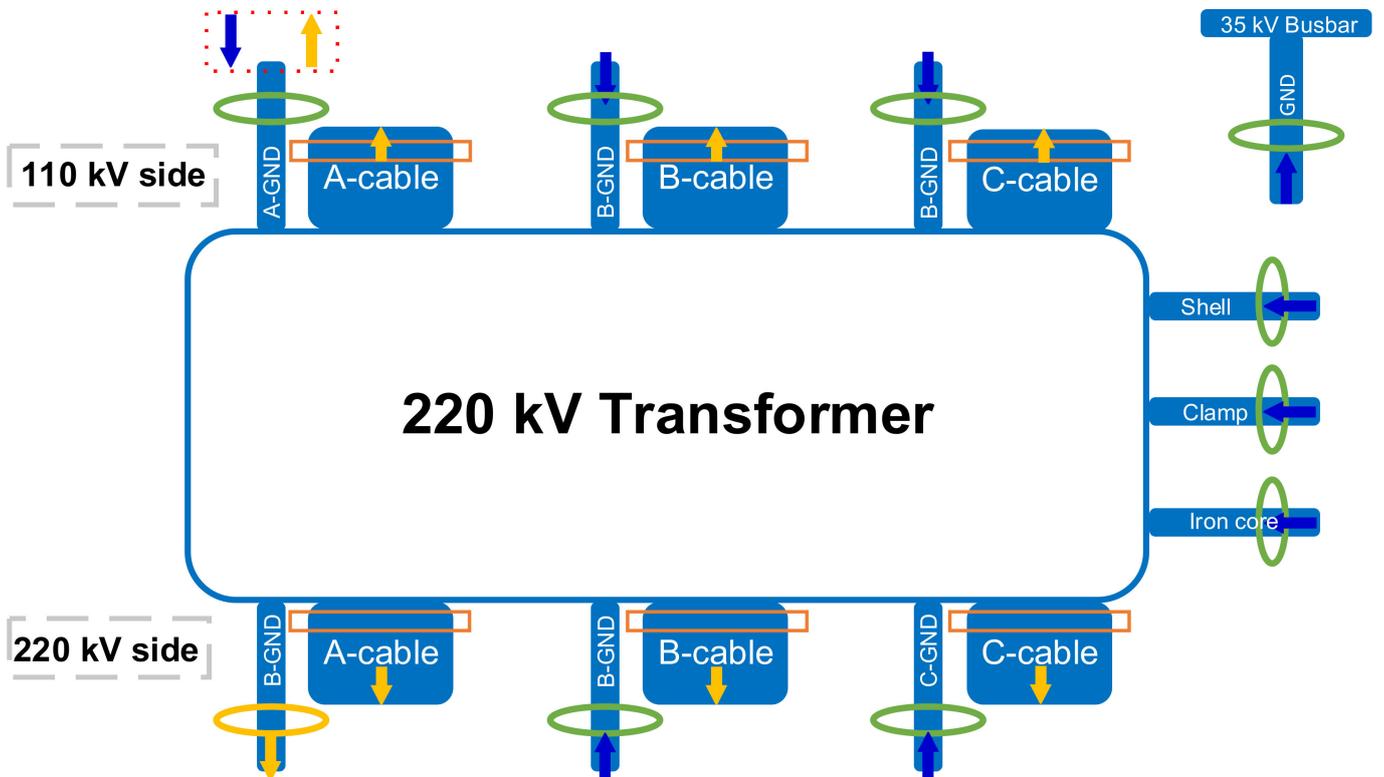
Figure 2 presents a typical HF signal polarity diagram of an oil–oil bushing transformer, when the 220 kV C-phase cable terminal was the signal source. The position of HFCT at the grounding wire of the phase A cable terminal on the 220 kV side should be kept unchanged each time (yellow ring). The red arrow represents the high-frequency current flowing from the equipment to the ground, and the blue arrow represents the high-frequency current flowing from the ground to the equipment. The red dotted box of phase A on the 110 kV side shows that two different types of data were collected many times, and the results were not unique.

Figure 2. HF signal polarity diagram of oil-oil bushing transformer (220 kV C-phase cable terminal is the signal source).

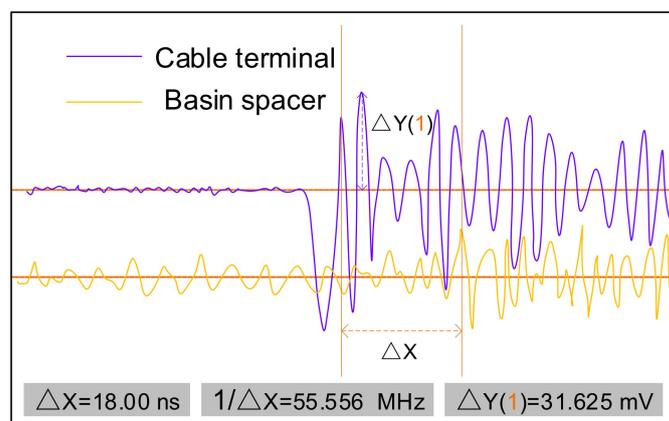
An abnormal partial discharge signal was detected at the 2215 bay A-phase cable compartment and basin insulator above the current transformer (CT) upper side, and there was no abnormality at other positions. According to the characteristics of the discharge spectrum, it was judged an insulation discharge. The amplitude at the cable terminal was greater than that at the basin insulator above the CT, and the maximum amplitude was  $-53$  dB. See Figure 3 for the detection location and Table 2 for the typical map.

**Figure 3.** Signal diagram of two detection positions in A-phase cable compartment.

In order to accurately locate the defect position of the discharge source, the inspector selected the discharge signal at the basin insulator above the CT side (yellow) and the epoxy resin flange at the cable terminal (purple) for local discharge source location analysis. It is shown in Figure 3 that the rising edge of the yellow signal curve was not obvious due to the small discharge amplitude.

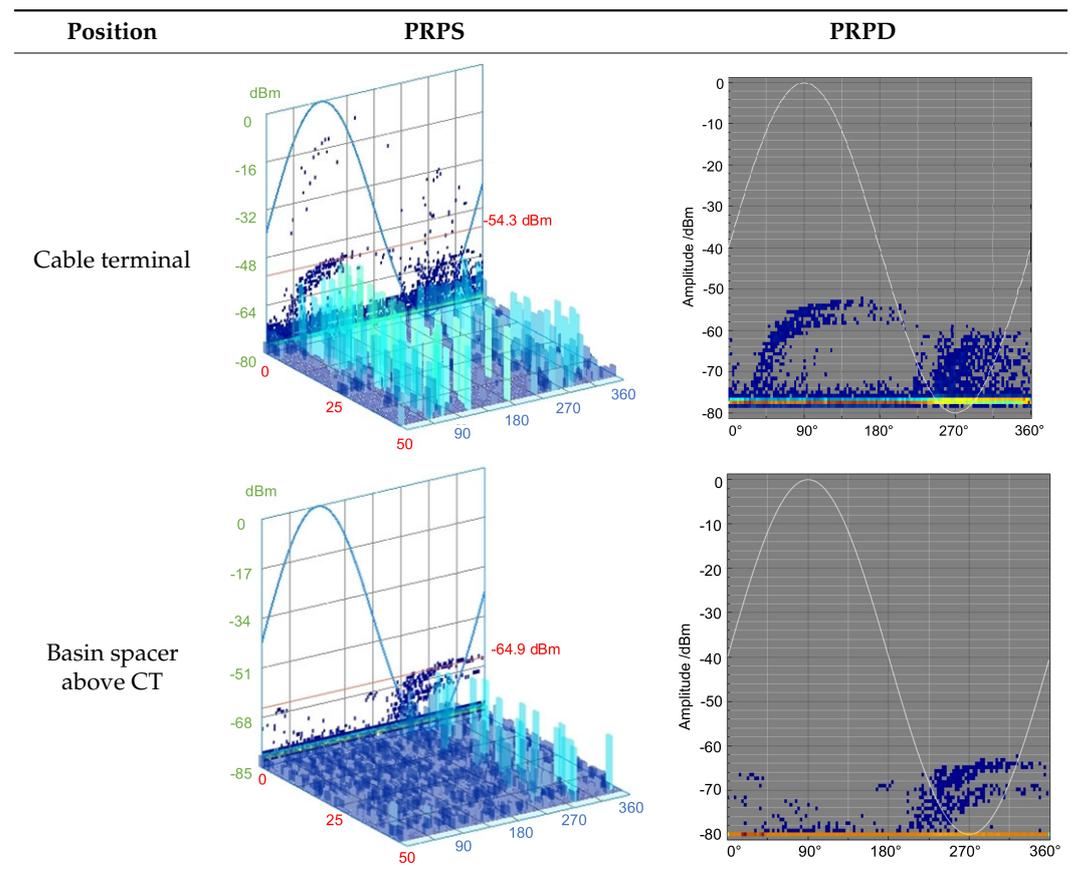
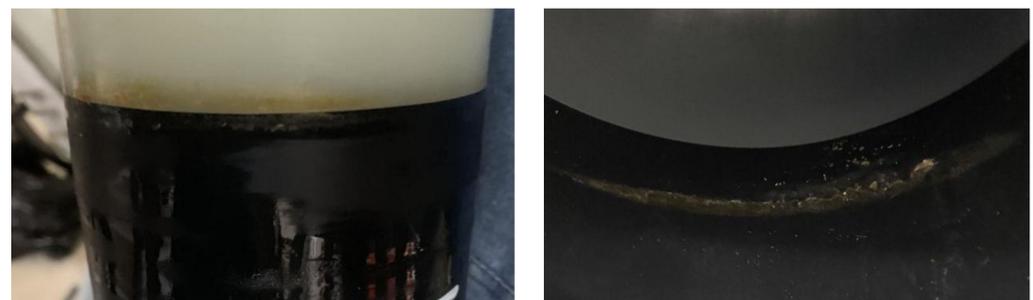
In order to verify the partial discharge detection results in Section 3.1.1., the A-phase cable was taken out of the cable chamber and disassembled to determine the defect location of the A-phase cable. It was found that there was a dark yellow solid substance in the area close to the fracture between the semi-conductive layer and the cable insulation, and the same substance also existed at the corresponding inner position of the stress cone, as shown in Figure 4.

**Figure 4.** Morphology of the abnormal area of cable terminal. (a) Semi-conductive layer, (b) inside the stress cone.

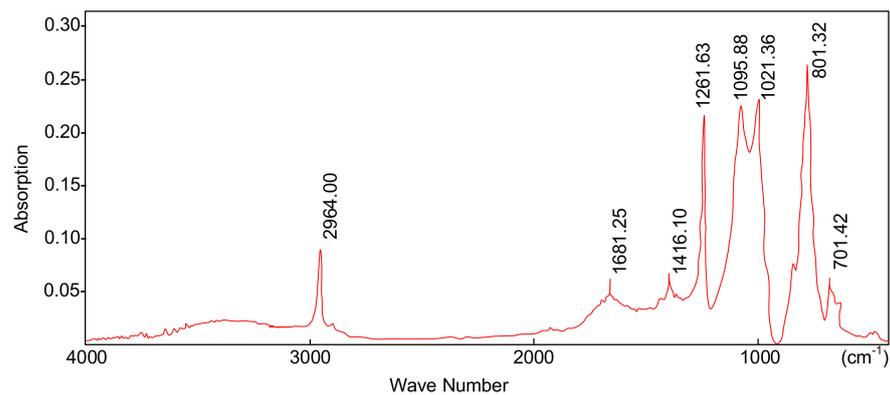
The dark yellow solid substance was tested by infrared spectrum. The functional group analysis results are shown in Figure 5. The wave numbers  $1261\text{ cm}^{-1}$  represented the Si-CH<sub>3</sub> functional group,  $1095\text{ cm}^{-1}$ ,  $1021\text{ cm}^{-1}$  for Si-O-Si functional group, and  $800\text{ cm}^{-1}$  for CH<sub>3</sub> functional group, which confirmed that the substance was silicone oil. The wave number around  $1681\text{ cm}^{-1}$  represented the carbonyl C=O functional group, which confirmed that the silicone oil had deteriorated.

**Figure 5.** Infrared spectral analysis of solid substance.

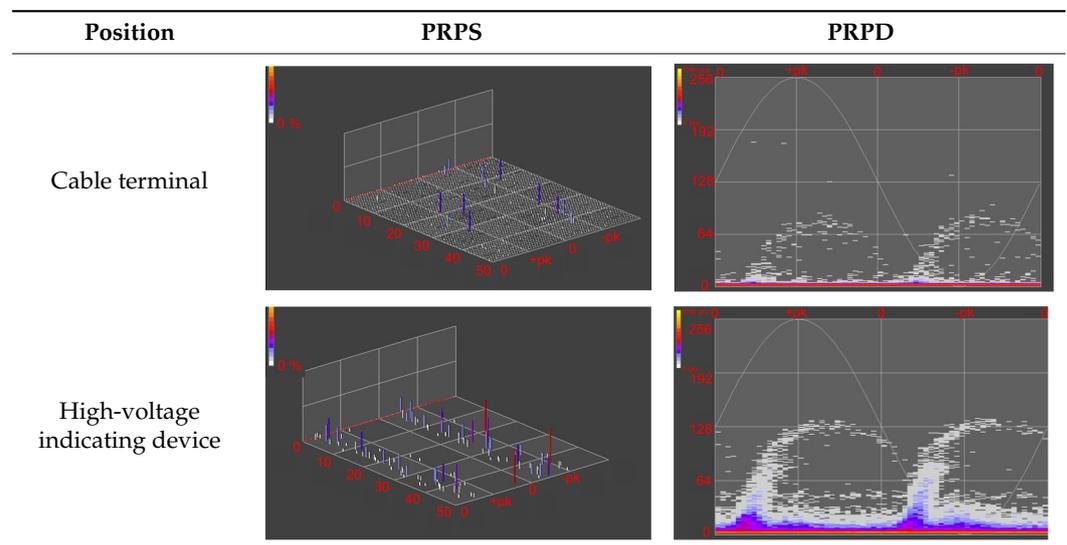
**Table 4.** Typical spectrum of UHF detection in A-phase cable compartment.

An abnormal partial discharge signal was also detected at the 2202 bay A-phase cable terminal and high-voltage indicating device of the GIS, and no UHF partial discharge anomaly map was found in the space background, phase B or phase C. It was seen from the results in Table 4 that the discharge pulse had obvious periodicity, large amplitude dispersion and an unstable discharge time interval, so the detection spectrum was similar to that of typical insulation defects.

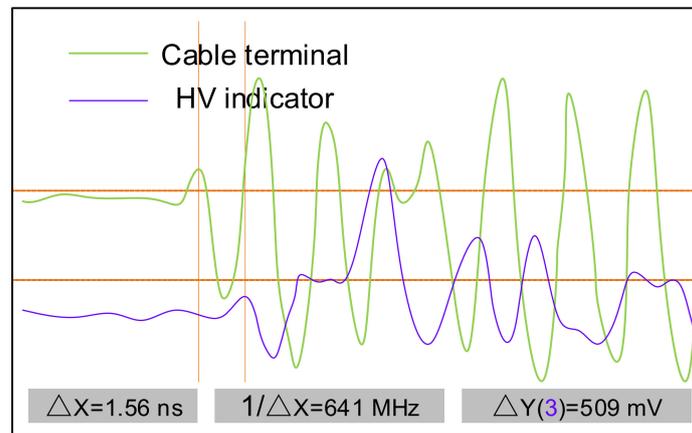
In order to reduce the measurement error, multiple time-delay positioning was carried out. As shown in Figure 6, the green sensor (cable terminal) waveform was always ahead of the purple sensor (high-voltage indicating device) waveform, and the time difference between the two positions was 1.56 ns. It was calculated that the discharge power was located 0.7 m above the bottom flange of the 2202 interval A-phase cable terminal.

**Figure 6.** Signal diagram of two detection positions in A-phase cable compartment.

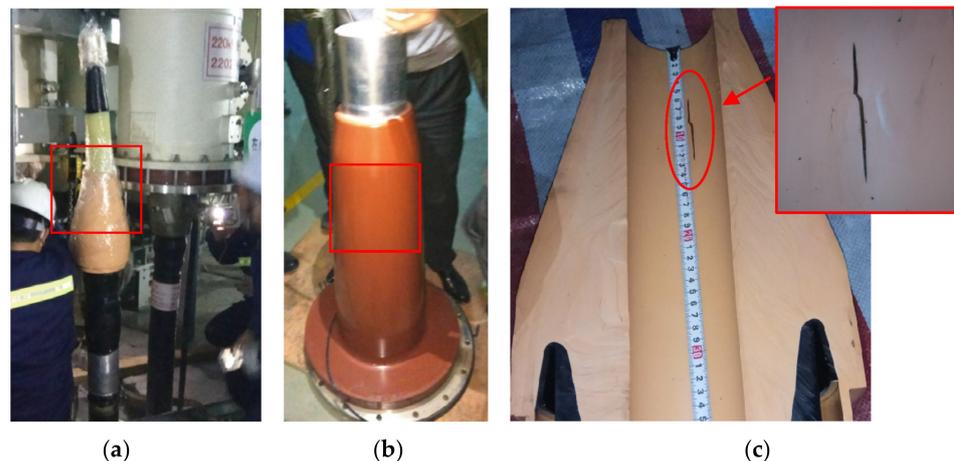
The A-phase cable terminal was drawn out from the lower end of the cable bin, and no obvious discharge trace was found on the outer surface of the stress cone and epoxy sleeve after careful inspection, as shown in Figure 7. The stress cone was split longitudinally. Through inspection, it was found that there was a 7 cm long crack on the inner surface of the stress cone (6 to 13 cm from the upper end of the stress cone), which was consistent with the detection results of partial discharge.

**Figure 7.** Morphology of the disassembled cable terminal. (a) Stress cone and XLPE insulation, (b) epoxy sleeve, (c) crack inside the stress cone.

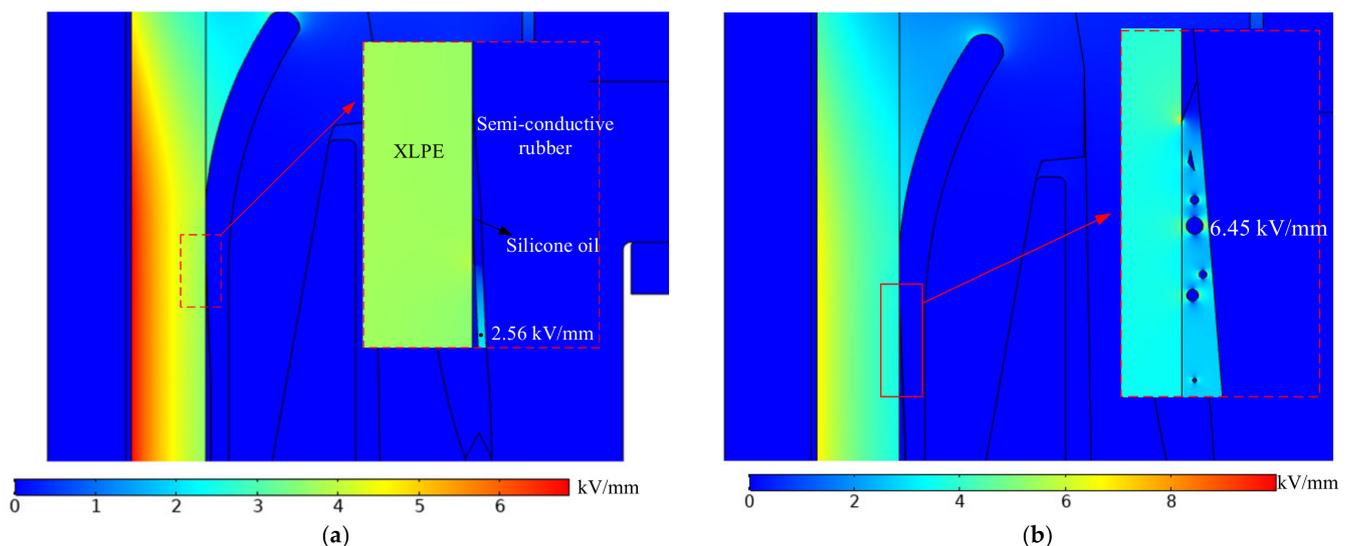
As shown in Figure 8a, the thickness of the silicon oil coating was set to 0.1 mm. Under normal working conditions, the maximum electric field strength inside the silicon oil coating is 2.56 kV/mm. Under this field strength, there is no possibility of partial discharge inside the cable terminal. In consideration of the irregular impurities in the coated silicone oil, we set different shapes of defects as shown in Figure 8. The results show that the maximum electric field strength in the coated silicone oil was 6.45 kV/mm, which was 252% of the normal working condition. With the electric field distortion, the discharge accident may have been further induced here, causing further deterioration of the silicone oil and insulation failure of GIS cable terminal.

**Figure 8.** Electric field distortion at the interface in GIS cable terminal: (a) without defects, (b) with defects.
