Cracking Analysis of a Brass Clamp Mounted on the Main Transformer in the Power Grid System

Jiahui Chen ^{1,*}, Jie Feng ¹, Fangqiang Wang ¹, Qian Peng ¹, Guitian Lan ², Lihua Zhao ² and Longwen Wu ²¹ State Grid Sichuan Electric Power Research Institute, Chengdu 610000, China² College of Electrical Engineering, Sichuan University, Chengdu 610000, China

Abstract: Cracking of conductive brass accessories in substations causes overheating or an open circuit, seriously affecting the safe and stable operation of the power grid system. A deep understanding of failure mechanisms could provide more safety, as well as lower down costs and save time for the power grid system, which have been seldomly involved in the literature. This paper presents a cracking analysis of a brass clamp in service for seven years that is mounted on the main transformer. The fracture morphology, chemical composition, and metallographic structure of the brass clamp were systematically analyzed, and the stress conditions were obtained by finite element simulation. The clamp exhibits transgranular brittle fracture with high oxygen content in the fracture, containing a crack propagation along the Pb particle conne

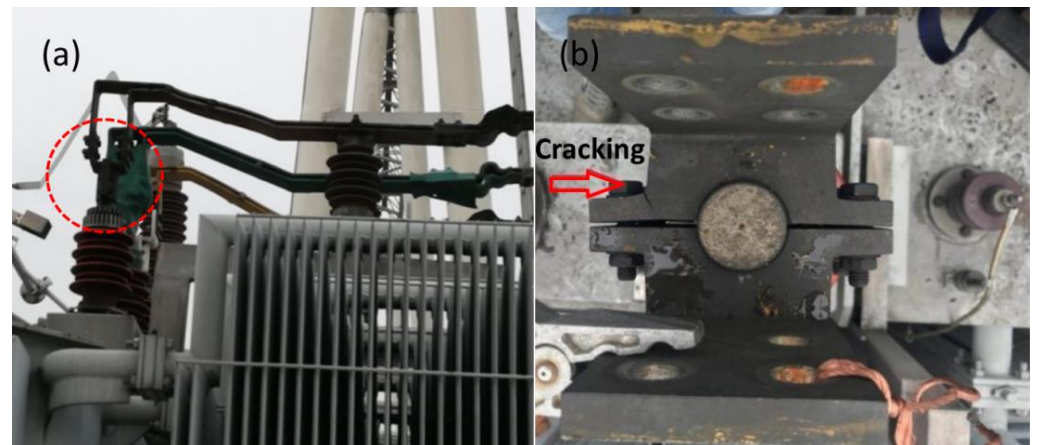
Figure 1. (a) The brass bushing clamp mounted on the main transformer. (b) General view of the cracked brass clamp.

From the installation and operation status of the main transformer in Figure 1, the clamp is combined with the bushing conductive rod, and the holding ear needs to be fastened by bolts. The main crack lies on the junction of holding clip and ear plate, where residual stress may appear after casting, and stress concentration is easily caused under external force. In this case, a finite element model was established, and the stress conditions were analyzed.

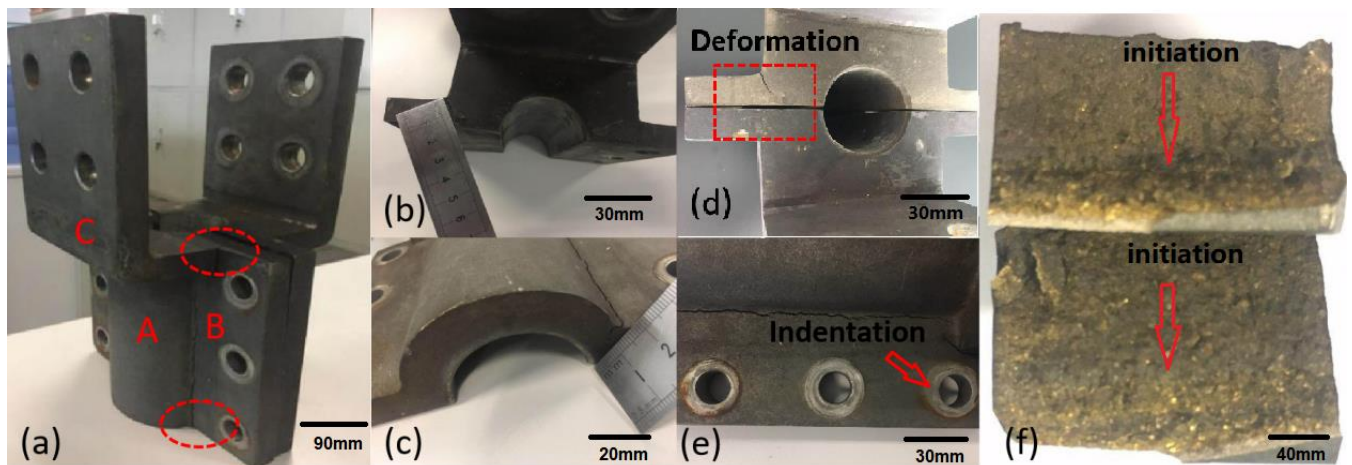
Figure 2. (a) Macro-appearance, (b,c) crack depth, (d) deformation, (e) indentation, and (f) fracture of the failed clamp.

The specific macro-appearance of the failed clamp is presented in Figure 2. The clamp is dark gray and contains three parts: a holding clip (A), ear plate (B), and terminal plate (C). A penetrative crack, lying in the junction between A and B and between B and C, expands from the outside to inside. The depth of crack is 12 mm and 14 mm at the top and bottom of the connecting region, respectively, indicating an incompletely fracture, as shown in Figure 2a–c. Furthermore, an ear plate deformation approximately 4° and an indentation near the bolt hole can be observed in Figure 2d,e. The high torque applied to the bolt of clamp could be the reason for these deformations.

The failed clamp was cut along the crack for a detailed Inspection of the fracture surface. As shown in Figure 2f, the fracture is basically flat with obvious corrosion traces, and the crack propagates from the top to bottom areas. No macroscopic fatigue features and plastic deformation are observed, exhibiting the characteristic of brittle fracture.

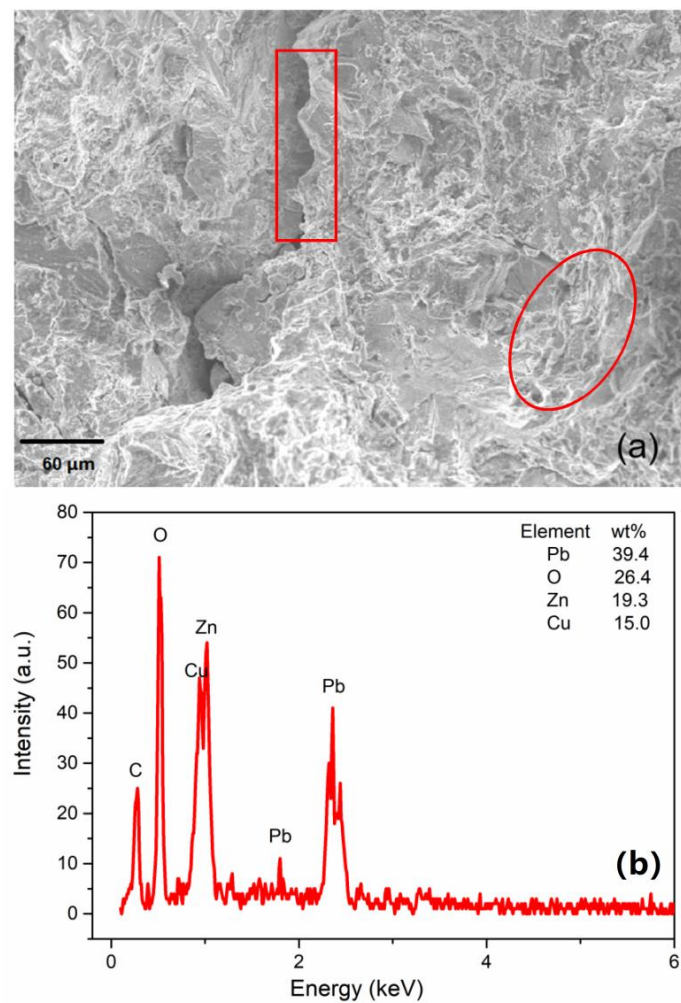
Figure 3 shows local magnified SEM micrographs and the EDS spectrum of the fracture surface. The brittle nature of the failure can be further confirmed by the quasi-cleavage morphology and secondary cracks, which were marked by the rectangle and ellipse, respectively, in Figure 3a. No fatigue striations appear on the fracture surface, and the fatigue failure mechanism is not applicable in this case. The content of Pb in the fracture surface is about 39.4%, far above the detection value of base material mentioned in Section 3.1, indicating a crack propagation along the Pb particle connecting pathways. Figure 3b shows a high oxygen content, and it can be inferred that clamp was subjected to a severe corrosion by environmental media.

Figure 3. Local magnified SEM micrographs (a) and EDS spectrum (b) of the fracture surface.

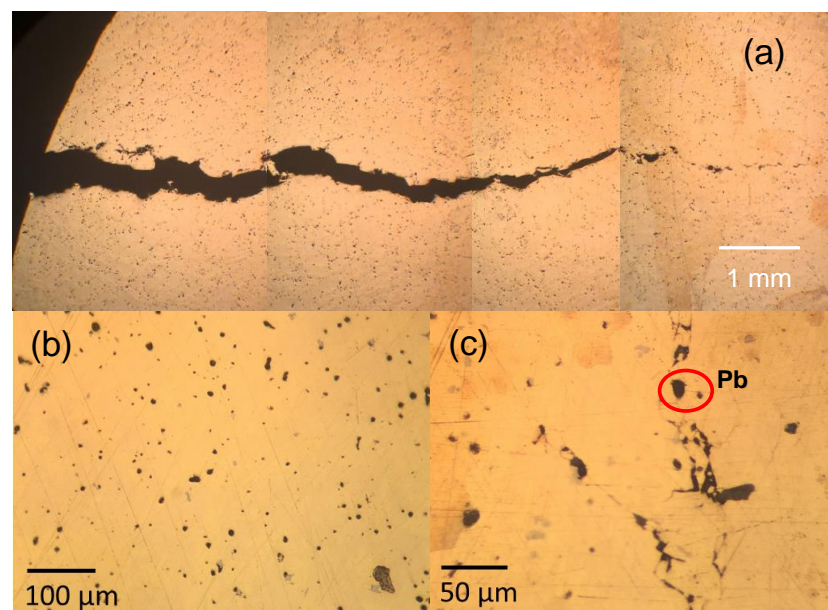
The optical micrographs of unetched profile are exhibited in Figure 4. The crack propagation observed in Figure 4a confirms a brittle fracture with secondary cracks. Large amounts of black Pb particles are dispersed in the matrix with different sizes and shapes. It can be confirmed by different Pb contents measured by EDS in certain particles and matrices, which are 58.8% and 0%, respectively. Some small cracks along the particles are observed in local areas, as shown in Figure 4b,c, which are mainly influenced by casting and solidification conditions.

Figure 4. Optical micrographs of the cross-section morphology. (a) crack propagation, (b) black Pb particles, (c) small cracks along the Pb particles.

Measurements of hardness were taken on the cross-section in Figure 4. The average hardness is 120 HV, which is in accord with the values reported of CuZn39Pb3 leaded brass reported by Anagnostis et al. and higher than lead-free brasses (CuZn36 [25] and CuZn38 [26]). A ductility loss was induced owing to the Pb distribution in phase boundaries, which can lead to the minimization of grain boundary energy.

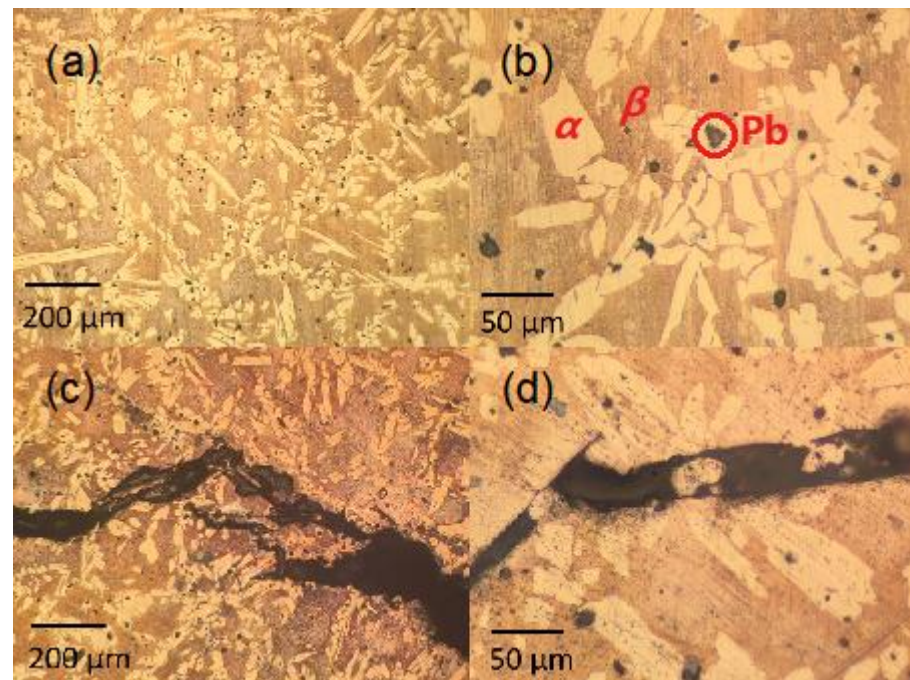
The microstructure is typically a mixture of bright flat-elongated α phase and “dark” β' phase. Pb particles distribute inside the α phase or at the boundary of two phases, as shown in Figure 5a,b. The metallographic graphs on the cracking zone are presented in Figure 5c,d. The crack is propagating prevalently through the grains and Pb dispersoids, indicating a trans-granular fracture. Moreover, secondary cracks can be clearly presented in Figure 5c.

Figure 5. The metallographic figures of failed clamp on the (a,b) uncracking zone and the (c,d) cracking zone.

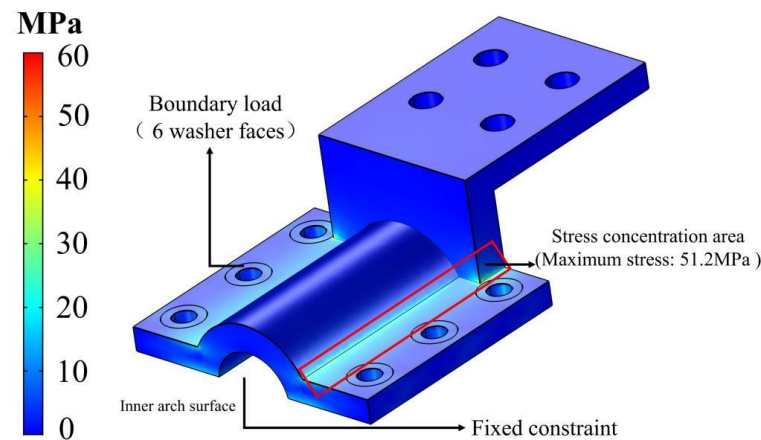
The model was established as follows. First, the geometric model was constructed based on the actual size of the clamp. Then, the geometric model was imported into the simulation software to build the physical model, and the material parameters of the clamp were set (Young's modulus of 1.08×10^5 MPa, Poisson's ratio of 0.30) [27]. Subsequently, according to the actual working condition of the clamp, the inner arch surface was applied with a fixed constraint, and a boundary load of 1000 N was applied to the washer faces at the six bolt holes, and the rest part was assigned with free boundary. Then, the tetrahedral mesh was adopted, which was refined until no obvious change of the stress distribution results. Finally, the steady-state calculation with the MUMPS algorithm with direct matrix decomposition was applied. It can be seen from Figure 6 that the Von Mises stress is mainly concentrated at the chamfer area, which therefore demonstrates that the fracture of the clamp is closely related to the stress concentration. Moreover, the maximum stress of

51.2 MPa does not exceed the yield strength of 92 MPa [27], which implies that the clamp maintains at the elastic state, and the cracking should not be originated from over stress.

Figure 6. Simulated stress distribution of the clamp.

Through proper geometry optimization, the stress concentration can be relieved. Since the stress of the clamp is mainly concentrated at the chamfer area, the stress distribution can be improved by filleting. Additionally, because the bolt is installed at the edge, the stiffness of the clamp can be improved by increasing the thickness of the middle circular arch to reduce the stress at the chamfer zone. To demonstrate this, a comprehensive optimization scheme was carried out. The chamfering radius was set to 1 mm, 2 mm, and 3 mm, respectively, and the arch thickness was set to two levels of 45 mm and 50 mm. As can be seen Figure 7, the maximum stress of the clamp can be reduced in comparison with that in Figure 6 by increasing the size of fillet and the thickness of the arch. Among them, when the chamfering radius is 3 mm and the curvature is 50 mm, the maximum stress of the clamp is only 25.6 MPa, which is 50% of the original one, demonstrating that the stress of clamp can be improved by a large degree.

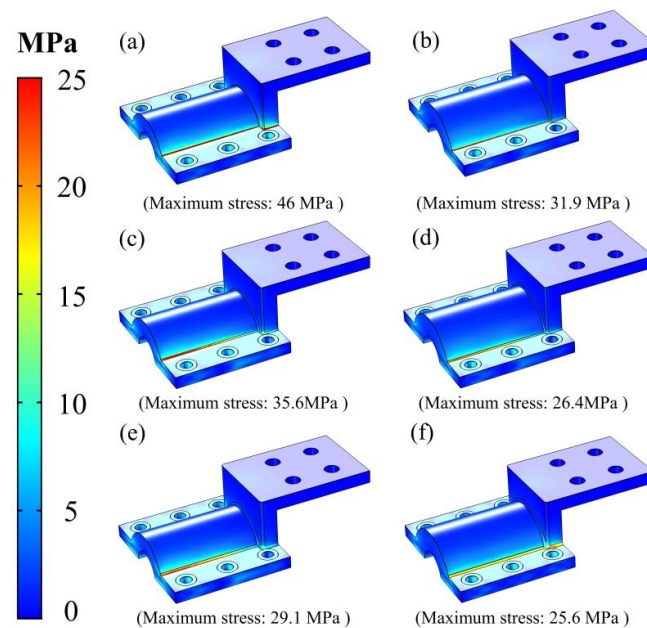
Figure 7. Results of the comprehensive optimization: (a) fillet of 1 mm, outer arch thickness of 45 mm; (b) fillet of 1 mm, outer arch thickness of 50 mm; (c) fillet of 2 mm, outer arch thickness of 45 mm; (d) fillet 2 mm, outer arch thickness of 50 mm; (e) fillet of 3 mm, outer arch thickness of 45 mm; (f) fillet of 3 mm, outer arch thickness of 50 mm. The values in brackets are the respective maximum stress.
