# Failure Analysis of a Flare Tip Used in Offshore Production Platform in Qatar

**Abstract:** An immature failure of a gas flare tip used in Qatar oil and gas offshore industry was investigated throughout this study. The design lifetime of the flare was fifteen years; however, it manifested immature failure resulting in a reduction of its lifetime to ten years. The flare is composed of different parts where the upper flare body and wind deflector showed failure while other components were still healthy. The material used for the aforementioned failed parts was Incoloy 800H, which is a highly corrosion and high-temperature resistant steel alloy. The material was rolled up and welded together with different welding joints. The root cause of failure was identified by using chemical analysis and microstructural and mechanical characterizations. For the mechanical characterization, an optical microscope (OM) and scanning electron microscope (SEM) equipped with energy dispersive spectroscopy (EDS) analyses were used for the specimen extracted from the failed part in order to ensure that the material mentioned by the manufacturer demonstrated the same metallurgical properties. For the me

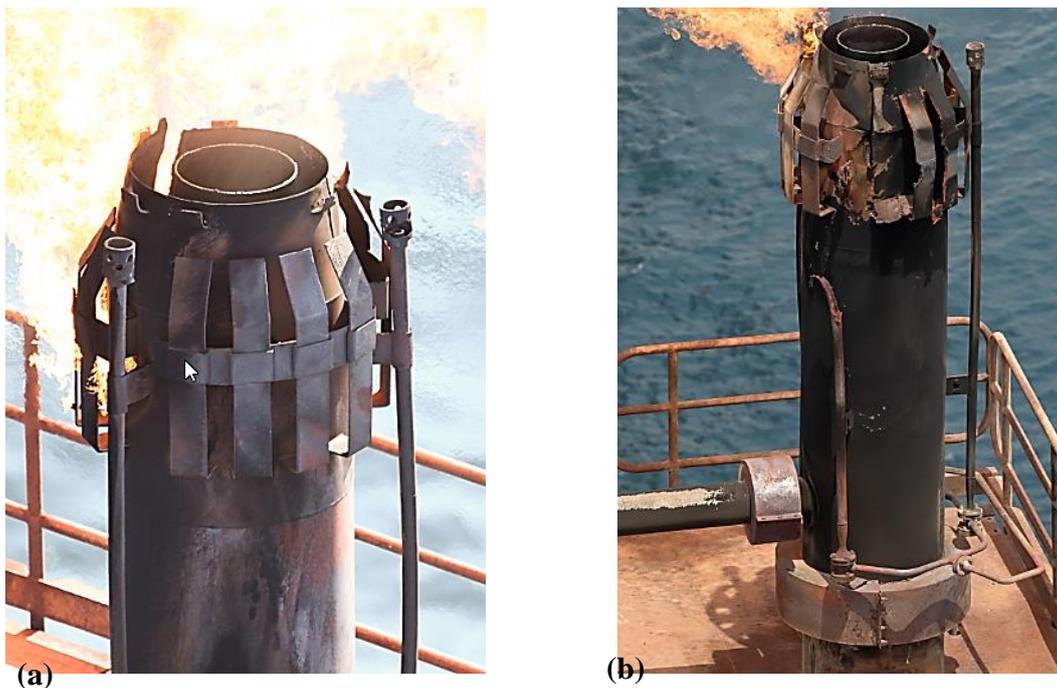
Figure 2. The investigated Gas flare Tip (a) Gas fare tip (b) Gas flare tip with immature failure.

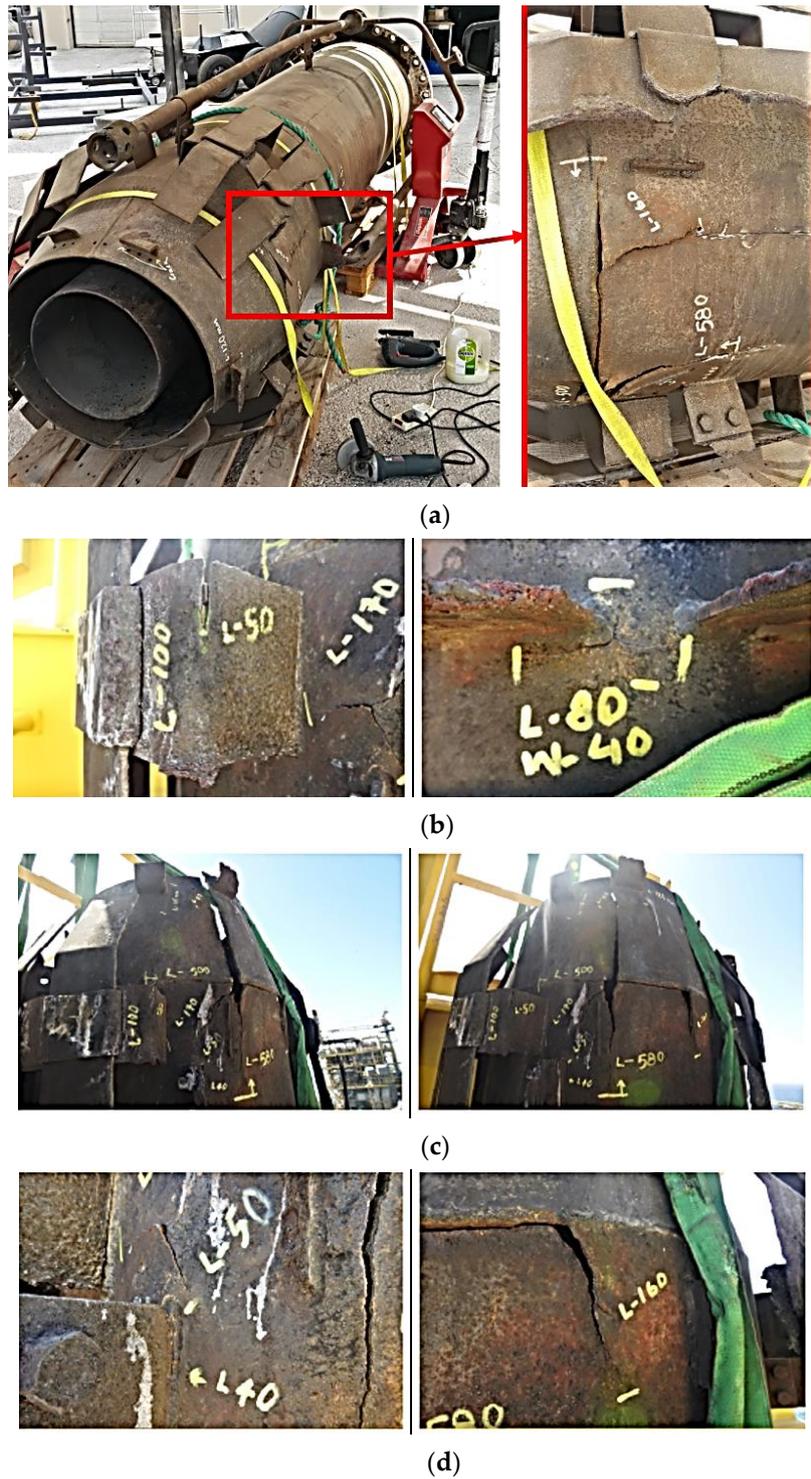
**Figure 3.** Failure regions of the different components of the flare in the vicinity of the welding region. (a) The cracks location. (b) Crack at wind deflector and crack on upper flare body near degraded wind deflector. (c) Crack at conical flare body. (d) Zoomed crack at conical flare body.

Moreover, the failure region in the parts mentioned above is located in the vicinity of the welding regions, probably the heat-affected zone (HAZ). Since the material for the upper body and wind deflector are Incoloy 800H, two different samples were extracted from the flare for the failure analysis, i.e., one close to the failure and the other quite far from the failure. This was done to truthfully compare the mechanical properties of the material near and far from a failure, i.e., the consequence of the failure

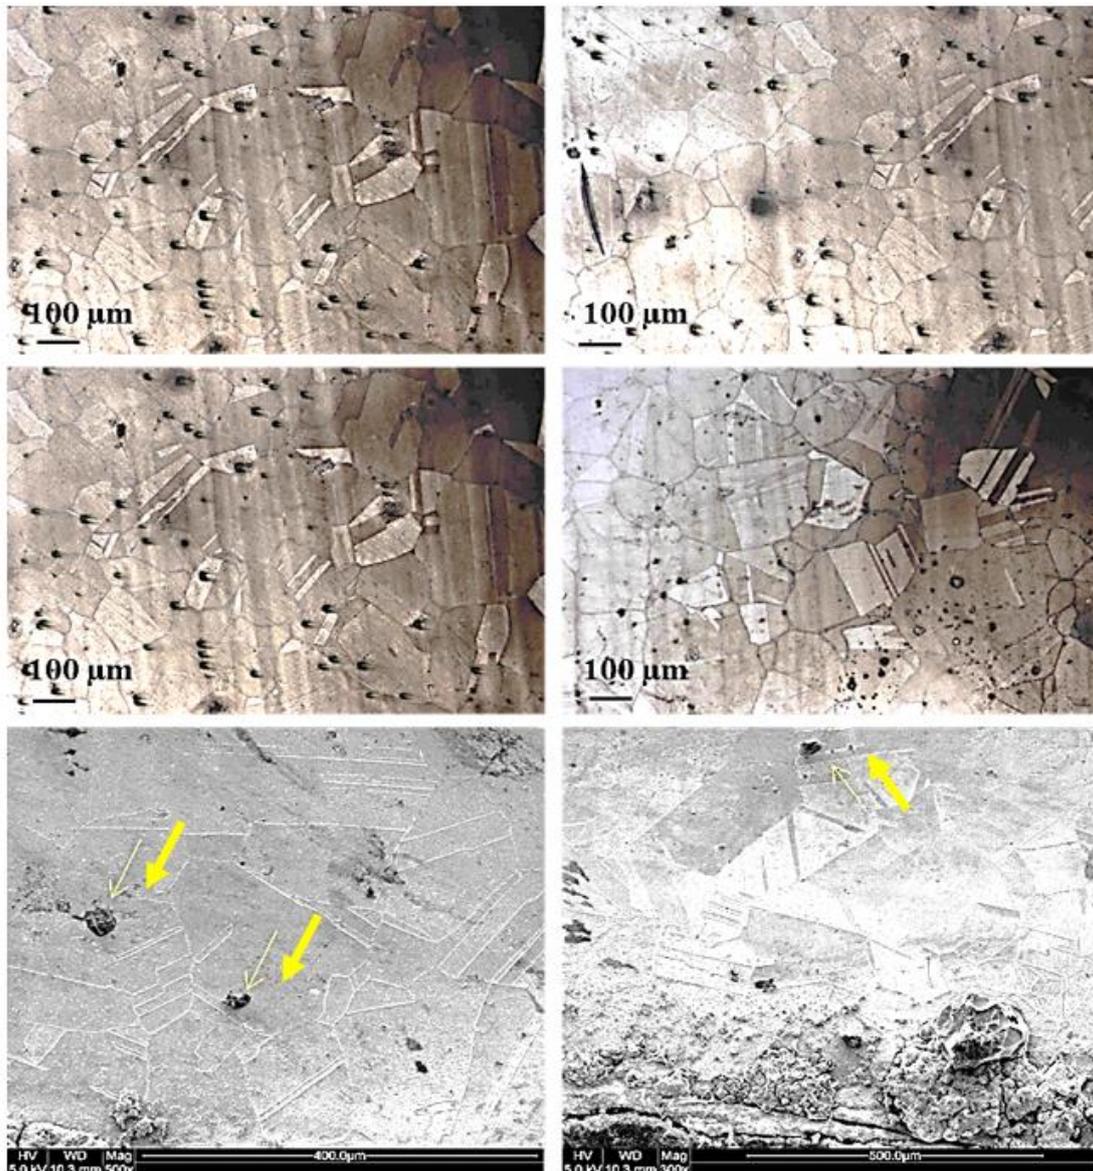
Figure 6 presents the microstructure of the Incoloy 800H. From the grain size and the twinning systems, the material used for the flare upper body and wind deflector can be proved to be Incoloy 800H. The average grain size of 100  $\mu\text{m}$  can be seen using the mean linear intercept methods. The microstructure of the material contains mainly the austenitic phase, i.e., Fe–Cr–Ni, which again demonstrates that material use is correctly Incoloy 800H. In addition, as can be seen from the SEM image highlighted by yellow arrows, the presence of precipitates is also common in the microstructure where the rich elements in the precipitates are Ti, N and C using EDS analysis. It can be concluded that the possible irregular precipitates dispersed in the microstructure are TiC.

**Figure 6.** The microstructure of Incoloy 800H, the yellow arrows show the twinning system as well as the presence of precipitates.

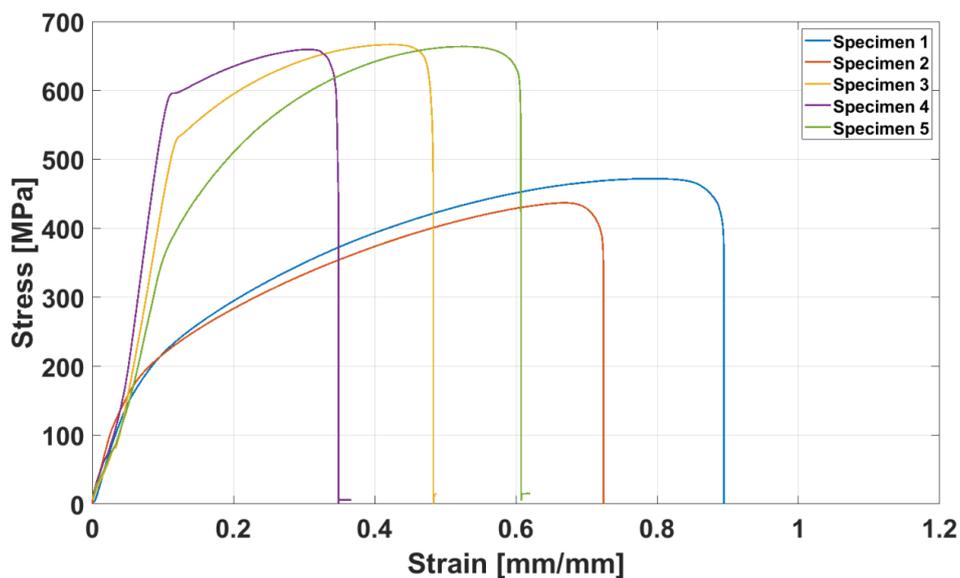
**Figure 8.** Tensile stress–strain curves.

Specimens 3 to 5 represent the tensile behavior of the materials far from the failure, whereas specimens 1 to 2 demonstrate the tensile strength of the samples extracted near the failure. From Figure 8, it can be concluded that the Ultimate Tensile Strength (UTS) of the latter, i.e., the materials near the failure parts, substantially decrease, with up to 44% reduction in UTS. Moreover, the yielding strength also shows a significant reduction from almost 600 MPa to 200 MPa for the area far from the cracks and the area near the cracks, respectively. On the other hand, the materials selected close to the failure shows more significant elongation for the one extracted far from the failure, though both samples were cut from the sample plate. This clearly indicates that the mechanical properties of the material dramatically reduced in the vicinity of the failure as a consequence of the failure.

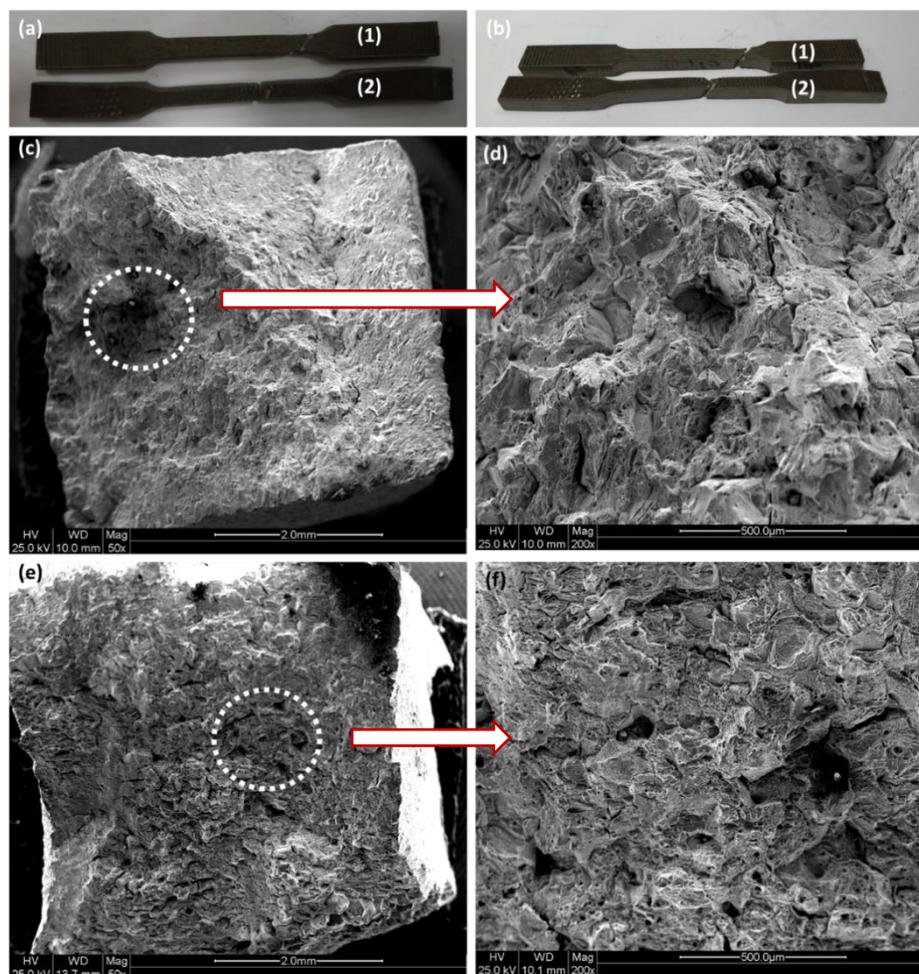
**Figure 9.** Fracture surface morphology: (a,b) Macroscopic images for specimens 1 and 2, respectively; (c,d) SEM images for specimen 1; (e,f) SEM images for specimen 2.

Specimens 1a,b and 2a,b represent the specimens far and near from the failure region, respectively. From the macroscopic image (Figure 9a,b), it is clear that the specimen near the failure (i.e., specimens 2a,b) manifest more considerable extension, i.e., higher elongation compared with the specimen taken far from the failure, i.e., specimen 1a,b. This again indicates the detrimental impacts of failure on the degradation of mechanical properties. In addition, as shown in Figure 9b, fracture took place at  $45^\circ$ , demonstrating the activation of the slip mechanism, which is again a typical fracture mechanism for a ductile material. Thus, the shear stress accounts for final failure for both specimens. SEM images of the fracture surface for specimens 1 and 2 are shown in Figure 9c–f, respectively. The white dashed circles represent the region where a higher magnification image was

taken. The fracture surface of both specimens presents a typical fracture pattern of ductile materials where dimple morphology can be identified, i.e., a large amount of plastic deformation can be seen for both specimens. This can also be proved by the formation of microvoids along the fracture surface. The presence of inclusion accounts for void nucleation, as can be seen by some inclusion at the bottom of each dimple (Figure 9e,f). In addition, specimen 1 manifests higher surface roughness (Figure 9c,d) with respect to specimen 2 (Figure 9e,f), which can be attributed to the higher tensile strength of the former compared with the latter. A Brinell hardness test (HB) was also performed for both specimens to compare the consequence of failure on hardness properties. Specimens 1 and 2 represent the samples taken near the failure part, whereas specimens 3 and 4 extracted far from the failure region. Similar to tensile test results, the hardness of the area in the vicinity of the failure is smaller than the area far from it, as shown in Figure 10. The average hardness for the specimen close to the failure region is approximately 60 HNB, while the average microhardness for the specimen collected far from the failure region is 85 HNB, i.e., the microhardness dropped to 41%. This finding again clearly indicates that the base material used for the upper flare body, as well as wind deflector (Incoloy 800H), loses its mechanical properties during flare operation.

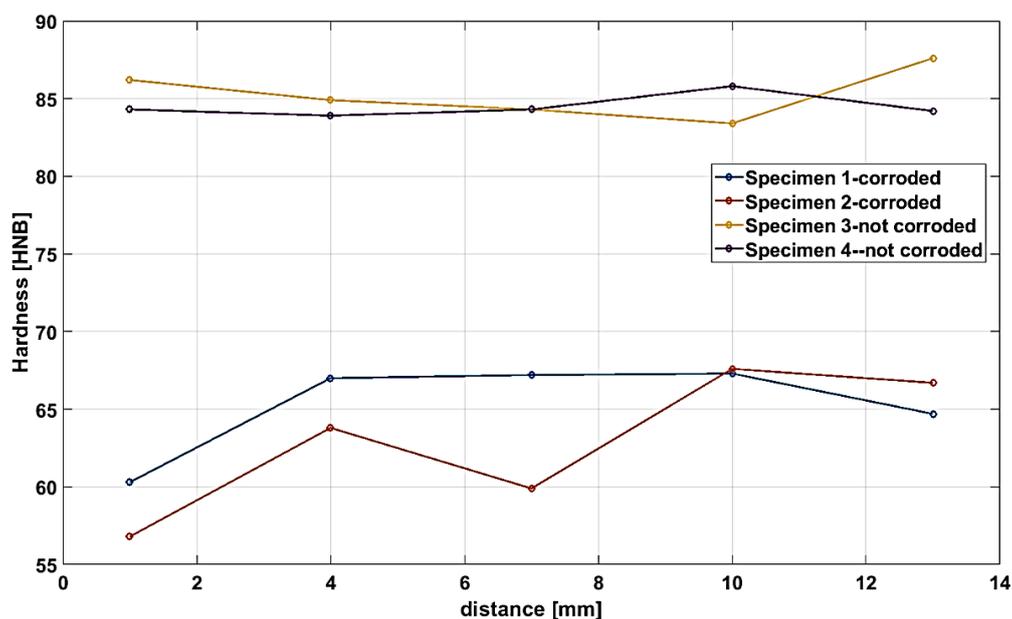
Figure 10. Microhardness of the specimens close and far from the failure region.

As discussed in the previous section, tensile strength and microhardness of the samples in the vicinity of the failure region substantially decreased, whereas the mechanical properties of the specimen cut far from the failure region demonstrated no change, i.e., showed the same mechanical properties like the primary material. As mentioned before, the failure mostly took place in the vicinity of the welding region for the flare upper body part and wind deflector, which were made of Incoloy 800H (Figure 3). This means that the welding procedure performed to join the parts might affect the mechanical properties, in particular, the presence of Heat Affected Zone (HAZ), which is the weakest region in welded structures [29]. Not only the welding procedure but also the improper design for welding joints, especially for joint as well as using a highly professional welder, might be other reasons for the failure that occurred in the vicinity of the welded areas. Another important fact that can be detected after the initial examination of the whole flare structure is that the failure mostly took place in the upper part of the flare body, whereas the lower part showed no failure. It is worth noting that the flare upper body parts are mainly made of Incoloy 800H, whilst the lower body part is made of SS316 (Table 1). This clearly indicates that, due to the harsh service condition of the flare, including

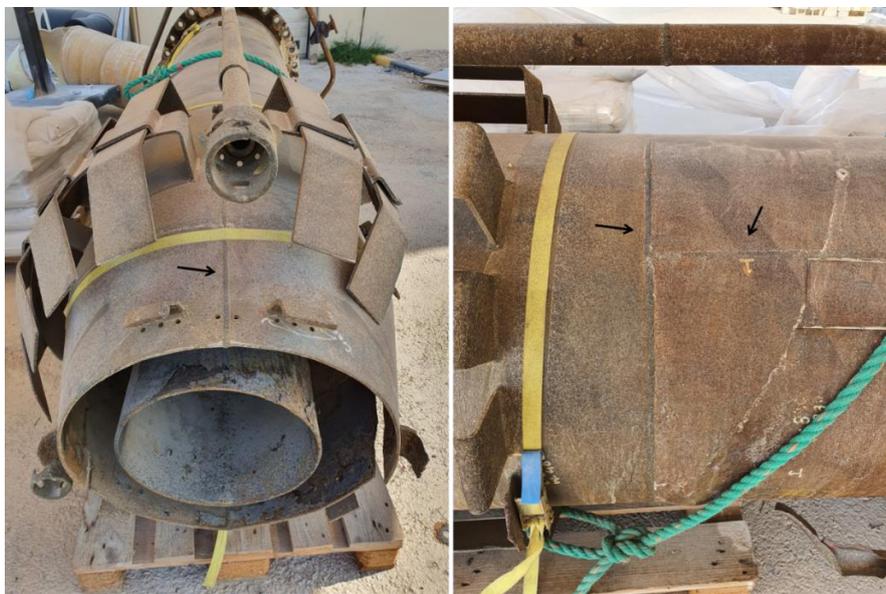
**Figure 11.** Longitudinal and circumferential welding line in the flare body part.

Thus, the welding performed to join the rolled Incoloy 800H plates to make them into cylindrical shapes was well done in terms of an appropriate welder, welding fillers and the proper welding procedure such as the number of welding paths, and possible heat treatment upon welding. On the other hand, many failure clues can be found mainly in the vicinity of the joint, as shown in Figure 12. This clearly indicates that the joint's design is detrimental in terms of mechanical properties. The most critical place that failure took place is shown by black arrows in Figure 12a,b. As can be seen, the three joints were designed in a tiny area. This improper design caused the weakness of HAZ for all three joints accumulated in a tiny area. This can also be approved by the crack nucleation started in the vicinity of the joints for all three joints, i.e., it begun from the HAZ, which manifested the lowest mechanical properties for all welded materials. A combination effect of this HAZ along with the severe service condition of the flare itself, i.e., high temperature in the range of 700 °C as well as high humidity, worsens the failure scenario. Thus, the initiated cracks propagate gradually (white dashed lines) during flare service until they merge, followed by final catastrophic failure. Moreover, the conic shape of the flare that was composed of a circumference welding to join the conic part to the cylindrical part (See Figure 11) is another reason that intensifies failure due to the stress concentration resulting from the conic shape of the flare. It is worth noting that the conic shape itself is not a concern; however, when the joint is placed in the vicinity of it, it will act as a suitable place for stress concentration resulting in final failure. As shown in Figure 12c,h, the presence of minor failure in other parts of the flare is

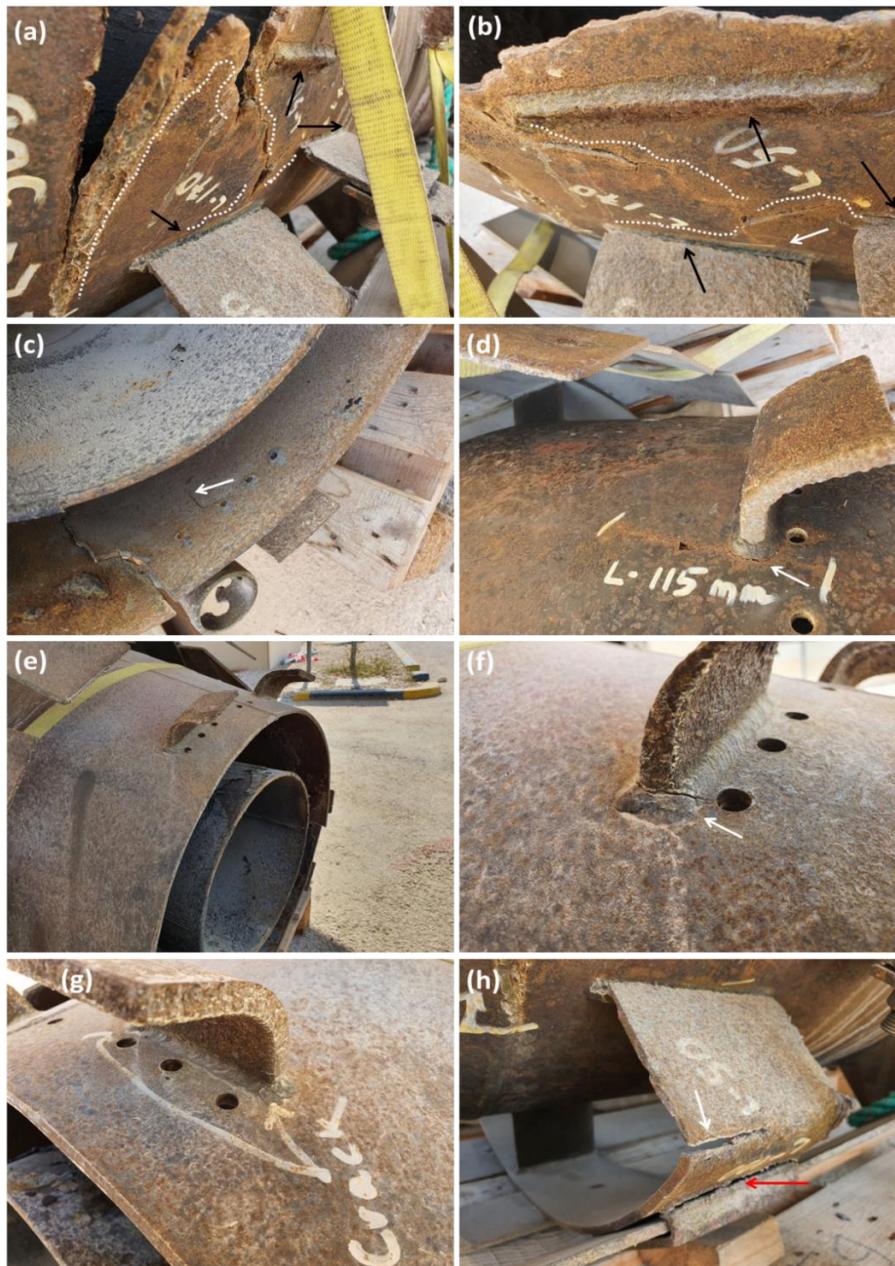
noticeable, mostly near the joints, as well as the holes in their vicinity. This observation can be seen in Figure 12f when the crack started from the joints and grew toward the holes. In this case, it seems that the quality of weld performed by the welder is not good. Thus the crack is initiated at the HAZ. Another minor failure that took place for the flare is related to the joint between the pockets and flare body (to hold the wind deflector) where a single joint was used for the connection. This improper design results in failure for most of the joints used for pocket [30].

**Figure 12.** A detailed study of the root cause of the failure region in the vicinity of the joints (a–c,f,h) The most critical sections that failure took place (d,g) welding at the vicinity of holes (e) the upper part of the flare tip.

1. The configuration of the joints should be optimized in a way to reduce the harmful effect of HAZ.
2. In addition, the number of joints should also be reduced due to the fact that they connect to the flare boy using a joint.
3. Moreover, the blind designs for the joints used for pockets should be improved, i.e., at least a two-sides joint should be performed. Herein, finite element analysis will be very useful to avoid the inappropriate design of the joints.
