# Preliminary Studies of the Durability of Tools Used to Form Ceramic Tiles Made of Hardox 600 and NC11LV Steel

**Abstract:** The study performs a comparative analysis of the wear of tools made of two wear-resistant materials: steel Hardox 600 and NC11LV, used in the process of forming a band for roofing tiles. The analyses were to allow the assessment of the possibility of replacing the standard material for tools in this process with a much less expensive tool steel for cold work after heat treatment (with a large number of carbides), as an alternative material dedicated to tools resistant to intense abrasive wear. The performed investigations included a macroscopic and geometrical analysis with the use of 3D scanning, microstructural analyses conducted by means of a light microscope, as well as an analysis of the topography of the working areas of the tools with the use of SEM, and microhardness tests. The obtained results demonstrate that the tools made of both materials were characterized with a similar level of wear, which, in the most critical area, reached over 4 mm, while the tools made of steel NC11LV worked over a much longer period of time without regeneration, equalin

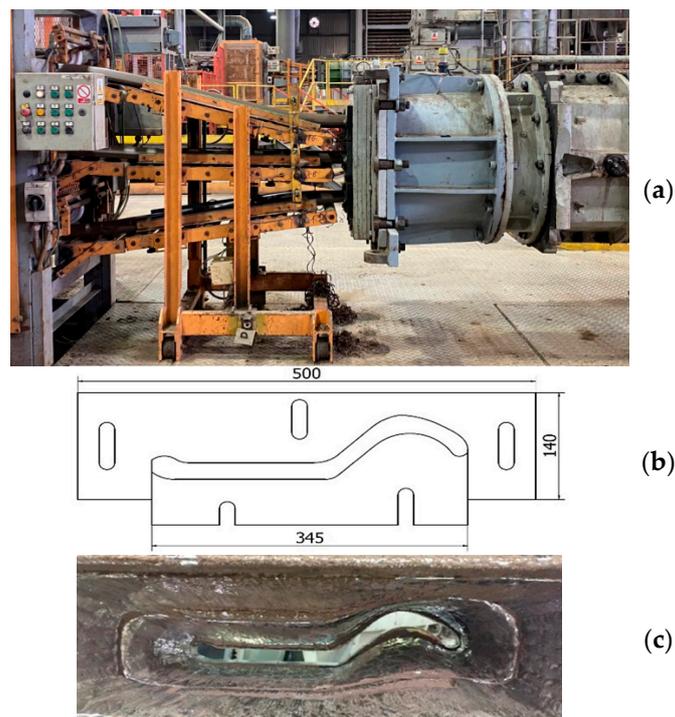
**Figure 2.** The process of extruding the clay band onto the ceramic tiles: (a) main view of the machines; (b) CAD drawing of a single set of tools with approximate dimensions; (c) photo of the worn chamber (mouthpiece).

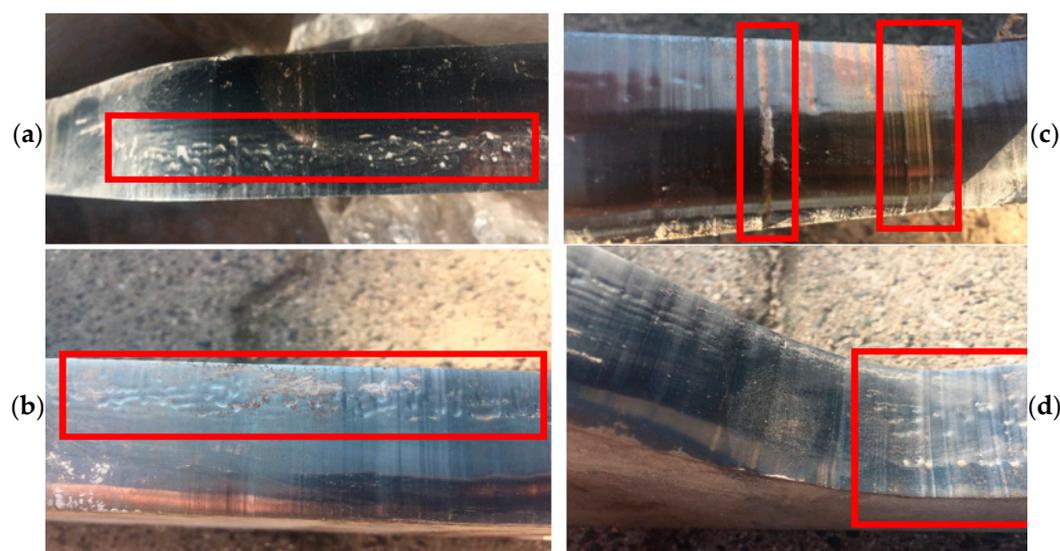
The macroscopic analysis (Figure 4) of the tools made of both materials demonstrated that their wear was similar. Numerous scratches were observed both in the direction of the extruded band (Figure 4b) and in the perpendicular direction (Figure 4c), as well as traces of imprints (Figure 4a) and cavities resembling plastic deformations (Figure 4d). The photographs presented above coming from the macroscopic analysis of the selected tools made of both materials show typical defects observed in the process of clay band extrusion.

**Figure 4.** Macroscopic analysis of selected inserts forming the clay band: (a) visible traces of imprints; (b) scratches and cracks; (c) perpendicular scratches; (d) plastic deformations.

They result from the difficult operation conditions, as such a band often contains hard particles, whose presence is a result of adding milled remains of burnt-out tiles, being one of the components, into each charge assigned for the band extrusion. An effect of the operation of the abrasion grains is the formation of scratches on the inner surface of the insert. The formed scratches can be reflected on the surface of the clay band, which can constitute a significant defect of the ready product. In the case of the presence of deep scratches on the inner surface of the inserts, it is necessary to grind them, so that they can be further applied.

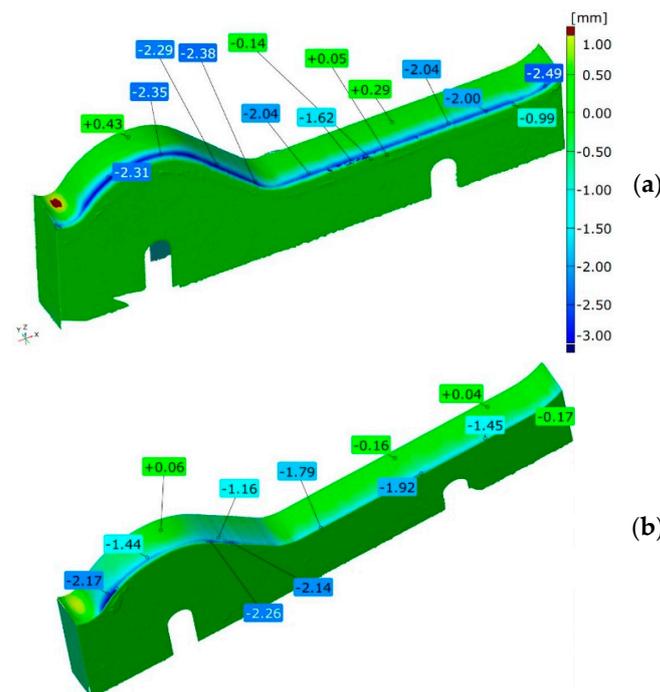
The following stage of the research was a geometrical wear analysis of the inserts based on 3D scanning. Figure 5 shows the results of scanning the lower inserts made of both materials. In the analysis of the obtained results for the lower insert made of Hardox 600 steel (Figure 5a), we can state that, in the case of the lower part of the insert, the biggest loss of material, where the most intensive wear occurs, is present in the area responsible for the formation of the so-called wave. This can also be noticed in the case of the insert made of NC11LV steel (Figure 5b). In this area, for the insert made of Hardox, the wear reaches 2.31 mm. The biggest loss of material occurs along the whole edge on the side of the pug mill. In fact, on the whole length of this edge, the wear exceeds 2 mm, reaching the maximum of 2.49 mm. For the insert made of NC11LV steel, the wear mechanism is similar. In the remaining part of the insert, the highest wear is still visible on the edge, but it oscillates in the scope of 1.45 and 1.92 mm. The biggest loss of material for this tool reaches 2.26 mm.

Figure 5. Results of scanning the lower tools made of steel: (a) Hardox 600 and (b) NC11LV.

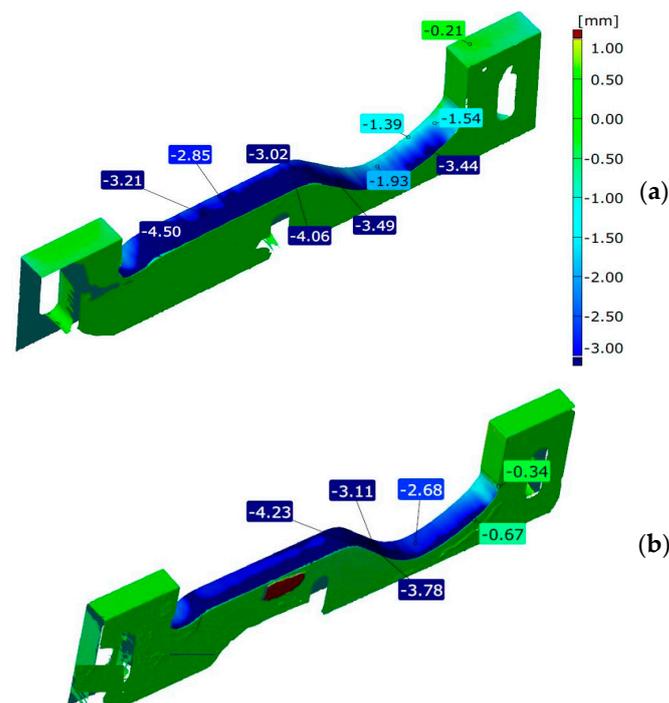
For the upper inserts (Figure 6), the wear reaches a much higher level than in the case of the lower ones. This is due to the fact that the upper inserts can be adjusted and lowered, if the appropriate, acceptable shape of the tool is maintained of course. The highest wear for the insert made of Hardox steel can be observed on the side of the die of the pug mill. The most intensively worn area is visible on the fragment where the shape of the insert transfers from the “wave” into a flat area. In this section, the wear throughout the whole thickness of the material exceeds 3 mm. The wear reaches its maximum towards the end of the plate fragment and equals about 4.5 mm.

Figure 6. Results of scanning the upper tools made of steel: (a) Hardox 600 and (b) NC11LV.

The wear of the upper insert made of NC11LV steel is also formed similarly to the insert analyzed before. Again, the highest loss of material is observed in the fragment shaping the flat part of the tile on the side of the pug mill. On this fragment, the wear varies between 2.7 and 4.3 mm.

2. On the performed 3D scans of the worn inserts, it is easy to observe that the inserts wear off non-uniformly. Regardless of the material, the upper part of the insert is characterized by a much higher degree of wear than the lower part. The cause of this non-uniform wear of the inserts is their construction as well as the system of mounting the inserts to the head of the pug mill. The vertical system in which the inserts are mounted on the press determines the regulation only with the upper insert. Therefore, the system should be modernized in such a way that it is possible to uniformly regulate both the upper and lower inserts.

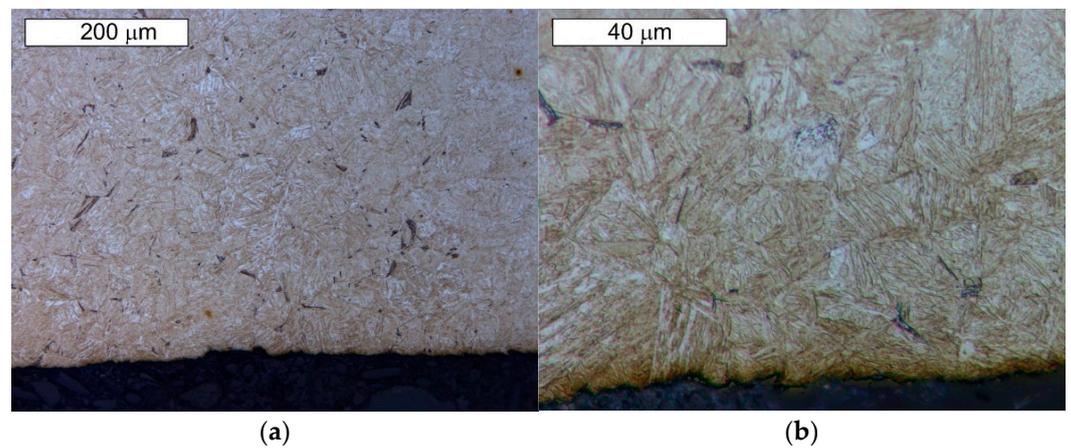
**Figure 9.** Material microstructure in the wear area on the cross-section of sample 1: (a) visible basically uniform surface fatigue; (b) magnified fragment of the area from Figure 9a. Light microscopy, etched state.

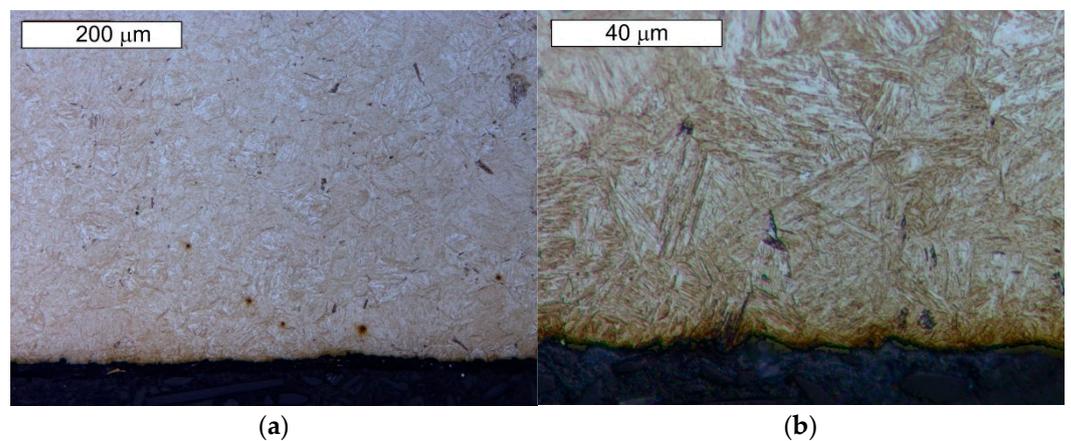
**Figure 10.** Material microstructure in the wear area on the cross-section of sample 2: (a) visible basically uniform surface fatigue; (b) magnified fragment of the area from Figure 10a. Light microscopy, etched state.

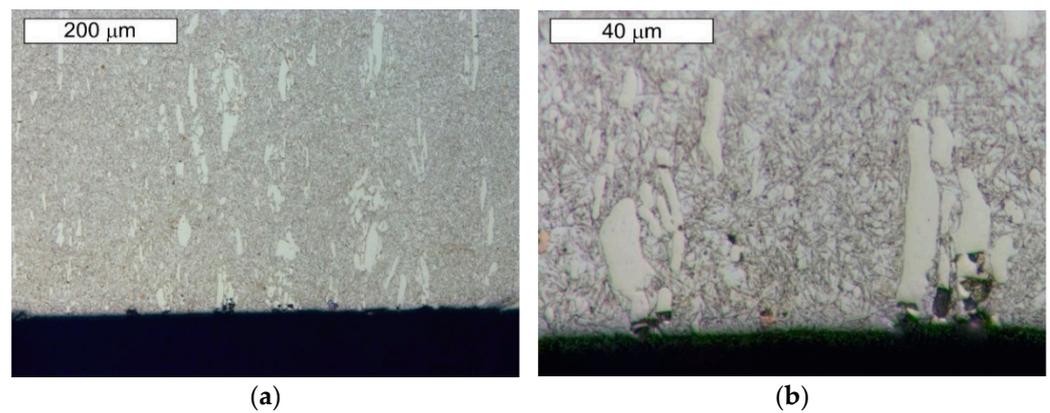
These steels, after quenching, undergo tempering at 180 °C, with the aim to obtain tempered martensite. During the tempering process, the needle-shape character of martensite becomes less profound, and, as a result of redistribution of the carbon atoms, fine, uniformly distributed secondary carbides precipitate, which, at this tempering stage, are coherent with the matrix. Secondary precipitation mainly occurs in the case of those carbides which dissolved during the austenitization. In the material microstructure, single orange nitride precipitations with irregular shapes were also observed (Figure 11b). Microscopic observations on the cross-sections were also performed on the edges subject to wear of both examined samples. No differences in the wear character of the edges of the samples collected from areas 1 and 2 were observed. In the microscopic area, the formation of small spallings in the primary carbide precipitation areas was recorded, yet they did not propagate into deeper material areas (Figures 14 and 15).

**Figure 14.** Material microstructure in the wear area of sample 1: (a) visible small spallings in the primary carbide area; (b) magnified fragment of the area from Figure 14a. Cross-section. Light microscopy, etched state.

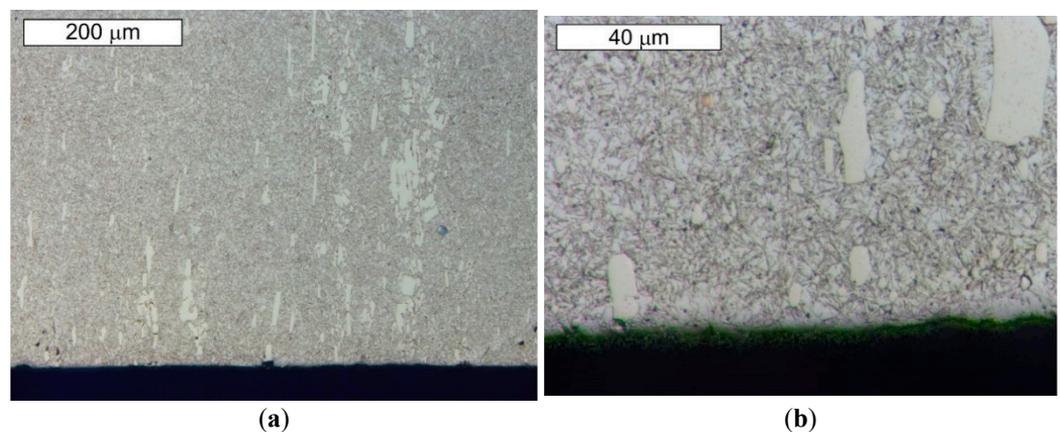
**Figure 15.** Material microstructure in the wear area of sample 2: (a) visible small spallings in the primary carbide area; (b) magnified fragment of the area from Figure 15a. Cross-section. Light microscopy, etched state.

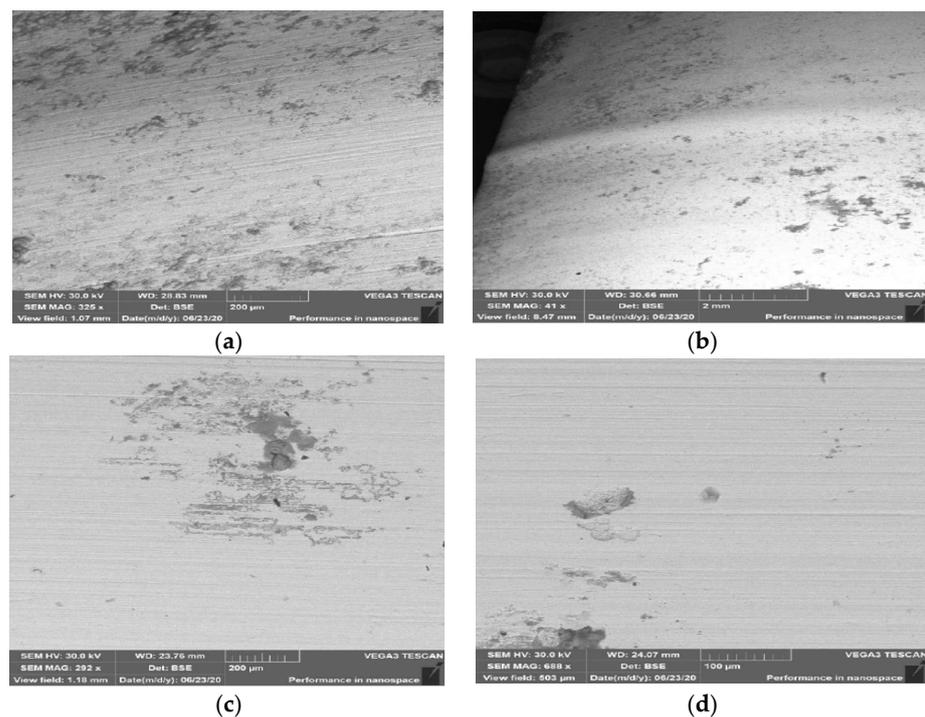
The examined samples underwent an analysis of the material's topography for both types of steel in order to reveal defects formed in the areas of contact between the tool and the band during its operation. Figure 16 shows the results of the surface topography tests for samples made of Hardox 600 steel. In the analysis of the topography images (Figure 16a,b) of the surface of the lower half of the insert made of Hardox 600 steel, we can observe numerous scratches. The scratches formed on the surface are the effect of abrasion wear. The direction of the scratches on the external surface of the insert is in accordance with the movement of the extruded band of the material. In turn, on the upper tool, we can see numerous linear surface scratches. Further, losses of material are visible. The presence of this defect can be caused by the pulling out of the material's surface layer as a result of structure disarrangement by the hard fractions of the processed mass. Of course, leaving such defects on the working surface of the insert can result in the presence of defects on the surface of the manufactured band, which can then become critical for the ready product.

**Figure 16.** Surface topography of samples made of Hardox 600 steel: (a) external surface for sample from area 1; (b) core for sample from area 1, for lower tool; (c) external surface for sample from area 2; (d) core for sample from area 2, for lower tool. SEM.

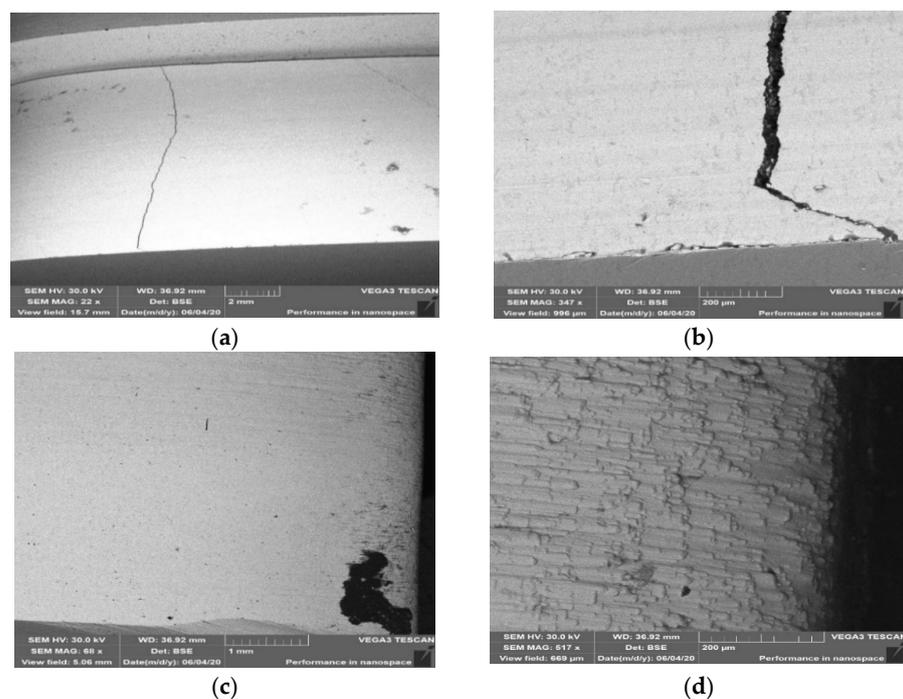
For samples made of NC11LV taken from area 1 shown in Figure 1, in the lower half of the insert, we can observe cracking of the material (Figure 17a,b), as well as point traces of indentations and growths on the surface (Figure 17c). The cracking occurred parallel to the edge shaping the clay band in the surface layer.

**Figure 17.** Topography of the surface for samples made of steel NC11LV: (a) external surface for sample from area 1; (b) core for sample from area 1, for lower tool; (c) external surface for sample from area 2; (d) core for sample from area 2, for lower tool. SEM.

The formed cracks on the surface of this material were probably caused by the effect of hardening, which resulted in increased hardness as well as brittleness of the surface layer. Further operation of the insert with such a defect can lead to the propagation of cracks or spalling of the material as a result of contact with the harder fractions present in the treated mass and a rapid acceleration of wear. On the edge onto which the treated material presses during the machine’s operation, we can observe plastic deformation (Figure 17c). The phenomenon of plastic deformation of the abraded material did not occur on the lower half of the insert, where the material’s abrasion mechanism is mainly based on ridging and micromachining. On a sample collected from area 2 from the upper half of the insert (Figure 4d), we can notice the material’s wear as a result of the operation of an abrasant in the form of mass used to manufacture the ceramic tiles. Such defects revealed at too high a degree are connected with the necessity to regenerate such a tool in order to enable its further operation.
