Modeling and Optimization of the Drinking Water Supply Network—A System Case Study from the Czech Republic

Abstract: In this study, we investigated the modelling and optimization of drinking water supply system reliability in the village of Zaben, Czech Republic. An in depth overview of the water supply network in the municipality, passport processing and accident and malfunction recording is provided based on data provided by the owner and operator of the water mains as well as the data collected by our own field survey. Using the data processed from accident and failure reports in addition to water main documentation, the water supply network in Zaben was evaluated according to the failure modes and effects analysis methods. Subsequently, individual water supply lines were classified based on their structural condition. In addition, a proposed plan for financing the reconstruction of the water supply mains in Zaben was created. As such, this study provides an overall assessment of the water supply network in Zaben alongside a proposed plan for the structural restoration of the water supply system, which accounts for the theoretical service life of the system and the financial re

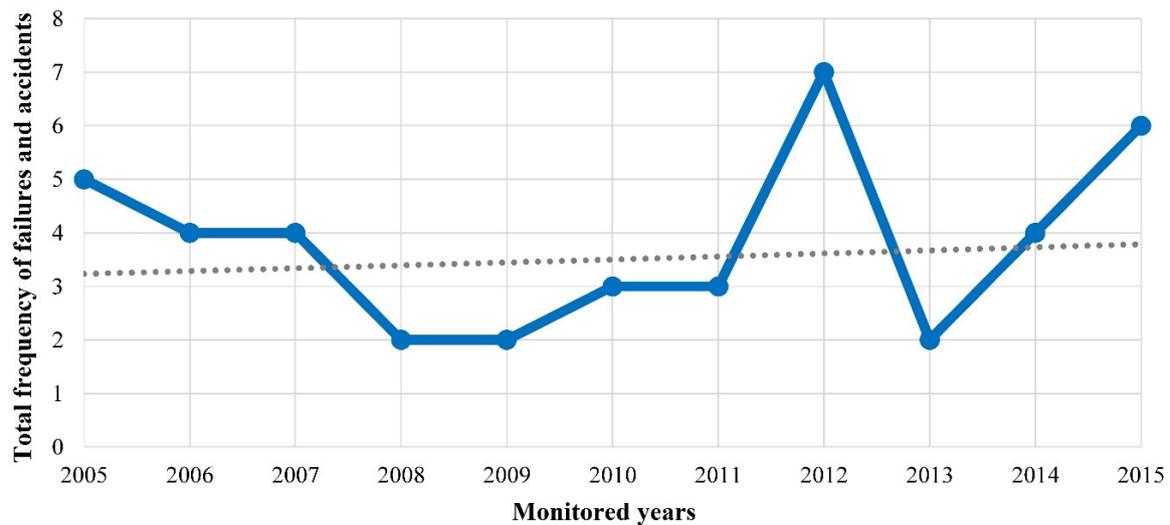
We also investigated the frequency of system failures by year from 2005–2015. These data are presented in Figure 3. There was a maximum of seven failures in 2012, which was due in part to the extensive reconstruction and completion of the village gas pipeline. Three defects in the water pipeline were caused by mechanical damage during gas line construction. We also evaluated the trend in the frequency of failures and accidents on water mains over time and observed a small but steady increase in frequency. This trend line is also shown in Figure 3.

Figure 3. History of the number of failures and accidents in the water supply system during the monitored period from 2005 to 2015.

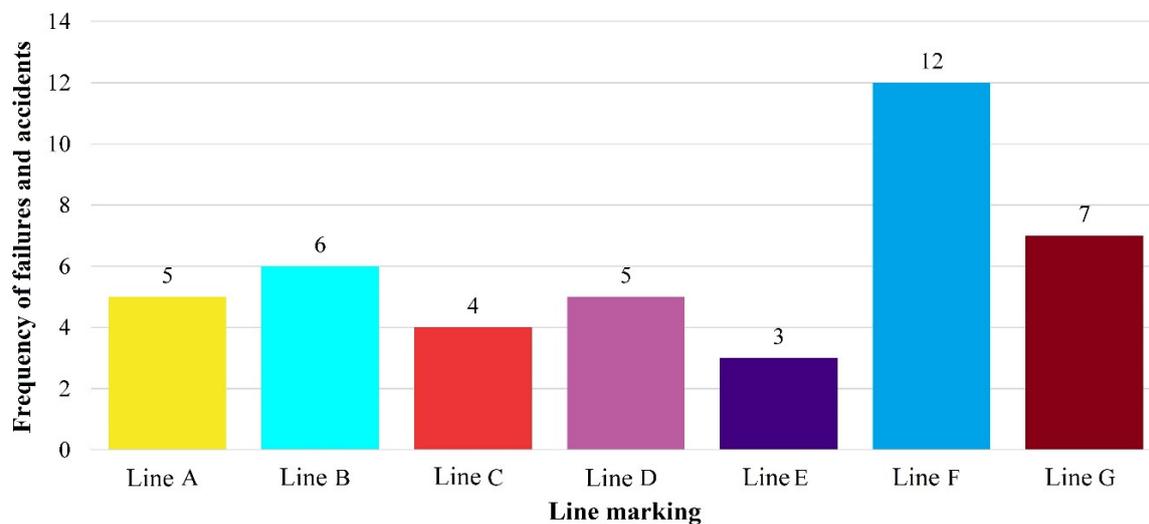
Figure 4 shows the frequency of failures and accidents in relation to individual water lines for the period from 2005 to 2015. There were 42 failures and accidents in the water supply network in the monitored period, which were not distributed equally between the water lines. In particular, Line F had the most failures with 12 events in the monitored period, while Line E had the fewest failures, with 3 events in the monitored period.

Figure 4. Frequency of failures and accidents in individual water lines for the period from 2005 to 2015.

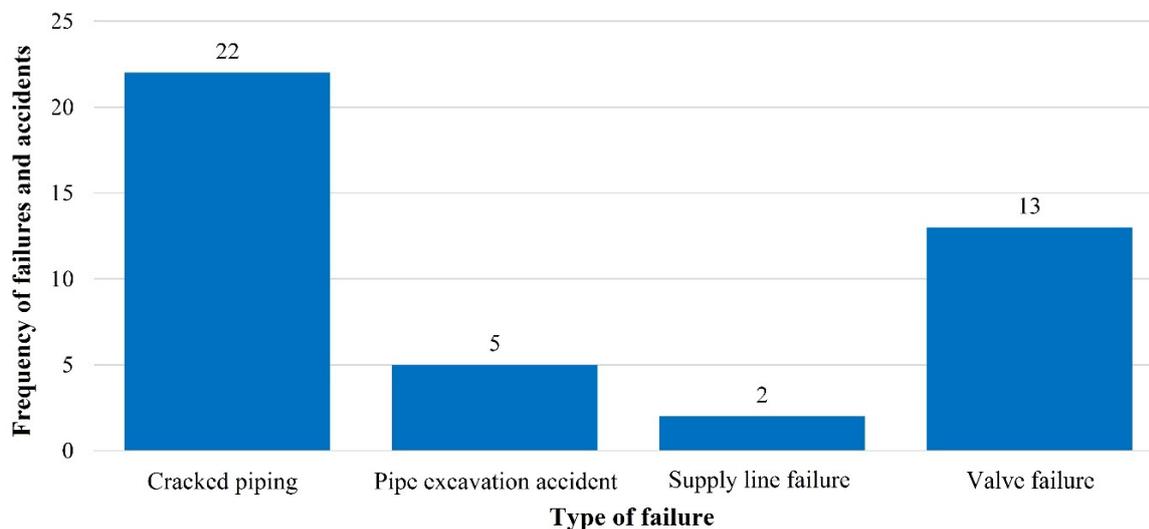
From Figure 5, it is evident that the most common cause of a malfunction or emergency was a cracked pipe ($n = 22$ cases). The cracked pipe category includes any disturbance of the line elements, and are a significant source of water loss in the network. It can be further assumed that across the network there are also other minor water leaks. From the list of failures in the monitored period, it was noted that many faults were repaired by replacing the pipe material for long (>10 m) sections of the pipeline. However, these changes were not reflected in the project documentation provided by the operator and thus, were not reflected in the data on the age of the pipe material or the list of components in the water supply network. It follows that these structural changes are addressed by a

reactive maintenance approach, so the problem is eliminated only after a failure occurs. According to the Civil Engineering Act No. 183/2006 Coll., as amended, this does not require any administrative construction proceedings, so the operator can improvise and carry out such repair even with no project documentation [27,28].

Figure 5. Frequency of failures and accidents in the water line according to the type of faults for the period 2005 to 2015.
