Evaluation of the Effectiveness of Trail Repair Works Based on Three-Dimensional Monitoring around Mount Kurodake, Daisetsuzan National Park, Japan

Yusuke Kobayashi ¹ and Teiji Watanabe ^{2,*}

Citation: Kobayashi, Y.; Watanabe, T. Evaluation of the Effectiveness of Trail Repair Works Based on Three-Dimensional Monitoring around Mount Kurodake, Daisetsuzan National Park, Japan. *Sustainability* **2023**, *15*, 12794. <https://doi.org/10.3390/su151712794>

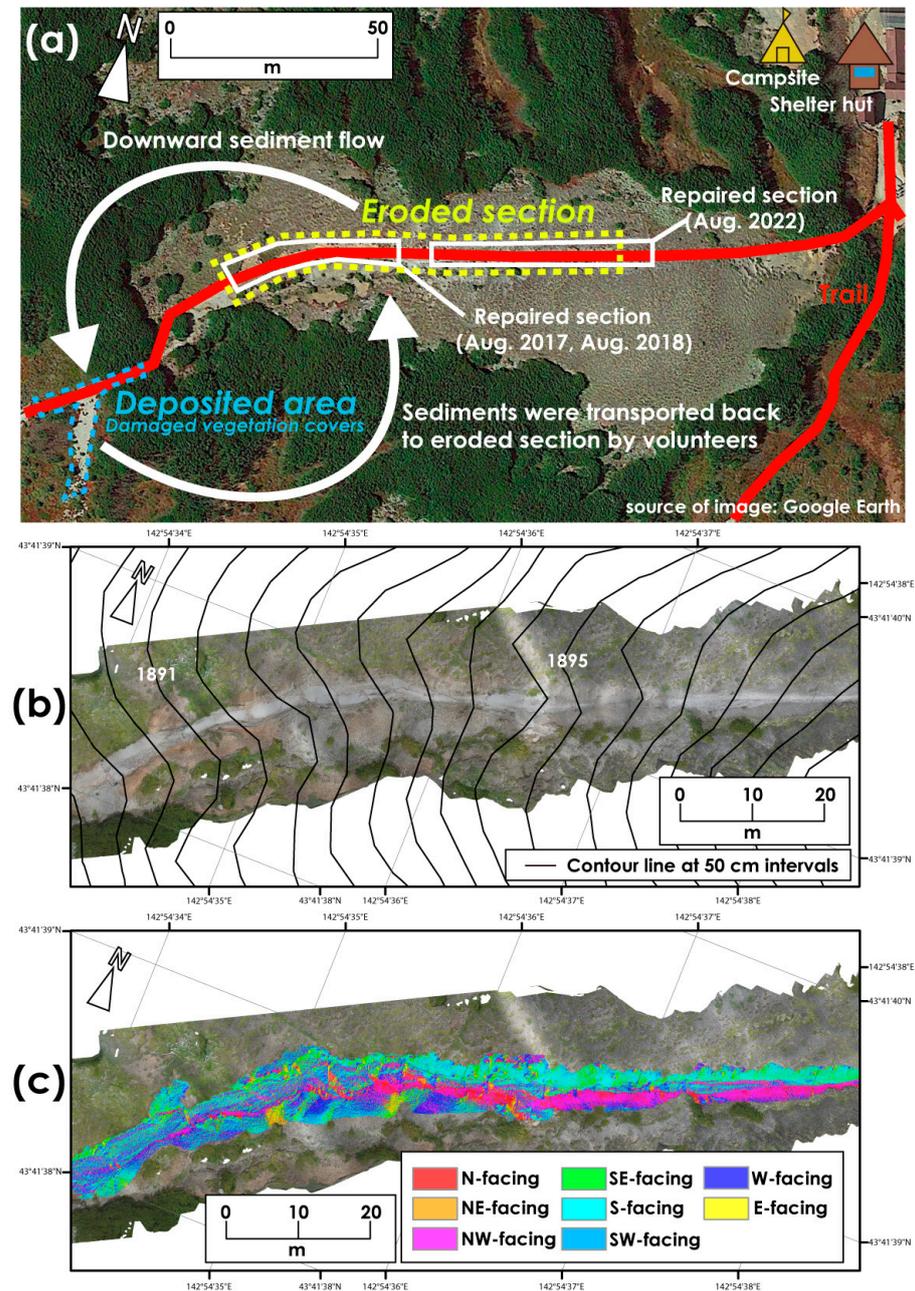
A black-and-white aerial photograph taken in 1986 shows trail erosion. Heavy rainfall occurred during typhoons in August 2016. As a result, the lateral slope of the trail collapsed, and the collapsed soil was washed away and deposited outside the trail in the lower section, which was covered by alpine vegetation (Figures 2a and 3).

Figure 2. Detailed topography of the study area: (a) distribution of erosion and deposition on the studied trail section and location of repair works; (b) orthophotograph with contour lines prepared using pole photography on 5 August 2022; and (c) slope distribution on and around the trail surface. To show the surrounding topography and location of the trail, contour lines in (b) were created with a 10 m resolution DEM provided by the Geospatial Information Authority of Japan. Therefore, detailed erosion of the trail is not represented.

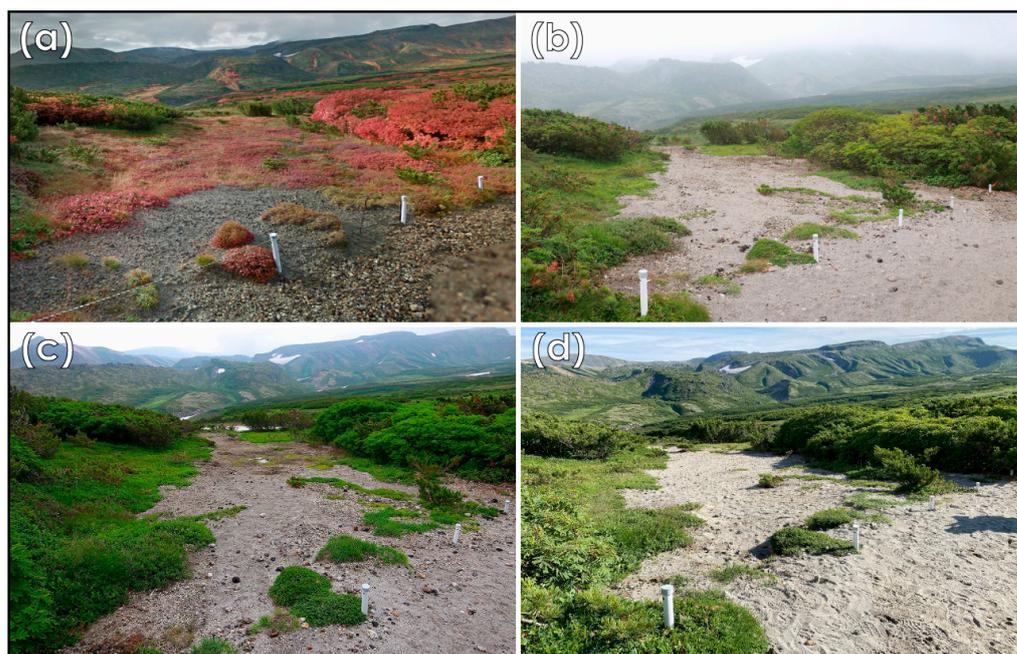
Figure 3. Deposition history of eroded soil flow on off-trail vegetation cover: (a) September 2014 (from Google Street view); (b) August 2018 (provided by *Yamamoritai*); (c) July 2019 (provided by *Yamamoritai*); and (d) August 2022 (provided by *Yamamoritai*).

The eroded soil flowed 50–60 m downward and covered the alpine vegetation, as previously stated (Figures 2 and 3). The first repair in 2017 involved removing the sediment from the deposited area (Figures 2a and 6a) and transporting it back to the eroded section (Figures 2a and 6b). The volunteers were briefed by a technical specialist belonging to *Yamamoritai* before work began. The technical specialist not only explained the workflow, but also explained why serious erosion occurred in Daisetsuzan National Park. The technical specialists emphasized the importance of observing the volunteers. The volunteers were divided into three teams based on their roles. The first team packed the sediment into palm-fiber bags (Figure 6a). Attention was paid to the alpine vegetation buried by the sediment flowing from the upper section of the trail and not to include the vegetation under the sediment in the palm-fiber bags. The second team transported the palm bags filled with soil to the upper section (Figure 6b), and the third team placed the soil-filled palm-fiber bags in the upper section (Figure 5). Volunteers from the trailhead carried out the palm-fiber bags used for the repairs. Palm-fiber bags are lightweight and easy to carry. Because the site is in the special protection zone of the national park (Figure 1a), as well as in the Daisetsuzan Grade 3 section, only the minimum necessary repairs were performed to protect the pristine natural landscape. Therefore, no materials from the outside were used, except for the natural palm-fiber bags.

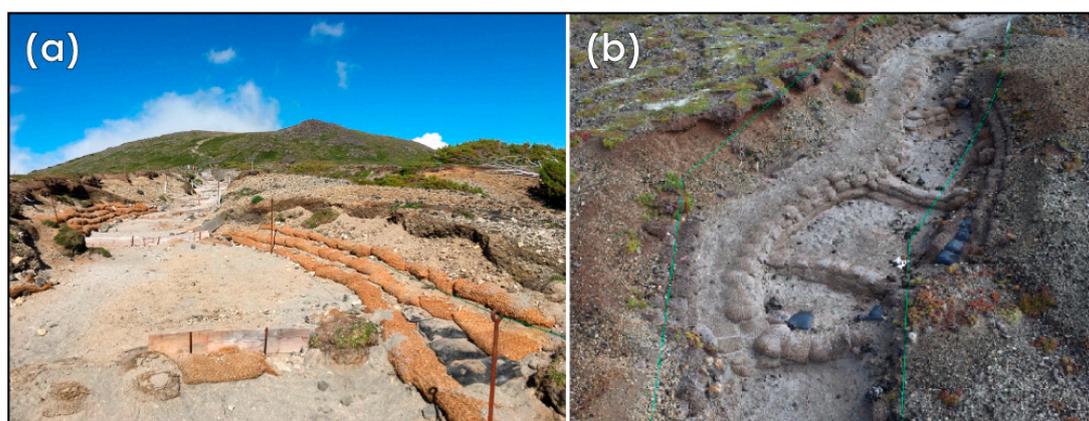
Figure 5. Soil-retaining structures for two purposes: (a) soil-filled palm-fiber bags on lateral slopes in 2017; and (b) soil-filled palm-fiber bags on tread surfaces in 2018. Note that the palm-fiber bags along with the wood steps were used on the tread surface in (a), but the wood steps were removed, as shown in (b).

There were two main methods of repair applied to the trail sections: (1) soil-filled palm-fiber bags and (2) wood steps. The soil-filled palm-fiber bags were installed for two purposes: (1) to prevent the soil from being washed away by surface water from the lateral slopes (Figure 5a), and (2) to hold soil so as not to prevent galley erosion on the tread surface (Figure 5b). The first purpose of the installation was to minimize further lateral erosion, that is, trail widening. The second purpose was to minimize the vertical erosion of the tread. For this purpose, existing wood steps were also utilized at some sites along with soil-filled palm-fiber bags (see the center of Figure 5a). The total number of soil-filled palm-fiber bags used was 300 in 2017 and 218 in 2018. In addition, some bags were cut to make mats, which were placed on the base of the lateral slopes for a 60 m section in 2017 and a 47 m section in 2018.

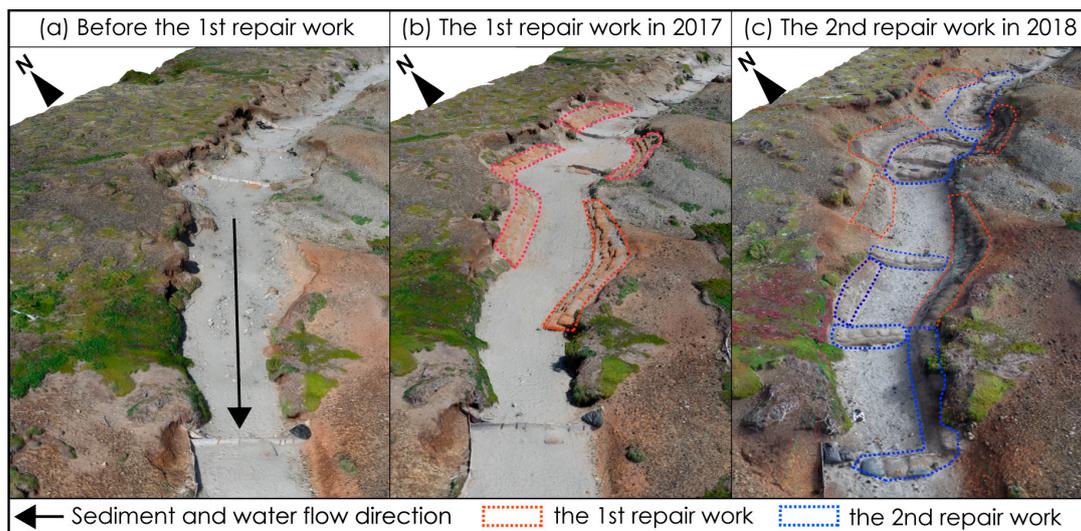
The lateral slopes of the trail collapsed owing to massive erosion caused by heavy rainfall in August 2016, the year before the first repair. Consequently, the slope degrees of both sides became nearly vertical and highly unstable (Figure 7a). Palm-fiber bags were placed on the base of the lateral slopes to hold the collapsed soil from the top of the lateral slopes (Figures 7b and 8a).

Figure 7. Trail surface (a) before the 1st repair work in 2017; (b) after the 1st repair work in 2017; and (c) after the 2nd repair work in 2018 (prepared using the UAV and pole-photography mappings).

The second repair work was performed in August 2018 (Figure 7c). More erosion occurred in the upper section than in the section repaired during the first repair, and the eroded sediment moved downward. Therefore, the installation of palm-fiber bags for lateral slope protection was expanded, and wood step structures were installed on the tread surface. Palm-fiber bags were used for five earth retentions (Figures 7c and 8b). Careful attention was paid to the height of the earth-retaining structure when installing it, as a large protrusion of the earth-retaining structure from the ground could lead to further vertical erosion owing to falling surface water. In addition, it was important to design the steps of the earth-retaining wall, because it is difficult for elderly hikers/trekkers to lift their legs high while walking.

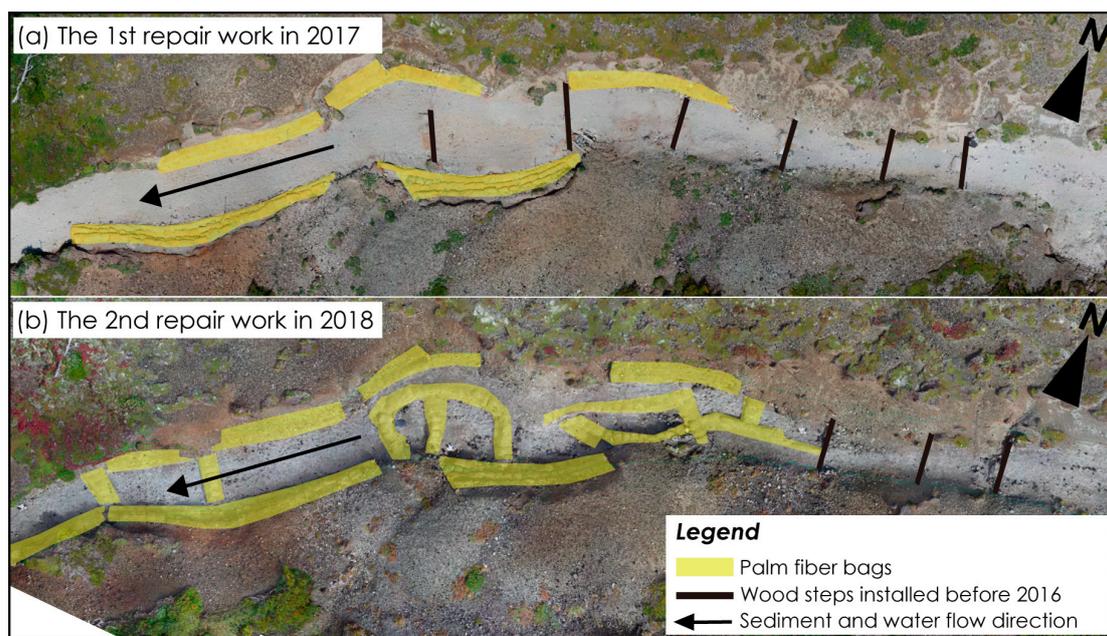
Figure 8. Trail surface (a) before the 1st repair work in 2017; and (b) after the 1st repair work in 2017 (prepared using the UAV and pole-photography mappings).

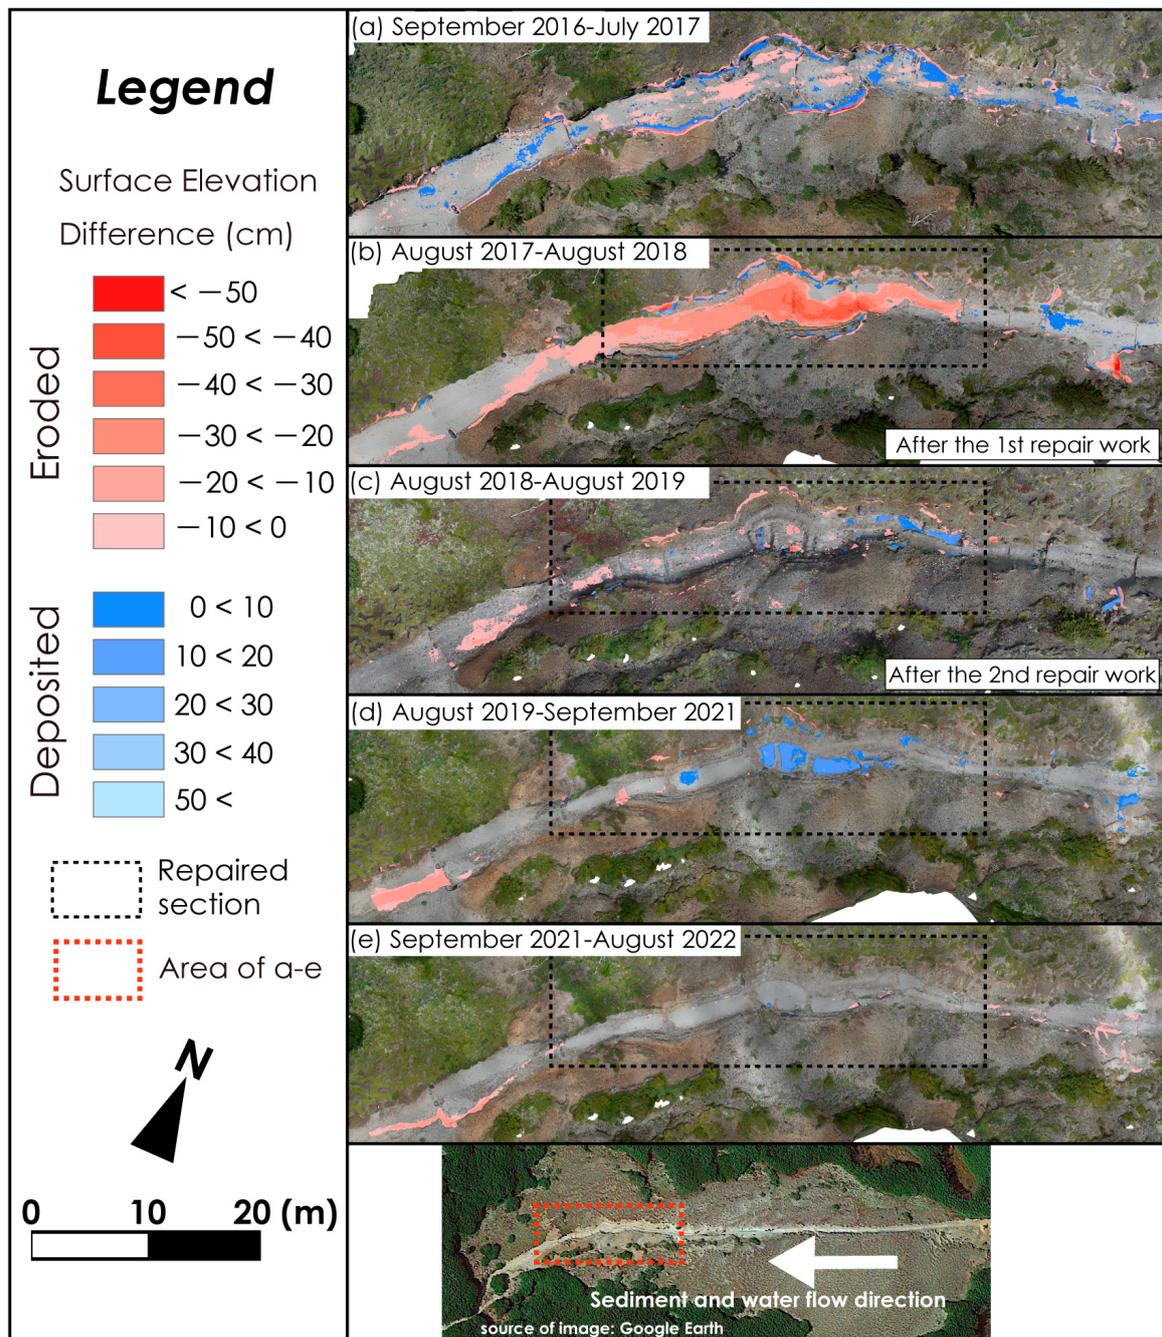
After heavy rainfall in August 2016, the changes from September 2016 to July 2017 showed the collapse of the lateral slopes of the trail and vertical erosion of the tread surface (Figure 9a). The collapsed sediment remained intact and was not transported downward. A slight but significant sediment discharge of $-0.83 \pm 1.02 \text{ m}^3$ was observed (Table 2).

Figure 9. The trail surface changed from 2016 to 2022 in the section repaired in August 2016 and August 2017. See Figure 2a for the location of the section.

Vertical erosion occurred at many sites between August 2017 and August 2018 (Figures 9b and 10b). Further collapses continued on the south-facing slopes of the trail; however, the collapsed soil mass was trapped by the soil-filled palm-fiber bags (Figures 9b and 11c–e). However, less collapse occurred on the north-facing lateral slope of the trail. Vertical erosion was observed across the entire trail tread. The red line in the profile in Figure 11c suggests 45 cm of vertical erosion, resulting in a large amount of sediment discharge, i.e., $-14.71 \pm 2.52 \text{ m}^3$. In addition, surface water damaged the soil-filled palm-fiber bags at the base of the lateral slopes. However, no lateral slope collapse was observed; therefore, no widening of the trail occurred.

From August 2019 to September 2021, deposition occurred at locations where earthen berms were installed. There was continued erosion on the south-facing slope of the trail; however, sediment was received by the soil-filled palm-fiber bags (Figure 9d). No significant erosion was observed in the upper segment.

From September 2021 to August 2022, some parts of the trail were eroded in the upper segment. No erosion or sedimentation was observed in the repaired segment (Figures 9e and 10e). However, erosion was noticeable in the upper section, and a sediment discharge of $-3.12 \pm 1.18 \text{ m}^3$ was observed.

More changes were observed in the upper part of the lateral slopes on the south-facing slopes than on the north-facing slopes (Figure 9a,b,d). The soil fell from the top of the lateral slopes, with the palm-fiber bags preventing the sidewalls from becoming vertical.

Three heavy precipitation events occurred in the study area after the first repair in August 2017 (Figure 12). As stated earlier, the red line shown in the profile in Figure 9c suggests 45 cm of vertical erosion and $-14.71 \pm 2.52 \text{ m}^3$ of sediment discharge was likely due to the heavy precipitation events. The installation of palm-fiber bags on the base of the lateral slopes successfully protected the soil from surface water. Without this protection in 2017, further loss of collapsed soil from the lateral slopes could have occurred during the heavy rain in 2018.

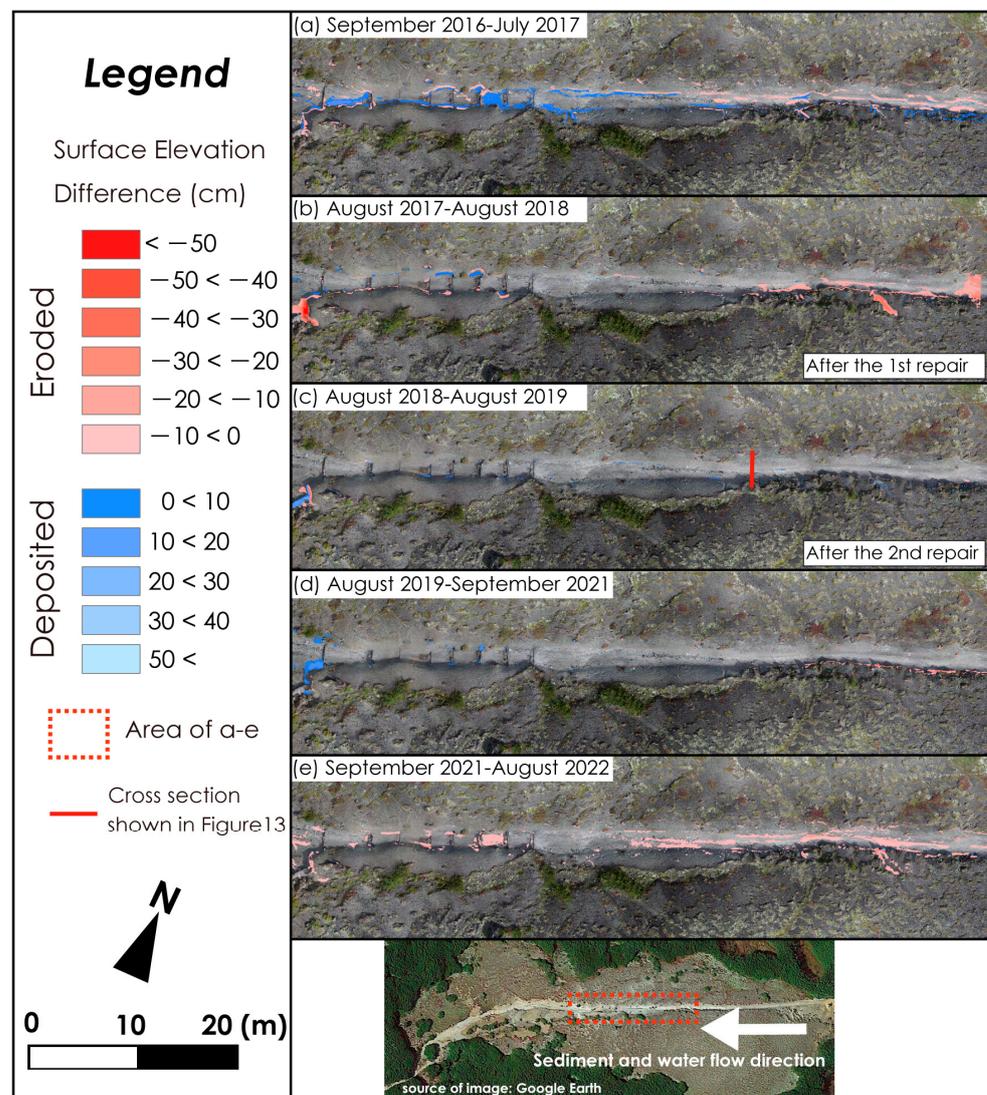
Figure 10. The trail surface changed from 2016 to 2022 in the upper section repaired in August 2022. See Figure 2a for the location of the section.

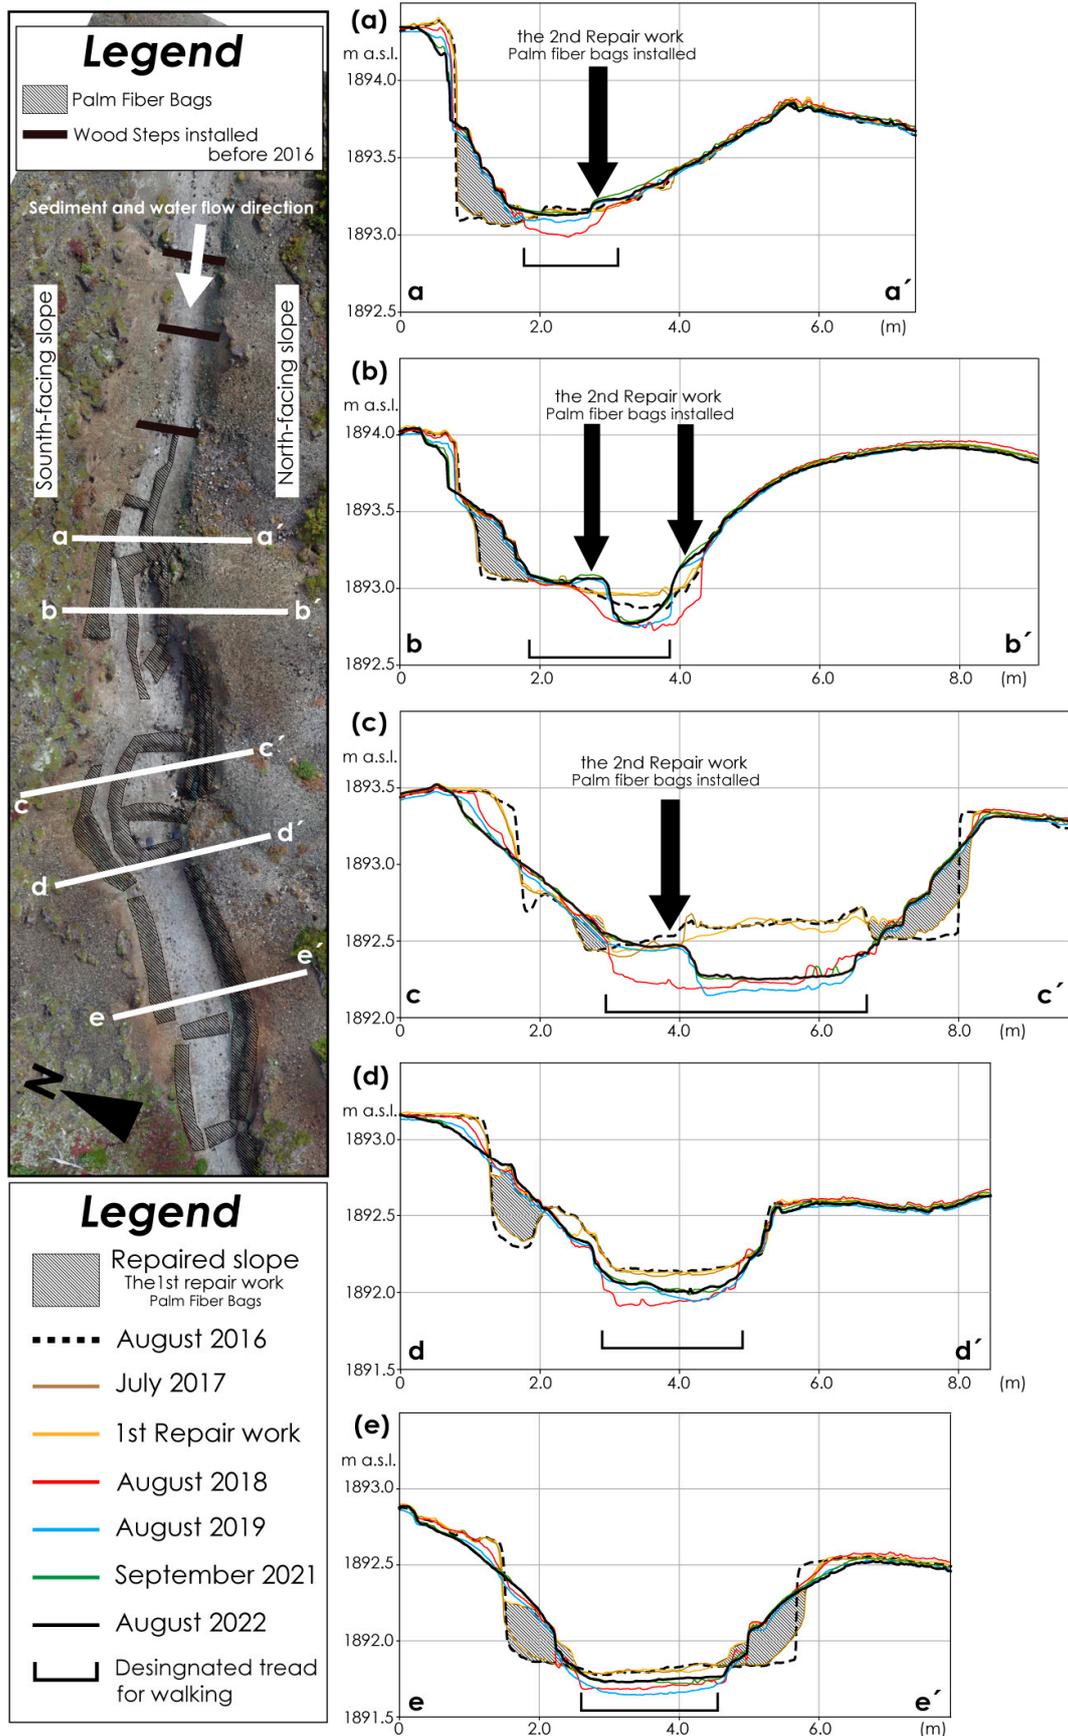
Figure 11. Trail profile changes at (a–e) in the repaired section from 2016 to 2022.

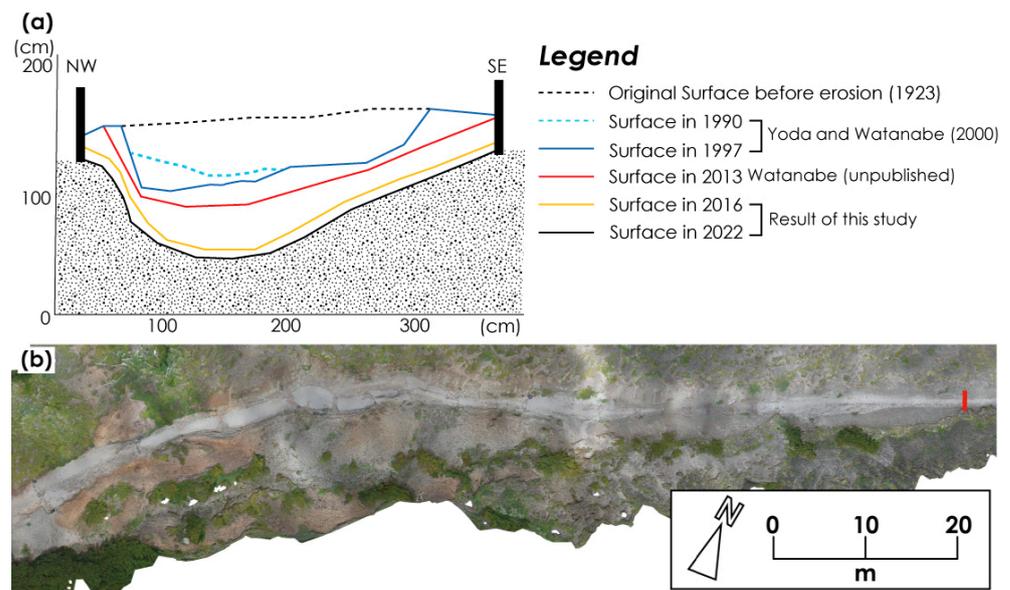
The authors of ref. [42] and one of the authors of this study (TW) conducted cross-sectional area measurements in the upper section in 1990, 1997, and 2013. Their results suggested that the maximum erosion depth was 35 cm from 1923 to 1990 (0.52 mm y^{-1}) and 70 cm from 1990 to 2013 (15.2 mm y^{-1}). Because the cross-sectional area measurement conducted in this study shows a maximum erosion depth of 110 cm from 2013 to 2022 (44.4 mm y^{-1}), the erosion rate has increased at an accelerating rate (Figure 13). One reason for the recent increase in the erosion rate may be that only three repair works have been performed. This suggests that repair work is becoming increasingly important.

Figure 13. The long-term cross-sectional profile: (a) changes from 1923 to 2022; and (b) the location (red line) of cross section (a). See Figure 2b for the location of (b).
