Research on Silicone Rubber Sheds of Decay-Like Fractured Composite Insulators Based on Hardness, Hydrophobicity, NMR, and FTIR

Keywords: composite insulator; decay-like fracture; silicone rubber shed; aging

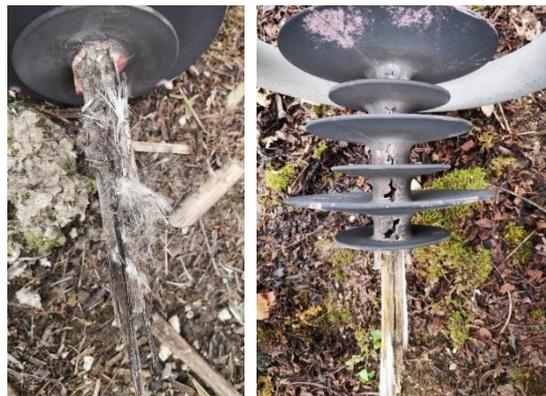
Figure 1. Field pictures of the decay-like fractured insulator.

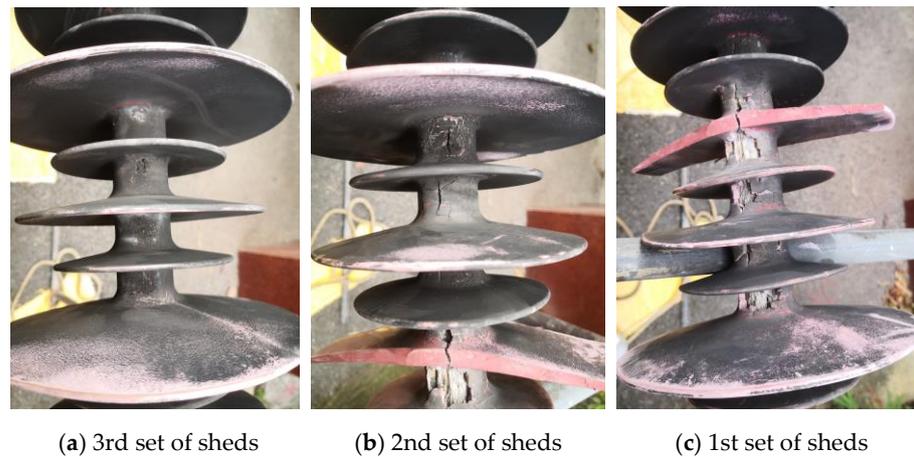
Figure 3. The appearance of 1# insulator (leeward side).

Figures 3 and 4 indicate that when the sheath goes closer to the high voltage end, the breaking worsens, and there are many cracks on the surface. The sheath's degradation is concentrated on the side with heavy pollution, with no notable occurrence on the other side. Along the direction of the grounding end, the degree of degradation diminishes. As a result, sheath deterioration is strongly linked to leakage current, heating generated by leakage current, and other relevant factors on the leeward side.

Figures 3 and 5 show that the core rod of the decay-like fractured insulator is severely damaged. The core rod's macroscopic section is rough and like decayed wood. The interface between the glass fiber and epoxy resin matrix is separated, and the interface close to the fracture is invalid. The shed colors are seriously faded. No cracks or fractures are visible on the surface of 2# composite insulator. However, sheds can be visually observed with faded color, chalking, and other deterioration phenomena from 2#.

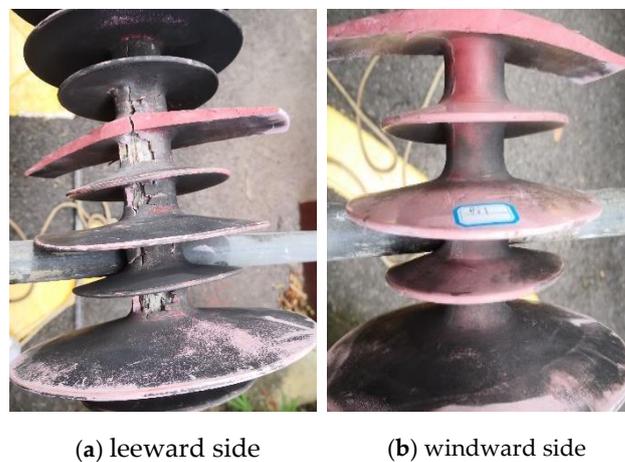
Figure 4. The appearance of the wing/leeward side in the 1st group sheds of the 1# insulator.

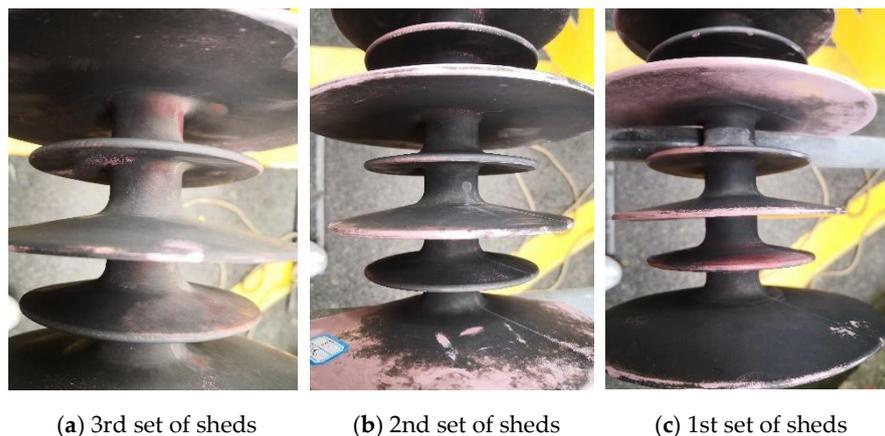
Figure 5. The appearance of 2# insulator (leeward side).

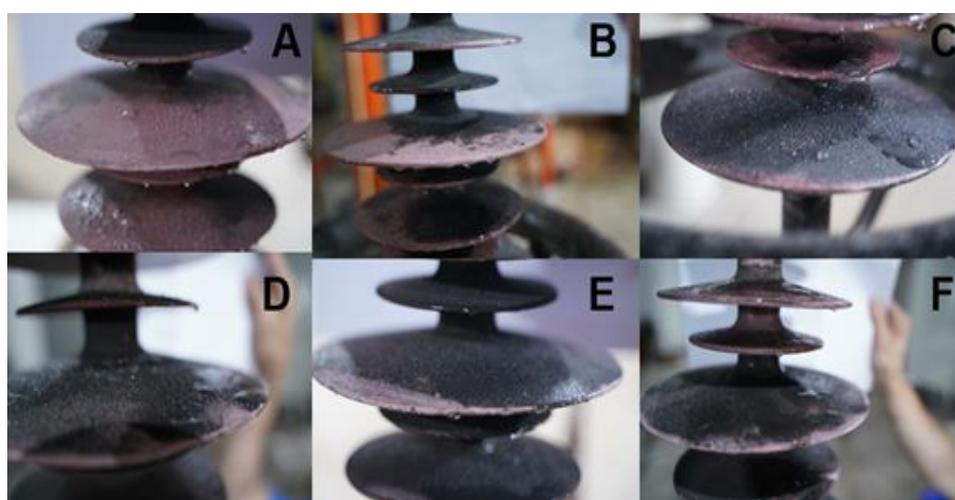
Figure 6. Hydrophobic Classification (HC) measurement of samples (A–F).

As seen in Figure 6, most of the water droplets on A, C, D, and F surfaces are small, and some are large. The HC values of A, C, D, and F are considered HC2 according to IEC/TS 62073. The water droplets on the surfaces of B and E are fine, and the HC values of B and E are judged to be HC1. After a long-term operation, the two insulators still maintain good hydrophobicity.

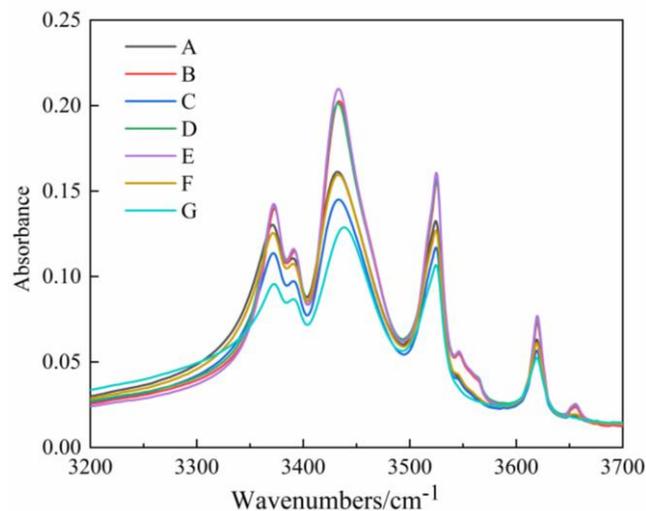
Figure 9. Infrared spectra of 3200–3700 cm^{-1} ranges ($-\text{OH}$).

The $-\text{OH}$ functional group causes four peaks at 3200–3700 cm^{-1} in the infrared spectrum. As depicted in Figure 9, $-\text{OH}$ content: $\text{E} > \text{B} > \text{D} > \text{A} > \text{F} > \text{C} > \text{G}$, which was consistent with the static contact angle. That is, $-\text{OH}$ content is high when the static contact angle is large. The highest and lowest $-\text{OH}$ contents on the decay-like fractured insulator are at the middle and high voltage side, respectively, and so is 2# insulator. It can be seen from the two running insulators that $-\text{OH}$ content at the corresponding positions is 2#>1#.

Figure 9 shows that the new insulator has the lowest peak value, meaning that its $-\text{OH}$ content is the lowest, which is consistent with the hydrophobicity test. Two processes may affect the $-\text{OH}$: (i) Hydrolysis of silicone rubber catalyzed by water, forming hydrophilic silanol groups ($\text{Si}-\text{OH}$) and silanol ($\text{Si}-\text{CH}_2-\text{OH}$) on the material surface; (ii) The ATH filler inside the sample continuously migrates to the surface and reacts with nitric acid, resulting in the loss of $-\text{OH}$ functional groups and the continuous deposition of aluminum (Al) element. At the same time, the migration process of ATH filler will lead to an increase in internal porosity and a decrease in tracking resistance. The increase of internal $-\text{OH}$ indicates that (ii) is greater than (i) on the surface.

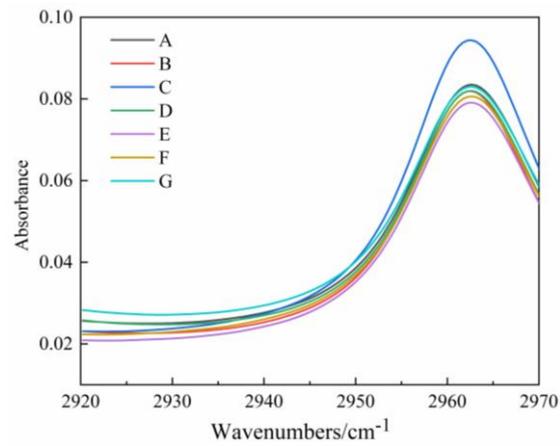
(a) 2920–2970 cm⁻¹ (C-H in CH₃)

- (1) The wavenumber of 2920–2970 cm^{-1} indicates the existence of methyl ($-\text{CH}_3$). As indicated in Figure 10a, the order of absorption peaks is $\text{C} > \text{A} \approx \text{G} > \text{D} \approx \text{B} > \text{F} > \text{E}$. The level of absorption peak represents the amount of methyl content. 1# insulator has the highest absorption peak at the high voltage end. The absorption peak at three positions of 1# insulator is higher than that of 2# insulator. 2# insulator among the seven samples has the lowest absorption peak (in the middle). The decrease in C–H bond content was mainly due to the fracture of $-\text{CH}_3$ functional groups in silicone rubber;

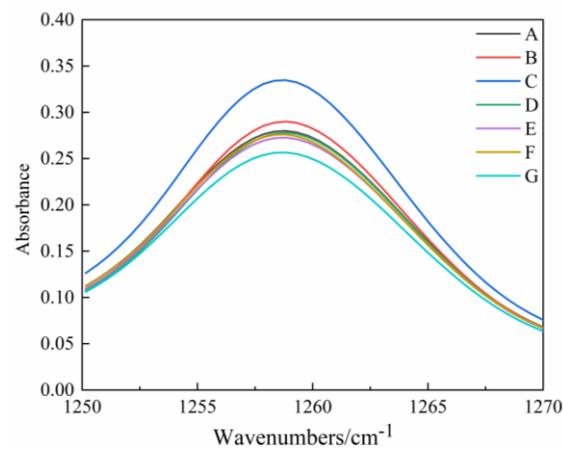
(b) 1255–1270 cm⁻¹ (C-H in Si-CH₃)

- (2) The corresponding functional group at the wavenumber of 1255–1270 cm^{-1} is C–H in $\text{Si}-\text{CH}_3$. As shown in Figure 10b, the order of absorption peaks is $\text{C} > \text{B} > \text{A} > \text{D} > \text{F} > \text{E} > \text{G}$. The absorption peak of the high voltage end of 1# insulator is the highest, indicating that the C–H bond in $\text{Si}-\text{CH}_3$ in the high voltage end is the most. The absorption peak at three positions of 1# insulator is higher than that of 2# insulator. The peak value of the low voltage side of the two operating insulators is close, indicating that the aging degree is similar. Furthermore, 3# insulator's absorption peak is lowest on the high voltage side. The decrease in $-\text{CH}_3$ indicates that the macromolecular chain is broken, further weakening hydrophobicity, according to the findings shown in Table 3. In addition, the degree of damage caused by $-\text{CH}_3$ can, to a certain extent, reflect the degree of aging. The Si–O–Si bond is broken, and small silicone molecules are lost, which reduces the absorption peak value;

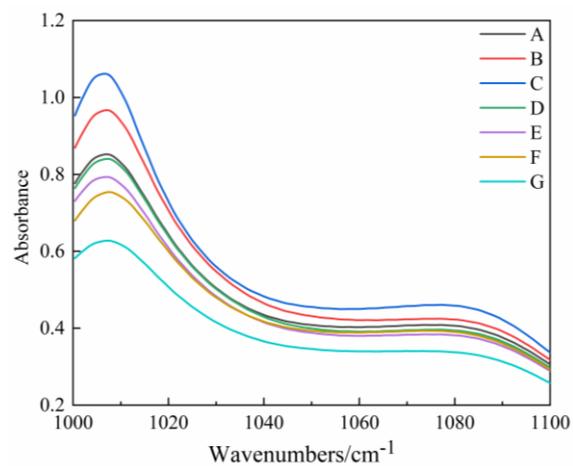
(c) 1000–1100 cm⁻¹ (Si-O-Si)

- (3) Figure 10c indicates that at the wavenumber of 1000–1100 cm^{-1} , the corresponding functional group is Si–O–Si, and the change in the absorption peak is identical to that of methyl ($-\text{CH}_3$);

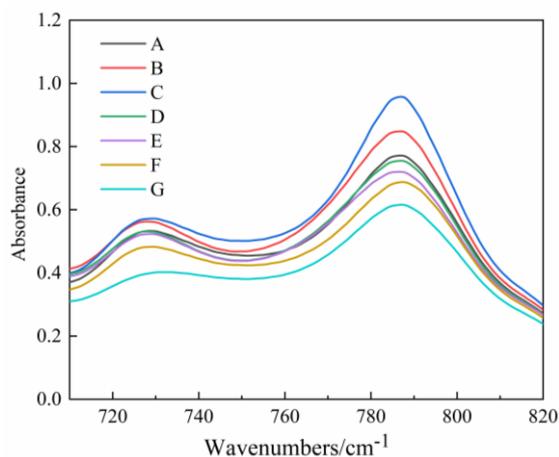
(d) 760–840 cm^{-1} ($\text{Si}(\text{CH}_3)_2$) and 720 cm^{-1} ($\text{Si}(\text{CH}_3)_3$)

- (4) The two peaks in Figure 10d represent $\text{Si}(\text{CH}_3)_2$ (760–840 cm^{-1}) and $\text{Si}(\text{CH}_3)_3$ (720 cm^{-1}), respectively. It can be seen from Figure 10d absorption peak: $\text{C} > \text{B} > \text{A} > \text{D} > \text{E} > \text{F} > \text{G}$. The decrease of $\text{Si}-(\text{CH}_3)_2$ groups means that the silicone rubber is polarized, and the hydrophobicity decreases.
