Case Report

Bank Protection Structures along the Brahmaputra-Jamuna River, a Study of Flow Slides

Maarten van der Wal

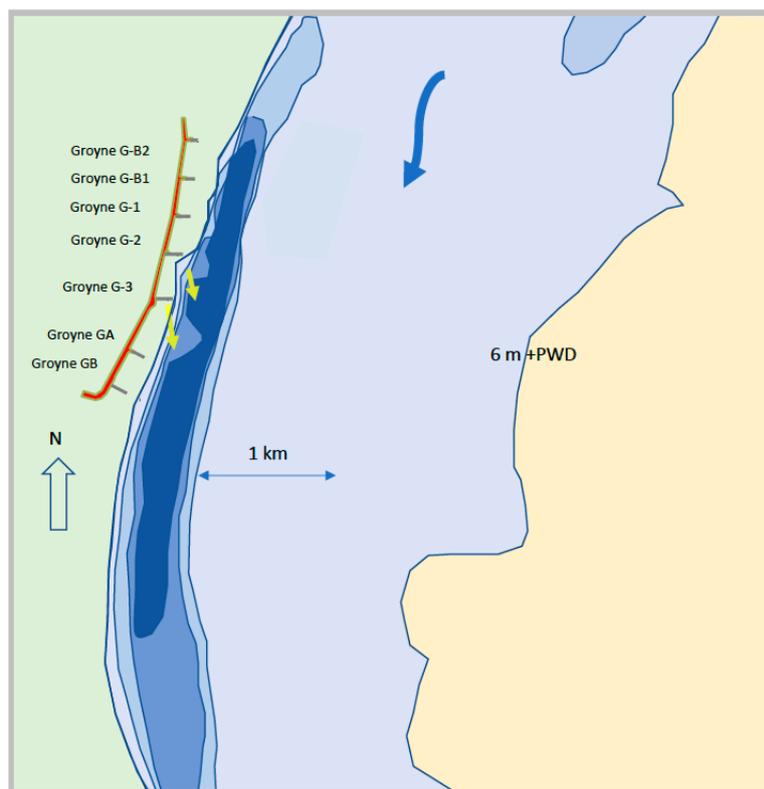
The test structure had been located at the right bank of the Brahmaputra-Jamuna River close to the village Kamarjani. The analysis of samples from borings showed layers of loosely packed sandy subsoil. The test structure was designed at the outer bend of an outflanking channel [8]. It has an upstream termination made of two short, permeable groynes connected to the embankment, a section with three main, permeable groynes G-1, G-2 and G-3 and a downstream termination also consisting of two short, permeable groynes connected to the embankment, see Figure 5.

Figure 5. Outflanking channel Brahmaputra-Jamuna River and the groyne test structure at Kamarjani in August 1995, a few months after completion of the construction during (blue = water, dark blue = deep water $< -14\text{ m} + \text{PWD}$, (PWD = Public Works Datum), green = land, yellow = char land, red = groyne test structure yellow arrows indicate the deposition after several flow slides) (sketch prepared by the author).

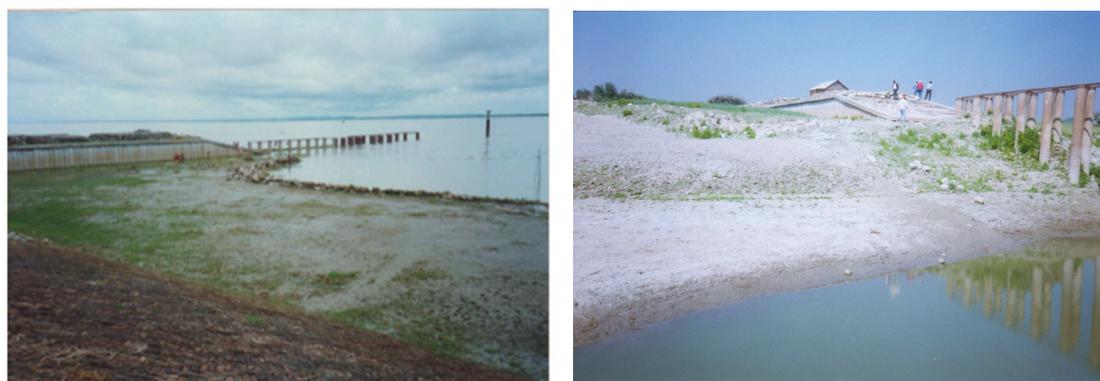
When the water level started to rise at a rate of about 1 m per day, high flow velocities were observed at the transition of the impermeable shank to the pile row of groyne G-2. Three days before the second flood peak on the 20 June, a flow slide occurred at the downstream side of the impermeable groyne head, see the scour hole in Figure 11, and a few days later erosion was measured at the toe of the main embankment, see the edge of extensive stone dumping in Figure 11. The gradual transition of the impermeable groyne head to the pile row was transformed in a sharp transition by a thick layer of floating debris piled up against the groyne. This transition had induced a local flow slide resulting in a scour hole just downstream of the transition and close to the embankment, see the sketch in Figure 12.

Figure 11. Damaged groyne G-2 with lost piles during high water and scour hole downstream of the transition shank and pile row probably caused by floating debris changing the gradual transition in a sudden transition during low water (photographs taken by the author).

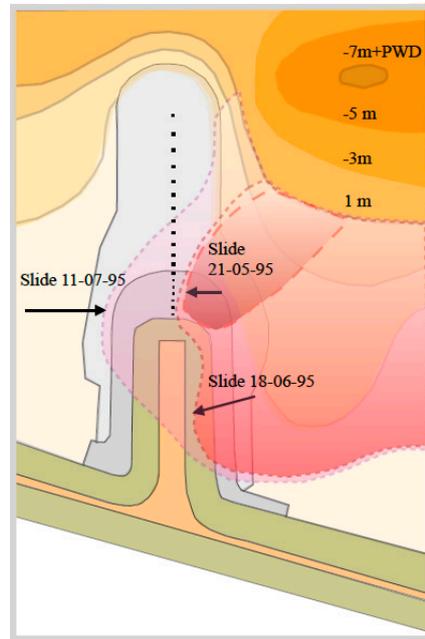
The groyne field upstream of G-2 was filled with floating debris consisting of water hyacinths and banana tree trunks, maximum 300 m² and about 1.5-m-thick in the first two weeks of June, with water levels between 20.50 and 21.00 m + PWD [23]. High flow velocities up to 2.8 m/s did increase the thickness layer of this debris. The maximum depth of the local scour hole increased by 5 m near the tip of the groyne within the 2 weeks before the main flow slide on July 9th, one day before the maximum water level of the third flood peak. The average scour rate of the river bed was 0.35 m/day in that period. That slide eroded about 20,000 m³ material with a maximum scour depth of 12 m close to the

pile row, filled the local scour hole with 12,000 m³ sediment and finally the maximum scour depth in the local scour hole was reduced to 6 m. The falling apron at the downstream side of the pile row disappeared completely. Extensive stone and sandbag dumping had prevented the impermeable shank from disappearing, see Figure 12.

Figure 12. Sketch of groyne G-2 with a local scour hole and with the damaged areas by three flow slides [23] (sketch prepared by the author). Legend: dark yellow = river bed with contour lines local scour hole, transparent red = damage area by a flow slide, grey = falling apron, black dot = pile of permeable groyne, green = slope embankment, sand color = top of embankment.

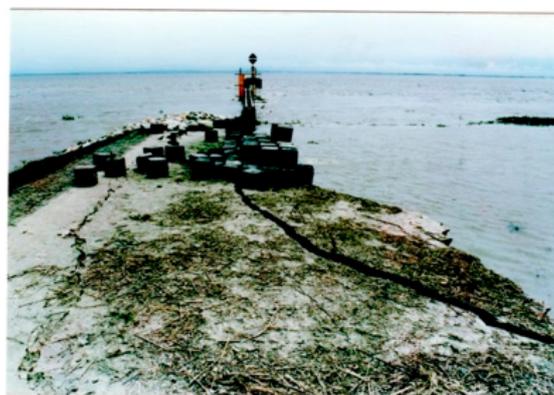
After a quick rise in the water level at a rate of 0.8 m/day for the third peak flow, a main flow slide started at 9 a.m. and stopped in the afternoon. Directly at the start of the slide, a long straight crack parallel to the axis of groyne G-3 was observed at the shank of the groyne. The total volume of about 34,000 m³ of material had moved in chunks of about a meter thickness. These chunks are part of the natural process, see Figure 13. The deepening of a local scour hole close to the bank and the transition of the impermeable groyne head to the pile row caused a gradual bank erosion at the rate of 0.5 to 2 m/day.

Figure 13. Kamarjani test site groyne G-3 with reserve stock cubes on the crest during an ongoing flow slide (photograph: project FAP21/22).

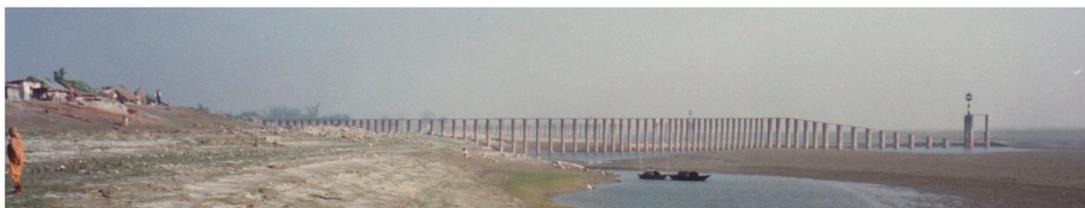
Figure 14. Groyne G-3 repaired and extended to the retired embankment during low water (photograph: project FAP 21/22).

After an assessment of the damage it was decided to repair the damage as part of adaptation works. These adaptation works include a retired embankment and also the pile rows of groynes G-2 and G-3 were extended and connected to the retired embankment without an impermeable shank, see Figure 14, [42]. This extension will accommodate the effect of the interaction between the test structure and the approach channel. In the design process, this interaction was unknown and it became one of the lessons learned from the analysis of the measurements [23,24].

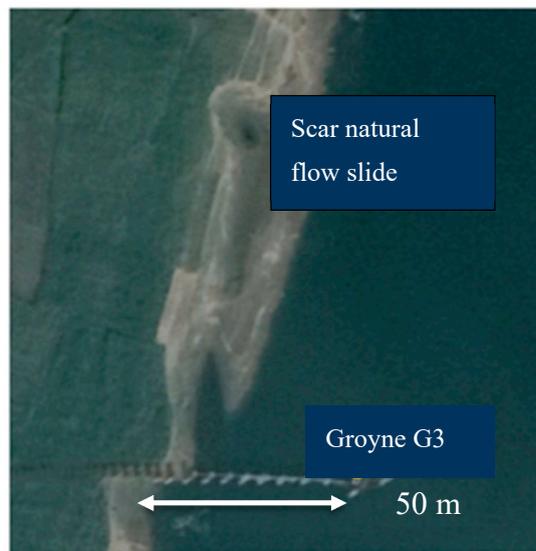
Shear failures are extremely common along the Brahmaputra River and the average radius of the scars is 25 to 300 m, see example in Figure 15.

Figure 15. Example of a scar of a small flow slide or slip circle failure at the edge of a minor channel probably initiated by pushing forcefully a country boat against the bank of the groyne test structure near Kamarjani (Google Earth, 2018).

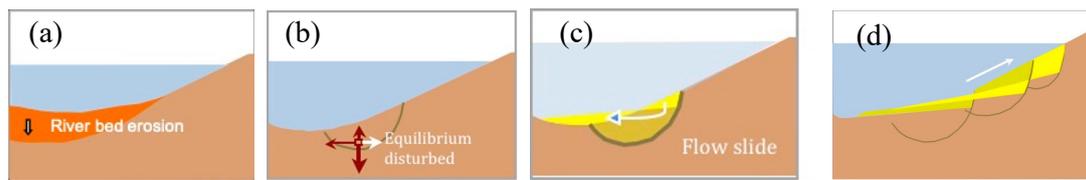
After a trigger, a large body of subsoil (mainly sand) starts to move. The unstable sliding plane can be determined by a slip circle computation, for example, applying the method of Bishop. All material above the slip circle starts to move under the action of gravity and settles partly in the scour hole or dredged trench and on the bank slope, the remaining very flat slope of the deposits varies from 1V:15H to 1V:30H, see the sketches in Figure 16. The process of a sequence of instabilities along slip circles is called retrogressive erosion. That erosion process normally takes several hours before the remaining slope is stable again. This temporary stability might be disturbed during a next flood peak flow when a next flow slide might be triggered. A series of flow slides can be observed in the Brahmaputra-Jamuna River within one monsoon flood.

Figure 16. Sketch series of three flow slides at a revetment: (a) and (b): bank toe becomes unstable because of river bed erosion, (c): flow slide and (d): next flow slides part of retrogressive erosion.
