Article Unveiling the Secrets of an Artwork through Non-Invasive Investigations—Case Study of a 19th-Century Female Portrait

Abstract: This article aims to present the results of the investigations performed on a 19th-century oil painting on canvas belonging to the Conservation and Restoration Department of the University of Art and Design in Cluj-Napoca, Romania. The artwork depicting the portrait of a lady originating from an important Irish noble family (Judith Bunbury, 1785–1861) has been investigated using only non-invasive methods. The investigation protocol included digital photography in different light sources at different wavelengths, which was used to document the current condition of the painting, UV fluorescence, which highlighted the previous improper retouches and the presence of a varnish coat, Infrared reflectography, which brought to light the underdrawing made by the artist and X-ray Fluorescence (XRF) spectroscopy, an elemental analysis technique which indicated the chemical composition of the pigments, suggesting the use of lead white, a barium white pigment, yellow and red ochre, vermilion, cobalt blue, and a manganese-based brown pigment. The results of this

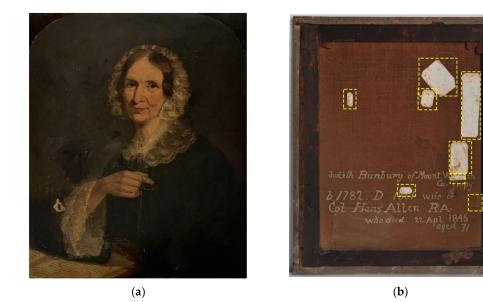
After photographing the artwork in visible light (Figure 2), it was noticed that the textile support is made out of a single piece of linen fabric that has been perforated in eight spots, mainly in the background area. Of these, seven perforations have been improperly consolidated with a thick layer of oil paint (overpaint) on the front and with unsuitable patches on the back (indicated in Figure 2b by yellow dashed boxes). The oil content of the overpaint has been proven by performing an oil test on an isolated area using a saturated solution of Sudan Black B. The patches were mechanically unsuitable due to the animal glue used to adhere them to the holes and tears. The fact that the adhesive is

protein-based (animal glue) was proven by a protein test performed on a patch using an acid fuchsin reagent. The glue, which lost its elasticity and contracted over time, caused some aesthetically disturbing bulges on the front of the painting and distinctive craquelure in the paint layer. The fact that one of the perforations has not been consolidated indicates that it might be more recent than the others. Additionally, it could be noticed that both the paint layer and the varnish layer were evenly applied. The paint layer has strong adhesion to the preparation layer, with only a few areas on the shoulder and above the right hand in which lacunae and flaking were seen (Figure 3). Due to aging, chromatic (yellowing and darkening) and textural (craquelures) alterations of the varnish layer took place. The chromatic alterations are probably photo-induced due to the fact that the edges of the painting layer that were covered by the frame did not show as severe an alteration as the areas exposed to light and oxygen.

Figure 2. The portrait of Judith Bunbury—photographs of the front (**a**) and back (**b**) of the painting in visible light.

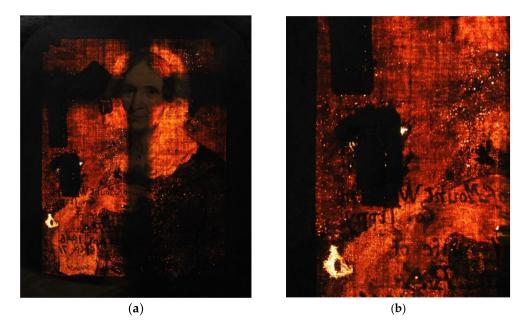
This investigation method proved to be very effective in highlighting the damages and imperfections of the canvas, technical aspects, and previous interventions. The most visible

flaws seen under this type of investigation were the perforations and the improper patching done on the back using thick cotton fabric, as can be seen in Figure 4a,b. Although patching was commonly used for lining and locally stabilizing gaps in paintings, their presence on the canvas can induce unwanted effects, such as contraction or swelling. The animal glue, which lost its elasticity, became brittle and contracted over time, causing bulges on the front of the painting and deformations of the textile support. Furthermore, it caused the appearance of distinctive craquelure in the paint layer in these areas [6].

Figure 4. Photography with transilluminating light; overview (a) and detail (b).

Transillumination also revealed details about the painting technique, such as the fact that some areas were painted in light coats of paint and others were applied in a pasty manner. Backlighting is also important to see if the added paint exceeds the margins of the existing lacunae. In this case, it showed that the overpainting was not limited to the edges of the lacunae, covering large areas of the original painting layer as well.

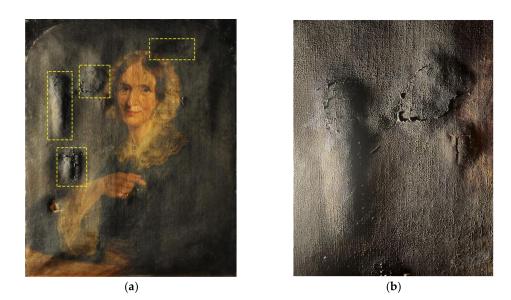
As can be seen in Figure 5a,b, the examination of the painting in raking light highlighted the thick layers of oil paint used to improperly retouch the painting and the deformations and bulges of the canvas caused by the patches on the back (alterations highlighted by the yellow dashed boxes). The areas painted in a pasty manner are also easily distinguished under the radiant source of lighting.

Figure 5. Photography with raking light; overview (a) and detail (b).

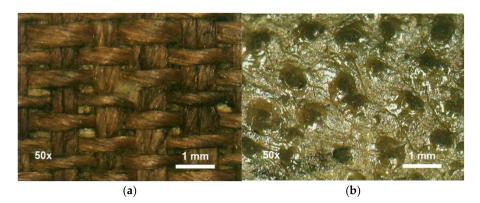
Thanks to its incorporated lighting system, the I-scope equipment generated detailed images of the examined elements. Therefore, the I-scope provided a close view of the canvas highlighting its texture and its warp and weft (Figure 6a), the varnish coat and its patinated, agglutinated look caused by aging and light/sun exposure (Figure 6b), of the improperly made retouches by a previous restorer (Figure 7a), and of the flaking paint layer (Figure 7b). In most areas, the paint layers separated, while the ground layer remained adhered to the textile support. This might have been caused due to loss of adhesion between the ground and paint layers. If the ground layer was applied early on to the canvas, but the painting took place sometime later, the excessive drying of the ground layer (containing lead, which has a drying effect) and an insufficient quantity of oil binder in the subsequent paint layer could have caused this form of flaking. Another explanation could be damage caused by humidity. The exchange of moisture between the front layers and the textile support of the painting occurs through the craquelure, and thus, moisture may accumulate between the paint and ground layer. The moisture may have softened the glue and ground layer, while the paint layers remained inelastic. This may have led to the lifting and separation of the layers.

Figure 6. The texture of the canvas (a) and of the varnish coat (b).

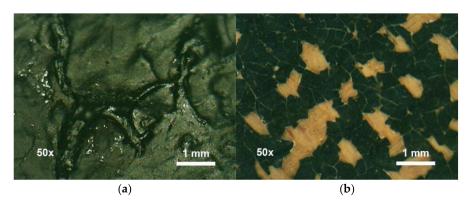
Figure 7. Defects on the surface: improperly made retouch (a) and flaking (b).

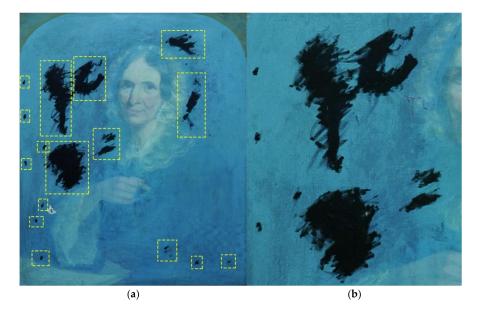
Even if the varnish of a painting can be easily observed in good lighting, using UV fluorescence helps to determine how homogenous the application of the varnish layer is [8]. It also allows us to see where retouching was done using similar colors. The varnish of a painting provides a protective role for the painting acting as a barrier to dirt, smoke, and injury caused by possible mechanical scratches. It also holds an aesthetic value providing depth and clarity to the colors [9]. Furthermore, the varnish layer protects against atmospheric pollutants, such as chlorine or sulfur emissions that can alter the color of certain pigments. It also offers protection against ultraviolet rays (which can cause the oxidation of the oil-based binder, as well as the discoloration of some organic dyes or the alteration of some inorganic pigments) and infrared rays (which, by heating the substrate, can cause the loss of mechanical resistance within the layers), originating from natural and/or artificial light sources. Putting the artwork under this method of investigation revealed that the painting has an evenly applied layer of varnish and some retouches that are improperly made (highlighted in Figure 8 by the yellow dashed boxes). The darker areas that can be seen in Figure 8, which can be easily distinguished from the original paint, correspond to areas where retouching has been made. Also, the greenish tint under UV light indicates the use of a natural resin varnish coat. The retouches were made in a single layer of paint, meaning they were applied during a single restoration intervention when the patches were also applied. The retouches did not cause any color change in the proximity of the retouched areas.

Figure 8. Photography in ultraviolet light; overview (a) and detail (b).

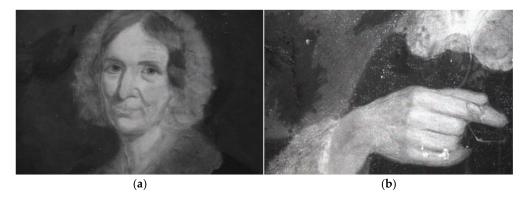
The use of IR allowed the underdrawing of the painting to be seen, which would not have been possible without the naked eye. The underdrawing made in graphite was obvious under the portrait, under the bonnet, under the neck area, and under the hand (Figure 9).

Figure 9. Infrared photographs showing the underdrawings made in graphite: portrait area (**a**); right-hand area (**b**).
