# Damage Assessment of Road Bridges Caused by Extreme Streamflow in Montenegro: Reconstruction and Structural Upgrading

**Abstract:** The extreme river streamflow that occurred during floods in 2010 in Montenegro caused significant damage to infrastructure and road facilities. The most severe damages were located on bridges crossing the river Lim, where a rapid water level increase in several municipalities led to failure or damage of almost 20 bridges. In this paper, a damage assessment of four significantly damaged reinforced concrete (RC) bridges, located in the affected zone of 40 km, is conducted. One bridge in Berane (bridge 1) and three bridges located on roads upstream from Berane (bridges 2, 3, and 4) were analyzed. Extreme water levels and inadequate flow profiles caused great damage to the bridges of which the piers were not adequately founded. A scouring process under the foundation of piers and abutments located in the riverbed occurred due to surface erosion and degradation of alluvial sediments. Applied methods and techniques for reconstruction and structural strengthening of bridges are presented in detail as well as results of conducted analyses of the design reco

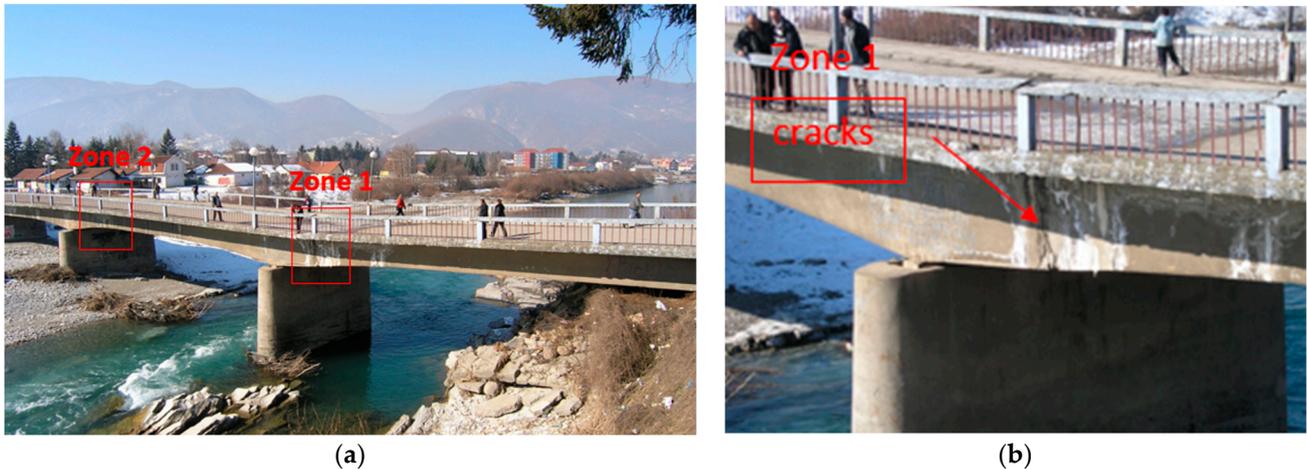
Due to extreme river streamflow, the settlement of the river pier S3 of 0.64 m occurred (based on the geodetic measurement of the deformed bridge), which caused serious damage to the bridge structure (Figure 5). In the span between piers S3 and S02 next to the S3 river pier, at a distance of 3.3 m (zone 1), the deck collapsed. In the longitudinal girders, the cracks about 15–20 mm opened in the bottom zone, while the concrete in the upper zone on the part of footpaths was crushed. At these sections, the concrete of the RC slab was

also crushed. With this level of displacements, it is reasonable to assume that the yield of reinforcement and the plastic hinge formation occurred. In the span between S2 and S3 next to the pier S2, at the distance of 2.35 m (zone 2), damage was also observed. At this section, cracks appeared in the upper zone, while no crushing of concrete was observed in the bottom zone of the longitudinal girders.

**Figure 5.** (a) The bridge after the settlement of the river pier and (b) cracks in zone 1.

Based on the visual inspection and geodetic survey, it was also observed that the pier S3 uniformly settled in both, the longitudinal and transverse directions. The pier S3 settled due to erosion and degradation of alluvial sediments under the water flow. During the field investigation conducted by diving, it is concluded that scouring occurred at the peripheral parts of the bridge pier foundation and that the pier was supported only by the central part of the foundation.

Regarding the damages to the bridge deck, the prestressing technique with cable tendons is selected as the solution for longitudinal girder strengthening. This strengthening method had multiple advantages. Even before the damage, the bridge deck structure did not have adequate resistance according to the currently valid domestic provisions adopted after the construction of the bridge. In addition, the formation of two plastic hinges in the bridge deck structure, after the settlement of the river pier, resulted in a redistribution of action effects with the exceeding of the bending moment capacity in several sections.

The arrangement of cable tendons that favorably affects the load-bearing capacity, balances the bridge system, and ensures its adequate resistance was adopted. Two 15 × 155 mm<sup>2</sup> high-grade steel cable tendons of the BBR VT CONA CMI system [54] with a tensile strength of 1860 MPa are used for prestressing. The tendons are placed along the inside part of the main girder (at the supports in the upper zone and in the spans in the bottom zone). The prestressing cable tendons' layout is linear (see Figure 10). One tendon is adopted along each main girder for the entire bridge length, and another two tendons are added in two damaged middle spans (Figure 10). The prestressing is done from both ends. The steel corrugated pipes are used for tendons installation. The deviators have been placed at the span transverse girders to provide adequate eccentricity of the prestressing force (Figure 11). The tendons are embedded into the corrugated pipes and injected with cement emulsion. At the end supports, the existing transverse girders are strengthened to be able to restrain the tendon forces in the anchoring zone. The steel construction of the deviator is designed for the forces caused by tendons (deflection forces and forces caused by friction forces) in tensioning phase and exploitation state using prescribed safety coefficients.

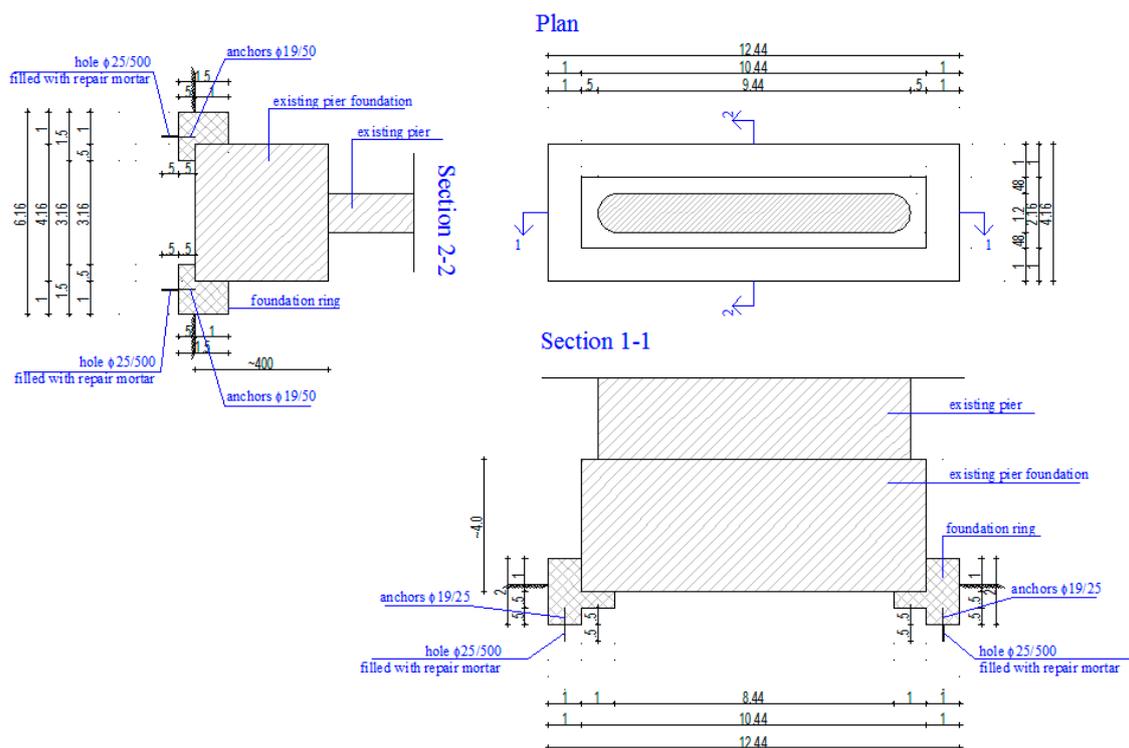
Figure 13. Strengthening of the foundation of river settled pier (units in meters).

The foundation of the river settled pier was strengthened by under-concreting and making the RC ring around the existing foundation. Under-concreting was done in camps with the prior cleaning of the degraded rock mass and the installation of anchors for the connection of rock and new concrete. The details of the foundation strengthening are shown in Figure 13.

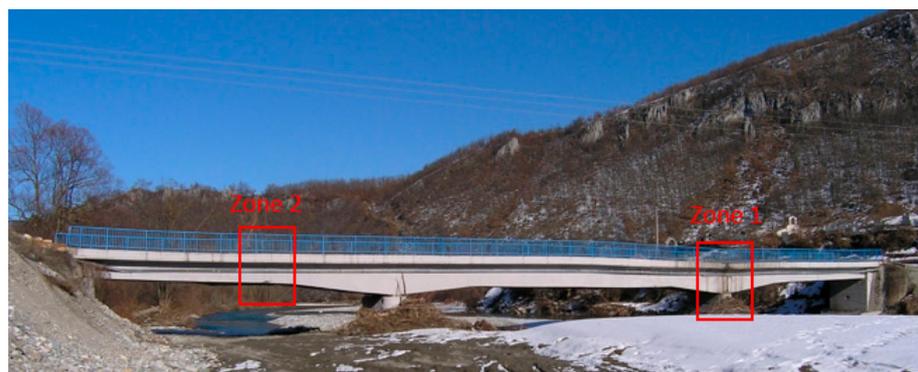
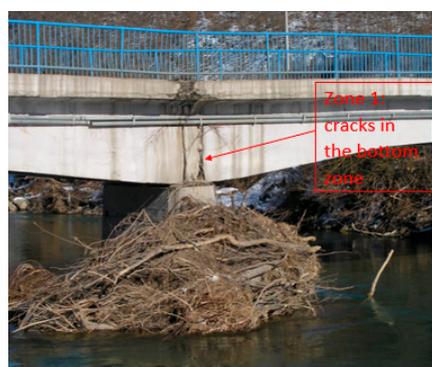
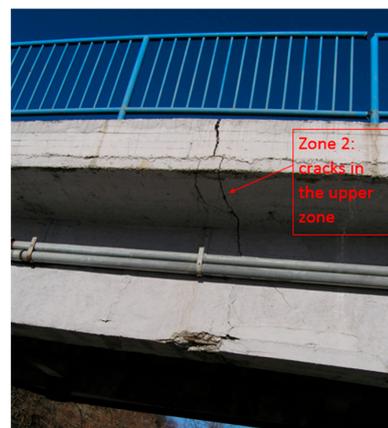
The extreme river streamflow that occurred in 2010 caused a settlement of the right river pier (S2), based on the geodetic survey, equal to 0.654 m. This settlement caused severe damage to the bridge deck. Above the settled river pier (S2) (zone 1), the cracks about 10 mm wide opened in the girder's bottom zone. The concrete was crushed in the upper zone along the effective footpaths slab width of 0.30 m. Similar damage happened on the deck in the first left span (S01-S1) where cracks appeared in the upper zone (zone 2). On the upstream girder side, a crack 10–13 mm wide appeared at a distance of 10.30 m from the abutment (S01). On the downstream girder side, two cracks 13 mm and 3 mm wide appeared at a distance of 9.78 and 10.95 m from the abutment, respectively. In these sections, concrete crushing occurred in the girder's bottom zone. The scouring was caused by the very high water levels of the river Lim, carrying the flood debris that accumulated at the upstream face of the pier causing increased pressure on the structure and additionally limiting the flow of the water around the bridge. Based on the evaluation of the bridge damage state, it can be concluded that the main causes for the extensive bridge damages were: extreme water level, the inadequate foundation of the pier, and the inadequate water flow profile. The damaged bridge 2 is shown in Figure 16.

**Figure 16.** (a) The bridge after the settlement of the river pier, (b) cracks in zone 1, and (c) cracks in zone 2.

Since the deck had sufficient load-bearing capacity for the new damage condition, no additional strengthening was required. The structural strengthening of the settled pier foundation was done by drilled piles. On the upstream and downstream sides of the foundation, 2 RC piles with a diameter of  $\varnothing 80$  and a depth of 9 m were designed. The length of the piles was determined on the basis of available geotechnical data according to which the solid rock is located at a depth of 5–6 m. Each of the piles entered in solid rock at least 2 m. An RC ring was made around the existing foundation. The pile heads are concreted into this ring that with the existing foundation ultimately formed a new pile cap. The coupling of new and old concrete pile caps was performed by the anchors  $\varnothing 19/50$  cm (Figure 21).

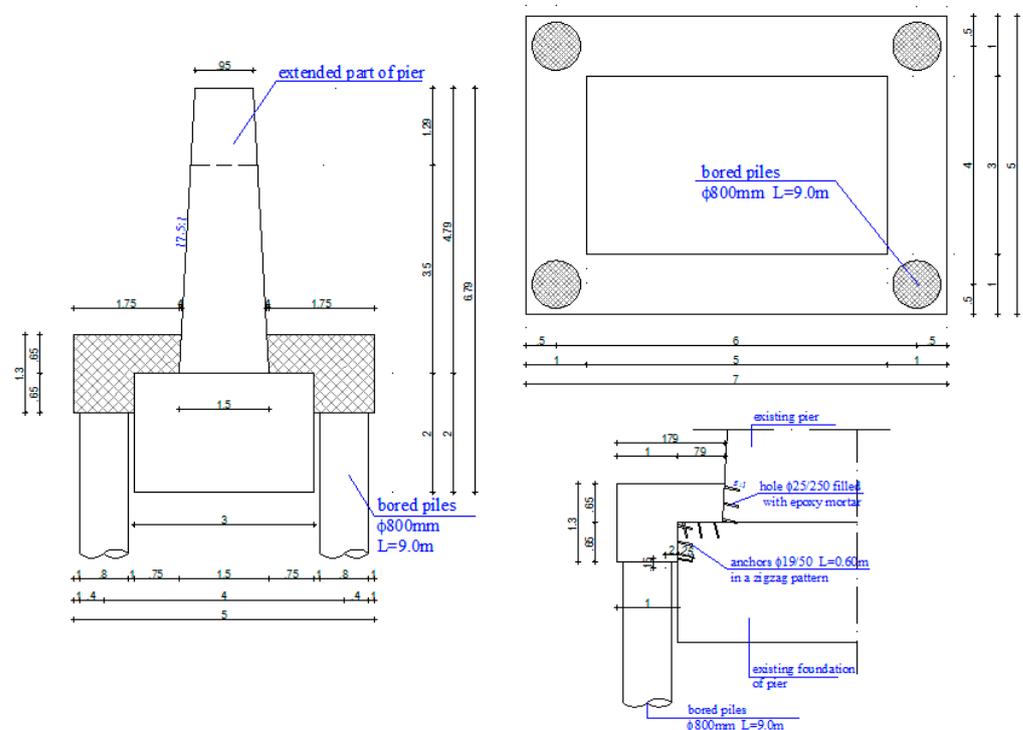
**Figure 21.** Structural strengthening of the settled river pier foundation.

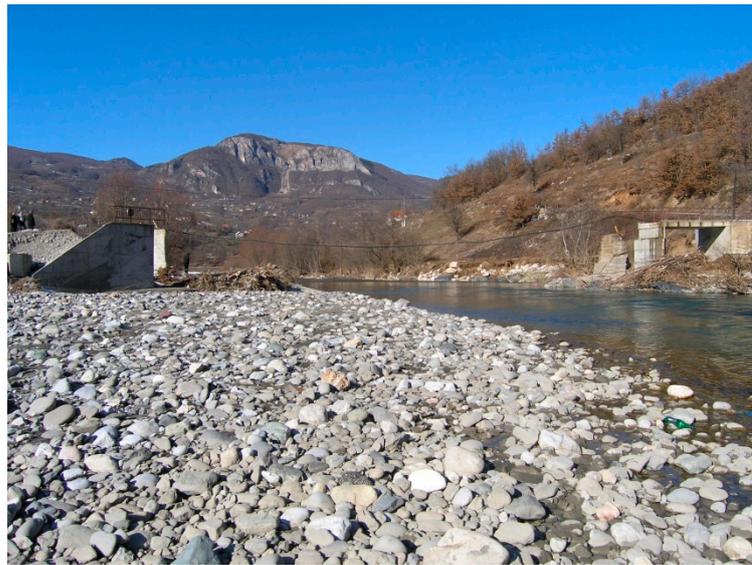
The deck supporting structure consists of two abutments and two river piers. The right abutment and right river pier are founded on the rock while the left abutment and the left river pier are founded on gravel. Due to the high water level of the Lim River and the local scour in the foundation of the left pier and left abutment zones, the river flow carried away both these piers as well as the deck over two larger spans of 18 m. Only a deck over a span of 6.20 m remained with the right river pier, right abutment, and the wing walls of the left abutment. The reasons for the collapse of this bridge were inadequate funding of the left river pier and left abutment in combination with extreme water levels and inadequate water flow profile. Figure 23 shows the bridge at its collapse.

**Figure 23.** The Seoca bridge after the collapse.

Having in mind the causes of the bridge collapse and remaining undamaged bridge elements, at the phase of reconstruction design, a solution for crossing the river Lim with one span, i.e., without river piers was adopted to avoid the negative effects of high water level oscillations. The new bridge structure with one span of 36.00 m was designed. The right-approaching bridge slab with a span of 6.2 m has been retained as part of the new bridge since it was undamaged. The structural system of the new bridge consists of two prefabricated prestressed RC girders with an “I” cross-section of constant height of 1.30 m, placed at a distance of 3.8 m. The longitudinal section and bridge deck cross-section in the middle of the span is shown in Figure 24. These girders are monolithized with a 0.20 m thick RC slab. The flange width (upper and bottom) is 1.00 m, the thickness of the lower flange is from 0.20 to 0.30 m, and the upper flange thickness is from 0.15 to 0.25 m. The thickness of the web is 0.25 m. The prefabricated girders are connected on supports and in the middle of the span with transverse girders 0.30 m wide and 1.10 m high. Over the existing RC approaching slab 0.35 m thick and 3.20 m wide, a new 0.20 m thick and 4.80 m wide RC slab is added over it. At the connection between the new bridge girders and the retained approaching slab, above the pier, a hinge is formed in the slab. The retained right pier is widened to form a suitable support for new prefabricated girders. The existing right abutment has been also retained. The adopted bearings are high-quality elastomeric pot bearings, fixed placed over the right support and moveable placed on the left support. The main girders are prestressed with three  $15 \times 150 \text{ mm}^2$  tendons with a tensile strength of 1860 MPa. The prestressing tendon layouts are linear and parabolic.

Based on the geotechnical survey on the left riverbank, the thickness of the gravel layer above the solid rock is 7.0 m. For these reasons, the left abutment is founded on 1.2 m diameter piles. Two piles placed in the axes of the main girders were designed. The pile cap of  $2.8 \times 1.2 \text{ m}$  was constructed over the piles. The designed length of the piles is 10 m with at least 4.0 m inside the solid rock. The existing wing walls are retained and connected to the new abutment.

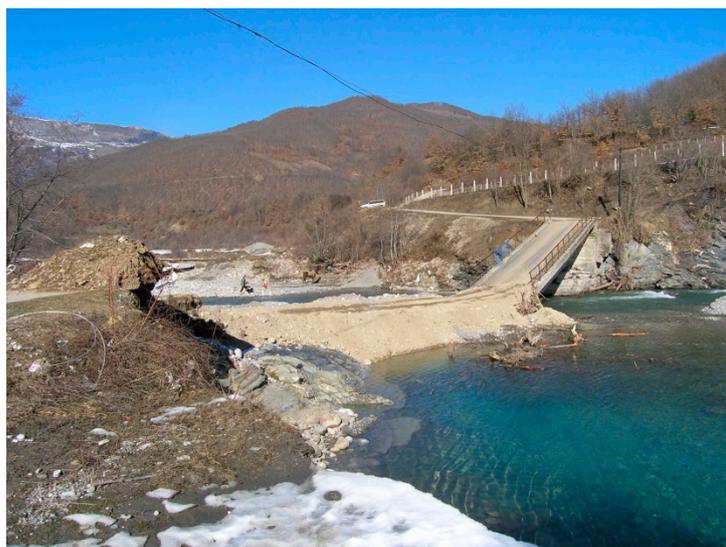
The Novsici bridge is located on the local road to the village of Novsici in the municipality of Plav. Since no existing design documentation for this bridge was available, precise data on the bridge structure could not be determined. It was built of reinforced concrete with a span of about 20 m. It had one traffic lane 3.10 m wide with two footpaths of 0.45 m each. The deck structure consisted of two RC main girders with a slab that were placed at a central distance of 2.70 m. The dimensions of the main girders were about  $0.30 \times 1.00$  m. The thickness of the slab could not be determined. During the on-site investigation, it was concluded that the Lim River carried the left abutment as well as the embankment behind it in the width of about 12 to 15 m. The deck structure fell from the left abutment into the riverbed and partially remained supported on the right abutment, so that it stood sloping in the riverbed. No significant damage was noticed in the bridge deck, despite its fall into the riverbed. It is obvious that the left abutment of the collapsed bridge was inadequately founded in gravel, i.e., alluvial sediments, which together with the extreme water level and inadequate flow profile, was the main cause of the bridge collapse. Figure 25 shows the bridge collapse.

**Figure 25.** The Novsici bridge after the collapse.

Taking into account the causes of the bridge collapse and the current on-site situation, similar to bridge 3, the reconstruction solution by crossing the river Lim with one wider span was selected to avoid the negative effects of high water level oscillations. The bridge with one span of 32.00 m was designed over the river. The longitudinal section of the designed reconstruction of the bridge is shown in Figure 26. The selected structural system of the bridge is the same as for bridge 3 (Figure 24b). In addition, the same supports of the girders are selected. Three  $15 \times 150 \text{ mm}^2$  tendons with a tensile strength of 1860 MPa are used for prestressing. The prestressing tendon layouts are straight and parabolic. Considering the severe damages to the right abutment, a completely new abutment has been designed. All cracked and degraded parts of the rock at this site are removed so that a healthy and solid rock is reached, on which the new abutment is founded. Anchors are drilled into the existing rock to connect the abutment foundation and the rock. The left abutment with wing walls is founded on a rock. In front of and behind the bridge, as well as in the wing zone, the large stone blocks are used to stabilize the slope and prevent erosion.
