Impact Analysis of a Building Collapse Caused by a Rainfall-Induced Landslide in Kerala, India

Abstract: This study presents the experimental, numerical analysis, and dynamic impact analysis of a building collapse caused by a rainfall-induced landslide (vertical cut slope failure) on 15 August 2018, in Peringavu, Kerala, India, which resulted in the death of nine people. The volume of 1500 m³ soil-applied lateral thrust force on the building's rear side led to its demolition. The study includes extensive geotechnical characterization. General limit equilibrium and finite element methods were used in the numerical analysis. The infiltration analysis involved a rainfall pattern of low, moderate, and higher intensities on the slope. The study involved a two-stage analysis. Firstly, the analysis of the vertical cut slope with the application rainfall intensities, and second, the analysis of the building under the dynamic impact of the landslide. As a result of the study, the failure mechanism of the vertical cut during intense rainfall and triggering factors were evaluated. The dynamic impact analysis was carried out to examine the effects of the impact of the landslide debris on the

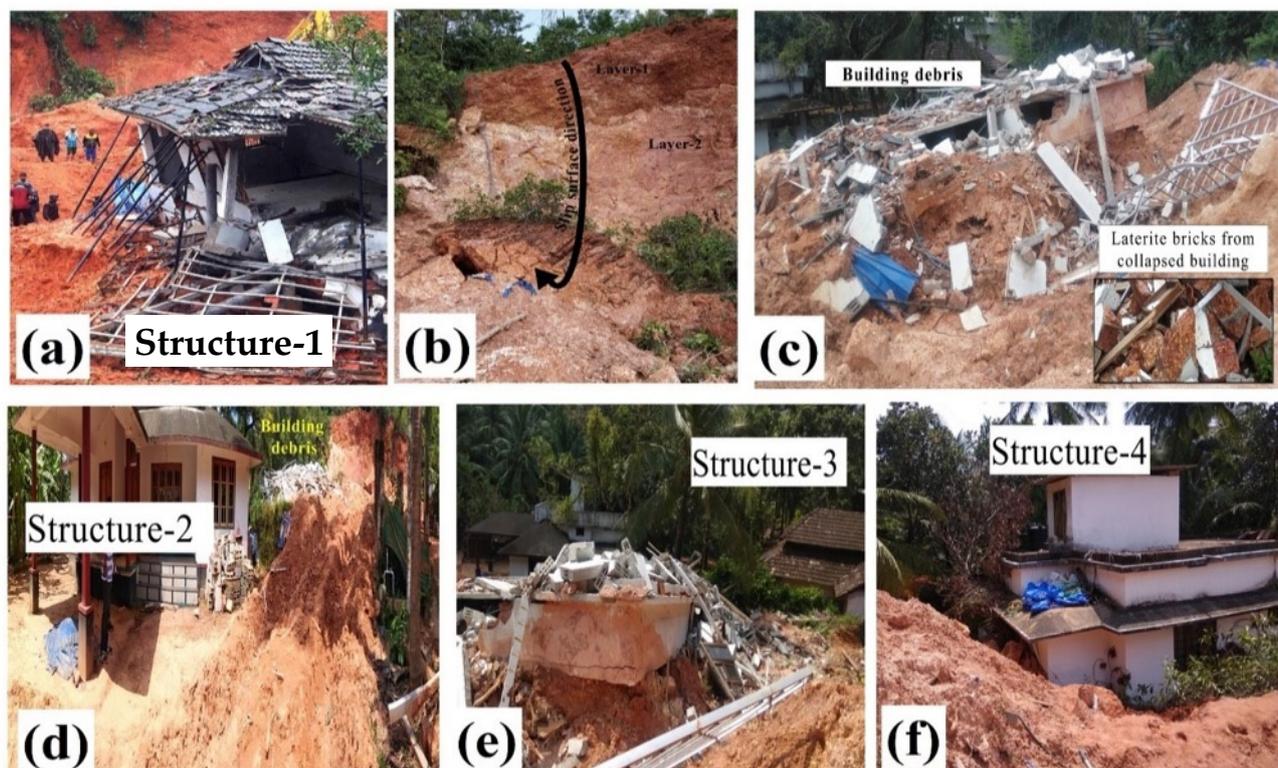
Figure 3. Condition of the site: (a) The collapsed building; (b) Failure slip surface; (c) Collapsed building debris; (d) Picture of soil and debris flow near the road (structure 2); (e) Partially damaged house (structure 3); (f) Picture of soil that drifted into an adjacent building (structure 4).

Before failure initiation, there were signs of failure; a small quantity of saturated soil spalling from the slope onto the pet cage placed at the back side of the building (structure 1) (Figure 3a), while all family members, along with two neighbors, were trying to move the pet cage to a safer place [34]. As rainfall intensity increased over time, a huge quantity of soil from the vertical cut drifted into the building, resulting in the demolition of the building. All family members, along with the two neighbors, were buried alive under the building debris and saturated soil.

Figure 3 depicts the condition of the location after the landslide. During the rescue process, the building was protected by adjustable floor support jacks for additional support to the trussed roof top observed in Figure 3a. As observed in Figure 3b, the slide was of a rotational type. Figure 3c illustrates the building (structure 1) debris after the landslide. Figure 3d depicts the condition of structure 2 and the soil spread near the road. Figure 3e

depicts the picture of a partially damaged house (structure 3). The rear side of a partially damaged building with soil (structure 4) is shown in Figure 3f.

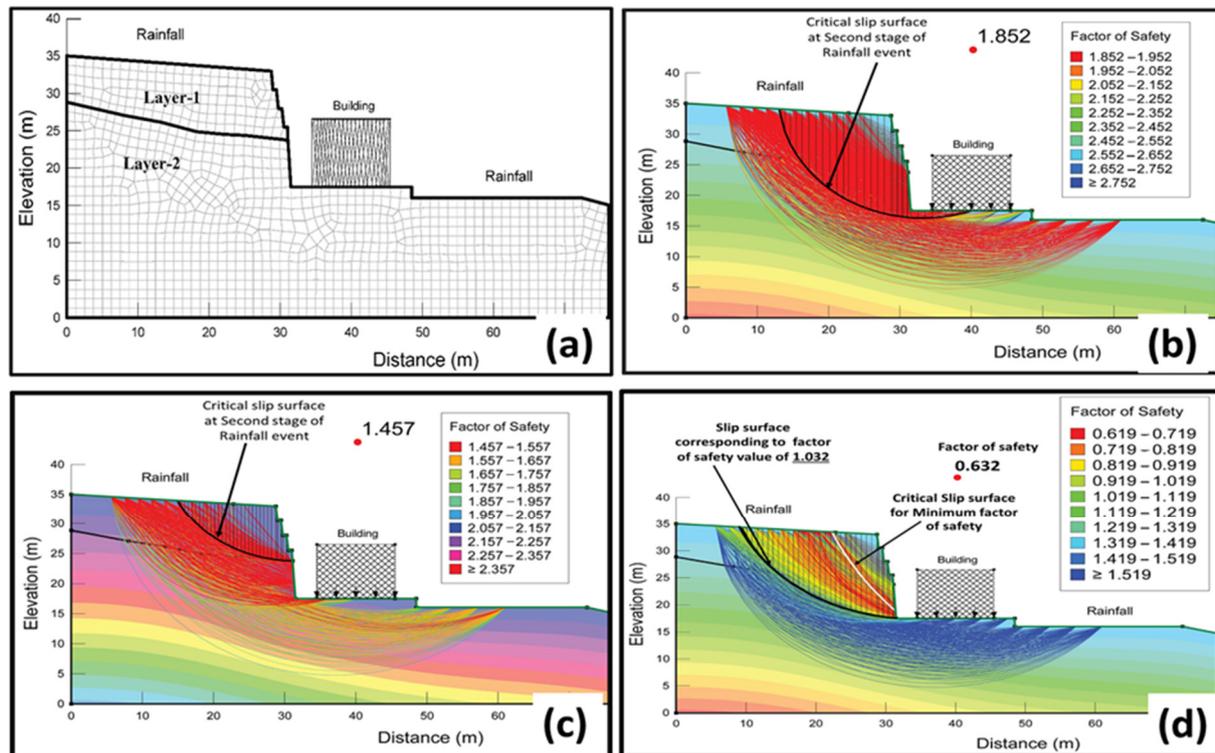
Figure 6. Numerical analysis: (a) Geometry of the model; Critical slip surface with factor of safety values: (b) First-stage rainfall event; (c) Second-stage rainfall event; (d) Third-stage rainfall event.

During the second stage, the degree of saturation changed from 0.86 to 0.56 (Figure 7a) and at shallow depths, the pore water pressure changed to a positive value. The effective stress decreased as there was an increase in the pore water pressure. The pore water pressure at the top was recorded as -29 kPa and it changed to a positive value at a depth of 3 m from the top surface (Figure 7b). The factor of safety at the initiation of the second stage was 2.0 and it subsequently decreased to 1.45 at the end, and this was due to the increase in saturation reducing the factor of safety of the slope (Figures 6c and 7c).

depicts the failure incidence that occurred on 15 August 2018. The factor of safety value decreased to 1 at the 32nd hour of the third rainfall event, but the slope failure occurred during the last hour of the third-stage rainfall event. In this case, the slope was stable.

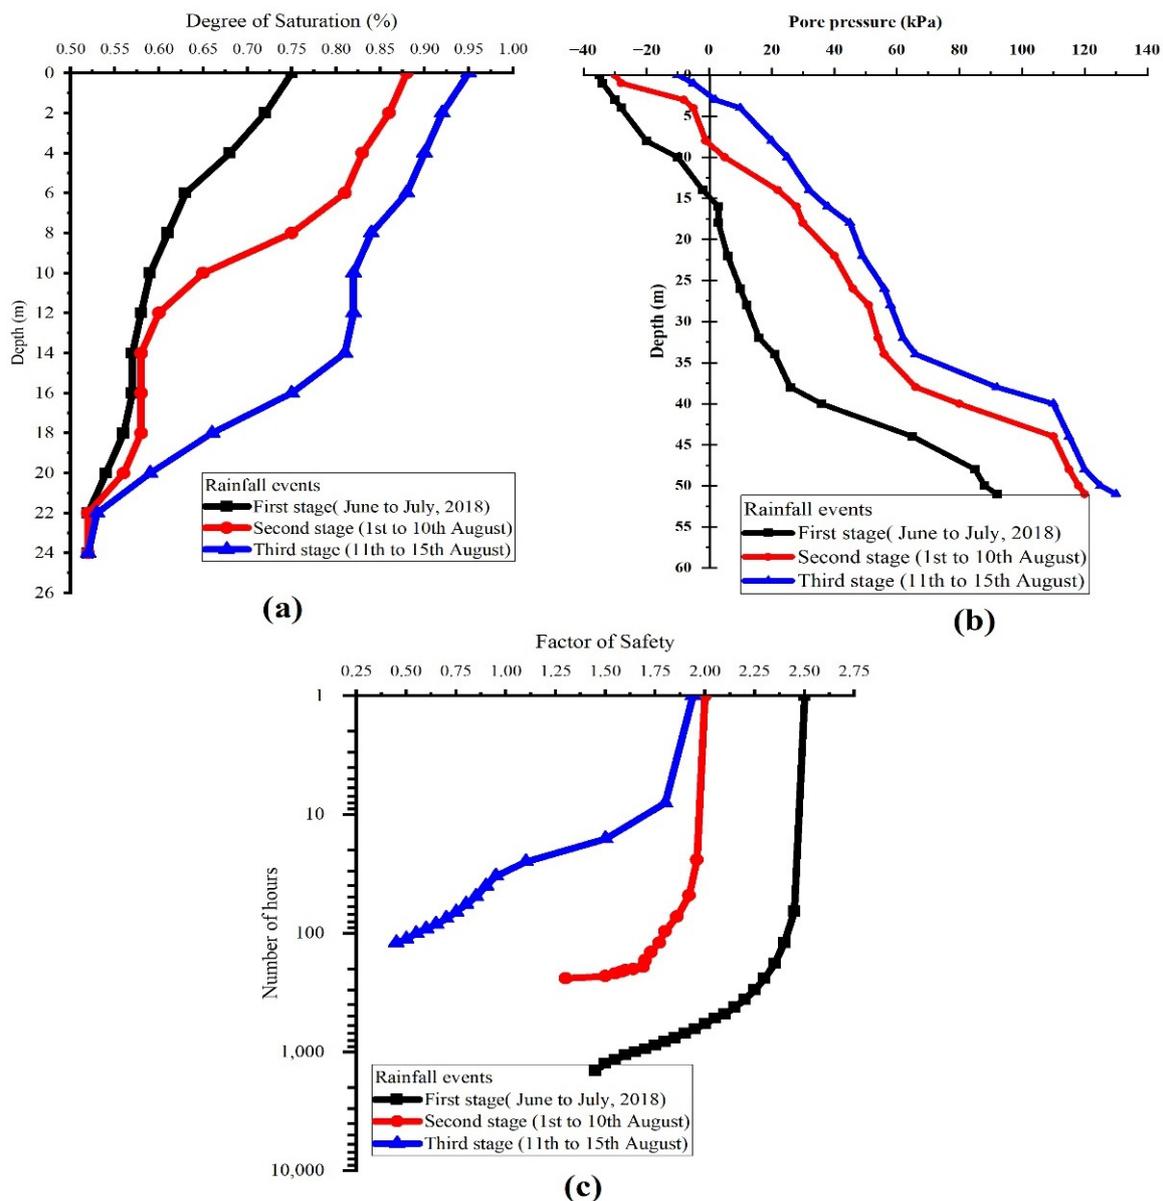
Figure 7. Numerical results: (a) Change in the degree of saturation; (b) Change in pore pressure according to depth; (c) Factor of safety corresponding to depth.

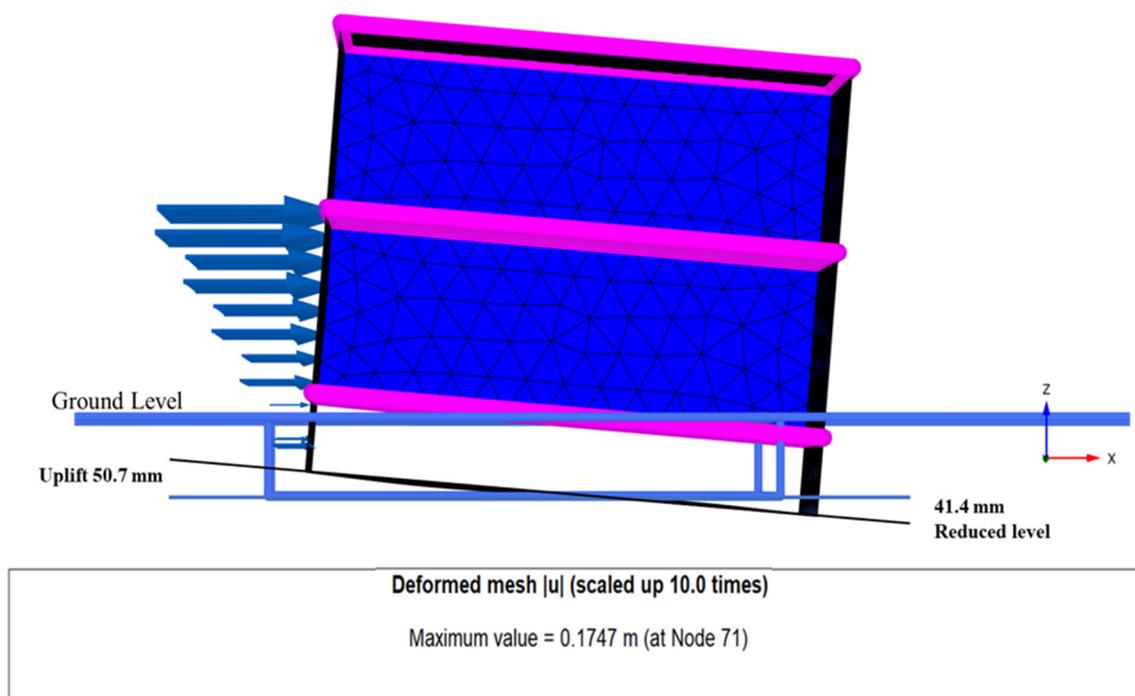
In the dynamic impact analysis, after applying the impact thrust, the building tilted and experienced a differential settlement of 92 mm, which is higher than the permissible limit. Figure 11 shows the settlement and lateral displacement of the building. Numerical analysis results show that the 170 mm lateral displacement of the building specifies failure. Settlement and displacement values indicated the collapse of load-bearing walls under the landslide thrust.

Figure 11. Differential settlement of the building after the landslide impact.

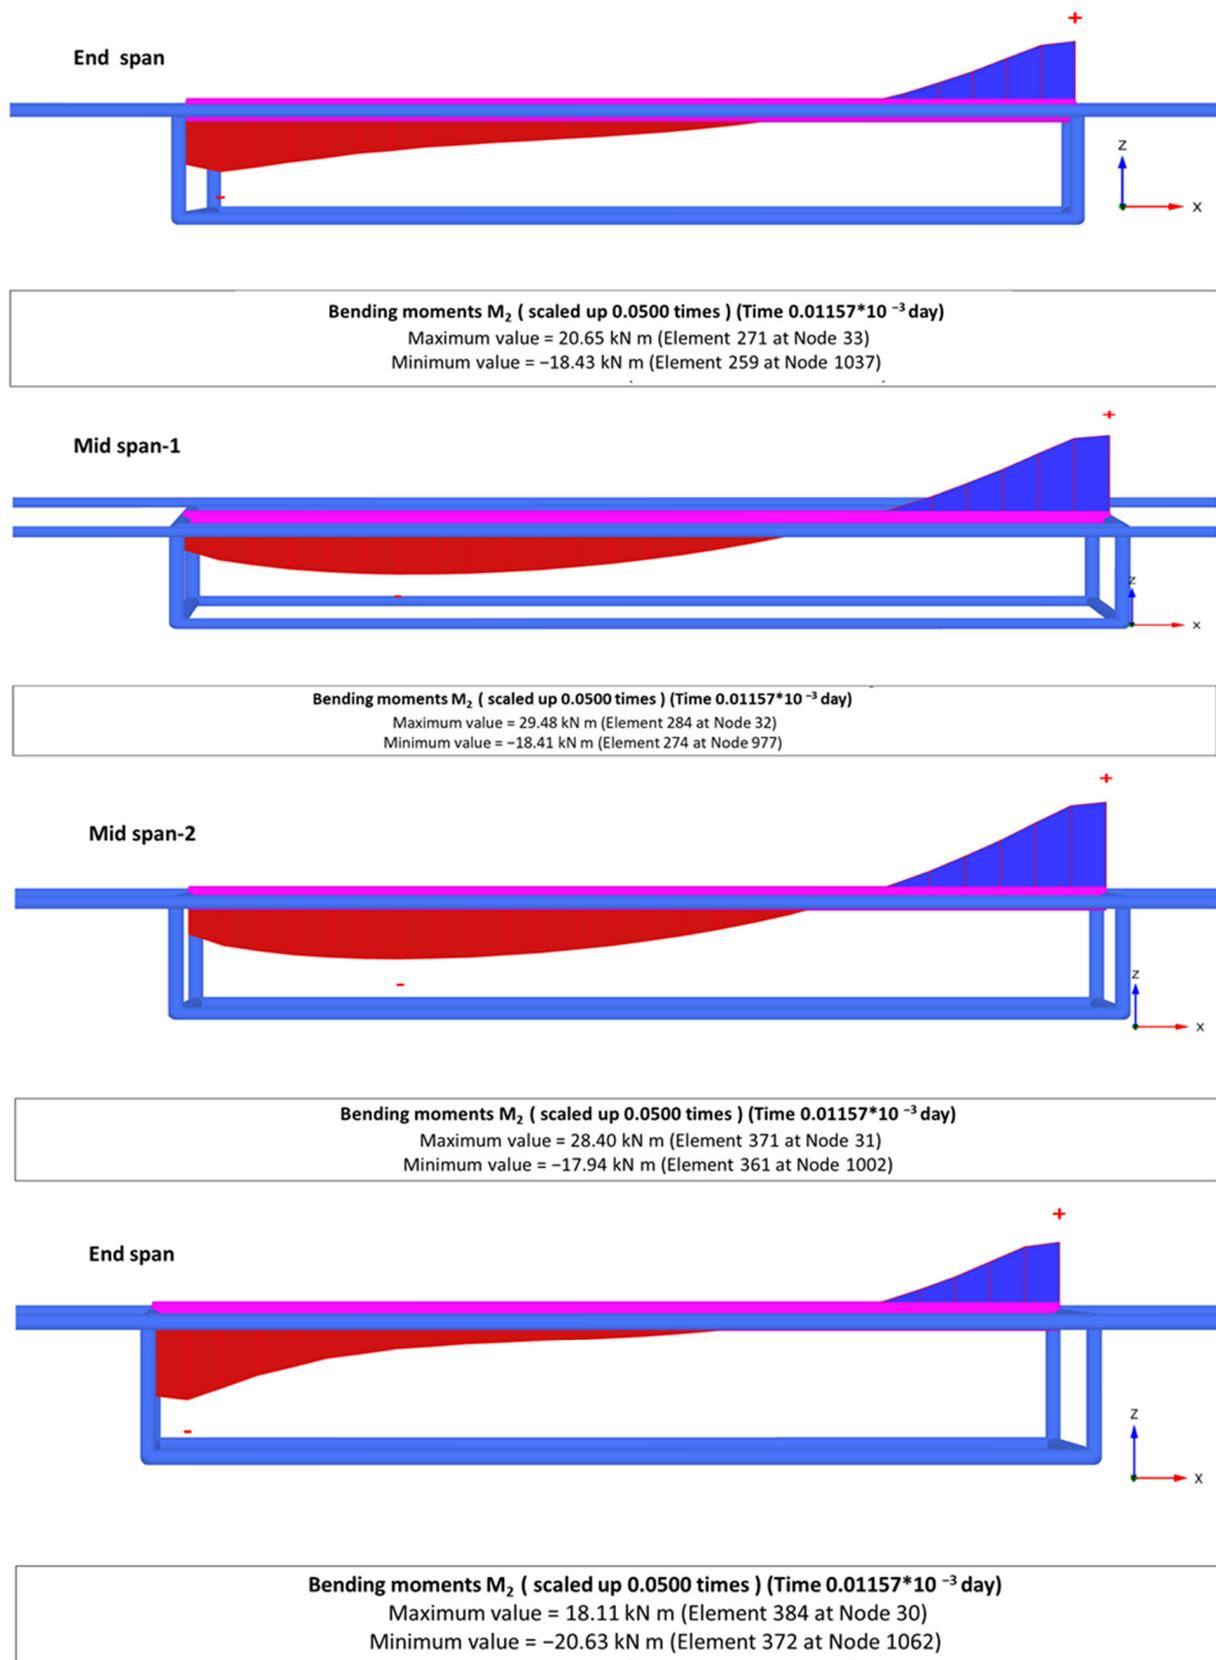
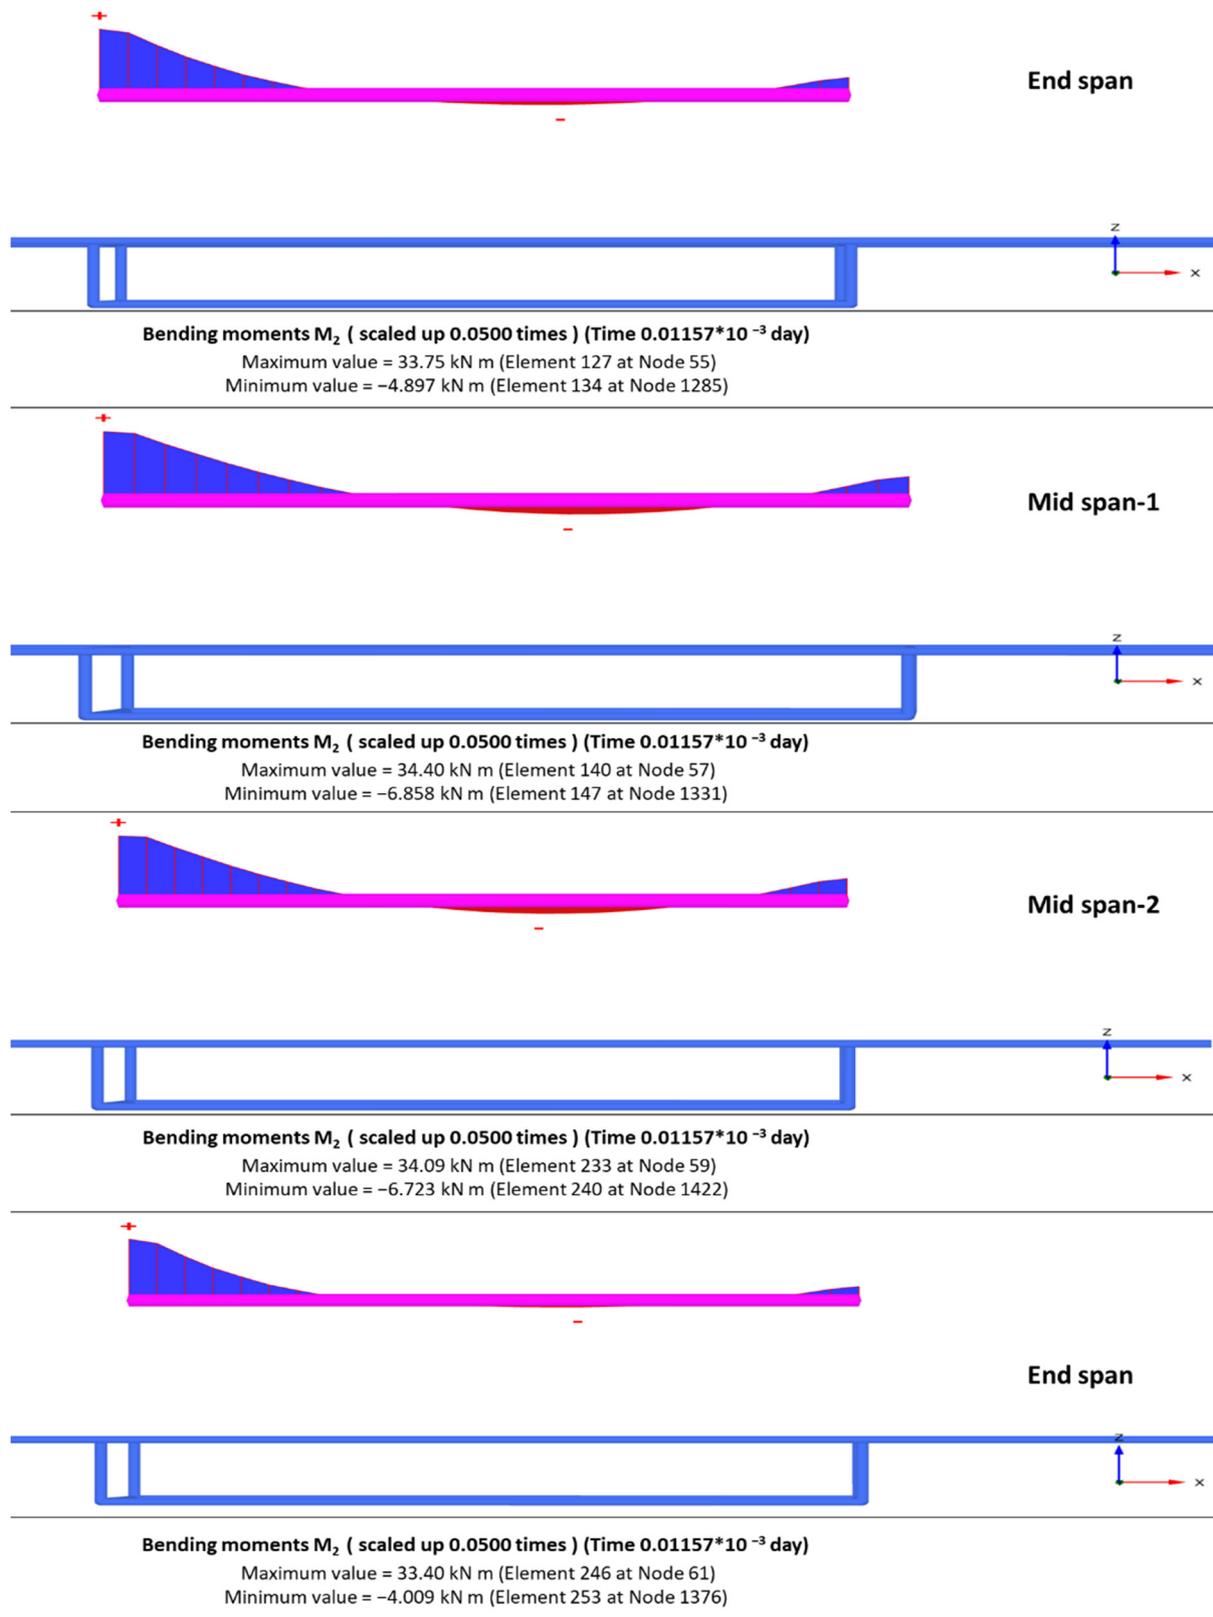
The bending moments of beams before and after the application of the impact force were obtained from the finite element analysis and are presented in Table 7. The permissible bending moments (allowed or limiting moment of resistance ($M_{u(lim)}$)) of the end and midpoints were 14 kN-m and 21 kN-m, respectively (Table 7). Before the application of the impact load, the plinth beams and first floor beams had safe bending moments against failure. Figure 12a,b shows the negative and positive bending moments of the plinth portion and first-floor beams. After application of the dynamic impact load on the building, the bending moments of the plinth beams and first-floor beams increased to twice the permissible limit (Table 7). The higher bending moments than permissible limits indicate the failure of beams resulted in the demolition of the building.

Figure 12. Bending moment diagrams of beams: (a) Plinth portion; (b) First floor.

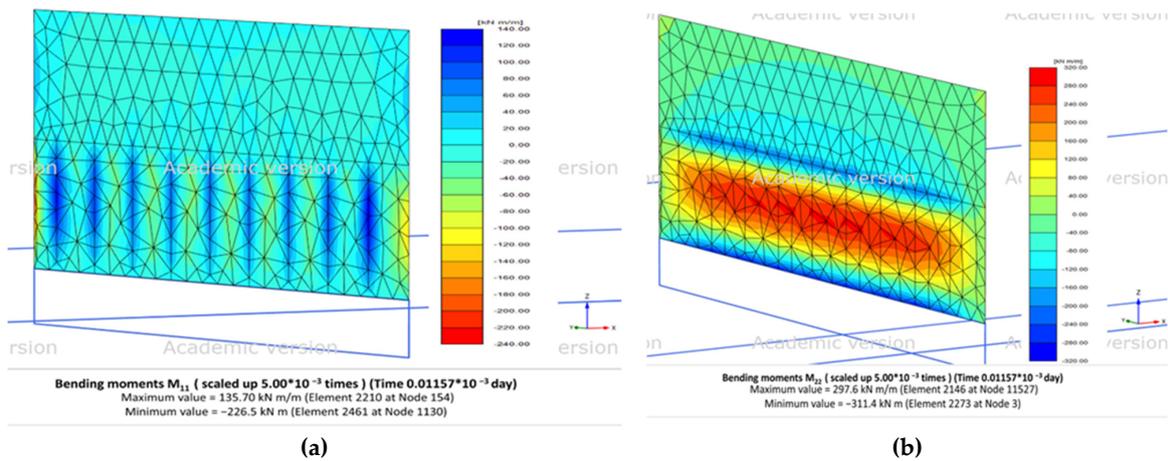
The bending moments of the wall (wall 1) (Figure 1) after the landslide are shown in Figure 13a,b; the maximum bending moment in the vertical direction was 226 kN m/m and in the longitudinal direction, 311 kN m/m . The bending stresses of the wall were calculated by using the maximum bending moment from the finite element model analysis. The actual and permissible limits of bending stresses are presented in Table 1.

Figure 13. Bending moment of the wall after the landslide: (a) vertical direction (out-of-plane behavior), (b) longitudinal direction (out-of-plane behavior).

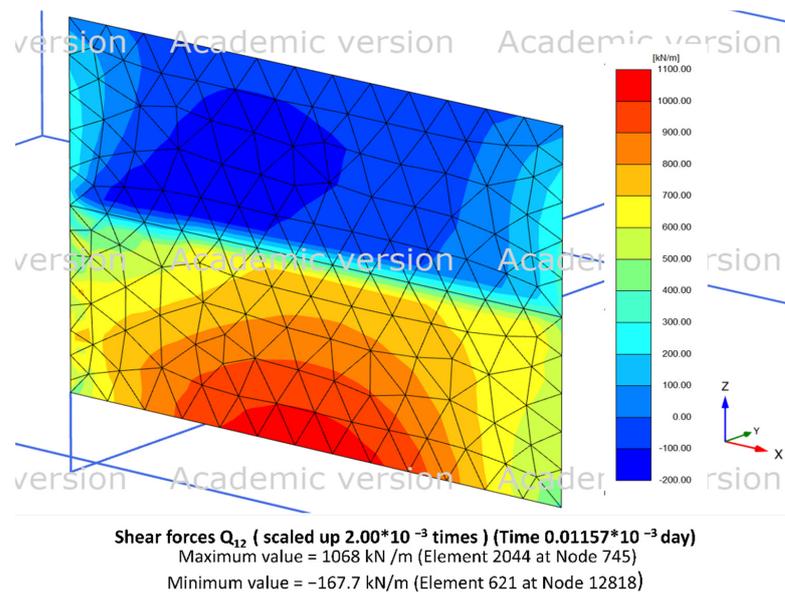
The permissible shear stress of the load-bearing walls was determined by the resisting horizontal forces in the wall and the cross-sectional area of the wall; the permissible limit of shear stress is 0.5 N/mm^2 . The shear stress of the wall (wall 2) (Figure 14) after the landslide is shown in Figure 14; the maximum shear stress of the wall was 1068 kN/m. The shear force after the landslide impact was calculated by using the maximum shear force from the finite element model analysis. The actual and permissible limits of the shear stress are presented in the Table 8.

Figure 14. Shear forces on the side wall (wall adjacent to the rear wall) after the landslide.

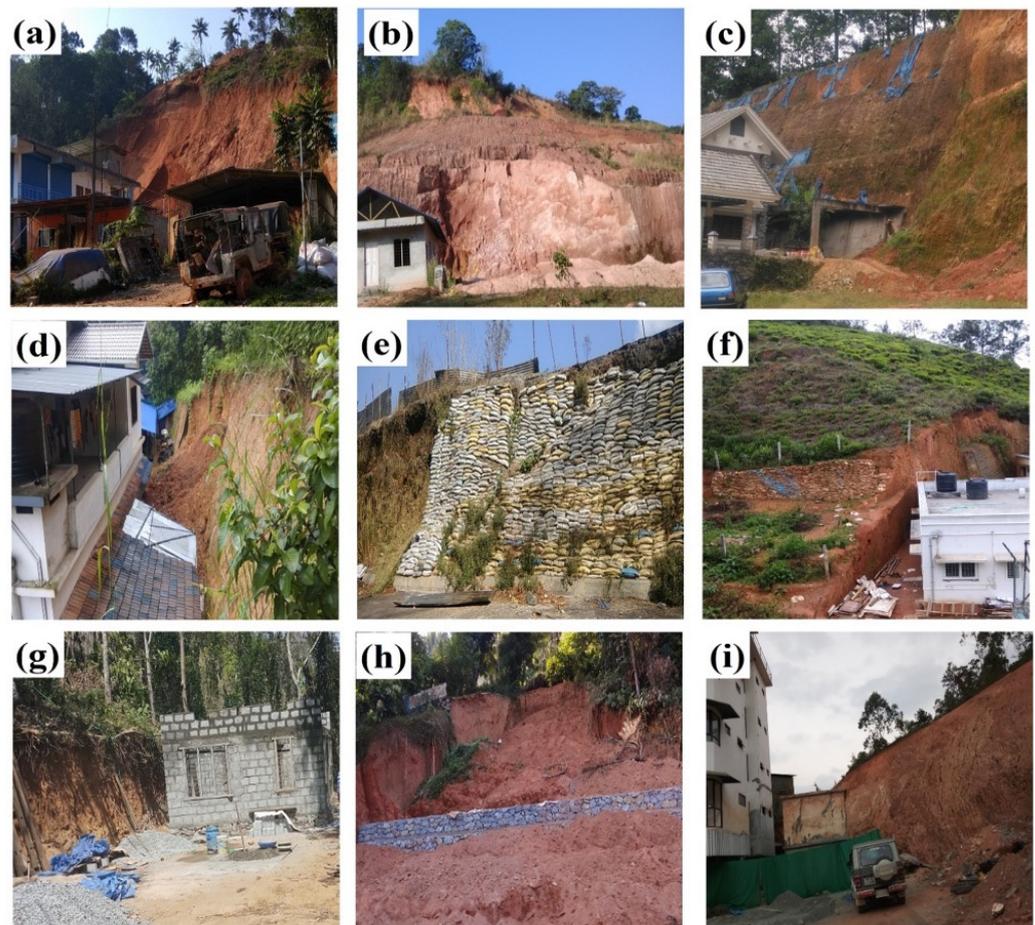
This paper highlights the performance of a building under the impact of landslides and the failure mechanism of rainfall-induced landslides (vertical cut slope failure). The building collapsed due to vertical cut failure and was constructed without proper remedial measures. Various engineering measures can be applied to protect soil vertical cuts. The construction of retaining walls, subsurface drains, gabion walls, horizontal drains, and mechanically stabilized earth walls can reduce the loss during disasters. The well-planned construction of buildings with high-strength structural elements and providing ample space between building and vertical cuts may reduce the damage due to natural disasters. Along the Western Ghats, thousands of buildings and other structures are constructed very close to vulnerable to vertical cuts, which tend to fail during high-intensity rainfall. Figure 15a–i shows that the many residential buildings, commercial complexes, and shops were constructed by making vertical cuts in the hill portion without any safety measures.

Figure 15. Vulnerable locations for vertical cuts: (a) Market place near the vertical cut; (b) Failed vertical cut; (c) Building constructed near a vertical cut; (d) Partial damage of a building due to vertical cut failure; (e) Improper stabilization for a vertical cut near the roadside; (f) Building very close to the slope and vertical cut; (g) New building construction near a vertical cut; (h) Retaining wall construction near a vertical cut; (i) Multistorey building near a vertical cut.
