# Seismic Performance of High-Rise Condominium Building during the 2015 Gorkha Earthquake Sequence

Suraj Malla <sup>1</sup>, Sudip Karanjit <sup>2</sup>, Purushottam Dangol <sup>1</sup> and Dipendra Gautam <sup>3,\*</sup>

Aiming to depict the seismic performance of a condominium located in Kathmandu, this study presents the details of damage recorded during the field reconnaissance. Thereafter then three-dimensional finite element modelling was done for the same building. Description of the case study block, site condition, strong ground motion and visual damage observation are presented together with the results of nonlinear time history analysis to highlight the seismic performance of condominium buildings in the case of low to moderate PGA occurrence.

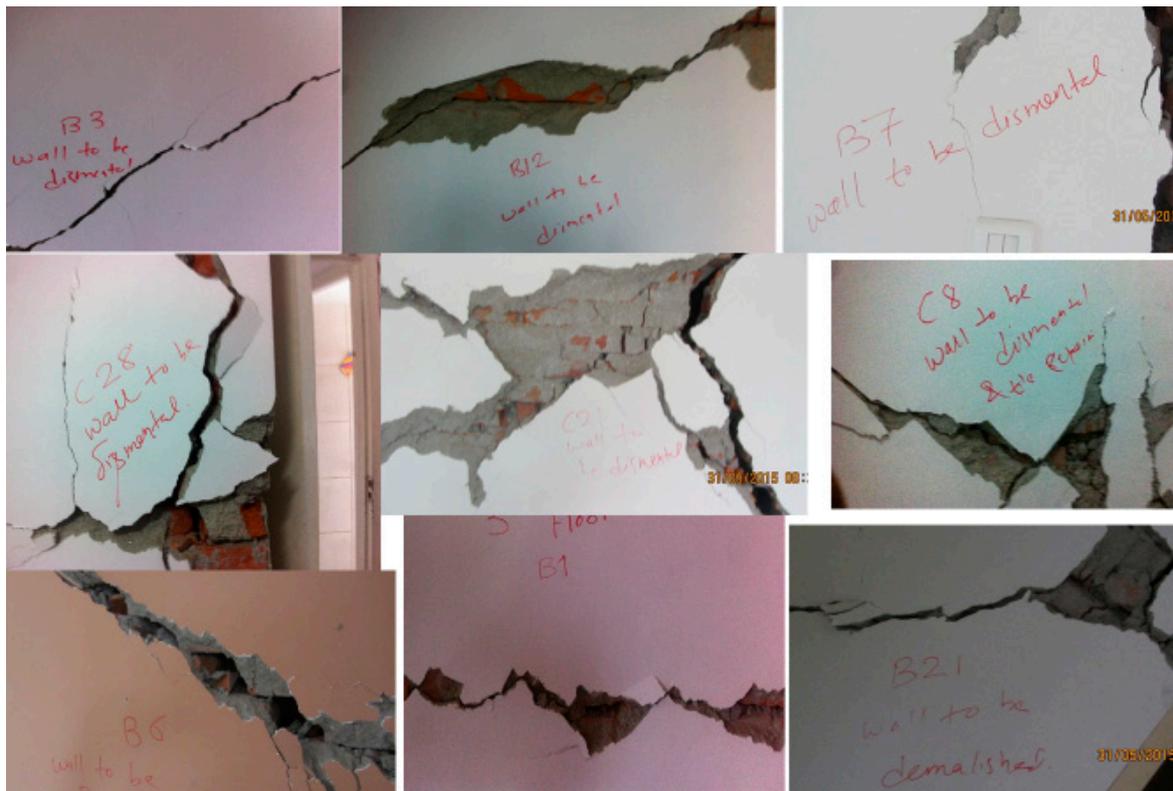
Figure 5 shows a field observation sheet recorded during rapid visual observation. As noted in Figure 5, the building is used for residential purpose and the occupancy range was 101–1000. The building is a space frame building containing infill walls. Infill wall was unreinforced brick masonry; thus, the building type was noted as C3 as shown in Figure 5. The building was constructed following the IS code provisions up to the 7th floor with basement and roof cover and from the observations, the case study building was irregular in vertical direction. As the total score (0.1) was less than the cut-off score of 2.0, detailed evaluation of the building was required. To perform the detailed evaluation of the building, detailed survey was conducted for each component of the building. Mostly, infill wall damage was noted throughout the building. Figure 6 shows the infill wall damage which is present throughout the building. Fundamentally, two major reasons would have contributed to the widespread damage to the infill walls. The first is due to lack of reinforcement so that the masonry units were not able to sustain the shaking as in such buildings infills are provided once the frames are finished. Due to prevalent construction practice of providing infill walls once the frame is completed, the structural and non-structural components would not be duly connected. In addition to damage in infill walls; other recorded damages were categorized into seven types: HLC (hairline crack), PC (plaster crack), PF (plaster fall), WC (wall crack/brick crack), WS (wall spill and shift, that is, shifting of wall due to concrete spill), WB (wall and beam joint crack), MJ (mortar joint crack), TC (tile crack and fall). Distribution of these seven types of damages in each storey was recorded carefully and the damage fraction to each category was also calculated. The distribution of various types of damages in each storey is presented in Figure 7. Different types of damages were noted for each storey of the building first and then as per the occurrence of each damage category, the total damage to each storey was converted to 100%. Thereafter, share of each damage mechanism was calculated and finally Figure 7 was plotted. As shown in Figure 7, plaster crack comprised the largest damage fraction throughout the building. In the ground storey, PC, PF and MJ crack were significant damage types observed during the assessment. Similarly, PF, PC, MJ and WC were noted as the significant damage types in the first storey. The second storey had HLC, PC and MJ as the dominant damage types. The third storey observed PC, MJ, TC and WC as the major damage types. The fourth storey depicted the similar damage pattern as that of the third storey. In the fifth storey, PC, WC, WS and MJ were noted as the significant damage types. The sixth storey reflected that the dominant damage types were TC, PC, MJ and WC. It is noted that the wall crack was also dominant in the upper storeys. This should be

probably due to the effect of strong vertical shaking during the 2015 Gorkha earthquake as highlighted by Gautam et al. [27] and Gautam and Chaulagain [3].

Figure 6. Infill wall damage due to Gorkha earthquake in the case study building.

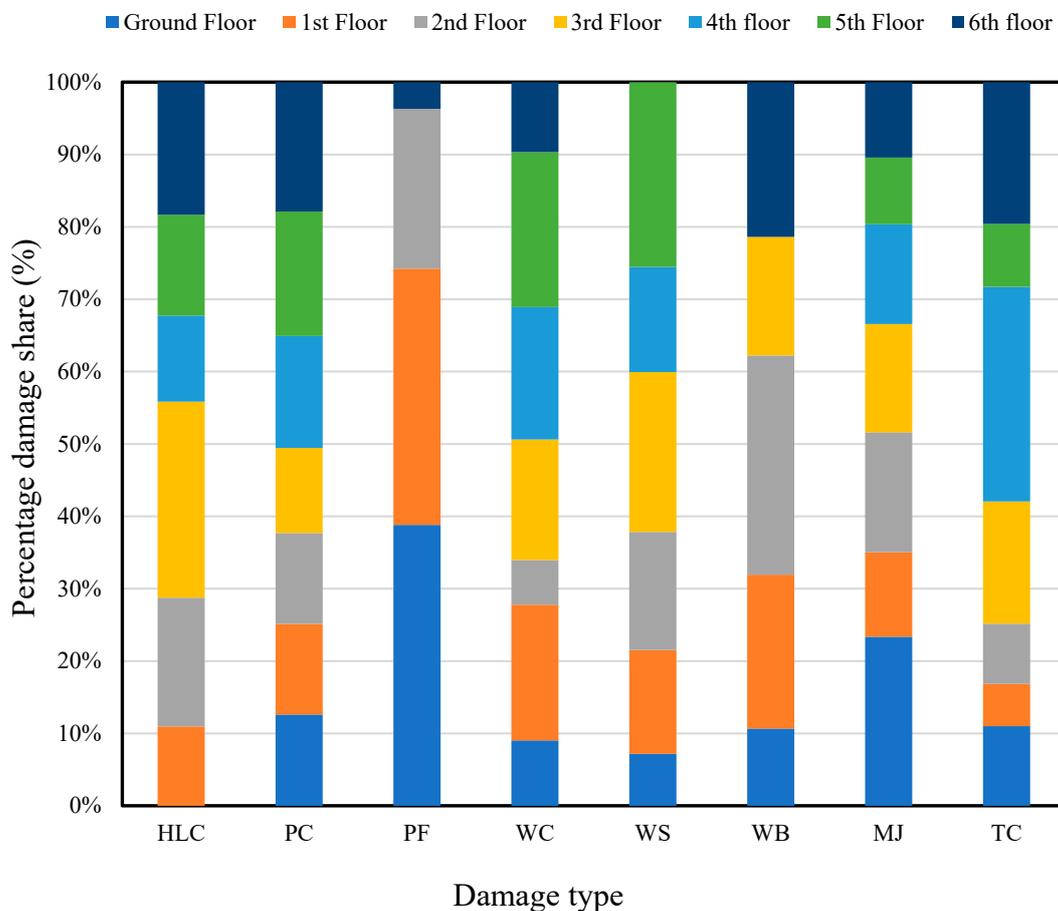
Figure 7. Storey-wise distribution of damage in the case study building.

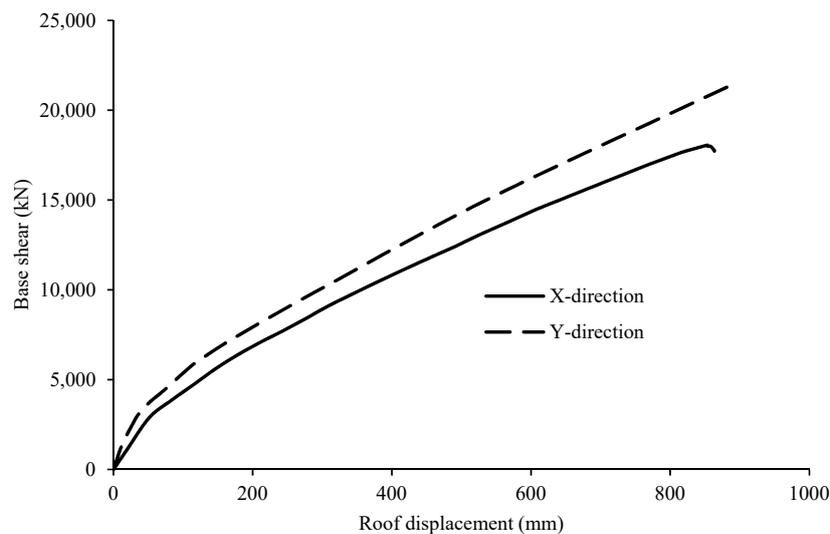
Pushover analyses in the x- and y- directions were performed at first and the pushover curves of the building are shown in Figure 8. As shown in Figure 8, base shear capacity of the case study building can be considered significantly high. The seismic weight of the building was calculated as 51,177.75 kN considering 100% of dead load (DL), 25% of live load (LL) (when  $LL \leq 3 \text{ kN/m}^2$ ) and 50% of live load (LL) (when  $LL > 3 \text{ kN/m}^2$ ). The natural periods of the building in x- and y-directions were obtained as 0.588 s and 0.551 s respectively. To perform pushover analysis, 11 diaphragms were created for the entire structure as shown in Table 1. After assigning the hinges, the storey drifts were obtained from the analysis for both 0.16 g (PGA equivalent to Gorkha earthquake) and 0.36 g (PGA equivalent to the maximum considered earthquake, that is, MCE) PGAs. Both pushover analysis and nonlinear time history analyses were conducted to check the variation of performance of the structure. Figure 9 depicts the inter-storey drift (ISD) plots for pushover and time history analysis for the corner column as well as the centre of mass (CM). As shown in Figure 9, the maximum drift was observed in the second floor (diaphragm 3–4) in the case of time history analysis along the x-axis. Figure 9 also highlights that the pushover analyses leads to conservative results than the time history in terms of inter-storey drift. As the maximum inter-storey drift was limited to 1.2% that falls under ‘operational’ performance level per VISION-2000 [28]. The same performance level was observed during the Gorkha earthquake as well (see e.g., [4]). One more analysis was conducted to depict the behaviour of the building in the case of MCE. Thus, the PGA was scaled up to 0.36 g and both pushover and nonlinear time history analyses were carried out in both x- and y-directions. Using the similar hinge conditions, the ISD for 0.36 g PGA is presented in Figure 10.

Figure 8. Pushover curves for the building.

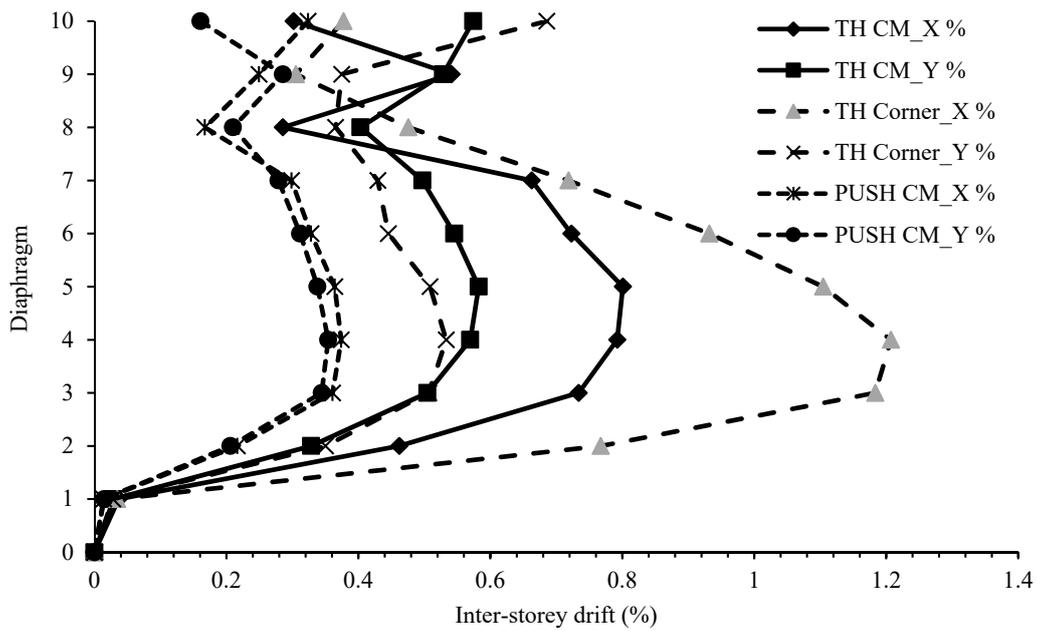
**Figure 9.** Inter-storey drift ratio for the 0.16 g PGA input. In figure, TH indicates the time history analysis and PUSH indicates the pushover analyses conducted in both x- and y-directions.

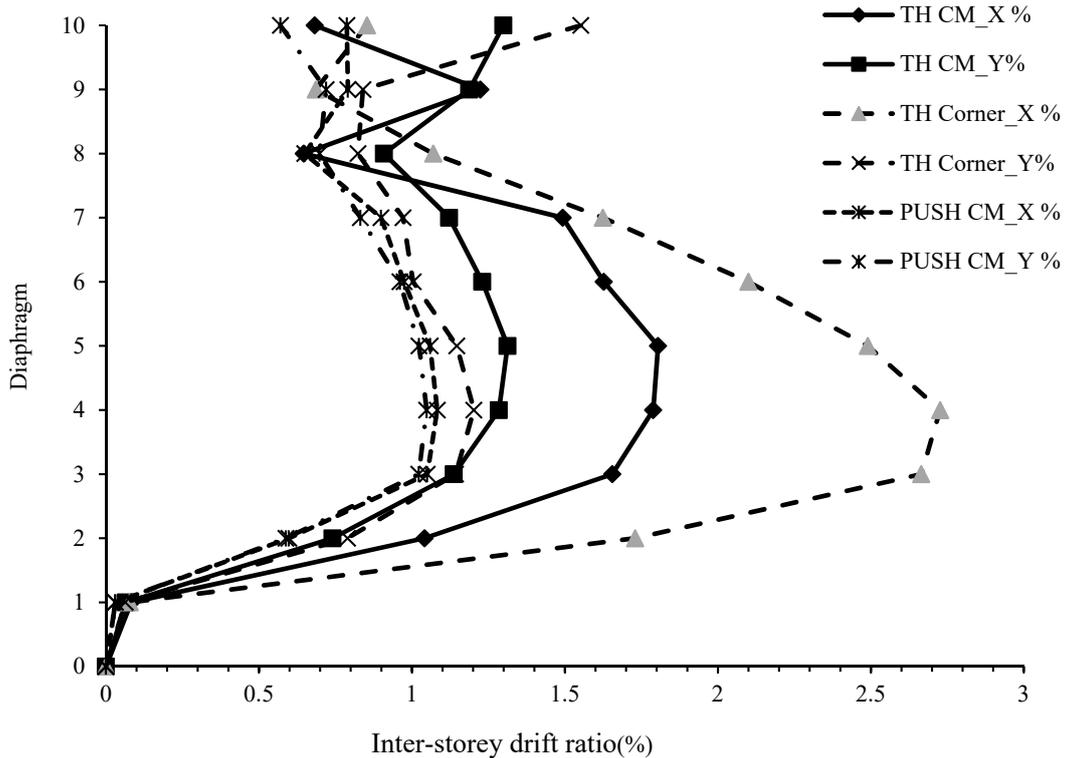
**Figure 10.** Inter-storey drift ratio for the 0.36 g PGA input. In figure, TH indicates the time history analysis and PUSH indicates the pushover analyses conducted in both x- and y-directions.

As shown in Figure 10, the maximum ISD has reached greater than 2.5% which denotes that in the case of MCE, the building would cross the life safety performance level. So, the moderate damage recorded during the Gorkha earthquake should be clearly due to the low PGA occurrence in Kathmandu valley. As in the case of 0.16 g PGA, pushover analyses depicted conservative results in terms of the inter-storey drift at 0.36 g too.
