Failure Analysis of Subway Box Structures According to Displacement Behavior on a Serviced Urban Railway

Keywords: failure analysis; displacement behavior; visual inspection; numerical analysis; subway box structure

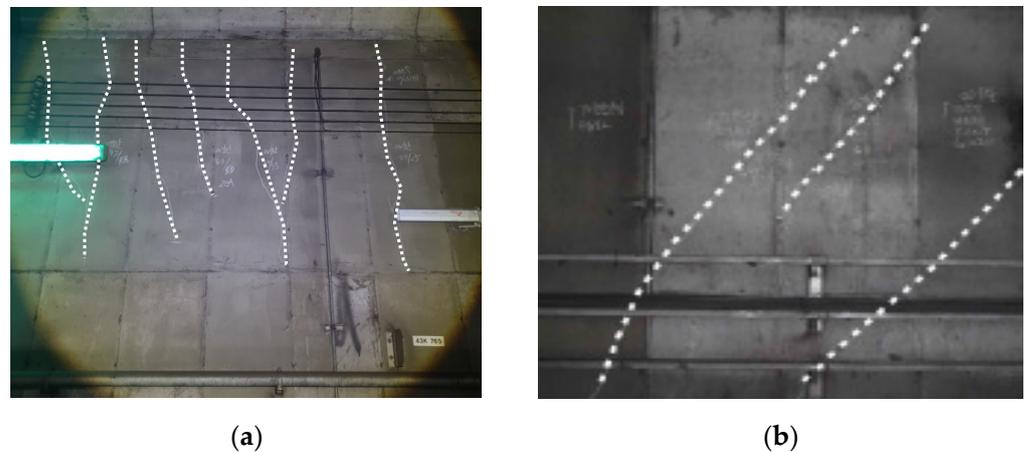
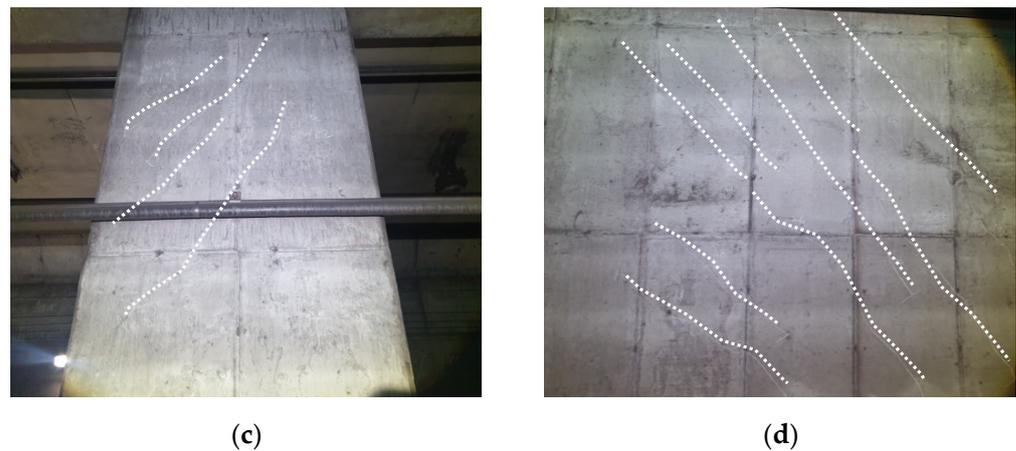
We examined the damage to the structure through a prevision safety diagnosis from 2011 to 2020, in Korea SeoulMetro line 7. The findings of the prevision safety diagnosis of cracks in 2011 indicated no structural safety issues. The findings of the prevision safety diagnosis of cracks in 2016 indicated that most cracks were short and did not cause significant damage. The results of the prevision safety diagnosis of cracks in 2020 showed transverse cracks in the ceiling and wall and diagonal cracks in the lower and upper sides of the wall.

The damaged area in the subway box structure was soft soil, in which the groundwater level quickly dropped during construction adjacent to the subway box structure, resulting in gradual ground subsidence for a long time. This resulted in heaving and settlement, affecting the subway box structure, and creating damage such as cracks.

Figure 1 illustrates the location of the damaged subway box structure. Most networks of fine cracks generated in the ceiling had a crack width of 0.1–0.2 mm. Several diagonal cracks (cw: 0.1–0.3 mm) and transverse cracks (cw: 0.2–0.4 mm) occurred, which were not found five years ago in the columns and walls in the mainline section, as illustrated in Figure 1a–d. The cracks in Figure 1a were caused by differential settlement. Figure 1b shows that diagonal cracks occurred owing to the increase in soil pressure, decrease in sidewall pressure, decrease in soil pressure, and long-term loading. Figure 1c,d shows the torsion due to flexural tension.

Figure 1. Major damage types: (a) wall, transverse crack; (b) wall, diagonal crack; (c) column, diagonal crack (1); (d) column, diagonal crack (2).

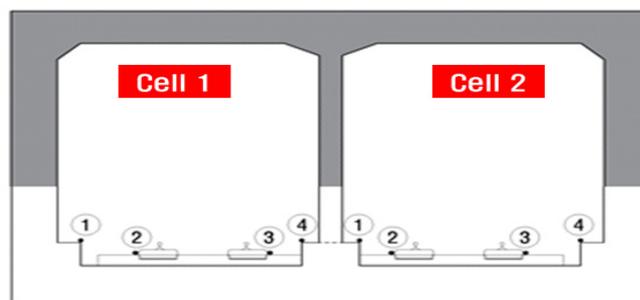
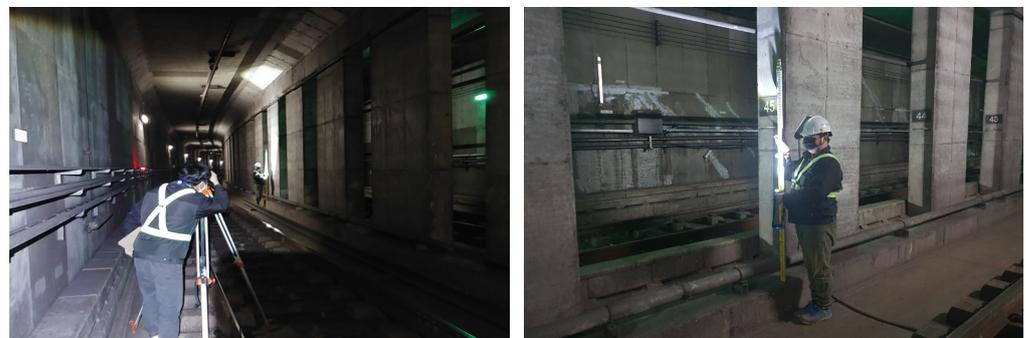
As shown in Figure 2a, to measure the displacement of the structure, leveling was conducted at four points in each up-track and down-track every 10 m, with a total of 104 points. Figure 2b shows the optical leveling. Damage to the subway box structure of Cells 1 and 2 occurred at the point of soft rock, resulting in tensile cracks in the upper part. A sinusoidal crack occurred at the boundary between the soft rock and granitic soil. Settlement occurred in the middle part of the granitic soil, resulting in tensile cracks in the upper and lower parts of the subway box structure.

Figure 2. Optical leveling: (a) points of optical leveling; (b) photographs of optical leveling.

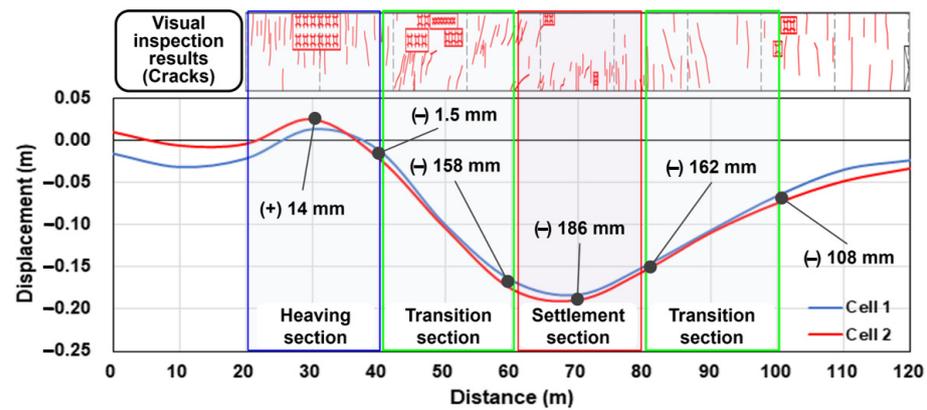
Heaving of 0.01–0.02 m occurred in the 25–35 m section, and the maximum deflection of -0.18 to -0.186 m occurred in the 60–70 m section (settlement section), as illustrated in Figure 3.

Figure 3. Comparison between optical leveling and visual inspection results for each section.

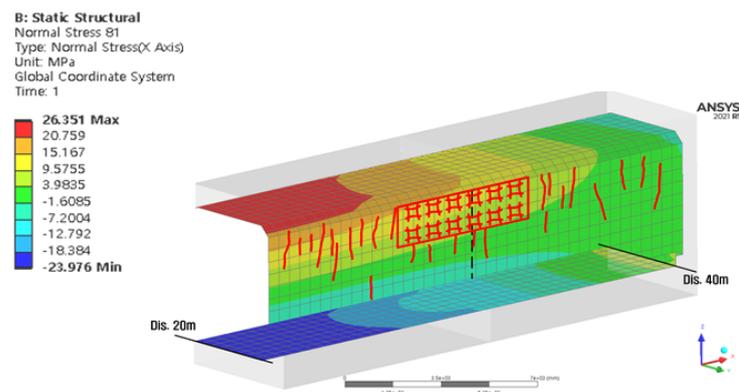
Figure 9. Comparison between the visual inspection mesh diagram and analysis results (Cell 1 wall) for the heaving section.

Compressive stress occurred in the upper part of the Cell 1 wall in the 20–40 m section, and transverse cracks occurred owing to the compressive stress in the upper and central parts of the wall. The analysis results of the stress in the wall at the maximum heaving section showed that the tensile stress that occurred on the lower side of the upper slab was transferred to the upper side of the wall, as shown in Figure 9. Therefore, the magnitude of the analyzed stress at the center of the wall reached the ultimate strength of the concrete.

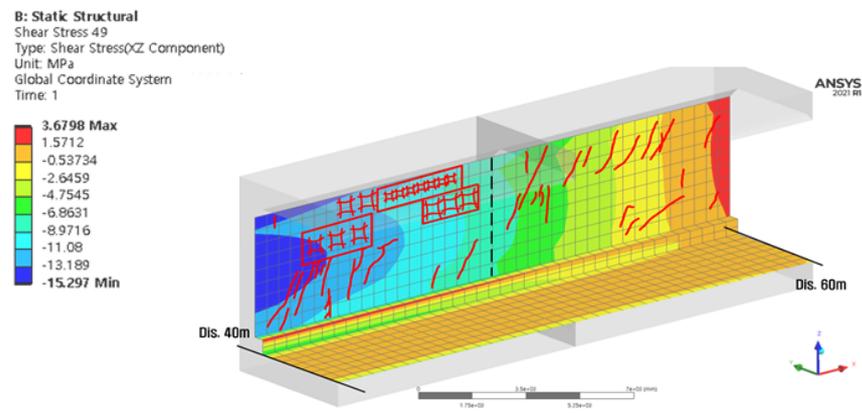
The analysis results of the wall stress in the transition section showed that shear stress that exceeded the allowable shear stress occurred in the wall at the 40–60 m section because of the extreme difference in the displacement and stress of the structure, which occurred in the maximum heaving and settlement sections, as illustrated in Figure 10a.

Figure 10. Comparison between the visual inspection mesh diagram and analysis results (Cell 1 wall) for the transition section: (a) 40–60 m; (b) 80–100 m.

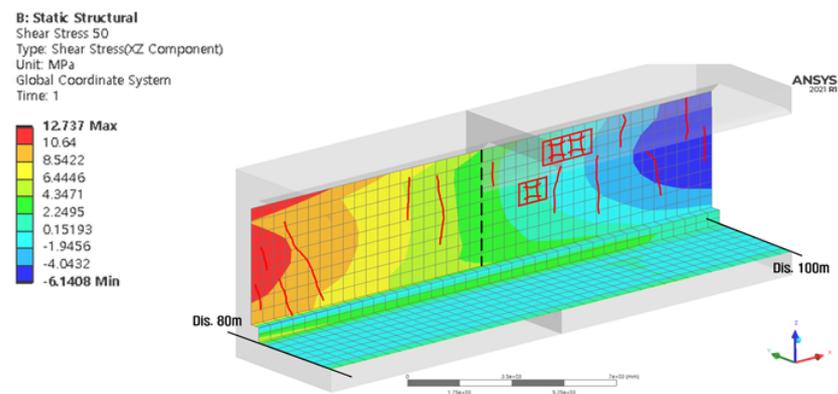
(b)

However, the level of shear stress was small and the onsite crack level was also relatively small in the 80–100 m section where the settlement was converged in the maximum settlement section, as illustrated in Figure 10b, which was a transition section whose deviation of displacement was evaluated to be relatively small. Therefore, the damage level at the transition section directly affected the deviation in the displacement at the adjacent section, verifying that the transition section where settlement and heaving occurred simultaneously, was more vulnerable.

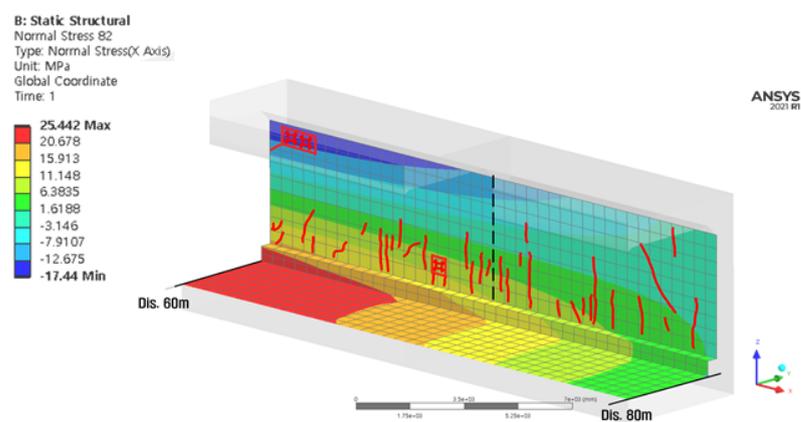
Figure 11. Comparison between the visual inspection mesh diagram and analysis results (Cell 1 wall) for the settlement section.

Transverse cracks in the lower part of the wall and lateral cracks in the construction joints occurred in the 60–80 m section of Cell 1 because of the compressive stress of the slab below the settlement end point, as shown in Figure 11.

The stress analysis results in the wall at the maximum settlement section showed that the tensile stress that occurred on the upper side of the lower slab was transferred to the lower side of the wall, thus affecting the section up to the center of the wall, as illustrated in Figure 11. Therefore, the level of the analyzed stress reached the ultimate strength of concrete. Additionally, the range of the stress levels in the analysis result was relatively consistent with the location and scale of crack occurrence.

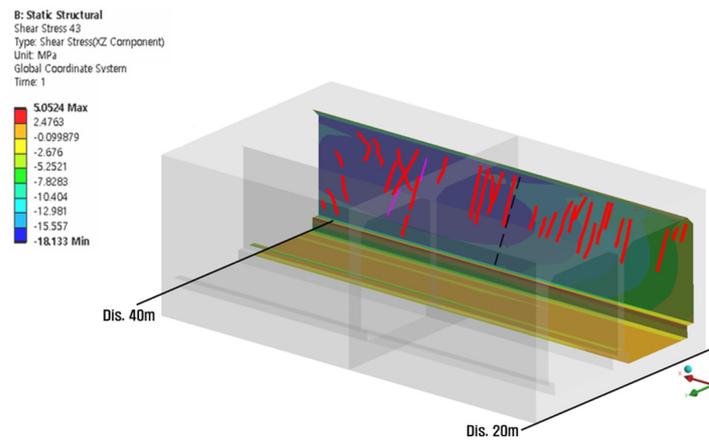
Figure 12. Comparison between the visual inspection mesh diagram and analysis results (Cell 2 wall) for heaving section.

Comparing the visual inspection mesh diagram and FEA of the Cell 2 wall, it can be inferred that transverse cracks occurred in the 20–40 m section because of the compressive stress of the heaving wall, as shown in Figure 12.

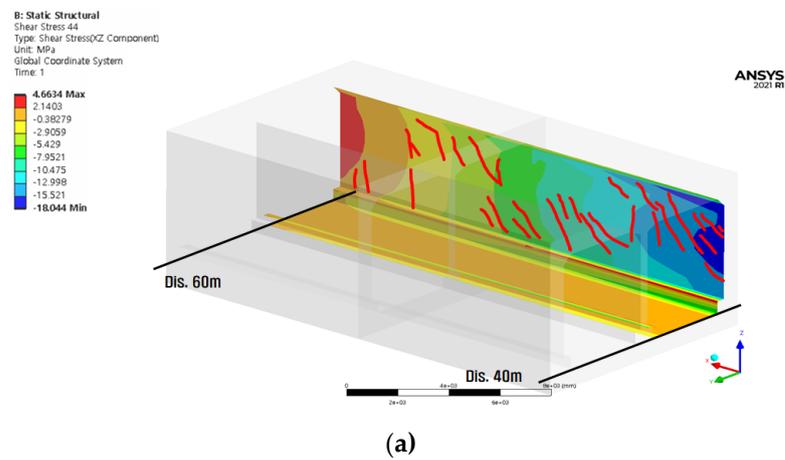
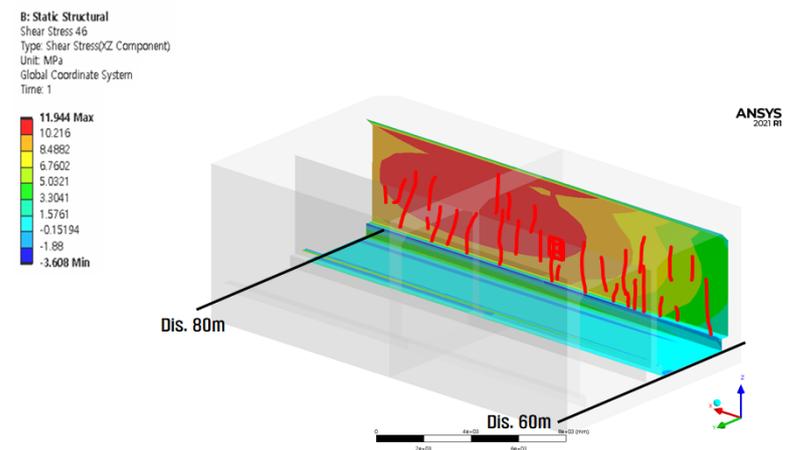
Figure 13. Comparison between the visual inspection mesh diagram and analysis results (Cell 2 wall) for the transition section: (a) 40–60 m; (b) 80–100 m.

In the 40–60 m section, when compressive stress was applied to the wall at the boundary point, a transverse crack at the top of the wall and a diagonal crack in the slab at the bottom of the end point occurred, as shown in Figure 13a. In the 80–100 m section, as shown in Figure 13b, oblique cracks occurred owing to the compressive stress on the wall at the boundary point. Transverse and oblique cracks occurred in the lower part owing to the compression of the end wall.

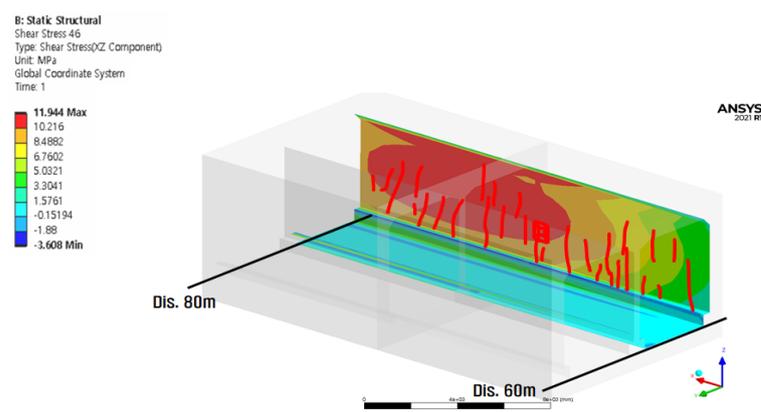
Figure 14. Comparison between the visual inspection mesh diagram and analysis results (Cell 2 wall) of settlement section.

In the 60–80 m section, transverse and oblique cracks occurred at the bottom of the end point of the wall owing to stress transfer owing to the compressive stress of the subsidence slab, as shown in Figure 14.

In the Cell 2 section, lateral cracks occurred in the heaving wall, at the top of the boundary, and at the bottom of the boundary, owing to the combined action of ground heaving and settlement. In addition, transverse cracks occurred in the lower part of the subsidence wall.

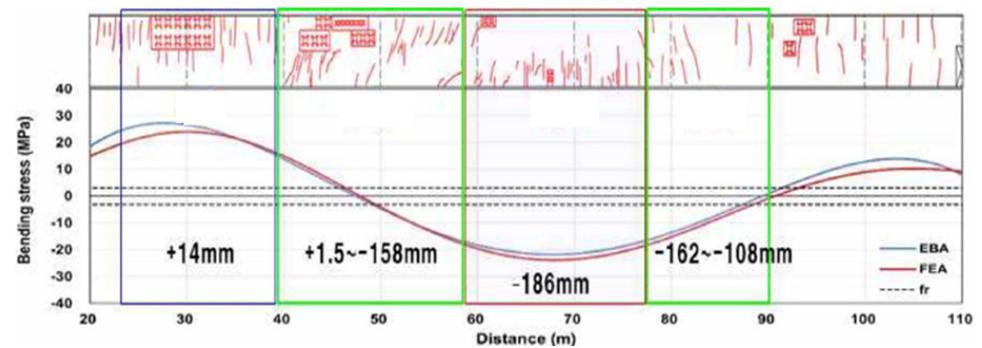
In the case of Cell 1, the compressive stress of most sections exceeded the concrete rupture modulus, as shown in Figure 16a, with transverse cracks in the elevation, diagonal cracks at the upper and lower edges of the boundary, and transverse cracks at the top of the subsidence.

Figure 16. Comparison result of elastic beam and finite element analyses: (a) Cell 1; (b) Cell 2.

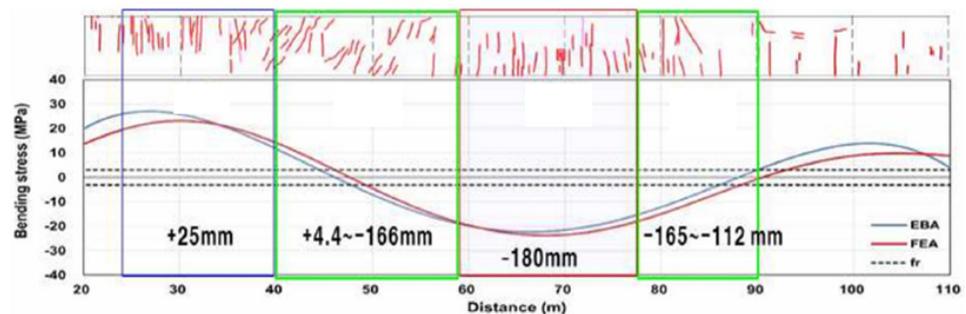
(b)

As shown in Figure 16b for Cell 2, most of the compressive strength exceeded the concrete rupture modulus. In Cell 2, several transverse cracks in the elevation, diagonal cracks at the boundary, and transverse cracks at the top of the subsidence occurred. In
