# Slurry Discharge Pipeline Damage and Wear Due to Transporting Rock Particles during Slurry Shield Tunneling: A Case Study Based on In Situ Observed Results

In this study, data from a slurry shield tunneling machine used to dig a tunnel for the Beijing South-to-North Water Diversion Auxiliary Project were introduced. The tunnel, 6 m in outer diameter and 5.4 m in inner diameter, ran through a pebble layer and rock ground. During machine driving, natural rock particles from the pebble layer and rock fragments due to rock cutting when tunneling through the rock ground were transported in the slurry discharge pipelines of the slurry shield machine. Based on field-measured and observed data, the mechanisms and causes resulting in the observed large, uneven damages and wear were identified and assessed. Countermeasures to address issues such as adjusting pipeline layout, welding reinforcement plates in advance, and preparing additional pipelines were highlighted. The wear rates of different types of pipelines, the effectiveness of new pipeline fixing methods, and the probability of pipeline leaks in different strata were discussed in detail.

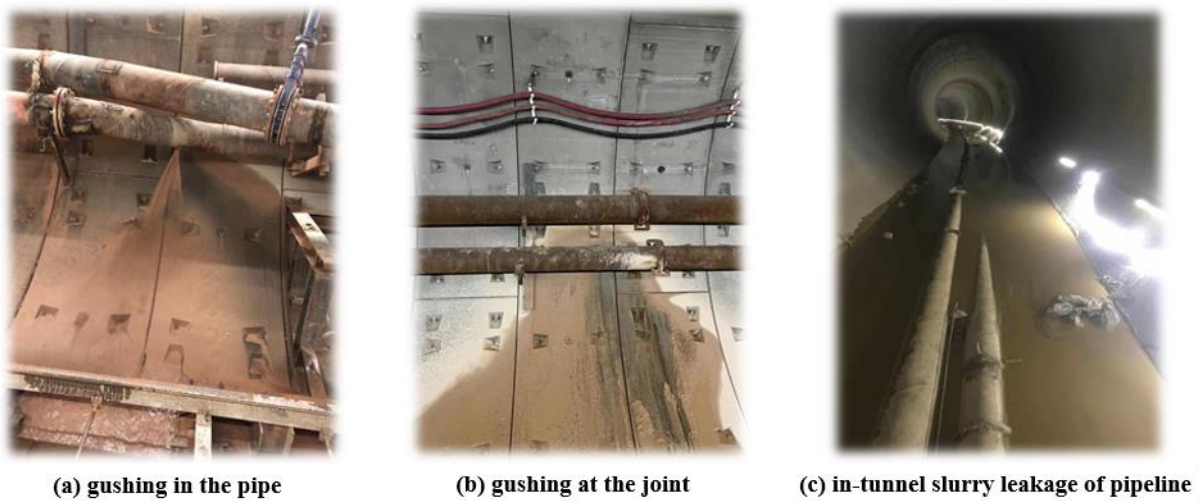
Contact between rock particles and the pipe wall surface is inevitable in slurry pipelining on account of the weight of the rock particles. The contact can be an impact or collision if the rock particles are large and the speed of the slurry is high. Frequent impacts can cause severe wear and even leaks in the pipes. This is true of other components of the slurry transportation system, such as the joints, valves, slurry pumps, and elbows/bends. Slurry gushing can occur in the middle of a pipe or at the joint, as shown in Figure 8a,b. For the pipelines laid in the existing tunnel, slurry even flooded the floor due to pipeline leaks, as presented in Figure 8c.

**Figure 8.** Leakages of pipelines.

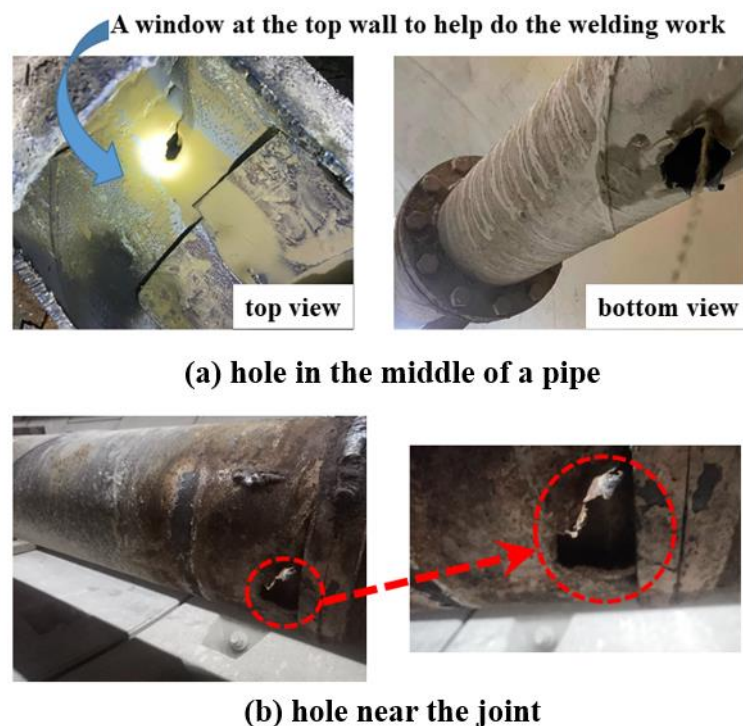
When slurry and rock particles travel quickly in a pipeline, they can add extra wear and tear to the inside. Pipeline leaks occur from the inside out, meaning that erosion works its way from the inside of the pipeline until it reaches the exterior surface. As a result of the accumulated abrasive erosion caused by the moving rock particles, wear and holes, either in the middle of a pipe or near a joint, can occur, as shown in Figure 9.

**Figure 9.** Worn-out pipes.

It was discovered at the jobsite that substantial wear occurred at the bottom half of the straight pipes, and no visible wear was found at the upper half. As a result, it was feasible to reuse the worn pipelines by rotating them 180 degrees, which was completed during construction to save cost.

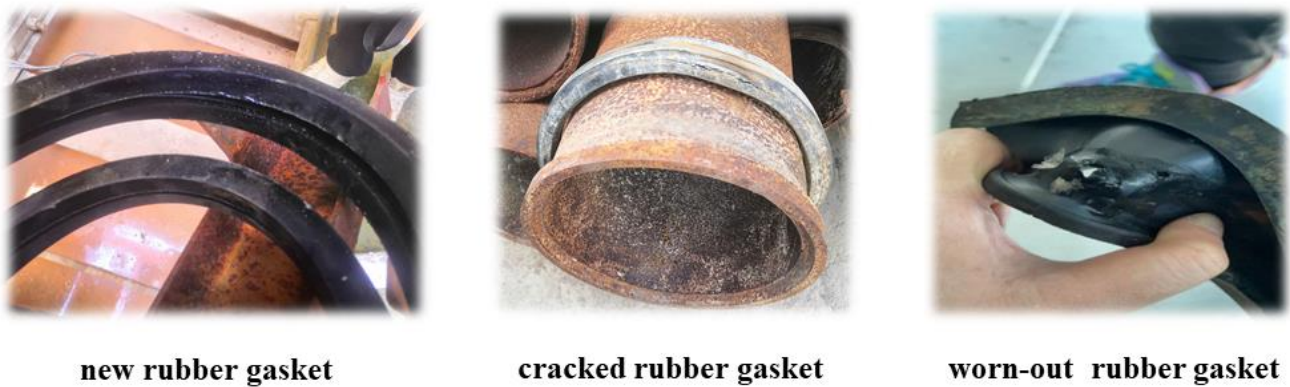
At the onset, two pipes of the slurry pipelining system were joined together by grooved pipe couplings with the aid of a rubber gasket, which, when impacted by many speedy rock particles, was liable to wear out. As shown in Figure 10, rubber gaskets were cracked or worn out over a period of use, which undoubtedly led to leaks in the pipelining system.

**Figure 10.** Damaged rubber gaskets.

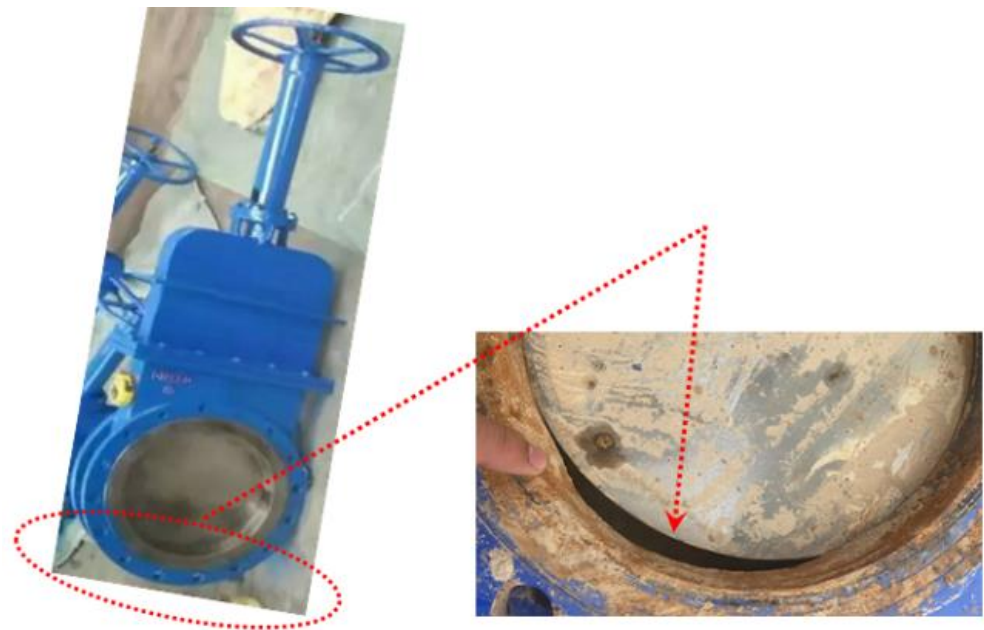
Knife gate valves, suitable for handling slurries of viscous and abrasive media, were employed in the slurry circulation system. As a result of sustained impacts on the gate (the knife-edged disc) of the rock particles, a crescent-shaped gap was created between the disc and the valve body, as shown in Figure 11. The gap resulted in failure to shut off the particle-laden slurry when necessary.

**Figure 11.** Gap between the disc and valve body.

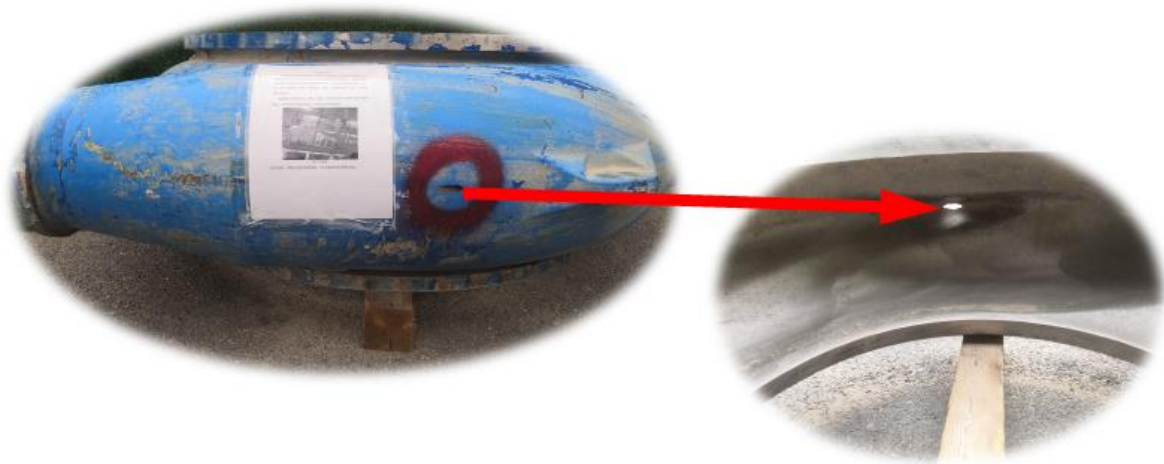
A slurry pump is designed to pump liquid containing solid particles, and hydroabrasive impact is the main cause of flow path wear in a slurry pump. Its intensity depends on many characteristics of the slurry and particles in the handled materials. In view of the large quantities of rock particles transported, the Warman slurry pump in use suffered substantial wear at the casing; as shown in Figure 12, a tiny hole was formed in the casing.

**Figure 12.** Worn-out pump casing.

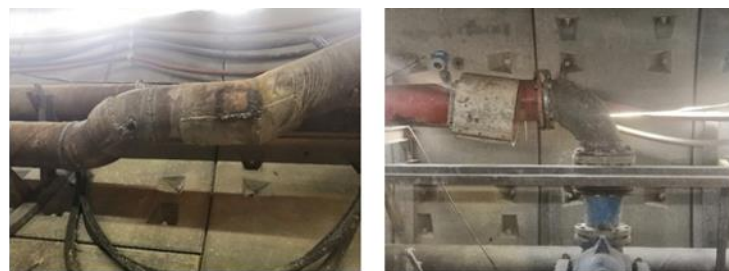
Elbows/bends suffered more wear as a result of changes in the movement direction of the rock particles. To save cost, repaired elbows/bends and pipes were still put into operation, as shown in Figure 13. Severely damaged components, such as the two worn-out elbows presented in Figure 14, were abandoned.

**(a)** Repaired pipe and elbow/bend near the No.2 slurry pump

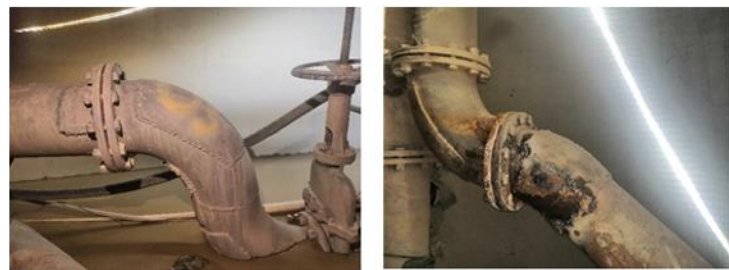
**(b)** Repaired pipe and elbow/bend near the No.3 slurry pump

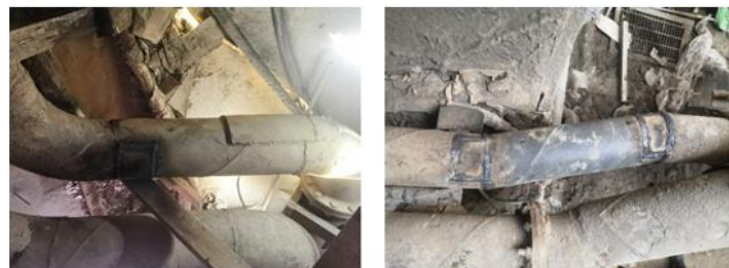
**(c)** Repaired pipe and elbow/bend near the auxiliary shaft

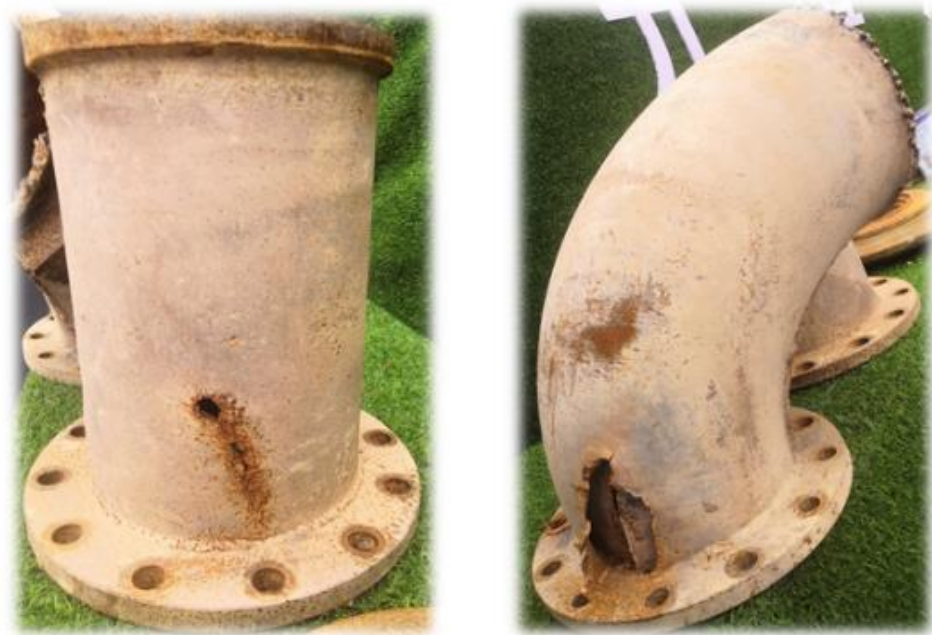
**Figure 14.** Worn-out elbows.

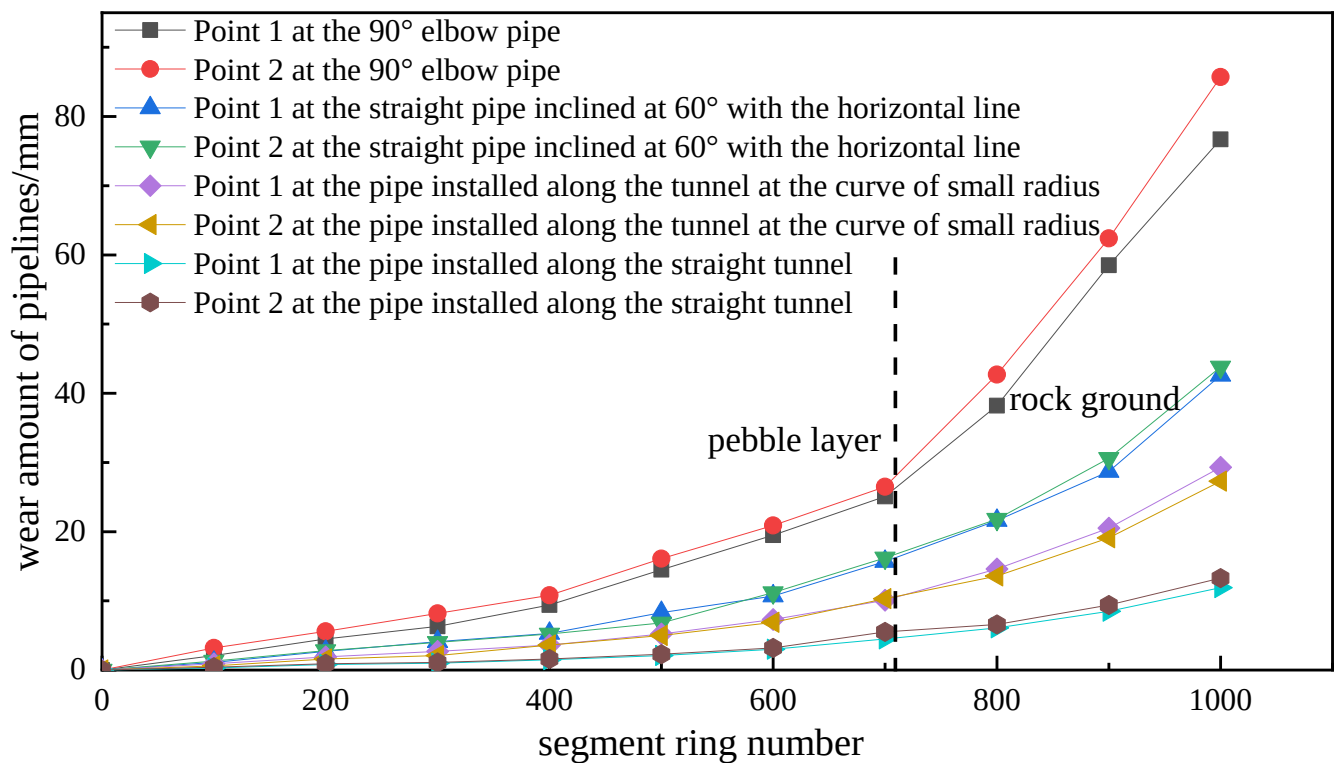
A construction schedule is heavily influenced by the issue of pipeline wear, and monitoring wear at representative positions of the pipeline system is of great engineering significance for taking measures against slurry leaks beforehand. Some representative results are introduced below. Eight monitoring points were arranged at four positions on the pipeline system, with two monitoring points at each position. The four positions were chosen at a 90° elbow pipe, at a straight pipe inclined at 60° with the horizontal line, at a pipe installed along the tunnel at curves with a small radius, and at a pipe installed along a straight tunnel section. From the construction of segment ring 1 to that of ring 1000, wear monitoring of the selected positions was performed. Wear mainly occurred at the pipe bottom wall, and ultrasonic thickness gauges were used to measure the varied thickness of the pipe bottom wall; the wear amount was defined as the decrease in pipe thickness. The monitored results are presented in Figure 15.

Figure 15. In situ measured wear in the pipeline.

Damage and wear caused by transported rock particles were found in each component of the pipeline system. To address pipeline wear, wear-monitoring work was performed, and the results are presented in Figure 15. The largest wear amounts measured were more than 80 mm at the two points of the 90° elbow pipe, indicating that the 90° elbow was the most severely worn part. The straight pipe inclined at 60° with the horizontal was second, with an attained wear amount of approximately 40 mm. The total wear amounts were approximately 27 mm at the monitoring points of the pipeline installed at the tunnel along a small radius curve. For monitoring points along straight pipe sections, the wear amounts were the lowest, at approximately 12 mm. It was found that before segment ring 705, the measured wear rates were slow, at approximately 4 mm per 100 rings of the 90° elbow pipe, approximately 2.14 mm per 100 rings of the 60° inclined pipe, approximately 1 mm per 100 rings of the pipe along the curved tunnel with a small radius, and approximately 0.71 mm per 100 rings of the straight tunnel segment. After segment ring 705, the machine drove into rock ground, and the wear rates increased by one to two times.

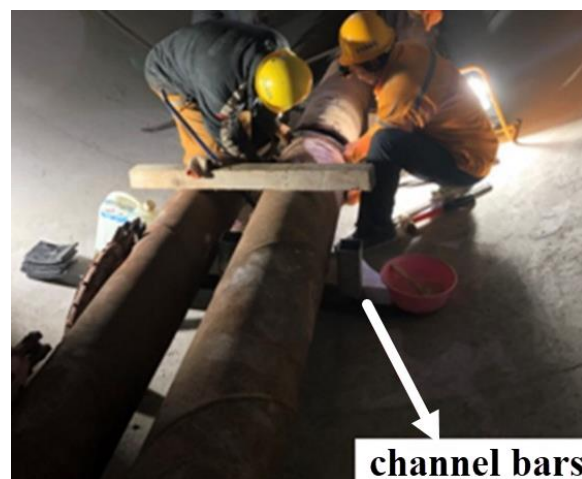
The secondary lining of the existing tunnel, generated from cast-in-place concrete, had already been completed. To protect the finished structure, fixed installations of the slurry pipeline were not allowed. Initially, channel bars, 10 mm wide and 1.5 m long, were laid on the floor. The slurry feed lines and the slurry discharge lines were simply placed on the channel bars with upright columns at the two sides to prevent roll, as shown in Figure 16. However, excessive vibration occurred, and slurry leaks, particularly at the joints, were frequently encountered. Worn-out pipeline sections were difficult to repair due to the wear-outs/holes at the bottom of the pipes, often causing an untemplated halt to construction. To address these issues, updating the mounting of the pipeline was performed.

Figure 16. Pipelines on channel bars.

The important lesson gained in the slurry shield tunneling project concerns the pipeline arrangement and fixation of the slurry circulation system. The slurry feed pipeline and discharge line, approximately 842 m in length, were put in an existing tunnel next to the new tunnel. The secondary lining of cast-in-situ concrete of the finished tunnel was completed, and no damage to the lining was allowed. Therefore, the in-tunnel pipelines were simply laid on brackets on the tunnel floor, as shown in Figure 16. Not enough space was left under the pipeline to perform repair work, and a window had to be cut at the pipeline top, as shown in Figure 9a. In the window, welding steel pads onto the broken pipeline was carried out from within the pipeline. Performing repairs in this fashion undoubtedly created excess work and delayed project construction.

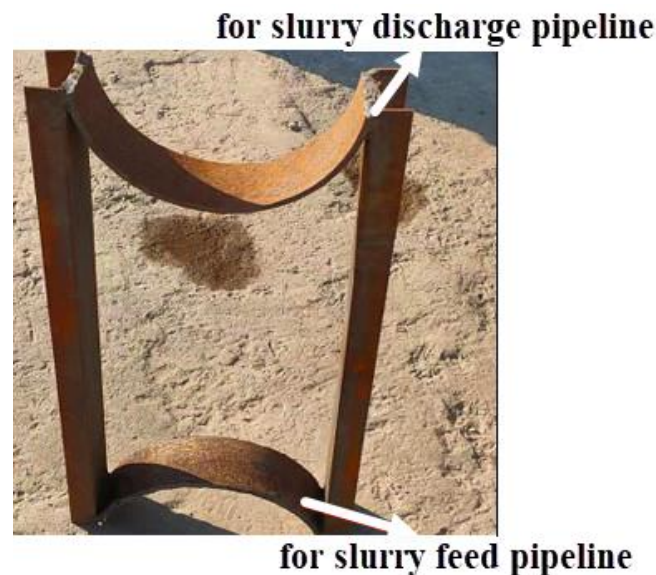
**Figure 17.** New brackets for pipeline.

As shown in Figure 17, newly designed brackets to support pipelines were generally ladder-shaped with two channel bars, 1000 cm in length, at the two sides. A semicircular steel arc with a diameter of 300 mm and width of 100 mm at the top was used to fix the slurry discharge pipeline; a semicircular steel arc with a diameter of 250 mm and width of 100 mm at the bottom was used to fasten the slurry feed pipeline. The steel arches were made from abandoned slurry pipeline components.

To address the issues of in-tunnel slurry discharge pipeline leaks, a new mounting method was adopted to arrange the pipelines on the redesigned brackets, as shown in Figures 17 and 18. This new arrangement allowed more efficient welding work to occur on the broken pipelines. Additionally, the pipelines could be more tightly fixed with the new brackets, thus reducing the transported rock particle-induced vibrations and wear on the pipelines.

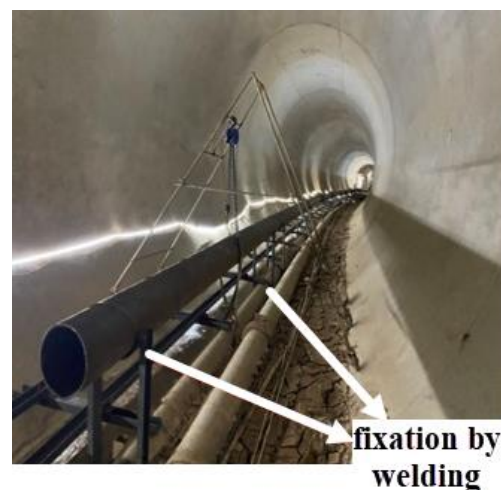
**Figure 18.** The elevated pipeline on the brackets.

As shown in Figure 18, fixed welding between the steel arch and the pipe wall was performed to reduce pipeline leaks associated with pipeline vibration. Most importantly, a working space for repairing leak points of the elevated slurry discharge pipeline was created.

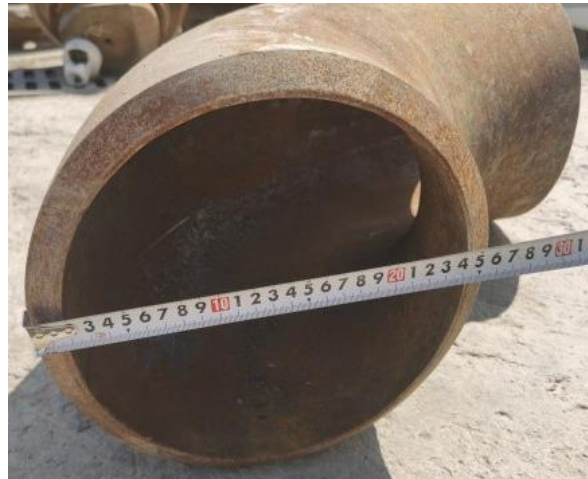
**Figure 19.** A wear-resistant 45° elbow.

Wear-resistant elbows with eccentric thickening were designed and adopted, as shown in Figure 19. The outside wall is 20 mm in thickness, and the inside wall is 10 mm in thickness. The usage of 90° elbows was minimized as much as possible, and the 90° elbows were replaced with 45° elbows to reduce the impact on the pipeline due to rock particle veering, consequently reducing pipeline wear.

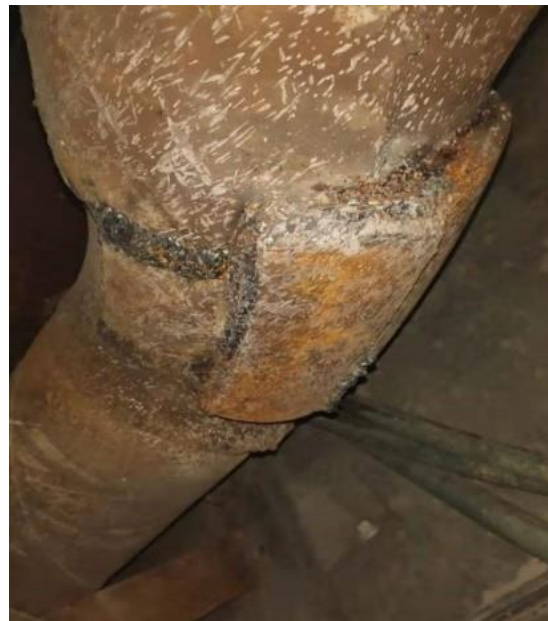
**Figure 20.** Welding reinforcement plates in advance to protect bends in walls.

Performing a jobsite statistical analysis of leak locations in advance allowed us to weld reinforcement steel plates to bends outside pipeline walls liable to be worn out, as shown in Figure 20. The outside wall of the bend pipe was changed to 40 mm in thickness after reinforcement. The reinforced bends could work well for shield driving of approximately 300 segmental ring width according to the experiences gained in the construction.

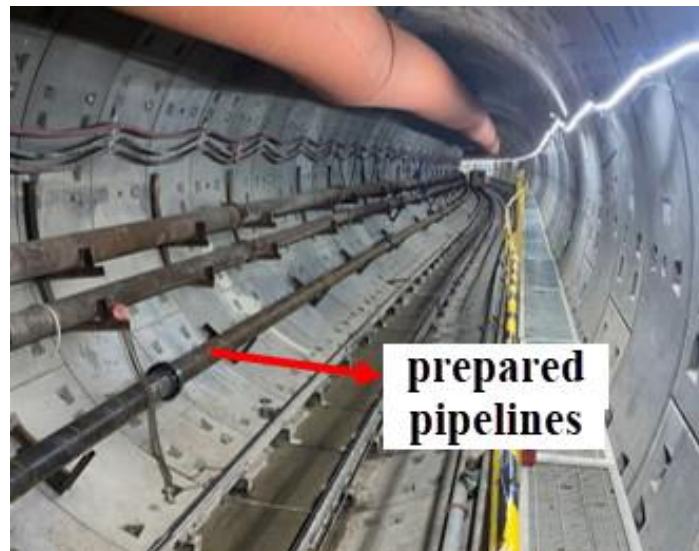
**Figure 21.** Preparing additional pipes beforehand.

was no longer economical, and the use of newly installed pipes was a reasonable solution. Referring to the in situ measured wear rate of pipes to reasonably evaluate the life of the pipeline, additional pipes were installed in time before the worst scenarios occurred, as presented in Figure 21. The prepared pipes could be quickly installed when necessary to reduce machine stoppage time.
