Influence of Discontinuous Linear Deformation on the Values of Continuous Deformations of a Mining Area and a Building Induced by an Exploitation of Hard Coal Seam

Justyna Orwat

Faculty of Mining, Safety Engineering and Industrial Automation, Silesian University of Technology, Akademicka 2A Street, 44100 Gliwice, Poland; justyna.orwat@polsl.pl

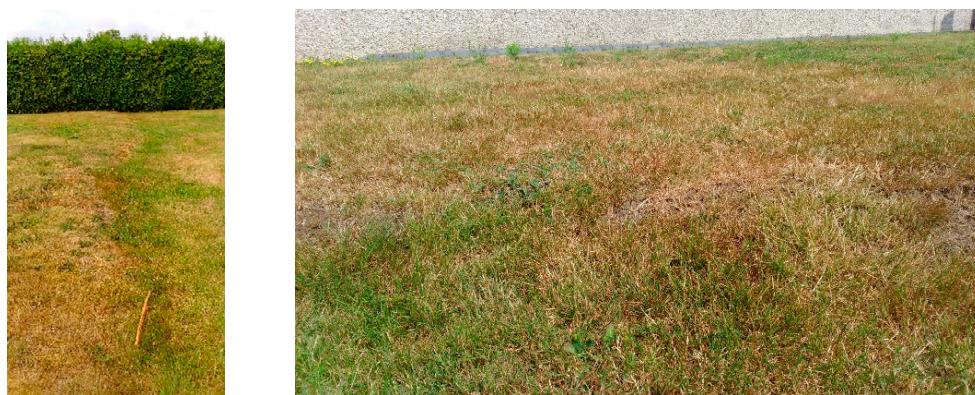
It should be emphasized that a ground step (0.2 m) in front of the north wall of the building, after the end of an exploitation in the 404 hard coal seam and during an extraction conducted in the 405 hard coal seam (in March 2019), has occurred (Figure 4). Therefore, the behavior observations of the terrain surface and the building under the influence of exploitation carried out in the 405 seam began.

Figure 4. Discontinuous linear deformation (a ground step) with a value of fault 0.2 m towards the south.

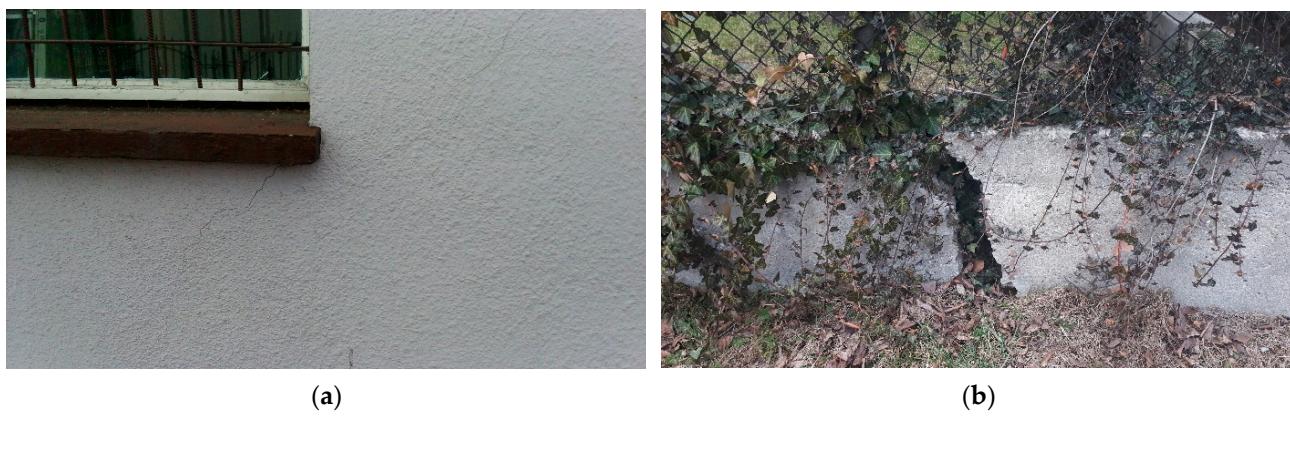
In the building (outside and inside), damage resulting from conducted exploitation has arisen. The eastern wall of the building was especially damaged with numerous scratches and fissures, as well as defects in the plaster. The fence was also damaged (Figure 5).

Figure 5. Damage outside the building: (a) a scratch near window in the east wall; (b) a crack of base of the fence.

- despite the significant leaning of the building and its numerous minor damages, its technical condition can be described as satisfactory. However, minor ongoing repairs and continuous monitoring are necessary.

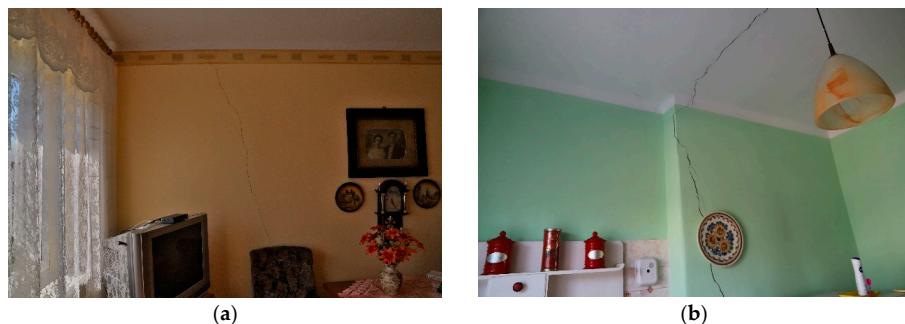
Damage to floors, walls, and ceilings were also noted in rooms located in the eastern part of the building (Figure 6).

It can be seen that the damage occurred in the rooms in the eastern part of the building located perpendicular to the longitudinal axis of the ground step. Minor damage to the rest of the building was observed. It should be kept in mind that the damage may increase if the exploitation in the area intensifies. In this case, the building should be protected against further damage.

Figure 6. Damage inside the building: (a) a fissure in the wall of the living room in the south-east part of the building; (b) a crack in the wall and ceiling in the kitchen in the north-east part of the building.

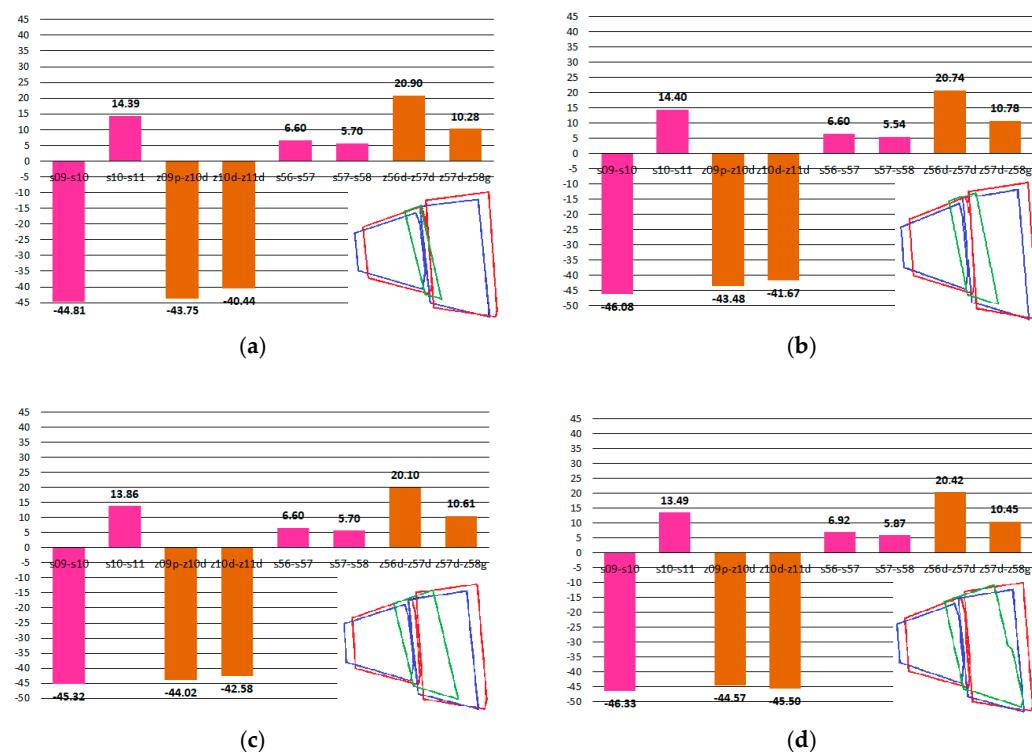
Figure 8. The values of inclinations (vertical axis) observed on the ground sections—brown color and the wall sections—pink color (horizontal axis) in the time period of March–May 2019, and the progress of the I/II longwall in the 405/1 hard coal seam: (a) 19 March 2019; (b) 3 April 2019; (c) 17 April 2019; (d) 10 May 2019.

Data presented in Figure 8 and Table 3 indicate that the exploitation of the 1/II longwall in the 405/1 hard coal seam in the time period of 2 months changes the primal values of inclinations.

A maximum change for the ground points had a place in the case of the 'z10d–z11d' section (a section located closest to a linear discontinuous deformation and perpendicularly to it). This, consecutively, amounted to 1.2 mm/m, 2.1 mm/m, and 5.1 mm/m in the subsequent cycles. This means that an operation of the 1/II longwall in the 405/1 seam caused an increase of 12.5% in the inclination value.

A minimum change for the points stabilized in the ground had a place for the 'z57d–z58g' section (a section located parallel to a ground step). An increase in the inclination value in the subsequent measuring cycles of: 0.5 mm/m, 0.3 mm/m, and 0.2 mm/m (a diminishing increase) has been consecutively noted. That means that the exploitation of the 1/II longwall in the 405/1 hard coal seam caused an increase of 1.7% in the inclination value.

For the wall points, a maximum change took place in case of the 's09–s10' section (a perpendicular section to a linear discontinuous deformation). An increase in the values (1.3 mm/m, 0.5 mm/m, and 1.5 mm/m) has been generally observed. Extraction of a hard coal from the 1/II longwall in the 405/1 seam caused an increase of 3.4% in the value of inclination.

In turn, the smallest change in the inclination values in the building occurred in case of the 's57–s58' section located parallel to a ground step (0.2 mm/m, 0.0 mm/m, and 0.2 mm/m in sequence), which means an increase of 3%.

It can be generally said that a change in the inclination values observed on the sections located in the ground (a maximum value of 12.5%) is greater than it was noted in the wall sections (a maximum value of 3.4%). This means that the ground and the building work in a different way because the building walls have a greater stiffness than the subsoil and are less susceptible to deformations.

The inclinations of the sections (in the ground and on the walls) arranged perpendicularly to the ground step are bigger than the inclinations of the sections lying parallel to the deformation. It can be noted that a discontinuous linear deformation causes an increase in inclination values in a perpendicular direction to its longitudinal axis and a decrease in the inclination values along this axis.

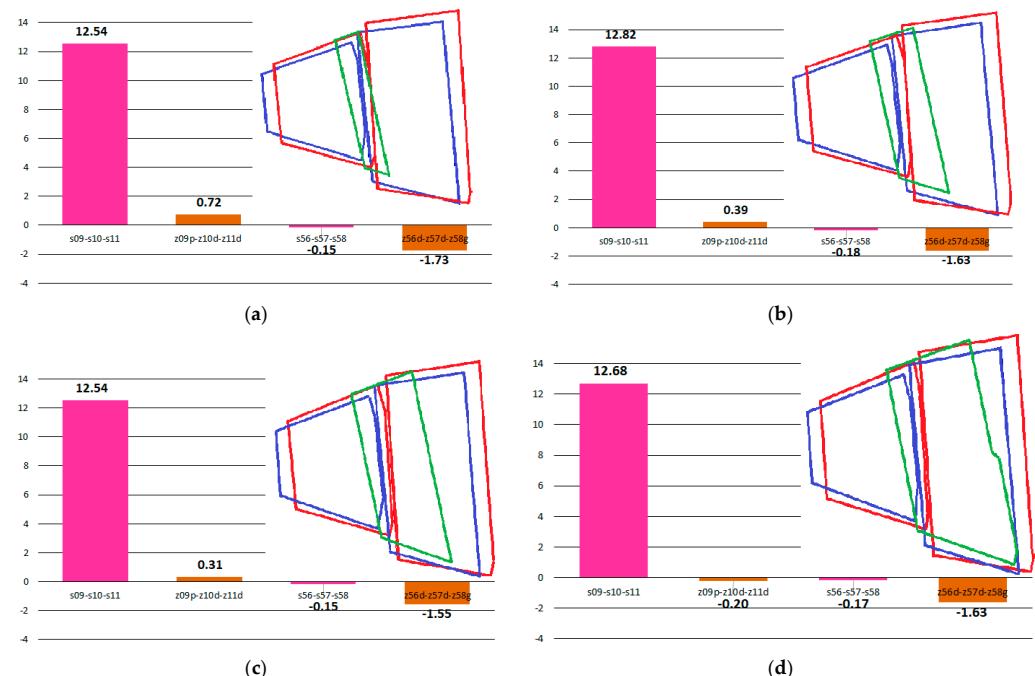
Figure 9. The values of curvatures (vertical axis) observed on two neighboring, ground sections—brown color and wall sections—pink color (horizontal axis) in the time period of March–May 2019, and the progress of the 1/II longwall in the 405/1 hard coal seam: (a) 19 March 2019; (b) 3 April 2019; (c) 17 April 2019; (d) 10 May 2019.

Calculation results shown in Figure 9 and Table 4 prove that the operation of the 1/II longwall in the 405/1 seam in the time period of March–May 2019 changes the primal values of the curvatures.

The general increase in the curvature's values occurred on the wall sections 's09–s10–s11' and 's56–s57–s58'. This, consequently, amounted to 1.1% and 13.3%, relative to the initial values.

A decrease in the initial values of the curvatures in the case of the ground sections 'z09p–z10d–z11d' and 'z56d–z57d–z58g' (127.8% and 5.8% in sequence) has been noted.

The change in the value range of curvatures from 0.02×10^{-3} 1/m for the 's56–s57–s58' sections (a building wall parallel to a discontinuous linear deformation) to 0.92×10^{-3} 1/m (a maximum change) for the 'z09p–z10d–z11d' sections (the ground sections perpendicular to a ground step) has occurred.

The maximum value of curvature was 12.82×10^{-3} 1/m, and, on 3 April 2019, along the 's09–s10–s11' sections located on and perpendicular to the building wall, a

discontinuous linear deformation was noted. The curvature had an about 40 times lower value (about 0.31×10^{-3} 1/m) along the 'z09p', 'z10d', and 'z11d' ground points stabilized in the same direction.

A minimum average value of the curvature as to the absolute value (about -0.16×10^{-3} 1/m) along the 's56', 's57', and 's58' wall points, located parallel to a ground step, has been observed. On the points 'z56d', 'z57d', and 'z58g', established in the ground in the same direction, the curvature achieved an about 10 times greater value (about -1.64×10^{-3} 1/m).

It can be generally noted that the curvatures achieved greater values in a perpendicular direction to a longitudinal axis of a ground step than in the direction parallel to it.
