Failure Mechanism of the Yizhuxiang Collapse under the Joint Effect of Freeze–Thaw and Mining

Abstract: At 10:05 a.m. on 4 February 2022, the perilous rock mass Yizhuxiang in Leizu Town, Yuan'an County, Hubei Province, China collapsed on a large scale. The Yizhuxiang collapse was about 35 m in length, 52 m in height, and 29 m in maximum thickness. The volume of the collapse was $5.32 \times 10^4 \text{ m}^3$. It threatened the transport of the national trunk road, destroyed the branch road and some cement mixing station workshops, and caused serious economic losses. The rock mass exposed in the collapse was dolomite with developed joint fractures. Under the effects of mining and unloading, fractures occurred in the rock mass; the top of the rock mass was bent and deformed towards the free face; and tension cracks were formed on the rear edge. The safety ore pillar directly below the collapsed body was compressed and deformed under the action of gravity, thus accelerating the internal deformation of the rock mass and leading to the formation of multiple dominant joints inside the rock mass. In the winter of 2021, the weather was extreme, with heavy snowfall and low temperatures. Un

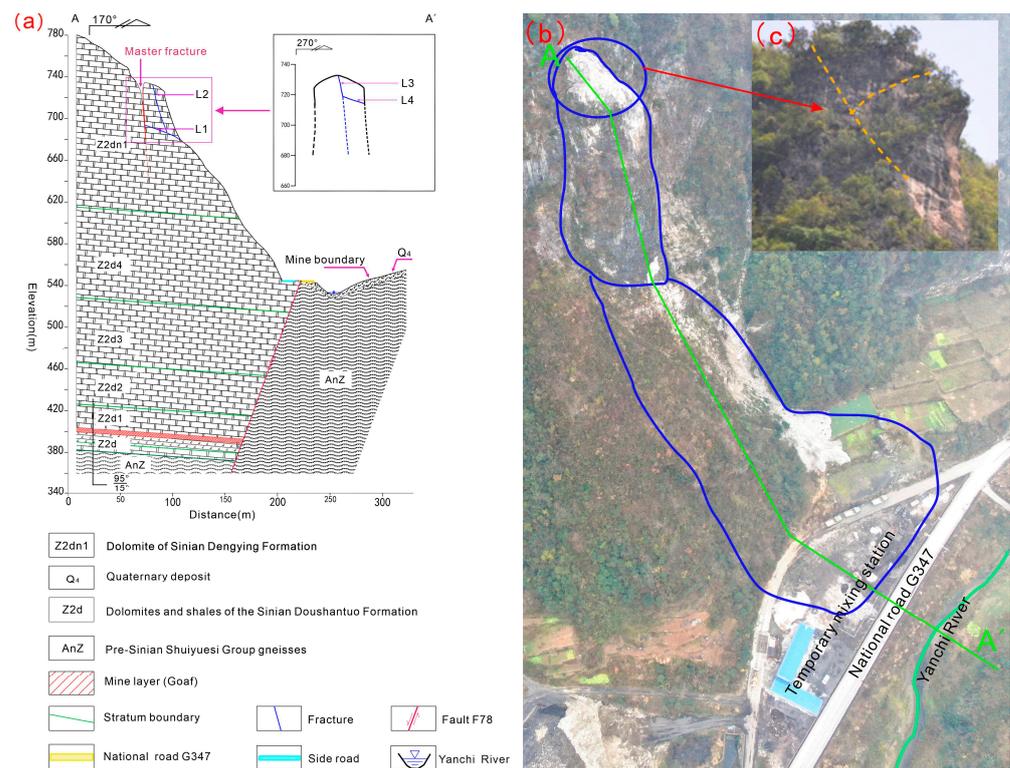
The perilous rock mass Yizhuxiang was “columnar”, had an elevation of 680–732 m and a vertical height difference of about 200 m from the road surface. The Yizhuxiang collapse had three free faces and steep fractures developed on the rear edge. National road G347 and a temporary mixing station were at the toe of the collapse (Figure 2). The rock mass collapsed as a whole along the master fracture on the rear edge. It was about 35 m in length, 52 m in height, 29 m in maximum thickness, and $5.32 \times 10^4 \text{ m}^3$ in volume. It was a medium rock collapse with a dominant collapse orientation of 170° and controlled by the master joints. The perilous rock mass was Sinian Dengying Formation (Z2dn) dolomite and dips 15° toward 95°. The top of the perilous rock mass was demolished by blasting on 3 August 2015.

Figure 2. Geological profile of the perilous rock mass Yizhuxiang: (a) Sectional view of Yizhuxiang collapse body; (b) Photos of the landform before the collapse of the Yizhuxiang collapse; (c) Partial photos of the dangerous rocks at the top of the Yizhuxiang collapse before the blasting.

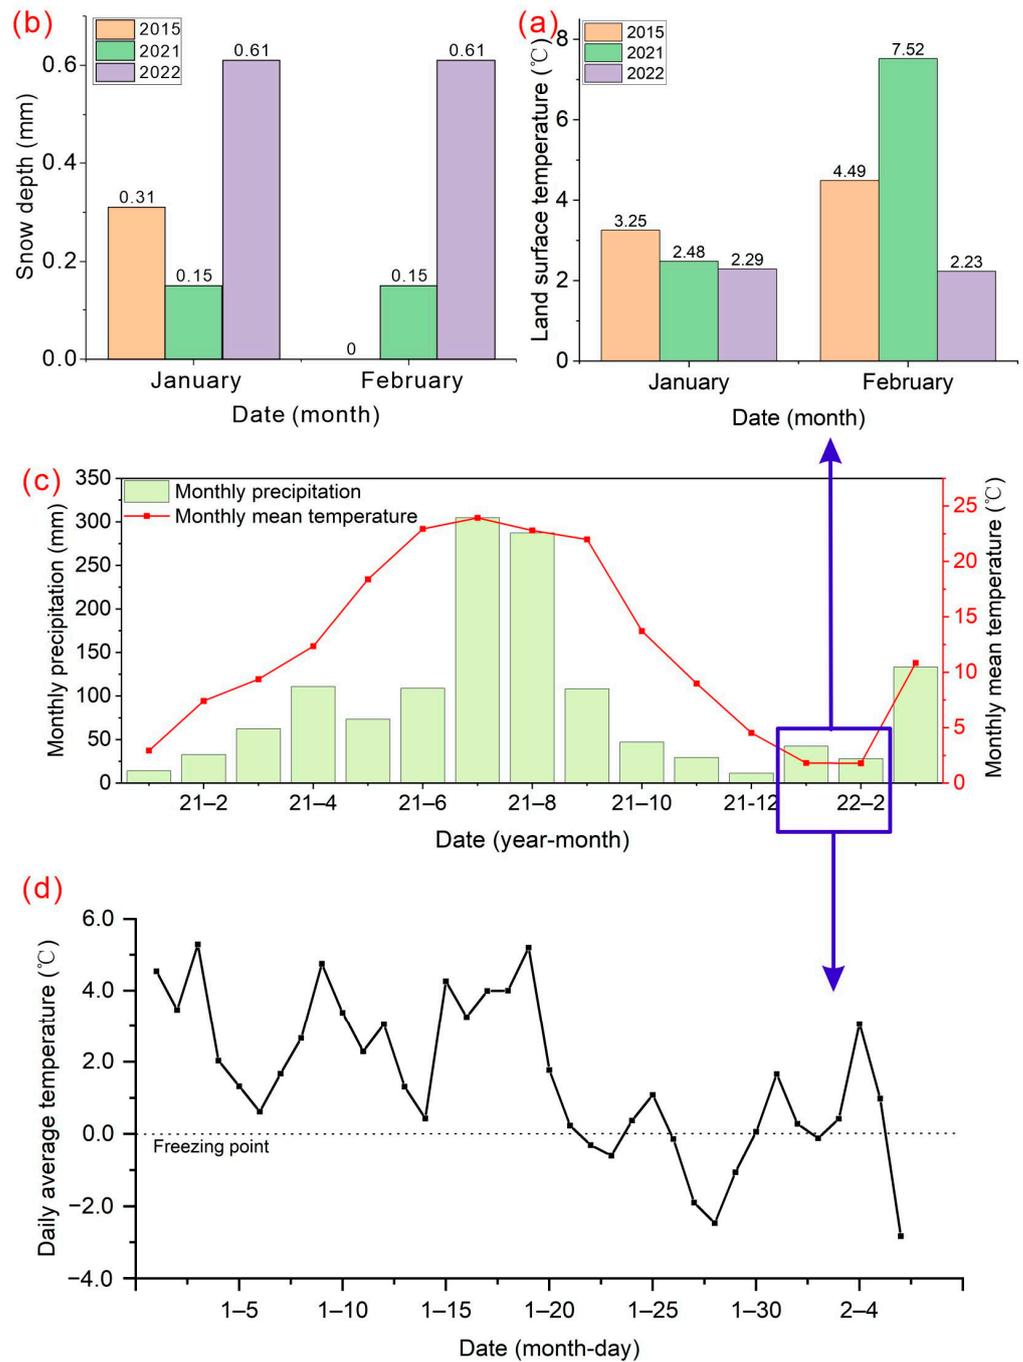
The Yizhuxiang colluvium area has a subtropical monsoon climate with humid air and abundant precipitation. The average temperature was 15.9 °C. The annual maximum and minimum temperatures were 40 °C and −13.5 °C, respectively. The annual average precipitation was 1114.5 mm. It is cold in winter and has a long period of ice and snowfall. The period from December to March of the next year is a period of intermittent freezing. The maximum snow depth was about 300 mm. The land surface temperature in February 2022 was about 5 °C lower than in previous years (Figure 3b). The average temperature from the end of January to the beginning of February fluctuated around 0 °C (Figure 3d). The snow depth was 4.07 times that in 2021 (Figure 3a).

Figure 3. Comparison of the weather conditions in the studied area in 2021 and January and February of 2015, 2021, and 2022: (a) Comparison of snow depth in January and February in the study area; (b) Comparison of surface temperature in January and February in the study area; (c) Climate conditions in the study area from January 2021 to March 2022; (d) Daily air temperature changes before and after the collapse of Yizhuxiang in the study area.

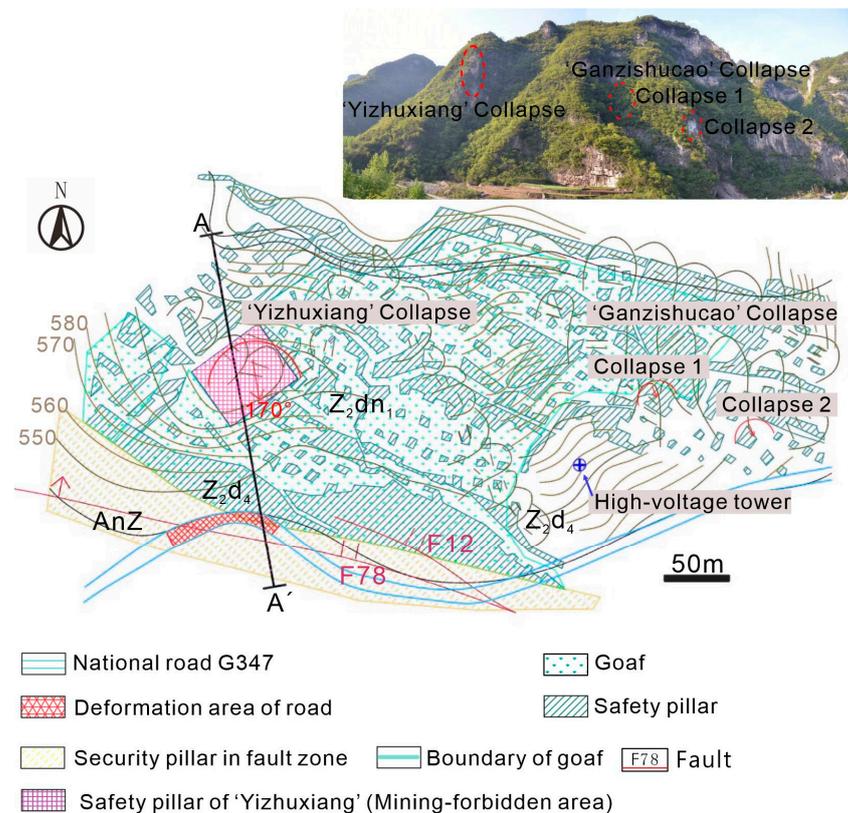
The mining of underground phosphate ores in the studied area was started in 2013 and stopped in July 2014. The goaf was nonfirmly backfilled with slag muck. The total area of the goaf was about 0.5 km². The safety pillars in the goaf had section dimensions of 1.5 m × 3 m and 2 m × 2 m and had a spacing of about 12.5–15 m. The safety pillars remained under the rock mass Yizhuxiang, with a length and width of 61 m and 52 m, respectively (Figure 4). An investigation in 2015 showed that the rock was relatively fragmented after the pillars were squeezed and collapsed. Structural fractures were relatively developed in the roof, and roof fall occurred. Three floor heaves were found on the floor. They had a height of 0.20–0.5 m and a maximum floor heave of 1.10 m. This showed that the tunnel and the safety pillars were subjected to great stress.

Figure 4. Floor plan of the goaf in the studied area.

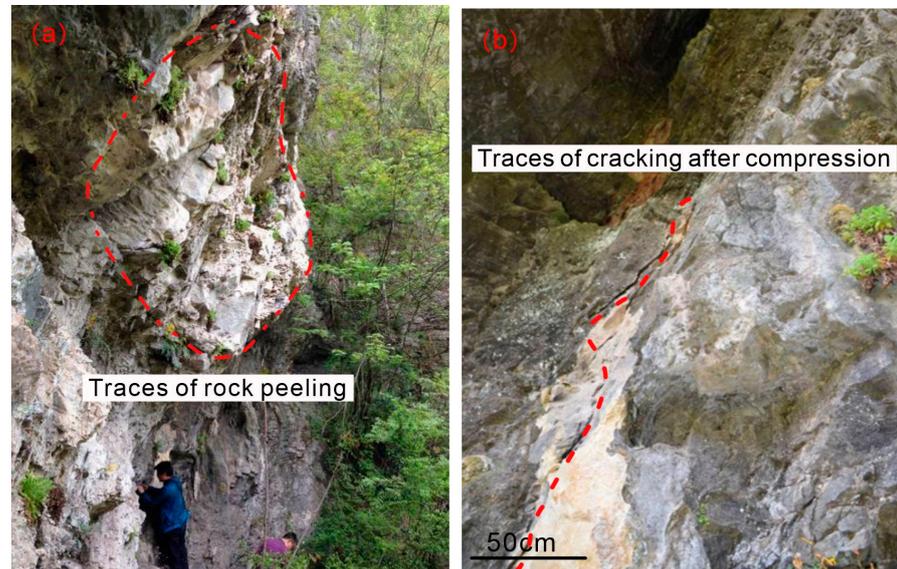
A field investigation was carried out after the deformation of the perilous rock mass significantly increased in 2015. The investigation found that the base surface was obviously split (Figure 5a), and had several traces of spalling of small-sized blocks with a diameter of 5–37 cm. In addition, traces of fracturing opening (Figure 5b) were developed on the structural plane of the master fracture on the west side of the base and showed twist compression towards the southeast. The rock mass was flaky. This showed that the

structural plane of the master fracture on the rear wall of the rock mass was in the stage of development and extension from top to toe, and from west to east, gradually cutting the rock mass from the base into an independent block.

Figure 5. Deformation of the rock base on the east side of the rock mass Yizhuxiang: (a) Rock spalling on the base surface on the east side of the collapse body; (b) Opening traces of fracturing at the base on the east side of the collapse.

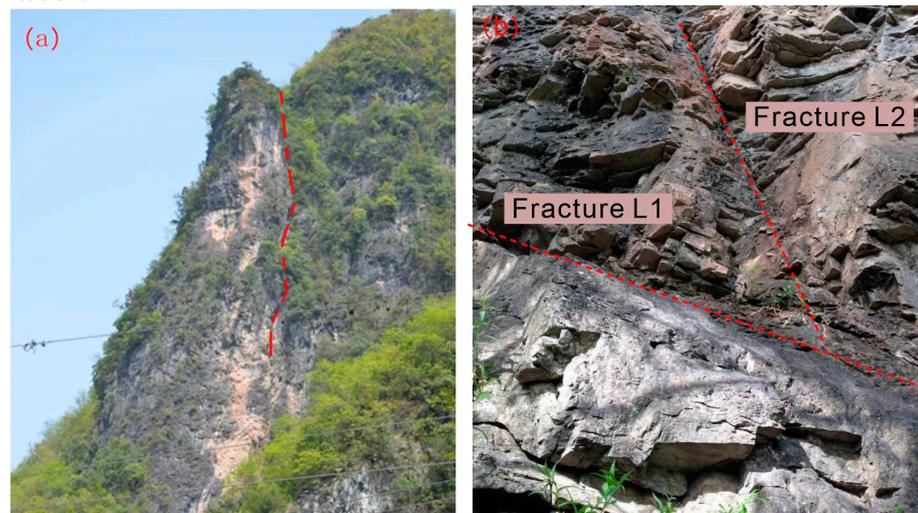
The rock mass was developed with joint fractures, including five dominant fractures in total: master fracture, L1, L2, L3, and L4 (Figure 2, Figure 6). The master fracture on the rear edge dips 83° toward 190° . The fracture surface was rough and locally filled with broken stones. The master fracture controlled the stability of the whole perilous rock mass. Figure 7b shows the changes of master fracture at the posterior edge of the dangerous rock mass and road cracks under the condition of rainfall. From 2 January to 8 February 2015, the width of the master fracture was basically unchanged. However, after the precipitation on February 26, the fracture width increased significantly and gradually increased at a rate of 0.13 mm/day. After 11 March, the displacement rate further increased to 0.37 mm/day. The cumulative displacement reached 25 mm on 10 April, and then gradually became stable. The crack on the road at the slope toe showed the same change trend. From 10 February to 27 March, the cumulative width of the crack reached 40 mm. On 15 April, the cumulative width reached 49 mm and then became stable. On 27 April, the cumulative displacement experienced a stepwise increase. The precipitation in the studied area had obvious characteristics from the end of February to the beginning of April. The daily precipitation increased, and the duration of precipitation increased. The precipitation on 17 March reached 33.528 mm, more than three times that on 10 February, and 15 times that on 29 January. Every day in the 14 days from 26 March to 8 April was a day of precipitation. After that, the precipitation frequency decreased significantly, however, the single-day precipitation was heavy. In 2015 (Figure 3a,b), the average snow thickness depth was 0.31 mm in January and there was basically no snowfall, and the land surface temperature was relatively high after February. The snow depths in January and February 2022 were much higher than those in 2015 and 2021, and the surface temperature in January and February 2022 was lower than those in previous years. Compared with January 2021, January 2022 had a similar temperature and higher precipitation (Figure 3c). Compared with February 2021, February 2022 had similar precipitation and a lower temperature. Therefore, the changes in the cracks were particularly obvious from the end of February to the beginning of April 2015, and the changing trend was similar to that of precipitation.

Figure 6. (a) Master fracture (before blasting) (b) Fracture L1 and Fracture L2 intersected.

The other four dominant fractures—L1: dips 33° toward 180° , about 18 m in length, the fracture surface is slightly open and straight, extending toward the rear wall of the dangerous rock mass; L2: dips 76° toward 175° , about 30 m in length, 1–5 cm in average crack width and 20 cm in maximum width; L1 and L2 intersected (Figures 2 and 6b); L3: dips 82° toward 285° , about 30 m in length, about 5–30 cm in fracture width; L3 was located on the back (north side) of the rock mass and developed from top to toe, with a rough crack surface. It was filled with broken stones and relatively fragmented stones at the bottom of the fracture; L4: dips 35° toward 210° , about 4 m in length and about 5–10 cm in width; L3 and L4 intersected. The rock mass at two fracture openings was obviously weathered. The surface of the rock mass on the rear (north side) was obviously split. There were signs of collapse and block falling near both the west and the east “base”, and “cavities” had been formed locally. The above content is the description of the morphology of the four nonmain control fractures by the surveyors in August 2015. According to

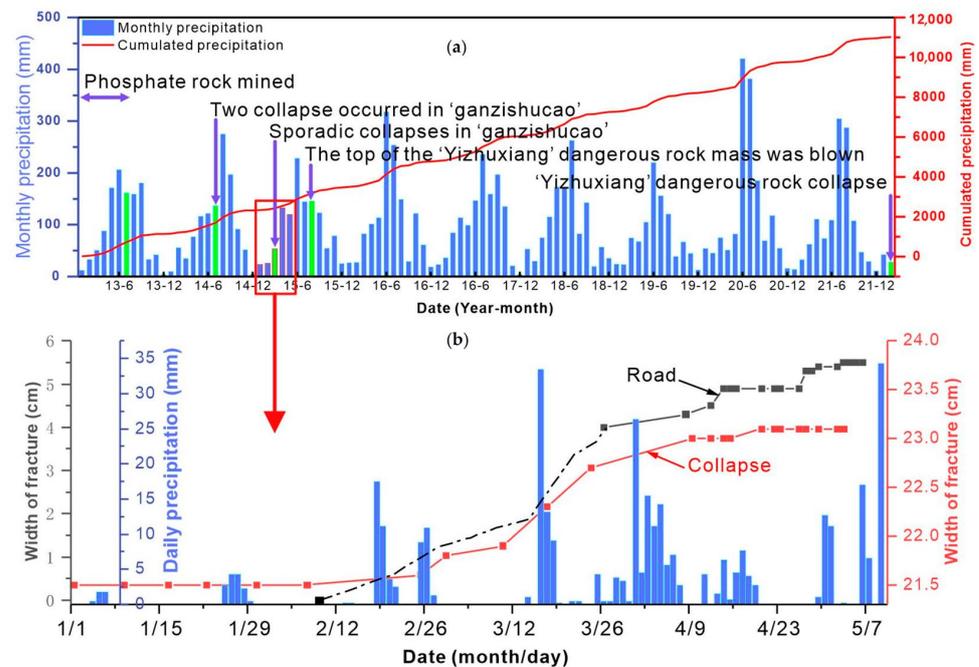
Figure 7. (a) Major events during the deformation process of the collapsed body; (b) Changes in master fracture [48] and road cracks under rainfall.

In 2015, the widths of the cracks on the rear edge of the perilous rock mass and the road cracks were positively related to the daily precipitation (Figure 7b). That is, the infiltration of precipitation increased the water content of the rock mass, thereby softening the structural plane of the rock mass, changing the mechanical state of the structural plane, and decreasing the antioverturning moment, so that the fractures on the rear edge of the rock mass became gradually connected [51–54]. Similarly, the fracture water pressure will cause additional deformation of the rock block, resulting in an increase in the opening of the fracture and an increase in the permeability coefficient. The shearing strength of dolomite decreased rapidly with the increase in water content so that the plastic deformation increased and the ductility after failure was significantly enhanced [55]. In 2022, extreme weather events occurred, with the snowfall much higher than those in previous years and the temperature significantly lower than those in previous years. As a result, the collapse occurred before the rainy season, indicating that the rock mass was continuously subjected to repeated freezing and thawing. In the process of freeze–thaw cycles, the damage of the water–ice phase change on the rock mass was gradually accumulated, specifically with the temperature change, the water-filled structural plane repeatedly froze and thawed, resulting in progressive rock mass damage caused by gradual splitting, and the elastic modulus, hardness, and fragmentation of dolomite were negatively related to the number of freeze–thaw cycles [56–60]. Especially for rock masses with fissures, the frost-heaving force caused by the freezing process of the fissure water is an important reason for the deterioration of the rock mass structure [61,62]. The lower the freezing temperature, the earlier the frost heave force will appear. The closer it gets to the freezing point [63]. Under the action of multiple freeze–thaw cycles, during the process of continuous accumulation, explosion and release of frost-heave force, a single fracture surface develops into multiple fracture surfaces, and the accumulated damage of cracks leads to further expansion and penetration of cracks [61]. The aforesaid causes ultimately led to a collapse.

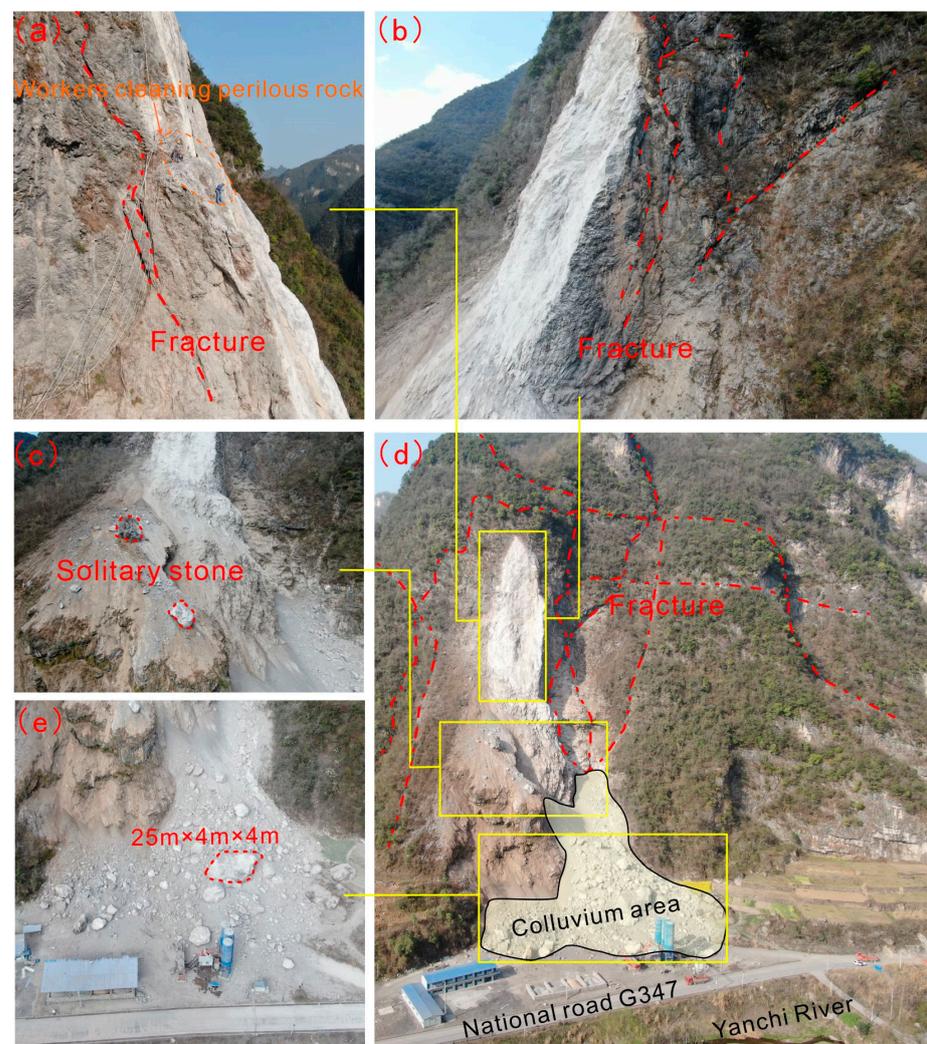
Figure 8 shows that the rocks in the collapse mainly rolled down along the slope, with some fallen rocks scattered on the slope, including two large solitary stones standing still on the slope and with dimensions of (length \times width \times height) $3\text{ m} \times 4\text{ m} \times 5\text{ m}$ and $1.5\text{ m} \times 1.5\text{ m} \times 3\text{ m}$. The fallen rocks had a total volume of about $1 \times 10^4\text{ m}^3$. Some of them were on the right side of the main colluvium area of the fallen rocks (major colluvium area), with a maximum block size of $25\text{ m} \times 4\text{ m} \times 4\text{ m}$, damaging farmland, the road, and the factory plant. The other fallen rocks were located in front of the rock mass, causing partial damage to the temporary cement mixing station and the road. According to the field investigation, a large “wedge-shaped” fallen rock remaining in the colluvium area had a volume of about 6000 m^3 . The rear fractures running from top to bottom can be observed on both the east and west sides of the residual perilous rock, with a width of 5–20 cm. The residual rock mass in other areas had a volume of about 500 m^3 , and some residual perilous rocks were unstable. The solitary stones on the slope seriously affected the safe operation of National Road G347 and the temporary mixing station below them.

Figure 8. (a) Fractures ran through the rear edge on the west side of the residual perilous rock; (b) Fractures ran through the rear edge on the east side of the residual perilous rock; (c) Solitary stones on the slope; (d) Full view after the collapse of the perilous rock mass; (e) Colluvium area of fallen rocks at the slope toe.

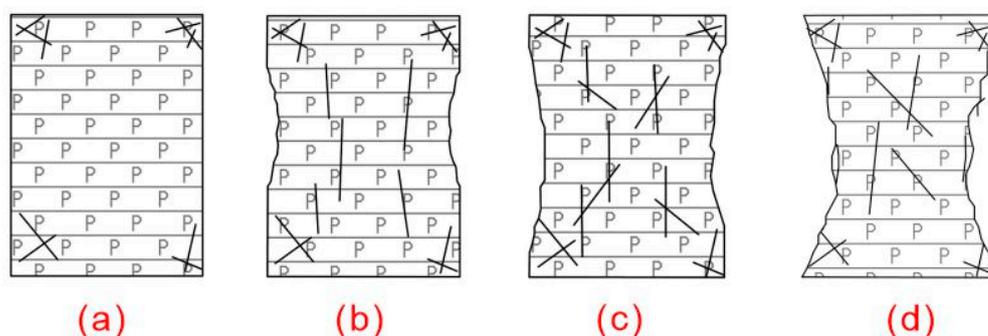
Mining was one of the main causes causing the collapse. During the mining process, the rock mass is under the action of unloading, which is mainly subjected to tension damage and shear damage [64], which induces cracks in the rock mass, and the security pillars left after mining provide sufficient support for the top rock mass. After mining operations ended, the pillars began to spall and collapse [65]. Under the action effect of pressure, the safety pillars were subjected to stress concentration at the corners and then broke (Figure 9a) [66]. When the pressure increased, the cracks inside the rock expanded, and new cracks were generated. The direction of the cracks was mainly vertical (Figure 9b). When the goaf continued to expand, the force shared by each pillar increased correspondingly, so that the internal cracks continued to expand, new shear cracks were generated, and the rocks on the pillar surface continued to spall (Figure 9c). Finally, when the cracks expanded to a certain extent, the strength of the pillar-supported rock mass was greatly reduced. When the force on the rock mass was greater than the strength of the rock mass, the pillars failed (Figure 9d). The main forms of pillar failure were peeling and necking of the pillar

surfaces. With the deformation of the pillars, the fractures in the upper rock mass gradually expanded [67].

Figure 9. Pillar cracking and failure evolution process: (a) Pillar corner stress concentration, resulting in peeling; (b) Pillar surface peeling, internal pressure crack; (c) Pillar surface continued to peel off, producing oblique shear stripes; (d) Pillars failed, leaving little residual strength.

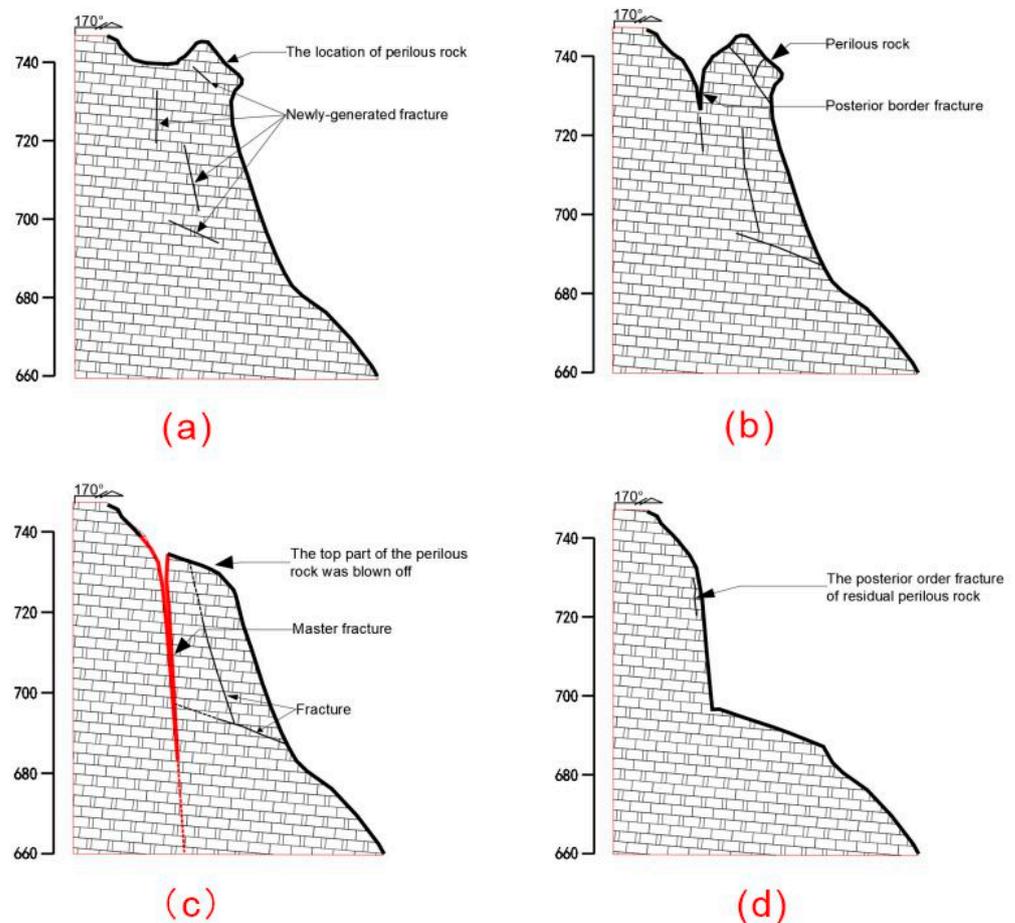
Fracture formation stage: during underground mining, cracks were formed in the rock mass under the joint effect of vibration loading and unloading. In addition, the continuous deformation of the pillars caused cracks in the rock mass. (Figure 10a).

Rear edge fracture formation stage: As dolomite was eroded and softened by precipitation, the existing internal fractures gradually developed and became connected. In addition, mining promoted the gradual expansion of the fractures to form dominant fractures. The top of the rock mass was bent and toppled under the action of gravity, and the fractures on the rear edge of the rock mass gradually expanded to the deeper part (Figure 10b).

Collapse formation stage: due to the deformation of safety pillars and the blasting of the perilous rock, the internal cracks became connected, and the rock mass was bent and toppled, and the master fractures on the rear edge gradually expanded. The precipitation infiltrated along the fractures, generating hydrostatic pressure, reducing the mechanical strength between the rock mass and the structural plane, increasing the downward and outward movement force of the unstable rock mass, and finally leading to collapse (Figure 10c).

Fracture penetration stage: Compared with previous years, the weather in the winter of 2021 changed greatly, with an increased snowfall and a low temperature, leading to more significant freezing and thawing, which caused the destruction of the rock mass structure, the gradual penetration and expansion of the fractures, and the accelerated deformation of the rock mass, and finally resulted in the complete penetration of the fractures on the rear edge of Yizhuxiang and the failure of the rock mass (Figure 10d).

Figure 10. Evolution process of Yizhuxiang collapse; (a) Fracture formation stage; (b) Rear edge fracture formation stage; (c) Collapse formation stage; (d) Fracture penetration stage.
