Health and Durability of Protective and Thermal Barrier Coatings Monitored in Service by Visual Inspection

Abstract: Protective and Thermal Barrier Coatings (TBC) applied on gas-turbine blades gradually degrade due to oxidation, aluminum depletion and impacts of environmental particles. Among various non-destructive coating testing methods (NDT), visual inspection can be undertaken regularly in service, but it provides little quantitative information, and only surface defects can be detected. This work aims at in-service monitoring of turbine blades with multilayer coatings applied by atmospheric plasma spraying (APS) in a few variants. They were validated during a series of accelerated mission tests of a retired military turbofan engine in a test cell together with five other technologies. The fifty-hour rainbow test focused on assessing coating durability. Between engine runs, 12 borescope inspections were conducted to monitor the health of the blades. Finally, the blades were disassembled and examined using computed tomography (CT) and metallographic methods. Throughout the testing, 31 newly-coated blades (66%) withstood the tests, producing results comparable to the reference

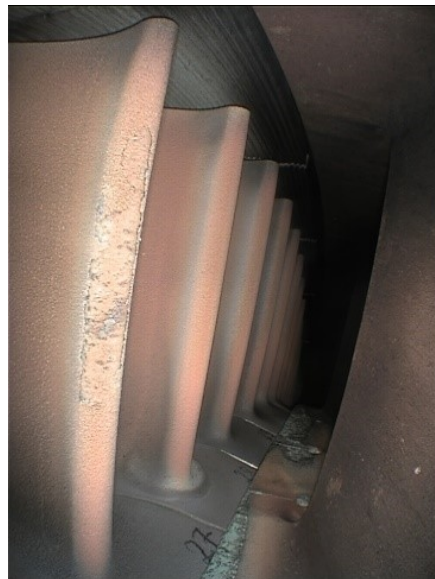
Figure 5. C-coated blade 27 viewed through the borescope at the 12th inspection.

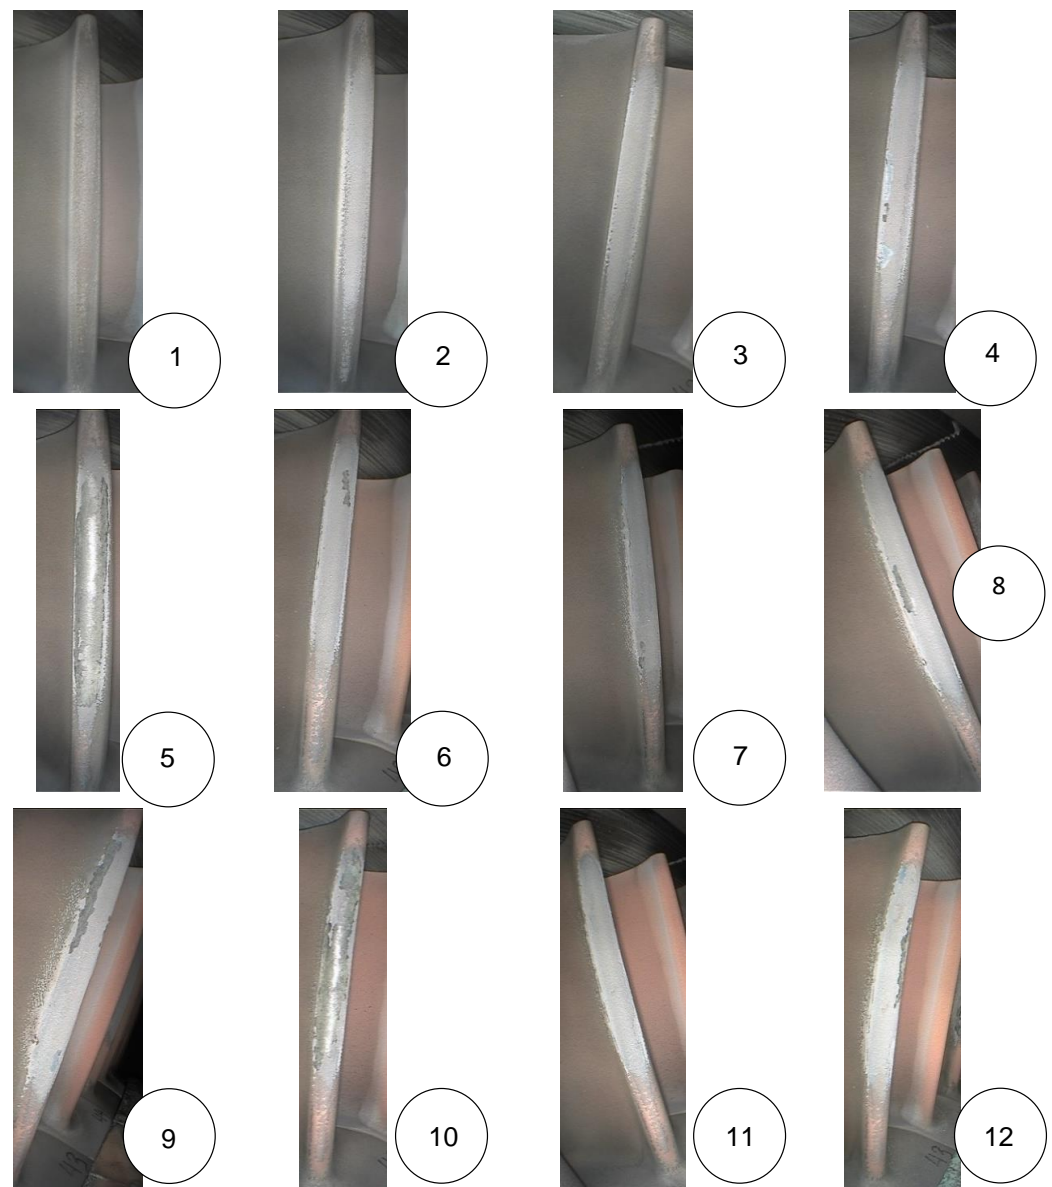
Coating B (CVD) was applied to 5 blades (No 1, 7, 43, 45 and 47). The first, noticeable flaws were found during the first inspection (Figure 6). The flaws developed during the initial engine run, before the main test program. During the subsequent test cycles, the destruction of the coating was found to progress in a characteristic way in relation to other tested coatings. The damage was observed on LE along the entire height of the airfoil and on the concave side, especially along the tip and in the trailing edge zone.

Figure 6. Deterioration of blade 43 observed at successive inspections (1–12).

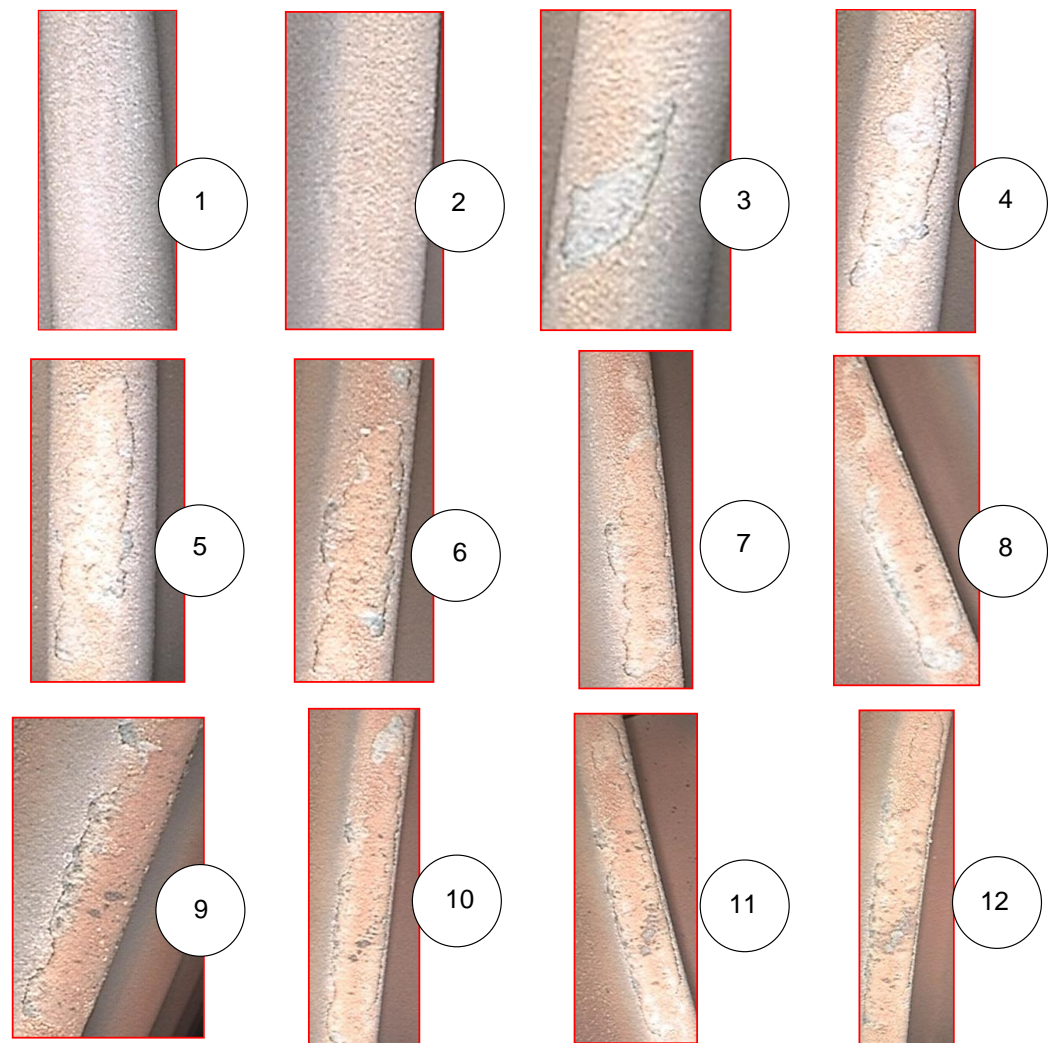
Coating C (APS + VPA) was applied to eight blades, but only blade 27 did not pass the test (Figure 7). During the third inspection, local chipping of the coating from LE was detected. The total area of this defect increased with the number of test cycles so that during the 12th and last inspection, the damage was observed along approximately 60% of the total height of the airfoil. Other C-coated blades were healthy, so it may, for example, indicate that before the destruction of the LE coating started, blade 27 could have been hit (or rubbed) by a foreign object.

Figure 7. Deterioration of blade 27 observed at successive inspections (1–12).

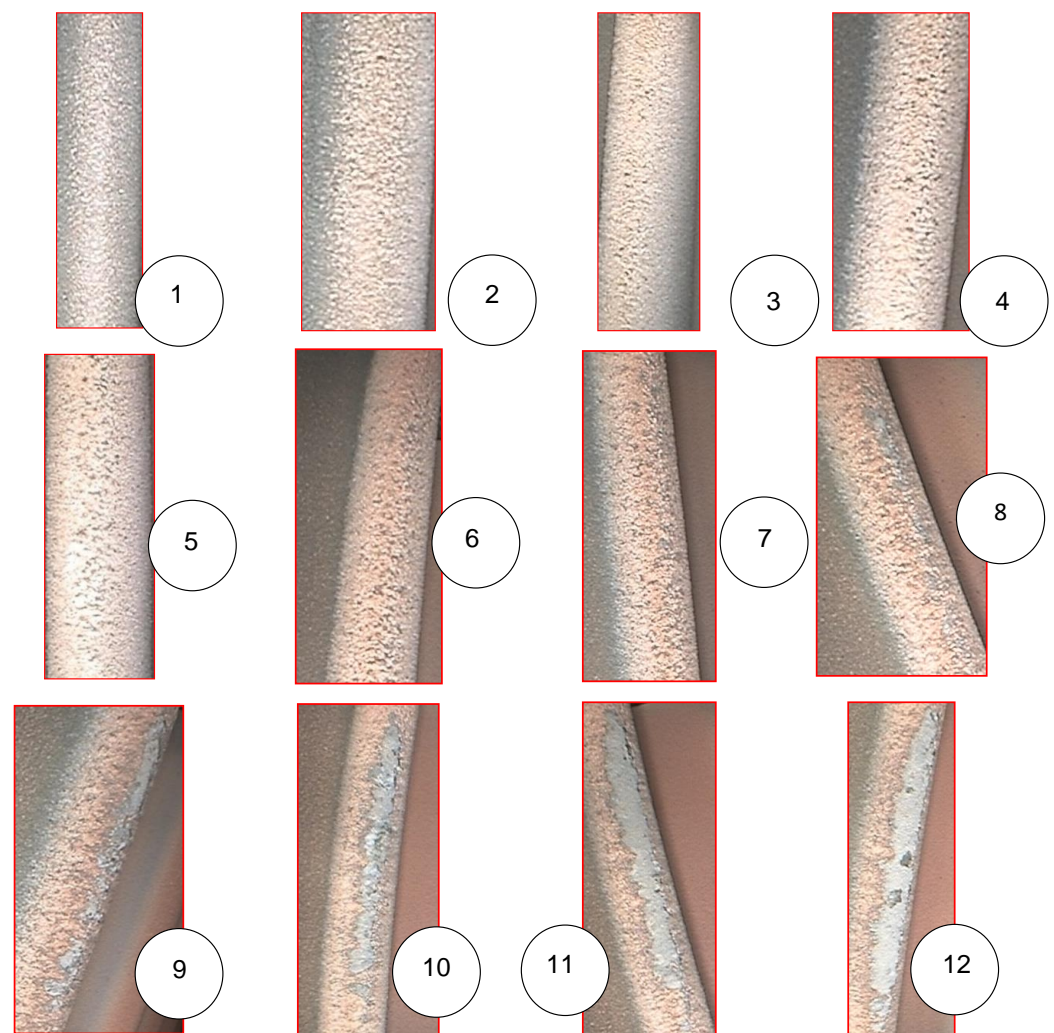
Coating E (APS) was put onto six blades, and three of them did not pass the test. Throughout the testing, it was found that the surface roughness increased compared to the standard blades (Figure 8). The leading edges of blades 11, 65 and 71 were damaged. However, the initial deterioration symptoms were found on the LE of the remaining three blades, which were similar to the previous ones. The lack of clear-cut damage symptoms for these three blades may indicate that the applied coating may be, for example, thicker than those on the other three.

The increase in the porosity of the coating at LE observed in subsequent inspections is due to the gradual oxidation of the coating material. This is one of the characteristic symptoms of failure in this type of coating. During the eighth inspection (Figure 8), the appearance of a bond coat at LE (in the midspan of the airfoil) was found. It has also been noticed that the damaged area increases along the height of the blade due to gradual chipping and further oxidation of the material. Thus, this coating is gradually depleted by the hot gas flow. For example, during the last, twelfth inspection, locations at the LE of blade 65 were found which would indicate a complete loss of coating.

Figure 8. Deterioration of blade 65 observed at successive inspections (1–12).

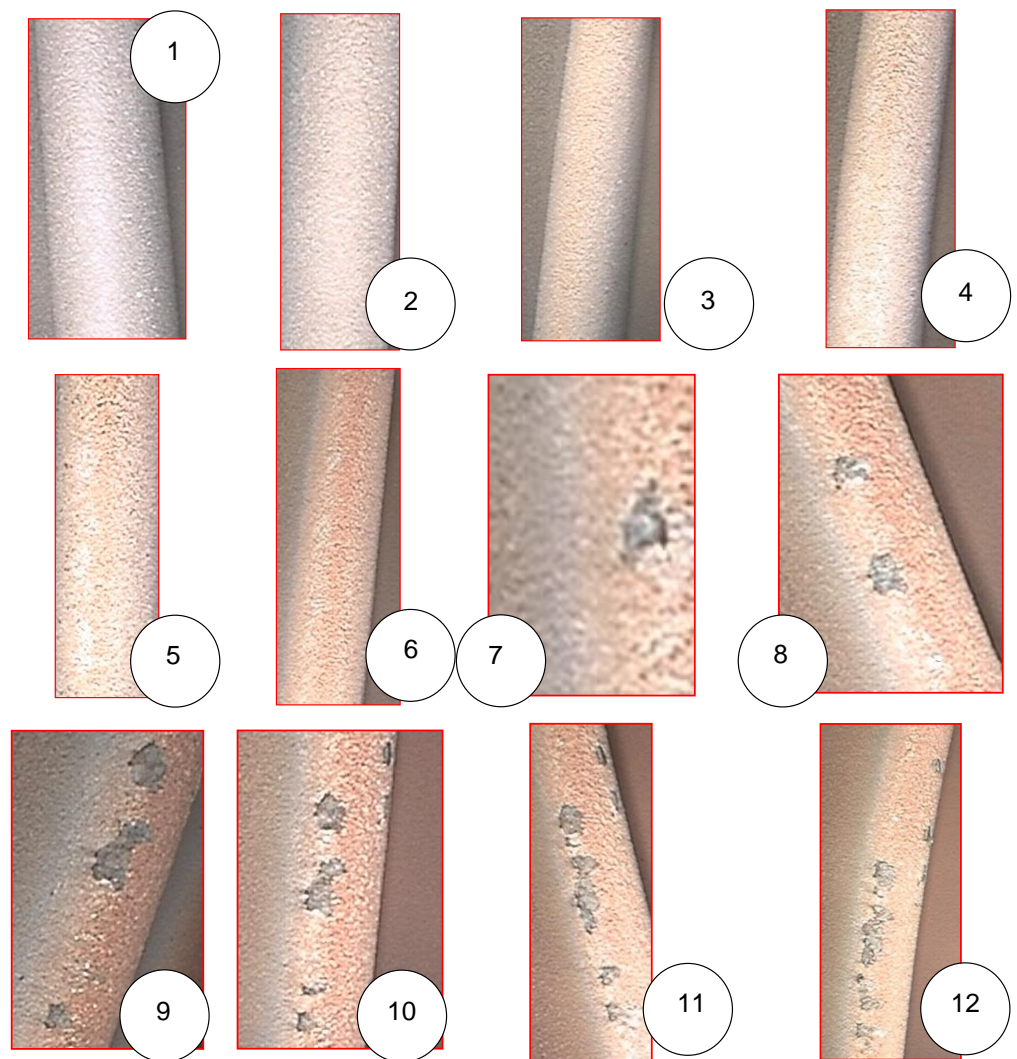
Five blades (No 13, 55, 57, 61 and 79) were coated with F coating (APS + SLURRY), and all of them were damaged prior to carrying out 128 of the 250 planned test cycles. During the seventh inspection (after the 128th cycle), local chipping of the LE coating was found in the midspan of blade 13 (Figure 9). Throughout subsequent inspections, an increase in the total area of the wound (along the height of the airfoil) was observed as a result of the gradual chipping of the material.

What is characteristic of this type of coating is that it is damaged locally via the formation of several LE flaws, which are separated (blade 13) or gradually merge, after some test cycles (other F-coated blades). Another characteristic feature of this damage is the fact that the first noticeable flaws occur at the LE arc where the concave side starts. The LE flaws observed later at the point of transition to the convex side are located slightly above those previously identified.

Figure 9. Deterioration of blade 13 (APS + SLURRY) observed at successive inspections (1–12).
