# Primary Corrosion Cause of P110S Steel Tubing Corrosion Thinning in CO<sub>2</sub>–H<sub>2</sub>S Well and Its Remaining Life Prediction

**Abstract:** To investigate the tube thinning of gas wells in the northwestern oilfield, the failed tubing was analyzed by using material property testing, SEM, EDS, and XRD. A novel model that was specific to the service life of tubing in terms of the wall thickness of tubing was established. The model is based on the circumferential stress of tubing. The safety factor against internal pressure and corrosion rate are considered in the model. Our results make clear that the chemical composition, non-metallic inclusion, hardness, and tensile strength of the pipe meet the requirements of relevant standards. The corrosion products on the inner and outer wall of the tubing are mainly FeCO<sub>3</sub> and BaSO<sub>4</sub>, while CaCO<sub>3</sub> exists in the outer wall. Additionally, we prove that the corrosion process of the failed tubing is CO<sub>2</sub> corrosion. The tubing under the packer suffers from water-accumulation corrosion, and the tubing above the packer suffers from water-carrying corrosion. It is observed that the failed tubing ar

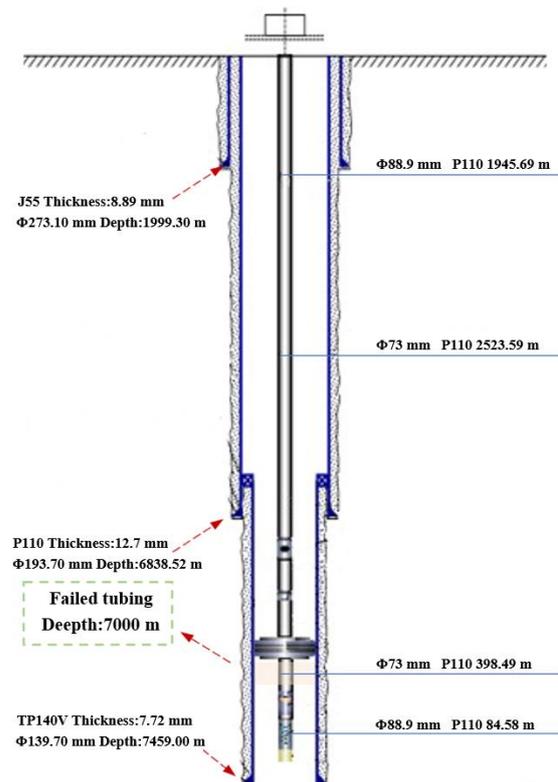
**Figure 1.** Failure position of tubing in the wellbore.

The depth of the failed well that is located in the northwestern oilfield is 7500 m, and the well is rich in CO<sub>2</sub> and H<sub>2</sub>S gas. Among them, the content of H<sub>2</sub>S is 9318 mg/m<sup>3</sup>, the partial pressure of CO<sub>2</sub> is 1.73 MPa; the temperature of bottom well is 160 °C and the water content is 0.1%. According to the thickness measurement and calculation results, the reduction in wall thickness of tubing above the packer is only 0.125 mm per year, while that of tubing below the packer is as high as 0.445 mm per year. Since the outer wall of the tubing above the packer is exposed to the annulus protection fluid, the outer wall of the

tubing is hardly corroded. Moreover, a trace of produced fluid is also found at the bottom of the wellbore. According to the location of the thinned tubing and well depth, it can be judged that the tubing under the packer is in water, leading to serious corrosion. Dong et al. pointed out that condensate, ponding in formation water, and water carried in produced gas are all types of produced water. Therefore, according to the corrosion characteristics of the well, it can be judged that the tubing above the packer is gas-carrying corrosion, while the tubing below the packer is ponding corrosion. The wellbore structure in Figure 1 shows surface casing ( $\Phi$  273.10 mm), technical casing ( $\Phi$  193.70 mm), and oil layer casing ( $\Phi$  139.70 mm) from top to bottom. There is a cement sheath between the casings. Tubes 88.9 and 73 mm in diameter are used above and below the packer, respectively.

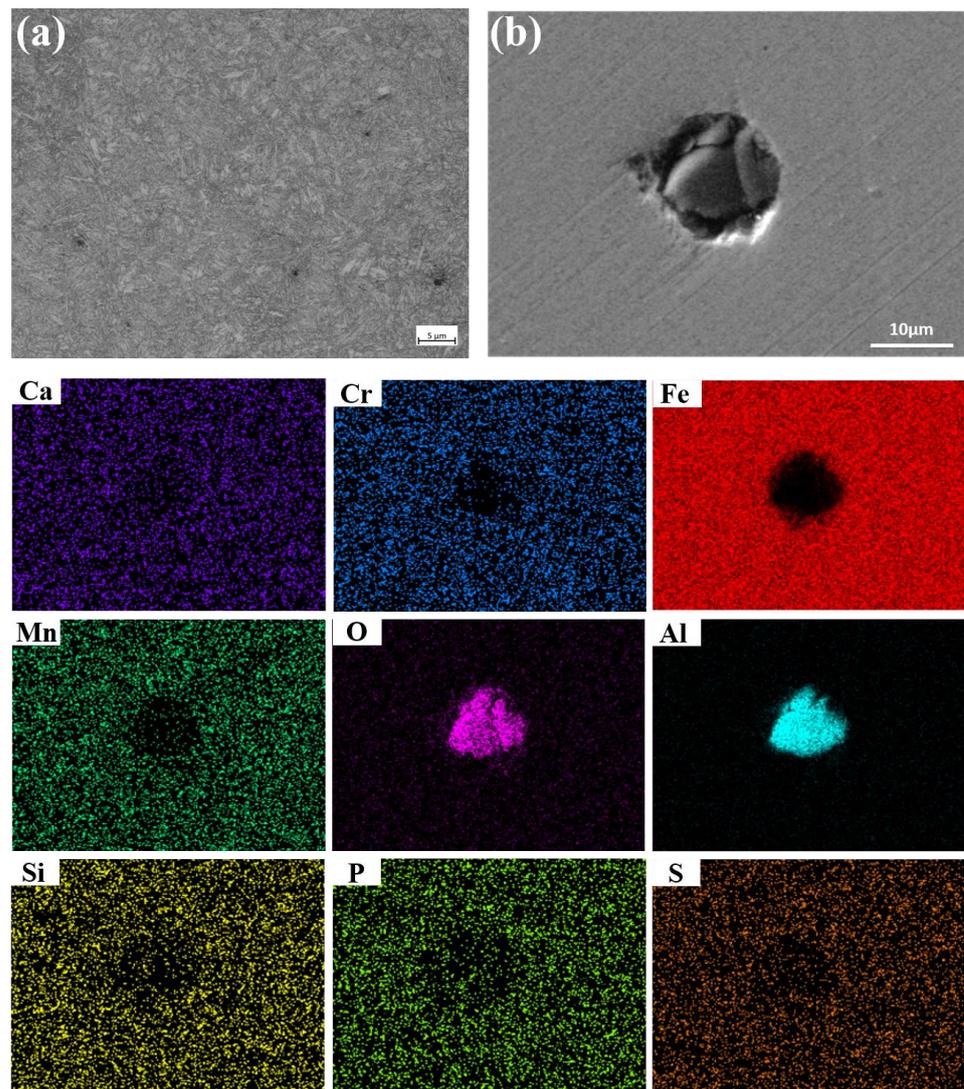
**Figure 2.** Metallographic structure and non-metallic inclusion of failed tubing. (a): Metallographic structure; (b): non-metallic inclusion.

According to ASTM E45-18a, GB/T10561-2005 [28], and ASTM E112-13 [29] standard, the samples are machined into 10 mm × 15 mm × thickness to analyze metallographic structure and the non-metallic inclusion and the microstructure, as shown in Figure 2. The microstructure of the failed tubing is tempered sorbite (Figure 2a). The diameter of the inclusion is 12 μm and it becomes an Al<sub>2</sub>O<sub>3</sub> inclusion mainly composed of Al and O (Figure 2b).

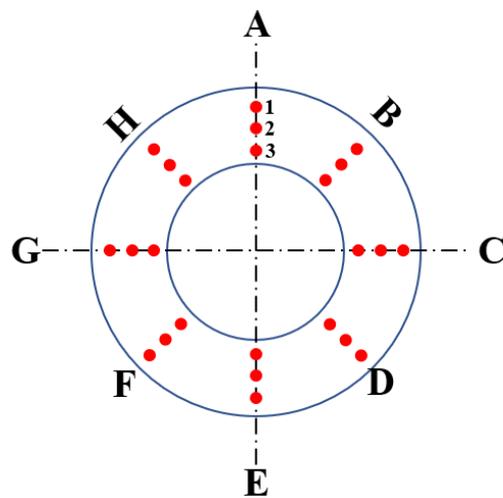
**Figure 3.** Hardness measurement point in A–H direction.

Referencing standard ISO 11960-2011, the annular specimens with a thickness of 10 mm are taken from the thinned tubing, and then the hardness of the samples (Figure 3) is tested by using a Rockwell hardness tester. The allowable error of calibration tool should be in the range of approximately 2%, and the standard deviation was given from three measurements [30]. The hardness of the thinned tubing is between 25.5 HRC and 30.1 HRC, and the average hardness is 27.89 HRC (Figure 4). According to the standard NACE MR0175, the hardness of P110S steel in H<sub>2</sub>S-containing surroundings should be lower than 37 HRC [31]. Therefore, the hardness of tubing does not exceed the standard requirements, which means that the hardness of oil pipe is qualified.

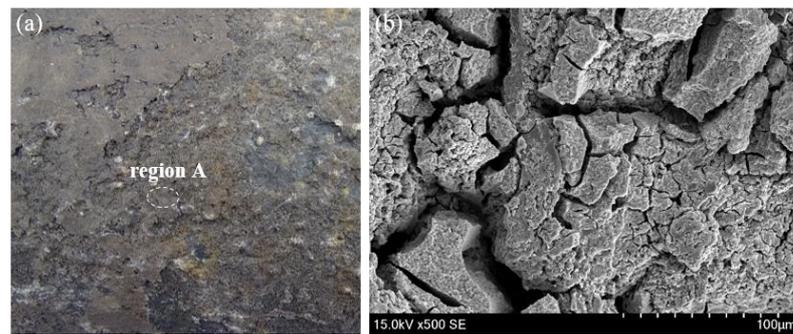
It is observed that the outer wall of the tubing is uniformly corroded and severely scaled, and a layer of black gray scaling products is attached to the outer wall. The adhesive tape is used to stick down corrosion products to observe the morphology due to the fact that the outer films of corrosion product on the outer wall easily fall off, as shown in Figure 6. The scraped corrosion products are extremely loose and many cracks are also observed, which is a channel for corrosion solution.

**Figure 6.** Sticking position of corrosion scales on the outer wall (a) and SEM images of corrosion stuck from the inner wall of tubing (b).

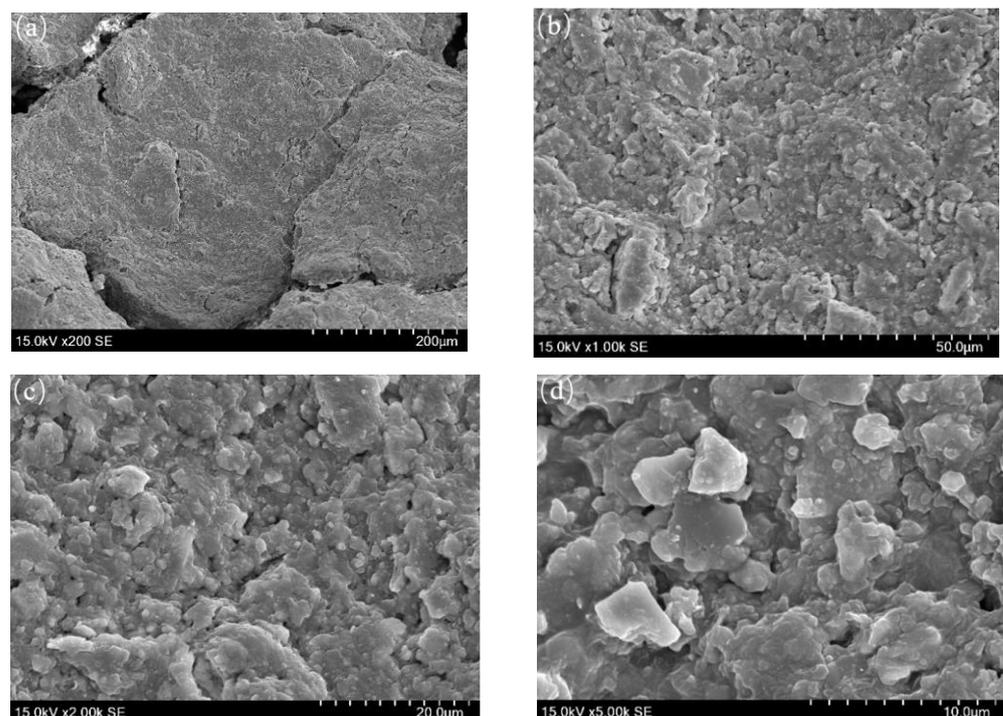
The SEM images, as shown in Figure 7, demonstrate that the corrosion product films on the inner wall of tubing show a layered structure. The corrosion product layer is thick, and there are a lot of micro-cracks on the surface of the corrosion product films.  $\text{CO}_2$  corrosion trace is found at high magnification, a small amount of  $\text{FeCO}_3$  grains have obvious edges and corners, but most of the grains have edges and corners dissolved. In addition, a large number of irregular spherical particles can be seen attached to the corrosion product film.

**Figure 7.** SEM images of surface morphology on inner wall of tubing. (a): 200 × SEM; (b): 1000 × SEM; (c): 2000 × SEM; (d): 5000 × SEM.

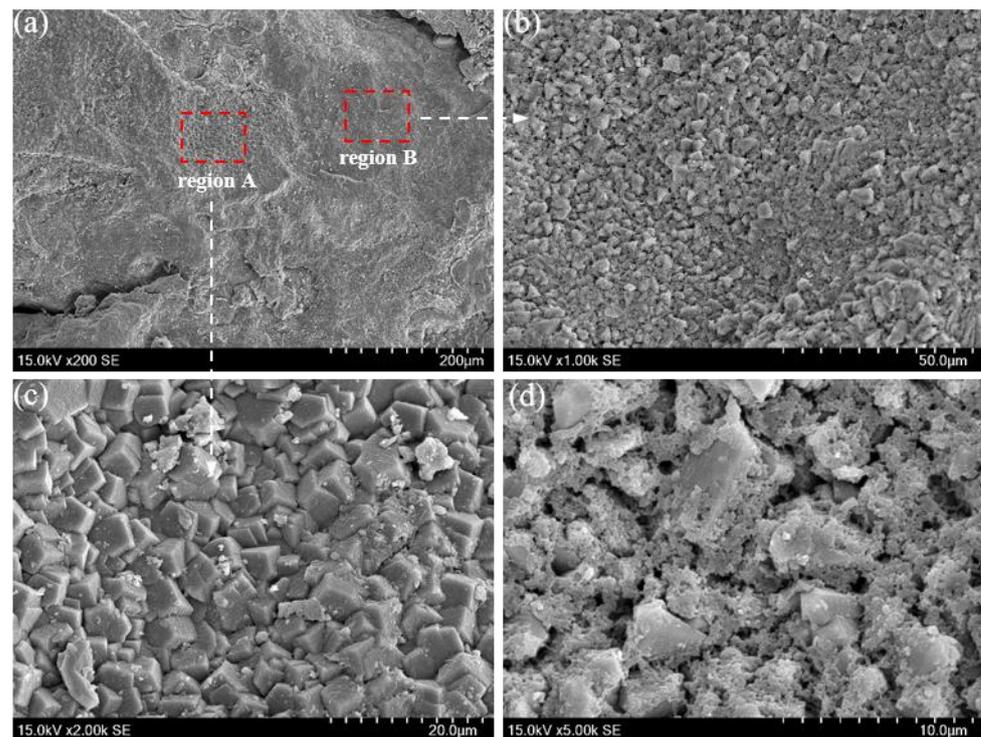
The SEM images in Figure 8 show that the corrosion scales on the outer wall of the tubing include two kinds of morphology (Figure 8a). The first one has some holes on the scales (Figure 8b–d). The second kind of the corrosion scales, which are very dense, are formed by the typical cubic crystal (Figure 8c). The corrosion morphology of the inner and outer wall of tubing is quite different, while the composition of those are similar according to XRD results. Due to the erosion of the corrosion scales on the inner wall by the produced liquid, the corrosion scales become flaky. However, the outer wall of tubing has less fluidity than the inner wall before the packer leakage, and the  $\text{FeCO}_3$  crystal formed on the outer wall is relatively intact.

**Figure 8.** SEM images of surface morphology on outer wall of tubing. (a): 200 × SEM; (b): 1000 × SEM; (c): 2000 × SEM; (d): 5000 × SEM.

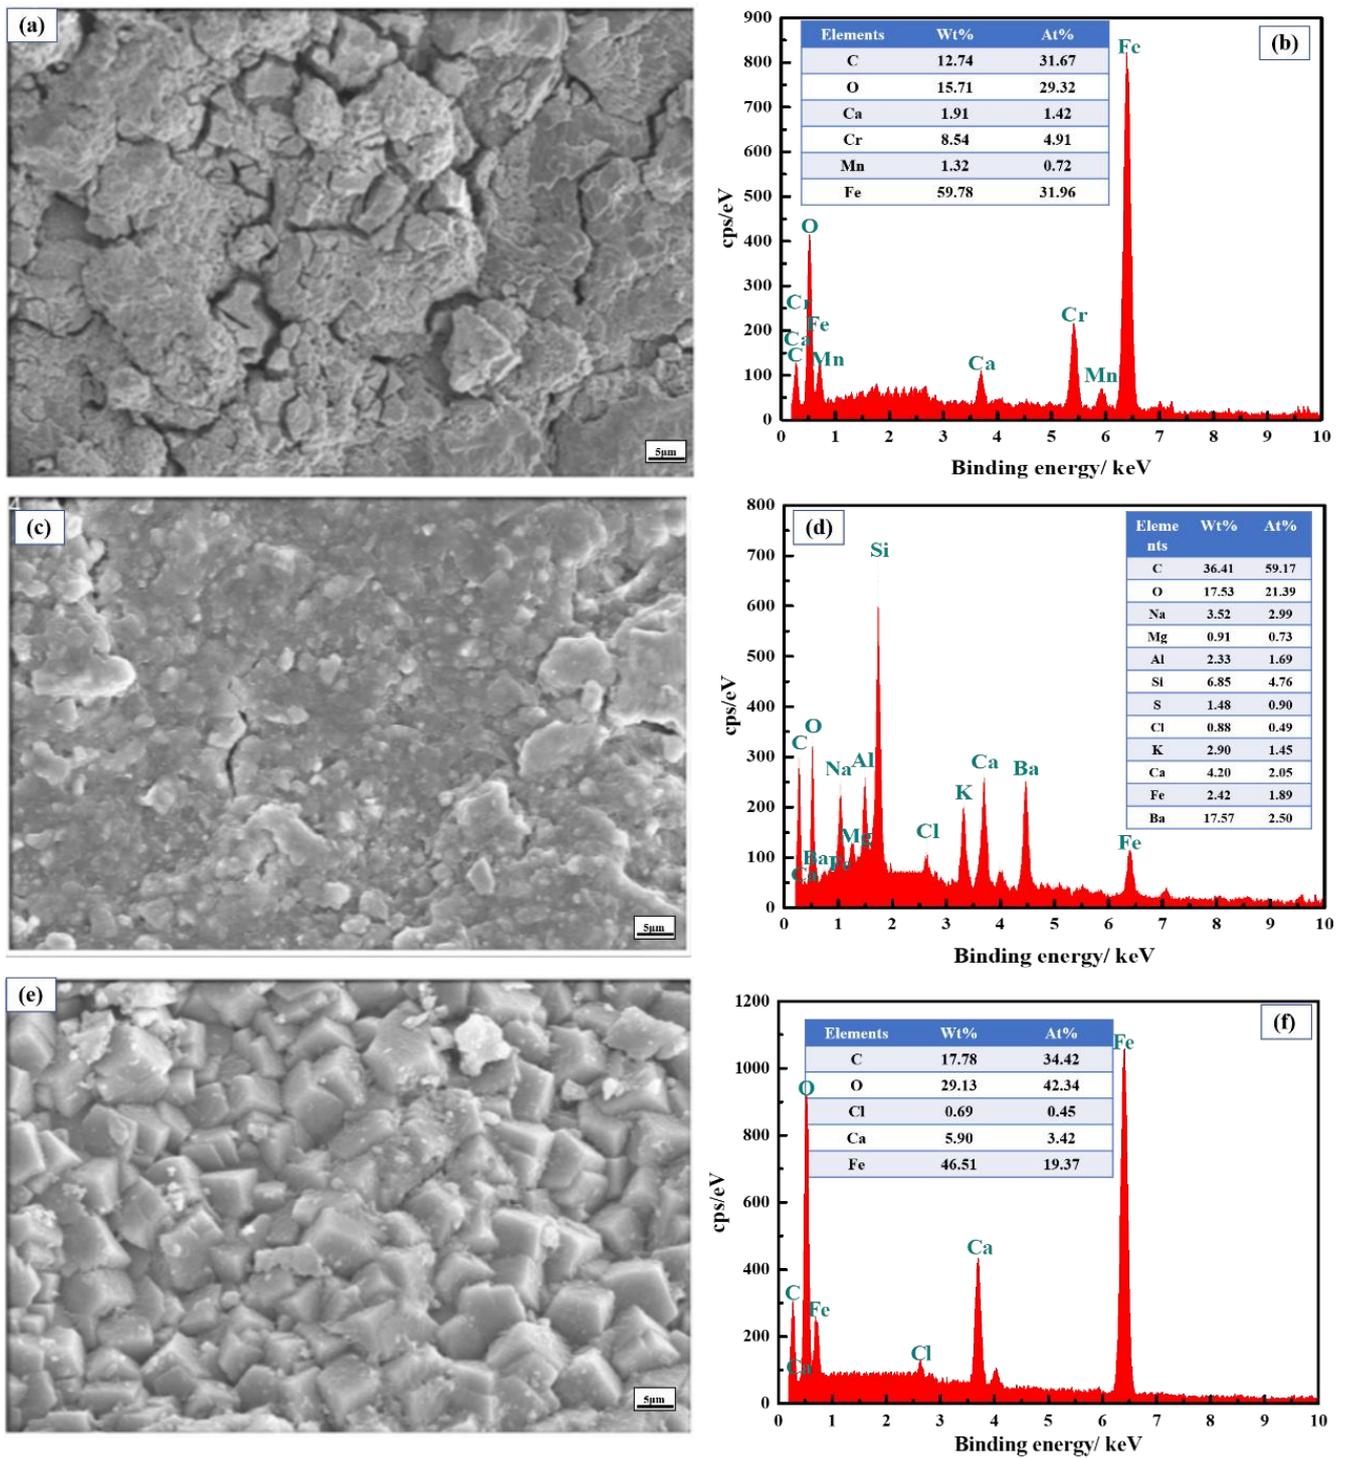
As it shows in Figure 9, the component of the corrosion scales on the inner wall of the tubing is more complex, while that on the outer wall of the tubing is less so. Moreover, the salt content in the corrosion scales that stuck from the inner wall is less, while the salt content is rich in inner wall, indicating that the salts are concentrated in the inner layer. The corrosion scales on outer wall consist of Ca, Fe, C, Cl, and O, implying that the CO<sub>2</sub> corrosion and calcium carbonate scales may be generated on the inner wall of the tubing [34,35]. It is worth noting that S elements are not observed in EDS results. Moreover, traces of Ba and Si elements are observed according to EDS results, which come from the drilling fluid.

Figure 9. EDS images of corrosion scales on failed tubing. (a,b): Stuck corrosion scales; (c,d): inner wall; (e,f): outer wall.

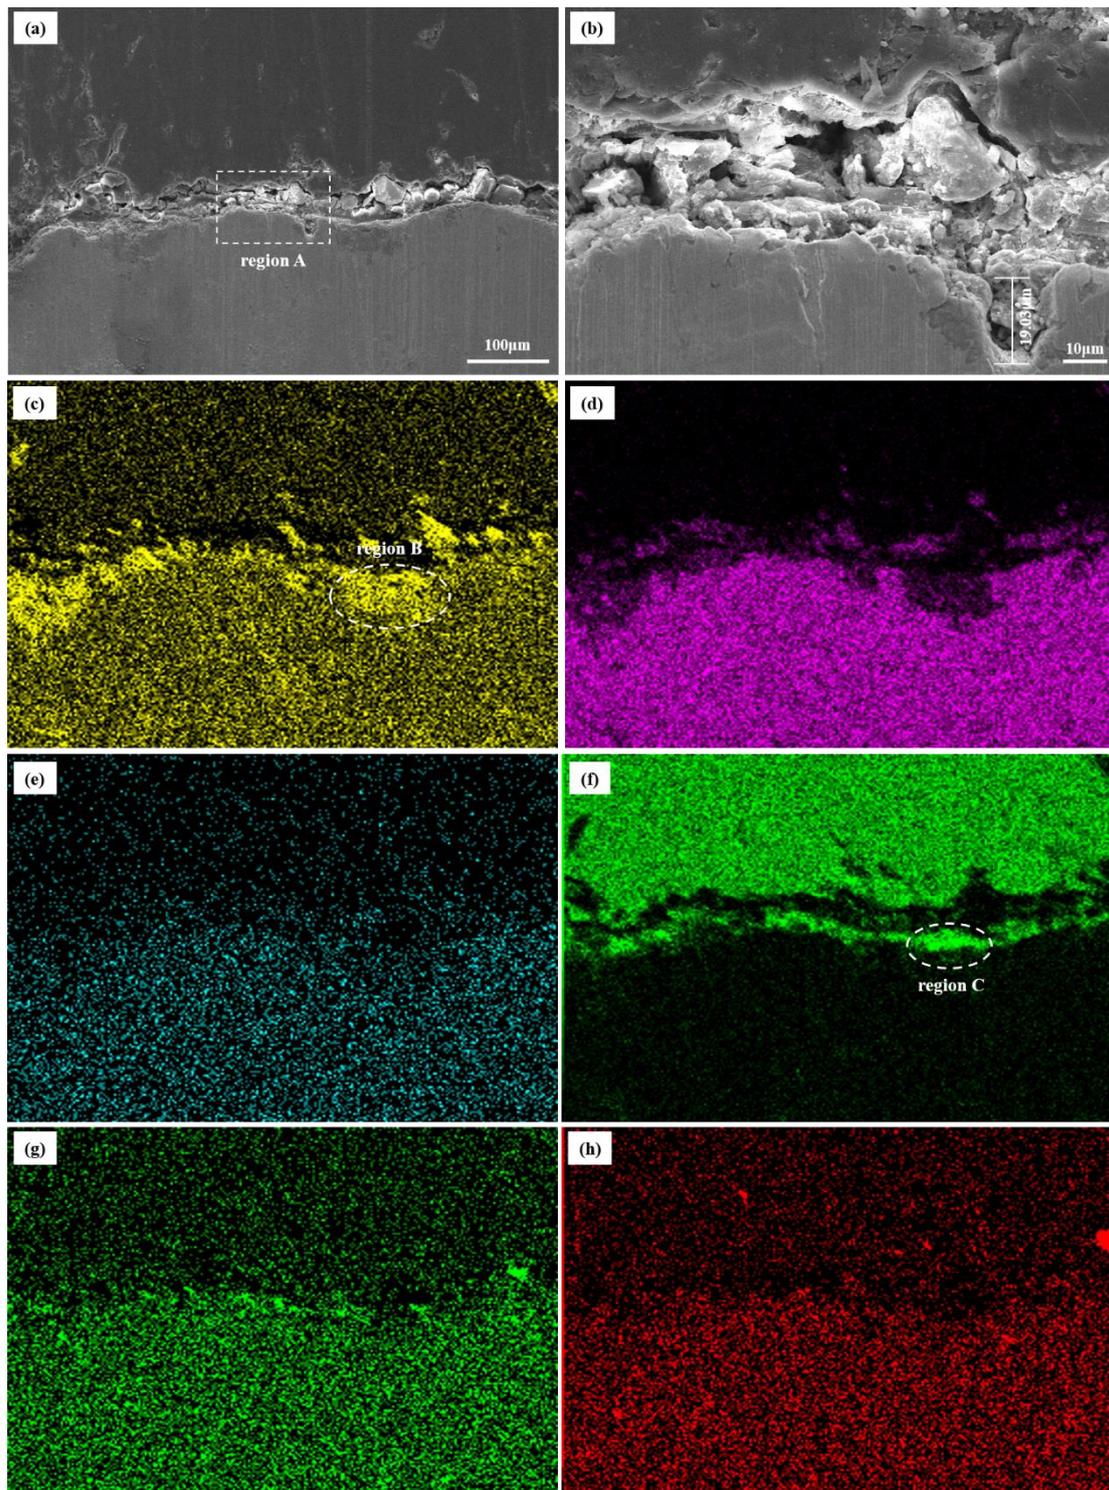
The cross-section morphology and corresponding element distribution images of the inner wall are displayed in Figure 10. The corrosion product films on the inner film are extremely loose and porous. In addition, a corrosion pit with the depth of 19.03 μm is also observed in Figure 10b. According to the element distribution of the corrosion scales, the main elements are O, C, and Fe. A trace of Ba, S, and Sr elements are distributed in the scales (Figure 10c–h). It is remarkable that the C element accumulates in the upper layer, while the O element accumulates in the lower layer (Figure 10c,f).

**Figure 10.** SEM/EDS images of corrosion scales on inner wall. (a,b): Cross-section SEM surface morphologies; (c): oxygen; (d): ferrum; (e): barium; (f): carbon; (g): sulfur; (h): strontium.

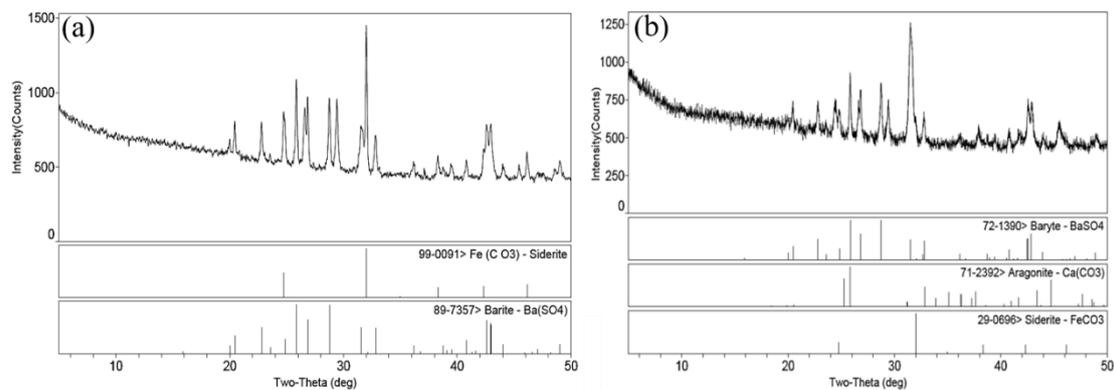
X-ray diffraction (X' Pert MPD PRO) was used to analysis the attachments taken from the surface of tubing wall (Figure 11). The main corrosion products of the inner and outer wall are  $\text{FeCO}_3$  and  $\text{BaSO}_4$ , while  $\text{CaCO}_3$  still exists in the corrosion products of the outer wall. In addition, no sulfide is found in the XRD results, and the results are consistent with

the EDS results. Hence, it can be judged that the corrosion process of the failed tubing is  $\text{CO}_2$  corrosion.

**Figure 11.** XRD results of adhesives on the inner (a) and outer (b) wall of tubing.

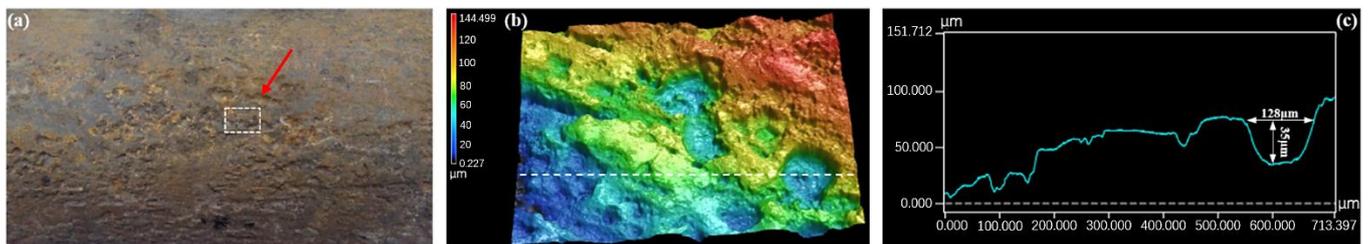
Taking samples on the inner wall of the tubing (Figure 12a), the corrosion products on the surface of the sample were cleaned with the de-filming solution. Then, a 3D confocal laser microscope (Keyence VK-X250K, USA) was used to analyze the pitting on the inner wall of the failed tubing. Figure 12b shows the 3D morphology of the inner wall of tubing after removing corrosion products. Lots of pitting is observed on the surface, and the pitting depth reaches  $35\ \mu\text{m}$ .

**Figure 12.** Three-dimensional morphology of the inner wall of tubing after removing corrosion products. (a): Sampling location; (b): 3D morphology; (c): pitting depth.

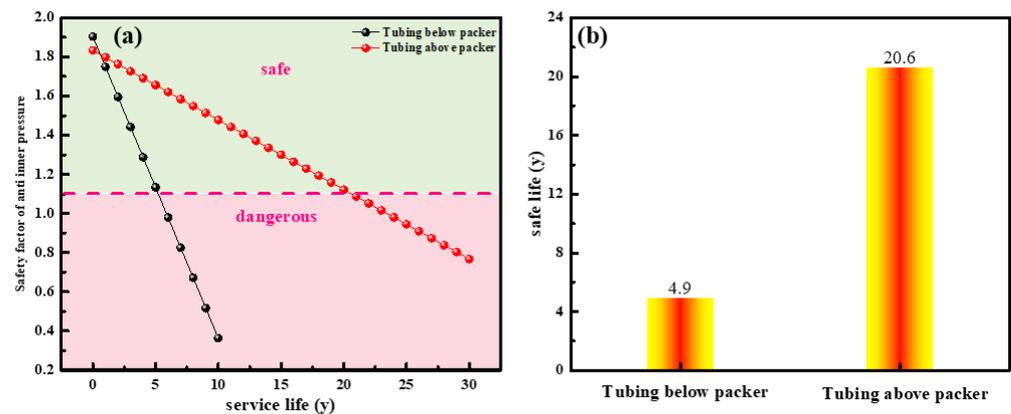
Figure 13. Safety factor of anti-inner pressure (a) and service life (b) of tubing.

According to Equations (1)–(6), the remaining safety life and safety factor against the internal pressure of the tubing are predicted. Figure 13 describes the safety factor of anti-inner pressure and service life on tubing. As it shows, the safety factor of anti-inner pressure on tubing below the packer rapid decreases when the service life increases, while that of the tubing above the packer drops slowly (Figure 13a). The safe service life of the tubing above the packer is 20.6 years, while that of tubing below the packer is only 4.6 years (Figure 13b). Hence, a corrosion-resistant alloy is required for tubing below the packer.

packer is 4.9 years. A corrosion-resistant alloy is required for tubing below the packer. It provides guidance for the safe servicing of tubing.

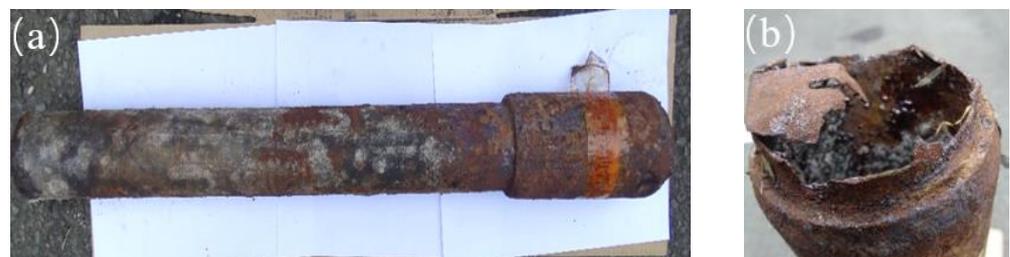
According to the survey data of a well in the same block, the well was completed in February 2015, and the tubing was found to be corroded and fractured in early 2019 (Figure 14a,b). The actual service life of the tubing is about 4 years. The tubing life prediction model has good reliability.

Figure 14. Fracture of tubing due to corrosion. (a): Tubing body; (b): local fracture.

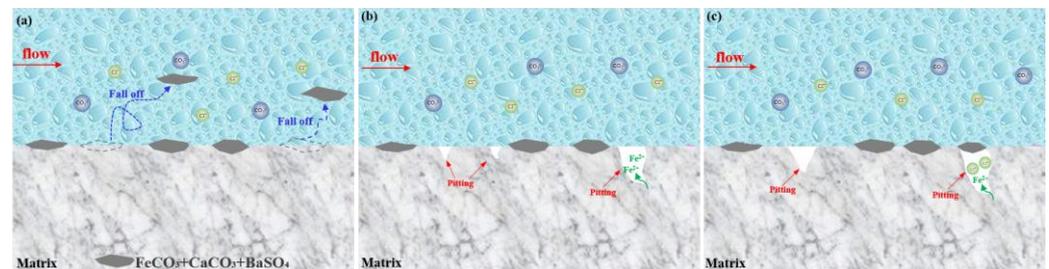
The under-deposit corrosion mechanism of the failed tubing is described in Figure 15. The produced liquid washes away the loose corrosion scales including  $\text{FeCO}_3$  and  $\text{CaCO}_3$ , and  $\text{BaSO}_4$  in some areas. Some corrosion scales are washed away, exposing the matrix, which is not corroded by the corrosive environment, becoming a fresh corrosion anode to further corrode (Figure 15a). For one thing, the damage region and undamaged region form the large cathode (the undamaged area)–small anodic corrosion (the damaged area), which promotes the advancement of corrosion pits. As the corrosion pit deepens, the mass transfer resistance of corrosive ions increases with the new formed  $\text{FeCO}_3$ , and the corrosion pit is gradually blocked by  $\text{CaCO}_3$  products, thus, composing a concentration cell (Figure 15b). In addition, chloride ions with a small radius easily penetrate the newly formed  $\text{FeCO}_3$  products and migrate to the pit (Figure 15c). As a catalyst, chloride ions accelerate the dissolution of  $\text{Fe}^{2+}$ , resulting in a deep corrosion pit. Also of note is the fact that the falling off scales makes a large area of the matrix become a fresh corrosion surface, hindering the longitudinal development of pitting corrosion, and promoting the overall corrosion of the tubing.

**Figure 15.** Schematic diagram of under-deposit corrosion mechanism in failed tubing. (a): Loose corrosion scales fall off; (b): concentration cell; (c): chloride ions penetrate  $\text{FeCO}_3$ .
