Use of UAV Monitoring to Identify Factors Limiting the Sustainability of Stream Restoration Projects

Jakub Langhammer

Department of Physical Geography and Geocology, Faculty of Science, Charles University,
128 43 Prague 2, Czech Republic

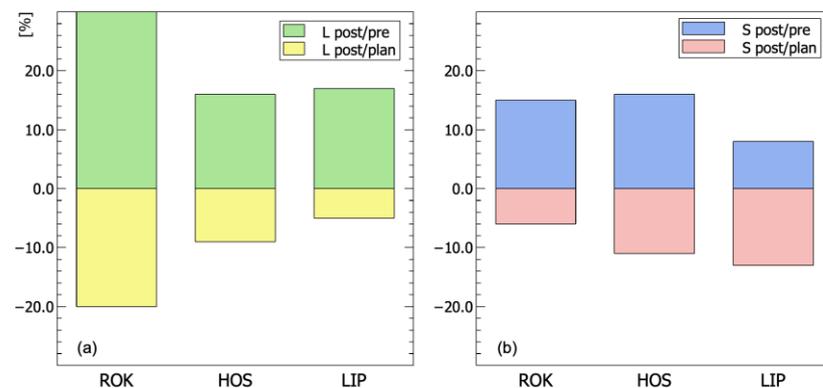
In all cases, stream restorations resulted in meandering channels that basically aligned with the plans and fit to the natural stream patterns corresponding to the given environment. However, all realized restorations are significantly less complex than planned. In the oldest restoration project (ROK), there is the highest deficit in length between the planned restoration and the realized restoration (−19.5%); in the most recent project, the new stream is shorter by just 9.5%. The deficit in stream sinuosity and the number of meanders are, to the contrary, the worst in the newest project, the LIP brook. The deficit in stream sinuosity reaches 12.8%, and the number of constructed meanders is lower by 58.2% (Table 2). In all projects, the deficiency of the stream length and sinuosity reaches almost half of the

gain reached by the restoration (Figure 4). Such reduced complexity significantly limits the expected hydroecological effects of the restorations.

Figure 4. The relative difference in the (a) stream length and (b) sinuosity of the assessed streams.

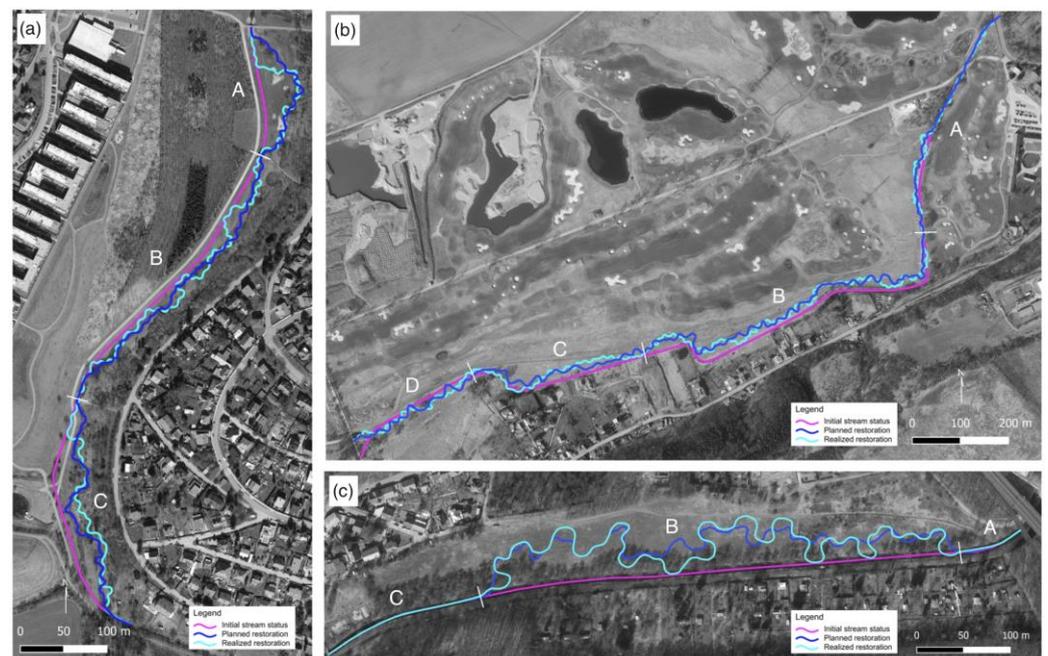
When assessing the stream geometry in individual stream reaches, there are even more profound discrepancies within the restored streams. In the boundary reaches around the bridges and regulation structures, where there is only limited space for deviations, the realized restorations mostly fit the plans (Table A1). In contrast, in the central parts of the restored streams, the channel route is formed relatively freely, with significant deviations in geometric parameters but also in the channel route from the approved plans (Figure 5). In all the realized restorations, the new channels substantially deviated from the planned route, with meanders built in the opposite direction compared to the plan. Most new meanders were built in different locations with different sizes and amplitudes. The same situation applies to the newly built ponds, which are chiefly constructed in different locations.

Figure 5. Stream restoration projects featuring the channel's pre-restoration, planned, and post-restoration status with marked delineation of reaches, used for the assessment of geometric properties. (a) Hostavický brook, (b) Lipanský brook, and (c) Rokytká brook.

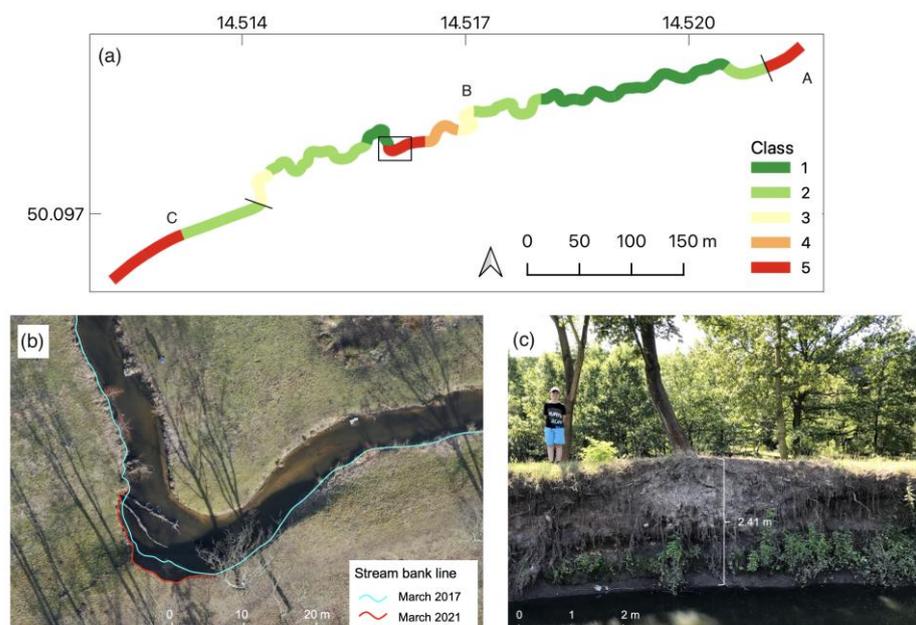
In the ROK brook, the restored reach is free from channel modification, with the exception of the initial and terminal segments. In both cases, straight segments are reinforced by riprap due to the vicinity of the road and railroad bridge. The central part features a meandering stream with no artificial barriers and high variability in the stream width and bed (Figure A1, Table A2). In this part of the restored stream reach, there is extensive bank instability (Figure 6b). The meander, which features the propagation of high-intensity bank erosion, is located in a segment built with substantially different geometric properties than those of the approved plan. The erosion in a bare bank has a height of 2.4 m, and an intense scour drives its propagation (Figure 6c).

Figure 6. Assessment of channel stability at the ROK brook. (a) Classification of channel stability in segments. (b) Progress of bank erosion in a highlighted critical segment between 2017 and 2021. (c) Bare erosion bank of the active meander in the given segment. Imagery: J. Langhammer, 2017–2021.

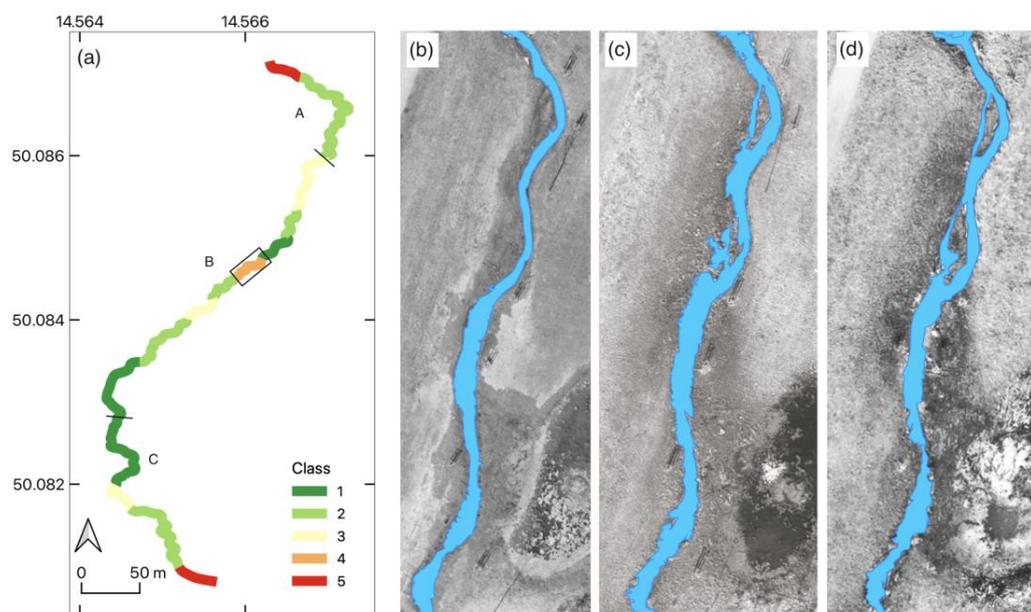
The HOS channel (Figure A2b) was disturbed by a spring storm flood in June 2016, just a few months after the completion of the restoration works. The flood reached the newly built channel with a bare riparian zone prior to grassing. In the central segment, the flood thus initiated several spots of minor bank erosion, from which the stream wandering started to propagate, although to a limited extent (Figure 7).

Figure 7. Stream wandering in the central segment HOS (a) after the completion of the restoration. (b) Bare riparian zone after the completion of the restoration in March 2016. (c) Initiation of stream wandering after the summer storm flood in June 2016. (d) Stabilized channel pattern after the first vegetation season, March 2017. Data: UAV monitoring, 2016–2017.

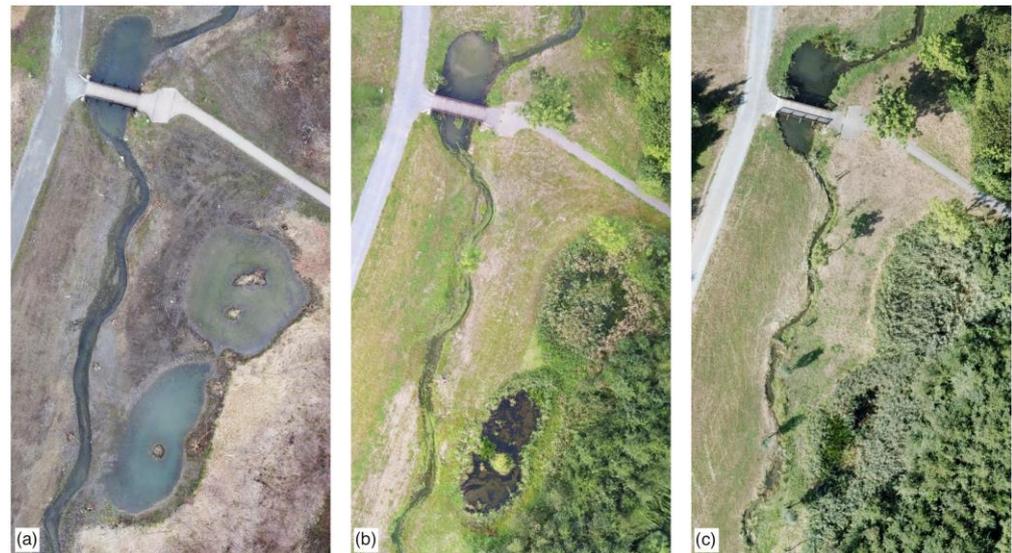
spill. More significant are the issues in the connectivity of newly built ponds. The ponds were built in different locations than those in the approved restoration plan and without a direct hydrological connection with the stream. As a result, extensive eutrophication in the ponds and overgrowth by reeds have occurred since the restoration (Figure 8). Five years after the restoration, both new ponds almost disappeared under overgrowing reeds. During the critical period of drought in the summer of 2019, the in-stream water had apparent signs of turbidity and algae, particularly in the low part of the segment.

Figure 8. Progress of eutrophication and overgrowth in the newly built ponds at HOS. (a) April 2016, (b) June 2017, (c) August 2018.

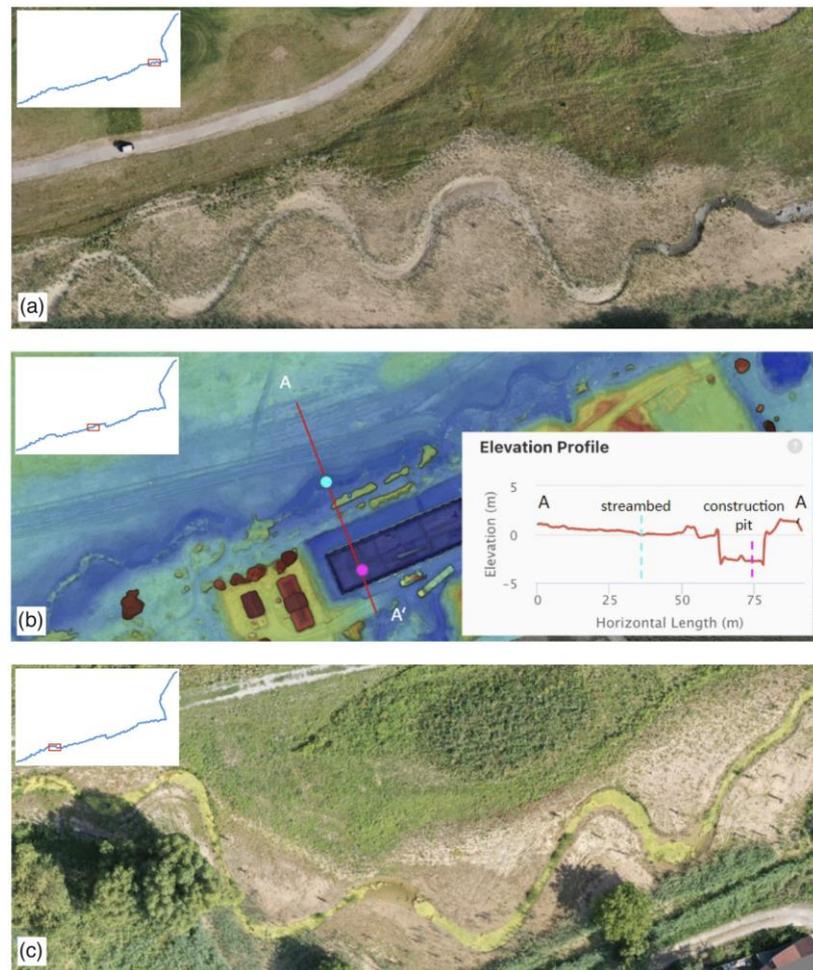
The new channel is almost twice as long, has a wide and shallow bed profile with a higher capacity that corresponds to the hydrological conditions, and is built on highly permeable soil. Moreover, the stream is subject to water extraction in the central part of the segment. As a result, the restored channel dries in summers in a coherent and long stream segment. The same condition applies to the ponds. The existing pond in the mid-section of the segment, which was formerly connected by an inflow and outflow with the stream, was cut from the channel during restoration works. Since then, the pond has dried and is subject to heavy eutrophication. The newly built ponds were designed without a direct connection to the stream; thus, they dry during the summer season (Figure 9a).

Figure 9. UAV-assisted detection of the qualitative issues in hydrological processes in the LIP brook. (a) Drying of the channel in the summer season, (b) 3D model of the construction pit along the restored stream, and (c) in-stream eutrophication developed after the project termination in July 2019.

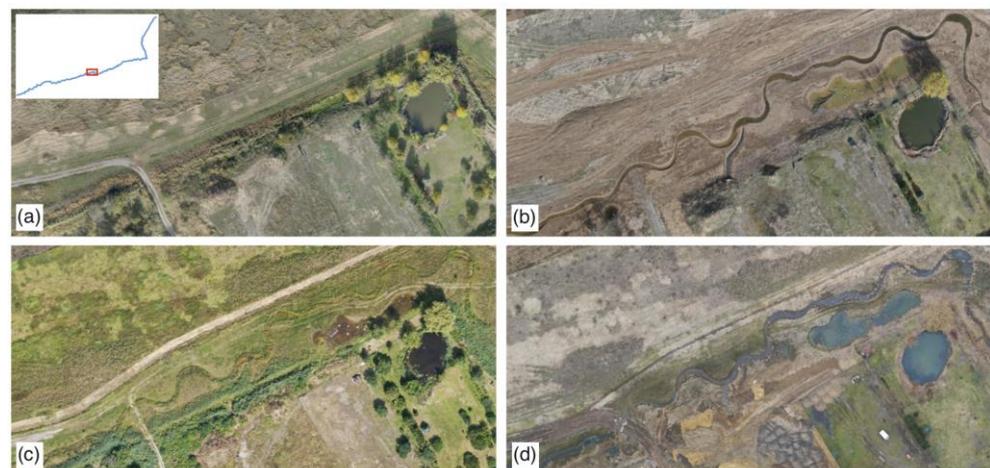
In the three observed streams, the assessment of the streambank vegetation restoration showed coherent grassing of the riparian zone within two years after the project completion (Figures A1g, A2g and A3g). In the ROK and HOS brooks, two years after the restoration, the riparian zone was covered by coherent grass, with newly planted trees on the banks and abundant riparian vegetation in the vicinity of the stream. In the LIP brook, the initial revegetation of the riparian zone successfully progressed over the first two years after the restoration despite the dry summer seasons. However, in the fall of 2020, construction works in the central part of the restored stream disrupted the newly vegetated riparian zone. Thus, at the beginning of the 2021 season, a substantial part of the streambanks in the central segment became bare again and vulnerable to erosion (Figure 10d).

Figure 10. Changes in riparian vegetation coherence in the LIP brook. (a) Pre-restoration status (October 2018), (b) Completed restoration (March 2019), (c) One year after restoration (July 2020), (d) Disturbance of the completed restoration by construction works (March 2021). Imagery: J. Langhammer, 2018–2021.

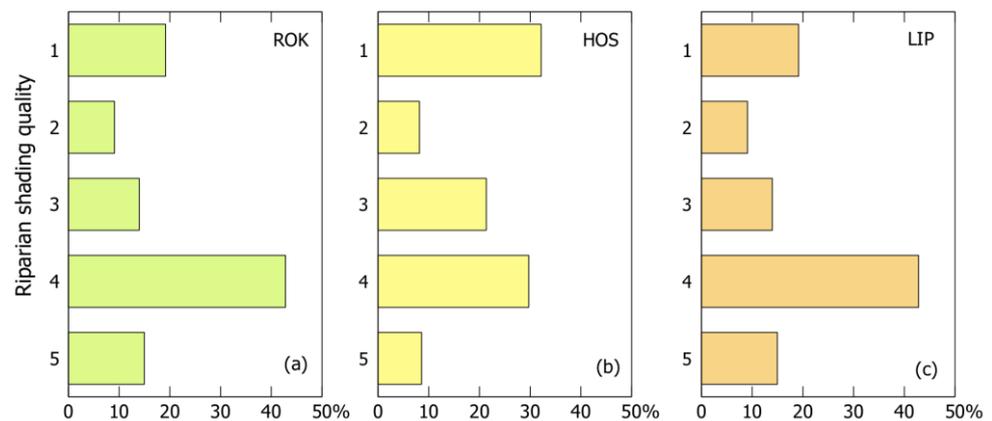
As a repeating problem, a deficiency of riparian shading has been identified. In all of the assessed streams, the restoration projects have deviated substantial parts of the new channels from the existing mature vegetation. Most of the extent of the restored channels was thus left without riparian shading (Figure 11). In part, such deficiencies are substituted by planting new trees along the channel in ROK and HOS.

Figure 11. Assessment of the riparian shading indicator. Share of riparian shading quality classes on the restored stream length. (a) ROK, (b) HOS, and (c) LIP. Data: UAV monitoring, 2021.

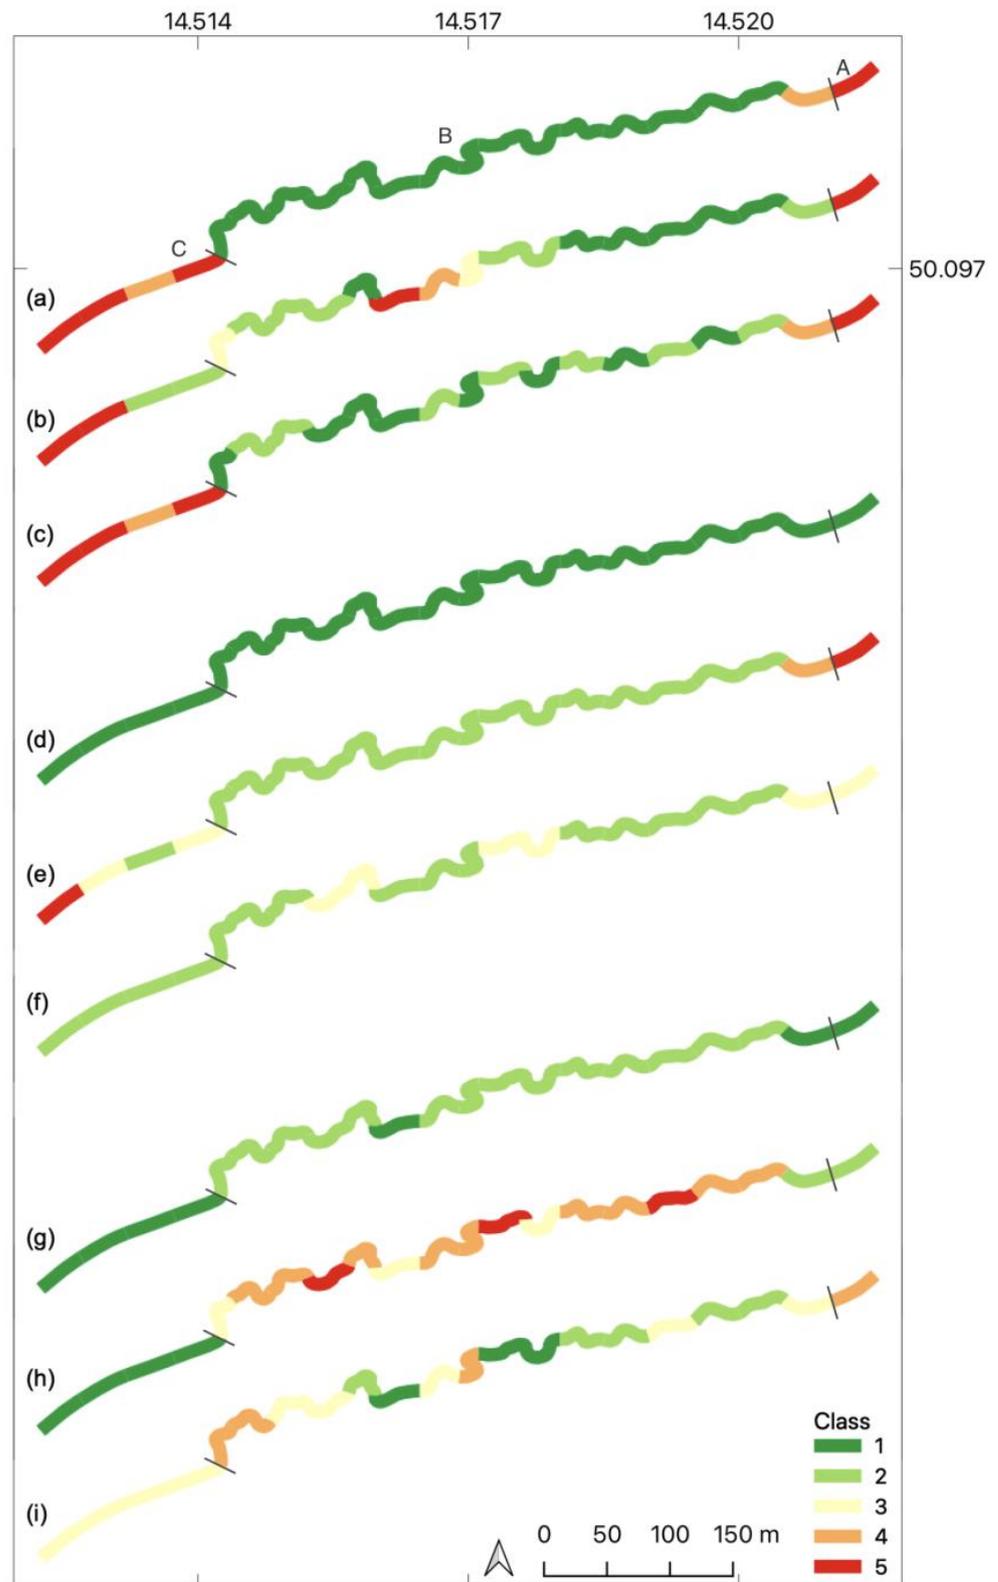
In the ROK brook, only the initial part of the assessed stream provides shading and potential for wood recruitment from large trees with overhang branches. The whole central segment with the new meandering belt is exposed to sunlight, and the isolated shrubs on streambanks provide only limited shading. The efficient shading by trees and overhang branches is at 19.2% of the stream, however, in a terminal straight segment of the stream (Figure A1h).

Figure A1. Assessment of restoration indicators in Rokytká (ROK). (a) Channel modifications, (b) Channel stability, (c) Bed variability, (d) Flow continuity, (e) Floodplain connectivity, (f) Water quality, (g) Vegetation coherence, (h) Riparian shading, and (i) Woody debris.

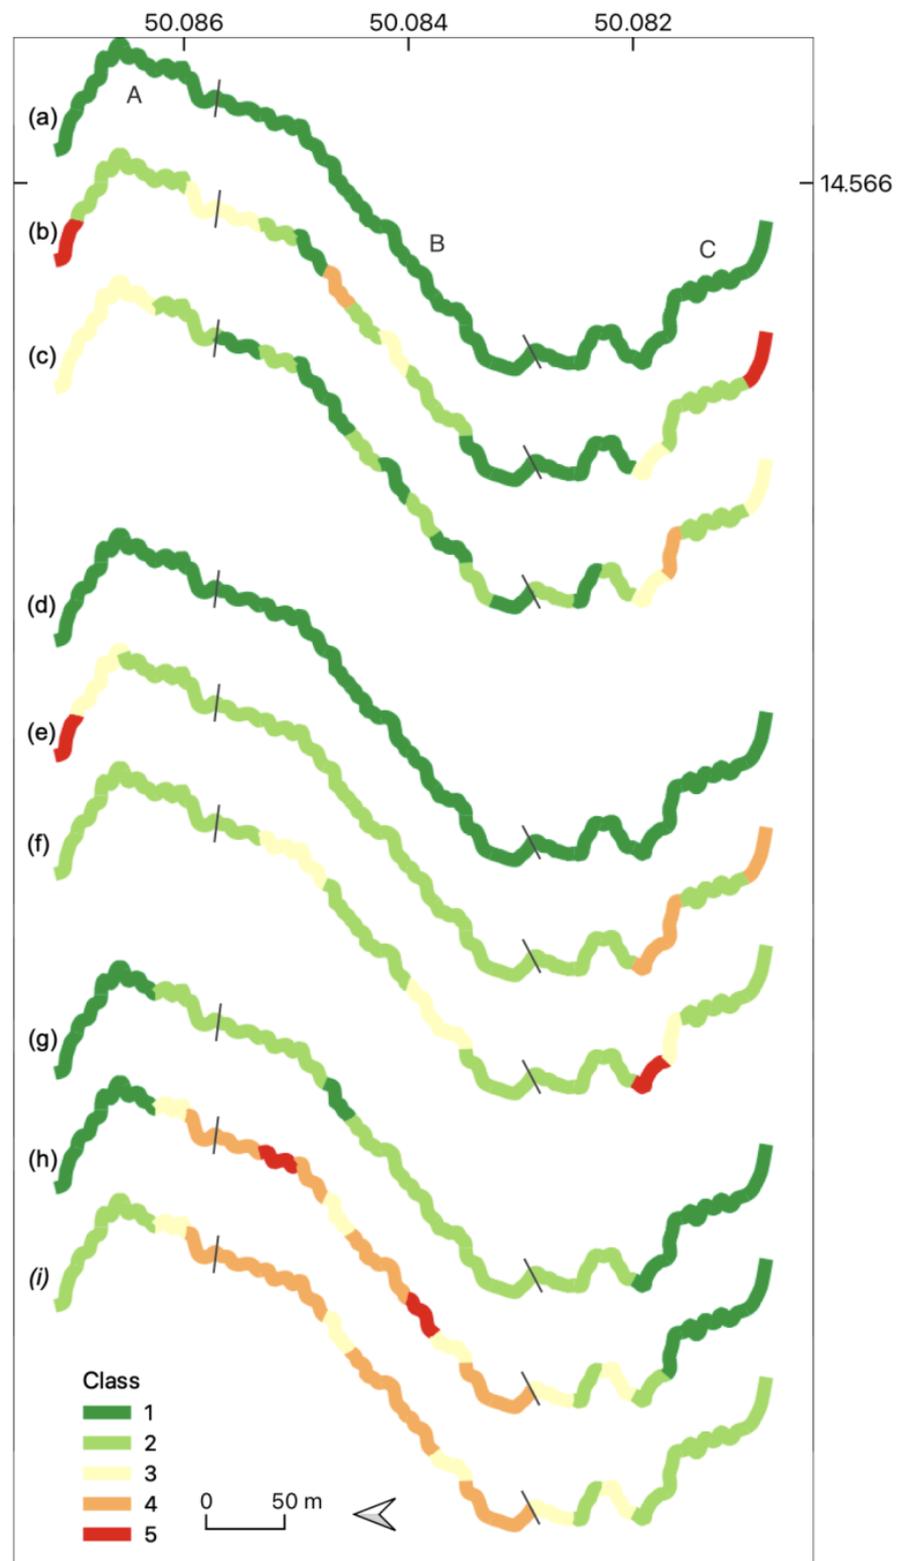
In HOS, minor limitations of the stream and floodplain connectivity (Figure A2e) by the sidewalks forming a dike in the outer space of the floodplain were detected. The spill during a flash flood in 2016 [8] showed their impact on the reduction of the potential flood

In HOS, the greatest extent of riparian shading was observed on the restored stream (32.2%), spread in different parts of the restored stream (Figure A2h). The channel is covered by the overhanging canopy of large mature trees in three parts, providing efficient shading in the summer season. In the long central segments exposed to sunlight, new trees were planted, with the potential for shading in the future.

Figure A2. Assessment of restoration indicators in Hostavický brook (HOS). (a) Channel modifications, (b) Channel stability, (c) Bed variability, (d) Flow continuity, (e) Floodplain connectivity, (f) Water quality, (g) Vegetation coherence, (h) Riparian shading, and (i) Woody debris.

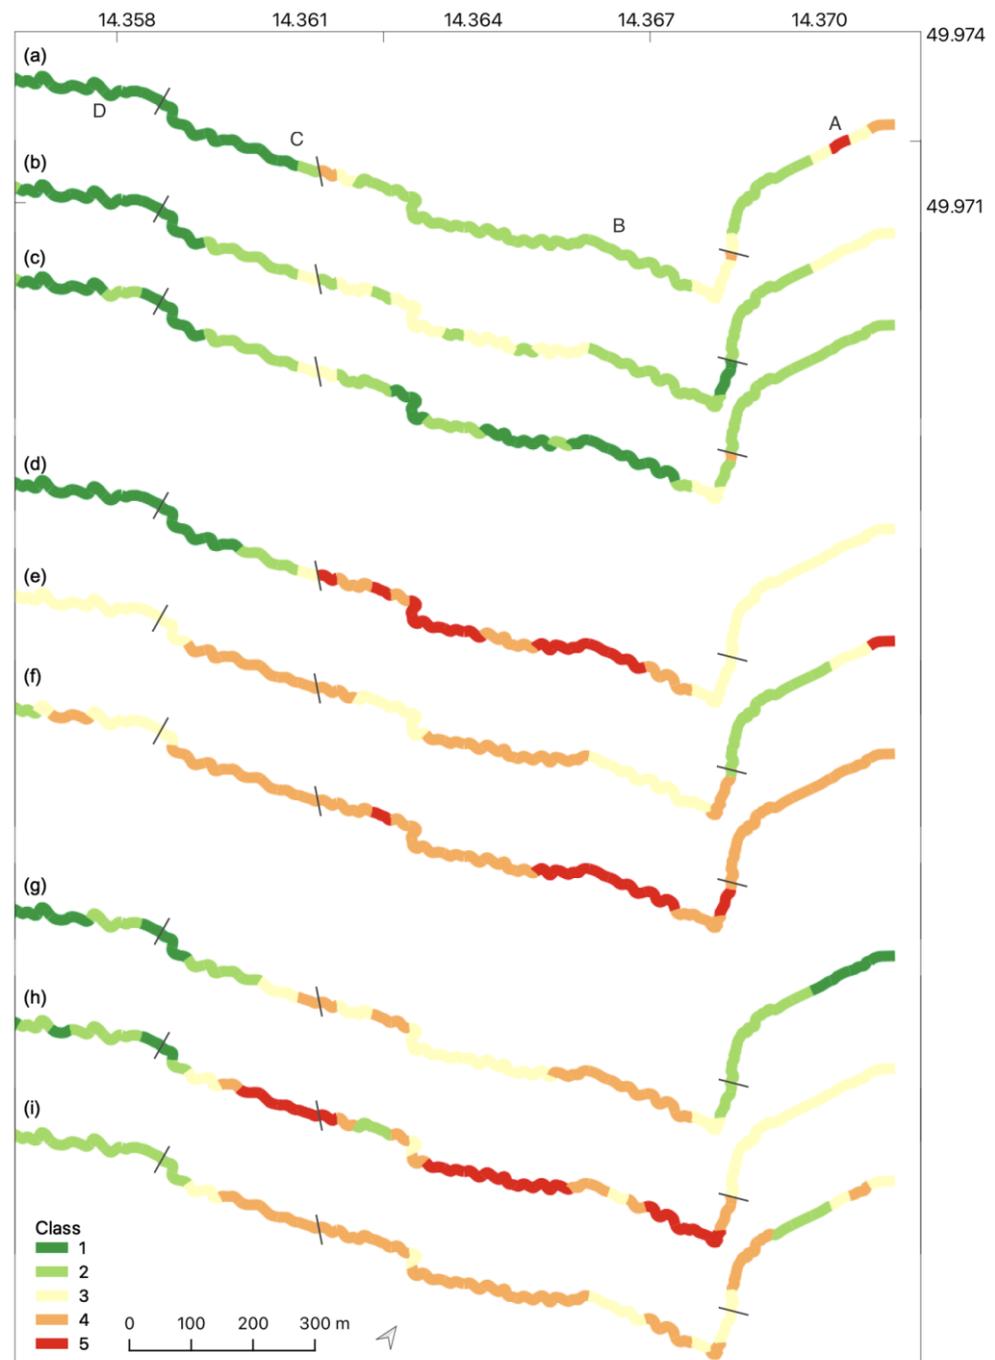
The most critical issues in flow continuity and floodplain connectivity were detected in the LIP brook, despite its highest potential given the natural conditions and low anthropogenic pressures (Figure A3). The restored segment of the LIP brook is located on a fringe of a large natural floodplain, and the restoration achieved the best fit of the geometric properties to the plan. However, UAV monitoring revealed significant issues in the flow continuity and floodplain connectivity, leading to the deterioration of the hydroecological functions of the stream. Before the restoration, the trained stream was located along the slope of the alluvial terrace with a road and sparse housing, limiting the spill on its right bank. The restoration could have used the wide and flat floodplain to re-establish the meandering system. This space is, however, occupied by a golf course and separated from the riparian zone by a new dike. The dike leaves only a limited corridor for the new meandering belt and breaks the hydrological connectivity between the stream and the floodplain (Figure A3d,e).

Figure A3. Assessment of restoration indicators in Lipanský brook (LIP). (a) Channel modifications, (b) Channel stability, (c) Bed variability, (d) Flow continuity, (e) Floodplain connectivity, (f) Water quality, (g) Vegetation coherence, (h) Riparian shading, and (i) Woody debris.
