A Brief Report on the Explosion on 13 June 2021 at a Market in Shiyan, China

Abstract: A huge gas explosion occurred on 13 June 2021 in Shiyan City, China, resulting in 25 casualties and serious injuries to 37 people. The main victims of this explosion were stall keepers and customers buying breakfast and fresh vegetables in the food market. There is a continuous need to enhance the understanding of such unfortunate events, given the dangers they pose. This study analyzes the causes of this accident considering the general background and scenes of the explosion, and then describes the rescue operations undertaken. The investigation results revealed that the explosion was caused by the poor maintenance of gas facilities and negligence of safety regulations. It is, therefore, recommended that the control of these two main aspects be strengthened to reduce the recurrence of such unfortunate accidents.

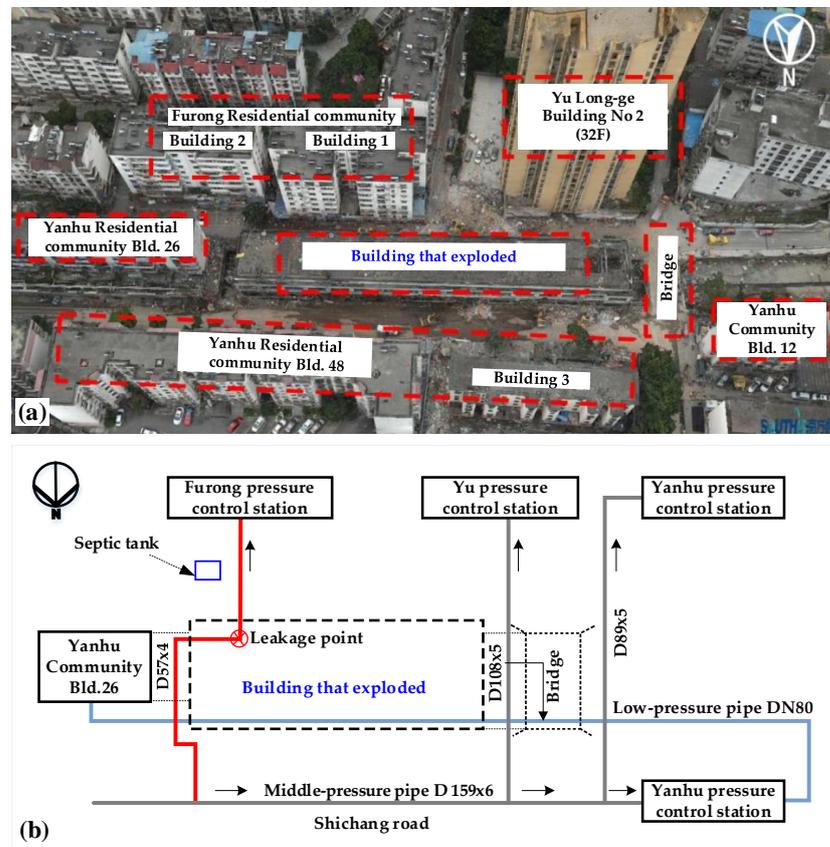
Figure 2 shows the buildings and pipelines arrangement before the explosion. It can be seen that the market building was surrounded by relatively high residential buildings. This two-story steel-concrete structure was illegally constructed on a river bed in 1991 [21]. Thenceforth, the lower ground floor of the building and the river below formed a closed space from North to South and partially blocked from East to West (the space was about 107 m long and 14 m wide, the height from east to west is reduced from 4.0 m to 2.7 m, and the volume was about 5300 m³) [21]. Moreover, the west end of the building was adjacent to the Yanhu bridge, while its east end was close to (6.2 m) the Yanhu community building No. 26. A convenient path was built with a cement plate between this residential

Figure 2. Main buildings and gas pipelines involved in the explosion (Recreated after [21]). (a) Surrounding buildings affected by the explosion. (b) Gas pipelines arrangement and leakage point.

Furthermore, it can be observed that the gas pipeline network in the explosion area was mainly composed of low- and medium-pressure steel pipes with various diameters. Particularly, the pipeline at the origin of the explosion (represented in red in Figure 2b) was a medium pressure pipe with a diameter of 57 mm. It can also be seen that these pipelines were conserved in a rather inadequate environment. Under the above-mentioned conditions, the steel pipe experienced severe corrosion over time (Figure 3b), resulting in cracking and gas leakage (the leakage point was located under the building that exploded). The leaked natural gas gathered and spread to the first and second floors, which was aided by poor ventilation of the confined space below the building, given that the leaked gas quickly became concentrated. Therefore, upon reaching the explosion limit, it detonated on contacting a fire source [22].

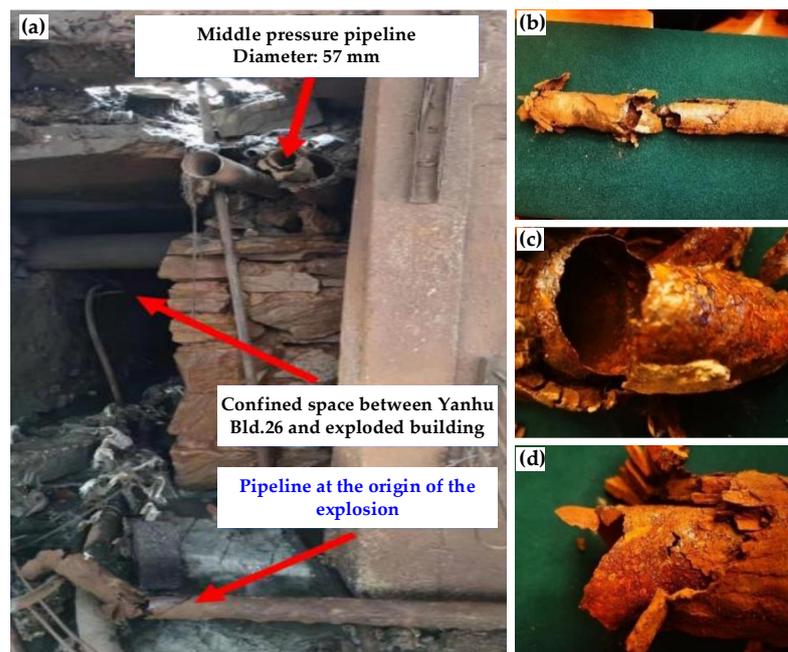
building and the one that exploded, causing another enclosed space below the ground surface (Figure 3a).

Figure 3. (a) Confined space below the ground surface and (b–d) different views of the corroded pipe (Recreated after [21]).

The primary cause of the accident was found to be a gas pipeline leak. The external surface of the pipeline experienced electrochemical corrosion (Figure 3b) as a result of long exposure to a humid environment. Indeed, much research has experimentally demonstrated the influence of environmental conditions on the corrosion behavior of pipeline steel [28,29]. Further, the technical audit revealed that the external anti-corrosion of the pipeline elbow was not manufactured according to the anti-corrosion specifications; yet, despite a recent reform aimed at improving the condition of gas pipelines, corroded pipelines were not attended to in this specific area [21]. Therefore, this is a typical case in which an instance of inefficient management of alarm bells and/or risks has evolved into a major disaster. Before the explosion, the relevant department had already received calls from residents complaining about a strong smell of gas nearby. Subsequently, the gas company inspected the neighborhood on June 3; however, they did not find any illegal gas storage facilities or equipment. In other words, when the gas leakage occurred, no adequate measures were undertaken by the relevant entities [21], which made the residents believe that there were no risks and they could normally proceed with their daily cooking activities. Consequently, the explosion occurred as a result of the gas build-up reaching its limit in a confined space.

It is suggested to strengthen the safety awareness of local residents so as to enable them to take remedial measures when there are alarming signs. In the vicinity of hazardous equipment (such as pipelines for transporting flammable and explosive gases), strict requirements of the working environment should be specified. For instance, when installed underground, such equipment should be ventilated, and the warning range should be marked near the ground. Regular inspections are also needed to guarantee the integrity of the equipment and surrounding environment. For major safety inspections, it is recommended to set up a multi-layered mutual supervision model, in which the responsibilities are shared to ensure the implementation of regular inspections.

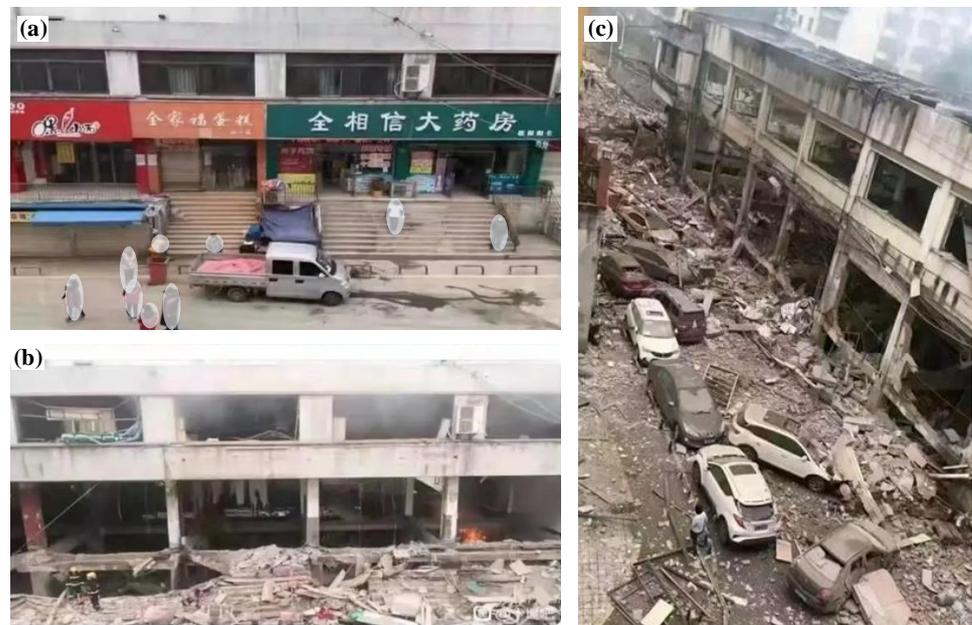
The blast hit shortly after 6 a.m., the time at which some residents were going to restaurants in the market for breakfast, among whom some died, while others were injured. According to some witnesses, the explosion was huge, and the resulting flying debris might have caused more injuries. In fact, according to the technical audit performed by the local government [21], the volume of natural gas accumulated in the confined space, i.e., the bottom of the accident building was approximately 600 m³. Yet, the energy of the explosion was equivalent to 225 kg TNT [21]. Figure 4 shows some pictures illustrating the severity of the explosion. It can be seen that the entire market building was overturned [22]. The ground floor slab on the first and second floors collapsed and fell into the river below, while the building walls and the roof were completely demolished. The explosion not only destroyed the market building but also affected the surrounding environment. Debris and fragments from the explosion were spread over a wide area, mainly due to the impact of the explosion, causing damages to the surrounding buildings. The doors and windows of the surrounding residential buildings (Furong residential community, Yanhu residential community, and Yu Long-ge building) were seriously damaged, affecting approximately 1678 residents. Further, several shops installed in front (North direction) of the market building, as well as cars parked in its vicinity were mostly destroyed. However, the environmental protection department confirmed that the accident did not cause any surrounding environmental pollution [21]. Similar explosion outcomes were reported by recent studies, and the reader can refer to them for a more comprehensive understanding [23–25].

Figure 4. (a) Market building before the explosion; (b) Market building destroyed by explosion; (c) Market street impacted by the blast (source: <https://baijiahao.baidu.com/s?id=1702438248131929294&wfr=spider&for=pc>, accessed on 14 August 2021).
