Environmental Decay of Ignimbrite Patrimonial Monuments in the Dry, Urban, and Non-Industrial Atmosphere of Morelia (México)

Rosalia Ruiz-Ruiz ^{1,2,*}

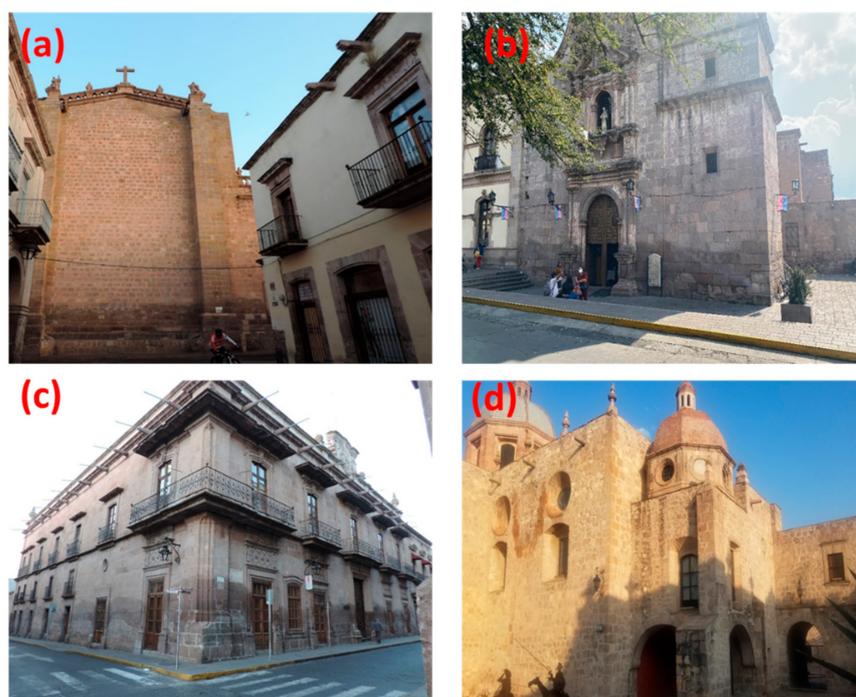
Damage begins with a change in the appearance of the ignimbrite surface. Regularly, a darker tonality is produced by pollutants in the atmosphere, black crust, and the wetting–drying process to which the ignimbrites are exposed. Several historical monuments have stains due to humidity on their facades, approximately between 2.0 and 2.5 m above the level of the sidewalk (Figure 8). The humidity is due to the existing water in the soil of the foundation, which by capillarity, is absorbed by the rocks that form the walls.

Figure 8. (a) The south facade of the cathedral (CAT), (b) the north facade of Capuchinas church (CAP), (c) the east and north facades of the Regional Museum of Michoacan (MR), and (d) the south and east facades of the Temple of the Carmen (CC).

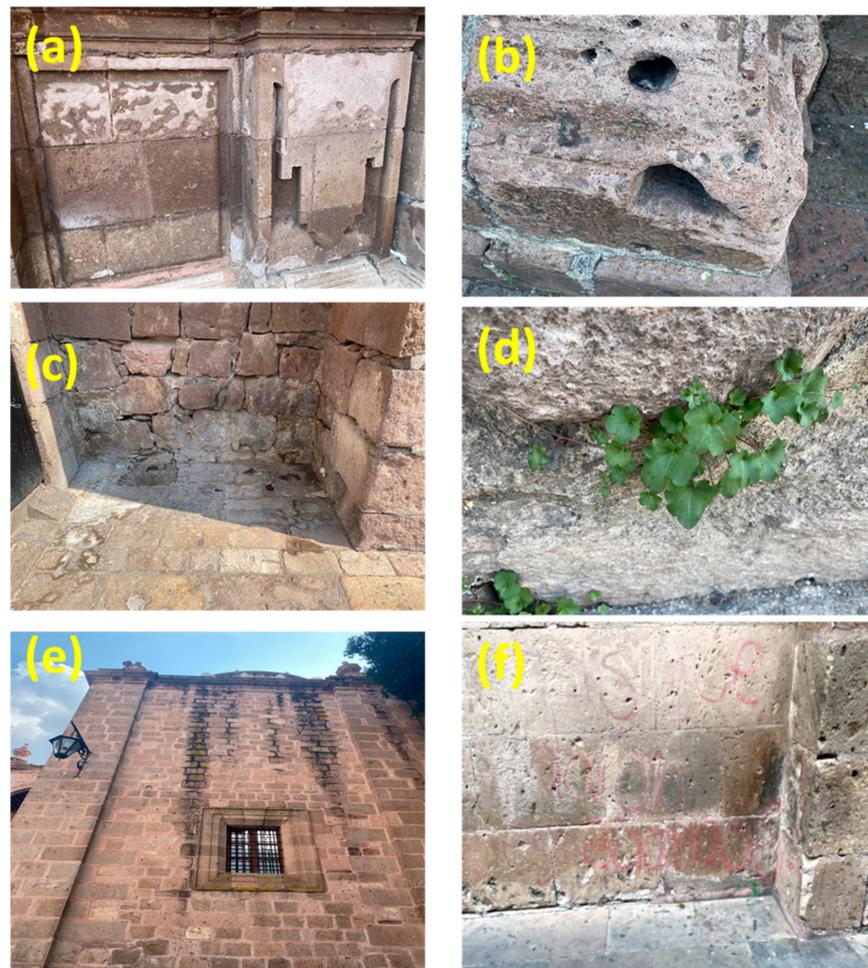
The existing damage, generated gradually over the years, begins with a change in the appearance of the surface (Figure 9a), detachment of the material in the form of fragments, shards, flakes, and powders (Figure 9a,b), the loss of the mortar that joins the ignimbrites (Figure 9c), and the presence of flora in the mortar that joins the stones (Figure 9d). In addition, there is friction damage caused by humans in the main entrances of the temples, causing significant loss of ignimbrites (Figure 9b). In some facades, human waste was observed at the ground level (Figure 9c), and the presence of lichens in the upper parts because of the accumulation of water and humidity, gradually causing the degradation of the ignimbrite at the surface level (Figure 9e). Graffiti was also found as part of the vandalism of the historical monuments. The mechanical abrasion method is used to remove them regularly, generating greater damage to the ignimbrite surface (Figure 9f).

Figure 9. Common forms of deterioration in the facades of historical monuments: (a) weathering of ignimbrites at the surface level, (b) damage due to contour scaling and deeper damage to ignimbrites, (c) loss of mortar between ignimbrite blocks, (d) flora at the surface level of the facades, (e) lichens on the highest parts of the facades, and (f) graffiti.

It is evident that there is deterioration in the buildings studied in this research; the damage is mainly in the lower zone of the facades, in the stones, and in the mortar that joins them. It was found in the altered samples of the different historic buildings and healthy rocks that there is a presence of silica (SiO_2), quartz (SiO_4), and albite, among other mineral particle compounds from each sample (Figure 10). According to the mineralogy of the SAN samples, the matrix is a greenish-brown glass with abundant recrystallization points and incipient appearance of chalcedony, containing small plagioclase microlites, pyroxenes transformed to magnetite or antigorite. The Capuchinas church (CAP) sample also presents a dark greenish matrix containing fragments of minerals and lithics of basaltic composition; in some parts of it, there is chalcedony and the punctual replacement of calcite. The few lithics it contains present an andesitic composition with plagioclase (Andesine) and pyroxenes (Augite) that, in some cases, are chloritized or transformed to antigorite. The ignimbrites are mainly composed of rhyolite [70].

To reduce the damage to architectural heritage caused by environmental contamination, it is pertinent to identify preventive and corrective measures. Some of these measures include the partial restriction of public transportation in the historic center of Morelia, the use of sacrificial coatings (mortars) that impede direct contact between the different agents of deterioration and the ignimbrites, and the search for quarries that meet the physical-mechanical characteristics of the ignimbrites used in historical monuments since the present work shows that the current quarries do not achieve this.

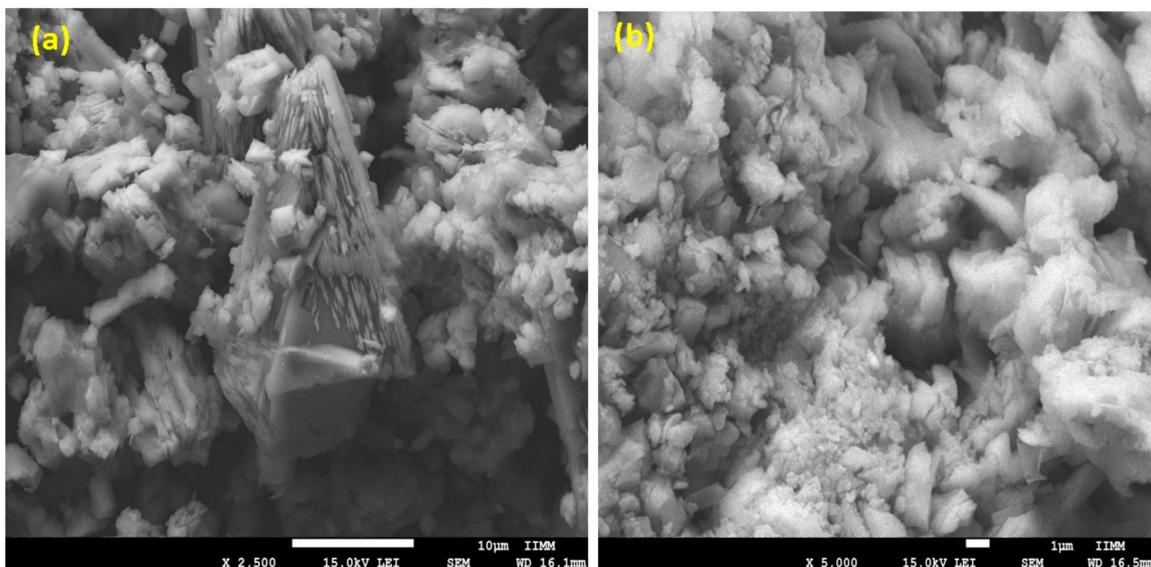
In the photomicrograph of the CAT sample (Figure 12a), there is a crystal composition with different shapes and dimensions, its grains have a large surface area, and the topography is irregular. In the SAN sample (Figure 12b), the grains are very close together, and its surface is compact with the presence of crystals and flakes of different sizes. The CAT and SAN samples come from the balustrade and the ribs of the dome, respectively, showing how the environment damaged and metamorphosed them, especially by the prevailing winds because they were at average heights of 50 m and the ignimbrite blocks of the lower parts are where the rain splashes occur, cleaning exhaust from motor vehicles. The monuments lasted decades in their construction, and the blocks came from different attack fronts or from different quarries around, which is observed in the different constructive strata, but in general terms, they are very similar.

Figure 12. Scanning electron microscopy (SEM): (a) CAT south facade balustrade and (b) SAN.

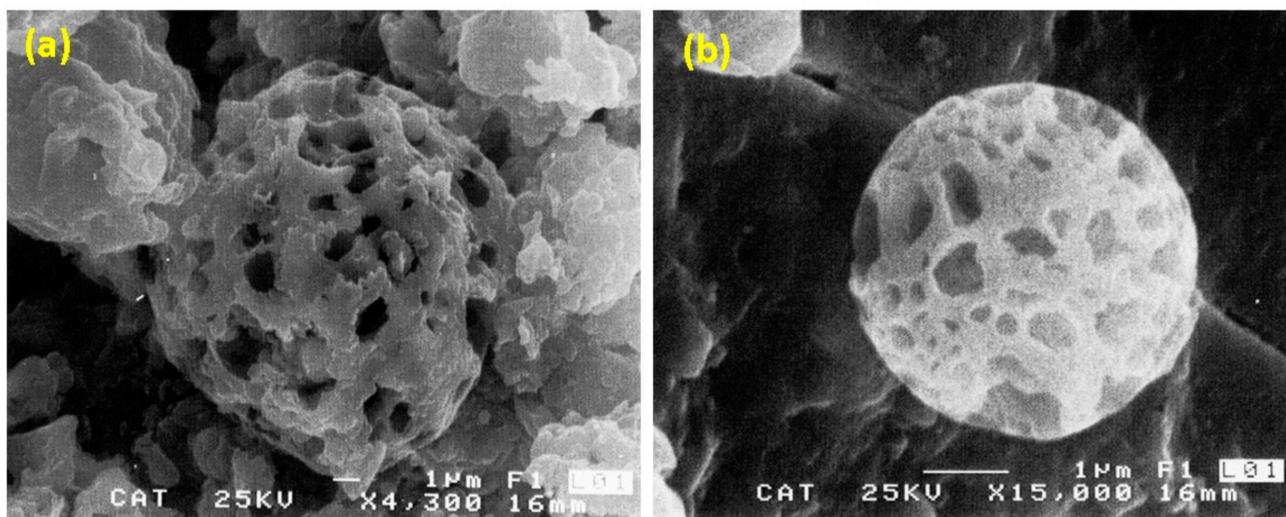
These characteristics found by SEM analysis allow us to infer that they are the product of the influence of pollutants, as shown in Figure 2a,b. It is clear that there are SO₂ emissions of which there is evidence in microphotographs (Figure 13a,b) that are known as environmental particles, in this case, with the presence of sulfur [85]. However, the presence of carbon monoxide produced by the incomplete combustion of fuels in the vehicle fleet of the city of Morelia is also observed.

Figure 13. (a,b) Environmental particles that form the patinas on the cathedral's balustrade (CAT).

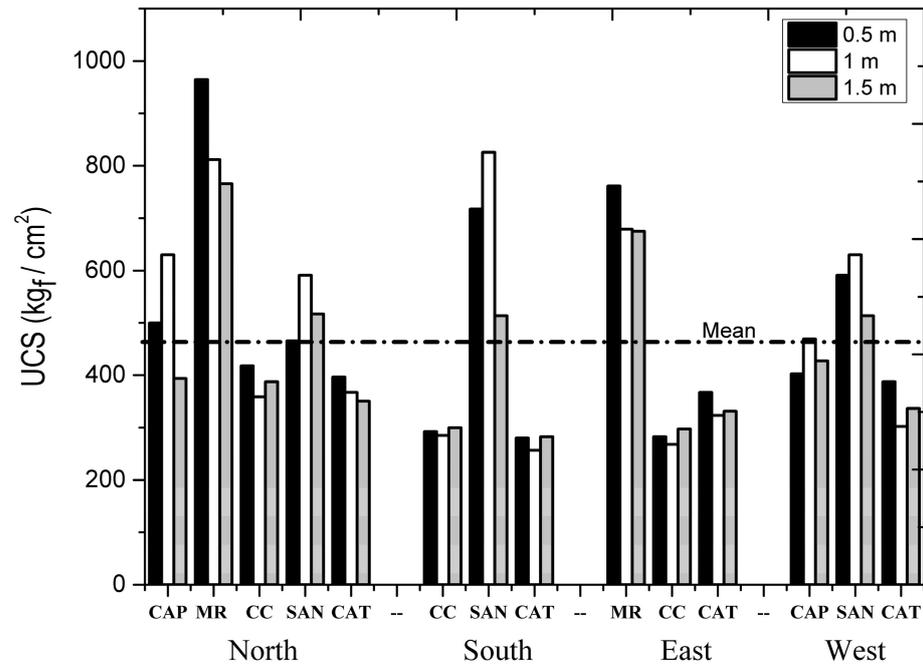
Figure 16 shows that the south-facing facades with the lowest UCS index resistance are CC and CAT. It is important to keep in mind that not all buildings have south facades in the historic center. As for the east- and south-facing facades, very similar resistances were recorded, coincidentally in the same historic buildings: CC and CAT. However, the west- and north-facing facades show higher resistances than the south- and east-facing ones, with this being more evident in the decrease in resistance in the south facade of CAT, as shown in Figure 17.

Figure 16. UCS of all the facades of the monuments studied.

Figure 16 shows that the UCS of historical monuments is diminished on the facades that coincide with the prevailing winds, which reportedly come from the southeast for most of the year. In addition, pollutant emissions due to vehicular traffic, the width of roads, and climatic conditions such as precipitation, solar radiation, wind speed, temperature, and relative humidity are also agents that intensify the deterioration process of the rocks of heritage buildings.

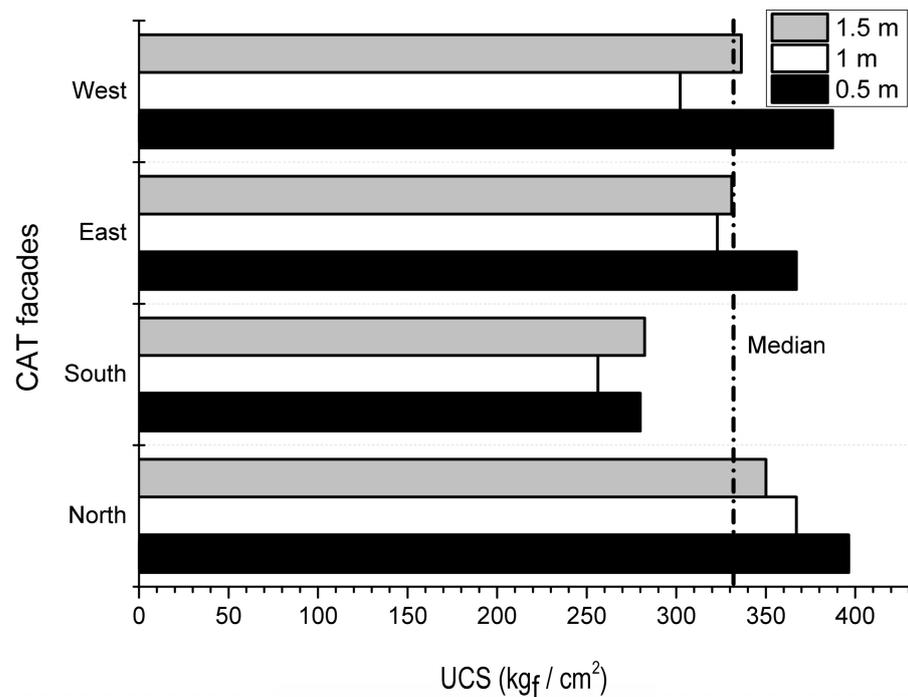
Figure 17. Comparison of the UCS of CAT by facade.
