Use of LiDAR Technology for the Study and Analysis of Construction Phases and Deformations in the Gothic Church of Biar (Spain)

Heritage **2024**, *7*, 122–138. <https://doi.org/10.3390/heritage7010006>

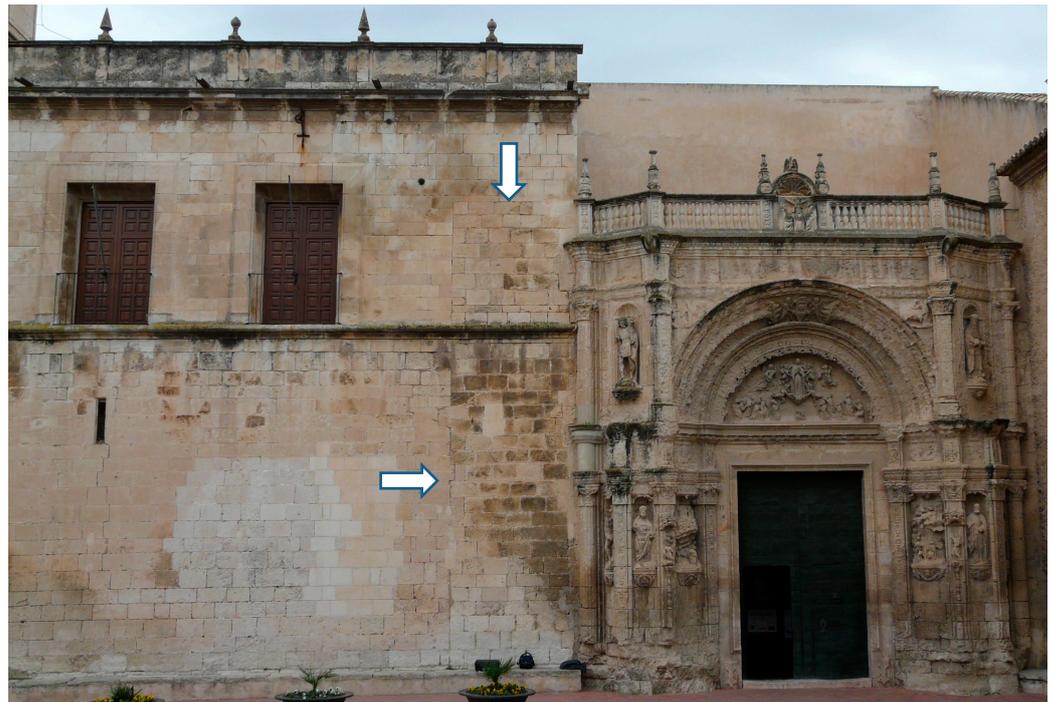
The façade shows numerous constructive anomalies because of the sum of several masonries with different types of ashlar in terms of format and size. There are vertical and horizontal constructive joints typical of the construction of masonry in different stages of construction. This elevation of the building also shows numerous degradations due to the alteration of the stone materials of which it is composed. The areas affected by damp are the most altered. Some ashlars show a high loss of their original shape with multiple cavities, mainly due to alveolisation and sandblasting [34]. The most affected parts are the plinth in the lower part of the wall and the areas of incidence of rainwater runoff from the gargoyles on the vertical of the wall below its location (Figure 6).

Figure 6. Northeast façade of the church.

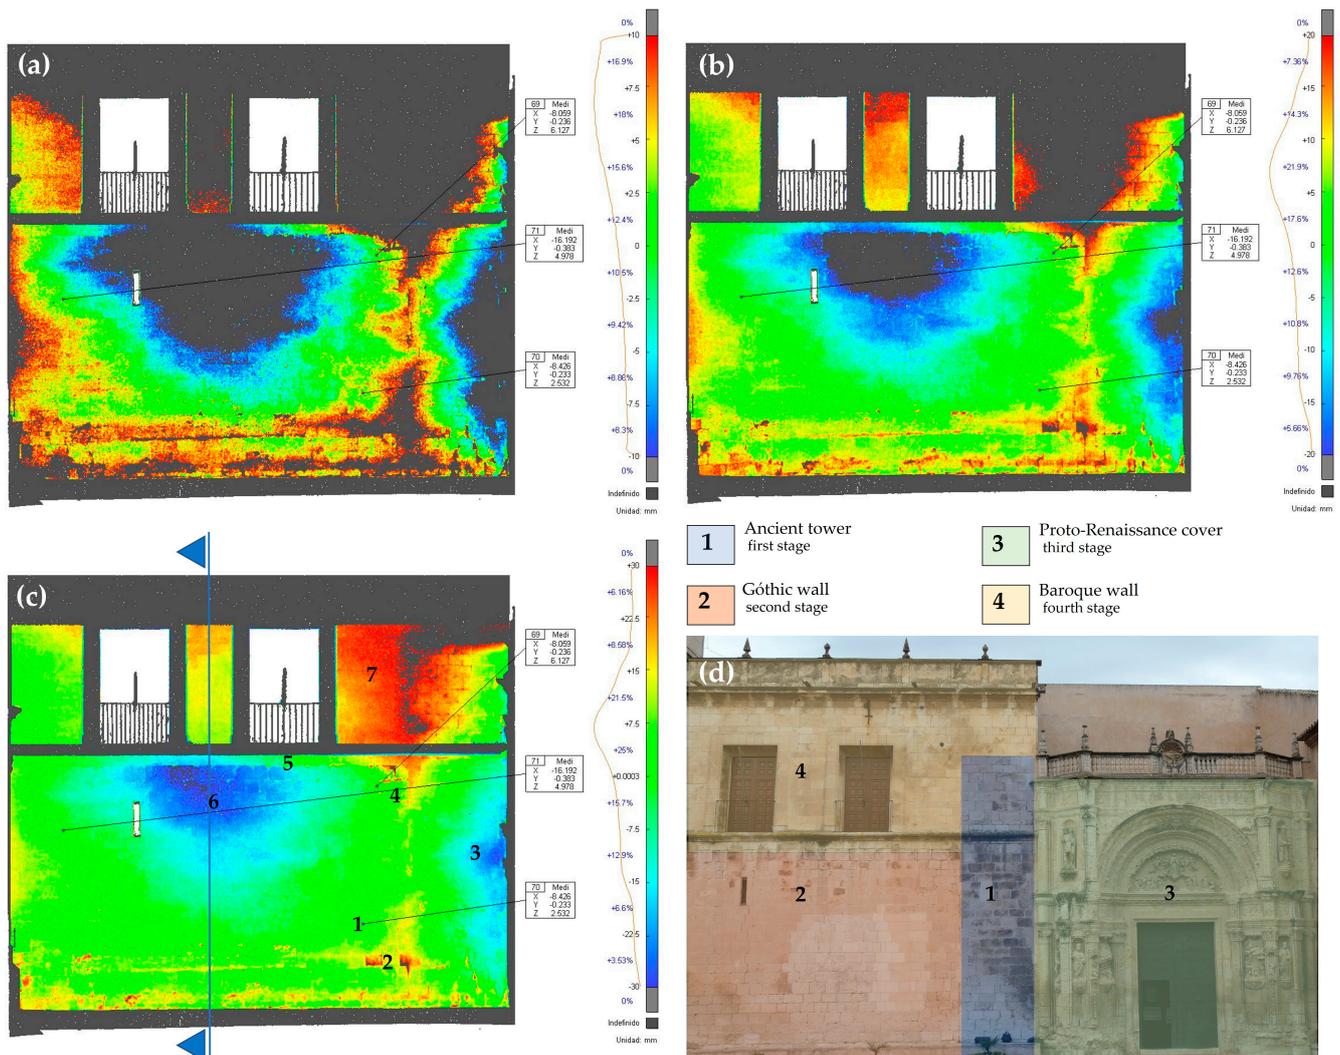
In the different images in Figure 9, the three points numbered “69, 70 and 71” that form the reference plane are indicated with their coordinates. The green points coincide with the plane. The red and blue colours indicate the distance from the reference plane (red towards the inside of the building and blue towards the outside). Surveys were carried out with three different ranges from (+10 mm) to (−10 mm) away from the plane (Figure 9a), (+20 mm) to (−20 mm) away from the plane (Figure 9b) and (+30 mm) to (−30 mm) away from the plane (Figure 9c).

The areas shown in black in the figures are located outside the study range. If the part closest to the black area has red borders, it means that the black area is behind the reference plane. If the black area has blue borders, the black part is outside the building and ahead of the reference plane, e.g., the part indicated as “6” in Figure 9c.

It has been observed that the central area of the façade protrudes outwards by more than 3 cm. This part coincides with the horizontal thrust of the arch between the chapels that absorbs the loads of the vaults and transmits them to the wall, indicated as “6” in Figure 9c.

The row of ashlar below the current intermediate cornice, indicated as “5” in Figure 9c, is not built on the same plane as the lower masonry and corresponds to the Gothic façade. In addition, the row of ashlar just below shows much greater degradation, as indicated above. This could indicate that the Late Gothic masonry was finished off in the deteriorated course with larger ashlar and therefore the Baroque masonry begins in the course indicated as “5”.

The plane that forms the façade of the original tower shows similar gradients of colours in vertical strips, which indicates that it is rotated with respect to the reference plane. The alignment of the plane of the chapel enclosure does not coincide exactly with the alignment of the former tower’s masonry, although it may appear so to the naked eye.

Figure 9. (a–c) Study of deformations in the façade in colour gradient. The green dots indicate the reference plane, the red and blue dots move away 10 mm in case (a), 20 mm in case (b) and 30 mm in case (c). The blue areas move away from the building, indicating outward slumps. The black areas of the wall do not fall within the range under study and are greater than ± 10 mm, ± 20 mm and ± 30 mm in figures (a–c). (d) Image of different construction stages.

In the upper part of the old tower, coinciding with the wall that was rebuilt in the Baroque period, there are deformations in deep red (indicated as “7” in Figure 9c) and black areas, indicating that there are parts of this wall that go into the interior of the building with respect to the reference plane.

As for the degradations of the walls, the lower part of the façade shows multiple anomalies, as well as the encounter with the masonry belonging to the original tower, indicated as “2 and 4” in Figure 9c.

From the analysis of the geometric anomalies obtained using 3D LiDAR, it can be seen that the plane that forms the façade of the Gothic chapels is mostly green in colour, which belongs to the plane of the façade, but there are areas that appear in black, indicating that they are located outside the range of the study carried out, which goes from (+30 mm) to (−30 mm). Most likely, the deformations were produced by the thrusts of the interior vaults.

The reference plane (the façade of the chapels) does not coincide exactly with the plane of the tower masonry, as the tower is slightly rotated (+30 mm). There is an obvious interface between the original tower and the Gothic wall. In Figure 9a–c, there is a very marked vertical strip coinciding with this construction joint between elements.

The row of large ashlar, located under the one indicated as “5” in Figure 9c and which is highly degraded, must have finished off the Late Gothic façade completed in the 15th century. Today, an additional storey and half of the roof in this area rest on this façade, increasing the compressive load on the lower part of the wall and serving to increase the vertical component of the thrusts transmitted by the interior vaults on the façade. For more than two centuries, the intermediate zone (indicated as “6” in Figure 9c) was supporting higher horizontal thrusts, which deformed this zone outwards, as can be seen in the coloured graphs of the point cloud. These deformations are very small and would not have been identified by simple observation in situ. In the interior zone of the church where the symmetrical thrusts are transmitted, no deformations are observed in the point cloud. This is due to the fact that in this area there are more vertical loads transmitted by the upper wall that closes the central nave and collects the loads transmitted by the central stone vaults. These vertical forces minimise the horizontal thrusts transmitted by the vaults on the side chapels, and the resulting final force has a more vertical direction.

Regarding the degradations, as we have seen in Section 3, the materials used in the construction of this façade are very porous and mainly of a limestone nature. The lower part of the wall shows multiple areas of red or black colour in the study of colour gradients, depending on the distance from the reference plane. This indicates distances greater than 3 cm from the reference plane. In Figure 9c, the area affected by the effects of capillary rising damp has been indicated as “2”.

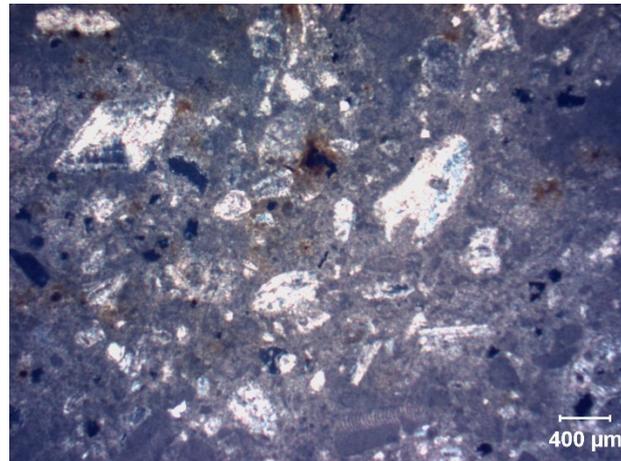
It is a white fine-grained biocalcarenite with high matrix content (biomicrite limestone). Fossil content corresponds to foraminifera and fragments of shells and echinoderm plates (according to POM observations) (Figure 10). Terrigenous content is low (<3%) and corresponds mainly to quartz, with trace contents of feldspar, opaque (dendritic structures) and clay minerals. According to XRD analysis, the mineralogical composition of this rock consisted of 95% calcite and 5% quartz.

Figure 10. Photomicrographs of the tower wall sample (Polarized Optical Microscope with crossed nicols). Biomicrite limestone.

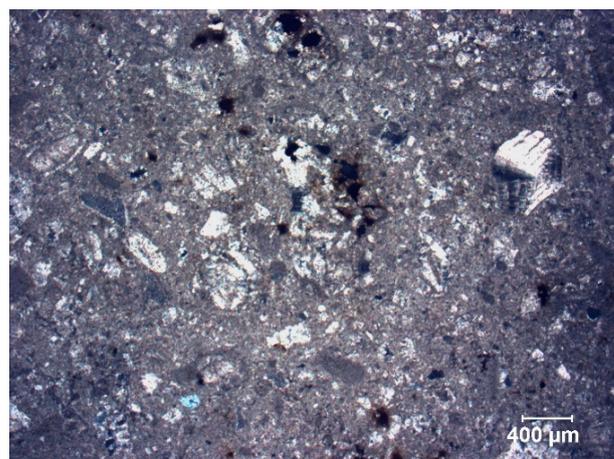
It corresponds to a white limestone similar to the rock used in the tower (fine-grained biocalcarenite, biomicrite) (Figure 11). The fossils are foraminifera, mainly globigerinids, some fragments of bryozoans and mollusks. Small discontinuous venules of sparite are observed. Terrigenous content is low, corresponding mainly to quartz, opaque minerals and iron oxides. Other accessory minerals observed under SEM were apatite, zircon, ilmenite and titanite. According to XRD analysis, the mineralogical composition of this stone consisted of 96% calcite and 4% quartz.

Figure 11. Photomicrographs of the central wall façade sample (Polarized Optical Microscope with crossed nicols). Biomicrite limestone.

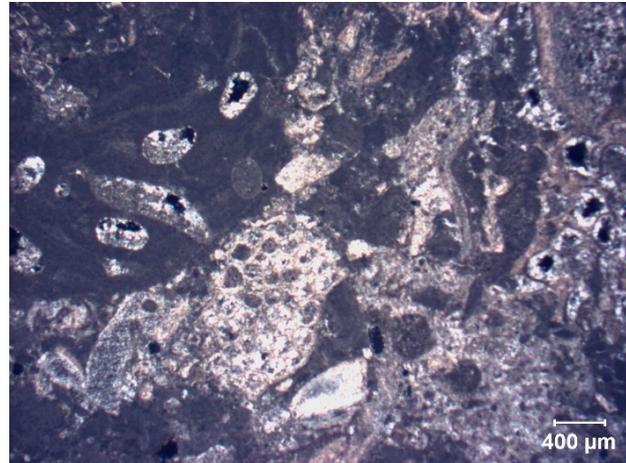
bryozoans). It has abundant intraparticle porosity mainly associated with bryozoan components (Figure 12). Pores appear partially filled with a druse calcite cement (sparite). According to XRD analysis, the mineralogical composition of this rock consisted of 94% calcite, 3% quartz and 3% microcline.

Figure 12. Photomicrographs Proto-Renaissance doorway sample (Polarized Optical Microscope with crossed nicols). Fossiliferous limestone.

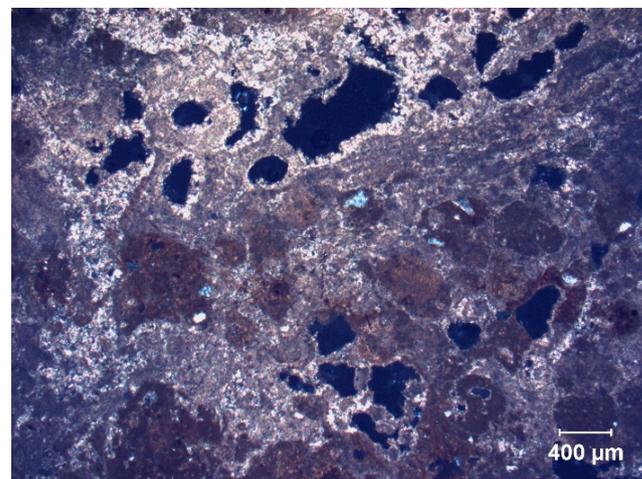
This rock corresponds to a white limestone with greyish and reddish chromatic variations. Terrigenous content is high (around 10%), corresponding mainly to quartz, opaque minerals and glauconite. The fossiliferous content corresponds to bryozoans, foraminifera and limeclasts (Figure 13). According to XRD analysis, the mineralogical composition of this stone consisted of 94% calcite and 6% quartz.

Figure 13. Photomicrographs at top wall façade sample (Polarized Optical Microscope with crossed nicols). Fossiliferous limestone.
