Article

Morphological Characteristics of Catalyst Layer Defects in Catalyst-Coated Membranes in PEM Fuel Cells

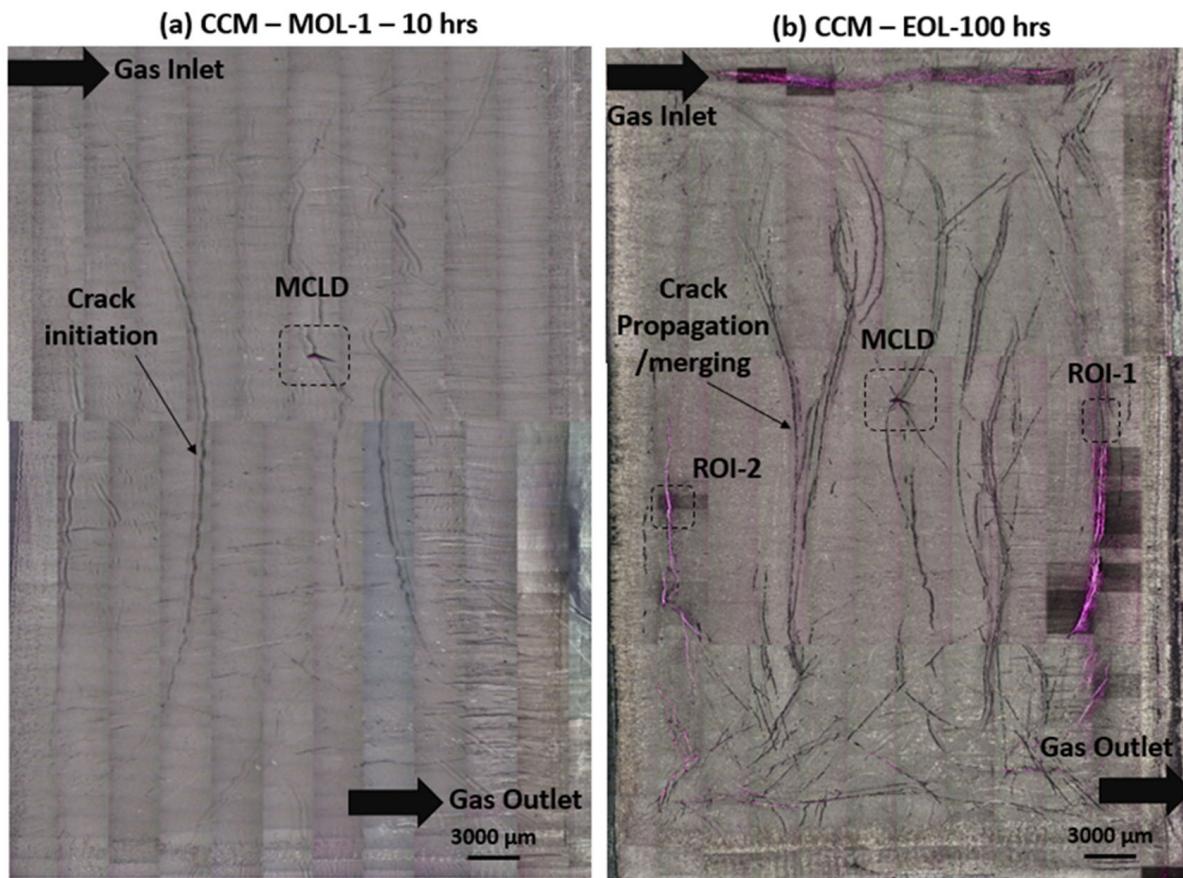
Crack growth and propagation were observed in this study to occur during three stages: crack initiation at MOL-1 (10 h), crack propagation at MOL-2 (50 h), and crack propagation/merging/delamination at EOL (100 h). As shown in Figure 3a, the number of cracks observed at MOL-1 was relatively modest. The stitched microscopic image of the aged CCM after 100 h of OCV-AST shown in Figure 3b revealed that many new cracks had formed and that they had propagated significantly by the time EOL was reached. Two regions in the EOL sample denoted as ROI-1 and ROI-2 had been specifically selected for closer examination of the damage to the catalyst layers. ROI-1 corresponded to an area where cracks had severely propagated in the catalyst layer. ROI-2 was an area where delamination

had occurred as a result of crack propagation caused by membrane swelling. The depth of the catalyst layer defect in ROI-2 had been determined using Z-profile and 3D imaging. This analysis showed that the catalyst layer in these areas had not been completely removed and that the delaminated or detached material amounted to ~50–70% of the original thickness over an average width of ~50 μm –150 μm , leaving behind thin portions of the catalyst attached to the electrolyte membrane. Furthermore, large catalyst layer pores with an average diameter of ~25 μm were observed in the leftover thin catalyst layers. Further examination of this type of delamination in CCMs and an image of the pores present in the remaining CL after delamination are presented in Section 3.3.2.

Figure 3. (a) Stitched optical microscopic image of CCL of defective CCM with MCLD captured after (a) 10 h (MOL-1) and (b) 100 h of OCV-AST (EOL). Locations ROI-1 and ROI-2 are specifically selected to investigate the delamination of CL.

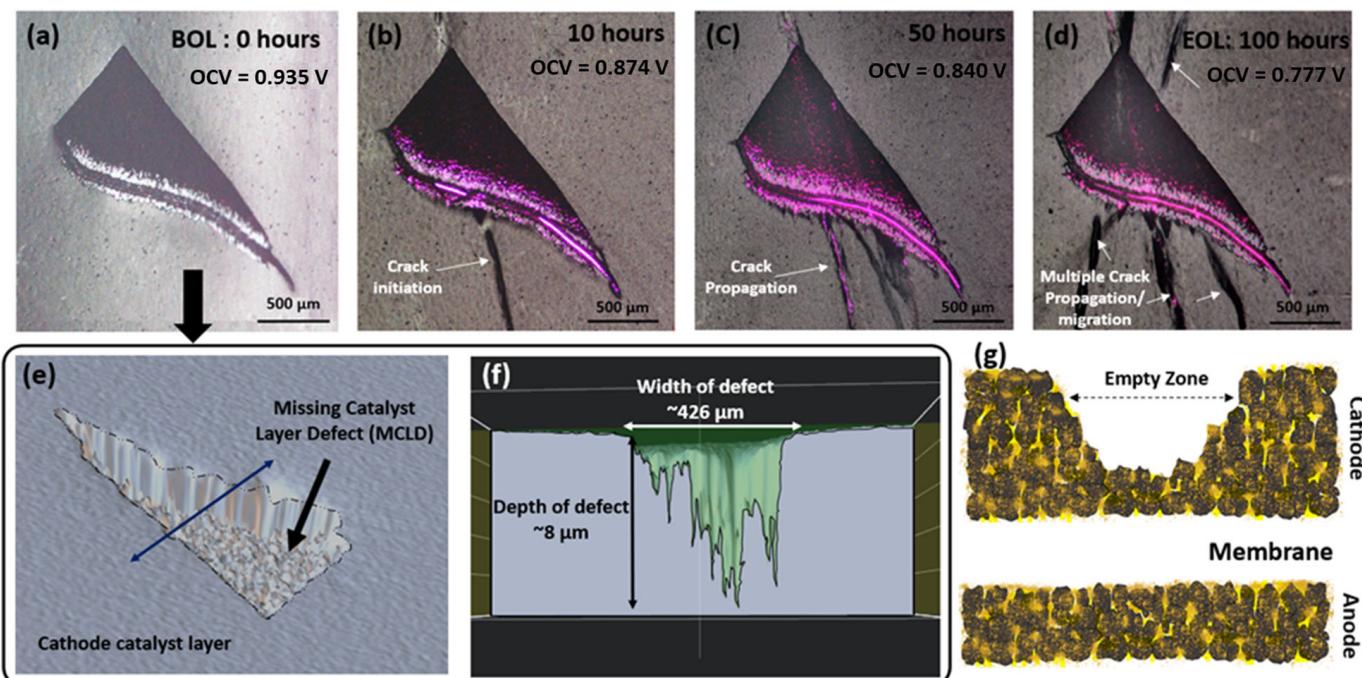
Figure 4 shows an overview of the morphological changes of an MCLD (dark triangular area) originally formed due to improper decal transfer. The MCLD here was the same as the one shown in Figure 3, except that the details of its structure were now clearly visible due to the much higher resolution of the image. The detailed geometric growth of the MCLD during OCV-AST analysis is shown in Figure 4a–d at BOL (0 h), MOL-1 (10 h), MOL-2 (50 h), and EOL (100 h). During the initial investigation of the unused defective CCM at BOL, the entire MCLD was found to cover a geometric area of 757,016 μm^2 . It should be noted that some catalyst still remained over most of the MCLD surface at the outset. As the sample aged, the propagation of defects at the corners of the MCLD appeared to proceed by the development of sharp cracks and degraded areas at its edges. A study by Pestrak et al. showed that the deformation of the electrolyte membrane had a strong influence on the structural changes of the catalyst layers in CCMs [32]. The results observed in our study supported the idea that the deformation of the membrane had a direct influence

on the crack formation and areal growth of the catalyst layer defect from MOL to EOL. The image analysis shows that the total defect area (dark triangular area) increased by 5.4% between BOL and MOL-1, 11.25% between MOL-1 and MOL-2, and 1.6% between MOL-2 and EOL. For a better view of the defect cross section, a 3-D diagram of the MCLD is depicted in Figure 4e, while a cross sectional view showing the depth of the defect as one moves along the blue line indicated in Figure 4e is presented in Figure 4f. The width of the defect is measured to be $\sim 426 \mu\text{m}$ across the blue line. Note that the depth of the defect is not uniform presumably due to the nonuniform removal of the catalyst during the decal transfer step. Figure 4g presents a schematic image of a cross section of the MCLD to provide a better view of the defect in the CCL.

Figure 4. Images of defect growth in an MCLD in a defective CCM-1 (a) BOL at 0 h, (b) MOL-1 after 10 h OCV-AST, (c) MOL-2 after 50 h OCV-AST, (d) EOL after 100 h OCV-AST, (e) 3D graphical view of MCLD with active area of $757,016 \mu\text{m}^2$ on CCL, (f) cross-sectional view of MCLD showing dimensions of depth, and (g) schematic view of MCLD in CCL across the CCM-1.

Two changes were observed in the first image analysis carried out at MOL-1. First, as shown by comparing Figure 4a,b, crack initiation occurred in the catalyst layer, most likely due to the deformation of the membrane. Second, a significant amount of catalyst had been lost inside the MCLD, as reflected in the significant increase in the pink area in

Figure 4b relative to that in Figure 4a. The loss of catalyst particles in the local defect sites stemming from catalyst erosion would significantly facilitate gas crossover of H₂ from the negative side to the positive side of the cell, which was one possible cause of the voltage loss at MOL-1.

A comparison of the dark triangular area in Figure 4b with that in Figure 4a shows that the MCLD grows by 5.9% with an aspect ratio of 4.4 over the first 10 h. The cumulative total areal growth of the MCLD (black curve) and the total catalyst loss inside the MCLD (pink area) with respect to time are shown in Figure 5b. Furthermore, the total pink area inside the MCLD increased by more than 2000%, indicating extensive catalyst degradation within the defect.

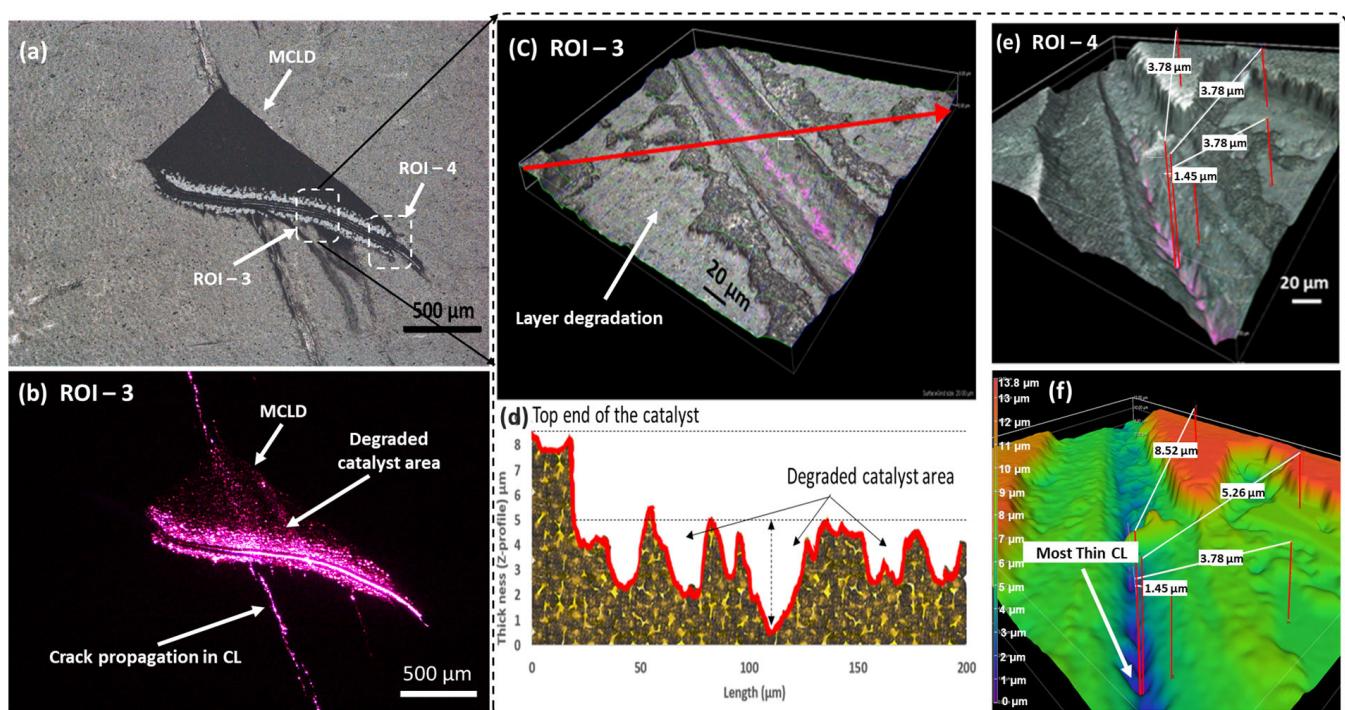
Figure 6. (a) Reflected microscope image of MCLD at MOL-2 indicating selected regions ROI-3 and ROI-4; (b) transmitted light microscope image of MCLD with pink area indicating degraded catalyst due to chemical degradation during fuel cell operation; (c,e) are 3D microscopic visualizations of enlarged regions ROI-3 and ROI-4, respectively; (d) Z-profile/height scan showing variation in thickness of degraded catalyst layer surface along the red line in (c); (f) colour mapping of morphological features of degraded catalyst layer: blue area represents thinnest catalyst, green represents uneven surface of degraded catalyst layer, orange represents nondegraded catalyst layer.

Regions ROI-3 and ROI-4 located at the middle and edge of the defect (Figure 6a) were selected for closer examination using transmitted and reflected light to characterize surface degradation within the MCLD. The catalyst surface in these two regions had clearly become irregular due to chemical/layer degradation inside the MCLD (Figure 6e,f). Previous studies have shown that these effects can be caused by ionomer leaching from the catalyst layers and H₂O₂ (hydrogen peroxide) formation at the defective catalyst sites [33].

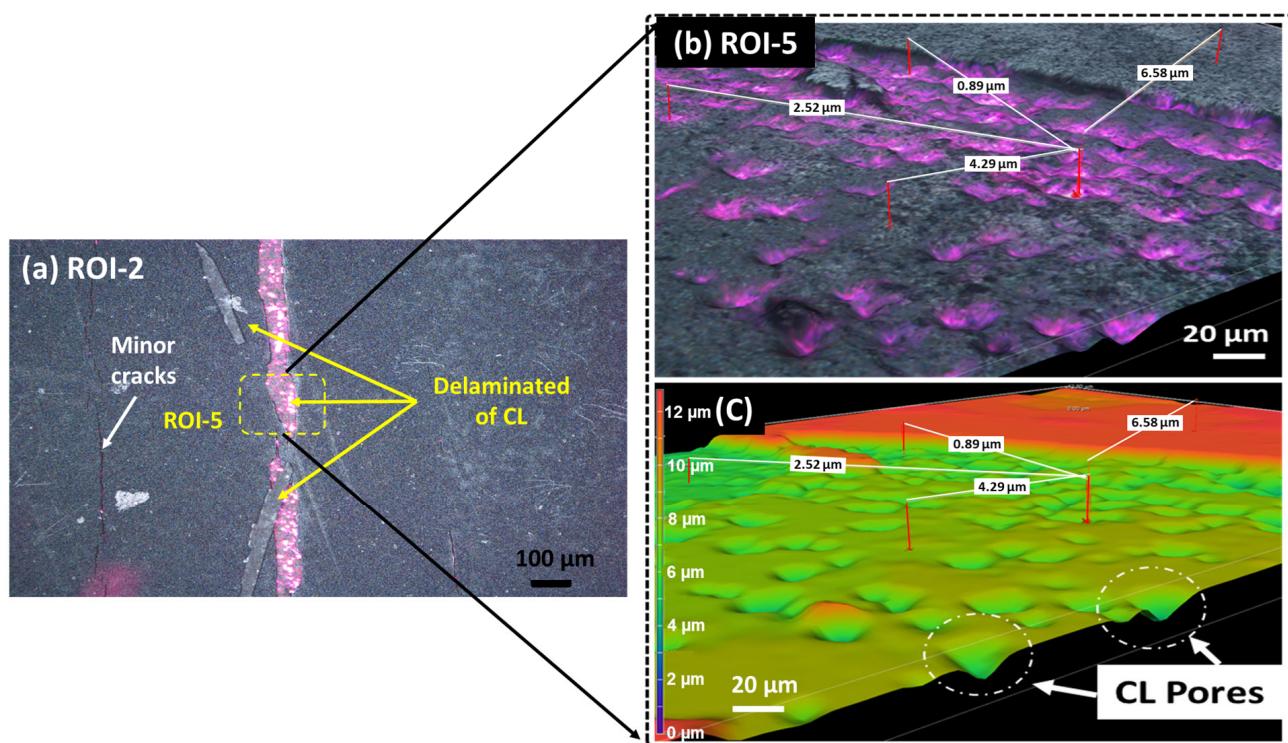
Figure 7a shows evidence consistent with catalyst layer delamination having occurred at ROI-2. Kai et. al. showed that static and humidity cycling caused deformation of the membrane and extensive crack propagation in the catalyst layer [39]. When a membrane underwent swelling, its pores gained moisture from the reaction gases and became thicker. In this situation, the catalyst layer could have difficulty accommodating the pressure developed by the membrane with the result that surface cracks form. The opposite effect occurred during shrinking/drying, i.e., the pores of the electrolyte membrane lost moisture, and the membrane shrank in thickness, causing the catalyst layer cracks to collapse or merge [18]. Ultimately, the combined effects of crack propagation and merging can cause delamination and detachment of the catalyst layer from the membrane.

Figure 7. Microscopic images of crack propagation on the CCLs at EOL: (a) delaminated catalyst layer, (b) ROI-5: 3D enlarged view of delaminated and degraded catalyst layer, and (c) color mapping of delaminated area of ROI-5 showing catalyst layer pores.

Even after 100 h of OCV-AST operation, it was observed that cracks had not propagated significantly in the vertical direction (i.e., not increased in depth) and had not penetrated beyond ~50–70% of their thickness (Figure 7a). Crack penetration and delamination had affected 50–70% of the catalyst layer. Closer visual examination at 100 \times magnification was conducted on a specific delaminated region labelled ROI-5 within ROI-2 (Figure 7a). A view of ROI-5 is presented in Figure 7b,c showing that a portion of the catalyst layer detached from the surface crack. Several Z-profile measurements across the delaminated areas on the CCM (inlet, middle, and outlet areas) were carried out to estimate the thickness of delaminated catalyst layers. This analysis revealed that the average thickness of delaminated CLs that originally ranged from 10–15 μm has decreased to 2–6 μm at EOL (some of these regions are shown in Figure 7a). The pink areas in Figure 7b represent the thinnest areas where the transmitted light could pass through the solid catalyst layers. The map showing the height of the catalyst layer in region ROI-5 is presented in Figure 7c. The orange areas represent defect-free catalysts, while the green areas correspond to defective catalyst remaining after delamination. The possible causes of the surface delamination may be traced back to the hot press step during fabrication. The uppermost catalyst surface that is first exposed to the hot plates during CCM fabrication presumably has a strong and uniform contact bond with Pt/C catalyst particles and ionomer composite in this portion of the catalyst layer [40]. When the lower portions of the catalyst layer became heated, the ionomer network in the catalyst layer also developed strong bonds with the ionomer in the electrolyte membrane [17]. At the interface between the lower catalyst layer and membrane, some portions of the ionomer migrated into the membrane and left behind large pores in the lower catalyst layer. This was also consistent with the idea that CCMs strongly interact with the CL and polymer membrane to reduce the contact resistance between adjacent layers [18]. When the membrane became humidified, it swelled and experienced stress elongation. This set up a pressure difference between the upper and lower portions of the catalyst layer that could lead to delamination in the middle

of the catalyst layer. The delamination occurred depending on the ionomer network in the catalyst layer. Some of the factors in the network that influenced delamination were catalyst layer thickness, membrane swelling, and ionomer concentration in the catalyst layers. On the cathode, the delamination was observed to leave behind ~30% of the catalyst layer thickness at the least. However, delamination on the anode was rarely observed. An important factor behind the difference in delamination of the two electrodes was that the anode was initially much thinner than the cathode. The white dotted circles in Figure 7c indicated larger pores in the catalyst layer after delamination. To investigate the pore size distribution, image analysis was performed on the defect-free and delaminated areas. The pore diameters were measured to be ~1–2.5 μm in nondefective areas, whereas they were more than five times as large with diameters of ~5–25 μm in the defective areas. Large pores are not favorable for fuel cell operation since they do not contain catalyst and become dead zones for electrochemical reactions and facilitate gas crossover and water flooding since water tends to accumulate at these sites, particularly at high current densities. From our overall examination of CCMs at BOL, MOL-1, MOL-2, and EOL, catalyst erosion is observed only in the defective areas, i.e., inside MCLDs and inside delaminated catalyst layers. No erosion effect was observed in defect-free areas. These observations are particularly important for the development of catalyst coatings and the integrity of catalyst layer fabrication. Although experiments in this study have been done at a particular RH and temperature, future research to investigate crack propagation when the RH varies in cycles would be useful.
