# Influence of Moisture in Museum Rooms on the State of Microbial Contamination of the Air and Decoration Surfaces: The Example of a 17th Century Monument in the Museum of King John III's Palace at Wilanow (Warsaw, Poland)

This study analyzes the microbiological contamination of the air and paintings mounted on the ceilings that were dampened as a result of a water supply system failure in part of the building at the Museum of King John III's Palace at Wilanów (Warsaw, Poland).

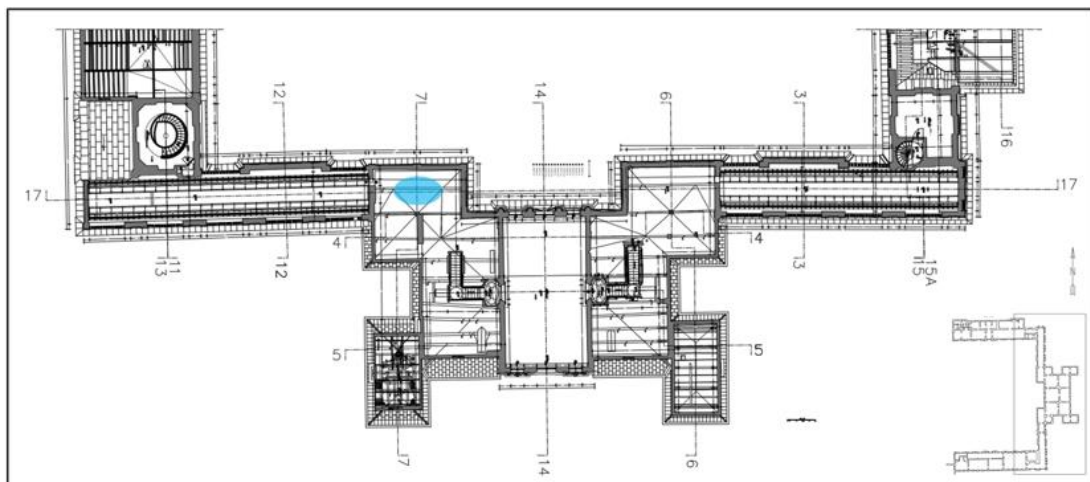
Description of the failure and the remedial actions taken. The failure consisted of a leak in the water supply to the humidifier of the air handling unit located in the attic of the alcove (Figure 1), and it occurred on the morning of 15 December 2020. At the time of the palace's commission opening, the water had already reached the first floor through a room on the second floor. Its rapid arrival on the first floor was possible due to the presence of light and smoke detection installations in the ceiling of the second floor. The ducts of these installations allowed significant amounts of water to quickly pass through the ceiling of the first-floor room and flood the wooden floor of that room. After passing through the floor, the water found its way into the inter-ceiling space between the second floor and the first floor, and had reached the stucco and painting decoration of the King's Library ceiling directly. There, due to the technical characteristics of the ceiling's painting decoration (the historical strong duplication of the canvases on wax, which caused them to become an air- and watertight membrane), part of the water was "channeled" and flowed out at the edges of the oil plafond paintings onto the surface of the ceiling, falling onto the marble floor of the King's Library, and began to seep into the stucco decoration.

**Figure 1.** Floor plan of the second floor of the building water system failure location (blue ellipse).

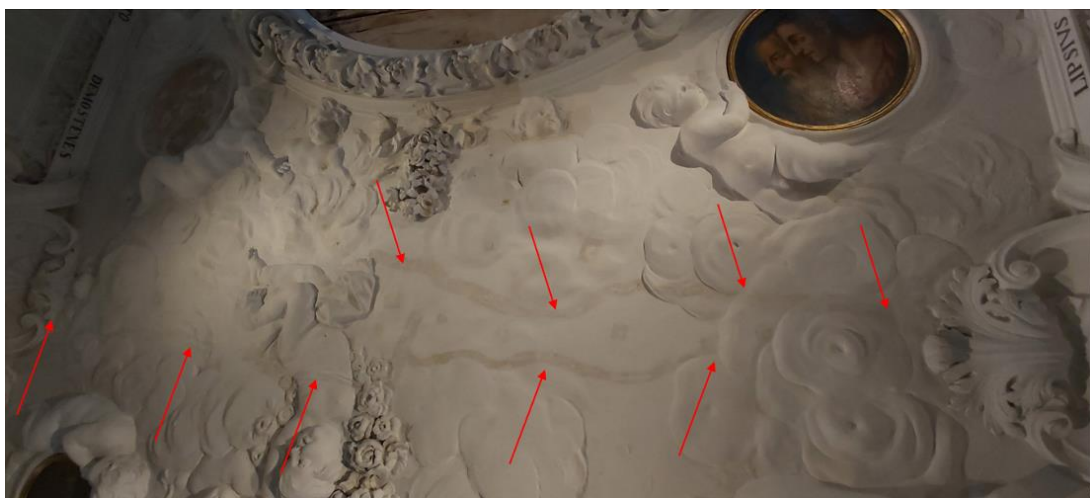
room were flooded. Cracks and separations in the plaster and stucco were located mainly in the central part of the ceiling. In this zone, in addition to the yellowish discoloration, cracks and spalling of the plaster and stucco were visible (Figures 3–6). Approximately a quarter of the ceiling area was in the affected zone. On the west facade wall, damp patches were visible from water running down the wall surface (Figure 7). In addition to the discoloration of the stucco, there were also innumerable cracks and spalling behind the surface. Mold colonies were found in the cavities of the stucco (Figure 8). The remaining surfaces of the building partitions were free of mold. The moisture content of the ceiling and walls was in the range of 0.4–3.0%. Locally, the west facade wall showed a moisture content of 0.9–3%. In Figure 6, the extent of this zone is marked with a black dashed line. Figures 9–13 show the results of the moisture content measurements of individual building partitions of the King's Library. The extent and depth of the cracks caused by the failure overlaid their previously benign structure.

**Figure 4.** Cracks in the plaster and stucco in the central ceiling of the King's Library.

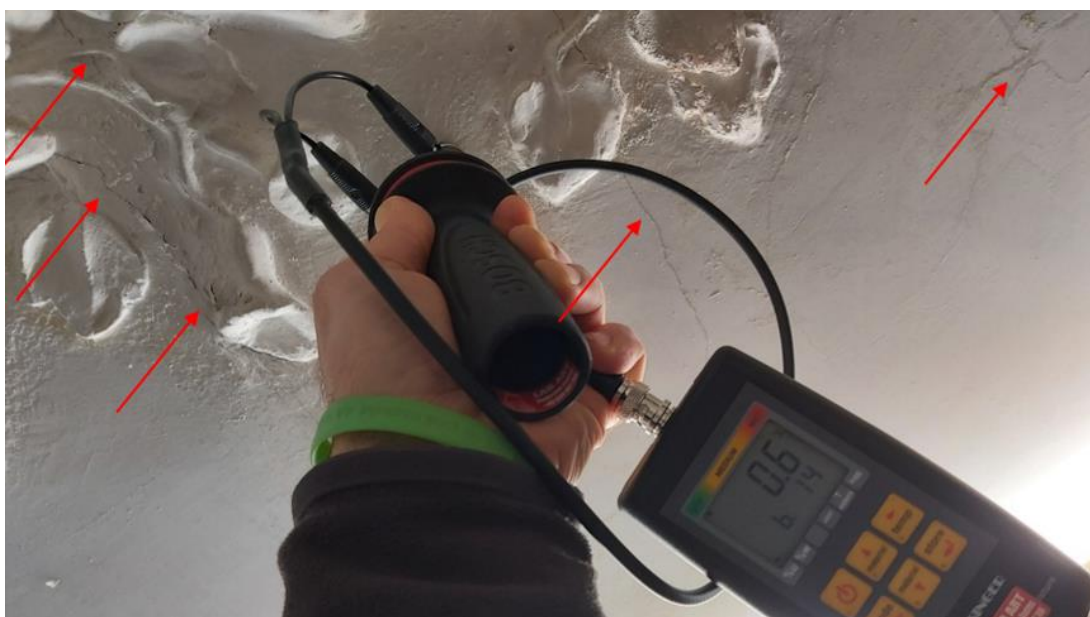
**Figure 5.** Cracking and chipping of plaster in the southern part of the ceiling of the King's Library.

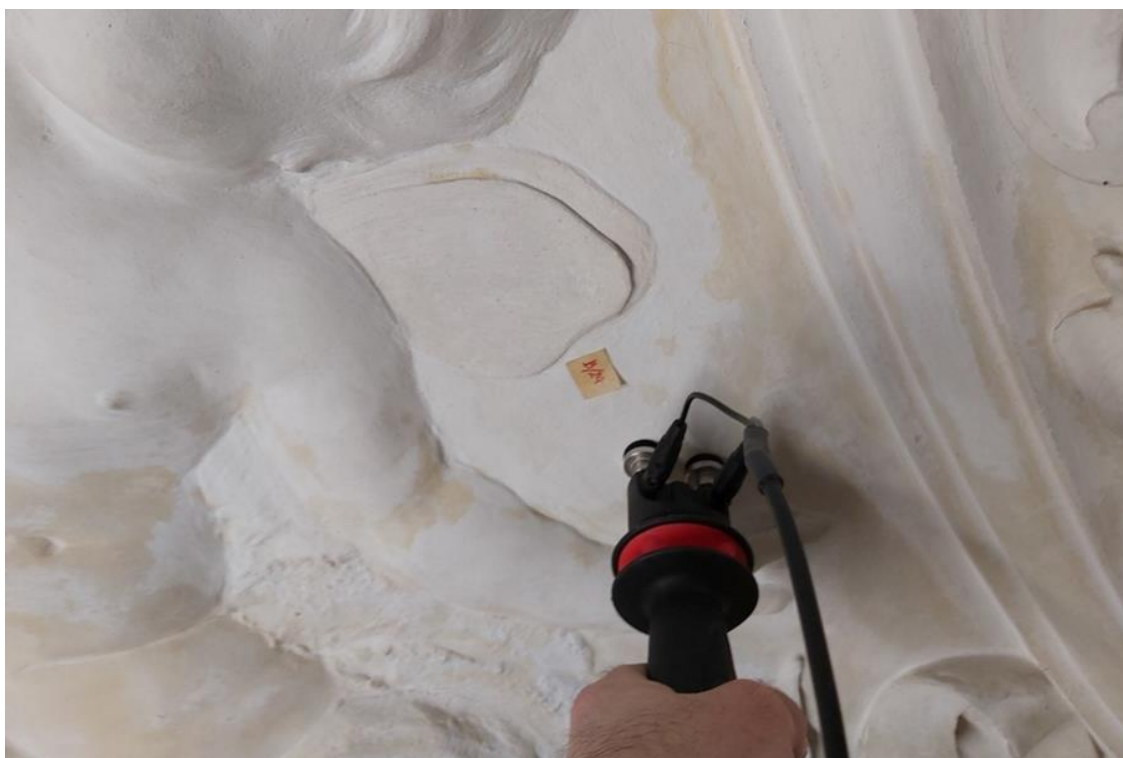
**Figure 6.** Discoloration of the stucco and plaster on the ceiling of the King's Library.

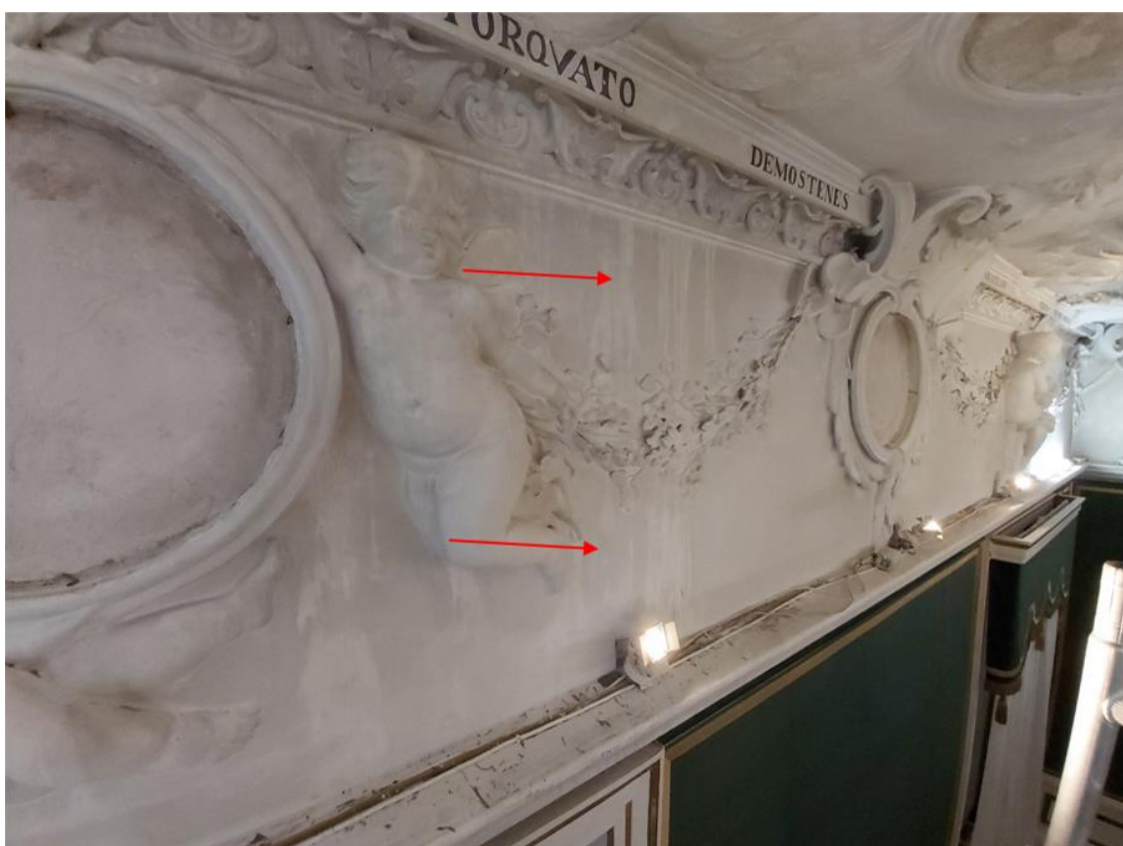
**Figure 7.** Stains on the west wall of the King's Library.

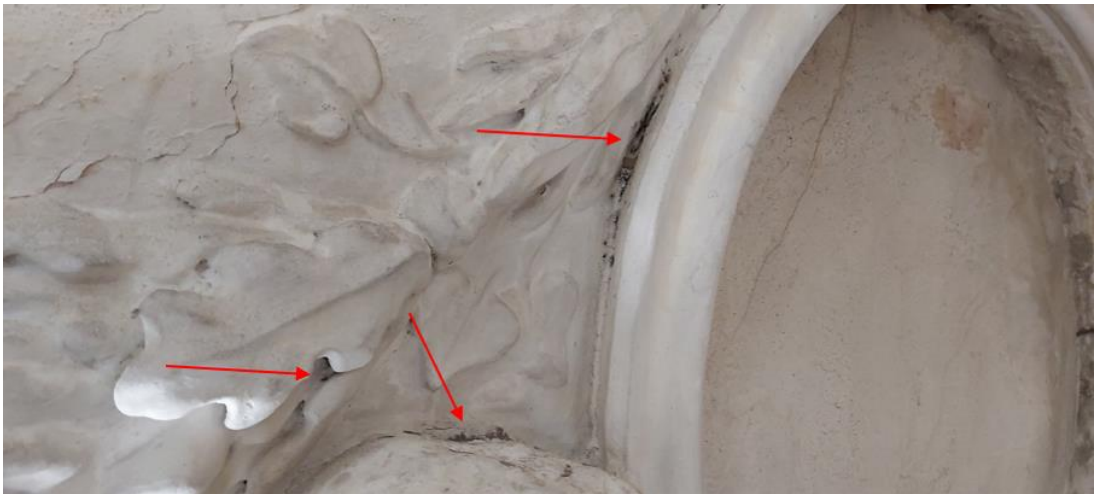
Figure 8. Mold colonies on the stucco of the west wall of the King's Library.

On the day of the visual inspection, a swab was taken from the stucco cavities (Figure 5) of the west wall in the King's Library. The results are shown in Table 3. The result of the swab sample complements the results of the air sample analysis.

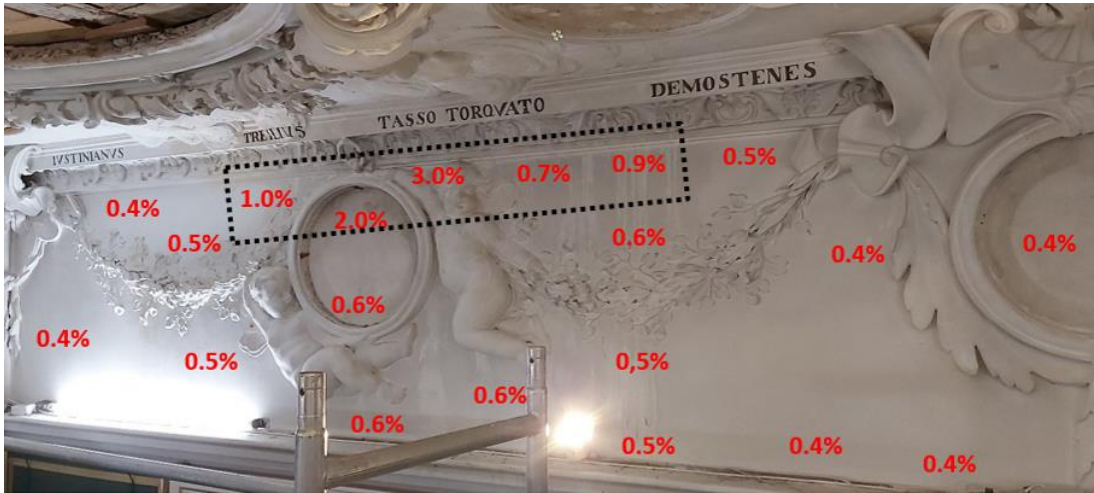
Figure 9. King's Library: the results of moisture measurements of the west facade wall.

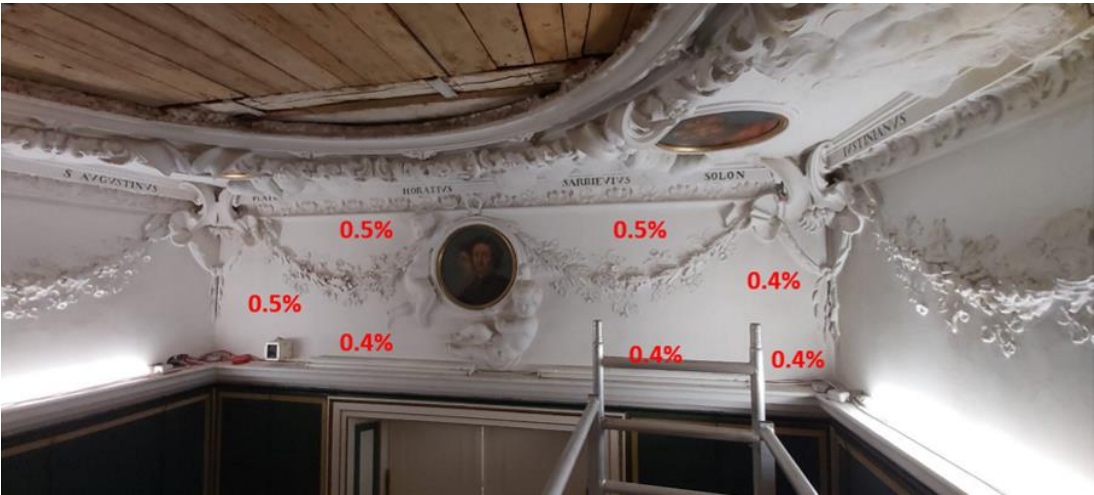
Figure 10. King's library: the results of moisture measurements of the south wall.

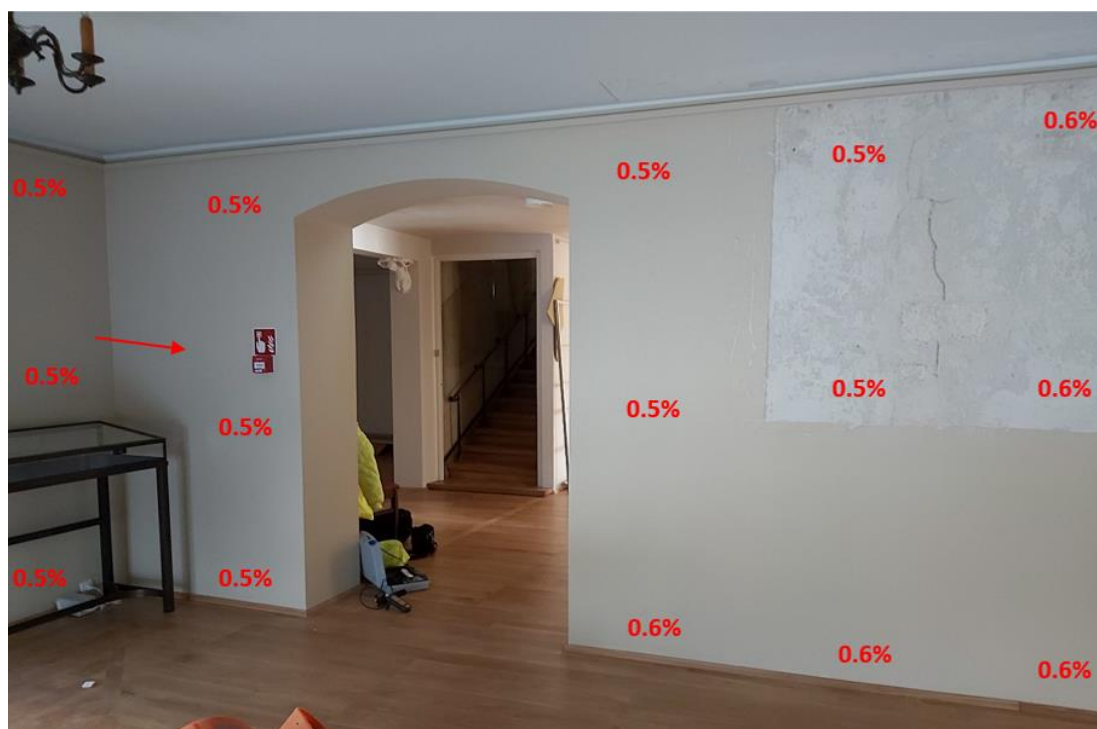
**Figure 14.** Historical Cabinet: the wall on the side of the Room above the Chapel, part 1.

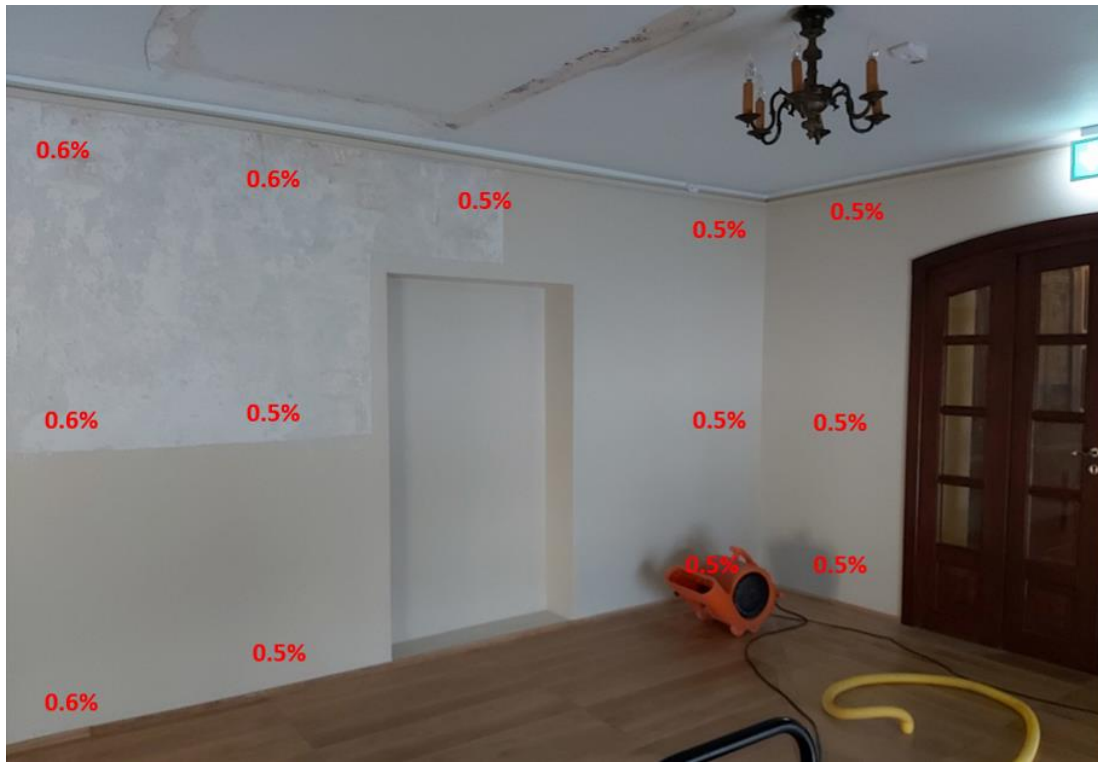
**Figure 15.** Historical Cabinet: the wall on the side of the Room above the Chapel, part 2.

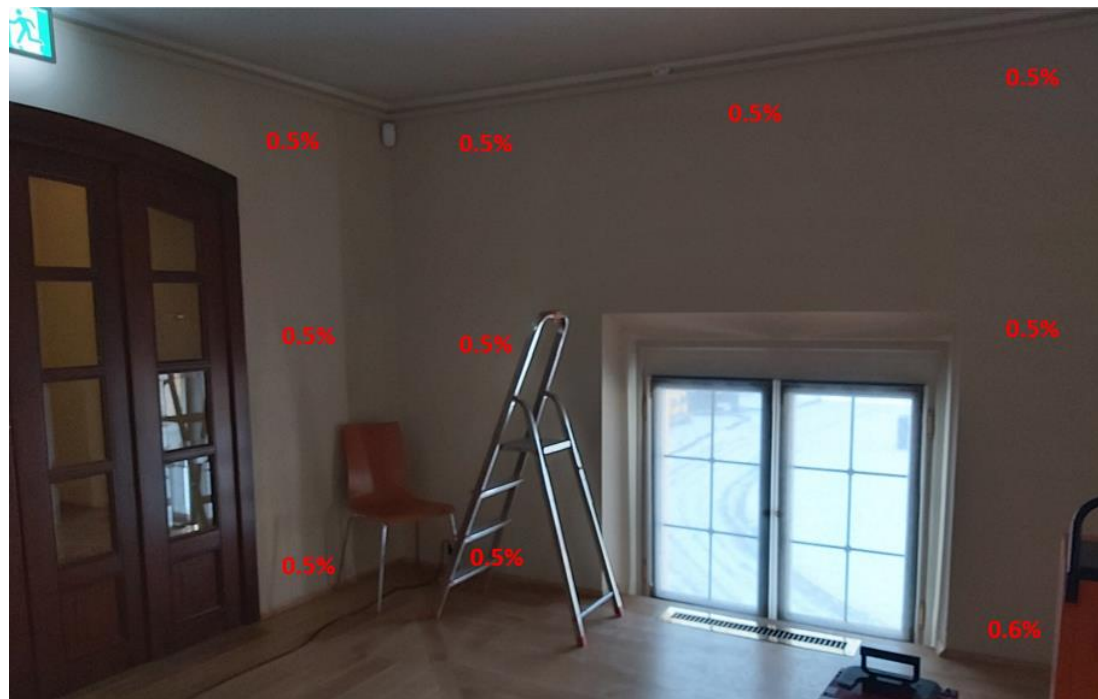
**Figure 16.** Historical Cabinet: the facade wall, part 1.

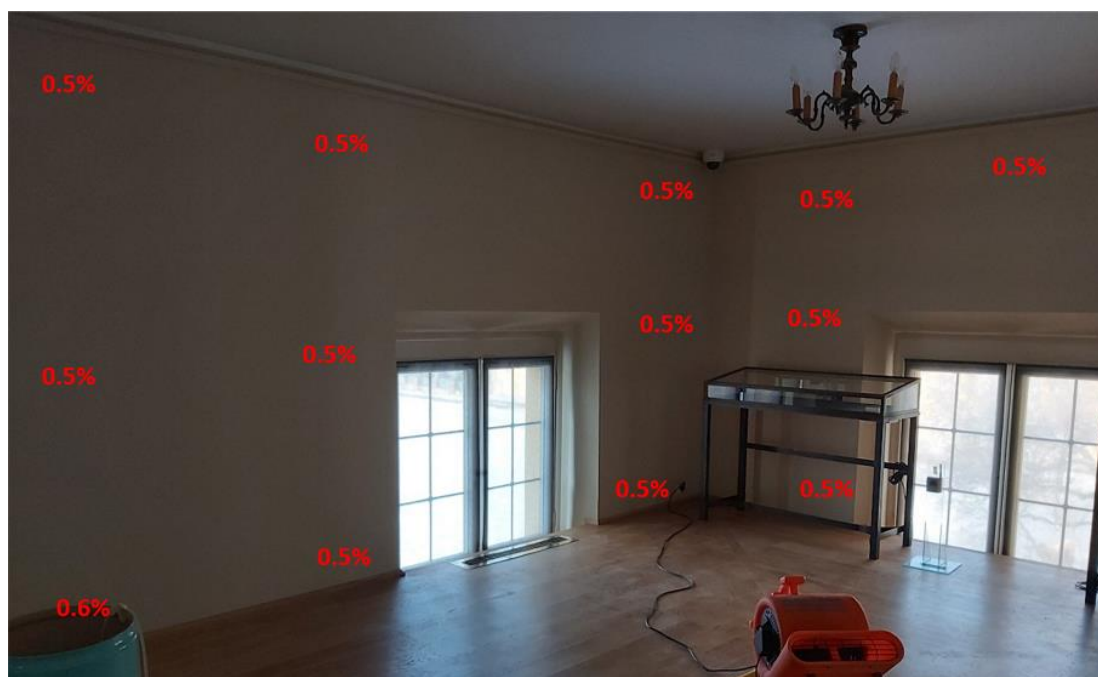
**Figure 17.** Historical Cabinet: the facade wall, part 2.

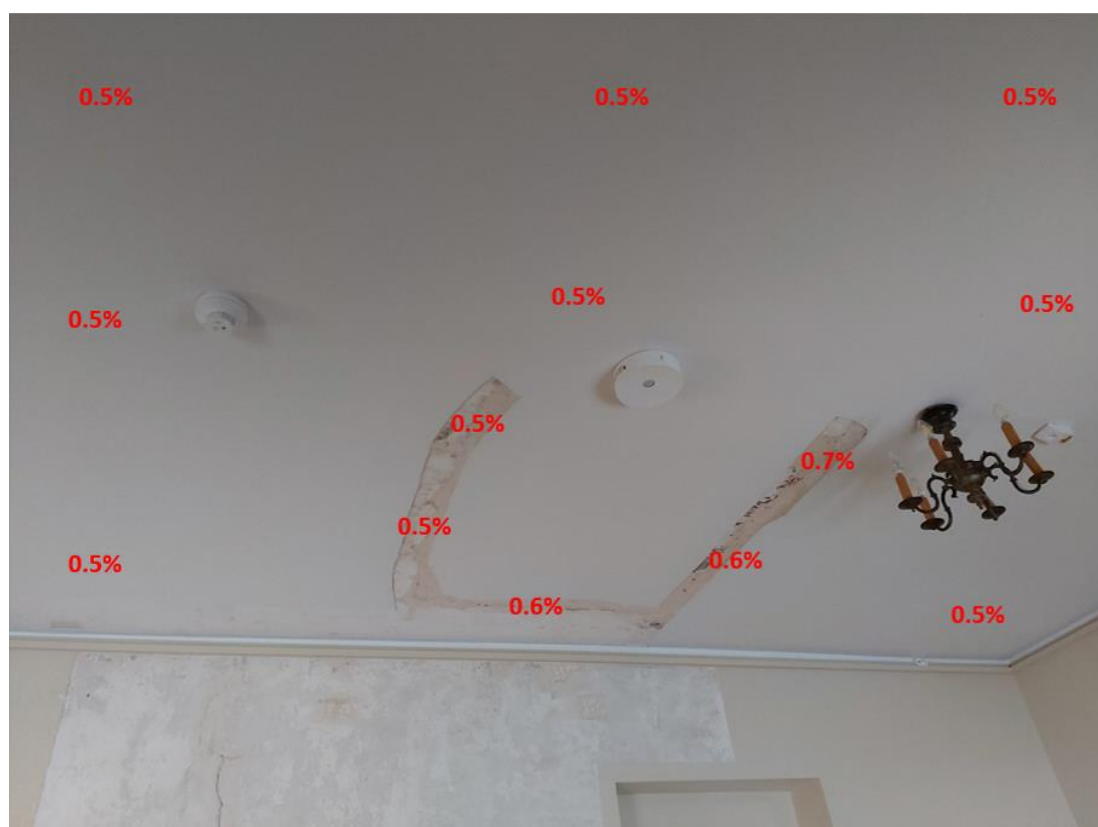
**Figure 18.** Historical Cabinet: the ceiling on the side of the Room above the Chapel.

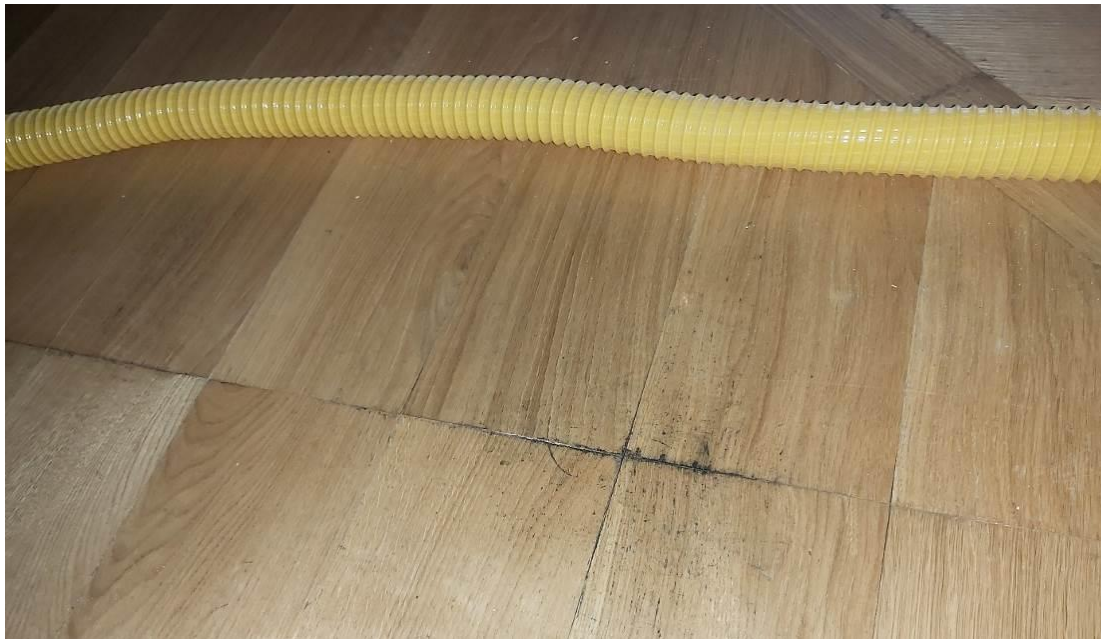
**Figure 19.** Deformation and discoloration of the oak flooring in the Historical Cabinet, part 1.

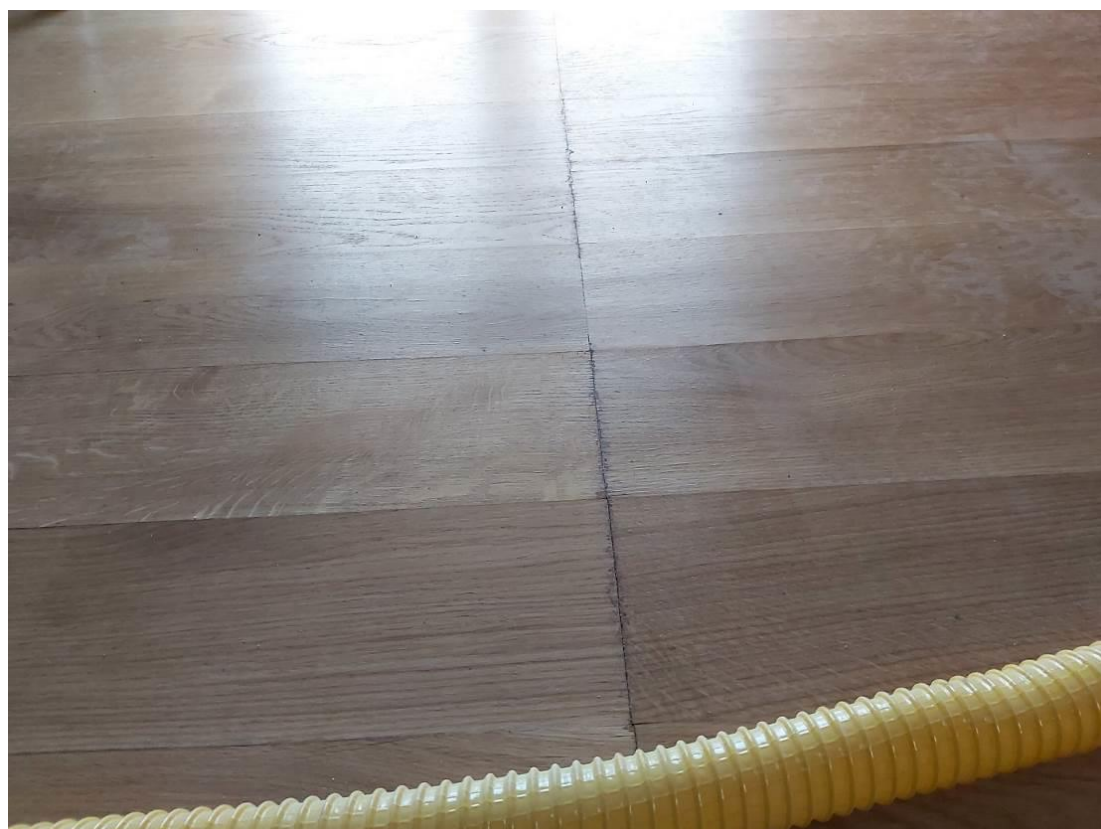
**Figure 20.** Deformation and discoloration of the oak flooring in the Historical Cabinet, part 2.

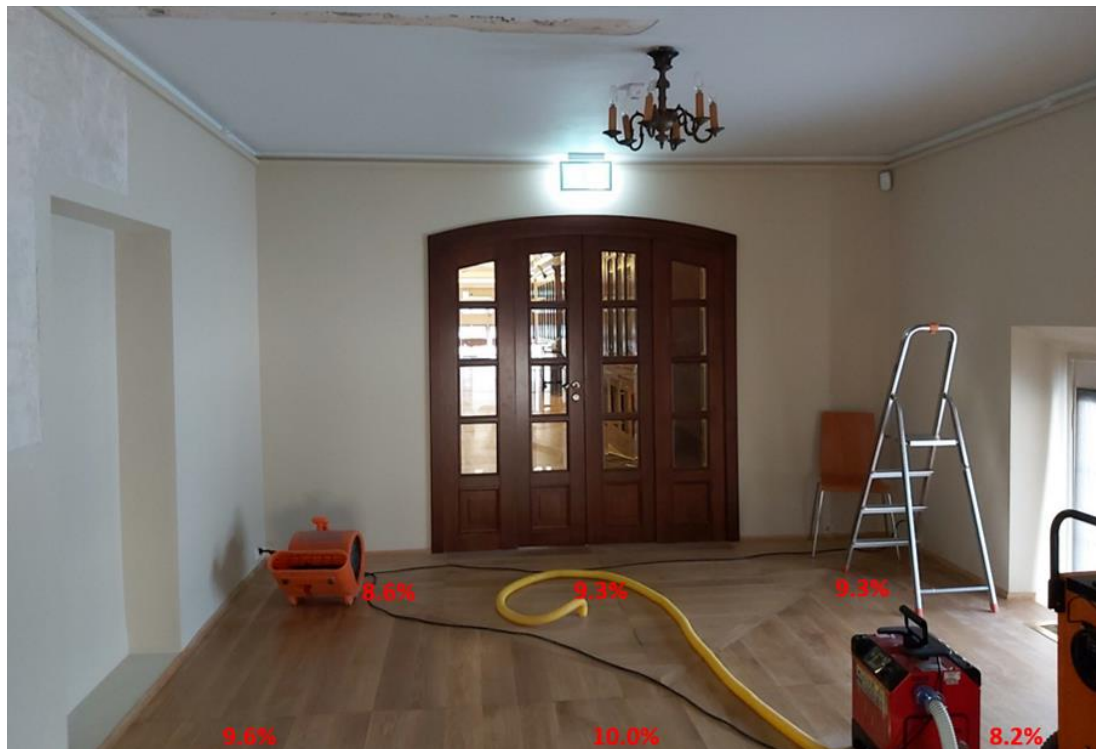
Figure 21. Historical Cabinet: the oak flooring, part 1.

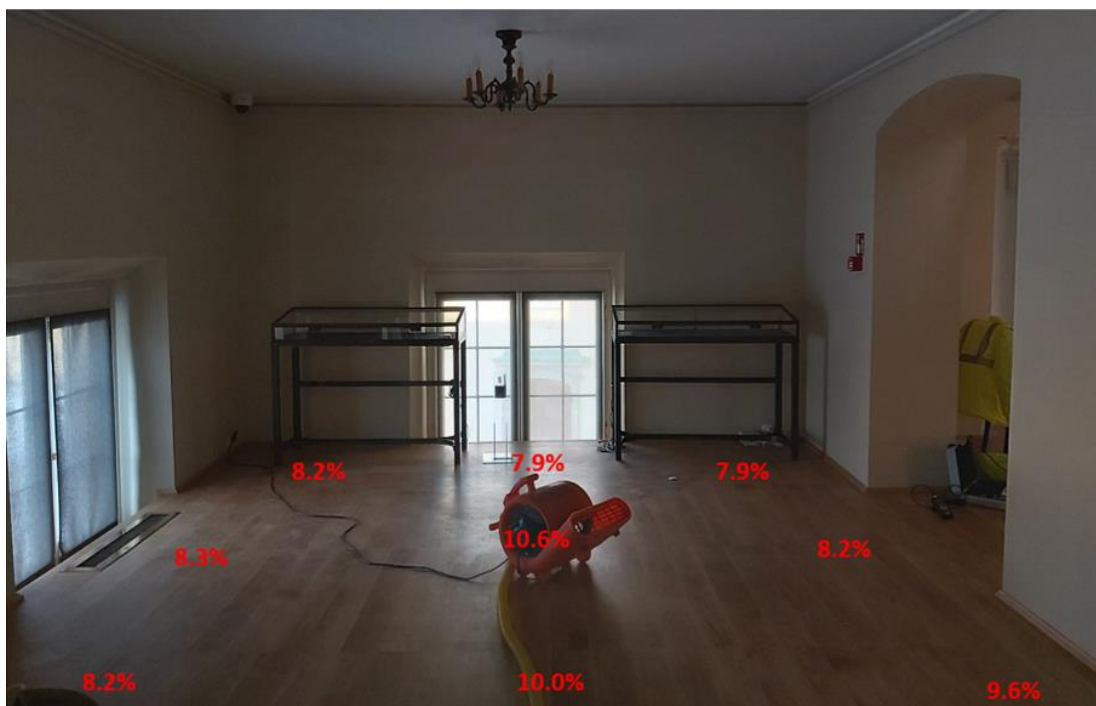
Figure 22. Historical Cabinet: the oak flooring, part 2.
