Article Chlorine Corrosion in a Low-Power Boiler Fired with Agricultural Biomass

Abstract: The selection of appropriate heat-resistant materials which are at the same time resistant to atmospheres rich in chlorine and its compounds is one of the most important current construction problems in steel boiler elements when using biomass fuels of agricultural origin. In the research presented here, an area was identified in the furnace of a 10 kW boiler where there was a potential risk of chlorine corrosion. This zone was determined based on numerical analysis of the combustion process; it is the zone with the highest temperatures and where the gas atmosphere conducive to the formation of chlorine corrosion centers. Subsequently, tests were carried out in the process environment of the combustion chamber of a 10 kW boiler (the fuel was barley straw) by placing samples of eight construction materials in a numerically-designated zone. These included samples of steel (coal boiler St41K, heat-resistant H25T and H24JS, and heat-resistant valve 50H21G9N4) as well as intermetallic materials based on phases (FeAl, Fe₃Al, NiAl, and Ni₃Al). The samples remained in the atmosphere of the boiler fu

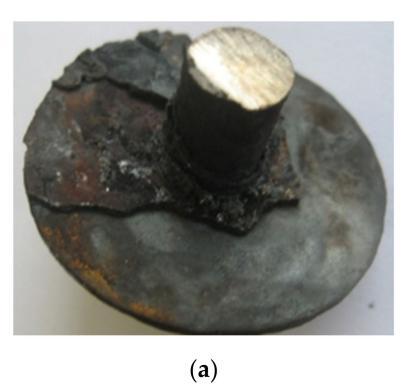
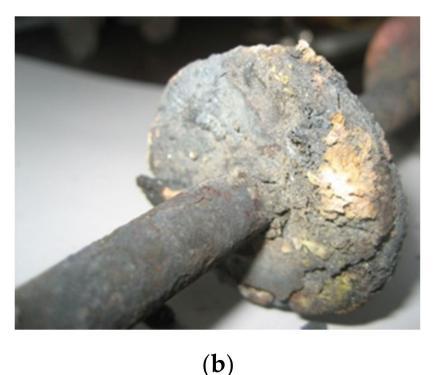
The visual assessment of the surface condition of the samples after taking them out of the boiler showed different levels of destruction of the construction materials. The test results of steel samples indicate that the St41K boiler steel is not suitable for operation under the assumed conditions. On the surface of the boiler steel sample, after 1152 h exposure at temperatures of 750–900 °C, a thick layer of complex corrosion products was visible (Figure 8).

Figure 8. Photos of samples of the St41K boiler steel after exposure in the combustion chamber of the boiler: (**a**) a layer of porous corrosion products; (**b**) exposure of the substrate.

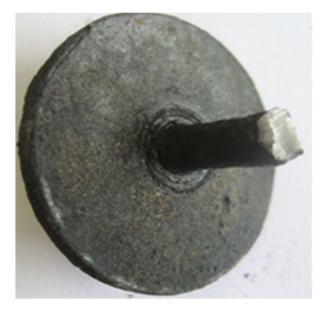
On the other hand, in the case of the alloyed steels, the thickness of the corrosion products on the surface of the alloyed steels was small. In addition to a dense gray bloom on the surfaces, slight delamination of flakes was visible (Figures 9–11). Thicker greenish layers appeared only on samples of H25T heat-resistant steel. These results are confirmed in the works of other authors. For example, in [30] the corrosion properties of high-temperature boiler steels (T91, 12Cr1MoVG and TP347H) during coal and biomass combustion were investigated. These fuels had a variable high or low chlorine content. Experiments were carried out over 168 h with SEH ash, Da Nahu ash (DNH), straw ash, wood chip ash and their mixtures in a tube furnace, with a corrosion probe taking into account the temperature

Figure 9. Photo of the 50H21G9N4 steel sample after exposure in the boiler combustion chamber.

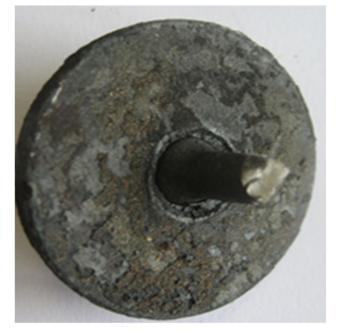
Figure 10. Photo of a sample of H24JS steel after exposure in the boiler combustion chamber.

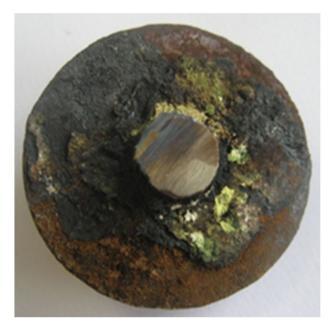
Figure 11. Photo of the H25T steel sample after exposure in the boiler combustion chamber.

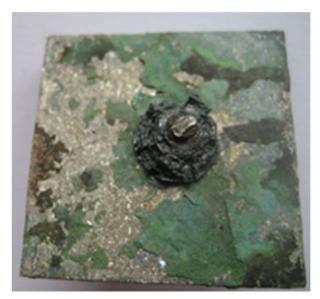
Figures 12–15 display pictures of the intermetallic material samples after 1152 h of exposure at temperatures of 750–900 °C in the combustion chamber of the boiler. As can be seen, these materials have good corrosion resistance. The colors of the layers formed on the surfaces of the samples are varied.

Figure 12. Photo of the FeAl intermetal sample after exposure in the boiler combustion chamber.

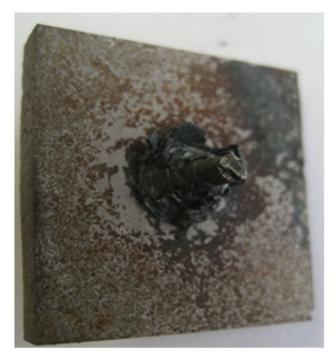
Figure 13. Photo of the Fe3Al intermetal sample after exposure in the boiler combustion chamber.

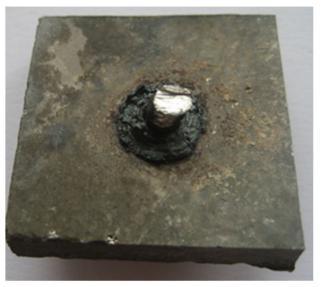
Figure 14. Photo of the NiAl intermetal sample after exposure in the boiler combustion chamber.

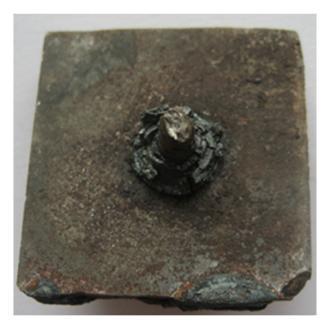
Figure 15. Photo of the Ni3Al intermetal sample after exposure in the boiler combustion chamber.

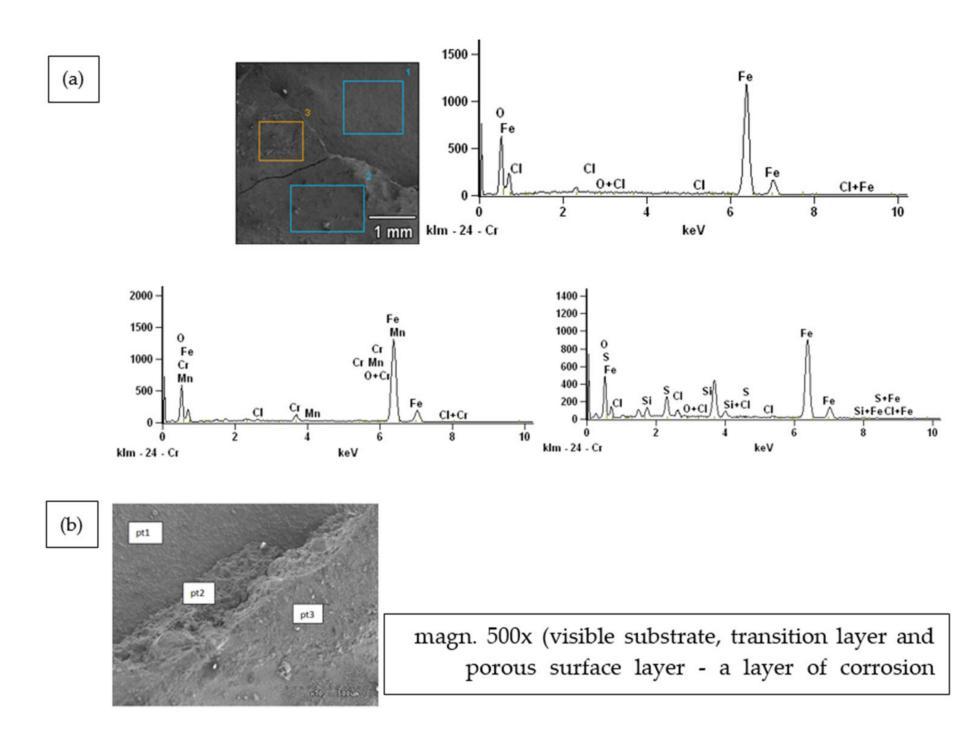
Figure 16. (a) The chemical composition of the surface of the St41K boiler steel in the planes pt1, pt2 and pt3 on the microscopic photo; (b) microscopic photo (SEM) of the surface of the St41K boiler steel.

The outer porous surface layer of the St41K boiler steel was mainly composed of iron oxides with sulfur and chlorine contents; the oxygen fraction relates to metal oxides. Between the corrosion layer and the metal surface an intermediate layer of approximately 200 μ m of pure iron oxide with a distinct crystal structure can be observed, the size of the crystallites being about 50 μ m (Figure 16b). On the other hand, the metal surface was covered with a dense, brown layer of iron oxide with a small admixture of chlorine, which may indicate the diffusion of chlorine into metal through the layer of corrosion products. However, none of the described layers constituted a protective barrier for the steel. The presence of chlorine in layers pt1, pt2 and pt3 proves the diffusion of chlorine from pt3 and pt2 to pt1.

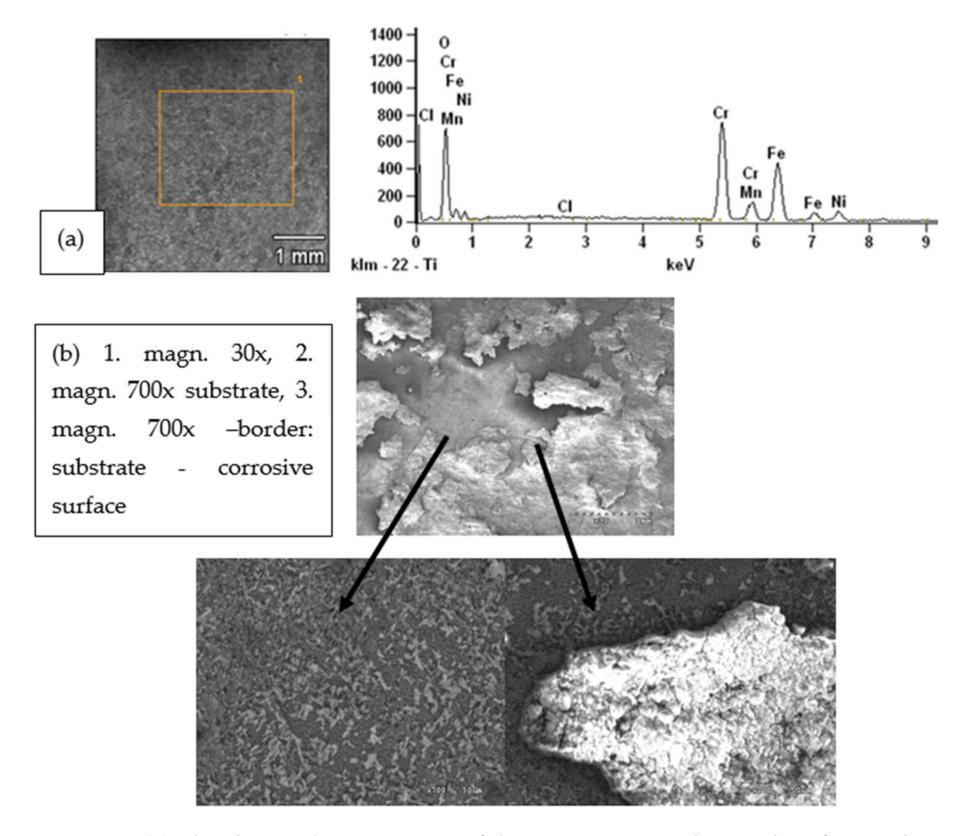
Figure 17. (**a**) The chemical composition of the 50H21G9N4 valve steel surface in the pt1 surface in the microscopic photo; (**b**) microscopic photo (SEM) of the surface of the St41K boiler steel.

The layer of oxides on the 50H21G9N4 valve heat-resistant steel was compact and protected the steel surface against the corrosive environment (Figure 17), which indicates that the valve steel is best suited to work in the combustion chamber conditions of a household boiler fired with agricultural biomass.

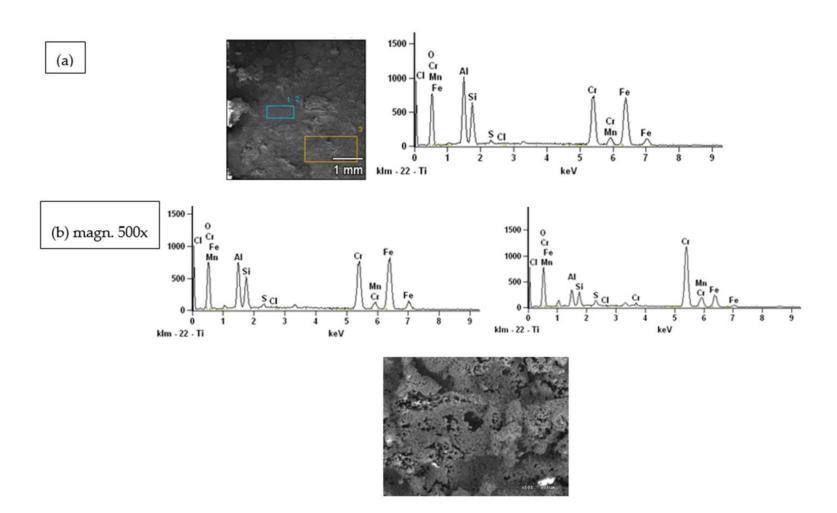
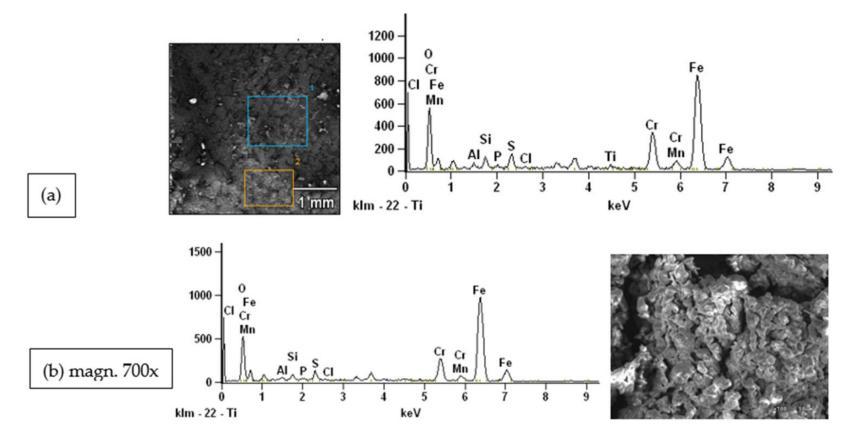
Figure 18. (a) Chemical composition of the surface of heat-resistant steel H24JS in planes pt1, pt2 and pt3; (b) microscopic photo (SEM) of the surface of H24JS heat-resistant steel.

Figure 19. (a) Chemical composition of the surface of heat-resistant steel H25T in planes pt1 and pt2; (b) microscopic photo (SEM) of the surface of H25T heat-resistant steel.

In the areas designated 1 and 2 and separated in the microscope image, no significant presence of chlorine was observed among the corrosion products, as is indicated by the analysis of the chemical composition (Figures 18 and 19).

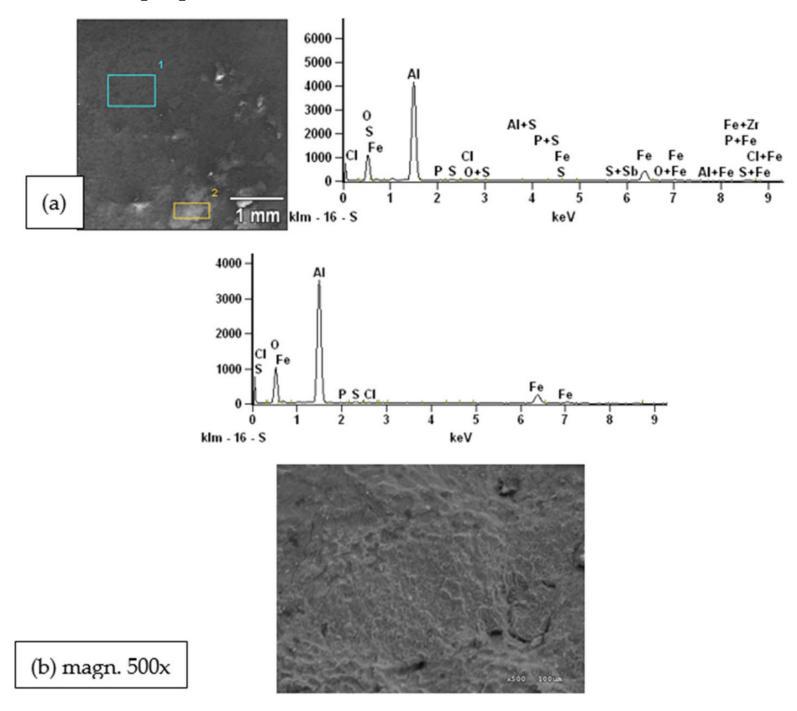
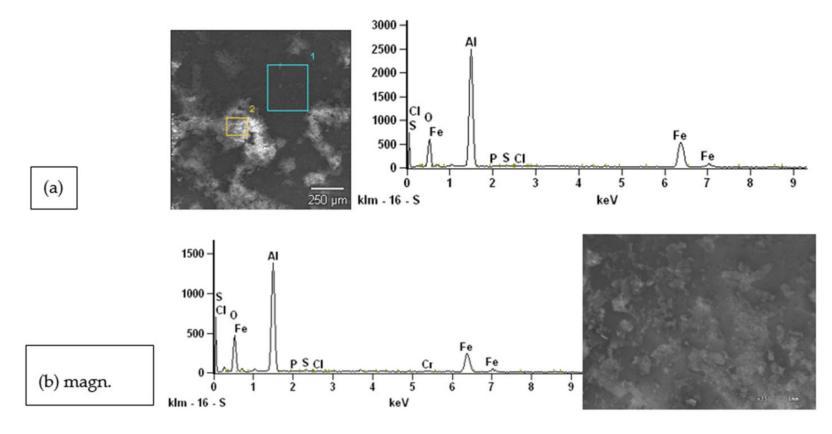
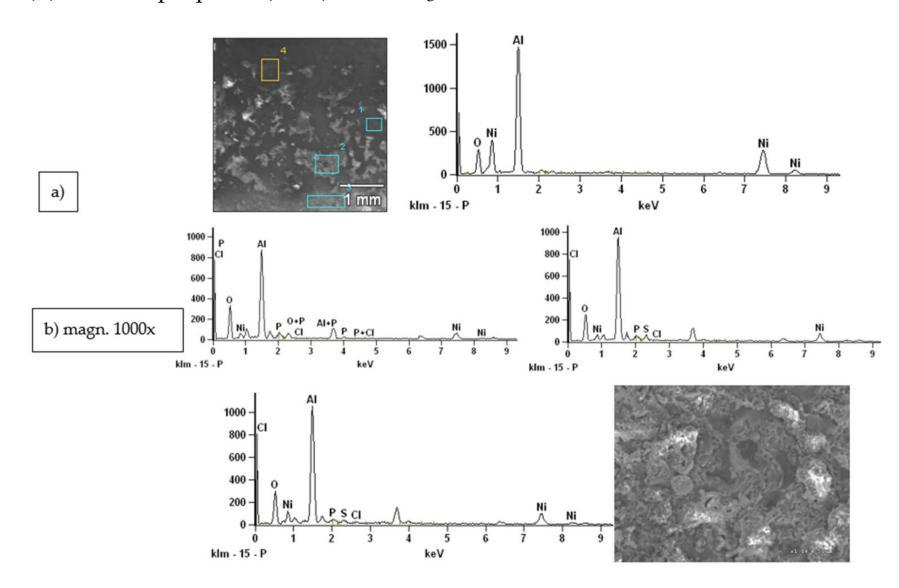
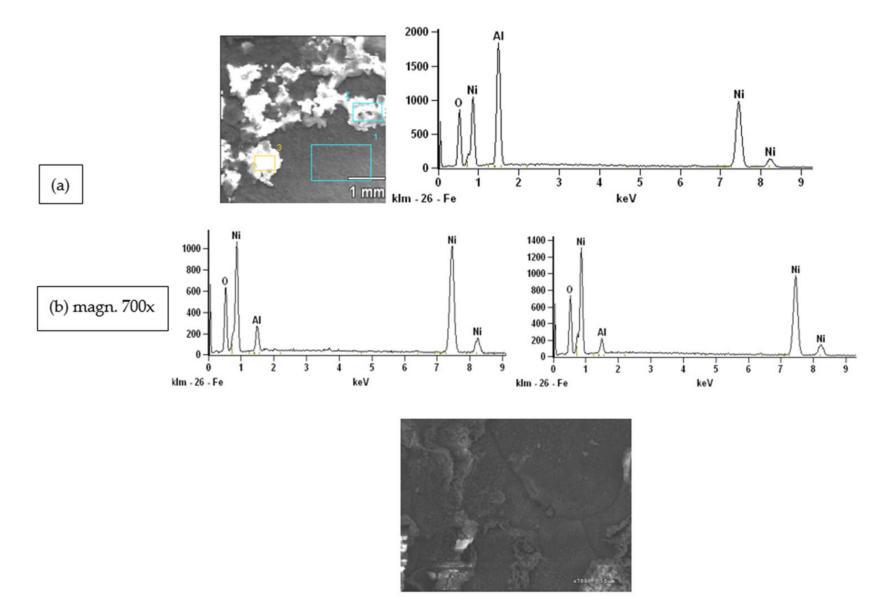
The results are shown in the Figures 20–23. The scanning research charts show that intermetals are characterized by good corrosion resistance under the operating conditions of a domestic boiler for agricultural biomass. The analysis of the chemical composition of the surface of the samples shows the dominant share of aluminum oxide in the surface layers. In the case of samples of intermetallic materials based on the FeAl phase and Fe₃Al phases, there are also iron oxides and trace amounts of gases from the chamber atmosphere. On the other hand, in materials based on the NiAl and Ni₃Al phases, only nickel oxides

In the case of all intermetals, despite the differences in the chemical composition of oxides, the good adherence of their compact structure to the metal surface effectively protects the materials against the aggressive action of the chlorine component of the gases (HCl or Cl₂) in the combustion chamber. Therefore, it can be concluded that these materials are characterized by good resistance to the corrosive atmosphere, and can be used as construction materials in boilers burning agricultural biomass.
