# Article Construction Techniques and Detailing for Romanian *Paiantă* Houses: An Engineering Perspective

# 1. Introduction

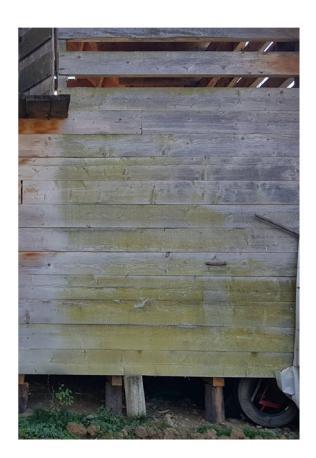
Figure 22. North side of a house affected by algae.

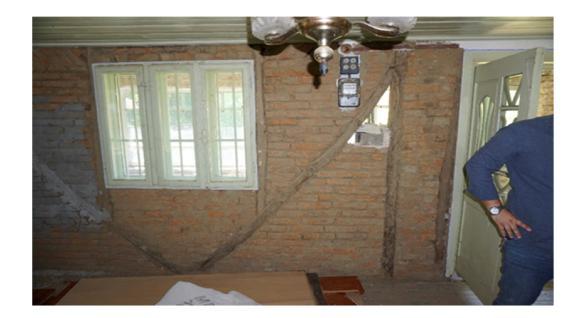
**Figure 32.** Window opening in a wall with mixed structure. The absence of the lintel above the gap can be noticed.

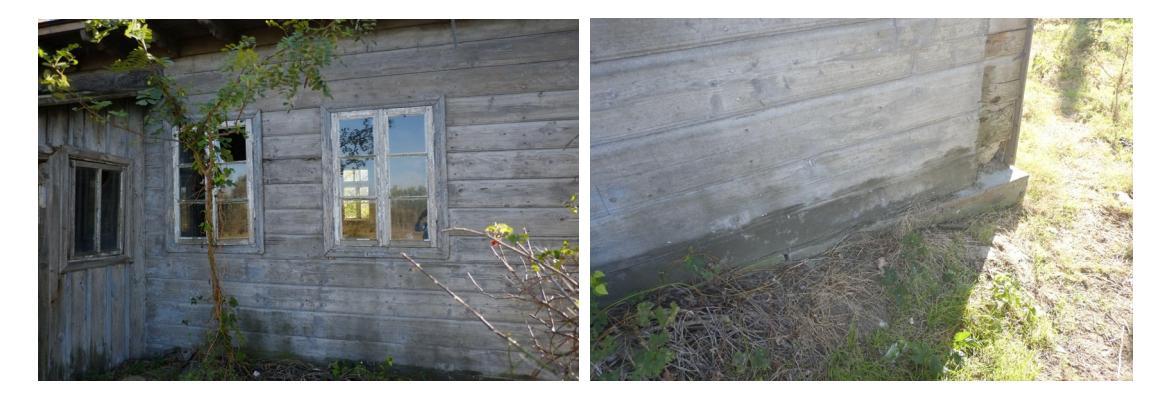
The house (Figure 43) has a **hip roof** with a simple framework made of rafters which are supported by props and connected with nails. The **roof cover** is made of steel sheets. However, specific for such houses are pantile roof covers. It is worth noting that there are no gutters continued by downspouts, to lead the rainwater away from the walls, thus the socle (bottom part of the walls) is always exposed to humidity. The vegetation is present just near the socle and, together with the absence of the perimeter pavement, this maintains a high humidity which, in time, causes the decay of the timber plank finishing (Figure 44)

Figure 44. The bottom part of the plank facade is affected by dampness.

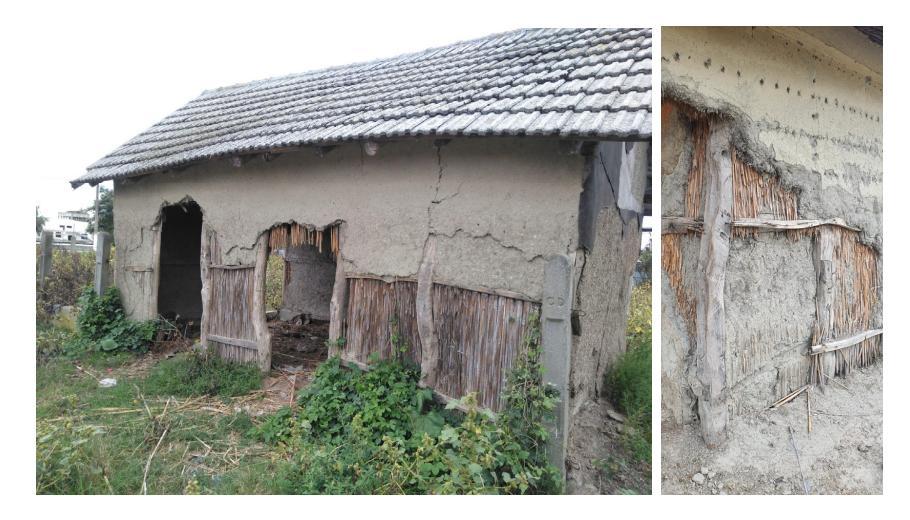
**Figure 45.** Neighboring abandoned houses, where the finishing is degraded and the inner structure is visible.

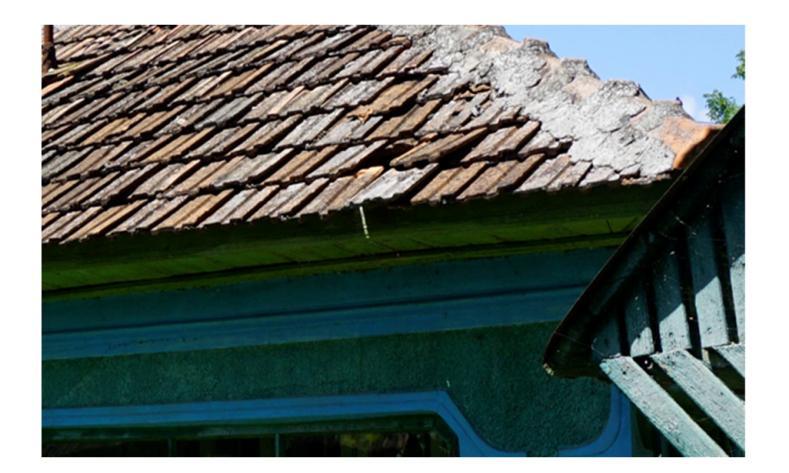
Figure 50. Missing roof tiles.

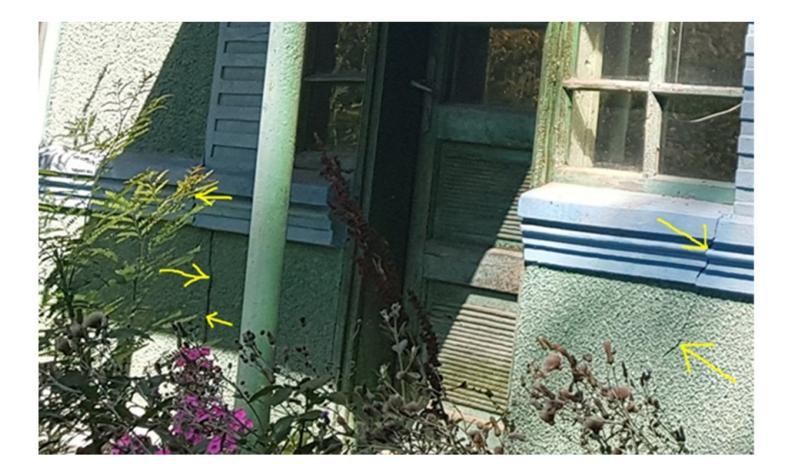
**Figure 51.** Cracks in the A-axis envelope wall, in the immediate vicinity of the entrance door. The path of the crack can be distinguished, starting from the corner of the window opening.

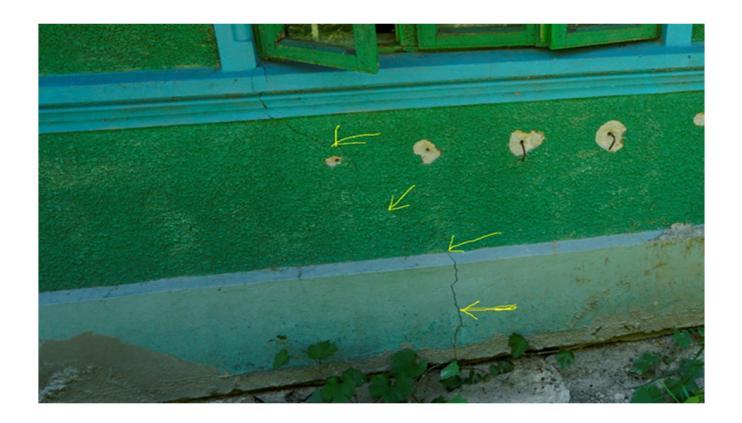
Figure 52. Crack in the envelope wall located in axis 5 (street-side).

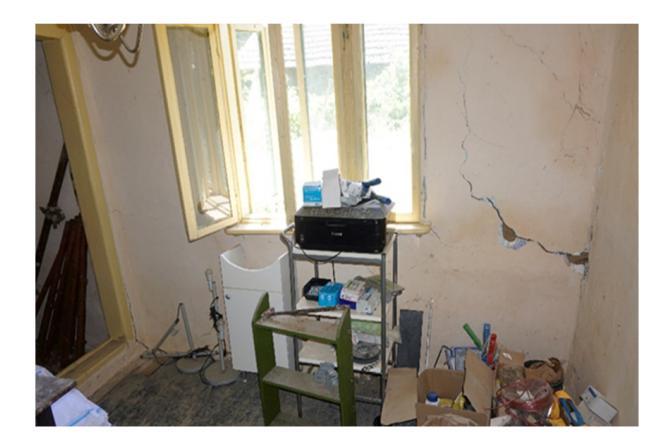
Figure 53. Crack in the A-axis wall, just near its intersection with the 1-axis envelope wall.

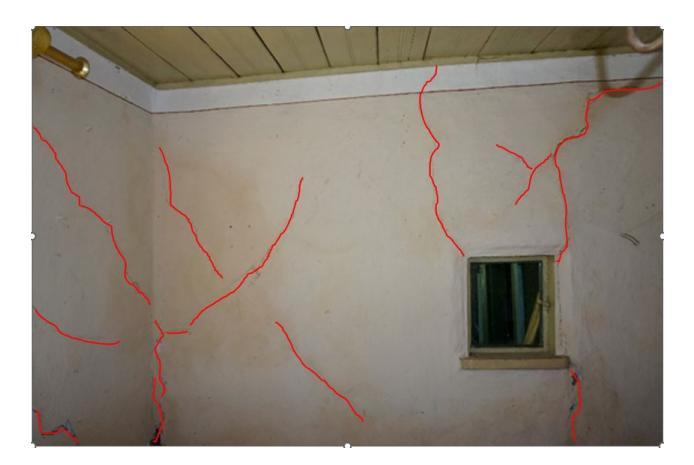
Figure 54. Envelope wall cracks in axis 1.

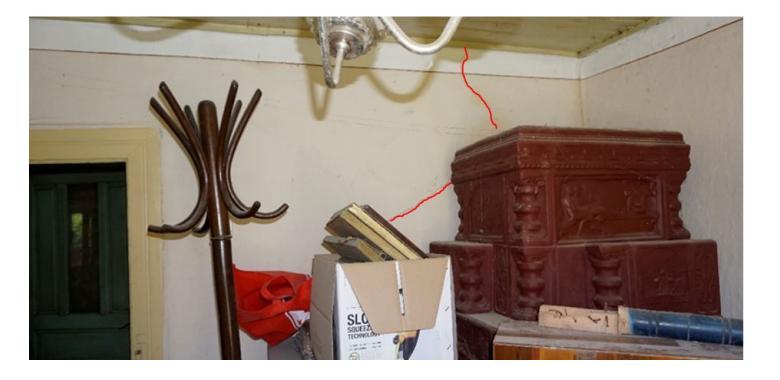
Figure 55. Inclined crack in the inner wall in the C-axis.

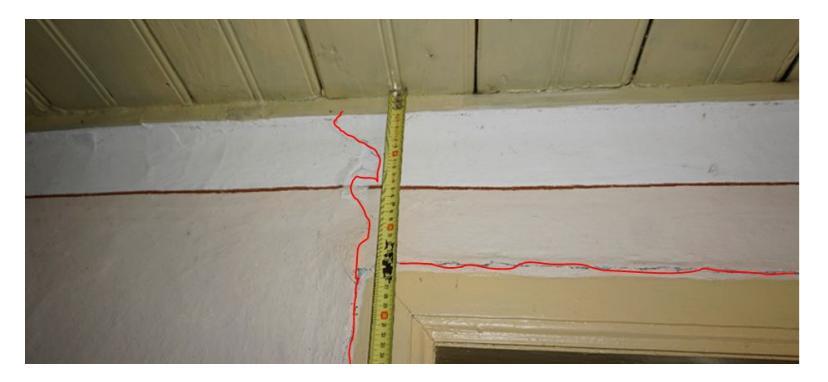
Figure 56. Vertical crack at the level of the inner wall in axis 2, just above the passage door.

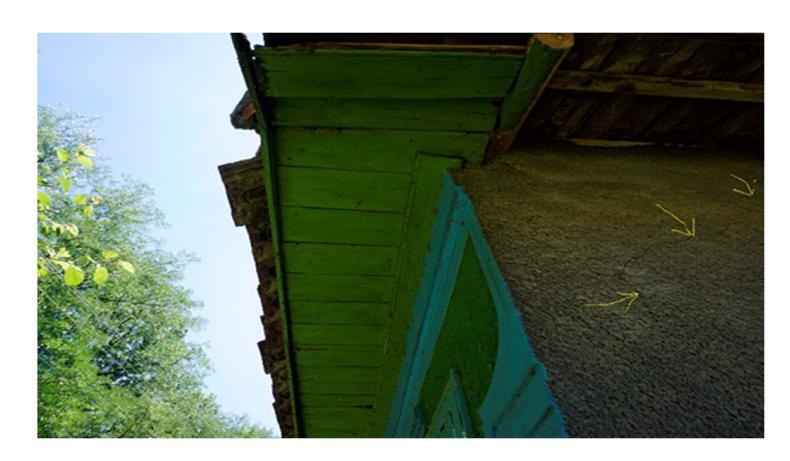
Figure 57. Crack at the top of the envelope wall located in the D axis (behind the house).

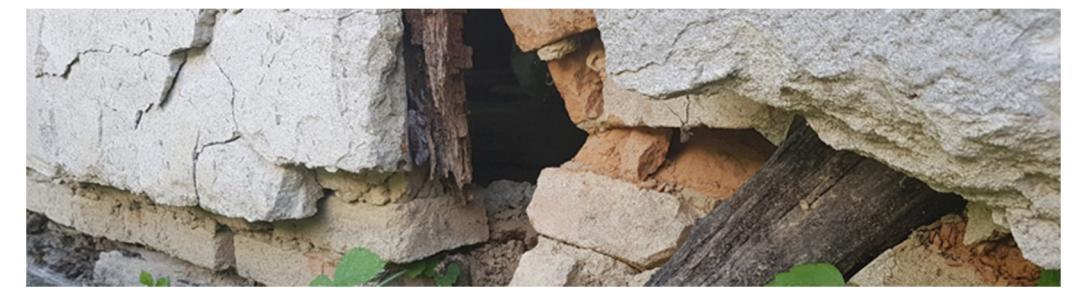
**Figure 58.** Masonry breaking in areas where segments of wooden elements embedded in the structure of the envelope wall in the D-axis have disappeared as a result of rotting.

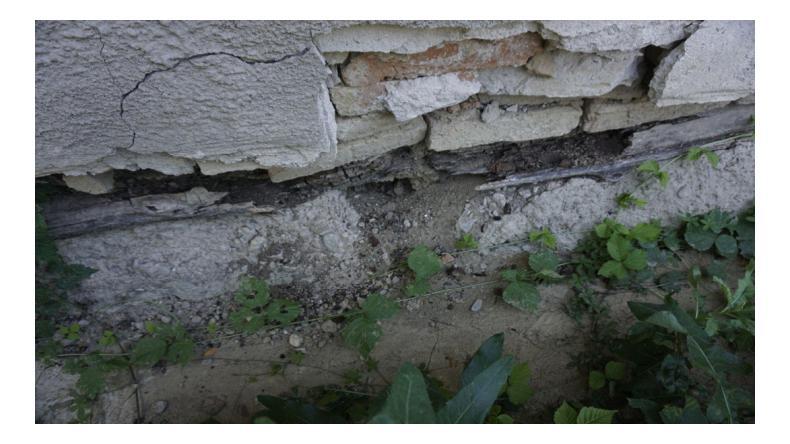
**Figure 59.** Rotting damage to the mudsill at the base of the envelope wall in axis D. The affected plaster is visible, as well as the masonry.

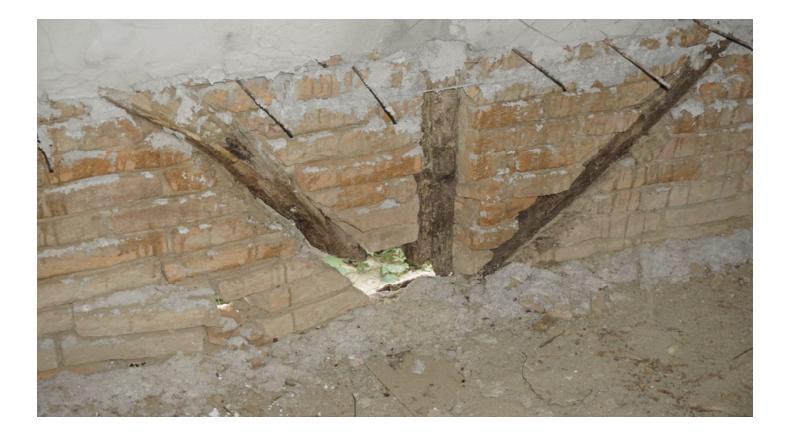
The damage observed on the outside of the envelope wall in axis D (the back of the house) can also be observed from the inside of the house, penetrating the entire wall thickness (Figure 60).

**Figure 60.** Rotting damage to the wooden elements embedded in the envelope wall structure behind the house (axis D). The affected masonry can be observed.

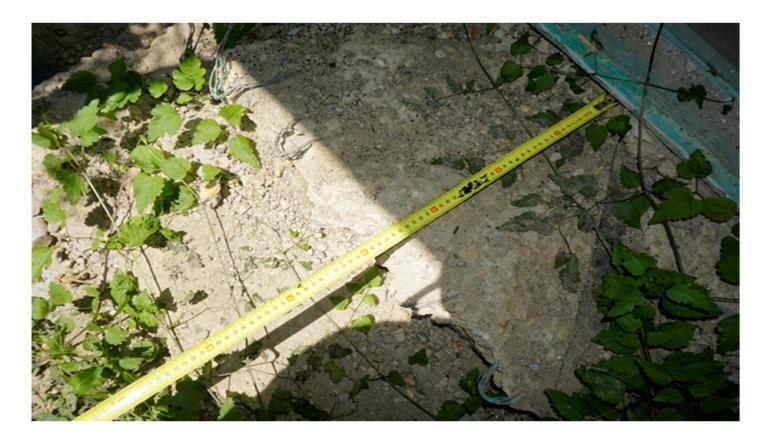
Figure 61. Damage in the concrete of the access staircase steps.

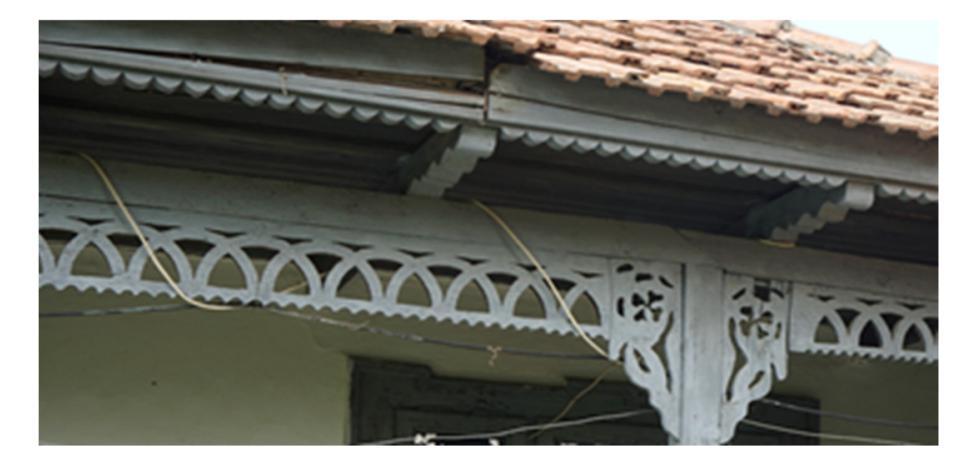
Figure 62. Damaged fascia at the eaves.

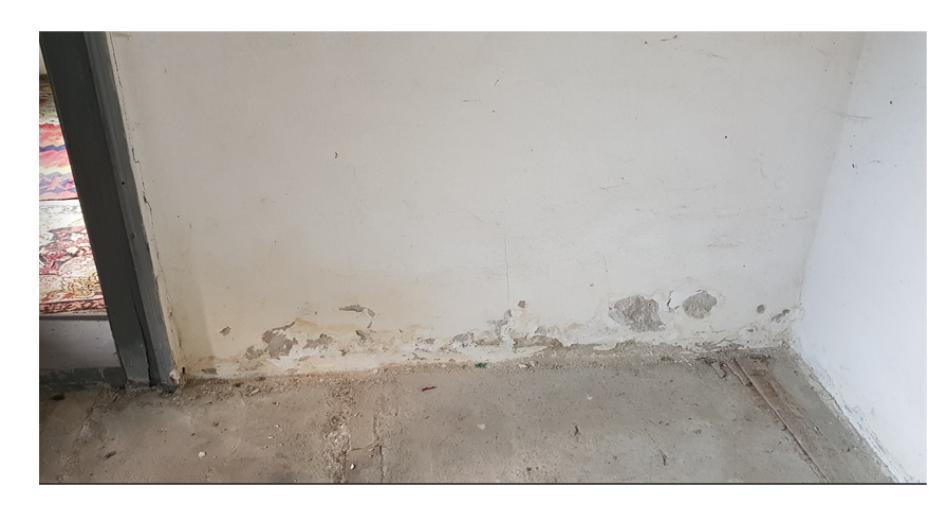
Figure 63. Plaster and wall finish, damaged by moisture in the wall structure.

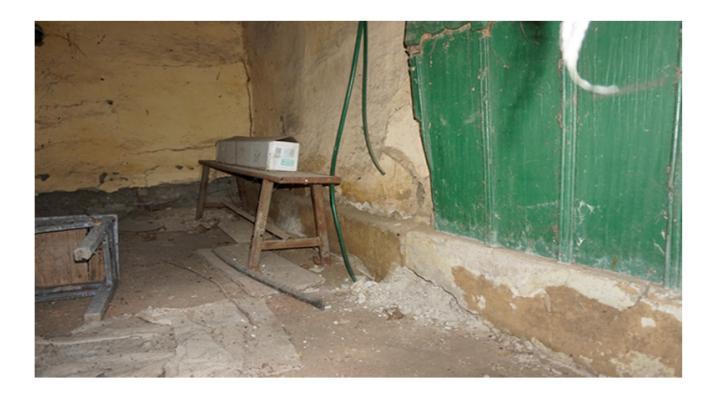
**Figure 64.** The plaster of the back wall of the house, degraded by moisture and exposure to freezethaw cycles in a wet state.

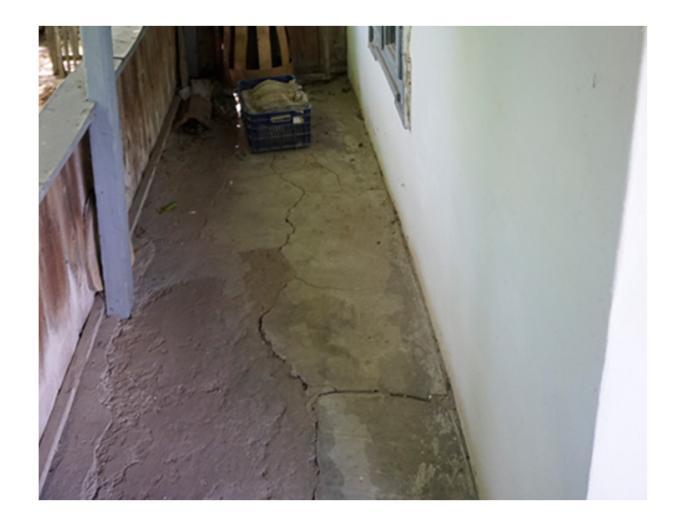
Figure 65. Cracks in the porch floor and areas of concrete peeling.

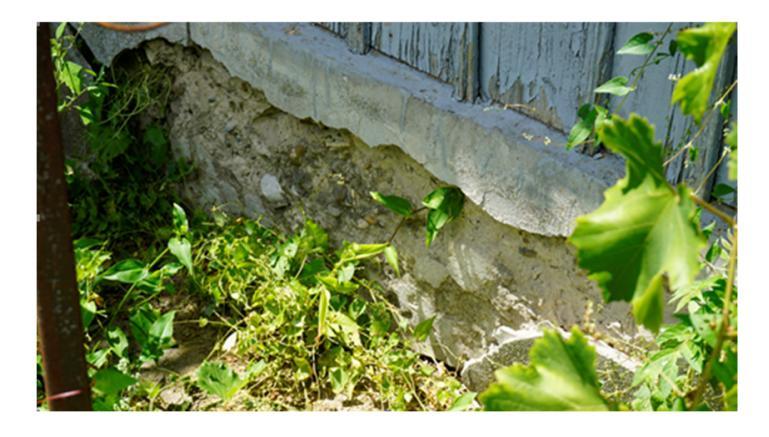
Figure 66. Plaster detached from the vertical surface of the perimeter plinth.

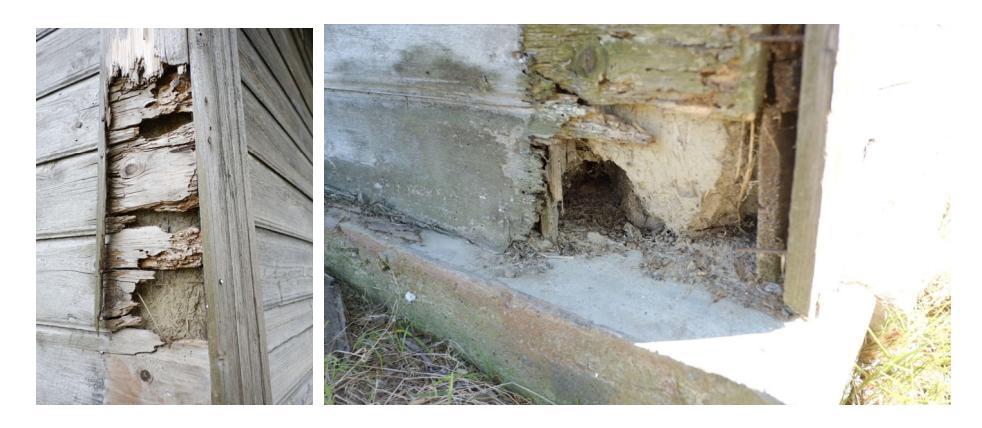
Figure 67. Degradation of the exterior plank facade and corner post due to biological decay.
