Article Research on Deformation Analysis and Rehabilitation for a Beam–Arch Combination Bridge Suffering an Extreme Temperature Field

Citation: Fu, M.; Liang, Y.; Wu, B.; Zhang, L.; Tang, G. Research on Deformation Analysis and Rehabilitation for a Beam–Arch Combination Bridge Suffering an Extreme Temperature Field. *Appl. Sci.* 2022, *12*, 6909. https://doi.org/ 10.3390/app12146909

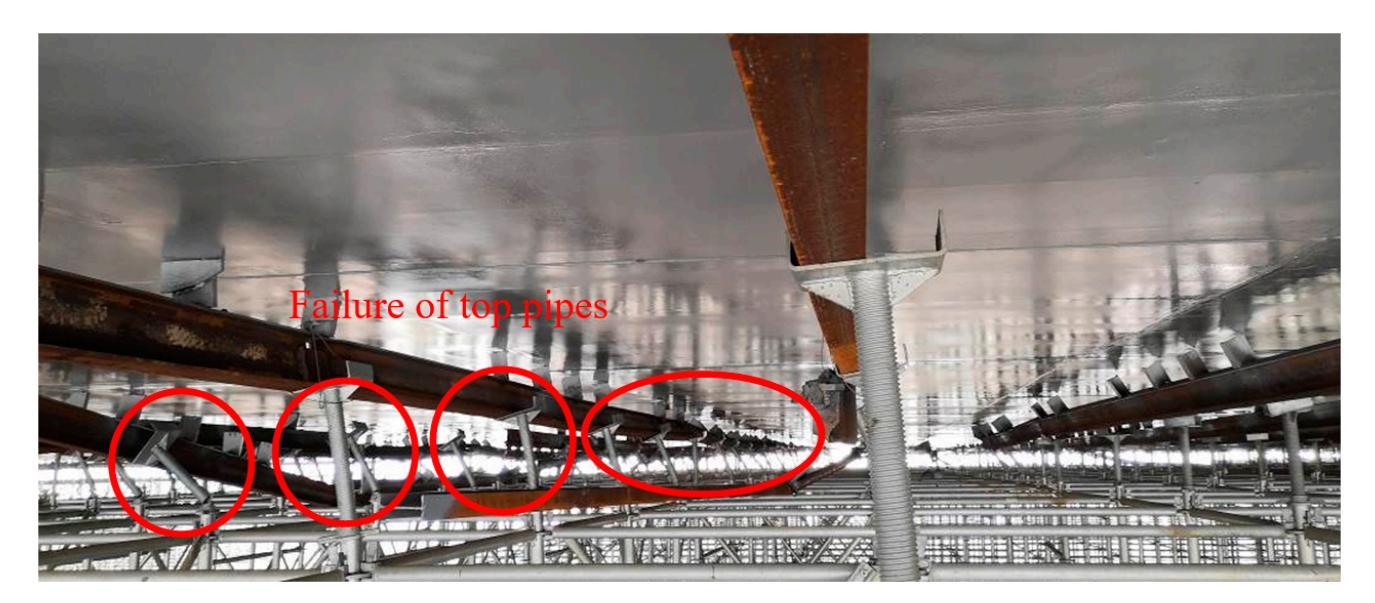
On 12 August 2019, Typhoon Lekima struck; as a result, the temperature dropped suddenly at night, followed by abnormal twisting deformation of the box girder, and failure of 2% of the top pipes of the frame scaffolding due to shear (shown in Figure 5). The bridge's bearings separated between the box girder and the pad stones (Figure 6). All these problems prevented the subsequent construction activities. Notably, there is a precedent for separating the support of the steel box girder bridge due to a temperature gradient [24].

Figure 5. Top pipes of the frame scaffolding failed after the typhoon.

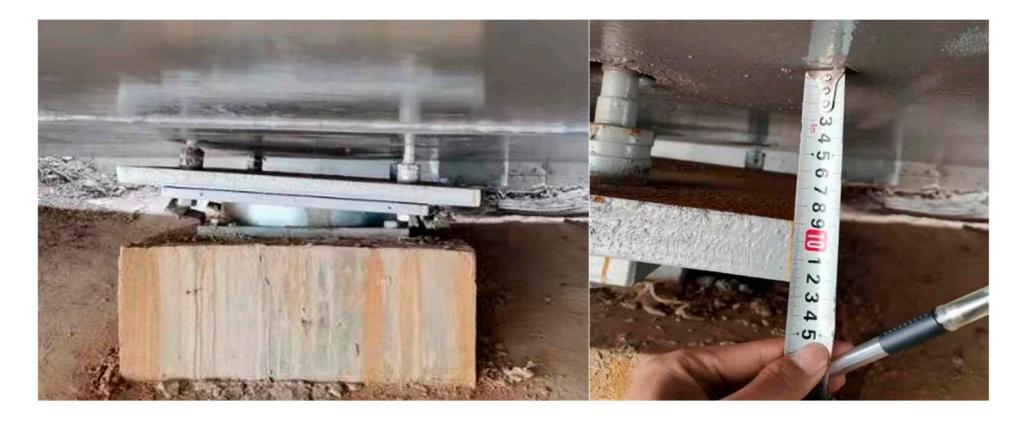
Figure 6. Bearings of the bridge separated the box girder and the pad stones.

After the first-phase stretching of the hanger rods, abnormal deformation still existed, which led to the bearings at the end of the box girder separating the box girder and the pad stones, with a maximum separated value of 8 cm, as shown in Figure 6. From the monitoring results (tested on 21 October 2019) shown in Figure 15, the distribution of the abnormal deformation was as follows: under different temperatures, for the section at the end of the side span it was from 1.5 cm to 7.8 cm higher than the design elevation, the section of the middle span was 6 cm to 8 cm below the design elevation, and the abnormal deformation directly affected the subsequent deck pavement and line shape of the bridge. The final welding phase of the top plate was from April to June, with the environmental temperature ranging from 25 °C to 42 °C.

Step 1: Increase the force of the tie rods by 1000 kN based on the original design, and adopt the temporary concrete block, shown in Figure 31a, to position the end of the box girder downwards while pre-stressing the tie rods.

Step 2: Remove the temporary concrete block, jack up the steel box girder and lower the pad-stones by 45 mm, and remove the bearing anchor bolts and the original bearing. Drop the elevation of the box girder, replace the new bearings, and then position the whole steel box girder in place, as shown in Figure 31b.

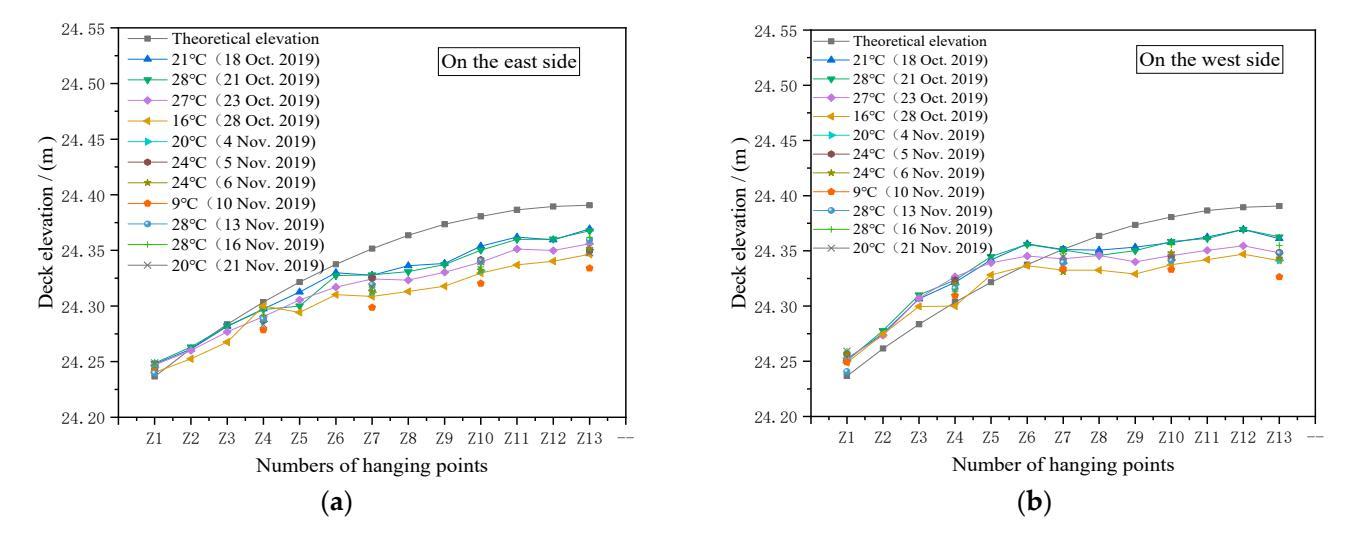
Figure 13 shows the deck elevation at the hanging points under different temperatures. The deck elevation was set according the theoretical elevation which considered the determination of the pre-camber before the typhoon. It can be seen that the lower the bridge deck temperature is, the lower the bridge deck elevation near the mid-span is, and the deck elevation is lower than the theoretical elevation after the typhoon, and thus cannot recover to its position before the typhoon. Combined with the damage to the frame scaffolding on the day after the typhoon struck, the unrecoverable deformation would be preliminarily due to the sudden change in the temperature field of the steel box girder; therefore, both the temperature field of the steel box girder and the status of the frame scaffolding could not be restored to the initial condition of before the typhoon struck.

Figure 13. Deck elevation at the hanging point under different temperatures. (**a**) Eastside hanging point area. (**b**) Westside hanging point area.

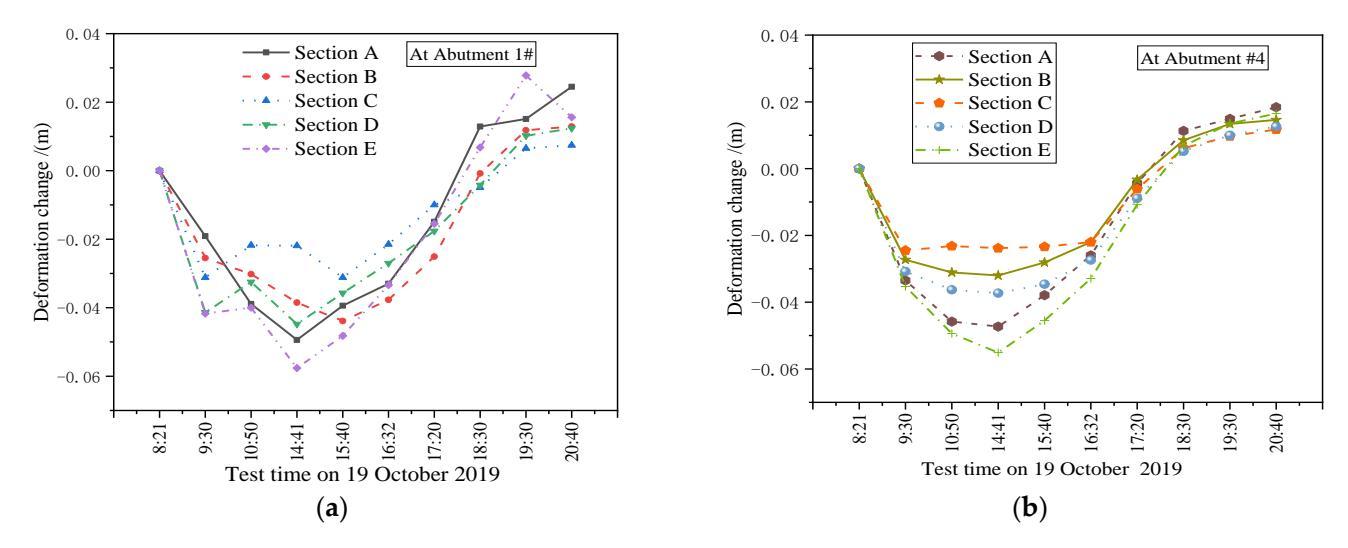
Figure 14 shows that the deformation change of the bridge deck at the end beam of the steel box girder was mainly affected by the temperature field. On the same day, the vertical deflection trend was consistent with the cooling trend of the bridge deck. The higher the temperature, the greater the vertical deflection, and the largest vertical deflection was 0.06 m.

Figure 14. Results of elevation measurement at the end of the box girder at the abutment. (**a**) At abutment #1. (**b**) At abutment #4.

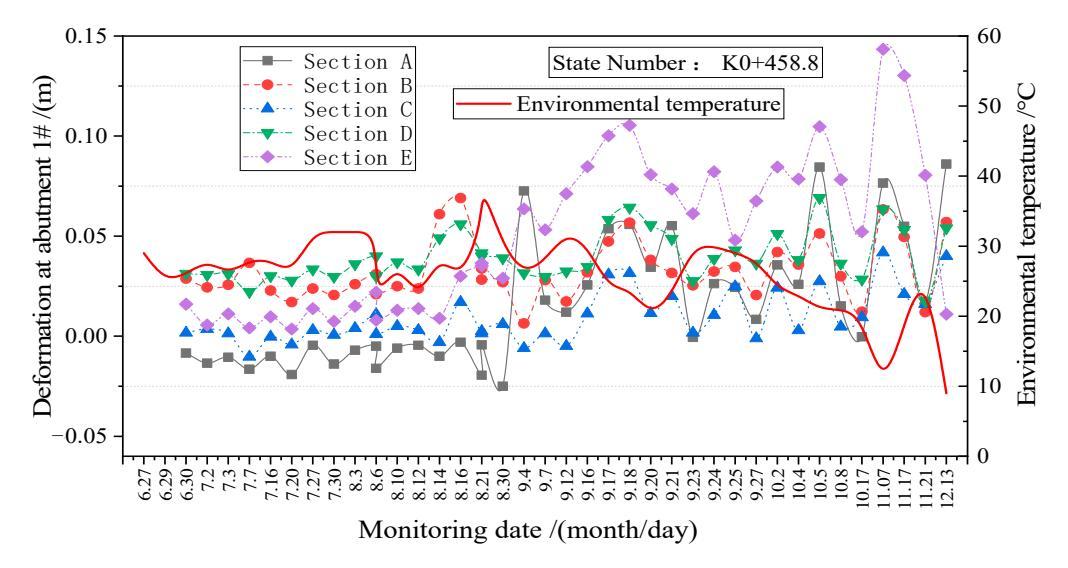
Figure 16 shows the deformation monitoring historical curves of the end of the box girder above abutment #1 (bridge state location K0+ 458.8). Figure 17 shows the deformation monitoring historical curves of the box girder at the mid-span of the main span. Figure 18 shows the deformation monitoring historical curves of the end of the box girder above abutment #4 (bridge state location K0+ 621.7). Figures 16–18 show that the line shape was stable during the assembly stage of the box girder and the pre-stress of the tie bars. On 12 August 2019, when Typhoon Lekima arrived, the deformation monitoring historical curves of the end of the box girder above abutments #1 and #4 suddenly changed upwards. On 4 September 2019, the deformation of the box girder decreased after the demolition of the frame scaffolding of the middle span. After the second fine-tuning of the stretch of the hanger rods on 23 September 2019, the deformation returned to a certain extent. The deformation monitoring historical curves show that the deformation of the box girder fluctuated with the temperature on different dates. When the temperature dropped to 9 °C on 7 November 2019, the warping of the end of the box girder above the abutment was particularly obvious. The ichnography of the box girder's deformation after the frame scaffolding's demolition is shown in Figure 19. The most significant deformation of the middle span is 0.085 m, and the shape of deformation appears to be 'a lid cover'.

Figure 16. Deformation monitoring historical curves of the box girder at abutment #1.

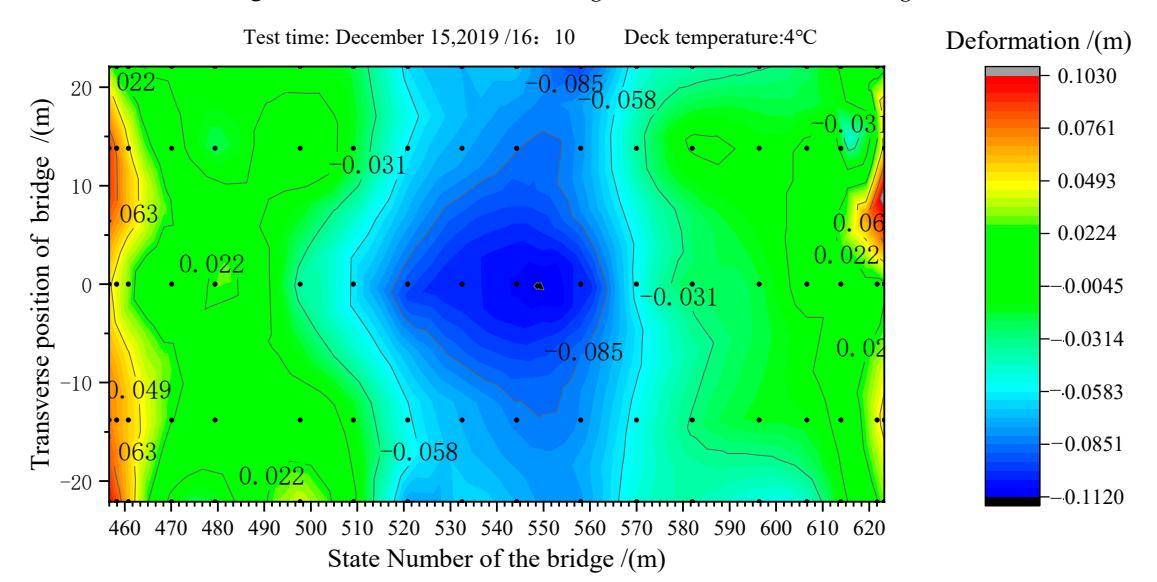
Figure 19. Deformation of the box girder after demolition of the frame scaffolding.

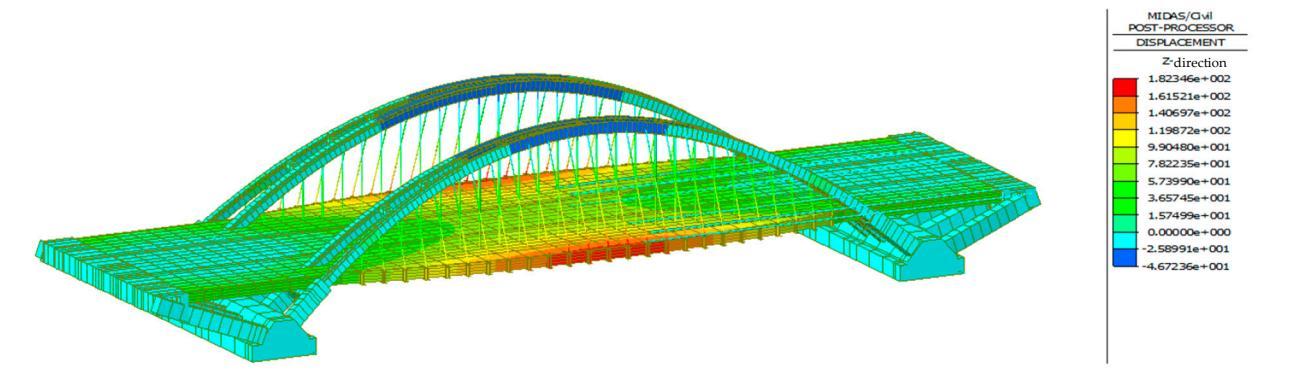
As shown in Figures 24 and 25, deformation still existed even after installing the steel arch ribs and hanging rods, which was consistent with the in situ monitoring results, and the deformation at the end of the box girder led to upwarping overall following local upwarping after the removal of the frame scaffolding.

Figure 25. Deformation of the box girder after the demolition of the frame scaffolding (unit: mm).

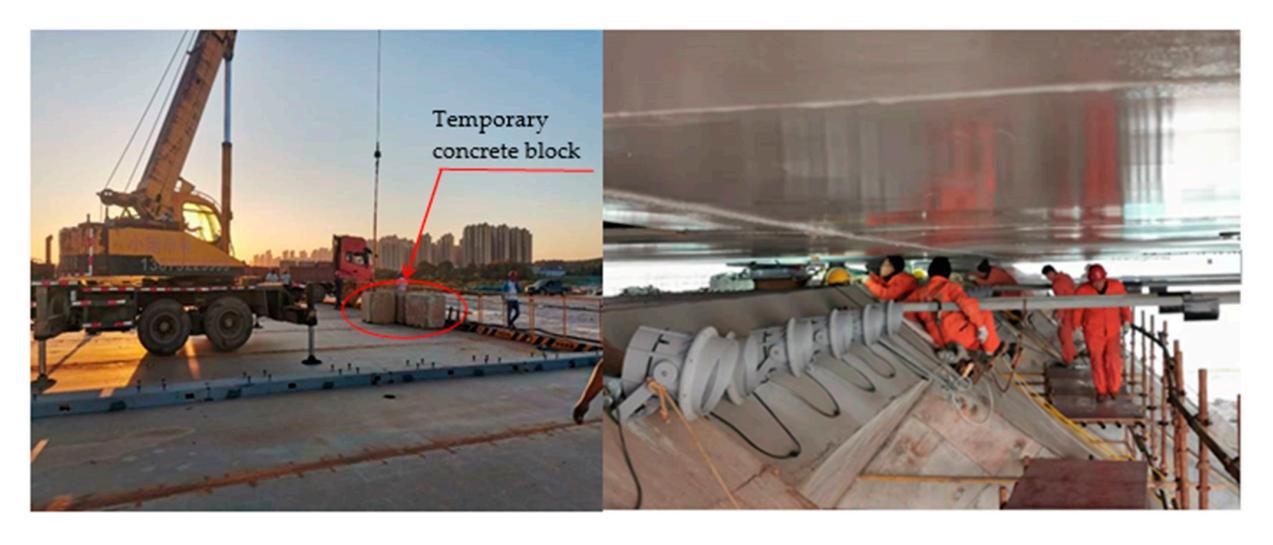
Figure 31. Rehabilitation measures: (**a**) Adopt the temporary concrete block to position the end of the box girder downwards. (**b**) Replace bearings by jacking up the overall box girder.

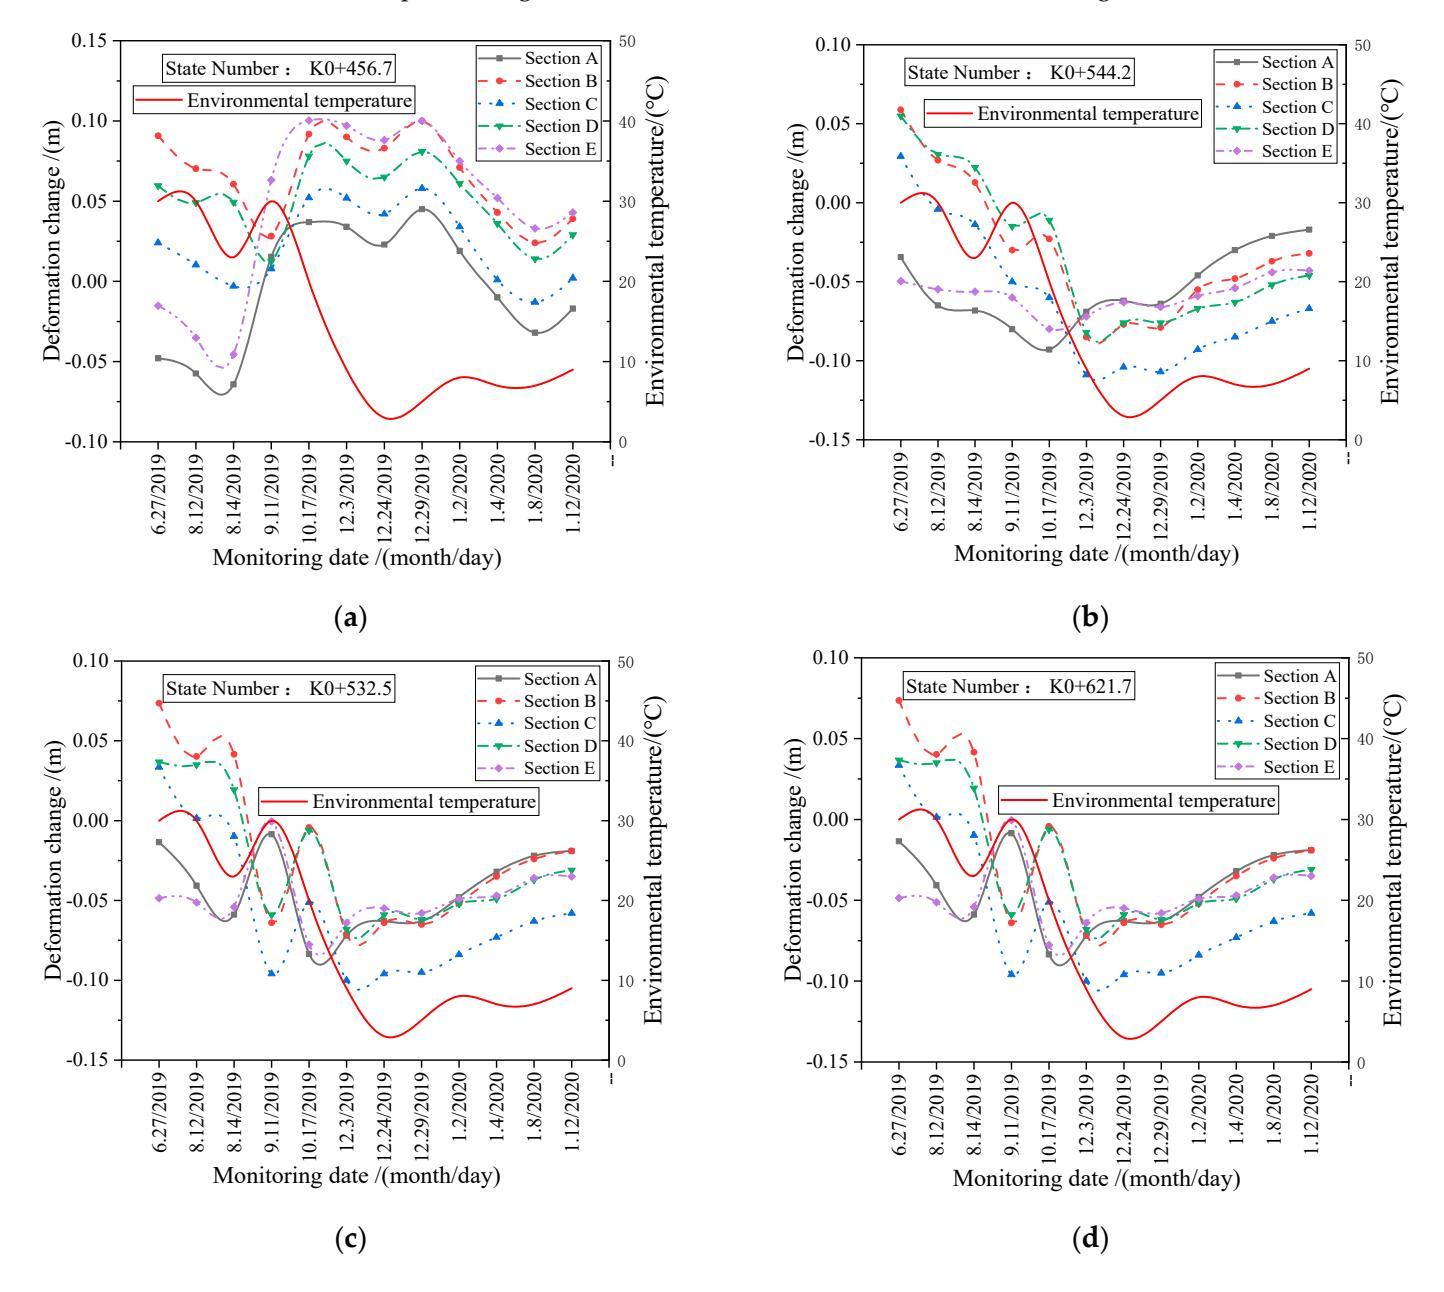
The changes in the elevation of the box girder are shown in Figure 32. Figure 32a shows the elevation change of the end of the box girder above abutment #0. The elevation of this section increased by 4 cm after the rehabilitation measures. Figure 32b shows the elevation change of the mid-span of the main span of the box girder, and the overall elevation at this section increased by 3 cm after rehabilitation. Figure 32c shows the elevation change of the box girder at the section of hanging rod #11, and the overall elevation of this section increased by 5 cm. Figure 32d shows the elevation change of the end of the section of this section increases by 6 cm after the rehabilitation measures.

Figure 32. Deformation of the key section of the box girder before and after the rehabilitation measures. (a) End of the box girder above abutment #1. (b) mid-span of the main span of the box girder. (c) Section of hanging rod #11. (d) End of the box girder above abutment #4.

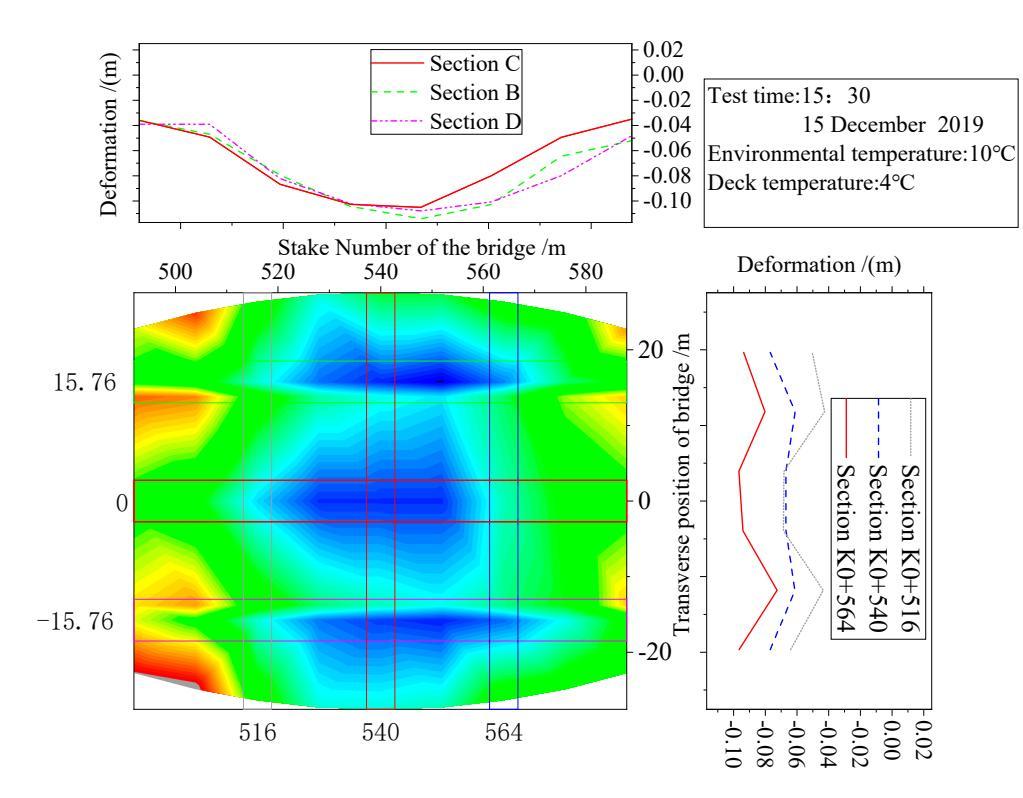
The contour map deformation of the box girder in the main span is shown in Figures 33 and 34. The deformation before treatment demonstrated obvious parabolic characteristics between the longitudinal section and the cross-section, and the maximum deformation was -11.5 cm, forming a concave "pot cover" shape as shown in Figure 33. After the treatment, the deformation ranged from -0.6 cm to -0.8 cm, and the error was close to the error value of -0.7 cm. This result means that rehabilitation measures improved the overall linearity of the bridge deck.

Figure 33. Deformation of the whole box girder before rehabilitation measures.

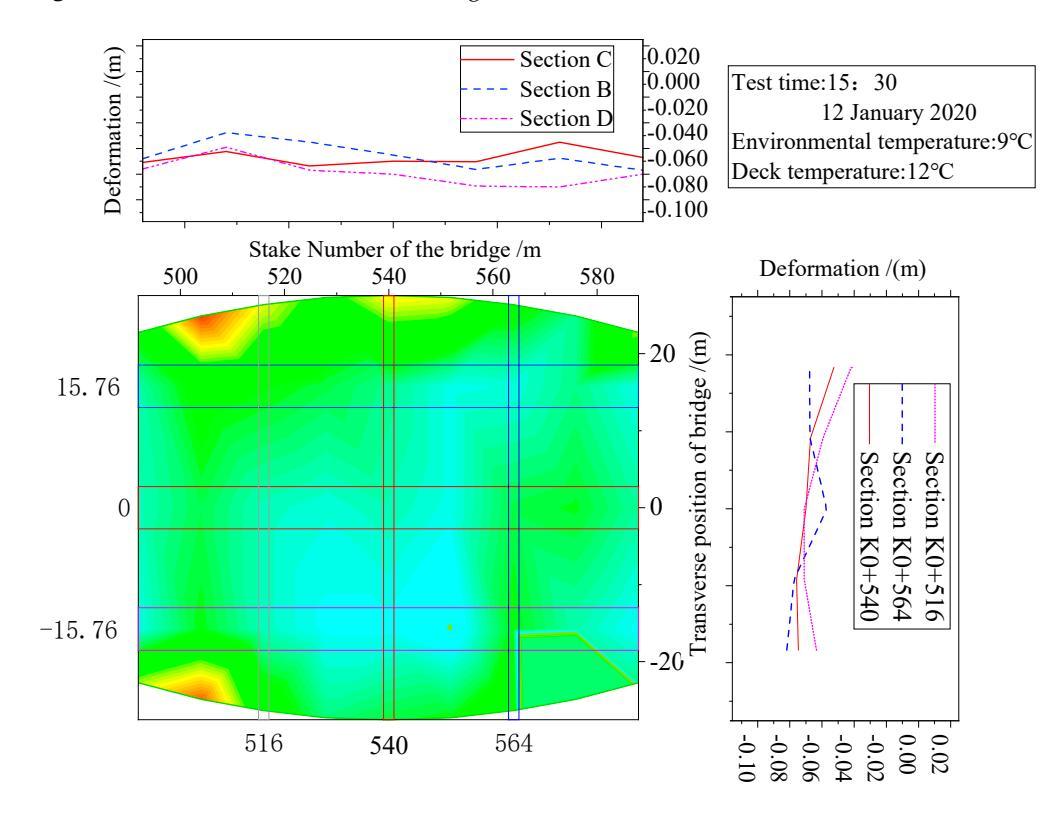
Figure 34. Deformation of the whole box girder after rehabilitation measures.
