Visual and Physical Degradation of the Black and White Mosaic of a Roman Domus under Palazzo Valentini in Rome: A Preliminary Study

Keywords: Roman domus; mosaic restoration; multi-method diagnostic; NMR; FT-IR; GC-MS

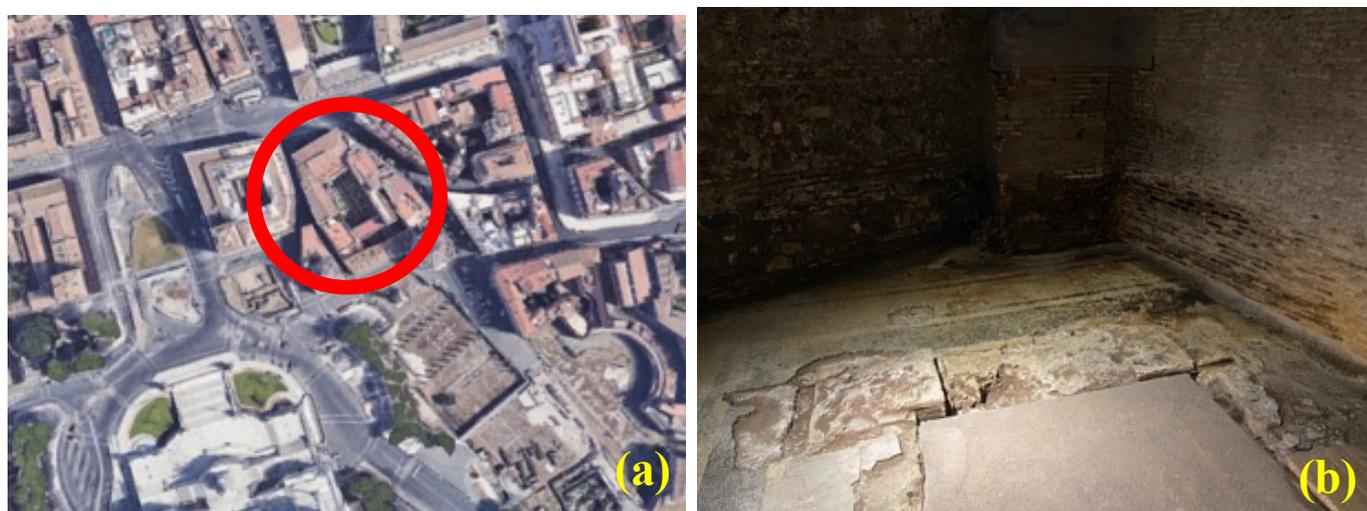
Figure 1. In the red circle is evidenced Palazzo Valentini (source: Google Earth [9]) (a). The pavement mosaic and the immediately facing wall (b).

The paper focuses on the state of chemical degradation of the mosaic's right part and the part immediately facing the wall (Figure 1b–d). The need to identify the causes of chemical degradation is important for the historical reconstruction of the use of this environment over time and for the correct restoration of the wall and, essentially, the mosaic itself. This paper shows the preliminary results in the possible identification of the compounds responsible for such degradation.

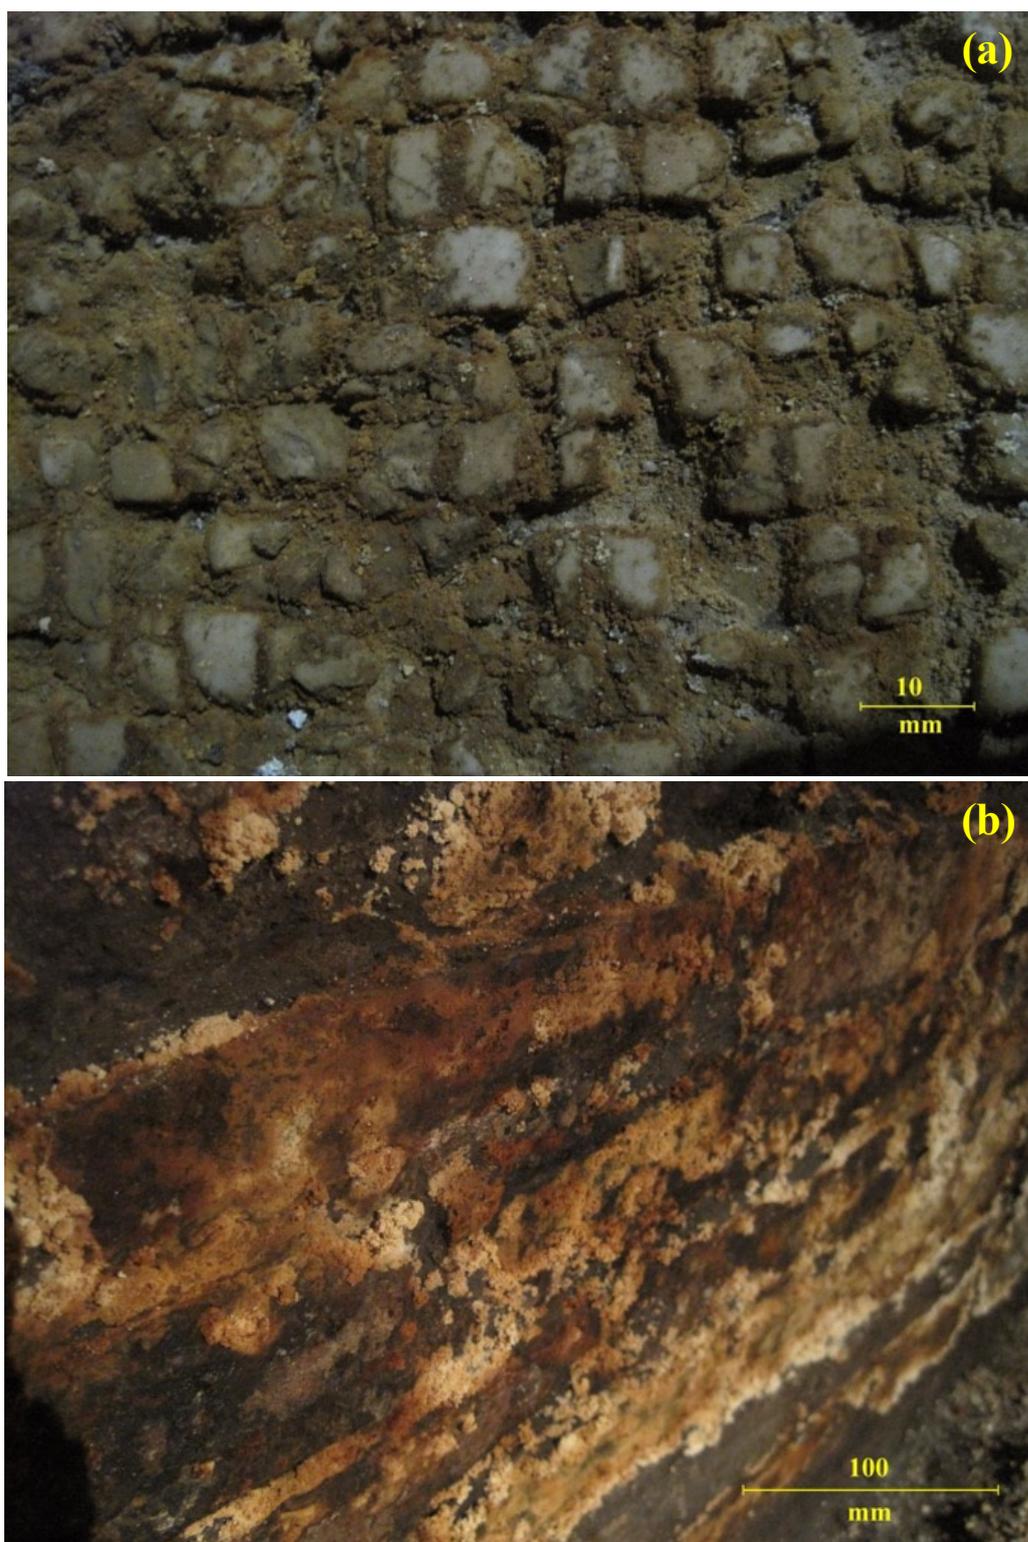
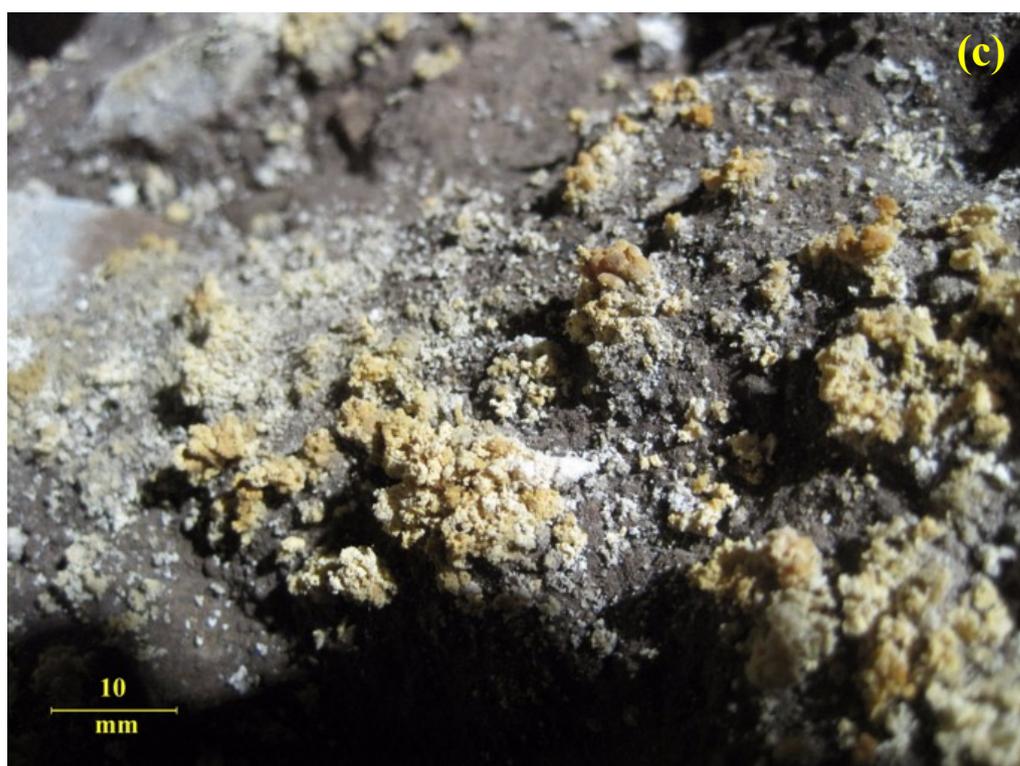
Figure 2. Cont.

Figure 2. Photos of the degradation (a) of the floor and (b) of the wall and optical microscope image (c) on the surface of the black and white mosaic pavement (10× and 40× magnification, respectively; width focusing 25 mm, 2 mm increments; 6 V/20 W halogen light). The sample of the degradation product of the black and white pavement mosaic of *domus B* was analyzed under an optical microscope in transmittance and reflectance).

By accurate examination, it was possible to observe that the mosaic tiles were intact, and the degradation product was lying over the surface of the tile and in the interstices between one tile and another; this suggested that the degradation mainly concerned the mosaic mortar layer, essentially made up of calcium carbonate (CaCO_3).

Degradation also extended to the room walls (Figure 2a,b) and seemed similar to that affecting the pavement. Over the centuries (especially after the sixth century), the functional use of these underground settings, located at between 3.5 and 5.5 m of depth in respect to the current ground level, is unclear because of fragmented or missing documentation.

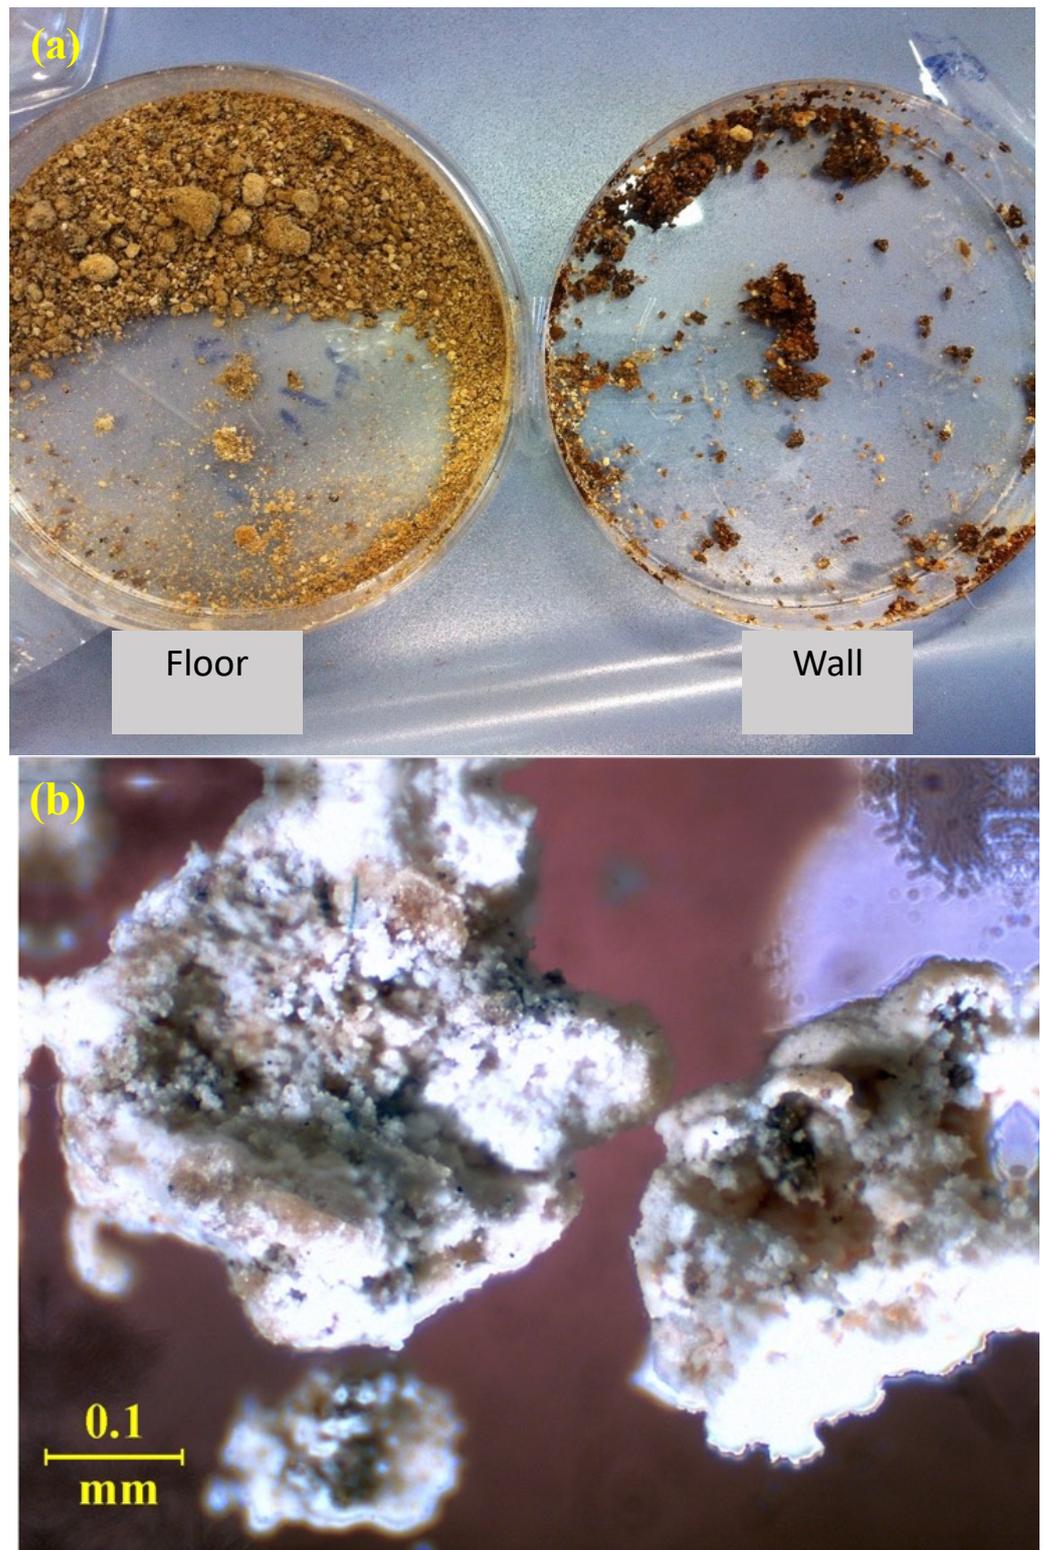
Figure 3. (a) Photo of the samples of the degradation product of both the floor and the wall (glass Petri plate 80 mm); (b) photo of the degradation product of the pavimental mosaic taken by the optical microscope (1000 \times magnification; width focusing 25 mm, 2 mm increments; 6 V/20 W halogen light).

By OM, it has been possible to highlight a substantial homogeneity of the degradation product, consisting of small grain aggregate with porous surface (Figure 3). Nevertheless, the mosaic tiles are entirely covered by a yellowish-brown degradation product of incoherent substance (Figure 2a,c), more damp and compact at some pavement points. In addition to the visual and aesthetic damage, there is the implication of a loss of mechanical–structural properties and, therefore, of binding power.

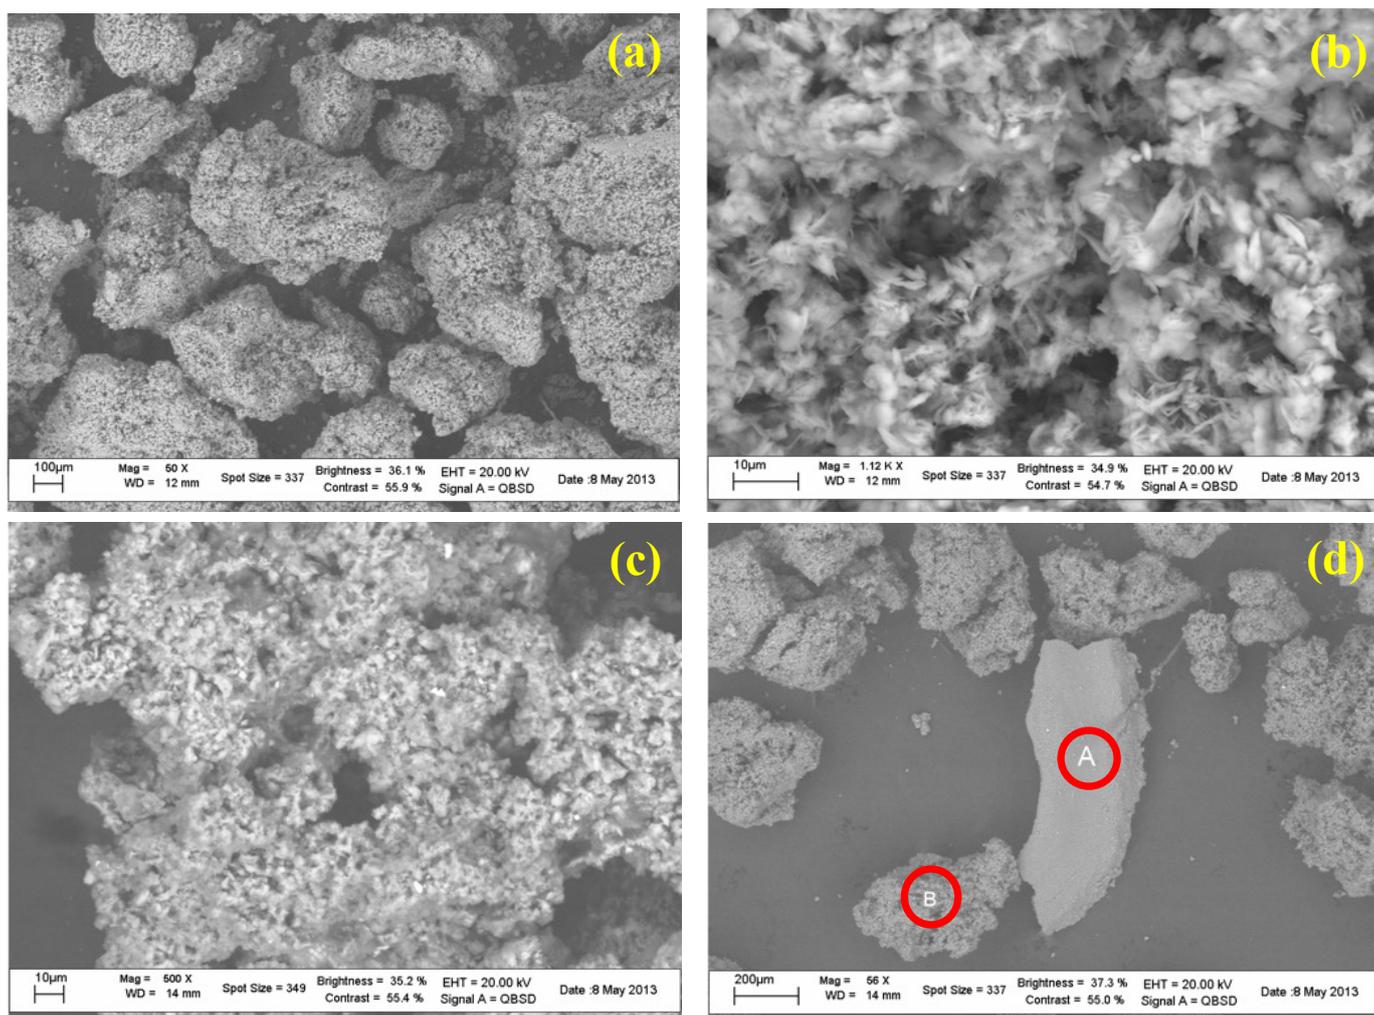
Figure 4. SEM micrographs of the samples collected from pavimental mosaic (a,b) and from the wall (c,d).

The samples taken from the pavimental mosaic and the wall were observed by SEM at magnifications from $50\times$ up to over $1000\times$ to highlight the crystalline structure. The SEM analysis confirmed the porous structure observed by means of optical microscope. EDS microprobe analyses were then used to identify the elemental composition of the samples. Figure 4a,b show the SEM images of the sample from the pavimental mosaic, whereas Figure 4c,d show the SEM images of the sample from the wall. Table 1 reports the EDS results obtained for both the floor and wall samples.

The sample from the wall (Figure 4c,d) looks similar to the pavement one but contains some fragments of a more compact aspect (zone A in Figure 4d). EDS spectra (Figure 5a,b, Table 1) revealed a lower gypsum content and a higher one of calcium carbonate. There is also a component, albeit minimal, of Mg (0.3%), Al (0.3%), and Si (0.8%), feldspars probably imputable to grains of earth.

¹ Portions (particles “A” and “B”) of the wall sample as shown in Figure 4d.

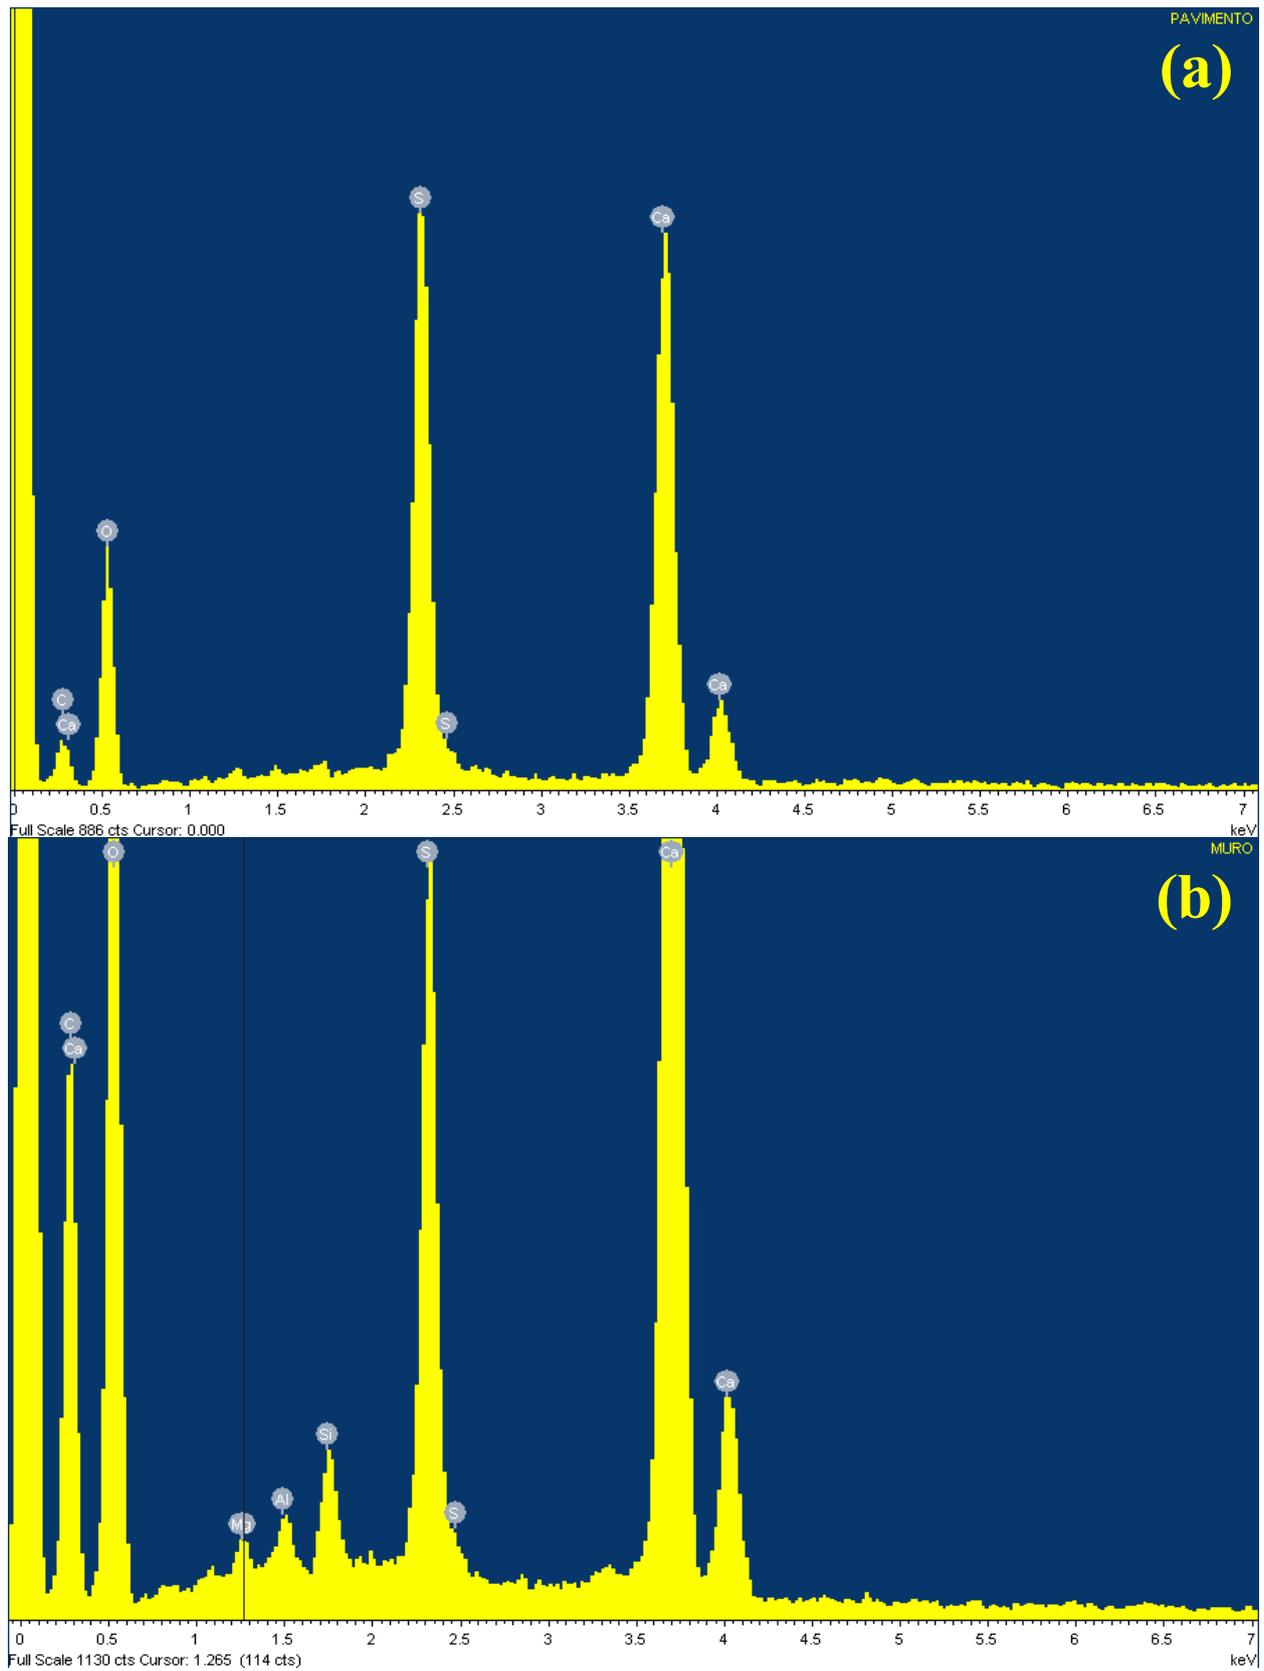
Figure 5. EDS spectra of (a) floor sample and (b) wall sample. For experimental condition: see Section 4 (Materials and Methods).

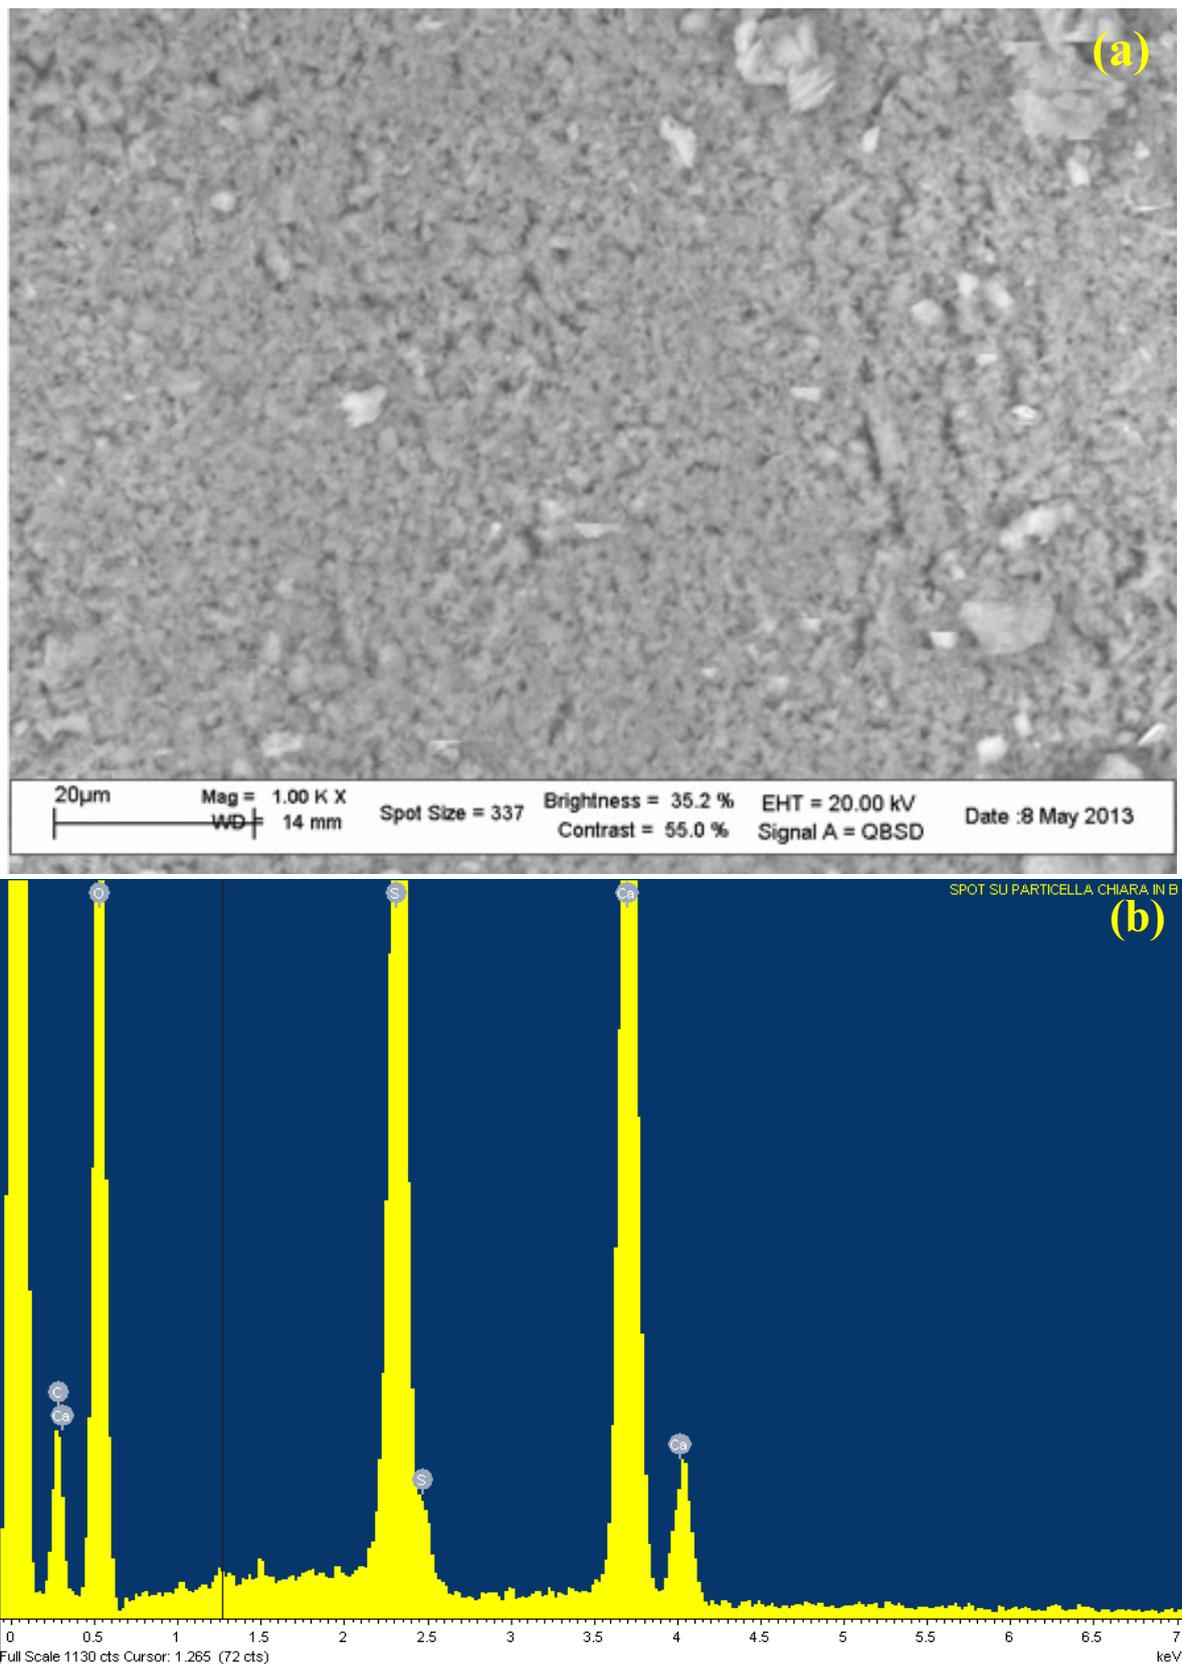
Figure 6. SEM photo (a) and EDS spectrum (b) of the spot of the particle “A” of the wall sample. For experimental condition: see Section 4 (Materials and Methods).

The more compact portion (particle “A”) differs from the others (particle “B”), with a higher gypsum content and higher calcium carbonate (Figure 6b and Table 1). At higher magnification (1000×) (Figure 6a), as expected very small grains became visible. Another significant difference between the pavement and wall samples was the higher content of Carbon, which cannot be fully imputed to the higher carbonate content because of the lower Calcium (which, as for the pavement sample also cannot satisfy both gypsum and carbonate stoichiometry), so revealing a higher content of organic compounds (Table 1).

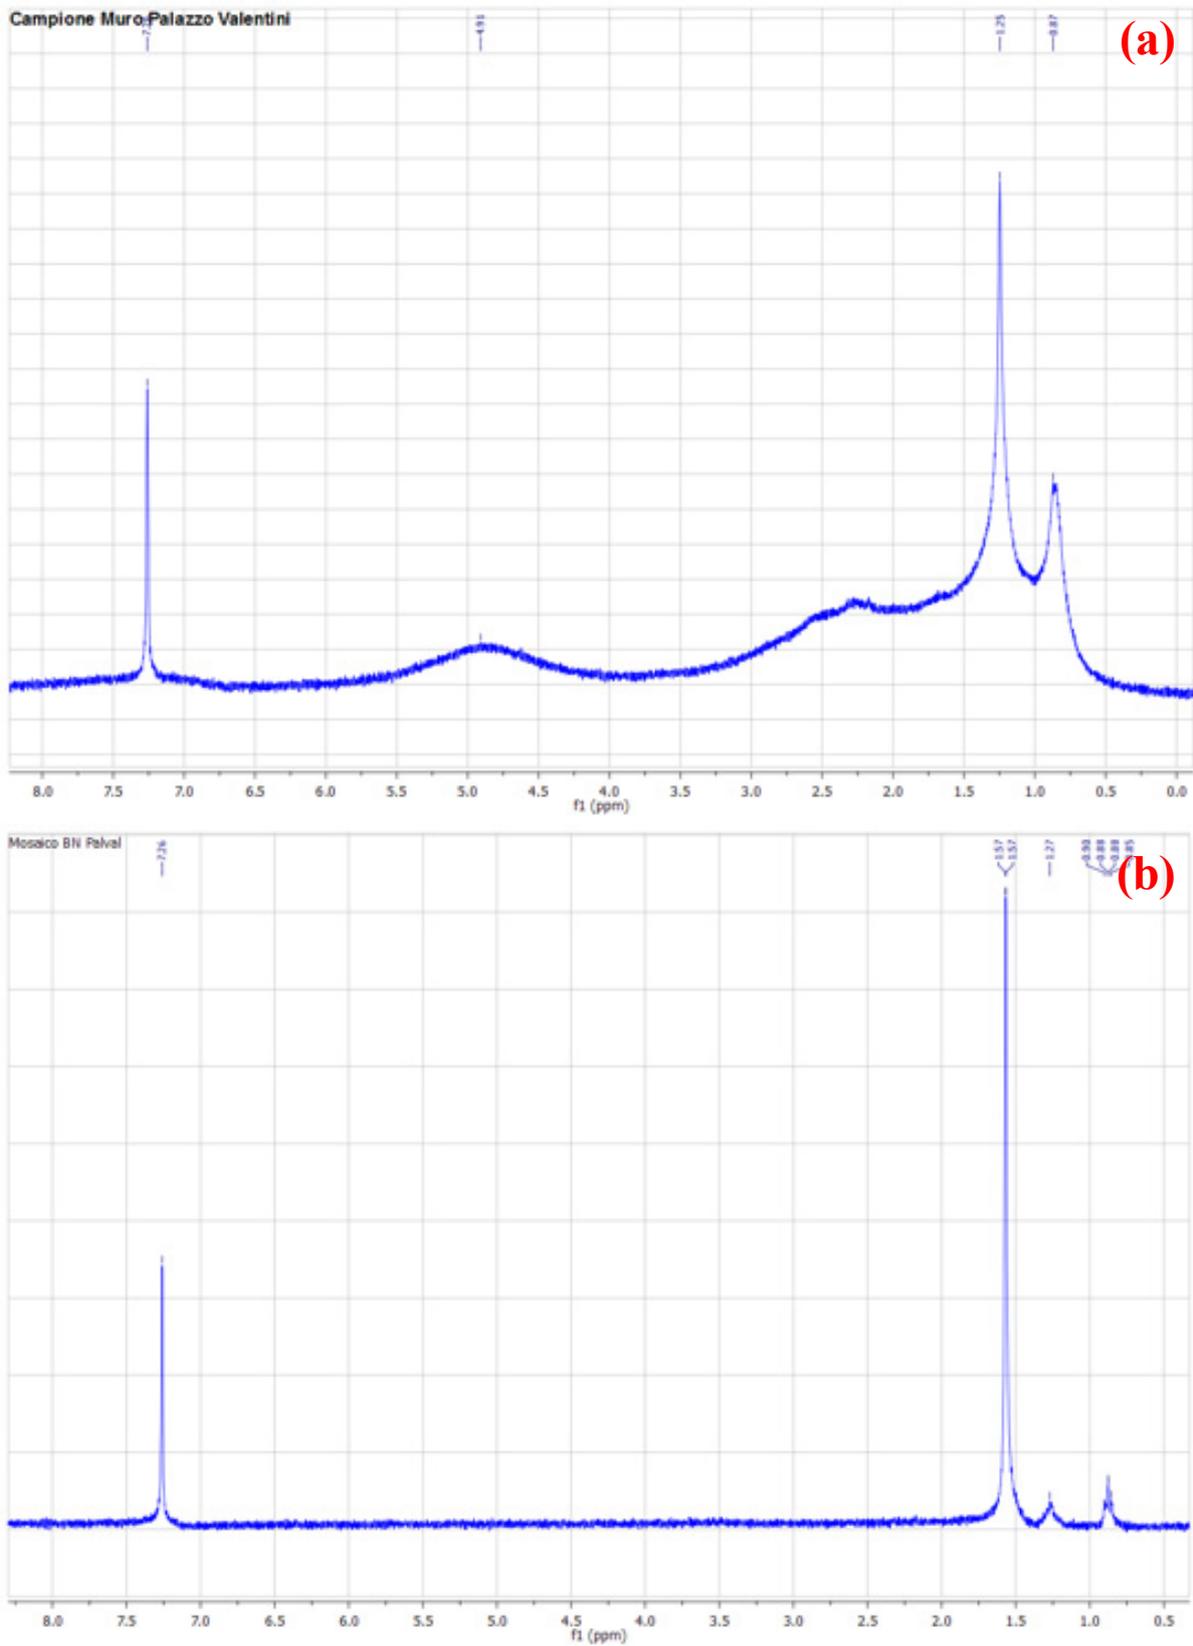
Figure 7. $^1\text{H-NMR}$ spectra (300 MHz, CDCl_3) of (a) wall and (b) pavement samples.

Analysis of the NMR spectra showed the presence of aliphatic hydrocarbons in the samples (shift at 7.3 ppm is deuterated chloroform used as solvent). In particular, Figure 7b clearly shows the presence of aliphatic hydrocarbons (shifts between 0.8 and 1.7 ppm). On the other hand, Figure 7a shows a broad signal. The presence of some -OH group caused a shift broadening. Basically, protons on carbon adjacent to the alcohol oxygen showed up in the region of 3.4–4.5 ppm. The electronegativity of the alcohol oxygen de-shielded these protons causing them to appear downfield, when compared to alkane protons. Further, protons directly attached to the alcohol oxygen often appeared in the region of 2.0 to 2.5 ppm. These peaks tended to appear as short, broad singlets [16,17]. Actually, there was also another reasonable interpretation of these broad signals in the NMR spectrum: They may also be the product of a larger molecular size of the compound or the presence of some paramagnetic impurities in the sample. In any case, the identification of the substance was carried out through a comparison with the online database of $^1\text{H-NMR}$ spectra of organic substances in CDCl_3 provided by the National Institute of Advanced Industrial Science and Technology (AIST). From the analysis of the $^1\text{H-NMR}$ spectra, the presence of aliphatic hydrocarbons seemed to emerge, some of which also contained amino and sulfur groups, such as octane, 2-methylhexane, 2-methylnonane, decylamine, 1-methylheptylamine, methylpentylsulfide, sodium 1-octanesulfonate (Figure S3 of the Supplementary Material), and, mainly, a more complex composition in the sample coming from the wall (Figure 7a) than that coming from the pavement (Figure 7b).

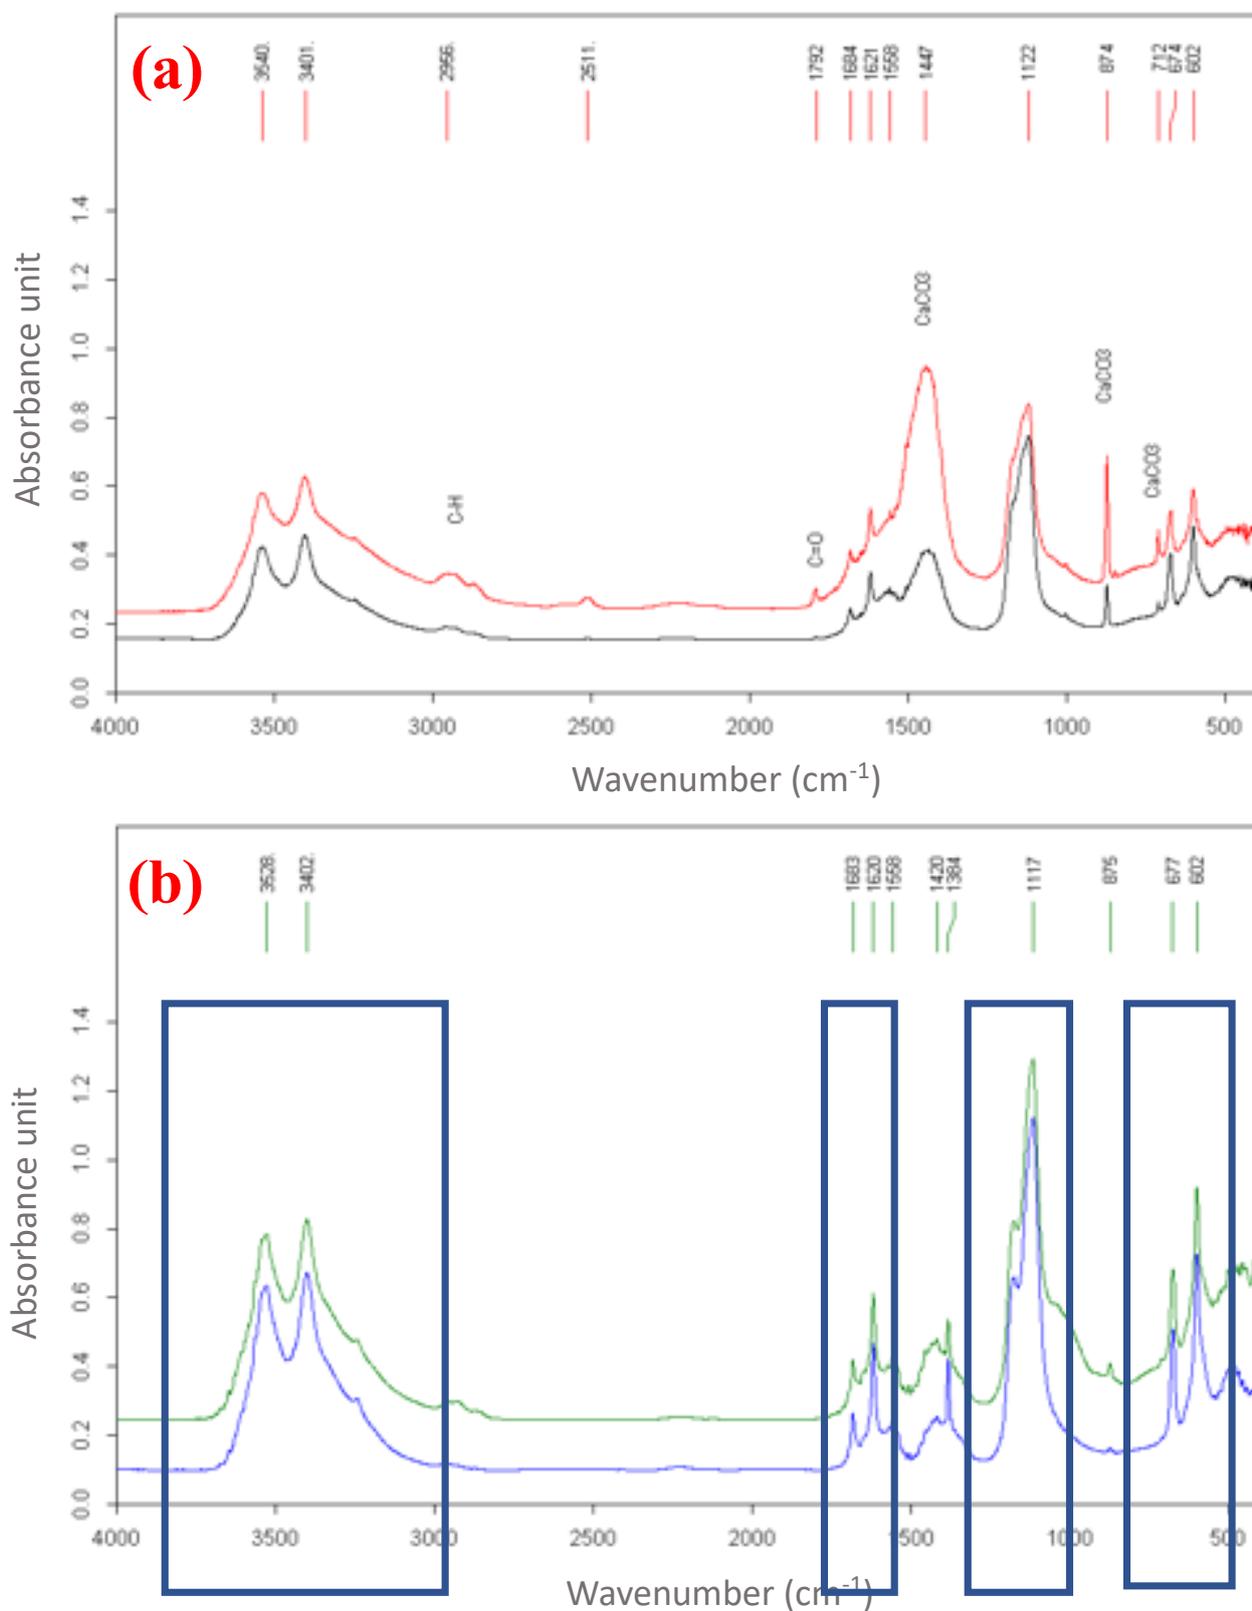
Figure 8. FT-IR spectra (4000–400 cm⁻¹; Globar source and deuterated triglycine sulfate, DTGS, detector; 200 scans; resolution 2 cm⁻¹) of samples taken from (a) wall and (b) floor (CaCO₃ 875 cm⁻¹; CaSO₄ 607 cm⁻¹). The red/black and green/blue spectra in figure (a) and figure (b), respectively, are related to two different samples from wall (a) and floor (b). The blue boxes show the signals due to calcium sulfate.

The FT-IR analyses were conducted by putting the samples from the wall (Figure 8a) and floor (Figure 8b) on potassium bromide (KBr) tablets. The spectra (recorded in the range $4000\text{--}400\text{ cm}^{-1}$) confirmed the presence of calcium sulfate (by diagnostic peaks at $607, 1117, 1620\text{ cm}^{-1}$) in the product lying on the mosaic pavement (Figure 8b). The calcium carbonate peak (at 875 and 1384 cm^{-1}) was attributed to mosaic mortar, while the double peak at $3400\text{--}3500\text{ cm}^{-1}$ was due to a N–H simple bond in the compound.

The FT-IR analysis of the samples coming from the wall (Figure 8a) and floor (Figure 8b) showed that their hydrocarbon compositions were essentially similar. The possible reason for this was common contamination. In addition, the study of the FT-IR spectra also indicated that the sample coming from the floor contained only gypsum, whereas that coming from the wall also contained calcium carbonate, which was associated with the binder of the mortar that constituted it. Further, the FT-IR spectra also demonstrated the presence of possible compounds containing N–H: these compounds could be the same as those identified by NMR analysis and reported in the Supplementary Material, namely 1-methylheptylamine and decylamine.

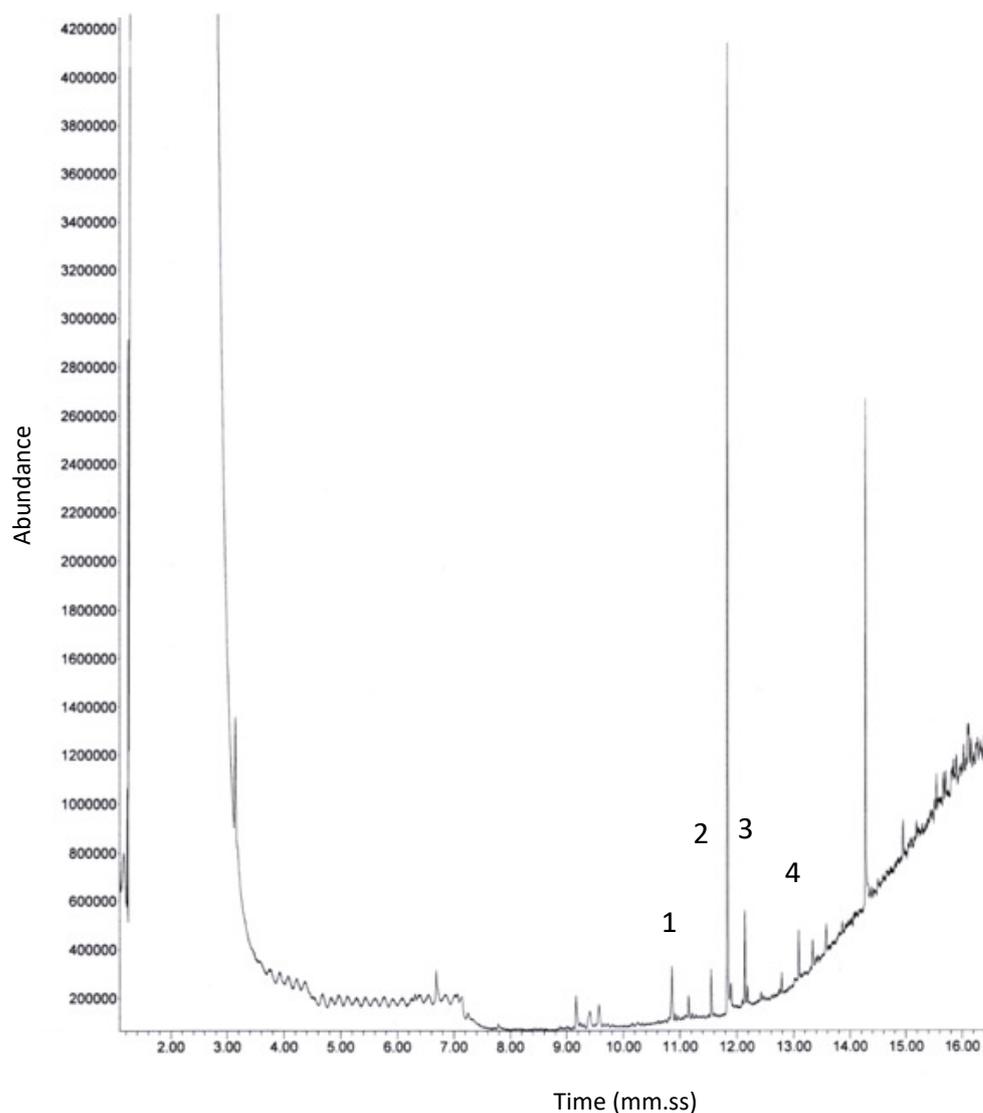
Figure 9. GC-MS chromatogram (fused-silica capillary column, HP-5MS; stationary phase SE54; 30 m × 0.25 mm I.D. and 0.25 μm d_f; T_{inj} 300 °C; splitless mode 30 s; T transfer line 200 °C; program: T₀ 120 °C, isothermal for 1 min, 30 °C min⁻¹ up to 200 °C, 5 °C min⁻¹ up to 230 °C, then 30 °C min⁻¹ up to T final 290 °C; carrier gas He; m/z from 50 to 700 at 70 eV.) of a pavement sample. Peaks: 1 hexadecane, 2 octadecane, 3 nonyl 2-propyl ester sulfurous acid, 4 tributylchloro-stannane. Mass spectra are shown in Figure S4 of the Supplementary Material.

Finally, the GC-MS analysis on a floor sample subjected to chemical degradation made it possible to identify the organic composition responsible for the yellow/brown color with greater accuracy. Figure 9 shows the Total Ion Current (TIC) chromatogram, whereas Figure S4 of the Supplementary Material shows the mass spectra of the identified compounds. The MS spectra confirmed the NMR results, namely the presence of low molecular weight hydrocarbons as octadecane and hexadecane, and the presence of sulfur as sulfurous acid, and the identification of complex compounds, such as ethyl 5-chloro-2-nitrobenzoate and tributyl-chloro-stannane.
