Preliminary Air Quality and Microclimatic Conditions Study in the Santuario della Beata Vergine dei Miracoli in Saronno (VA)

Abstract: In the present work, the microclimatic conditions (temperature (T), relative humidity (RH), and illuminance (I)), together with the air quality (both aerosol particulate matter (PM) and gaseous pollutants), were monitored to evaluate the environmental conditions inside the *Santuario della Beata Vergine dei Miracoli* in Saronno (VA), a masterpiece of the Italian Renaissance. For this purpose, dataloggers were used to carry out the T, RH, and I measurements, whereas an optical particle counter (OPC) was employed to perform the particle count and determine the concentration of the aerosol PM. Finally, diffusive passive samplers were used to determine the concentration of nitrogen dioxide (NO₂) and BTEX (benzene, toluene, ethylbenzene, and xylenes). To identify possible spatial variations, the studies were conducted at different sites and different heights in the Sanctuary. Particular focus was given to the Easter week during which liturgical services attracting large numbers of people were carried out. Additionally, a comparison with the outdoor valu

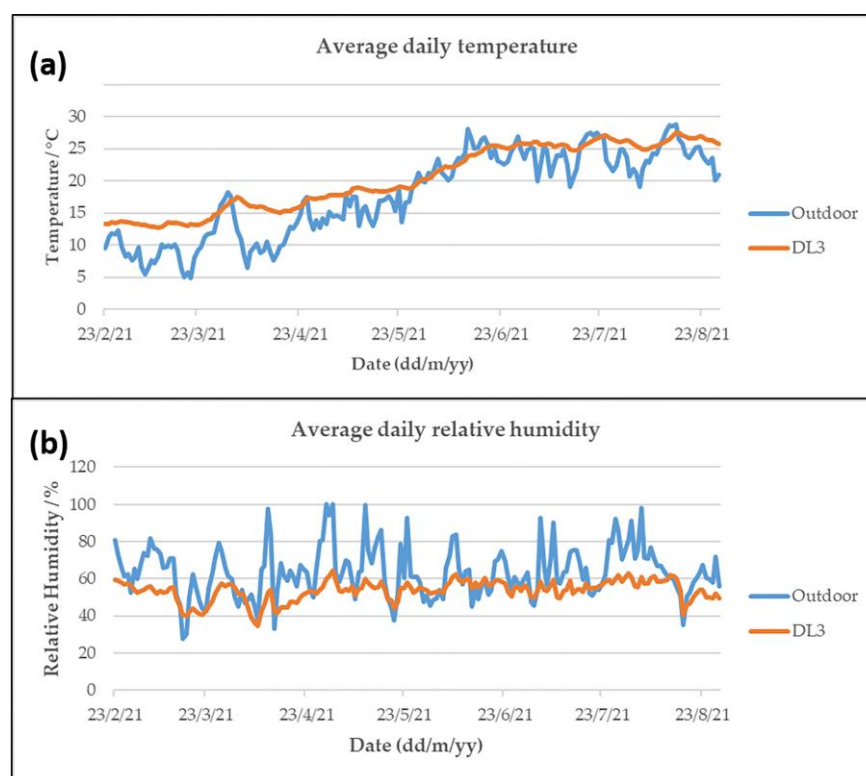
In Figure 1, the average daily temperature and relative humidity values are reported for DL3, along with a comparison with the outdoor values (ARPA Sensing Station, Saronno Santuario). Similar trends were observed for the other sampling sites and no significant differences in terms of the absolute values were found (Figures S1 and S2), indicating the presence of homogenous conditions within the Sanctuary.

Figure 1. (a) The average daily temperature and (b) average daily relative humidity values reported for DL3 compared to the outdoor trends.

The trends observed in Figure 1 show a lower indoor temperature and relative humidity variability than outdoors. On the one hand, with a view to avoiding abrupt variations, the fact of not being significantly affected by external events is positive for the conservation of cultural heritage. However, compared to the recommended ranges and maximum values indicated in the UNI 10829:1999 technical standard, there were significant days in which these limits were overrun (Table 3).

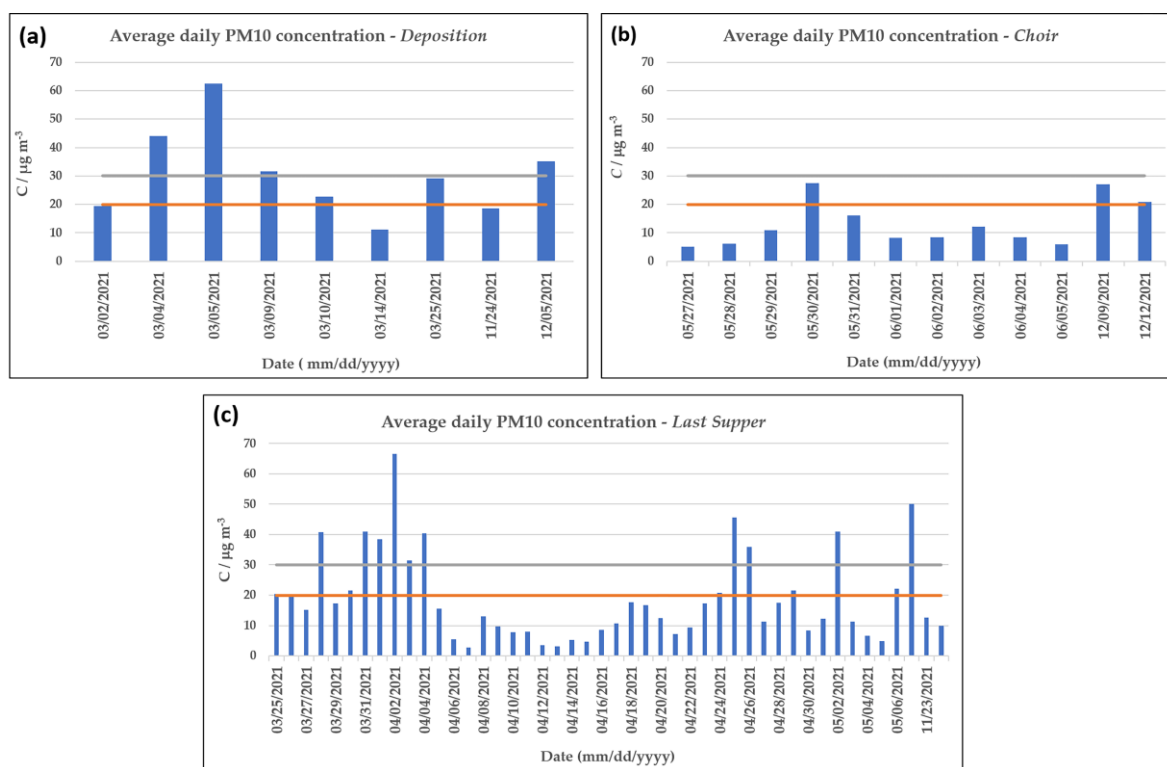
Figure 2. Average daily PM10 concentrations in the three sampling sites: (a) *Deposition*, (b) *Choir*, and (c) *Last Supper*. The orange and grey horizontal lines indicate the two maximum concentration limits indicated in the D.M. 10 May 2001.

For most of the monitored days, the PM10 concentration levels were below or within the specified range. However, occasional days of overrun were observed for the sampling sites in the two main later chapels, *Deposition* and *Last Supper*. Despite not performing the monitoring campaigns in parallel for the three sites, these preliminary results seem to

suggest that particulate matter is mostly concentrated on the ground floor of the Sanctuary and is not transported quantitatively at greater heights.

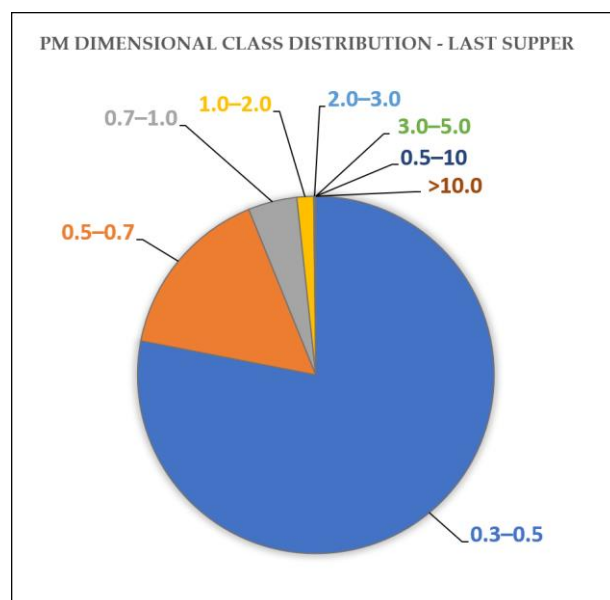
Figure 3. Dimensional class distribution of the particulate matter for the sampling site at the *Last Supper*. The ranges of the dimensional class are expressed in μm .

The results show the predominance of smaller particles ($0.3\text{--}0.5\ \mu\text{m}$) and an overall decreasing contribution to the total number of particles with increasing size. This is also reflected in the mass concentration values since PM1 (particles with an aerodynamic diameter of less than $1\ \mu\text{m}$) almost always accounts for more than 50% of the mass of PM10 (Table 5).

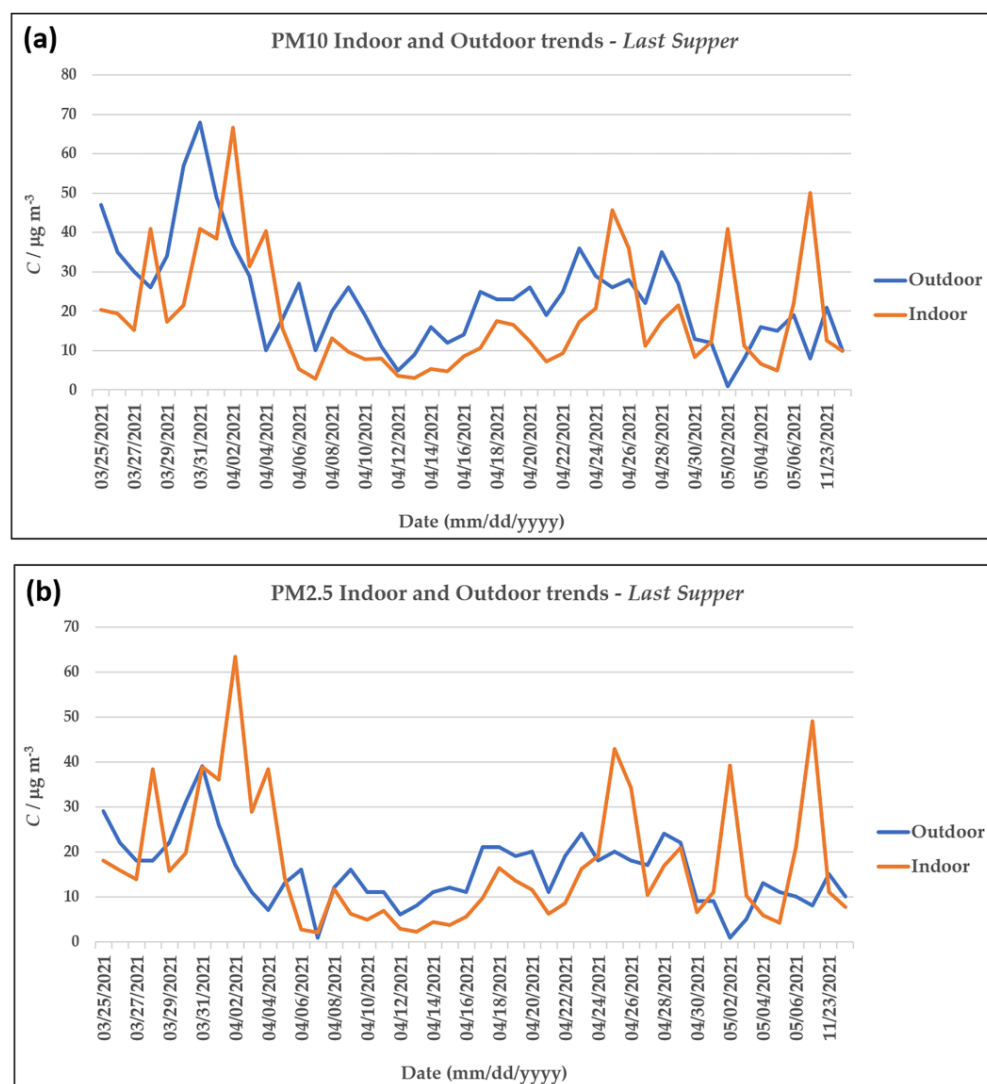
Figure 4. (a) The PM10 and (b) PM2.5 indoor and outdoor trends for the sampling site at the *Last Supper*.

For most of the sampling periods, the indoor values followed the outdoor trends whilst remaining at lower concentrations, highlighting a shielding effect of the Sanctuary, which prevents the penetration of a fraction of the particles. However, occasional days in which the indoor values were higher than the outdoor ones were observed. Almost all these cases coincided with weekends or public holidays, which are known to attract a greater number of visitors and worshippers. Indeed, the sampling conducted during the Holy Week (28 March 2021–3 April 2021) highlighted numerous days in which the outdoor concentrations were overrun for both PM10 and PM2.5.

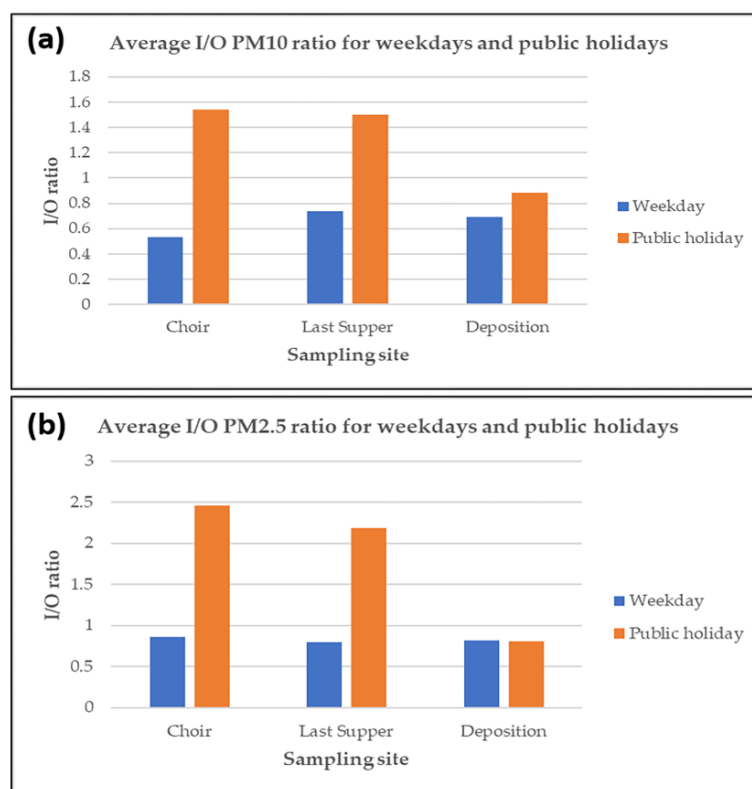
Figure 5. Average I/O ratio for (a) PM10 and (b) PM2.5 during the weekdays and public holidays for the three sampling sites.

Moreover, the indoor/outdoor (I/O) ratios were calculated for weekdays and public holidays (Figure 5). For the sampling sites at the *Last Supper* and *Choir*, a clear difference could be observed between the two different periods. The average I/O ratios were lower than 1 during weekdays, confirming a partial shielding effect of the Sanctuary, whereas they were higher than 1 during the public holidays, indicating the presence of specific sources to the days in question such as a higher influx of people, the use of candles, and incense burning. The effect was less pronounced for the sampling site at the *Deposition*; this was probably due to a minor impact of the sources on the days on which sampling was carried out for this site. Indeed, the monitoring campaigns were not carried out in parallel and the number of visitors and the use of candles and incense may have varied from day to day.

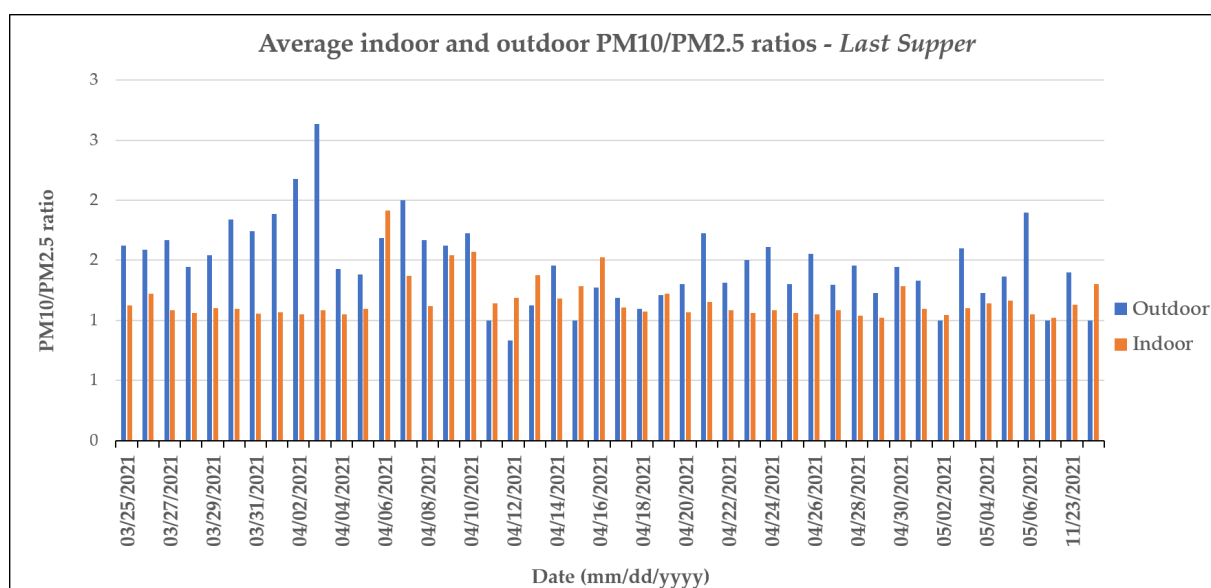
Figure 6. Average indoor and outdoor PM10/PM2.5 ratios for the sampling site at the *Last Supper*.

More in-depth analysis of the PM10 and PM2.5 values also enabled us to conclude that smaller particles are the ones that tend to accumulate indoors during public holidays and other festivities. Indeed, the PM10/PM2.5 ratios calculated for both the indoor and outdoor environments show that while these values were comparable during the weekdays, during the public holidays, the outdoor PM10/PM2.5 ratios were often higher than those indoors (Figure 6).

These differences were particularly evident at the *Last Supper* sampling site because the monitoring campaign was carried out partly during Holy Week, in which numerous festivities and religious ceremonies are concentrated. Indeed, the results showed that on the same days in which the indoor concentrations were higher than those outdoors, the difference between the PM10/PM2.5 ratio increased in favor of the outdoors. This suggests that the transport of larger particles from the outdoors to indoors is limited compared to the smaller ones, which tend to accumulate in closed spaces, leading to higher average indoor daily concentrations of particulate matter.

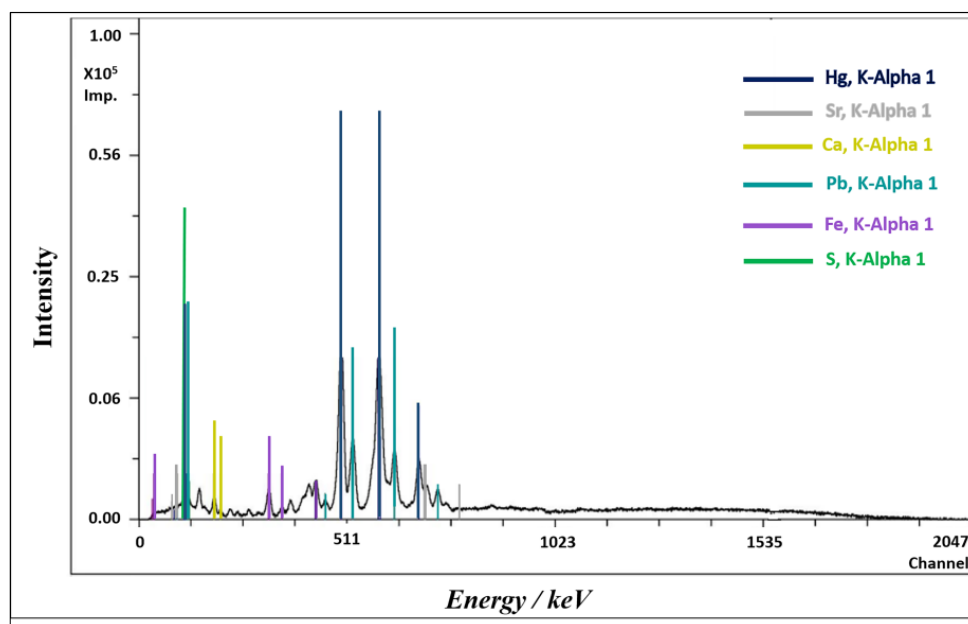
Figure 8. X-ray fluorescence spectrum of the wooden sculptural group.

Preliminary analyses on the conditions of some of the wooden sculptures present in the two main chapels of the Sanctuary were carried out using X-ray fluorescence (XRF) directly on the works of art and scanning electron microscopy coupled with energy-dispersive X-ray spectroscopy (SEM-EDX) on the dust deposited on the sculptures. This enabled us to establish the presence of degradation phenomena originating from poor indoor air quality and microclimatic conditions. Indeed, the X-ray fluorescence spectra highlighted the presence of cinnabar (HgS) as the main pigment used to decorate the sculptures (Figure 8), and the same elements (Hg and S) were identified in the EDX spectra of the retrieved dust (Figure 9).

The combined results of the two techniques indicate a poor state of conservation of the wooden sculptures. Considering that the powder was retrieved with the simple use of a brush, the fact that the same elements making up the substrate (identified thanks to the use of XRF) were also found in the deposited powder highlights the fragility of the artifact. The partial detachment of the pigment that was observed could be due to the chemical–physical interaction between the substrate and the deposited particulate matter, the degradation induced by the poor microclimatic conditions and air quality highlighted in the study, or a combination of both.

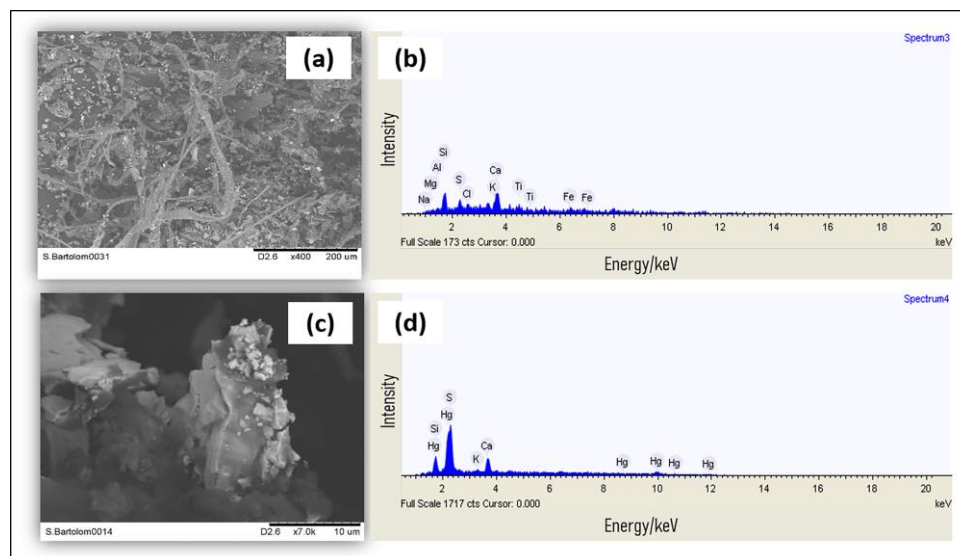
Figure 9. (a) SEM image of the dust deposited on the wooden sculptures (area = 0.80 mm × 0.60 mm, 400× magnification). (b) EDX spectrum of the image presented in (a). (c) Point image of the dust deposited on the wooden sculptures (Area = 0.04 mm × 0.03 mm, 7000× magnification). (d) EDX spectrum of the image presented in (c). Experimental parameters: accelerating voltage = 15 kV; working distance = 6500 µm; emission current = 65 mA; acquisition time = 150 s.

SEM analysis of the dust deposited on the wooden sculptures highlighted the presence of all the main constituents of atmospheric dust [27] including magnesium, sodium, calcium, chlorine, silicon, potassium, and iron. However, point analyses at greater magnifications enabled the detection of mercury, which is an element that is hardly ever found in concentrations above the instrumental SEM-EDX detection limits in atmospheric dust. The presence of this element is most certainly derived from the underlying substrate, which is represented by the wooden statue, highlighting the partial detachment of the pictorial film.

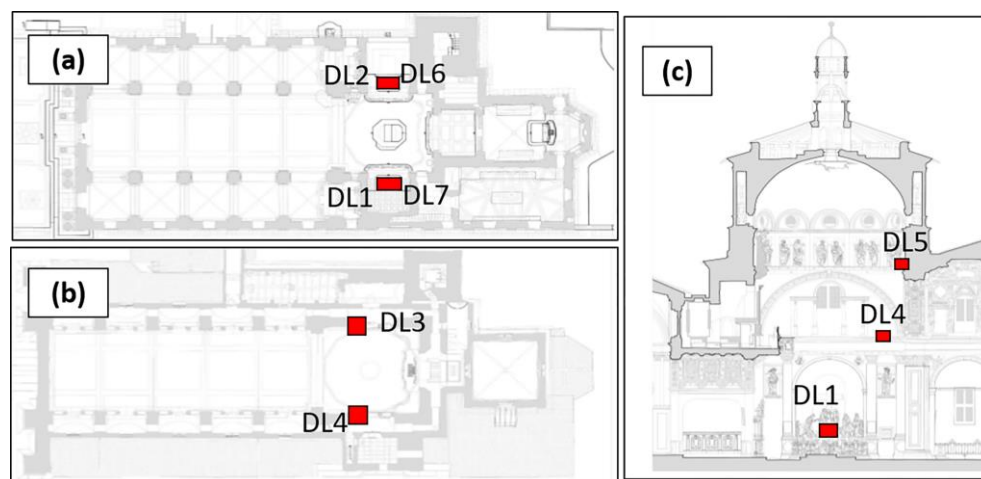
Figure 10. The floor plans and sections of the sanctuary showing the placement of the dataloggers: (a) Ground floor plan, (b) first floor plan, (c) right-side section (*Deposition*).

A total of seven dataloggers were used in this study (DL1–7), five measuring temperature and relative humidity (DL1–5), and two measuring illuminance (DL6–7). The instruments were placed in five different sampling sites and at three different heights in the Sanctuary (Figure 10). On the ground floor, dataloggers were placed close to the two main lateral chapels hosting the wooden sculptural groups *Last Supper* and *Deposition*. On the first floor, the instruments were positioned on the two ledges directly above the chapels, and on the second floor, one datalogger was placed on the side of the dome. Table 7 summarizes the locations and parameters monitored by each of the dataloggers.

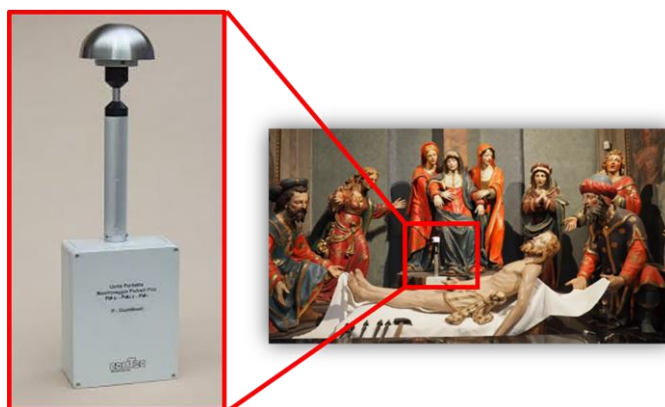
Figure 11. P-Dust Monit positioned in one of the main chapels close to the sculptural group of the *Deposition*.

An optical particle counter (P-Dust Monit, conTec Engineering Srl, Milano, Italy) was employed to monitor the particulate matter concentrations (Figure 11).

The aerosol particles were aspirated with a constant-flow pump, which sucks in air through a radially symmetrical probe and conveys it into a chamber where they are individually hit by a laser light beam. The energy reflected by each particle, which is proportional to its size, is measured by a high-speed photodiode that outputs both the counting and dimensional characterization signals. The measurement sampling range was between 0 and 1000 $\mu\text{g m}^{-3}$ with a sensitivity of 0.1 $\mu\text{g m}^{-3}$. Measurements were performed in real-time with a detection every 60 s.

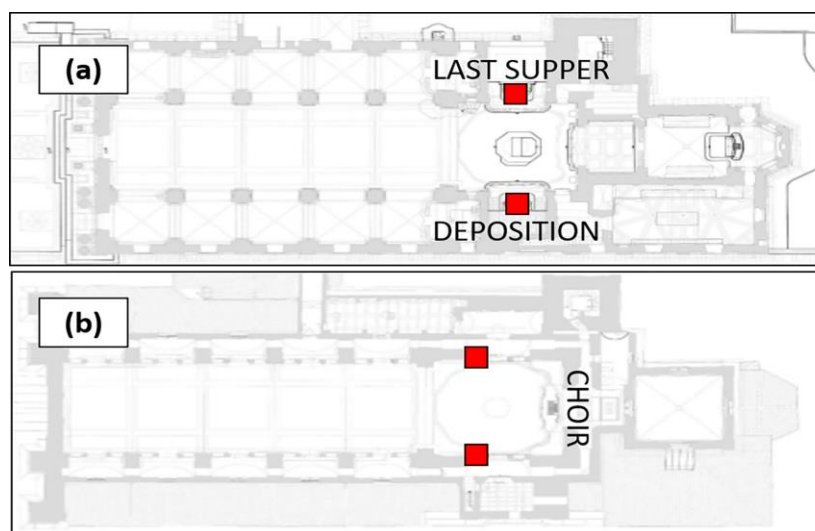
Figure 12. Planimetry of (a) the ground floor and (b) the first floor showing the three sampling sites.

The particles were classified into eight different dimensional classes (0.3–0.5 μm ; 0.5–0.7 μm ; 0.7–1.0 μm ; 1.0–2.0 μm ; 2.0–3.0 μm ; 3.0–5.0 μm ; 5.0–10 μm ; >10 μm) and PM concentrations were expressed as PM10, PM2.5, and PM1. The campaign was carried out between 2 March 2021 and 12 December 2021, in which the P-Dust Monit was placed alternatively at three different sampling sites: the two main lateral chapels (*Deposition* and *Last Supper*) and the *Choir* on the first floor (Figure 12).

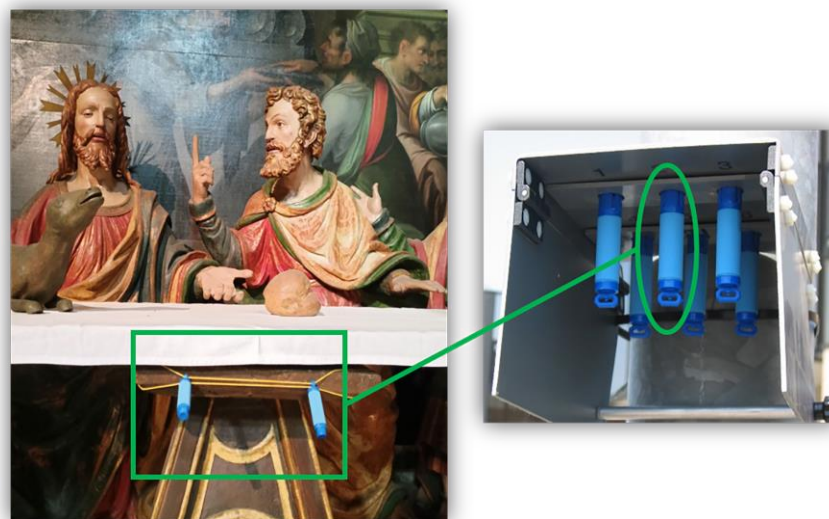
Figure 13. Diffusive passive samplers positioned in one of the main chapels close to the sculptural group of the *Last Supper*.

Passive samplers, RING[®] radial diffusive devices purchased from Aquaria (Aquaria Srl, Milan, Italy), were used for pollutant sampling (Figure 13) according to NIOSH methodologies no. 1500 for BTEX and no. 6014 for NO_2 . The devices were positioned at the same sampling sites chosen for the monitoring of PM (Figure 3). Nitrogen dioxide was sampled from 23 March 2021 to 2 April 2021 (*Deposition* and *Last Supper*) and from 14 December 2021 to 28 December 2021 (*Deposition*, *Last Supper*, and *Choir*). Instead, BTEX were sampled from 23 March 2021 to 2 April 2021 (*Deposition*).
