Article

Postmortem Analysis Using Different Sensors and Technologies on Aramid Composites Samples after Ballistic Impact

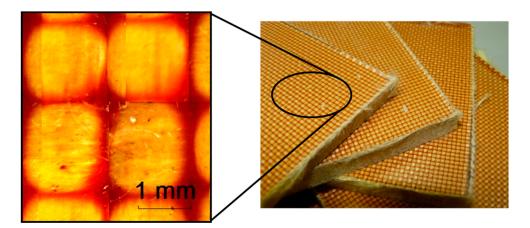
Figure 1. K129 aramid composite used in this work and description of the size of the fibres.

Aramid composite material used in this work is shown in Figure 1. The scale presented gives an idea of the size of the fibre in the compound and leads to a more macroscopic analysis of the induced damage.

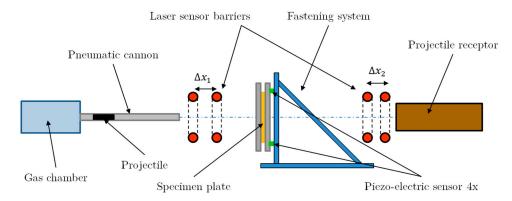
Figure 2. Experimental impact setup description.

The plate fixation device is a rigid structure that allows the secure placement of the specimen. Two steel frames fasten the sample in the perimeter, allowing an effective impact area of $100 \times 100 \text{ mm}^2$. This structure is close enough to the cannon muzzle to ensure the normality of the impact and placed in the centre of the plate.

Four piezoelectric force sensors (9011A Kistler) are used to measure the global force induced by the projectile on the target during impact. These sensors are fixed over the plate holder (Figure 3) and allow measuring the dynamic force along the impact velocity direction. The range of the maximum force that the sensors system can measure is 60-80~kN ($15\pm5~kN$), and the natural frequency is 65~kHz for each sensor. The four sensors are coupled to an amplificatory device.

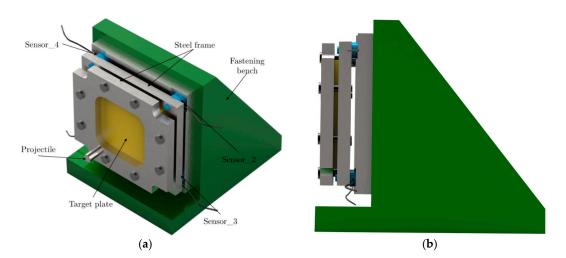
Figure 3. Target elements locations. (a) Perspective view; (b) Lateral view.

Figure 4. Dimensions of the projectiles for impact. (a) Conical projectile; (b) Blunt projectile. Dimensions in mm.

The structural support has been designed by Kistler and presents a high stiffness and yield stress ($\sigma_y \approx 850$ MPa) to avoid bending during an impact event. The mass of the complete structure is close to 40 kg (Figure 3).

projectile is 12.8 mm which is slightly smaller than the diameter of the barrel, to avoid the use of the sabot. The dimensions of the two projectiles are shown in Figure 4.

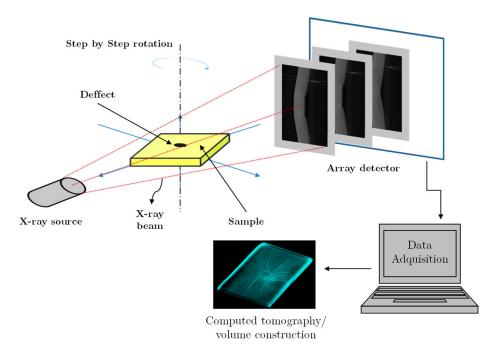
Figure 5. Computerised micro-tomography (CT) process scheme for measurement and acquisition.

Computerised micro-tomography (CT-scan or CT) is a powerful technique which consists of X-Ray scanning axial images of high quality and precision. An X-ray beam is projected on the sample to be analysed, and part of the radiation that has not been absorbed by the object is collected by detectors like a spectrum. A data acquisition system transforms the data obtained by the sensors into digital images. From this, a grayscale voxel image that depends on the number of electrons that has been absorbed by the object is obtained. Greyscale is limited by white colour, associated with undamaged material, and black colour, due to a change in density because of the presence of air as a result of breaks or defects. A scheme of a CT process is shown in Figure 5.

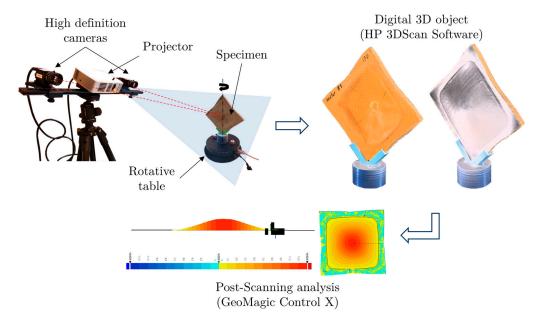
Figure 6. 3D scanner equipment to measure permanent deformation on samples.

As part of the post-processing of the scan, final shape representation is exported to the GeoMagic Control X^{TM} software that allows the display and quantification of dimensions, superficial defects, wear and tear compared with the no tested specimen, among others. In our case, it allows us to determine the induced deflection in the plate due to the type of projectile and impact velocity. A scheme of the scanning process is represented in Figure 6.

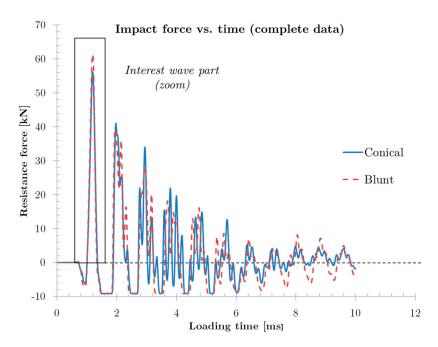
Figure 7. Resistance force history recorded using piezoelectric sensors for blunt and conical projectile (impact velocity v = 174 m/s).

In Figure 7 is showed the force history transmitted by the plate during the impact process and recorded using the four piezoelectric sensors for both projectiles impacting at 174 m/s. The represented wave is the sum of the individual waves of each sensor. The two curves in Figure 7 are quite similar as it is a non-perforation test using two different projectiles with the same mass. Therefore, because in these cases where the projectile does not produce complete perforation on samples, the plate absorbs most of the impact energy (around $454 \, \text{J}$ at $V = 174 \, \text{m/s}$) through failure mechanisms.

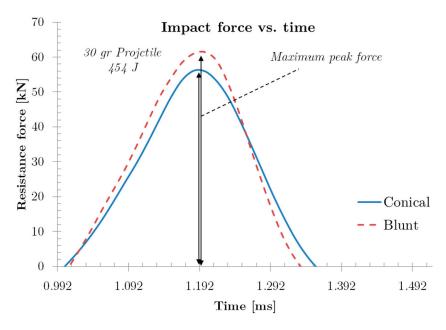
Figure 8. Detail of peak force obtained from resistance force history.

The most remarkable part of this figure is the first peak (shown in detail in Figure 8), corresponding to the time when the impact takes place; the rest of the curve history represents wave reflections due to little rebounds of the plates and frame on the sensors.

As mentioned, all the projectiles analysed in this work have the same mass, although the nose shape may be different. Curves represented in Figure 8 for projectiles with similar impact energy lead to different maximum impact force peak due to the different shape nose. Blunt projectile presents higher values ($F_{impact} = 62$ kN) than the conical one ($F_{impact} = 56.0$ kN). The maximum peak force occurs when projectiles transferred all kinetic energy to the plate. The time amplitude of the force-time curve of the blunt projectile ($\Delta t = 0.333$ ms) is smaller than for the conical projectile ($\Delta t = 0.388$ ms), this may indicate lower overall plate deformation as will be shown below.

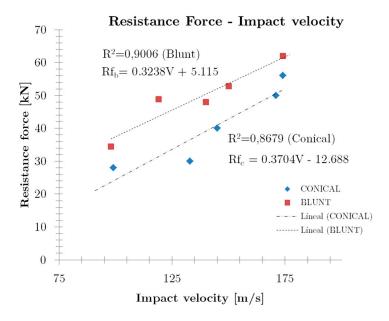
Figure 9. Impact velocity and resistance force comparison for both projectiles.

A correlation for the impact velocity with the maximum peak force from each test, obtained using the piezoelectric sensors, is presented in Figure 9.

The results for the impact range considered have been adjusted to a linear trend for every nose-shape. The correlation coefficients (R-value) are $R^2 = 0.9006$ and $R^2 = 0.8679$ for the blunt and conical case, respectively, representing a good (and adequate) correlation with experimental values, as can be seen in Figure 9. Although both slopes are quite similar, resistance force for any impact velocity is always lower in the conical case, due to its greater penetration power than the blunt projectile, reducing the stiffness of the plate and producing a lower peak force for the same impact load.

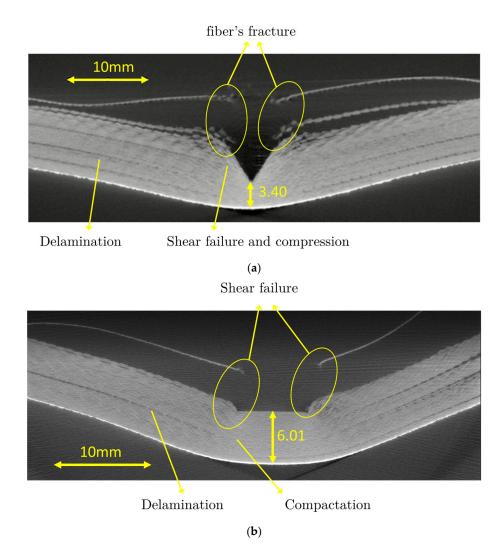
Figure 10. Tomography of different plates impacted to 454 J ($V_o = 174 \text{ m/s}$). (a) Conical projectile test; (b) Blunt projectile test.

The failure mechanisms and the morphology of the penetration process have been analysed through computed tomography, described in Section 2.3.1. Figure 10 demonstrates the capacity of this technique to report, in a non-destructive mode, the internal damage of the specimen after impact. These images are taken close to the impact zone, where the most significant penetration of the projectiles is observed. The high-resolution images allow distinguishing delamination, ruptures and crushing.

According to Min et al. [35], the region where delamination is most widespread is the area where the impactor stopped, which is the last penetrated layer. Thus, the delamination is most notable with the conical projectile where the penetration into the specimen is higher than the blunt, Figure 10a.

Moreover, conical projectile leads to higher layer breakage compared to the blunt-shaped projectile, Figure 10b. In the first layers at the impact zone, higher delamination is found for the conical projectile. However, in the case of the blunt projectile, fibre breakage of the first two layers is caused by pure shearing. This statement is commonly observed in the literature [18] due to the geometry of the projectile. Crushing of the fibres along the generatrix of the tip cone is caused by the conical projectile. For the blunt projectile, Figure 10b, compression and crushing of the layers in the impact zone along the thickness of the specimen is found. For the case of conical shape, a thickness reduction of 54% was

observed due to penetration and compressing action of the projectile. On the other hand, as stated above, the blunt projectile does not produce a remarkable penetration, providing a reduction in the thickness of 18% due to layers compression principally. This thickness reduction generates a residual stiffness higher for the blunt projectile than the conical projectile.

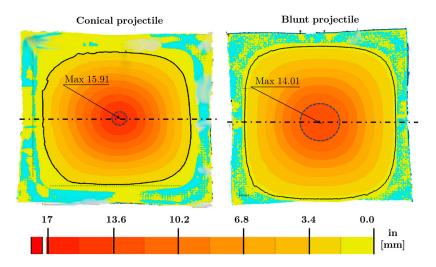
Figure 11. Impact direction displacement map. (left) Conical and (right) blunt projectile ($V_0 = 174 \text{ m/s}$).

Figure 11 shows the displacement map in the projectile impact direction on plates impacted by a conical and blunt projectile at 174 m/s. In all cases, the maximum displacement is obtained at the impact zone, close to the specimen centre, decreasing to the encastred perimeter. For the velocity presented, these maximum values are 15.91 and 14.01 mm for the conical and blunt projectiles, respectively. Due to the characteristics of the problem, symmetric patterns are displacement is achieved. Contour lines indicate higher displacement gradient for the conical tip-shape. For a particular impact velocity, the larger area of deformation is obtained with the blunt projectile (marked with the continuous black line built thanks to by the GeoMagic Control XTM software), being very close to the encastred boundary.

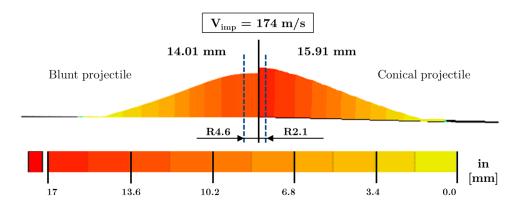
Figure 12. Results of the permanentback face deformation (PBFD) measured with GeoMagic Control X^{TM} from the 3D scan.

The 3D scanner allows analysing any virtual cut section of the specimen through the thickness. In particular, virtual sections by the dotted line (through thickness plane) sketched in Figure 11 are presented in Figure 12 for a better comparison. It can be observed that the specimen impacted with a blunt projectile has a lower displacement gradient and a more permanent deformation than the conical one, and it is flattened due to the morphology of the projectile, being less pronounced than with the conical projectile. The maximum deflection, reached in the conical case, is obtained strictly at the projectile/plate impact point; meanwhile, the blunt projectile presents an almost constant value close to the impact zone.

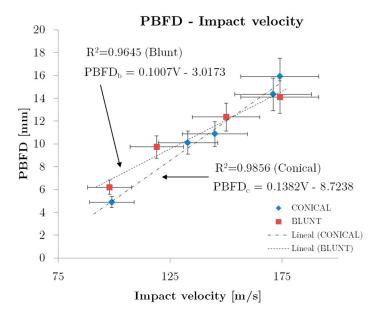
Figure 13. Back Face Deformation—Impact velocity correlation.

A correlation between the permanent back face deformation and the impact velocity for both tip-shapes are shown in Figure 13. A linear dependence of the back-face deformation with the impact velocity for both projectiles can be observed. The correlation coefficients (R-Value) are 0.9645 for blunt and 0.9856 for conical, showing a good correlation of experimental values obtained with linear regression. Although both trends are very similar, the fitting line slope is slightly higher for conical projectiles than blunt ones due to the penetration power of this projectile.

In the author's opinion, this correlation for PBFD as a function of the impact velocity in conjunction with the resistance force versus impact velocity as presented in Figure 9, are of great interest to better understand the impact behaviour of aramid composite panels for personal protections in the impact energy range considered.

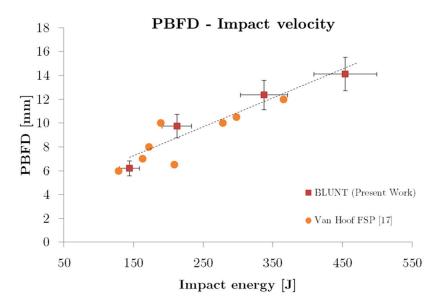
Figure 14. Comparison between existing data on literature and present work.

Although there are other works in the literature about ballistic impact testing on aramid composites, there is a wide variety of impact range (mass, velocity tip-shapes), types of aramid and specimen dimensions that complicate comparisons with the present results. However, within the limited literature for the blunt projectile, the results have been compared with the work developed by Van Hoof [17], see Figure 14. In that work, the dimensions of the specimen, number of composite layers, and the boundary conditions are similar, although the projectile used (FSP) has a reasonably similar geometry to the blunt projectile, the size and the aspect ratio is lower, hence the possible differences that can be observed. Both results present similar trends for the back face deformation (PBFD) in the impact energy range studied, where the PBFD increases linearly in all cases with energy, with a similar slope considering a linear regression.
