Communication

Monitoring of Large Diameter Sewage Collector Strengthened with Glass-Fiber Reinforced Plastic (GRP) Panels by Means of Distributed Fiber Optic Sensors (DFOS)

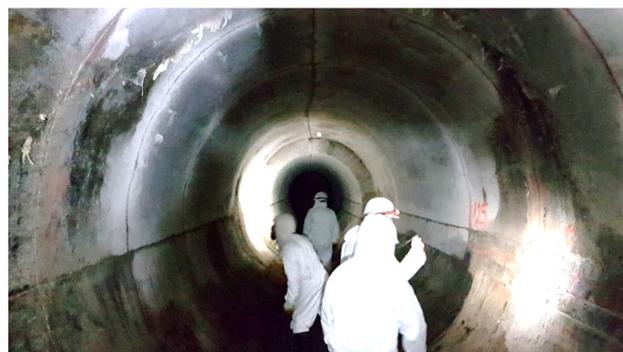
Figure 1. The view of Burakowski concrete collector during its technical inspection.

The Burakowski sewage collector is an important element of the Warsaw sewage system. It was built in the 1960s using the mining method in a concrete casing, with segments of lengths from 2 to 3 m and an internal diameter of approximately 3 m, buried under the ground surface at a depth of 4.5 to 7.5 m (Figure 1). Its purpose is to transport sewage from the part of Warsaw situated on the left bank of the Vistula River to the transmission system that subsequently transports it under the river to the sewage treatment plant. Its calculated capacity is about 12 m³/s (the actual recorded capacity of the collector may be higher during heavy rainfall).

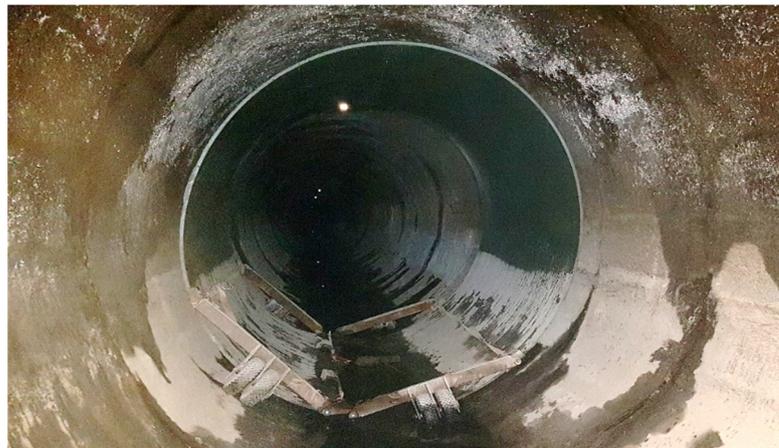
Figure 2. GRP test panel inside a collector before installation.

In 2019, a decision was made to retrofit a 4.8 km long section of the collector using non-circular GRP modules and relining technology [3]. The interior of the collector was lined with 1600 modules of polyester resin panels, each 3 m long (Figure 2). The space between the panels placed inside and the existing inner walls of the collector was filled with a cement grout.

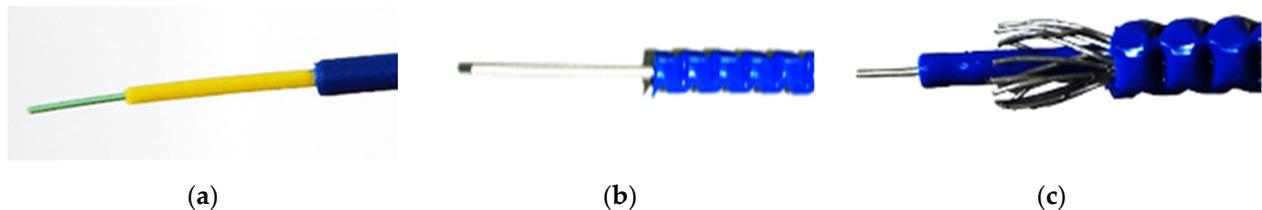
Figure 3. Examples of sensing cable designs: (a) with plastic coating; (b) with metal coating and single or multiple plastic coatings; (c) with metal coating and additional metal reinforcing elements and with single or multiple plastic coatings.

The key task preceding construction of the monitoring system was to select fiber optic elements used to measure strains. A popular and widely used market solution is layered sensing cables. A common feature of all commercially available solutions is their multi-layered designs (Figure 3).

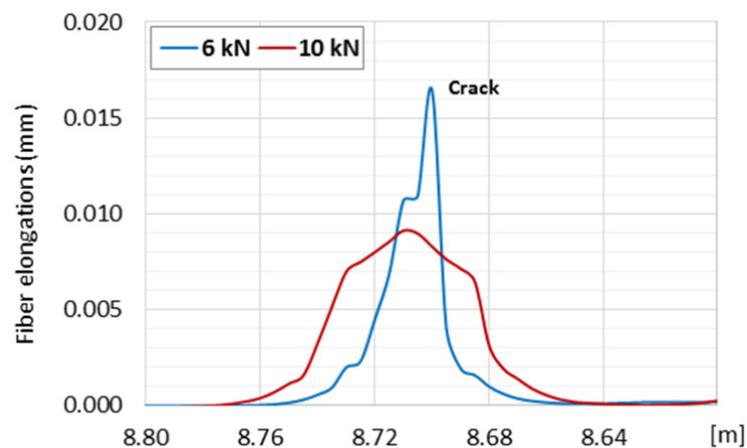
Figure 4. The effect of slippage inside layered sensing cable when measuring crack opening in concrete member under axial tension. As the load increases, the crack peak is reduced, instead of higher. Blue—force of 6 kN, Red—force of 10 kN. When measured correctly, an increase in force should result in increase in the measured strain peak.

Plastic (nonlinear) effects including slippage between intermediate layers but also yielding of steel components in the cable (responsible for mechanical memory of events) make it impossible to monitor the current deformation state of the structure, e.g., closing of cracks under the impact of external factors. Such characteristics of layered cables prevent their application for monitoring the strengthened collector described hereafter in the article.

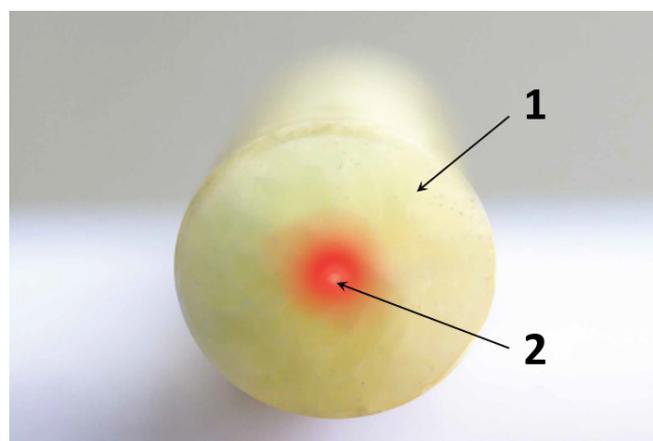
Figure 5. Cross-section of DFOS measurement sensor used for strain measurement. 1—monolithic core, 2—optic fiber [7].

The other possible solution is distributed fiber optic sensors (DFOS) designed specially to measure strains of the monitored structure. The sensors consist of a monolithic, composite core in which a measuring optical fiber in its primary coating is integrated during production process (pultrusion). There are no intermediate layers or external coatings, what allows for unambiguous, predictable transmission of strain from the surrounding material (e.g., concrete) to the measuring fiber inside the core. Figure 5 illustrates a monolithic cross-section of a typical DFOS strain sensor.

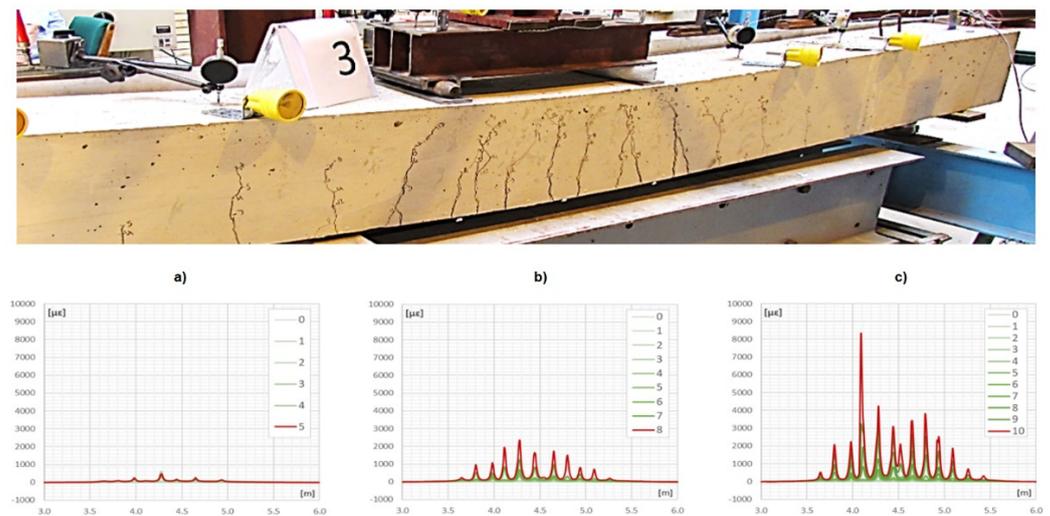
Figure 6. Crack analysis in reinforced concrete beam using monolithic DFOS sensors. Sensor was embedded inside the beam at the height of main bottom reinforcement (courtesy by [8]). Graphs show strains development during increasing the load (local peaks correspond to cracks near to the bottom surface); (a) initial phase; (b) middle phase; (c) final phase.

Figure 6 shows the example results of crack analysis based on indications of DFOS monolithic sensors during 4-point bending test of a reinforced concrete beam. Local strain extremes (peaks) registered in length domain correspond to all the cracks, which were also clearly observed by unarmad eye. Three plots show the strain distributions for three selected load steps during research: in the initial, middle and final phase (before beam failure). The increase in load caused the increase in the measured strain peaks without any smoothing caused by the slippage effect, which has been observed previously inside the layered sensing cable.

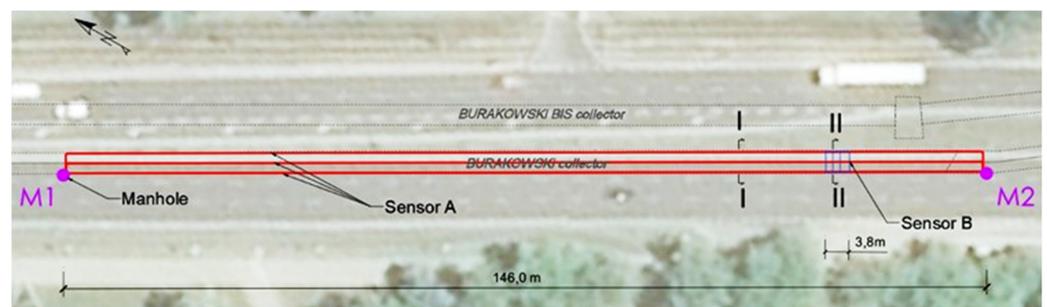
Figure 7. Sensor locations along the collector.

The monitoring covered the renovated segment of the Burakowski sewage collector, specifically the section where the structural damage was most significant. The length of the pilot section equipped with sensors was about 146 m (Figure 7). The sensors were brought to the ground surface through two inspection chambers M1 and M2 (Figure 7) located in the road lane at opposite ends of the installation to allow placement of the measuring equipment outside the collector.

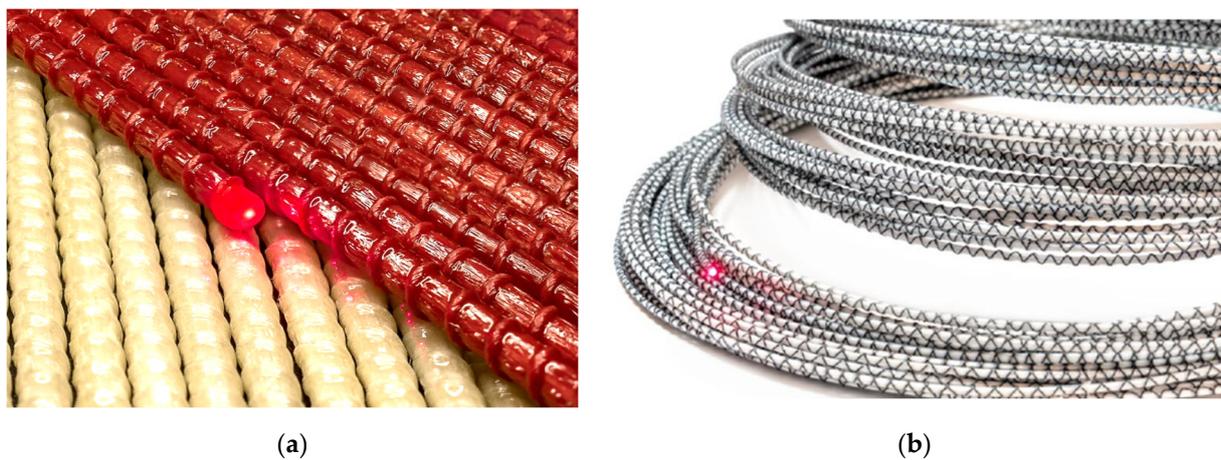
Figure 8. Sensors used in the monitoring system. (a) Sensor A—EpsilonRebar, (b) Sensor B—EpsilonSensor [8].

Two types of sensors were installed in the monitored section—see Figure 8. The first one (type A—EpsilonRebar) is constructed from glass-fiber core with a measuring range of $\pm 2\%$. The second one (Sensor B—EpsilonSensor) is based on a polyester fiber core with a measuring range of $\pm 4\%$. The optical fiber is fully integrated with the sensors' core during their production process (pultrusion).

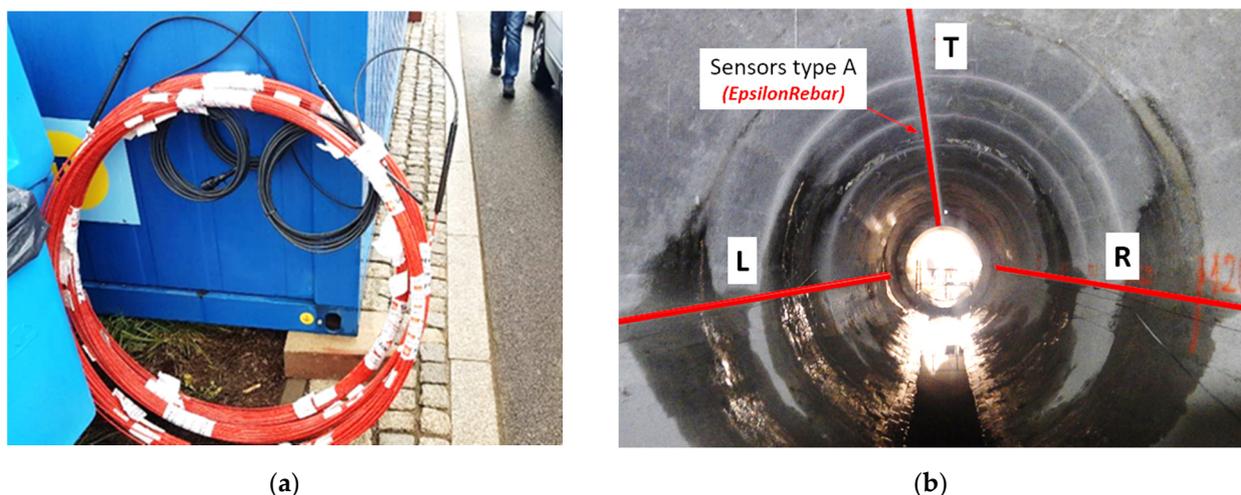
Figure 9. (a) EpsilonRebars delivered to the site in coils; (b) arrangement of DFOS sensors (type A) in the cross section of the collector.

All sensors with appropriate lengths were delivered to the site in coils (Figure 9a). Three longitudinal measurement lines were installed along the axis of the collector: L, T and R (at 9, 12 and 3 o'clock positions respectively—Figures 9b and 10a). Sensors were placed in prepared longitudinal grooves with dimensions of approximately 8×12 mm (width \times depth), made in the wall of the existing collector. The grooves were finally filled with chemical anchor—see Figures 10b and 11.

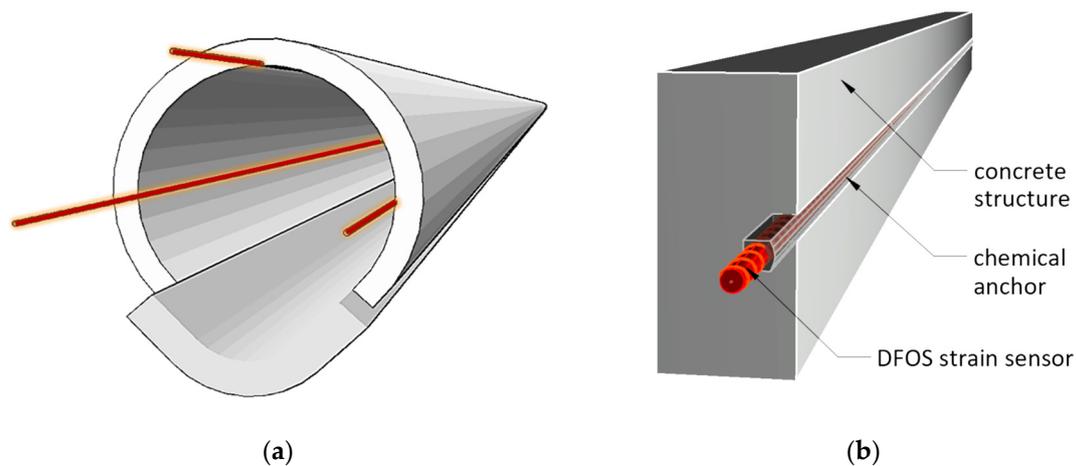
Figure 10. Spatial visualizations: (a) longitudinal sensors arrangement; (b) scheme of installation inside the groove filled with chemical anchor.

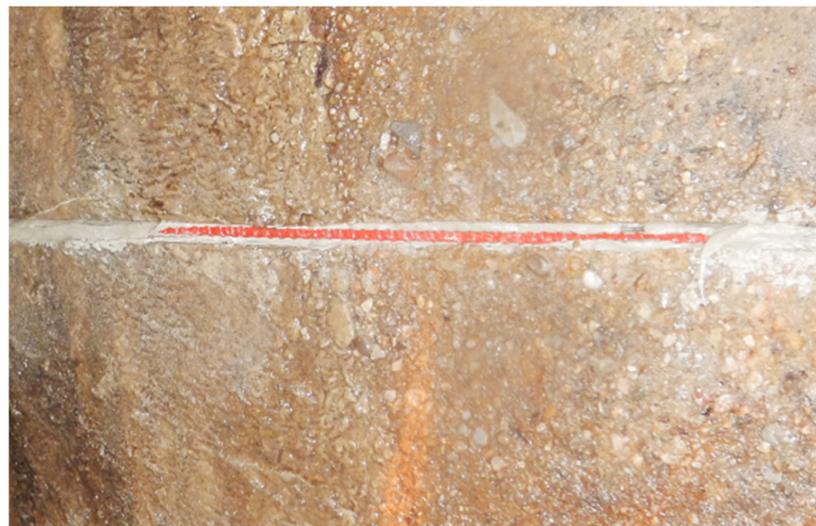
Figure 11. View of the sensor on the collector wall inside the groove during filling it with chemical anchor.

Sensors installed in grooves are protected from mechanical damage during installation of the GRP modules and properly integrated with the existing concrete casing.

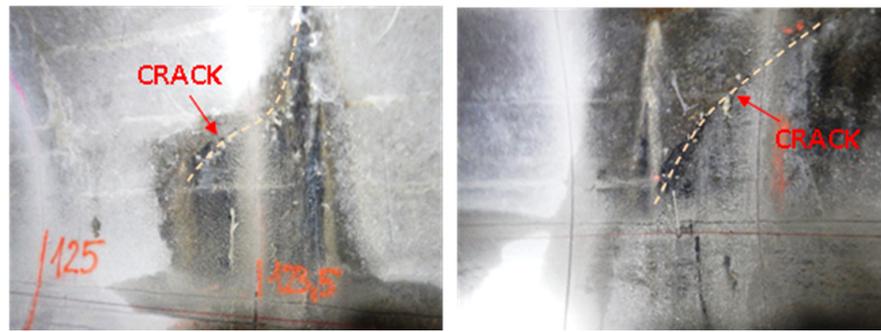
Figure 12. Examples of diagonal cracks of a collector concrete structure.

The other type of sensor—EpsilonSensor (B)—was used to measure circumferential strains between 120–125 m of the monitored section, where diagonal cracks in the collector walls were visible with an unarmed eye (Figure 12). EpsilonSensor with elastic modulus equal to $E = 3 \text{ GPa}$ is a flexible tool and could be freely and precisely shaped in the grooves located along the circumference in selected safety-critical cross sections. The measuring range of EpsilonSensor is equal to $\pm 4\%$ and allows to monitor even large cracks without risk of sensor breakage. A 62.6 m long sensor was installed on loops in four measuring sections (Figures 12 and 13). The sensor was installed in grooves similar to EpsilonRebars described before. Scheme of DFOS sensors arrangement in walls of the various section existing collector is presented in Figure 14: I—section outside the loops, II—intersection of sensors A and B.

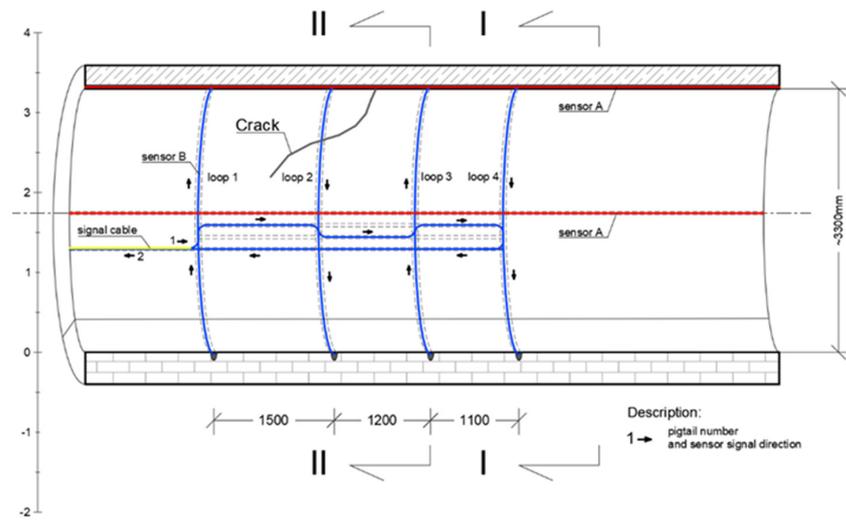
Figure 13. Scheme of DFOS sensors (type B) installation in the cracked section of collector.

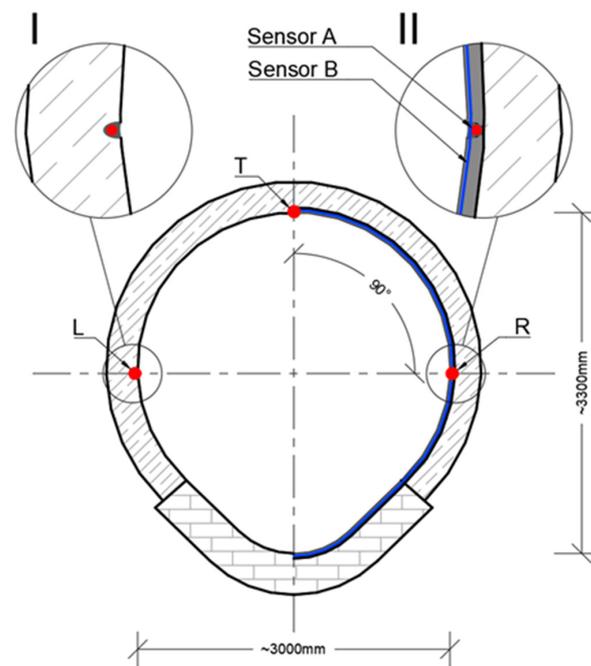
Figure 14. Scheme of DFOS sensors arrangement in walls of the existing collector. I—section outside the loops, II—intersection of sensors A and B.

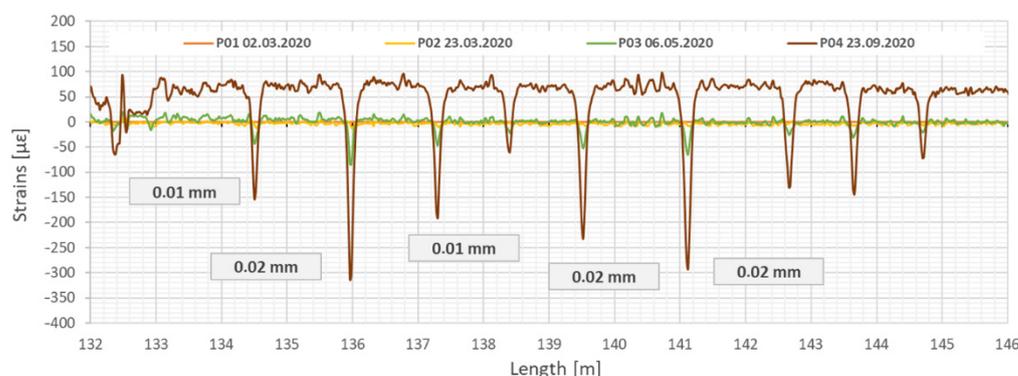
Figure 15. Strain profiles measured by sensor (T) along the test section showing the primary discontinuities in the concrete collector closing during strengthening process. Example section from 132 to 146 m. Measurement P01—after installation of GRP panels, P02—during grout injection, P03—after completed grout injection, P04—after filling the collector with sewage.

A particularly significant effect observed due to the DFOS measurements was revealing the original structure of the concrete collector casing, related to technological breaks during its construction. Increasing load on the concrete casing during the renovation works revealed cracks caused by technological breaks and changes in their widths were carefully analyzed during this process (Figure 15). Concrete casing sections originally constructed were from 2.2 to 2.9 m long. The application of monolithic fiber optic strain sensors allowed to identify all discontinuities in the collector structure and to observe their development over time (most of these cracks were undetectable by unarmored eye).

Figure 15 shows example results of measurements taken with longitudinal sensor located at the top (T) of the collector. Under the additional load related to strengthening process (including dead weight of GRP panels, grout injection and sewage during operation), the cracks were closing (decreasing their width). The observed changes were small (less 0.02 mm), but they still were clearly detectable.

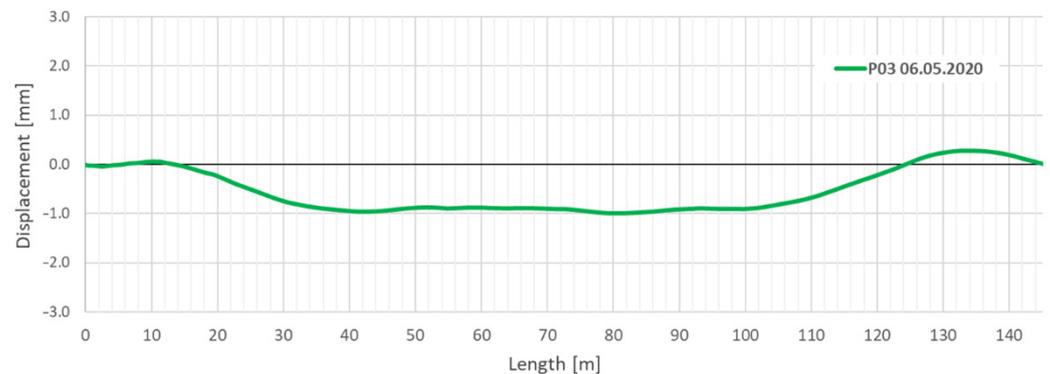
Figure 16. Relative vertical displacements (change in shape) of the collector after installation of GRP panels and grout injection.

Based on the strain measurements acquired from three lines of EpsilonRebars, vertical displacements of the collector caused by the strengthening works (including dead weight of the composite panels and mortar injection) were determined. The analysis was based on the trapezoidal method [13–16]. The main operation rule of this method is to divide the structure into the discrete sections (trapezoids) with the base equal to the spatial resolution of distributed measurements. The height of the trapezoid is equal to the distance between the upper and lower DFOS sensors. In the present case, strain values were obtained from the top (T) and arithmetic mean from left (L) and right (R) sensors (see also Figure 11). Deformations of individual trapezoids are calculated using only geometrical relationships and they are summed up over the length to obtain displacement profiles. This method does not require the knowledge on material properties of the monitored structure. Detailed drawings, equations and further explanations of the method applied are presented in paper [13].

The mid-length displacement (settlement) of the collector determined after the grout injection process relative to its ends was about 1 mm, as shown in Figure 16.
