# Characterization of Damage Progress in the Defective Grouted Sleeve Connection Using Combined Acoustic Emission and Ultrasonics

**Abstract:** The grouted sleeve connection is one of the most widely used connections for prefabricated buildings (PBs). Usually, its quality can have a significant impact on the safety of the whole PB, especially for the internal flaws that form during sleeve grouting. It is directly related to the mechanical performance and failure behavior of the grouted sleeve. Therefore, it is essential to understand the damage progression of the defective grouted sleeve connection. However, destructive testing is the mainstream measure to evaluate the grout sleeves, which is not applicable for in situ inspection. Therefore, this paper proposes a combined acoustic emission (AE) and ultrasonic testing (UT) method to characterize the damage progress of a grouted sleeve with different degrees of internal flaws under tensile loading. The UT was conducted before loading to evaluate the internal flaws. Additionally, the AE was used as the processing monitoring technique during the tensile testing. Two damage modes were identified: (i) brittle mode associated with the re

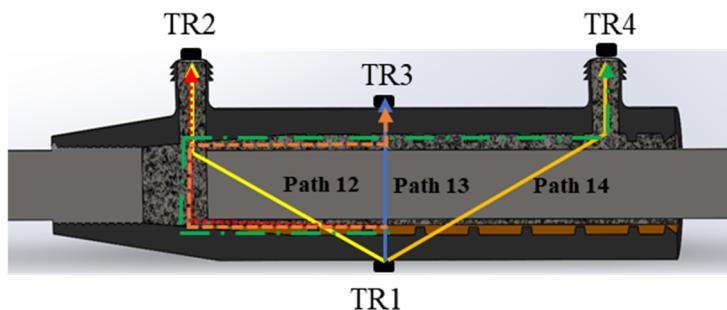
**Figure 1.** Grout defect detection system based on UT wave measurement.

In order to illustrate the mechanism of the ultrasonic-based method in the detection of internal flaws in the grouted sleeve, theoretical and numerical analysis were conducted in this section. The UT method is based on the propagation of an ultrasonic wave. The targeted objects (e.g., flaws, cracks, material change, deterioration, etc.) can disturb the ultrasonic wave propagation, which will reflect on the change in the UT signal. Though the mechanism is straightforward, the signal change could be caused by multiple factors, and the path of the wave propagation is varied. Therefore, we need to understand that the main reason causing UT signal changes is the internal flaw due to the lack of grouting, which is essential to determining the proper UT wave propagation path and feature. Firstly, three assumptions were made: (i) the path of ultrasonic wave propagation is straight; (ii) the

only first arrival wave packet was considered; and (iii) scattering and absorption were ignored. Therefore, to make sure that the UT wave can pass through the grout defect area, with consideration of the layout of the grouted sleeve, the arrangement of the transducers is shown in Figure 1. In this case, the transmission mode was adapted: each transducer was used as a transmitter and receiver. Four UT transducers with an application frequency of 200 kHz were attached. In order to illustrate the wave propagation, the excitation signal with a certain frequency signal was applied to the UT transducer 1 (TR1). The other three UT transducers and receivers were arranged on the surface and the grouting inlet and outlet of the sleeve forms multiple propagation paths for the UT waves through the defect area. In order to better detect the grouting defects of the sleeve, the propagation paths are mainly discussed as Path 12, Path 13, and Path 14, including reflection and refraction that occurred on the interface of different materials.

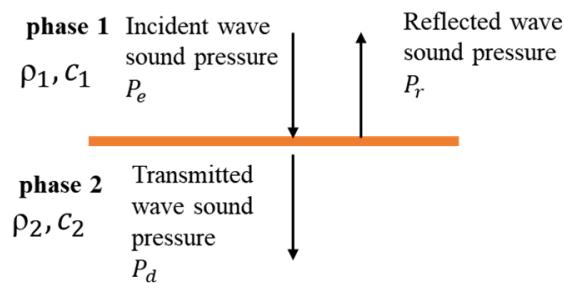
**Figure 2.** Calculation example: sleeve-plasticine interface.

where  $Z_i$  is the acoustic impedance of a material, in this case, the wave is transmitted from phase 1 to phase 2, which is represented as subscripts 1 and 2, respectively.  $\rho$  is the density,  $c$  is the velocity of longitudinal waves.  $R$  is the reflection coefficient,  $P_r$  is the reflected wave sound pressure, and  $P_e$  is the incident wave sound pressure.  $T$  is the transmission coefficient,  $P_d$  is the transmitted wave sound pressure. According to the calculation results in Table 1, most of the UT energy is reflected due to the larger reflection coefficient of the UT wave energy at each interface, and the change in the UT energy is the most obvious. To this end, the UT wave energy ratio can be used to quantitatively evaluate the defects. Most of the energy is reflected, the transmitted UT energy can be negligible. Therefore, the significant path of UT wave propagation is marked in Figure 1. For Path 13, the propagation mode is linear due to the vertical incident wave. However, the transmitted energy is relatively low. Both Path 12 and Path 14 can pass through the area with a flaw. However, Path 13 is longer than Path 12, which may introduce more complexity. Therefore, Path 12 is considered the most sensitive and best path.

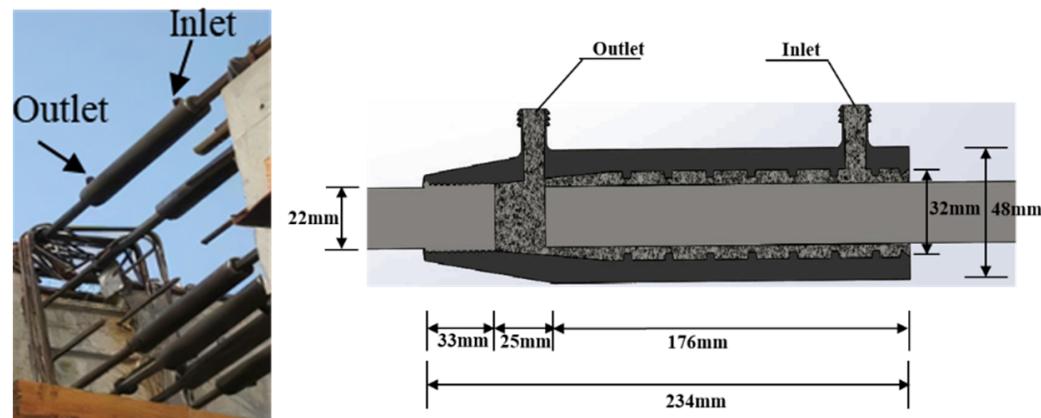
**Figure 3.** The details of the grouting sleeve.

The grouting casing often has horizontal defects due to irregular operations. Especially for the beam-column or beam-beam connection, the in situ grouting implementation is shown in Figure 3. The most commonly used grouting sleeve is modeled, and its detailed dimensions are shown in Figure 3. In order to simulate the internal flaws, artificial flaws were introduced by adding oily plastic clay material. Six models of grouting sleeves with different volumes of plastic clay were established, as shown in Figure 4, and one transducer was attached to the surface of the sleeve as a transmitter, and the other three transducers were receivers attached to the grouting inlet, outlet, and opposite surface of the transmitter, as shown in Figure 5. In order to simplify the model and reduce the computational cost, the transducer was not included in the model; instead, the averaged displacements over the transducer-contacted area were used to represent the input and output response.

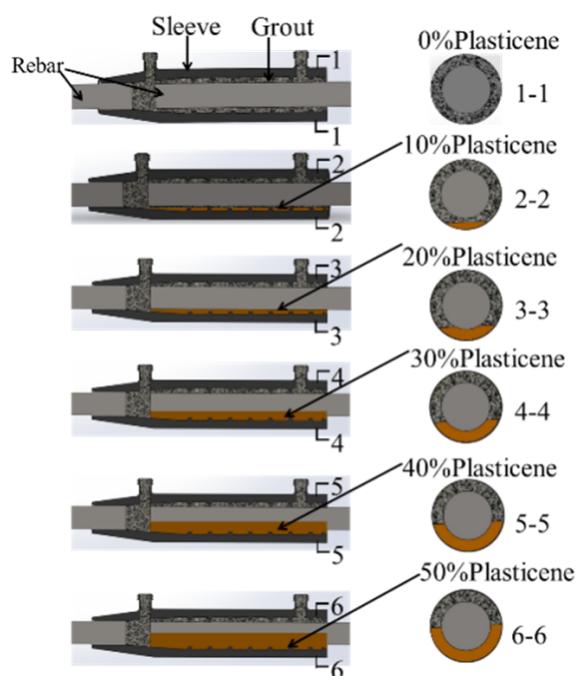
**Figure 4.** The grouting sleeve with different flaws.

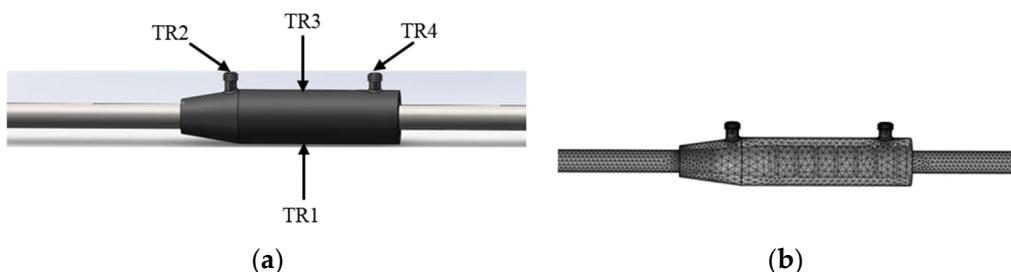
**Figure 5.** Numerical simulation: (a) FEA model and transducer setup; (b) meshing.

The numerical model was built using COMSOL Multiphysics 5.5 software. Table 2 lists the material properties. The mesh size of 0.162 mm and a time step of 0.25  $\mu$ s were adopted, respectively, to achieve the 400 kHz resolution of wave propagation. Five-cycle tone burst signals modulated by the Hanning window with a frequency of 200 kHz were used as excitation. The transducer was not considered in the model for simplification. Therefore, the amplitude of the displacement input over the transducer-contacted area of the excitation signal was selected to be 1 nm (the same magnitude as 1 volt of electrical excitation), see Figure 6.

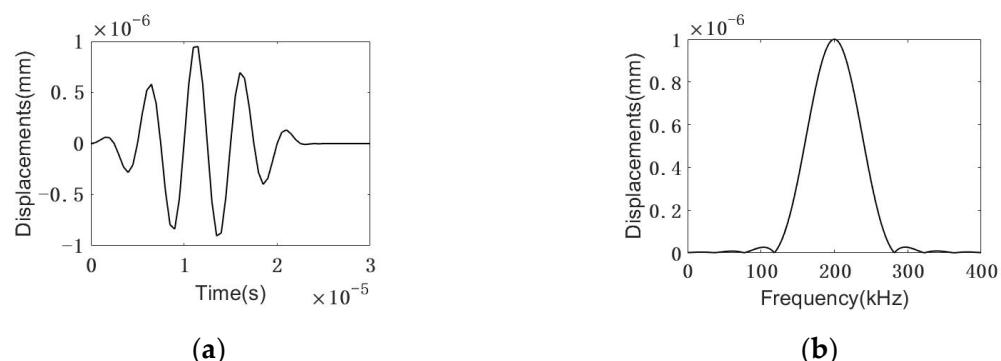
**Figure 6.** The excitation signal (a) in time domain, (b) in the frequency domain.

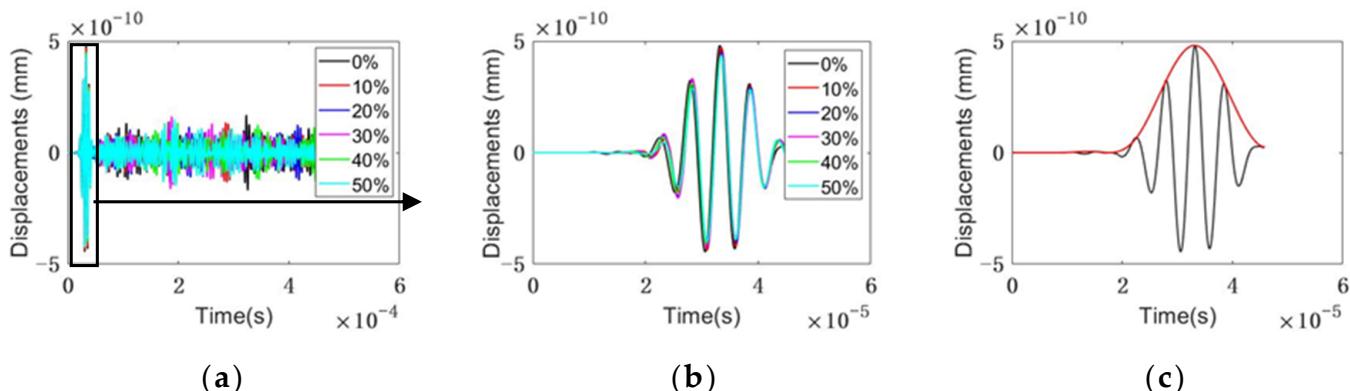
**Figure 7.** The time domain of Path 13: (a) The time domain; (b) the first wave; (c) an example of a Path 13 signal in the time domain indicating the envelope (red line) to calculate the ultrasonic energy.

The energy of the signal envelope [46] was obtained using MATLAB signal processing. Taking the signal from Path 13, for example, the time-domain signals from different samples are shown in Figure 7a,b. The calculation procedure is illustrated in Figure 7c. The energy of the signal envelope of the first arrival wave is calculated and summarized in Figure 8. As shown in Figure 8, for the response to 200 kHz, the transmitted UT energy decreases with the increase in the defect rate. Compared with Path 13 and Path 14, Path 12 is the most sensitive propagation path. The change in the UT energy ratio is the most significant among the three paths.

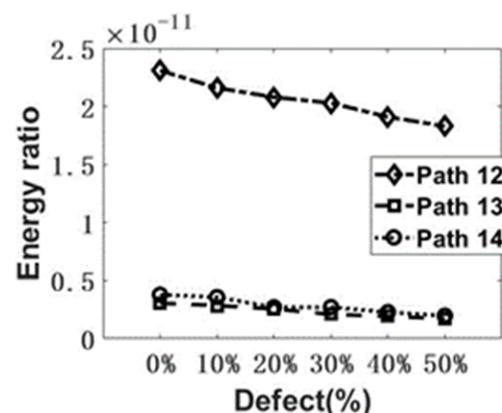
**Figure 8.** The numerical comparison of the UT signal energy ratio among the Path 12, Path 13, and Path 14.

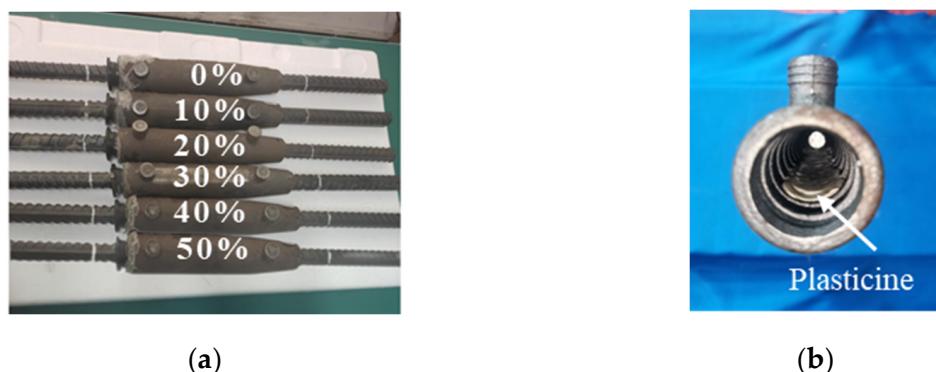
**Figure 9.** (a) grouting sleeve defect specimen; (b) schematic diagram of internal defects of sleeve.

In order to verify the theoretical analysis and numerical model, six samples with the same internal flaws as the numerical models were fabricated, see Figure 9a. Artificial defects were designed to simulate grouting defects in horizontal grout sleeve connectors due to leakage or under-grouting. The defects were long and strip-shaped and were manufactured between the bottom of the sleeve and the reinforcement. Since plasticine has the advantages of good plasticity, excellent bonding properties, and does not react with grouting materials, by adding plasticine to the grout sleeve, it can perfectly simulate artificial defects, as shown in Figure 9b. The different volume of plasticine was added to mimic the flaw rate. The volume ratio of plasticine to the capacity of the mortar in the grouted sleeve is marked in Figure 9 and used to represent the degree of the internal flaw. The position of the internal flaw is the same as the numerical model, see Figure 4. The grouting sleeve specimens with different defect rates are shown in Figure 9.

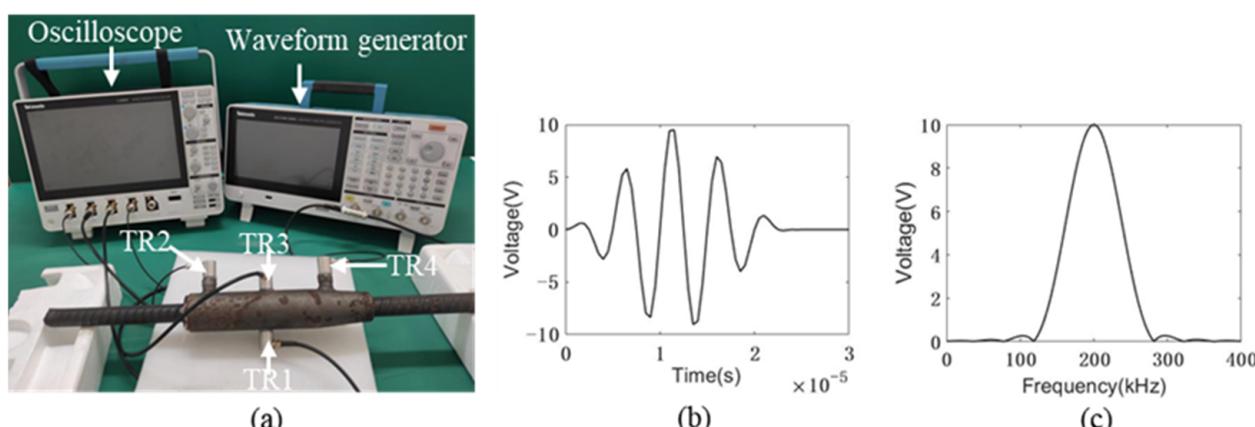
**Figure 10.** The setup of the active grout defect detection system: (a) experimental setup; (b) the excitation signal in time domain; and (c) the excitation signal in the frequency domain.

The same transducer arrangement as the numerical and theoretical models was adopted. The experimental setup is shown in Figure 10a. In this case, the same configuration as the numerical model was repeated. Transmission mode was used. Four transducers with a central frequency of 200 kHz were attached to the grouted sleeves as transmitters and receivers, see Figure 10. A tone burst signal with 5 cycles is generated by the waveform generator as an excitation signal with an amplitude of 10 V, see Figure 10b,c. Additionally, all the signals were collected by the oscilloscope. A 10 MHz sampling frequency was used.

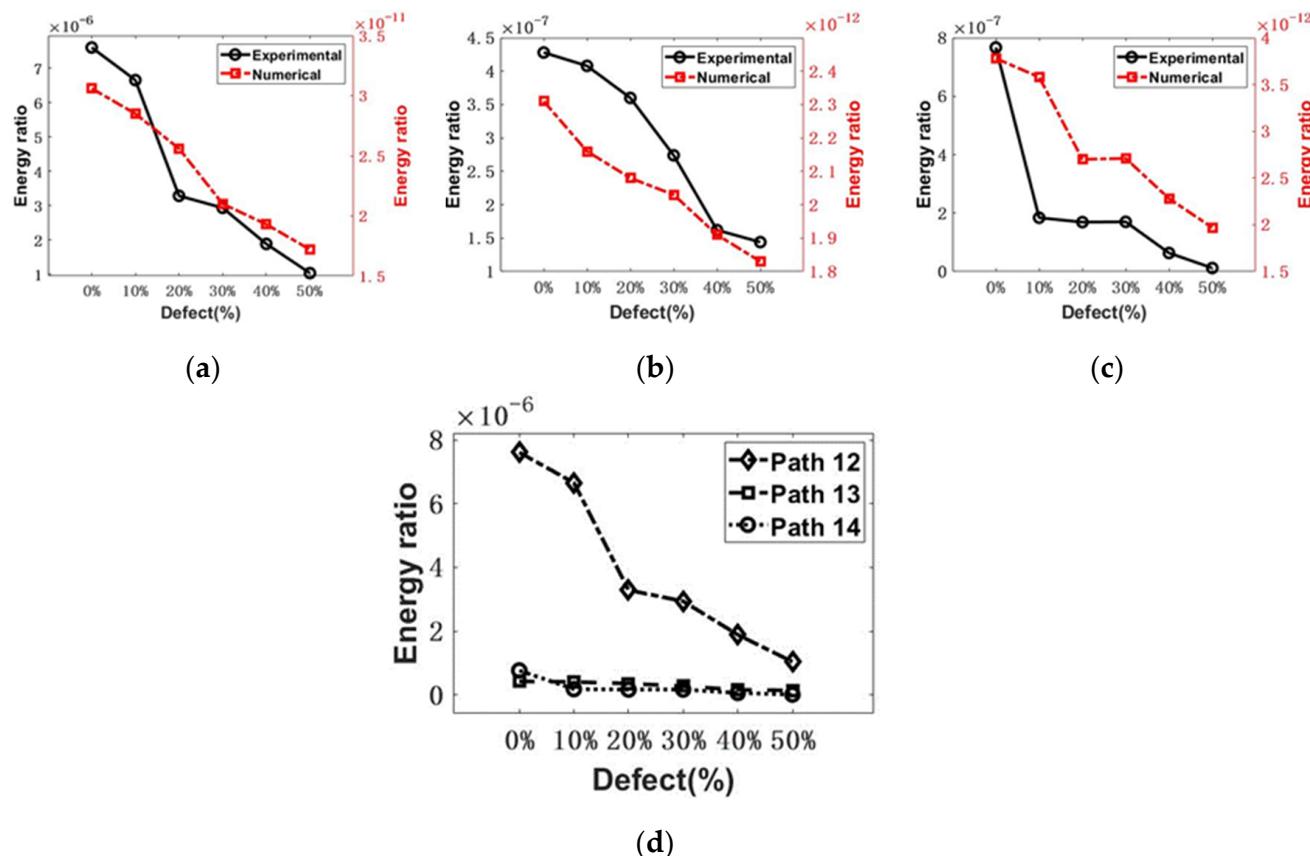
**Figure 11.** The comparison of UT signal energy ratio between experimental and numerical study from (a) Path 12, (b) Path 13, and (c) Path 14, (d) the experimental comparison of UT signal energy among Path 12, Path 13, and Path 14.

The time-domain signal collected in the experiment was filtered with the Butterworth bandpass filter, ranging from 10 kHz to 400 kHz, using the MATLAB software to reduce the EMI noise and other unexpected noise. The detailed signal processing method was described in Section 4, and the signal energy of the first arrival envelope was calculated. The comparison of numerical and experimental results is shown in Figure 11. The experimental results agree well with the numerical results, but still, differences can be observed because the transducer was not considered in the numerical model and some uncertainties rose. Similar to the numerical results in Section 4, the received UT energy decreases with the increase in the defect rate. It confirmed the mechanism of UT detection. The most sensitive path is Path 12 in this scenario. Moreover, before conducting UT, the proper experimental configuration should be determined: (i) the transducer should be placed to form the UT propagation path across the area with possible defects or flaws; (ii) the relatively simple path is highly recommended because a more complex path will bring uncertainties to the signal interpretation. Therefore, for evaluating the grouted sleeve, one transducer close to the grouting inlet and the other one in the middle of the sleeve is recommended to be optimum if the position of the internal flaw is unknown.

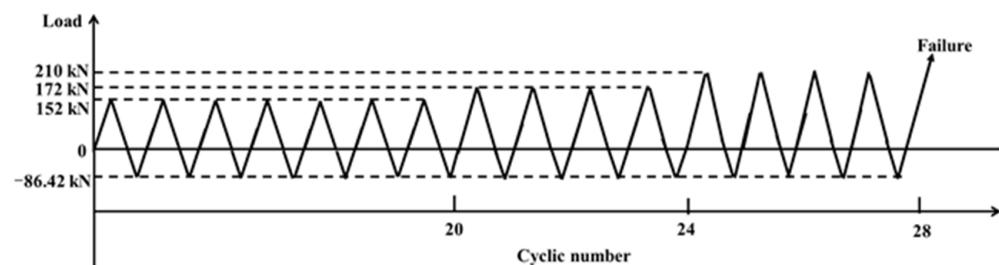
**Figure 12.** Loading procedure.

The AE monitoring test pieces are six grouting sleeves with different defect rates, as shown in Figure 9a, and the material properties of the test pieces are shown in Table 2. The specific cyclic loading mode presented is adopted as required in ISO 15,835 [47], as shown in Figure 12. As shown in Figure 13a, the clamping length of the grouting sleeve rebar is 150 mm. The grouting sleeve is loaded by the high-speed impact testing machine.

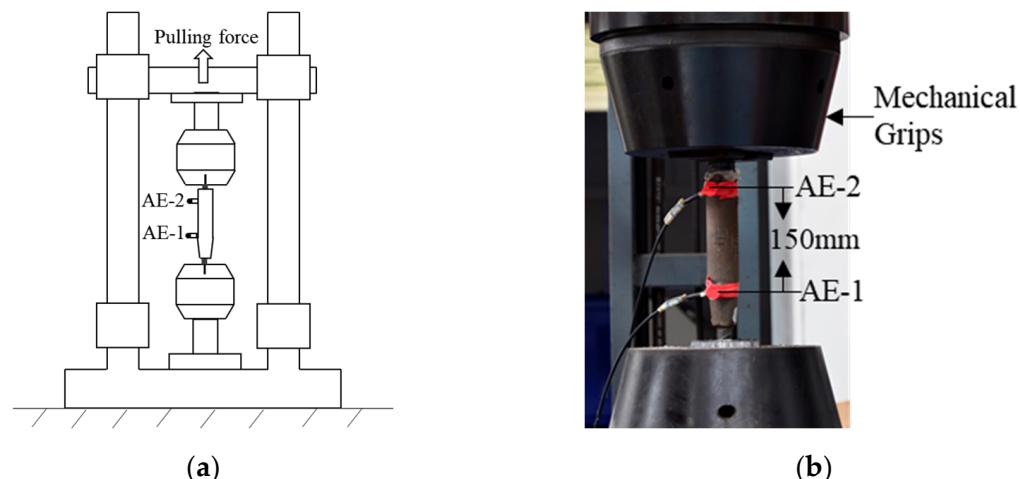
**Figure 13.** Test setup: (a) test setup design; (b) experimental setup.

The AE instrument adopted the Sensor Highway III of the American Physical Acoustics Company. The system is used to monitor the cyclic loading test of the grouting sleeve. As shown in Figure 13, two piezoelectric ceramic sensors, PK151 are used for source positioning. Sensor 2 is placed at the grouting inlet, named AE-2, and sensor 1 is placed at the slurry outlet, named AE-1. The sensor is coupled with hot melt adhesive and connected to a 26 dB gain preamplifier. The main data acquisition variables are the analog filters between 5 kHz and 400 kHz, the peak definition time is 300  $\mu$ s, the hit definition time is 600  $\mu$ s, the hit locking time is 1000  $\mu$ s, and the threshold is 45 dB, which depends on the hit rate. The AE waveform is recorded at a sampling rate of 1 MHz, and the maximum duration is 1000 ms.

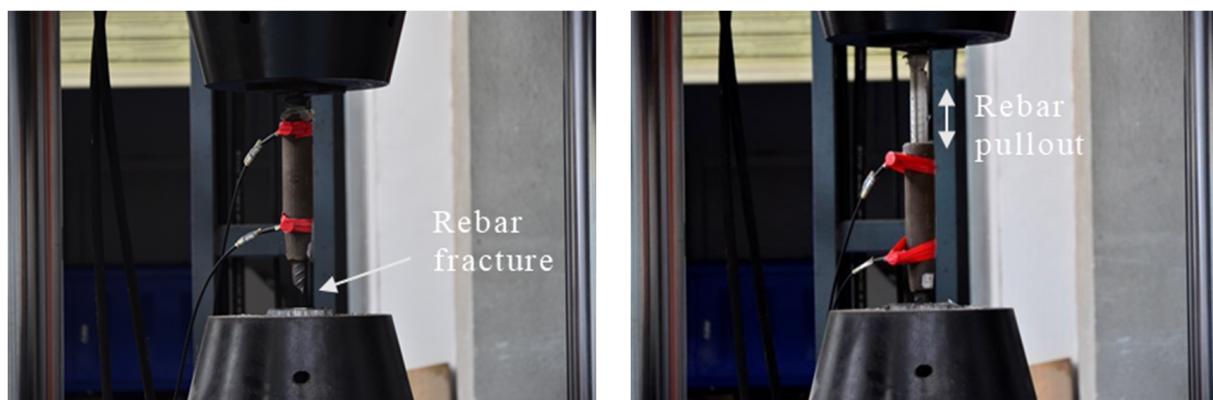
**Figure 14.** The two typical failure mode of the grouting sleeve connector: (a) rebar fracture; (b) rebar pullout.

The same cyclic loading for six samples is conducted and shown in Figure 14. Additionally, all the specimens were tested for failure. In general, two failure modes were observed: (i) rebar fracture; and (ii) rebar pullout. The detailed information is summarized in Table 3. The entire process of the testing was monitored by AE. The AE signals collected from the cyclic testing process were synchronized with the displacement response. In this case, the AE events were used to represent the AE activities. Figure 15 shows the relationship between the cumulative AE events and the displacement response. The AE activities show similar trends as the displacement response, which can reflect mechanical behavior. Firstly, the prescribed internal flaws played a crucial role in determining the failure mode: the ultimate failure mode of the rebar fracture corresponds to defect rates of 0%, 10%, and 20%; and the rebar pullout happened in the sleeve with defect rates of 30%, 40%, and 50%.

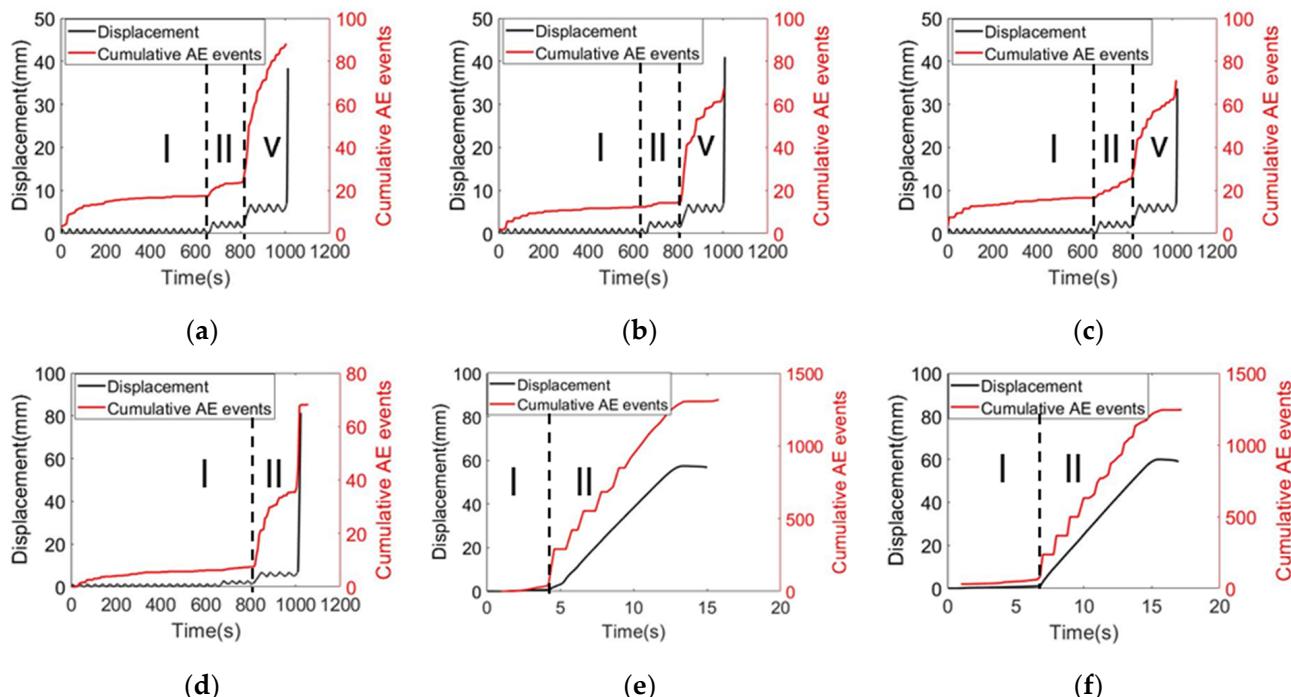
**Figure 15.** AE cumulative event history: (a) 0% defect; (b) 10% defect; (c) 20% defect; (d) 30% defect; (e) 40% defect; and (f) 50% defect.

Moreover, the damage progress also shows different patterns: ductile damage for rebar fracture and brittle damage for the rebar pullout, respectively. It reflects on the corresponding AE event history. As mentioned in the previous section, the internal defects or flaws are the decisive factor. For rebar breakage, three stages can be observed: as shown in Figure 15a–c. In the first stage, AE cumulative events are caused by friction between mechanical fixtures and steel bars, elastic compaction of high-strength concrete

grout materials, and other unexpected uncertainties. In the second stage, due to the yield of reinforcement and the full development of the grouting crack, the AE cumulative event curves the mutation and rises slowly. In the third stage, a large number of acoustic emission signals were observed due to the necking and fracture of steel bars. AE cumulative events increase sharply.

For pullout damage, it shows brittle behavior as shown in Figure 15d–f. Unlike the rebar fracture, the damage progress can only be divided into two stages: the first stage is similar to the rebar fracture scenario, only few AE activities happened and were caused by friction or testing uncertainties. In the second stage, the jump of AE signals was observed. Most of signals were caused by concrete crushing. Since the internal flaws exist, the bonding strength among mortar, sleeve and rebar in the grouted sleeve reduced, leading to concrete crushing. As the interlock between steel bar and grout material losses, the rebar is pulled out quickly. For Figure 15e,f, the prescribed internal flaws already changed the entire mechanical performance of the grouted sleeve. Its tensile capacity is relatively low compared to the 30% defect case due to massive volume of the flaws. The damage grows very fast to failure. During this process, massive AE activities were observed. AE signals were caused by various sources (e.g., friction between rebar and mortar, concrete cracking and crushing). Under the same loading rate, for the sleeve defect rate of 0%, 10% and 20% of the specimens, the sleeve, mortar and rebar have good bonding connection performance, and rebar damage is the main damage. Rebar can be deformed under a certain bearing capacity, ultimately leading to the damage. This process was dominated by the ductile behavior. On the other hand, for the sleeve defect rate of 30%, 40% and 50% of the specimens, the sleeve, mortar and steel bonding connection performance is poor, mortar damage is the main form of damage. Mortar damage is the brittle damage, only few rebar deformations can be observed before eventual damage (concrete crushing). Therefore, the damage behavior corresponds to the slope of the cumulative AE event history. In the brittle damage process, the AE cumulative number increased dramatically during the second stage due to concrete crushing caused by rebar pullout and the third stage disappeared, no rebar fracture damage was observed, as shown in Figure 15. As a result, a rapid increase in the AE cumulative number of events may be a precursor of sleeve failure.

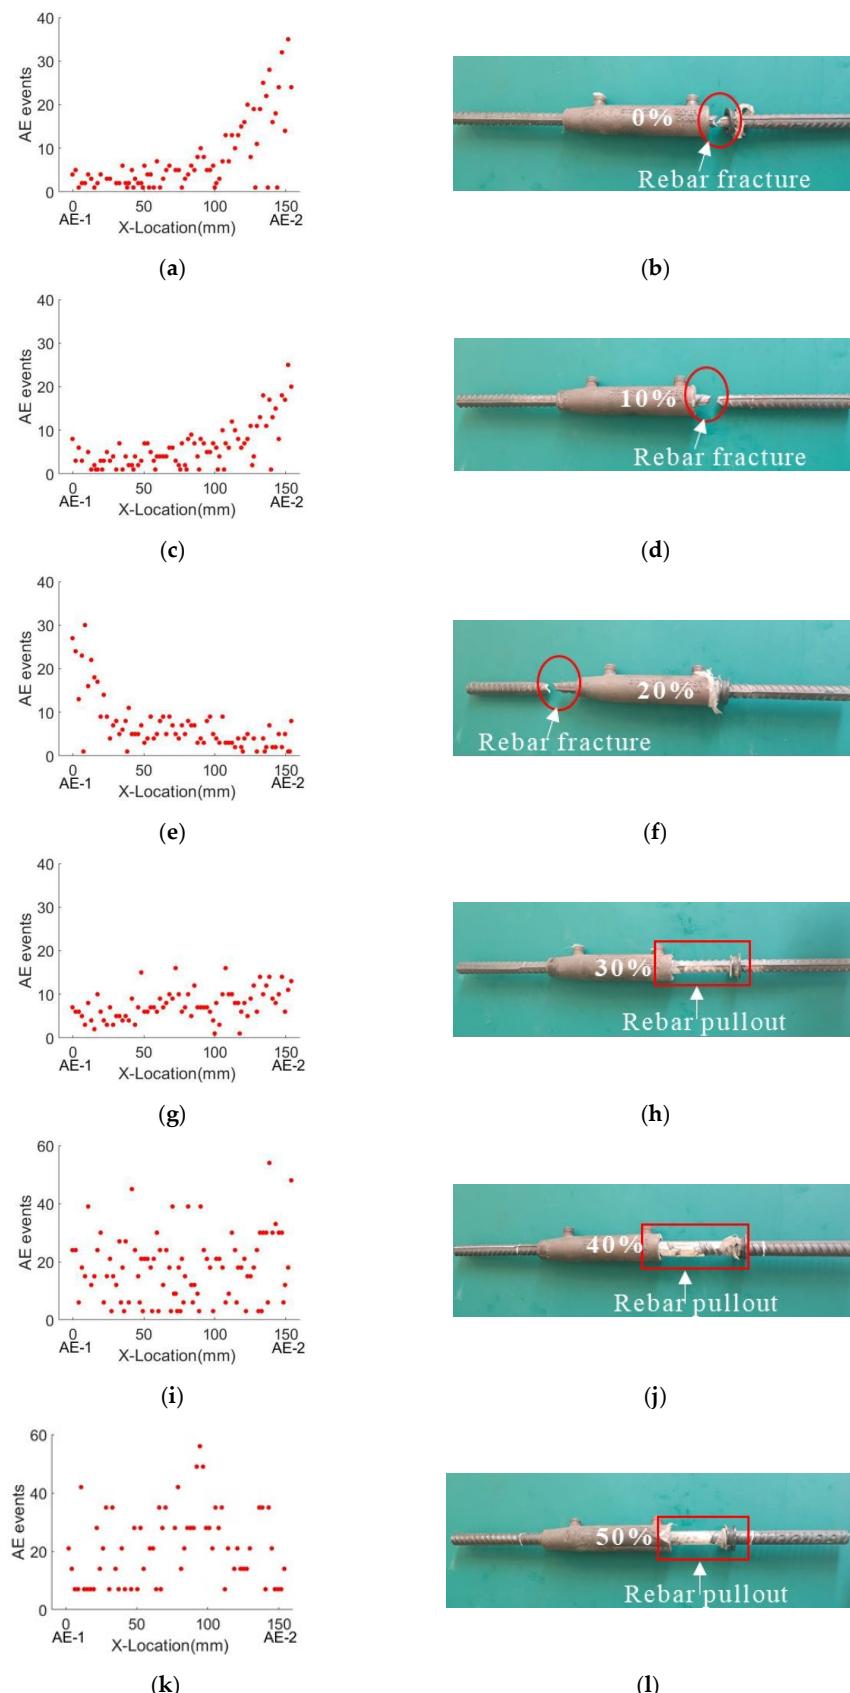
**Figure 16.** AE event distribution versus specimen failure diagram: (a,b) 0% defect; (c,d) 10% defect; (e,f) 20% defect; (g,h) 30% defect; (i,j) 40% defect; and (k,l) 50% defect.

As described in Section 6.2, under cyclic loading experiments, the six specimens with different defect ratios have two failure modes: the failure modes of rebar fracture correspond to 0%, 10%, and 20% defect rates; the rebar pullout happens in the sleeve with defect rates of 30%, 40%, and 50%. To further locate the location of the damage, a 1D linear localization method was used with the AE-1 (grouting outlet) sensor as the x-axis origin and the AE-2 (grouting inlet) sensor as the x-axis end point. The acoustic emission localization results, as shown in Figure 16, use the AE event number distribution to locate the damage location. For rebar-breaking failure, a large number of acoustic emission signals were recorded due to the necking and fracture of steel bars. At the location of failure, the number of AE events increases sharply, as shown in Figure 16a,c,e. For specimens with a 0% and 10% defect rate, the steel bar fracture occurred near the grouting inlet, as shown in Figure 16b,d. For the specimen with a 20% defect rate, the steel bar fracture occurred near the grouting outlet, as shown in Figure 16c. The failure position is consistent with the acoustic emission localization results. For rebar pullout failure, the acoustic emission signal mainly comes from the friction between mortar and steel bars and the breakage of mortars. The number of AE events mainly occurred between the AE-1 and AE-2 sensors, as shown in Figure 16g,i,k. The failure signal and friction signal of the mortar mainly occurred between the grouting inlet and the grouting outlet, as shown in Figure 16h,j,l. The damage location is consistent with the acoustic emission localization result.

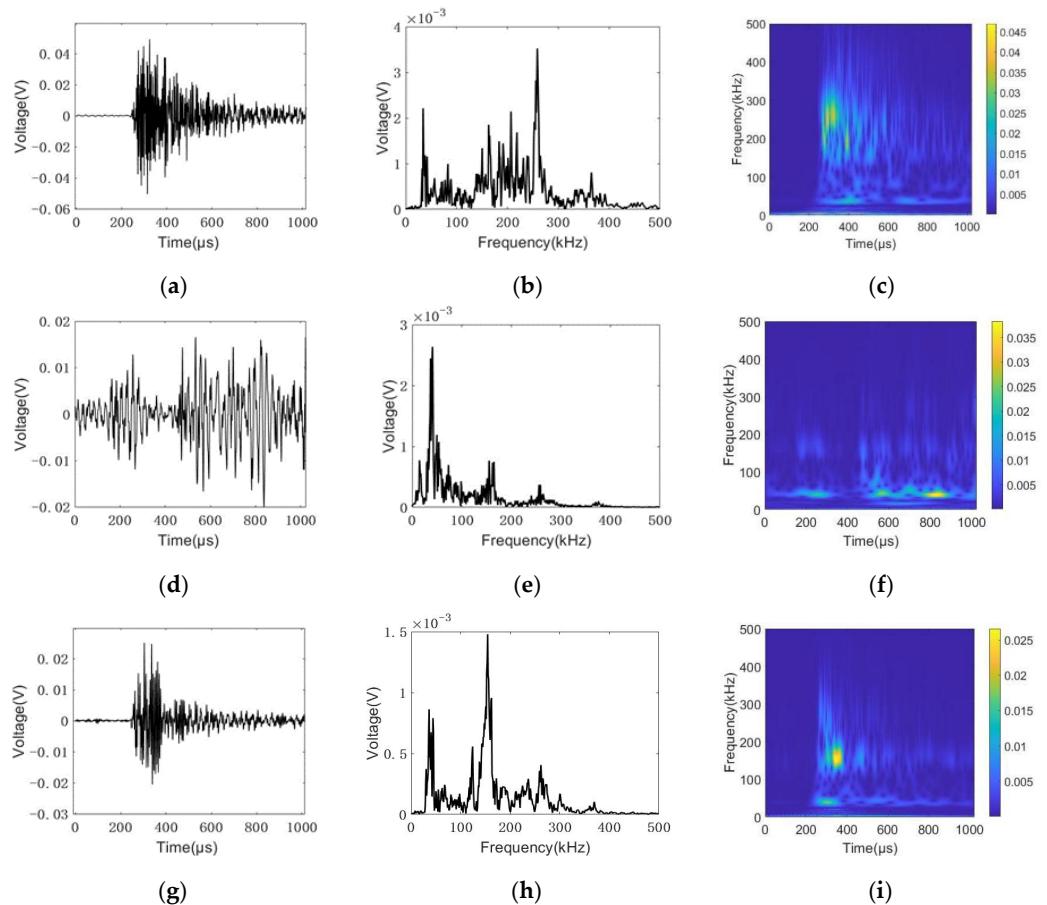
**Figure 17.** Time-domain histories, frequency domain histories, and frequency spectra of the AE signals detected by PK151 sensors, where (a–c) are from rebar fracture; (d–f) are from friction among rebar, mortar, and sleeve; and (g–i) are from concrete crushing.

As discussed in Section 6.2, two damage modes (ductile and brittle damage) correspond to different AE signatures. By extracting the typical signals from different AE events, see Figure 16, three types of AE signals were dominant: (i) For rebar fracture, when the steel bar fracture signal appears, a large number of high-frequency signals with a peak frequency of 260 kHz was recorded, as shown in Figure 17a–c. Usually, the AE signal of metal fracture reflects in a high frequency range from 200 kHz to 400 kHz. Additionally, the signal shows more burst types, see in Figure 17a. In this case, it indicates the fracture of the rebar. (ii) Many low frequency signals were observed during the rebar pull-out. The main frequency component was lower than 100 kHz. It was caused by friction among rebars, mortars, and sleeves. The secondary or third AE phenomenon happened. Usually, the massive low frequency signals with secondary AE are the precursor of the rebar pull-out in the sleeve. For concrete crushing, usually accompanied by the rebar pullout failure, the peak frequency of the signal usually happens at 150 kHz. Other than it, partial AE energy was concentrated in a low frequency range of approximately 50 kHz, which is very similar to the AE signal due to friction. By further analyzing these two AE events, they usually were observed simultaneously. Moreover, concrete crushing and friction were involved during the rebar pull-out process. With the increase in the internal flaw, more AE signals appeared due to concrete crushing and friction. The damage mode tended to be the rebar pullout (brittle mode). It coincided with mechanical behavior and indirectly confirmed the AE findings.

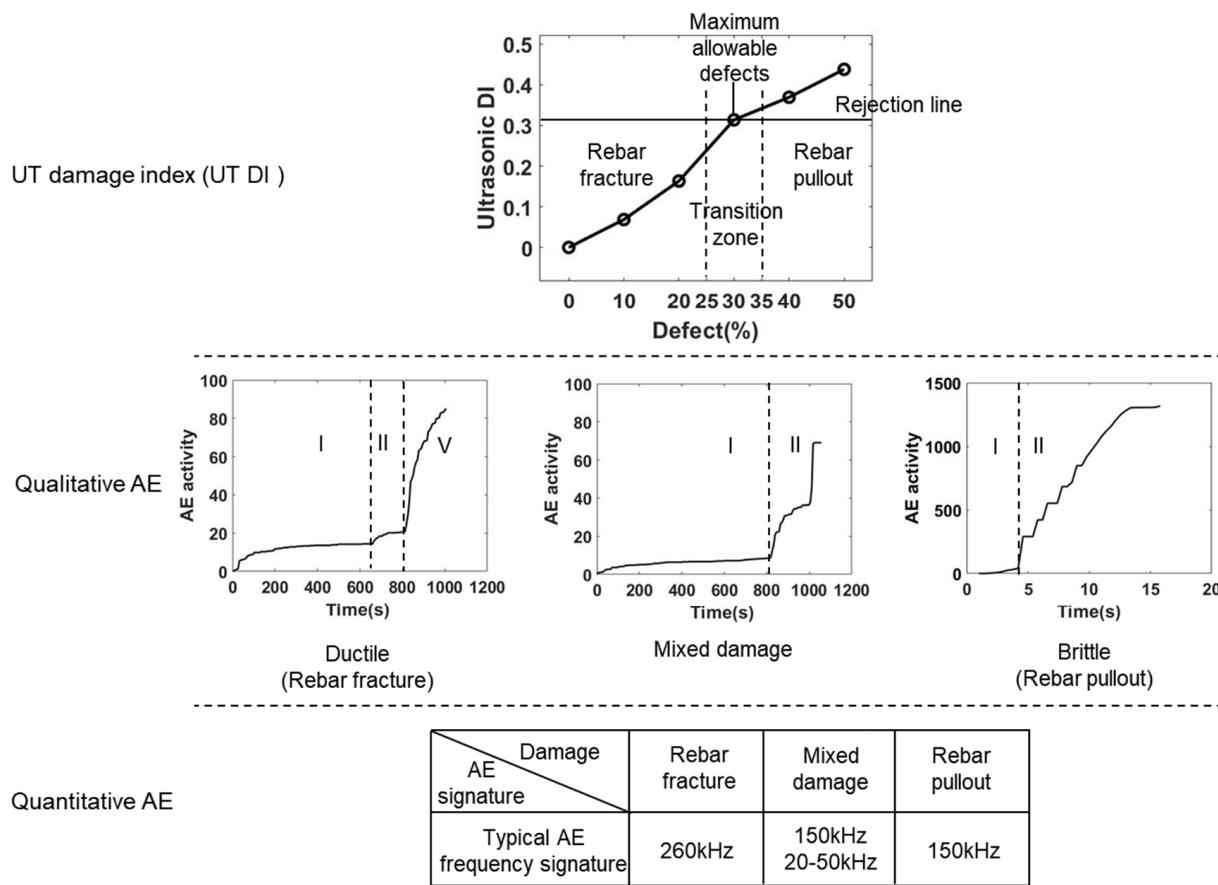
**Figure 18.** The correlation of the UT damage index, qualitative AE, and quantitative AE.

where  $E_0$  represents the UT signal energy ratio of the defect-free sample.  $E_i$  represents the UT signal energy ratio of the defective sample, and  $i$  represents the defect rate of the grouting casing. The results of UT DI are shown in Figure 18. With the increase in the volume of the internal flaw, the DI increased. Moreover, it shows a double broken line model. The inflection point was at 30% defect, which corresponds to the DI of 0.31. With consideration of the tensile test, the mixed damage mode (rebar fracture and pullout) happened. The strength of grouted sleeve failed very fast. The damage changed from ductile mode to brittle mode. Additionally, the safety margin was reduced. Therefore, a rejection line was defined as the DI value of 0.31. It means that the UT DI of the sleeve connection above the rejection line, the connection had a great risk in failure due to the effect of internal defects. Thus, for rapid evaluation of UT, the grouted sleeve connector should be disposed as long as the DI is larger than 0.31.

For AE characterization of damage progress, qualitative and quantitative evaluations were conducted, and the results are shown in Figure 18, respectively. In general, if the DI is lower than 0.31, the three stages of damage were observed in AE activities. The damage shows more ductility, and rebar fracture is the main result. Accordingly, the strength of grouted sleeve connector wasn't impaired by internal flaws. The high frequency AE signals were dominant. On the contrary, once the DI is higher than 0.31, the damage shows more brittleness and the rebar pullout is dominant, which reduces the strength of the grouted sleeve connector and negatively impact the safety. The two stages of AE activities and the frequency of 150 kHz was dominant in AE signals. Approximately DI of 0.31, a transition zone was defined. According to the description in Section 6.2, the specimen with a 30% defect rate is the critical value for rebar fracture failure and rebar pullout failure. Therefore, the 30% defect rate was defined as the maximum allowable defect for bond strength failure of mortar, sleeve, and rebar in grouted sleeves, as shown in Figure 18. By further analyzing the 30% defective sleeve, both ductile damage (plastic deformation of the rebar) and brittle damage can be observed inside the sleeve. To better characterize the damage pattern of the sleeve, the 25–35% defect rate was defined as the transition zone. In this region, both ductile and brittle damage occur inside the sleeve. In this region, the mixed damage modes were observed; and the AE activities show a combined pattern of rebar fracture and pullout. One point needs to be noticed: massive friction signals with low frequency were observed, which is a precursor of failure of the grouted sleeve connector, see the quantitative AE evaluation in Figure 18.
