# SMART SKY EYE System for Preliminary Structural Safety Assessment of Buildings Using Unmanned Aerial Vehicles

**Keywords:** SMART SKY EYE; unmanned aerial vehicle; safety inspection; thermography; structural safety assessment

**Citation:** Bae, J.; Lee, J.; Jang, A.; Ju, Y.K.; Park, M.J. SMART SKY EYE System for Preliminary Structural Safety Assessment of Buildings Using Unmanned Aerial Vehicles. *Sensors* **2022**, *22*, 2762. <https://doi.org/10.3390/s22072762>

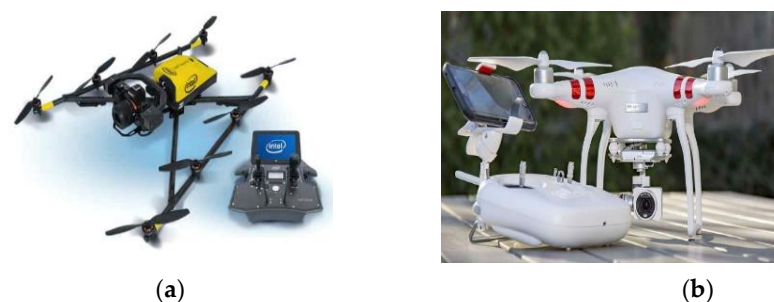
**Figure 2.** Drones: (a) Intel Falcon 8+. (b) DJI Phantom 3 Standard.

SMART SKY EYE is a preliminary safety inspection system that can enhance detection efficiency by employing UAVs. With this methodology, defects in structures can be detected and the safety level evaluated before the conventional precise safety inspection. DJI Phantom3 Standard and Intel Falcon 8+ were the UAVs used in this research and are shown in Figure 2.

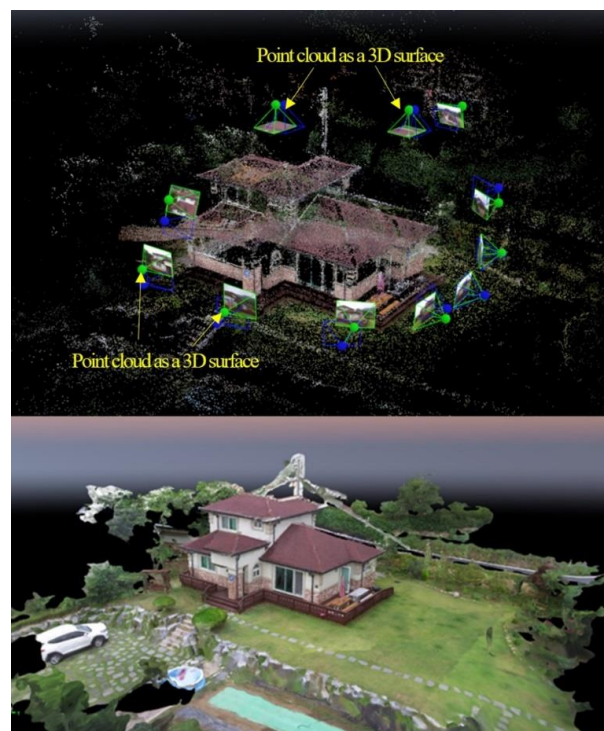
In the 3D point cloud modeling methodology, each of the images captured with the UAV depicts a limited section of the building. The point cloud methodology reconstructs the 3D surface of an object through an alignment of extracting and matching feature points of an object photographed from various angles and represents the point cloud as a 3D surface. In this paper, an image-based architectural exterior 3D point cloud model was created using Pix4D commercial software for point cloud construction and mesh generation. The methodology of realizing 3D location information through a point cloud after shooting a flight using an uncrewed aerial vehicle utilizes the GPS position coordinates and image data acquired at the time of the shooting. This GPS-based survey method allows for the detection of building tilt and vertical displacement measurements and generates high-resolution 3D models (Figure 6).

**Figure 6.** SMART SKY EYE application example of 3D print cloud.

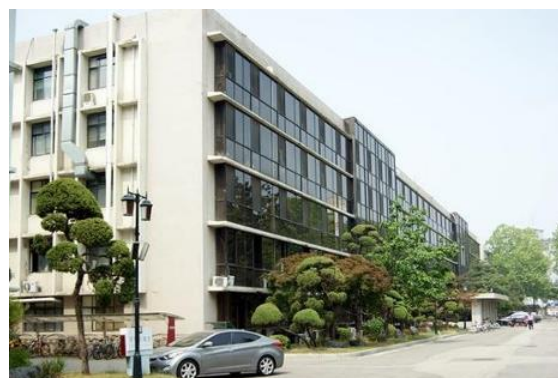
Figure 11. Campus building.

The entire procedure was applied to a campus building (Figure 11) located in Seoul, South Korea. DJI Phantom3 was used for the inspection flight. The construction of the building was completed in 1964. As the building was sufficiently old to have developed exterior defects and is located inside a campus where students congregate, it was appropriate to apply the proposed method. Moreover, there was already an available safety inspection report for this building, against which we could compare the results of the proposed process.

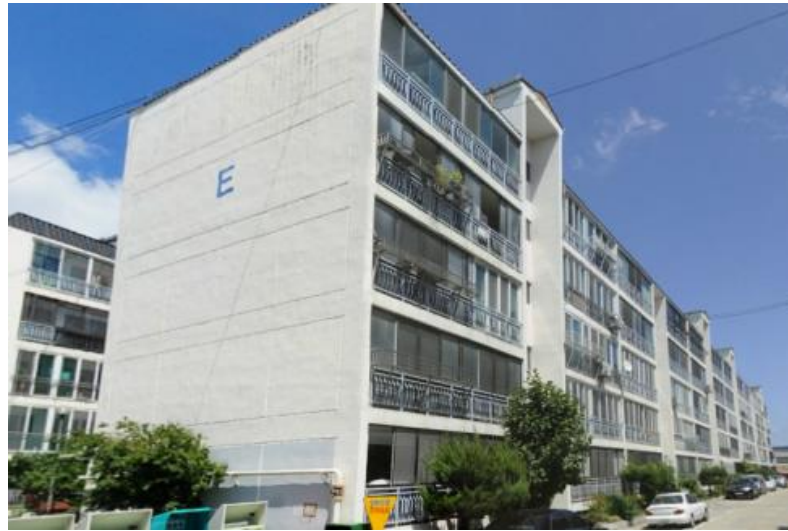
Figure 13. Residential building.

The proposed method was applied to an earthquake-damaged residential building in Pohang (Figure 13). The real flight time for the Intel Falcon 8+ was approximately 40 min, and 1561 pictures were captured with a shot distance of less than 5 m to secure a 2 mm GSD. To assess the damage of the building, the rapid evaluation safety assessment criteria (this is a type of preliminary fast safety inspection to determine the accessibility of a building) were used. Usually, when an earthquake widely affects a city, the evaluation criterion focuses on rapid visual inspection. South Korea's safety evaluation assessment for earthquake-damaged buildings involves both quantitative and qualitative evaluations.

Qualitative evaluation is based on categories; for example, the risk that the surroundings might collapse or that a facility in the building may fall. This evaluation was performed with the original aerial photographs captured by Intel Falcon 8+. The integrated result was a level-2 rating, or "limited use of the building". The total result was rated as level 3 (danger) per the rule of selecting the highest risk level.

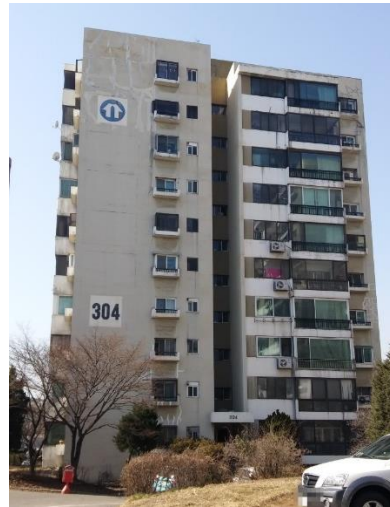
**Figure 15.** Residential building (Seoul).

Exterior inspection, including a crack depth inspection, was performed on a high-rise residential building (Figure 15), the most common form of an apartment building in South Korea. This building consists of 10 floors of typical box-shaped apartments [20]. The air temperature, humidity, and illuminance were 28 °C, 30%, and approximately 9000 lux. An Intel Falcon 8+ equipped with Matrice 600 Pro was used to photograph the entire facade. The flight path was set the same as the campus building project, taken perpendicular to the exterior wall of the building. After a total time of 3 h spent in the field, 1561 aerial photographs were captured during 1 h of actual flight time. Conventional depth detection equipment, the Tc-To method was used to assess the results of the proposed method.

The Tc-To method uses an ultrasonic detector to sound the velocity difference in the time taken by an ultrasonic wave to traverse across undamaged and cracked surfaces to measure crack depth. As inspectors cannot approach cracks located higher than 2 m above the ground, three cracks located at the bottom of the apartment were detected and labeled in order as a, b, and c. The conventional method with the ultrasonic detector, measured crack depths for a, b, and c were 80, 43.1, and 55.4 mm, respectively. The crack depth results from a, b, and c, obtained using the proposed defecting crack depth method, were measured as 80, 60, and 60 mm, respectively. The error rates between the conventional and proposed methods, calculated for cracks a, b, and c were 0.5%, 28.17%, and 7.67%, respectively.
