# Advanced Video-Based Processing for Low-Cost Damage Assessment of Buildings under Seismic Loading in Shaking Table Tests

**Abstract:** This paper explores the potential of a low-cost, advanced video-based technique for the assessment of structural damage to buildings caused by seismic loading. A low-cost, high-speed video camera was utilized for the motion magnification processing of footage of a two-story reinforced-concrete frame building subjected to shaking table tests. The damage after seismic loading was estimated by analyzing the dynamic behavior (i.e., modal parameters) and the structural deformations of the building in magnified videos. The results using the motion magnification procedure were compared for validation of the method of the damage assessment obtained through analyses of conventional accelerometric sensors and high-precision optical markers tracked using a passive 3D motion capture system. In addition, 3D laser scanning to obtain an accurate survey of the building geometry before and after the seismic tests was carried out. In particular, accelerometric recordings were also processed and analyzed using several stationary and nonstationary signal processing

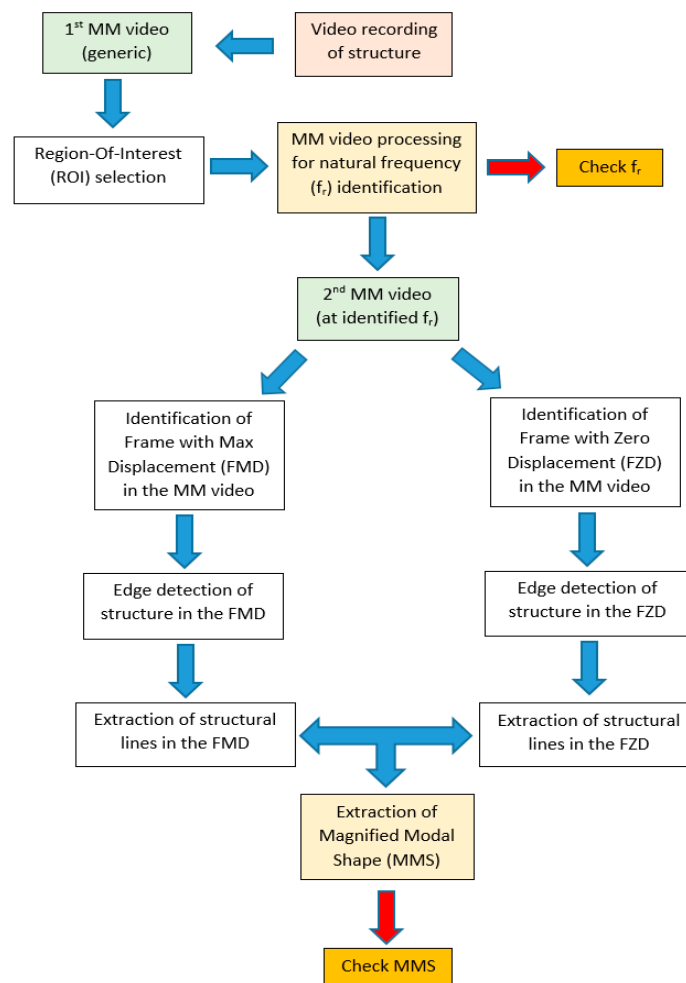
**Figure 1.** Flowchart of proposed video-based MM processing and analysis method.

The proposed procedure comprises different processing steps. In Figure 1, the essential flowchart of the proposed procedure is illustrated.

A video camera records footage of only a few minutes of the object. In the second step, the footage is processed using a software tool provided by the Computer Science and Artificial Intelligence Laboratory at the Massachusetts Institute of Technology (MIT-CSAIL). The phase-based MM version (PBMM) of the algorithm is implemented with this software is used [31]. The main parameters to be set are the frequency range and the amplification factor.

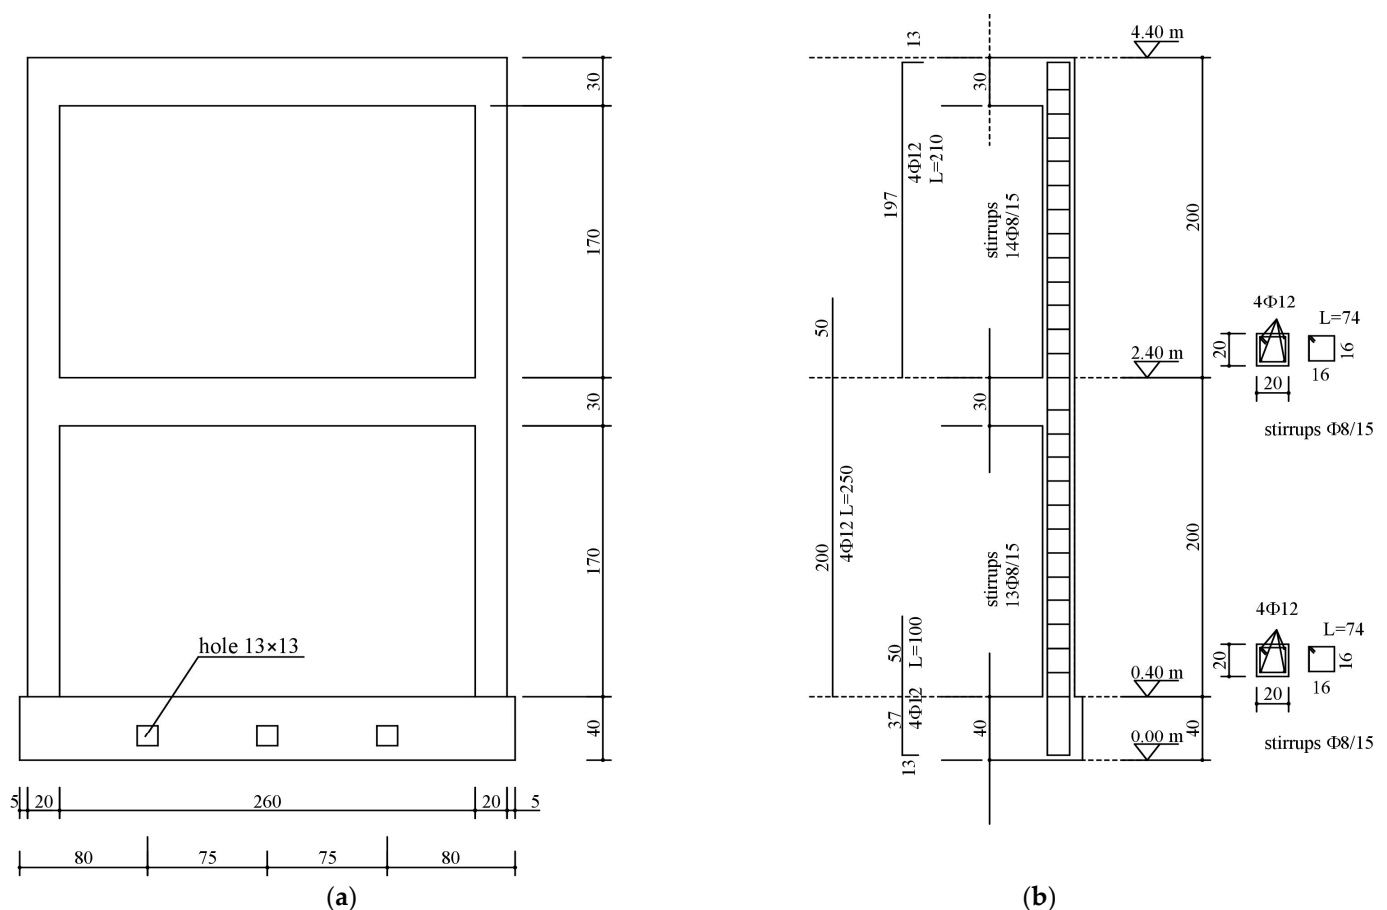
**Figure 2.** Tested structure: (a) building’s dimensions (cm); (b) steel reinforcement of columns.

As for the material properties, the utilized concrete had a characteristic compressive strength of 20 MPa, and the steel bars had a tensile characteristic yield strength of 450 MPa. Extracts of the design drawings and the dimensions of the tested mockup are illustrated in Figure 2. In addition, the slabs were typical of common Italian building stock, and they were built as one-way ribbed floor slabs (drawing of the design shown in Figure 3) and lightened in weight through the use of hollow clay bricks, and the floor slab weight was approximately 21 kN. The overall mass of the building was approximately 150 kN. An additional load of 12 kN was added to each floor by steel plates placed at nine positions in a  $3 \times 3$  matrix. The configuration of the additional load is shown in Figure 4a, with slight eccentricity with respect to the building center of mass.

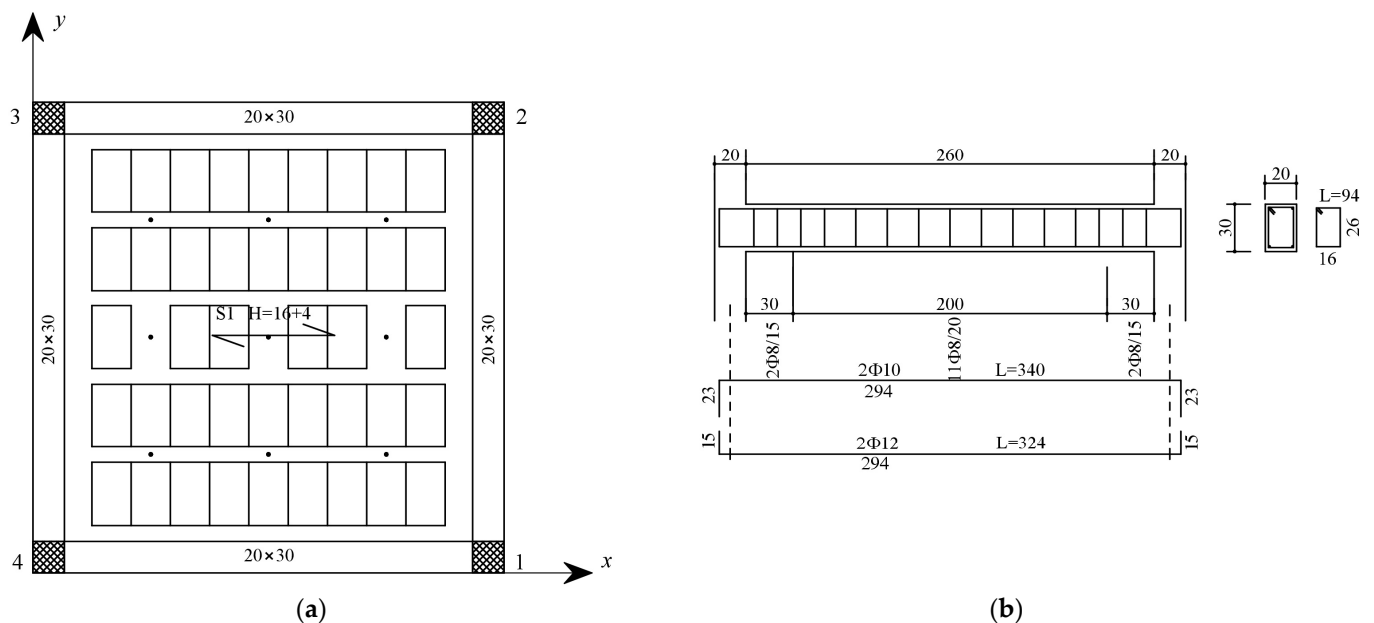
**Figure 3.** Details of the tested structure's floor: (a) top view of the slabs; (b) steel reinforcement of the beam.

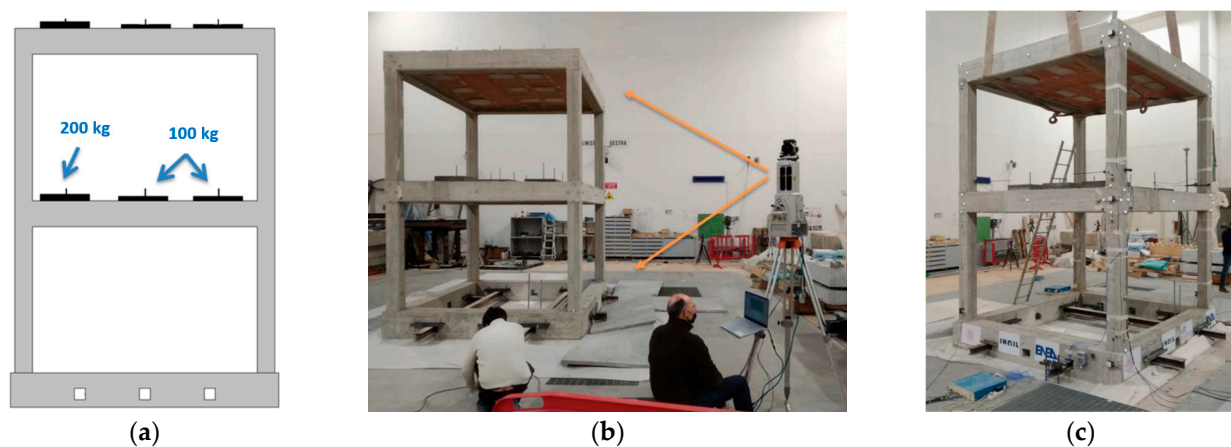
**Figure 4.** Test set-up: (a) additional load mass and geometry; (b) 3D geometry survey by laser scanner; (c) final set-up ready for shaking table tests.

After positioning on the shaking table, the building’s base was fixed to the table and a 3D geometrical survey using a laser scanner was carried out. Four stations placed near each building column were acquired (Figure 4b). This acquisition was repeated after the end of the shaking table tests.

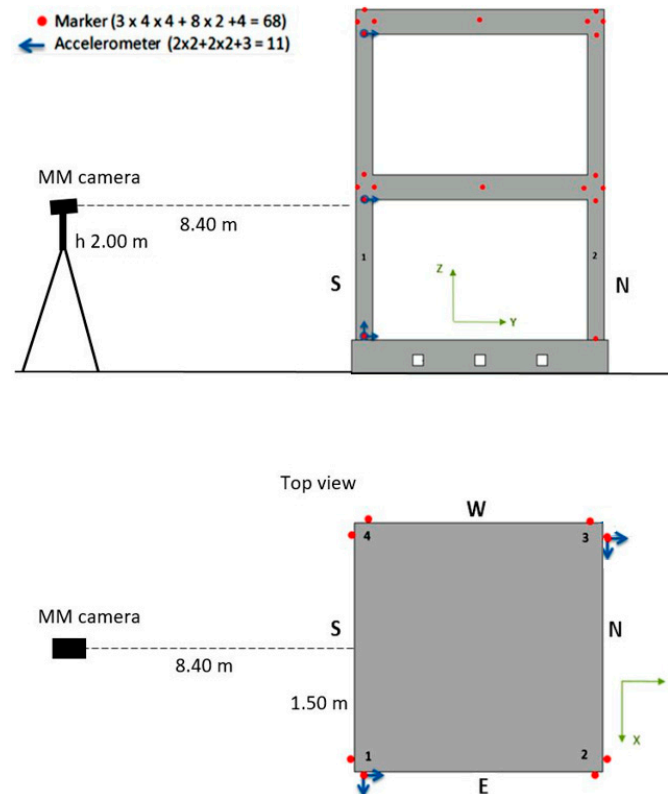
**Figure 5.** Instrumentation positions in the lateral (**up**) and top (**bottom**) views. Columns are numbered from 1 to 4 counterclockwise. Building facades are named S, E, N, and W according to cardinal points.

sensors had a 3 g peak measurement range. They were acquired at a sampling frequency of 200 Hz. Eleven accelerometer channels were positioned on each floor and at the specimen's base, as shown in Figure 5a.

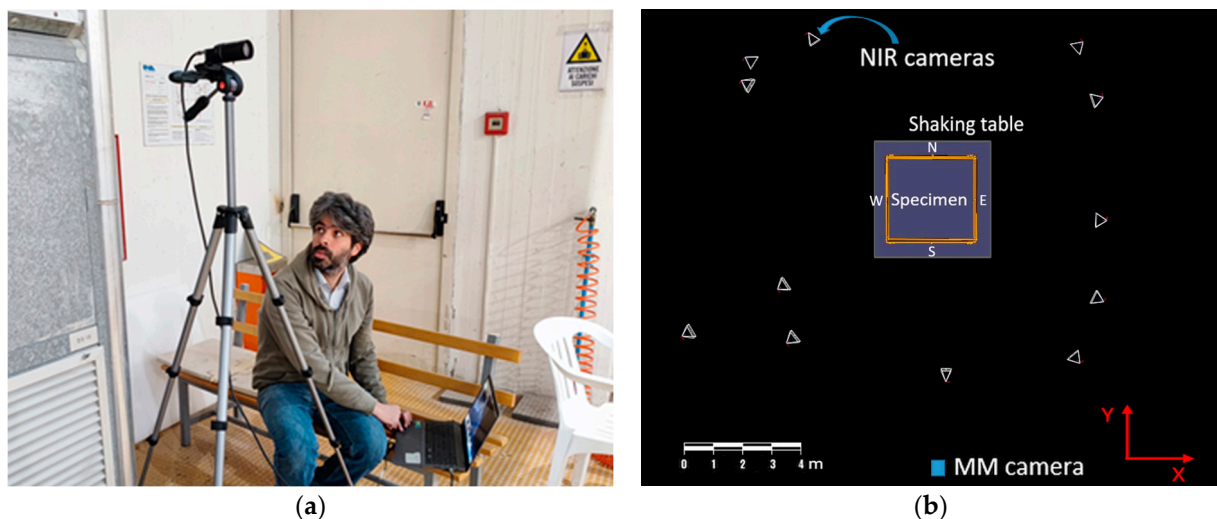
**Figure 6.** Instrumentation set-up: (a) MM camera acquisition station; (b) top view of the acquisition geometry of the optical 3D MCS NIR cameras (white triangles).

The camera used for the MM acquisitions had mounted a CMOS sensor Onsemi PYTHON 1300 with a full resolution of  $1280 \times 1024$  pixels ( $1264 \times 1016$  pixels in the color mode) and a maximum frame rate of 210 fps with reduced resolution (Figure 6a).

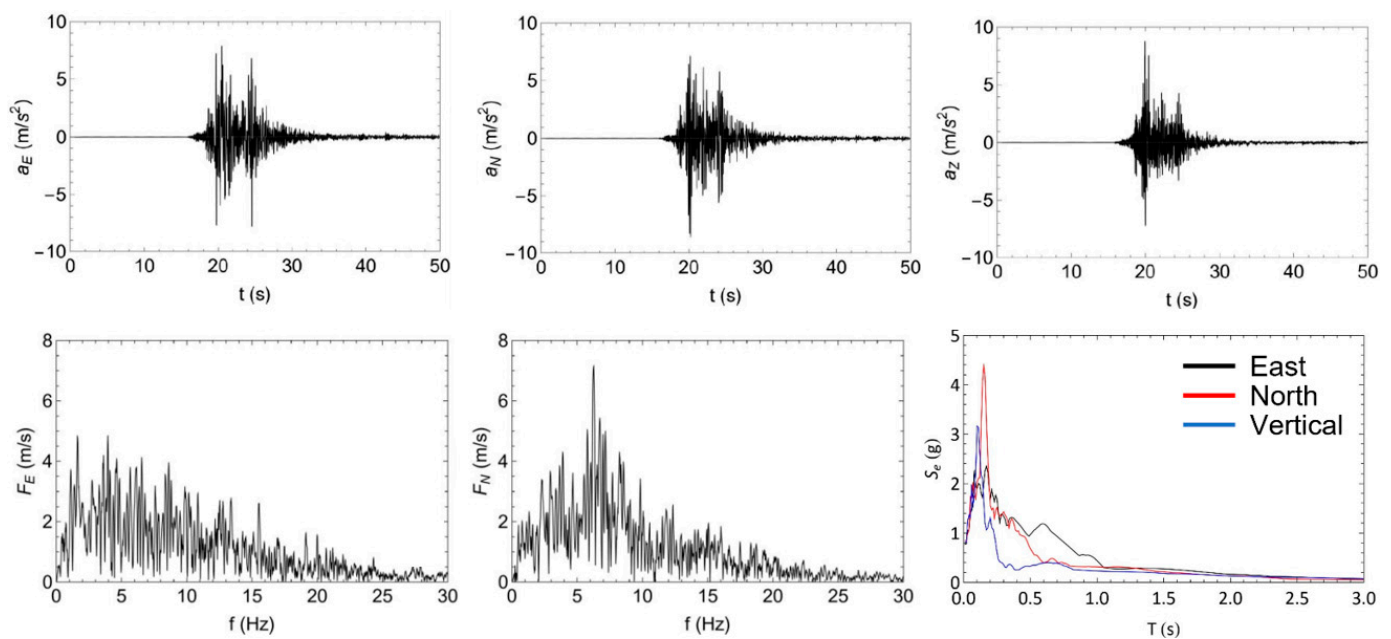
**Figure 7.** Characterization of the reference input accelerograms of the seismic NRC shaking table tests (record NRC station, 30 October 2016, 06:40 UTC, Norcia, Italy).

(06:40 UTC). In particular, the shake recorded at the Savelli seismic station (NRC, Lat. 42.72492 Lon. 13.12578 WGS84, soil type A), located near Norcia (Figure 7), was considered. This was scaled in acceleration in order to obtain the NRC tests (see the shaking table sequence in Table 1), with an increasing step of 0.1 g of the peak ground acceleration (PGA) up to the natural shake of 0.87 g of the PGA. Each seismic test was intercalated with dynamic identification tests with the white noise frequency spectrum (also known as “random” tests) at 0.05 g of PGA (Rnd tests in Table 1). The seismic NRC\_100 test was repeated to assess degradation cause by damage with same earthquake. The two random Rnd\_10 and Rnd\_11 tests were executed for checking the repeatability of the modal identification with MM using different camera parameters. All tests were triaxial.

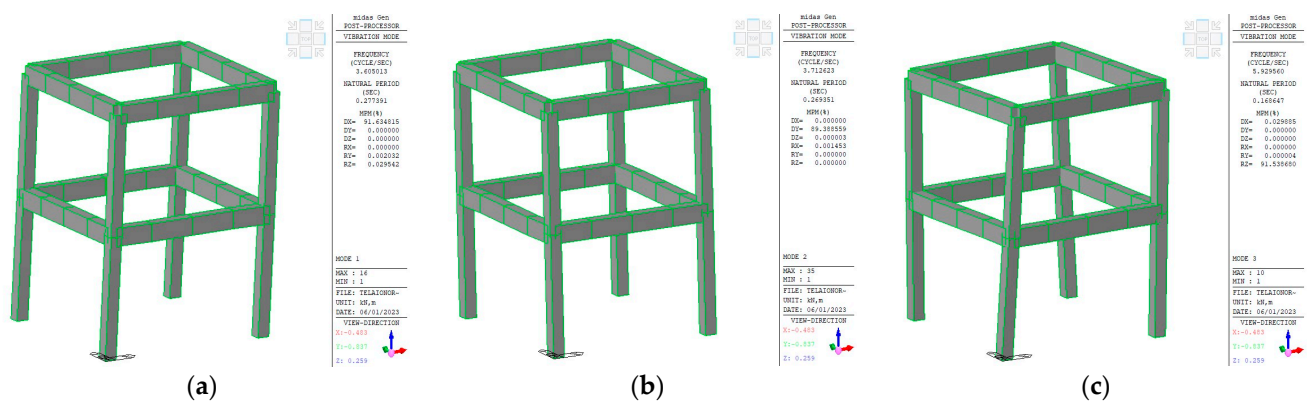
**Figure 8.** First three modal shapes: (a) first bending mode in the  $x$ -direction; (b) first bending mode in the  $y$ -direction; (c) first torsional mode.

However, the analysis of the experimental dynamic data from the first random test (Rnd\_01), which was representative of the undamaged structure, showed much lower frequency values than those derived from the initial linear FE model (see Table 2). Instead, a good agreement was obtained by assuming a cracked flexural stiffness in the model, as is reasonable according to the technical codes for seismic analyses, even in the case of service limit states. Therefore,  $E_c$  was finally assumed to be equal to 20 GPa, and a reduced inertia of the structural members was adopted. In more detail, we considered stiffness ratios of 0.7 for the columns and 0.64 and 0.4 for the  $x$ -directed and  $y$ -directed beams, respectively. The difference attributed to the beams is related to the different contributions of the one-way floor. Figure 8 shows the first three mode shapes and their associated frequencies after updating the linear model.

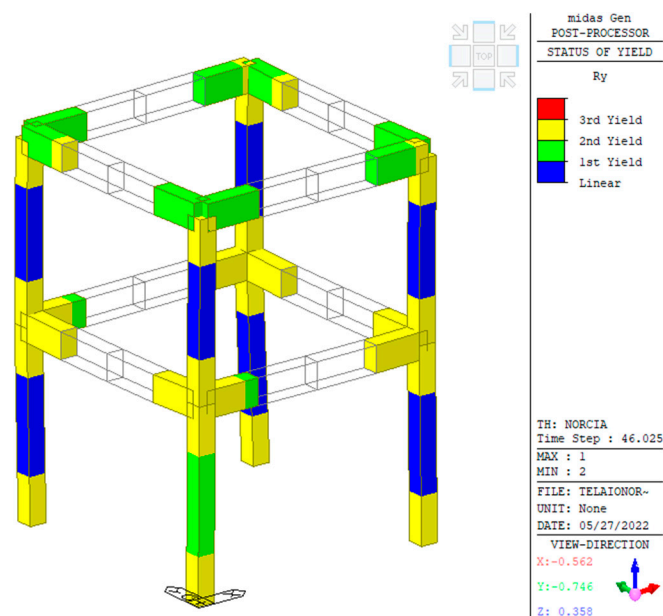
**Figure 9.** Yielding state at the end of the analysis with unscaled seismic input (NRC\_100).

A seismic analysis was performed with the direct integration of the equations of motion using the earthquake recorded at the Savelli station in Norcia, 30 October 2016 (NRC\_100). The final state of the plastic zones due to the rotation around the  $y$ -axis in the local reference of the element is shown in Figure 9. No collapse was to be expected, but the structure was expected to exhibit serious damage, according to the objectives of the test. Concerning the top of one of the columns, some of the details of the results are reported in Figure 10, showing the partial cracking of the concrete at the end of the analysis with a scaled input factor of 0.1, which approximately corresponds to NRC\_01g.

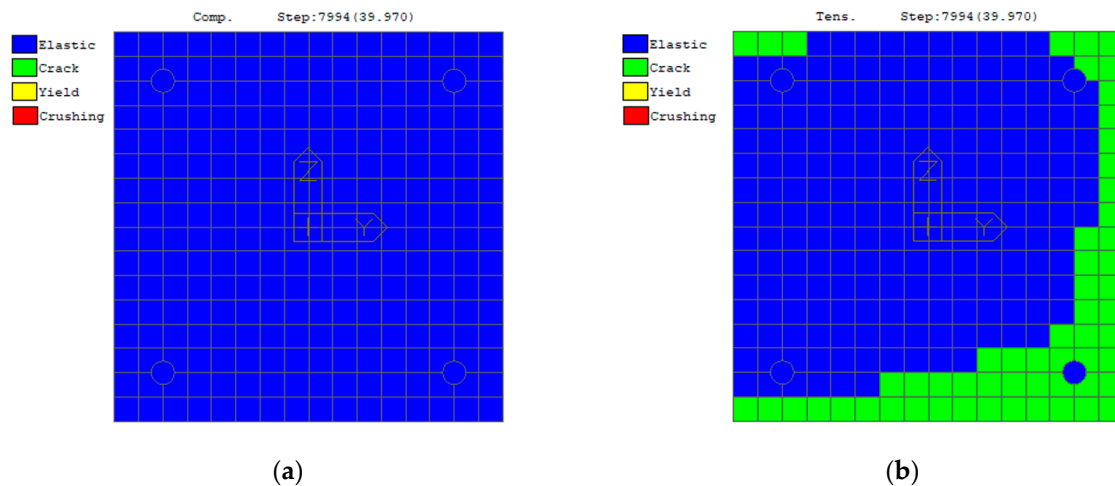
**Figure 10.** Analysis of a column's top at a seismic input with a scale factor of 0.1: (a) tension; (b) compression.

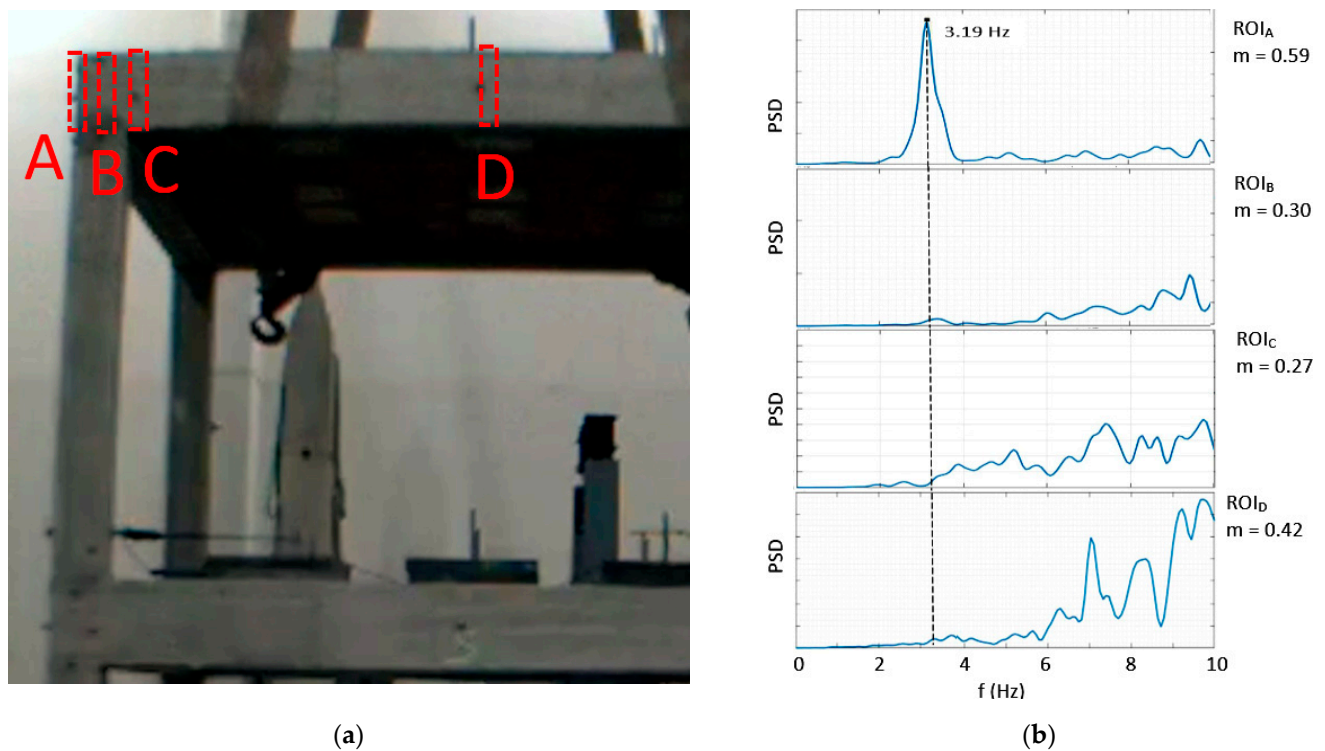
**Figure 11.** Comparison of ROIs with different image contrasts: (a) details of the selected ROIs (red, dotted lines), named A to D; (b) PSD and contrast index  $m$  for each selected ROI.

where  $I_{\max}$  and  $I_{\min}$  are the highest and lowest pixel values in the ROI, respectively. Then, the ROIs' pixels were analyzed in the frequency domain, and the PSD was calculated. As illustrated in Figure 11b, ROI<sub>A</sub> has with the highest  $m$  value and provided a good identification of the modal frequency. In fact, the contrast in ROI<sub>A</sub> was determined by the difference in color between the column edge and the white background, while the contrast in the other ROIs was very poor, as it was only because of the slight heterogeneities in the color of the concrete and the presence of markers. Thus, the final ROI was chosen, enlarging ROI<sub>A</sub>, as shown in Figure 12a. The PSD was then calculated for each Rnd test (Figure 12b).

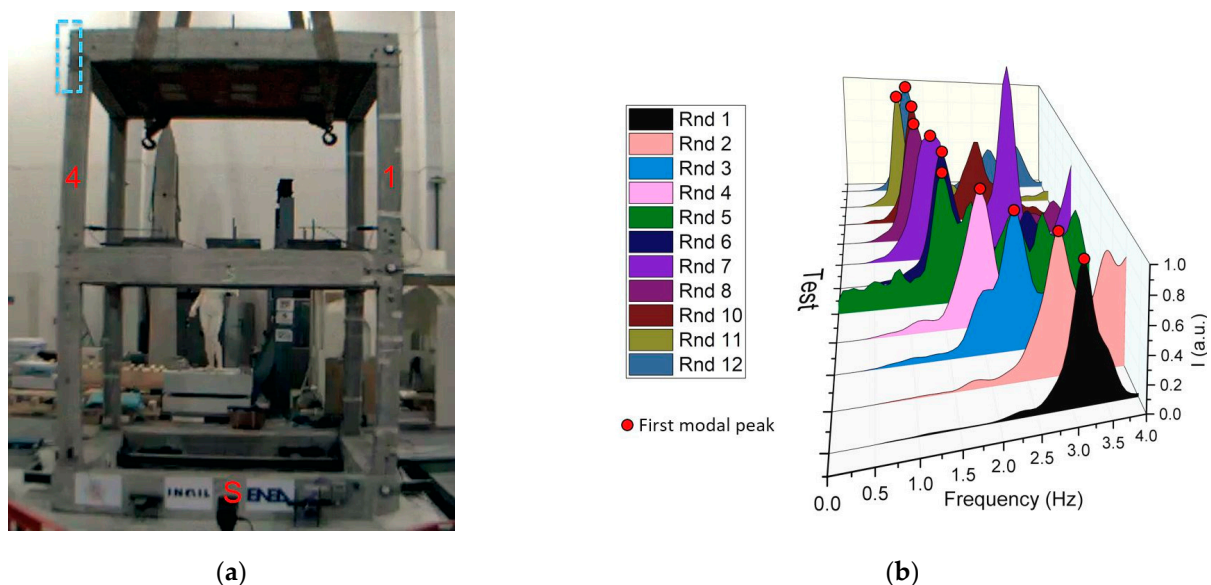
**Figure 12.** Video processing using motion magnification (MM): (a) final ROI (blue, dotted line) at the south (S) side of the top column 4; (b) identification of the first mode peaks in the frequency domain for all white noise Rnd shaking table tests.

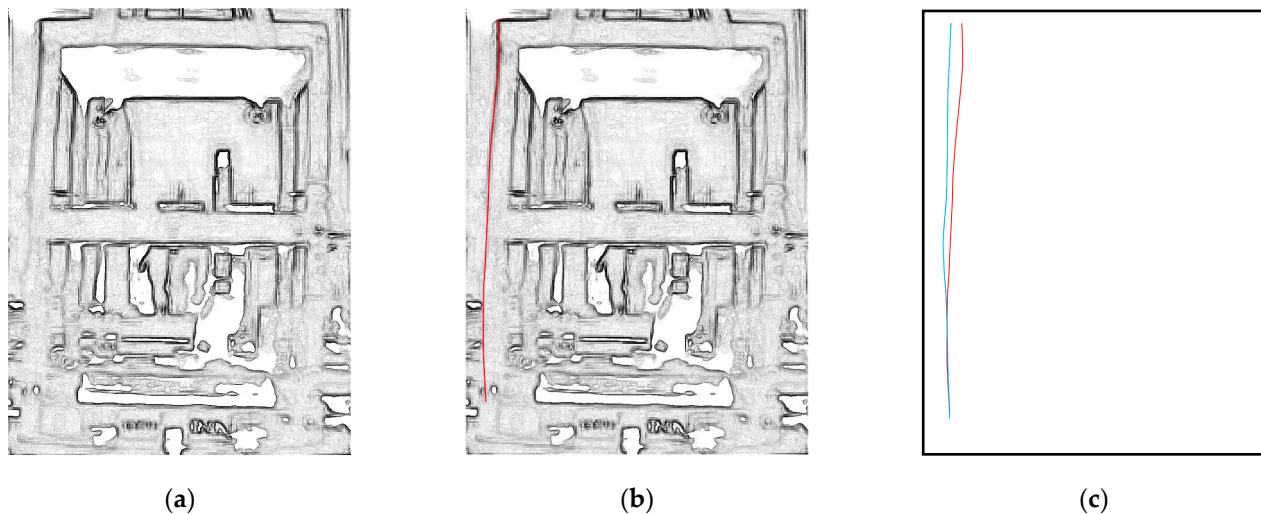
**Figure 13.** Video processing for the modal shape extraction: (a) FMD after edge detection; (b) identification of the structural line of column 4 (red line) in the FMD; (c) extracted structural line of column 4 from the FMD (red line) and from the FZD (blue line).

ROI was assumed as the FZD of the MM video. The FMDs and FZDs were processed using color adjustment and contrast maximization. Then, the invert edge detection algorithm was applied to outline the main structural lines of the columns and floor slabs (Figure 13a). In particular, the column lines were considered for the first modal shape identification, as it was expected to be an x-direction bending mode (Figure 13b). The column lines were digitized with 100 points (one point every 4 cm, for a total height of 400 cm). The relative displacements in the x-direction between the corresponding structural lines in the FMD and FZD were calculated to extract the modal shape (Figure 13c).

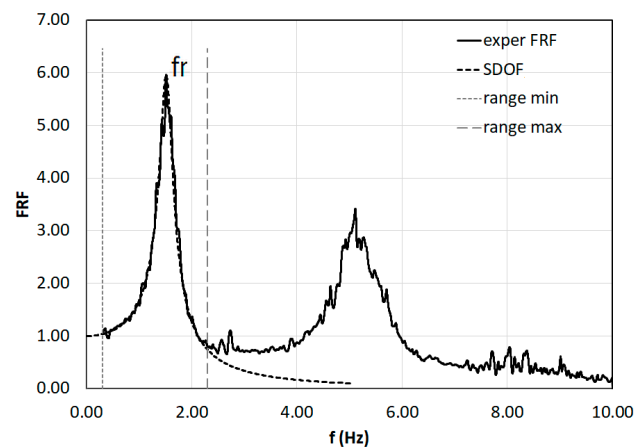
**Figure 14.** Identification of the first modal frequency ( $f_r$ ) of the FRF of the marker data (exper FRF).

where  $S_{io}$  is the cross power spectrum of the input and output signals, respectively;  $S_{ii}$  is the auto power spectrum of the input signals; and  $\omega$  is the angular frequency, calculated as  $2\pi \cdot f$ , where  $f$  is the frequency. The  $H_1$  estimator, obtained from the marker data, is then compared with the theoretical single-degree-of-freedom (SDOF) response by curve-fitting method for the accurate extraction of the resonance frequency (Figure 14).

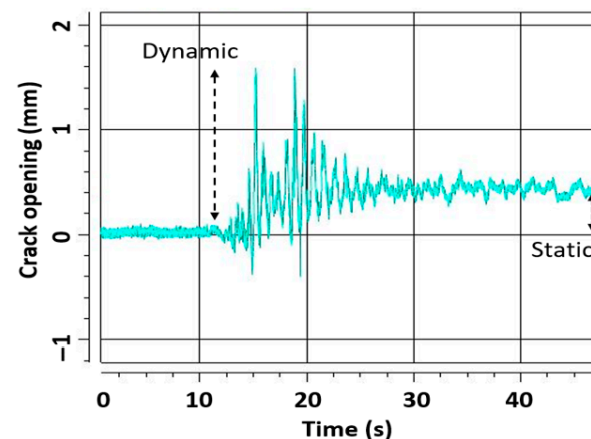
**Figure 15.** Typical crack opening during a seismic test. The shake began at 11 s.

The distances between markers were also investigated to detect structural deformations and, notably, a crack's opening and width [40]. In particular, in Figure 15 the typical behavior of a crack's opening during a seismic shake is depicted. Cracks typically open and close during a shake (i.e., dynamic condition) and eventually remain residually open at the end of the test (i.e., static condition) when permanent plastic deformation of the structure is achieved. Markers can detect a crack's width in both dynamic and static conditions so as to accurately characterize the crack's behavior.

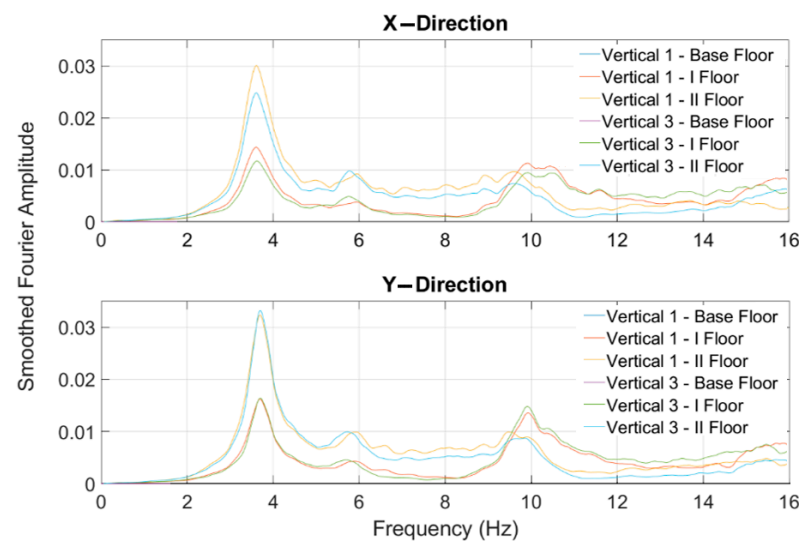
**Figure 16.** Smoothed amplitude Fourier spectra evaluated for the RND\_01 test.

where  $a_r$  represents the relative floor acceleration. The modulus of the relative acceleration of spectra  $|A_r(\omega)|$  were smoothed using a 75-point moving average filter implemented in MATLAB®. Figure 16 shows the smoothed amplitude Fourier spectra evaluated in the experimental model, considering the data acquired during the NRC\_01g test. The same results were also used to evaluate the mode shapes associated to the first fundamental modal frequencies related to the x- and y-directions.

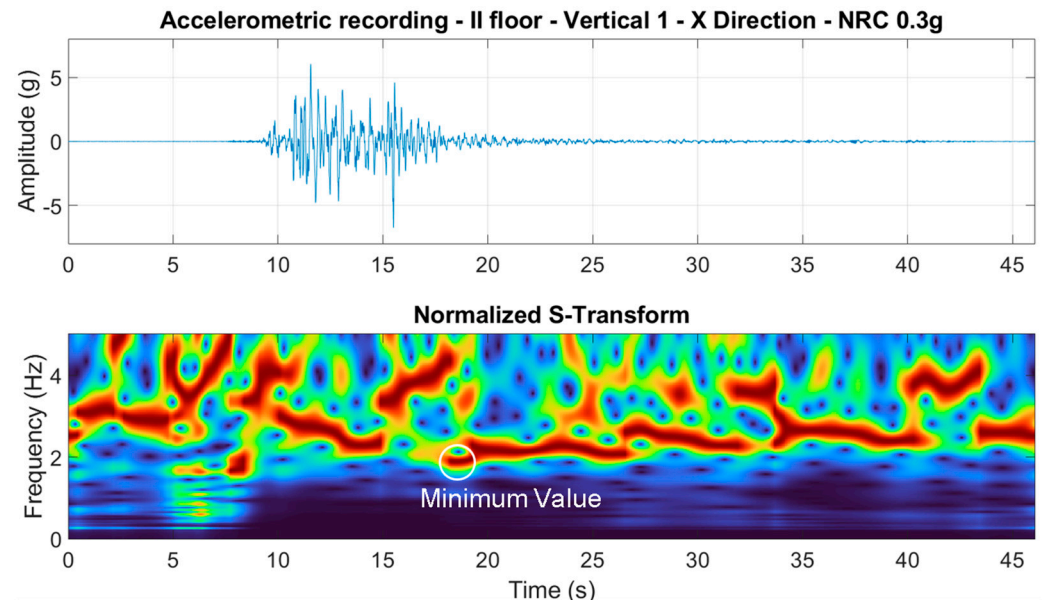
**Figure 17.** Stockwell transform (bottom graph) evaluating the NRC\_0.3g test (top graph), related to column 1, second floor, in the x-direction. In the bottom graph, false colors indicate values from 0 (blue) to maximum (red).

where  $t$  is the time;  $f$  is the frequency; and  $\tau$  is a parameter controlling the position of the Gaussian window along the time axis. An example of the application of the ST is presented in Figure 17, and it is related to the test where the NRC\_0.3g earthquake was applied.

The ST analysis allowed for the evaluation of the fundamental frequency variation of the structure during the strong motion test. Along the x-direction, the minimum value of the fundamental frequency exhibited by the structure during the NRC\_0.3g test was equal to 1.86 Hz. Similar results were found using STIRF [30] analyses on the same accelerometric recording, not shown here for the sake of brevity. More details concerning the nonlinear behavior of the structure exhibited during the shaking table tests are reported in Section 6.

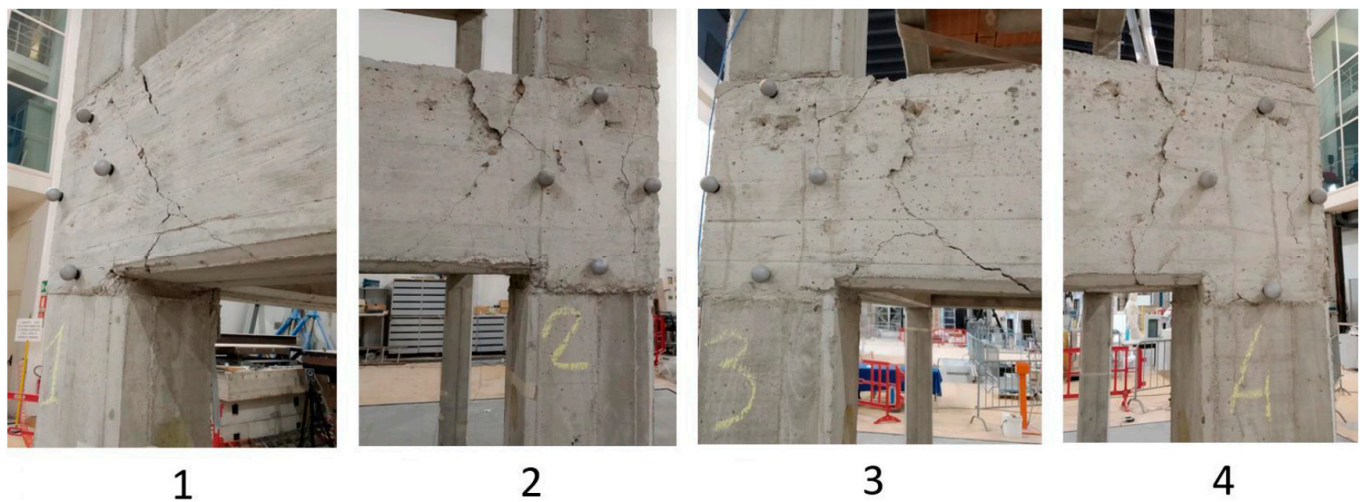
**Figure 18.** Details of the damage at beam column joints on first floor (the numbers indicate the columns).

After the shaking table tests, a visual inspection was carried out in order to assess the crack pattern and state of damage to the structure. The visible cracks were essentially concentrated at the beam column joints on first floor (Figure 18). Fewer cracks were also visible at the beam column joints on second floor (Figure 19). Only a limited number of small cracks arose at the column's base.

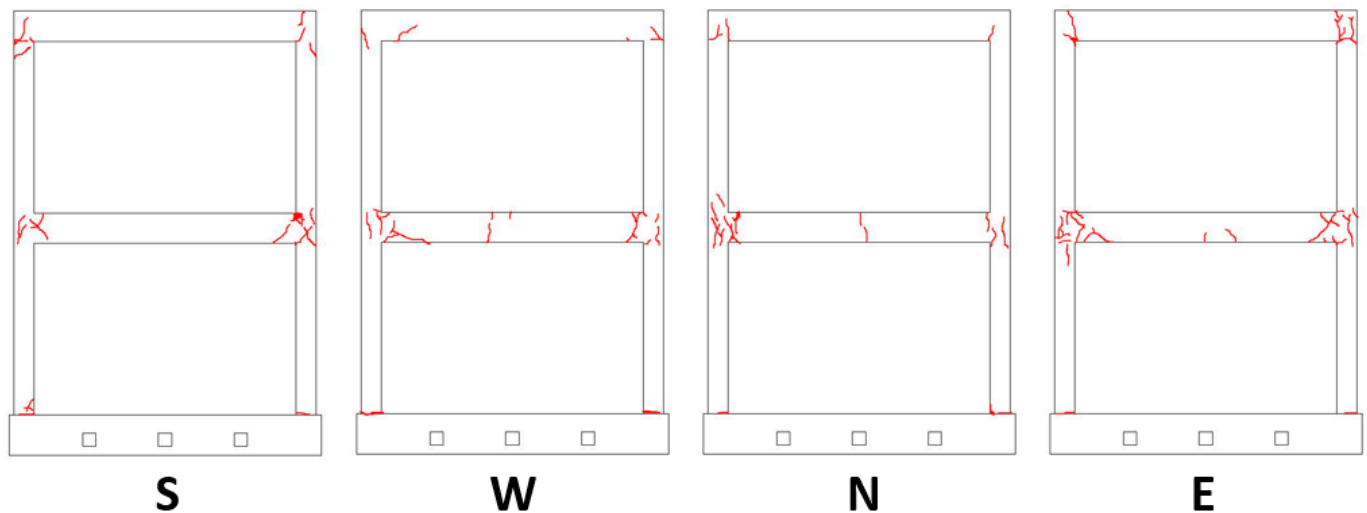
**Figure 19.** Cracks (red lines) at the end of the seismic tests. Letters indicate the facades.

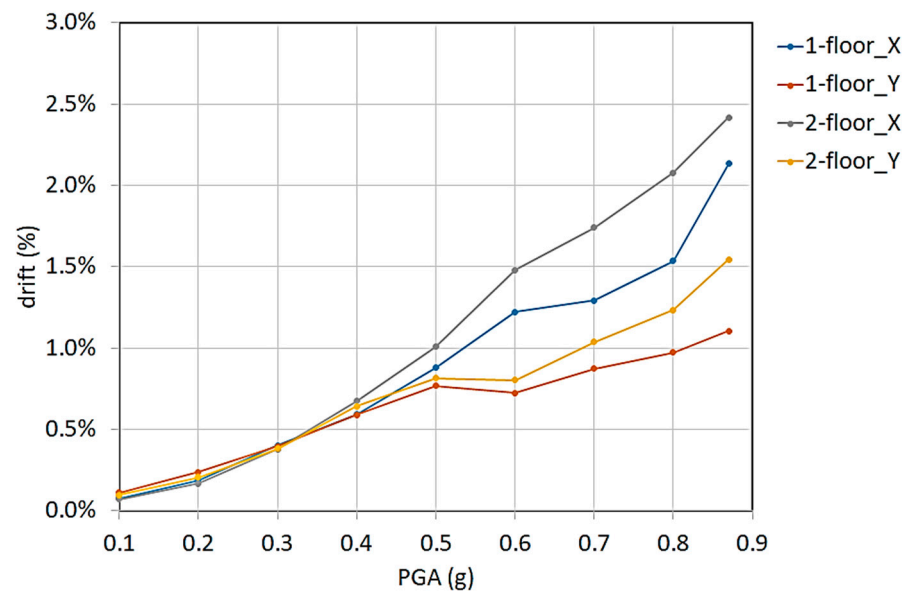
**Figure 20.** Inter-story drifts (1 and 2 floors) in the x- and y-directions vs. shaking table PGA.

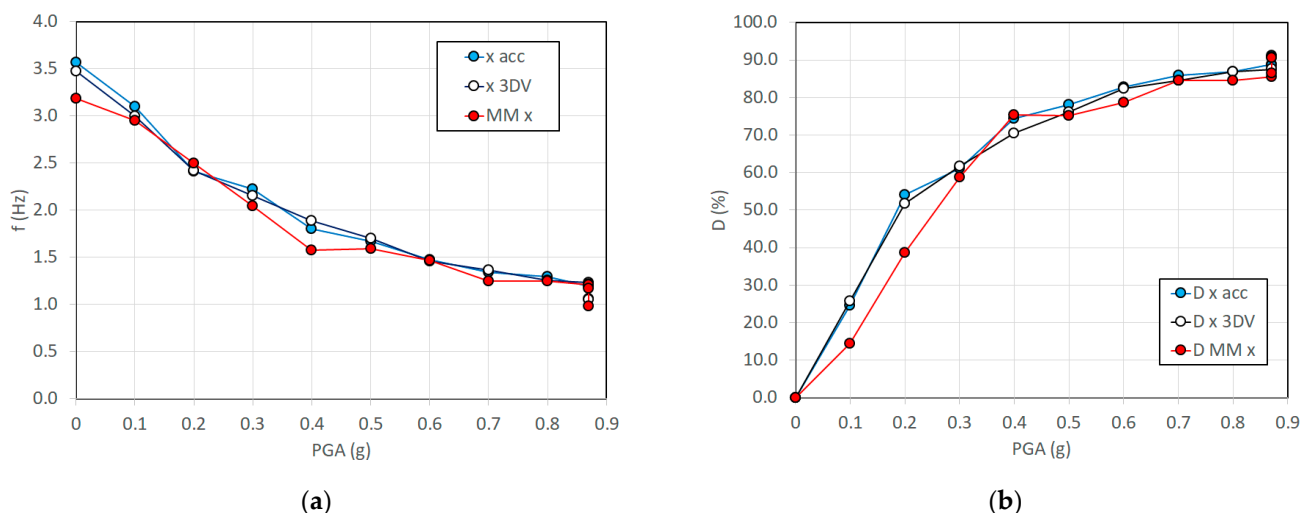
**Figure 21.** First modal frequency ( $f_r$ ) of the tested structure calculated with marker data (3DV), accelerometers (acc), and motion magnification (MM) in the x-direction: (a) evolution of  $f_r$  in white noise random tests during shaking table sequence; (b) corresponding damage index D%.

In Figure 21a, a comparison of the  $f_r$  estimates in the Rnd tests with the accelerometers, markers, and MM videos is depicted vs. the PGA of the previous shaking table test. In order to assess the state of damage of the structure, a damage index (D) can be formulated based on  $f_r$ , according to the following equation:

where  $f_0$  is the first modal frequency in Rnd\_01, which was performed before the seismic tests so that it was representative of the undamaged structure. Figure 21b shows the estimated D values.

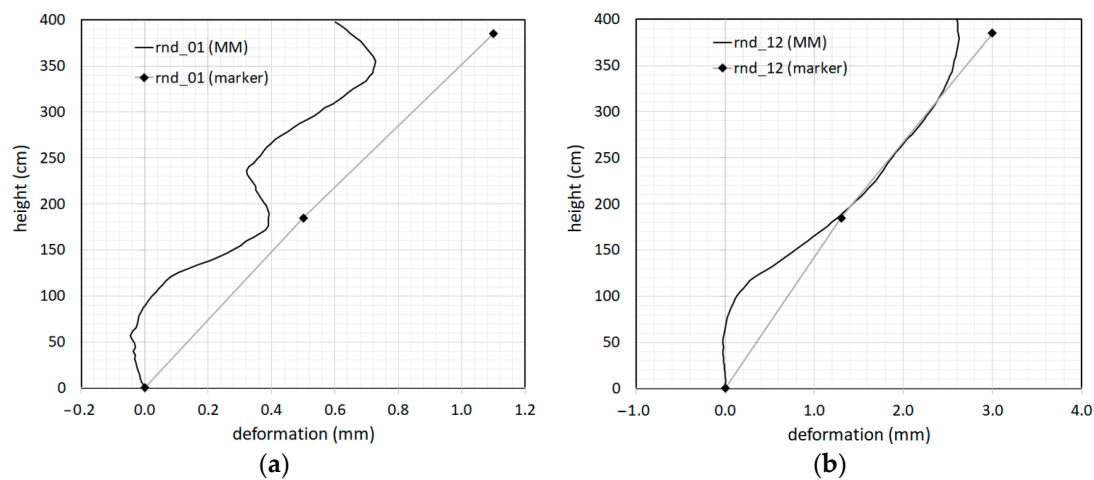
**Figure 22.** First modal shape calculated using the MM and markers in the  $x$ -direction: (a) modal shape extracted with the “Rnd\_01” test; (b) modal shape extracted with the “Rnd\_12” test.

The first modal shape obtained by the MM videos and 3D MCS markers are illustrated in Figure 22. Here, the modal shape during the Rnd\_01 (undamaged structure) and Rnd\_12 (final damaged condition) tests can be compared. The modal shape was characterized by markers at only three measurement positions (base, first floor, and second floor), because the marker locations were mainly concentrated at the beam column joints to monitor the cracking where most of the damage was expected. Of course, many more markers could be used on the columns. However, the number of usable markers was limited in comparison to the positions detectable by video pixels. In fact, the modal shape by the MM video was obtained by digitizing 100 points, meaning one point every 4 cm in height. In Figure 22a, the effect of the beam column joints is extremely evident, especially in terms of the relationship between the flexural stiffness of the beams and columns.

As it is often the case in low-rise and mid-rise buildings, the relative stiffness of frame members lies in between flexural-type and shear-type behavior. As a consequence, both beams and columns bend in a double curvature, which typically results in an almost shear-type response. Moreover, the rotational flexibility of the columns at the base of the building is determined by the degree of fixity at the structure's base. The slightly negative rotation detected at the structure's base and both beam column joints of the first and second floors can partially be due to the nonperfectly vertical positioning of the MM camera. However, such rotations were on the order of 0.1 mm in 50 cm, which is very small. In Figure 22b, it is interesting to note that the double curvature of the first floor beam column joint disappeared completely in the Rnd\_12 test, which is the effect of advanced damage to the joint, making the column unable to effectively connect to the first floor beam. The curvature at structure's base and the second floor are still visible but clearly reduced with respect to the initial undamaged condition as in Rnd\_01, which indicates less damage.

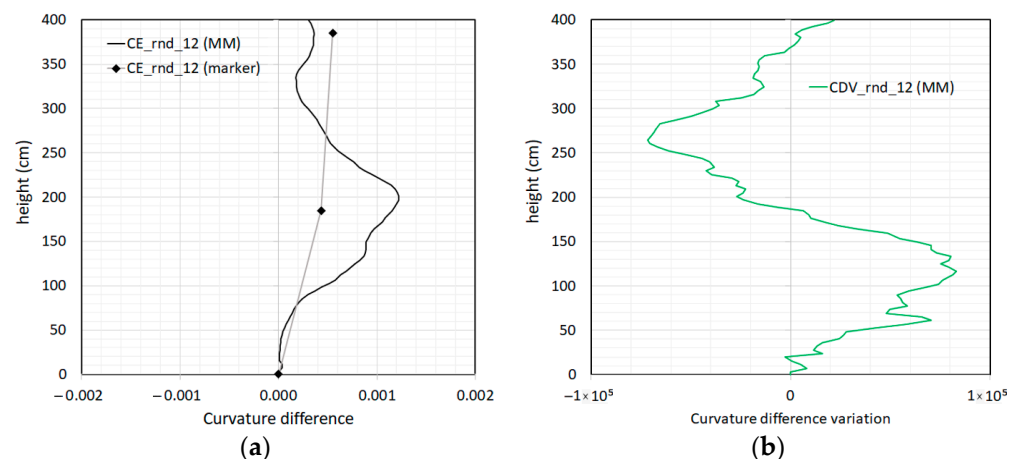
**Figure 23.** Analysis of the first modal shapes: (a) modal shape curvature difference (CE) between the “Rnd\_12” and “Rnd\_01” tests; (b) corresponding curvature difference variation (CDV).

In Figure 23a, an analysis of the evolution of the first modal shape is illustrated in terms of the curvature difference between Rnd\_01 and Rnd\_12. As a confirmation, the curvature difference using MM showed higher values in correspondence with the first floor beam column joint, locating with remarkable accuracy the main damage.

The location of the damage seemed to be even more accurately indicated by the zero crossings of the curvature difference variation in Figure 23b, even if zero crossings cannot provide an estimate of the severity of the damage.

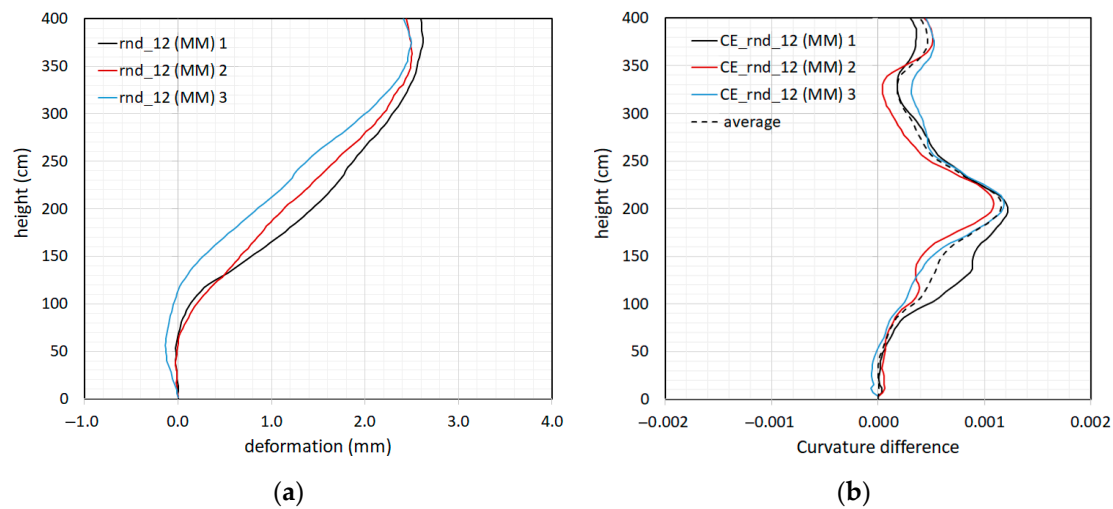
**Figure 24.** Repetition of the modal shape extraction using the three amplest oscillations (“1”, “2”, and “3”): (a) modal shape extracted using the “Rnd\_12” test; (b) modal shape curvature difference (CE) between the “Rnd\_12” and “Rnd\_01” tests.

In order to prove the consistency of the obtained results, the modal shape was extracted using the three amplest oscillations (Figure 24a). The corresponding curvature differences depicted in Figure 24b clearly confirm the damage location obtained with the absolute maximum FMD and minimum FZD frames.

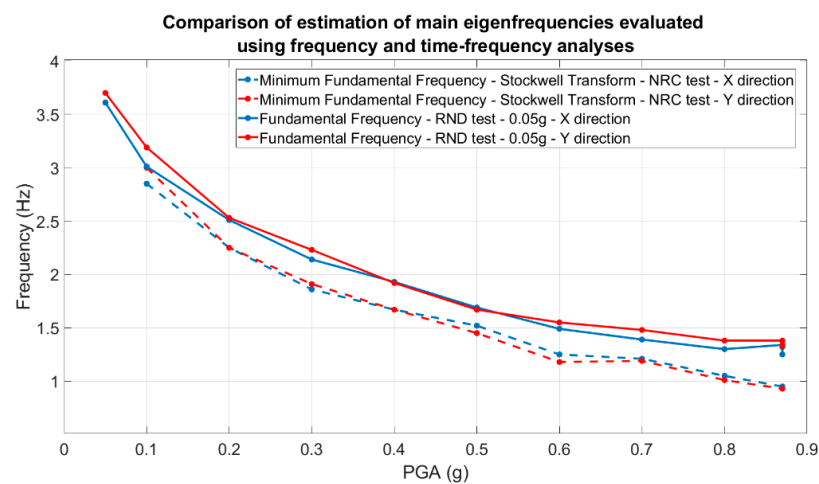
**Figure 25.** Comparison of the main structural modal frequencies evaluated using random tests (stationary values of the modal frequencies) and Stockwell transform (minimum value of the modal frequencies).

Using the modulus of the Fourier spectra of the relative accelerometric Rnd recordings acquired from the top floor, the main modal frequencies were evaluated along both the  $x$ - and  $y$ -directions. Using the NRC accelerometric recordings, time-frequency ST analyses were performed with the aim of evaluating the minimum value of the fundamental frequency exhibited by the structure during each shaking table test. In Figure 25, a comparison of the estimated modal frequencies along the  $x$ - and  $y$ -directions is shown.

It is worth noting that the higher the level of structural damage, the greater the difference between the structural natural frequencies estimated using the random tests (stationary behavior) and those evaluated using the Stockwell transform during the strong motion phase.

Analyzing the results shown in Figures 25 and 26, the importance of using time-frequency analysis techniques is demonstrated, as the correct evaluation of the structural modal frequencies of the damaged structure and, consequently, the correctly estimation of the relative structural damage can be observed. Using the performed random tests, the fundamental mode shape evolution relative to the x-direction was evaluated and depicted in Figure 27.

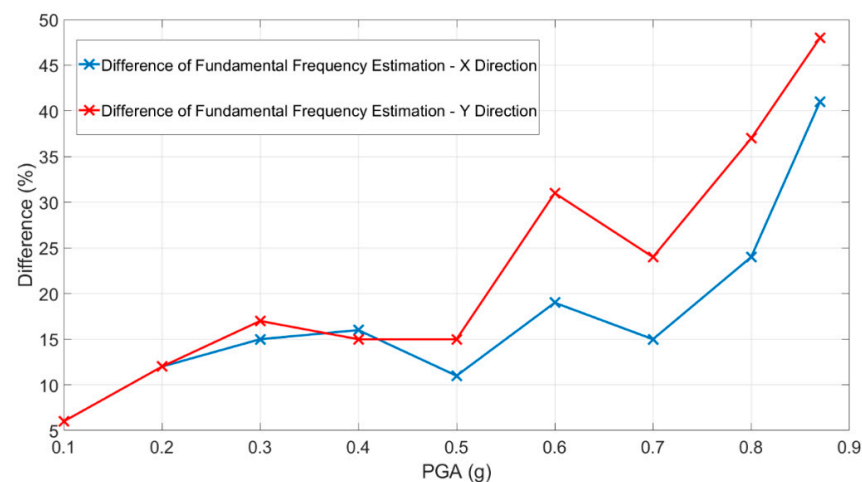
**Figure 26.** Differences in the estimation of the structural modal frequencies using random tests (stationary values in the modal frequencies) and Stockwell transform (minimum value of the modal frequencies).

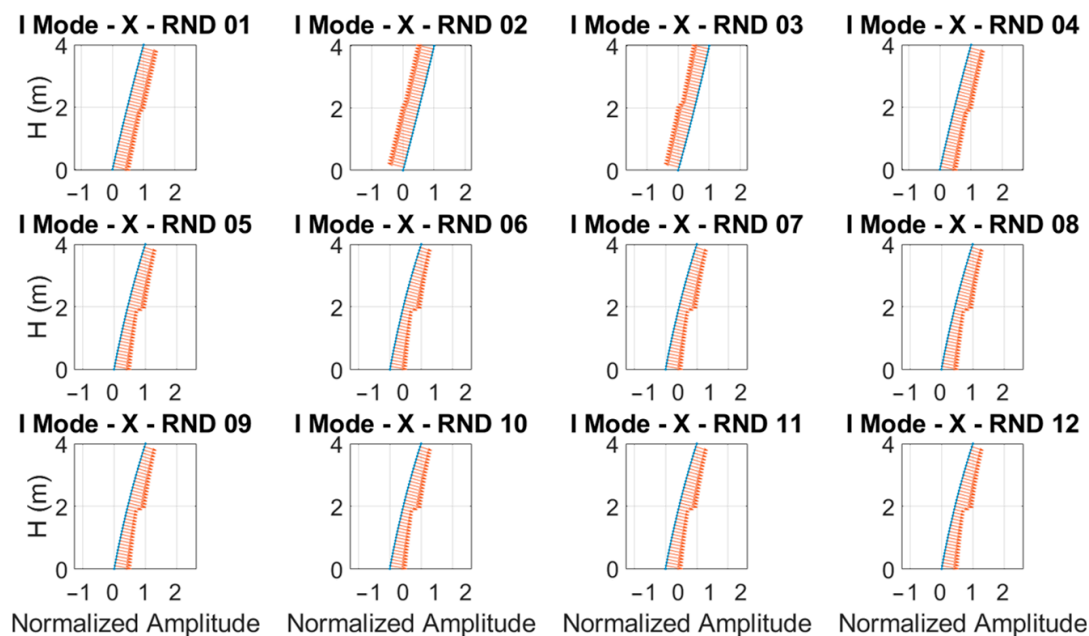
**Figure 27.** Fundamental mode shape (blue lines) and related curvature vectors (red arrows) evaluated along the  $x$ -direction using random tests.

The curvature variation was evaluated on the interpolated mode shapes retrieved using piecewise cubic Hermite interpolating polynomials, where the most damaged floor was the first floor. The results obtained for each random test in terms of the curvature variation confirmed what was found in the laboratory using traditional visual inspections and using the MM-based technique.

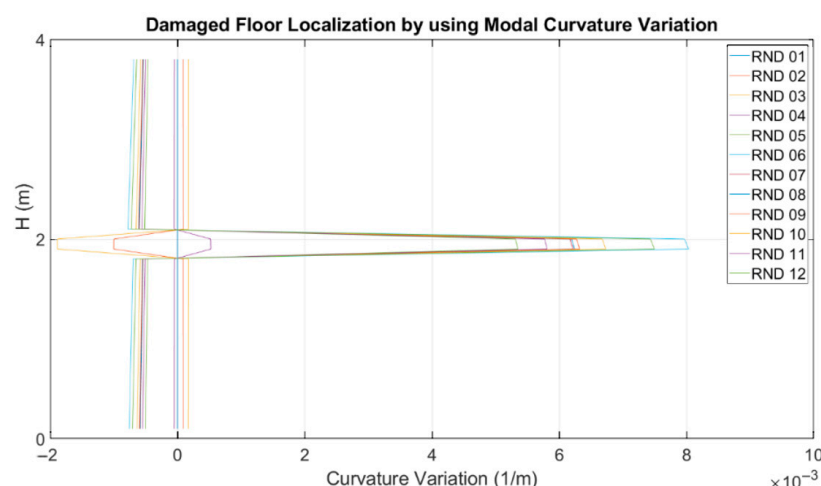
Figure 28. Damage level localization by using the modal curvature variation.

In order to identify the most damaged floor using the accelerometric dataset, the curvature variations were evaluated using the procedure described in [29,44,45] and shown in Figure 28.
