# Structural Monitoring of a Large-Span Arch Bridge Using Customized Sensors

**Citation:** Ietka, I.; Moutinho, C.; Pereira, S.; Cunha, Á. Structural Monitoring of a Large-Span Arch Bridge Using Customized Sensors. *Sensors* **2023**, *23*, 5971. <https://doi.org/10.3390/s23135971>

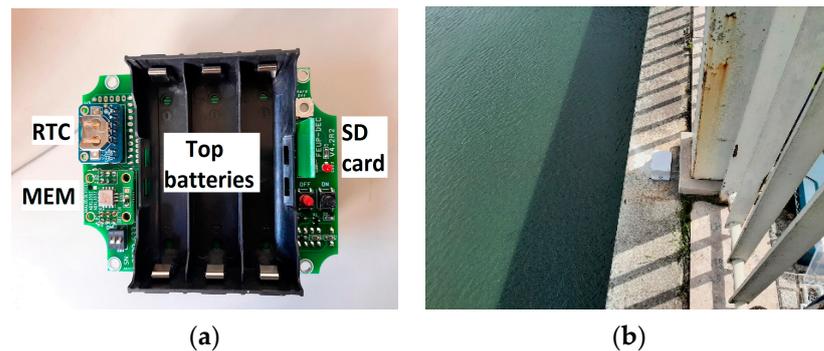
Figure 1 shows some photos of the accelerometer module used for Arrábida bridge. The external enclosure has an IP65 and is made of polycarbonate material. The box is fixed to the structure by means of its flanges to a pre-installed flat base. To change batteries and SD cards, the module is removed from its location, and after replacing these components, it is installed back in place. This operation takes about 10 min for each accelerometer.

**Figure 1.** Accelerometer modules: (a) view inside the module; (b) view on the bridge.

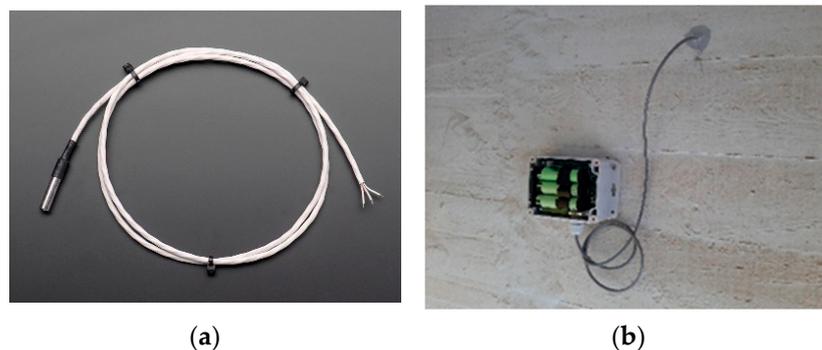
Figure 2 shows a photo of the temperature sensor inside a stainless-steel capsule, as well as a photo of one instrumented section.

**Figure 2.** Temperature sensors: (a) view inside the module; (b) view on the bridge.

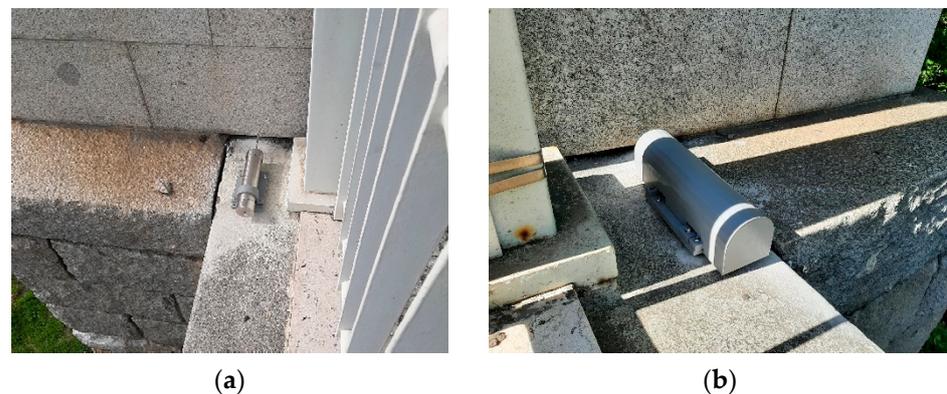
Figure 3 shows two photos of the displacement sensor installed in this structure. As can be seen, after installing the sensor, mechanical and visual protection is used to prevent or minimize acts of vandalism, as the sensors are accessible from the deck.

**Figure 3.** Displacement sensor at expansion joint: (a) view of the cylinder enclosure; (b) external protection.

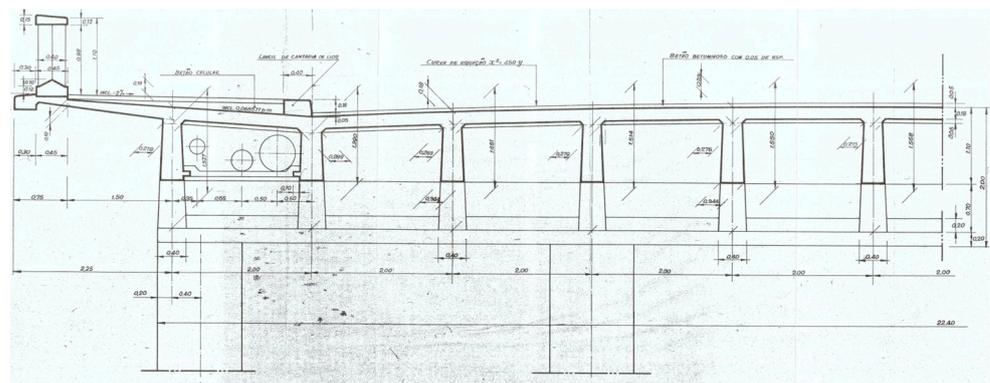
A total of 12 longitudinal beams compose the deck of the bridge, which has a transversal length of 25 m (Figure 5) and longitudinal spans of 21.2 m (Figure 6). The transversal alignments of the deck are supported by four columns through transversal beams, and these columns are supported by two twin arches with an 8 m length each and a bi-cellular box girder cross-section (Figures 7 and 8).

Figure 5. Transversal section of the deck.

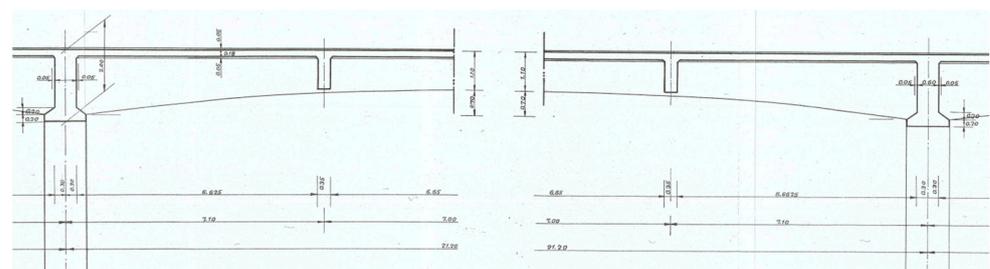
Figure 6. Longitudinal beams with a 21.2 m span.

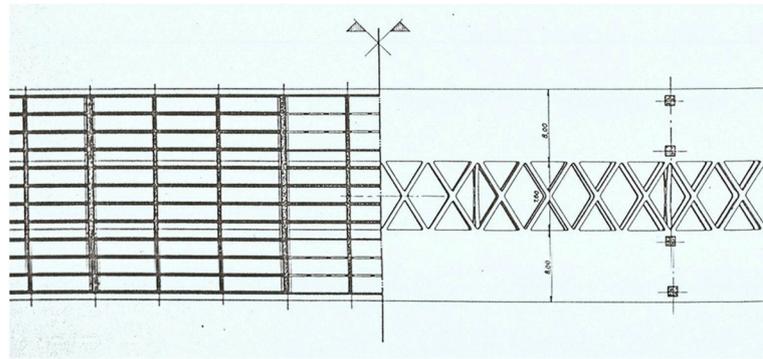
Figure 7. Plan view of the beams and twin arches.

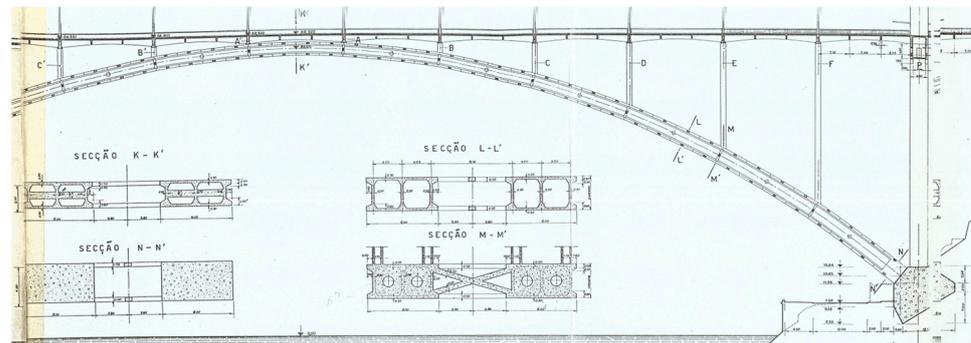
Figure 8. Different cross-sections of the arches and respective alignments.

The twin arches present four different types of cross-sections, which are located in the respective alignments: the mid-span of the bridge (center of the arch, section K–K'), the remaining spans (section L–L'), the column support areas (section M–M') and the end joints connected to the main columns through the foundation massifs (section N–N'). Each section can be visualized as shown in Figure 8.

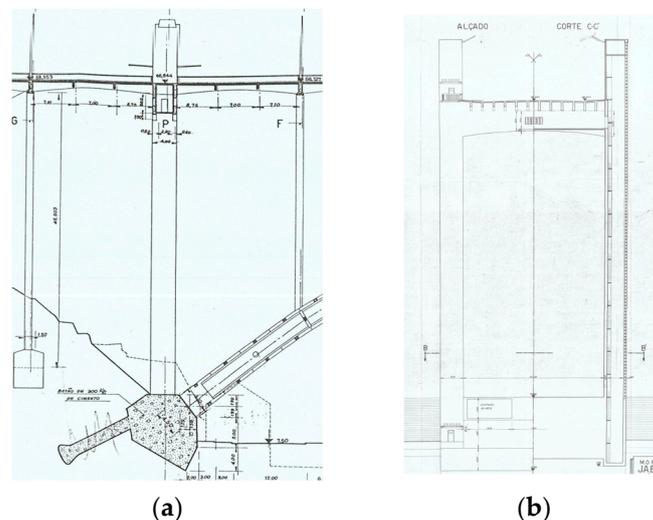
In addition to the columns supported by the twin arches, the bridge is supported by two pairs of main pilasters, which are located on each side of the bridge and are connected at the base to each extremity of the arch, as shown in Figure 9. These pilasters are transversally connected by special beams that are significantly more robust than the remaining ones and present as a cross-section, as indicated in Figure 10.

Figure 9. Pilasters of the bridge: (a) longitudinal view; (b) transversal view.

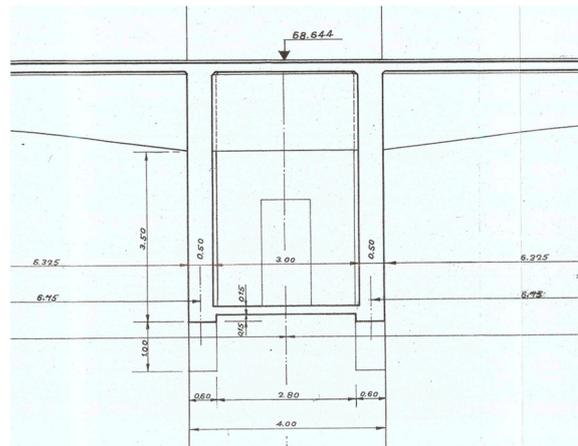
**Figure 10.** Cross-section of the beams that connect the pilasters.

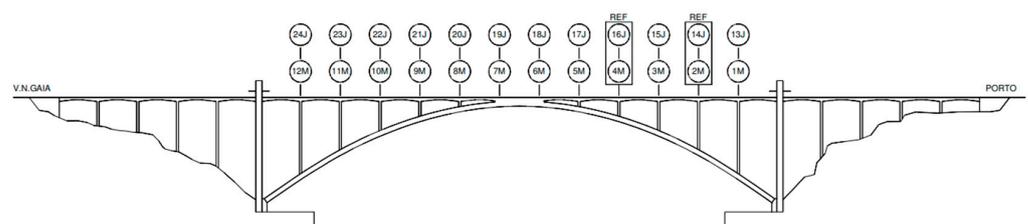
The measurement sections are indicated in Figure 11, where four sensors were positioned at fixed reference stations (sections 2M, 14J, 4M, 16J; M, upstream; J, downstream) and the remaining 20 units at mobile stations.

**Figure 11.** Location of the measurement points and fixed stations.

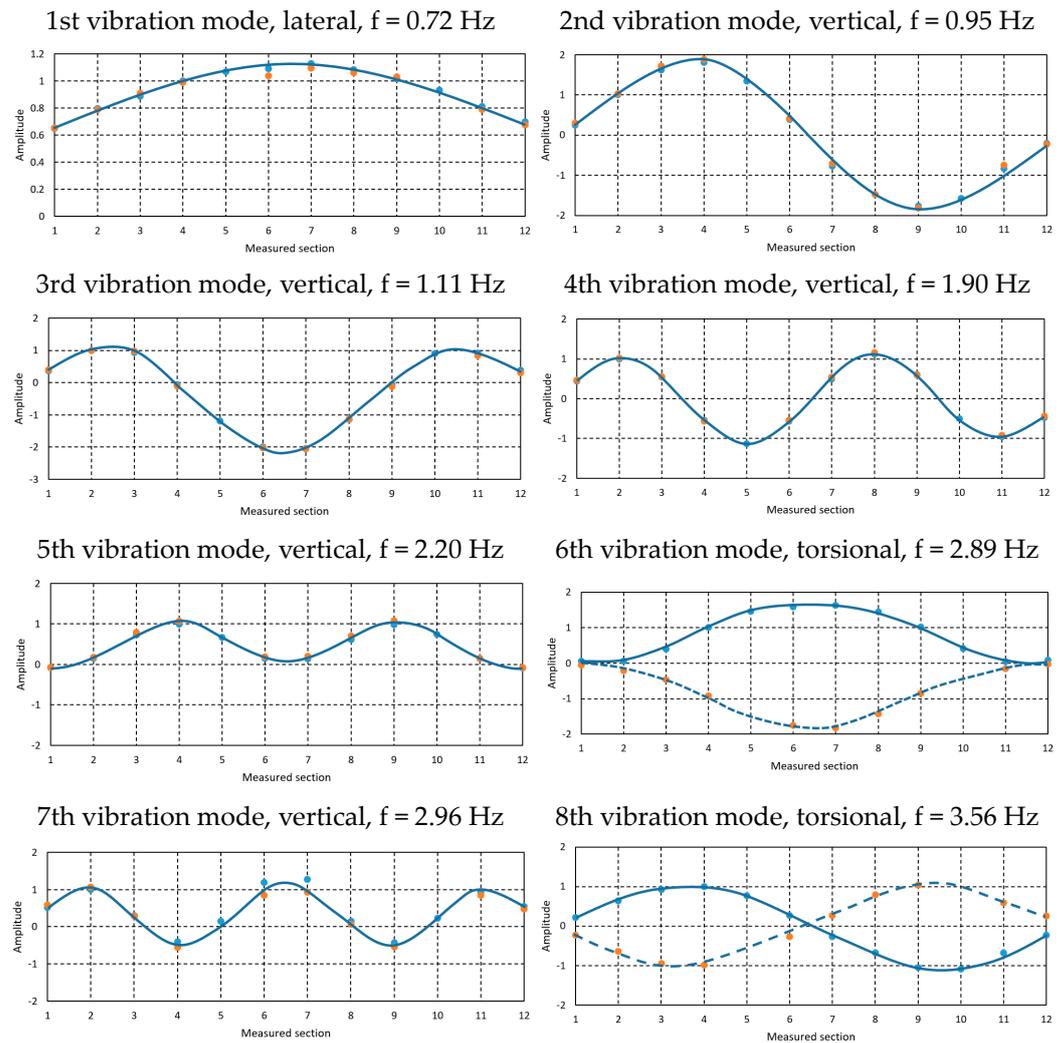
The registered signals were processed using the “Peak-picking” method, which permitted the identification of the first natural frequencies and respective vibration modes of the deck, as indicated in Figure 12 and summarized in Table 1. In these graphics, the blue points correspond to the modal coordinates identified on the upstream side of the deck and the orange points on the downstream side. The full line represents the approximate shape of the expected modal configuration.

**Figure 12.** Natural frequencies and vibration modes obtained in the ambient vibration tests.

As can be observed, the first natural frequency is 0.72 Hz, corresponding to a lateral vibration mode. The vertical modes follow the typical flexion modes of symmetrical structures, and the torsional modes present natural frequencies of 2.89 Hz and 3.56 Hz.

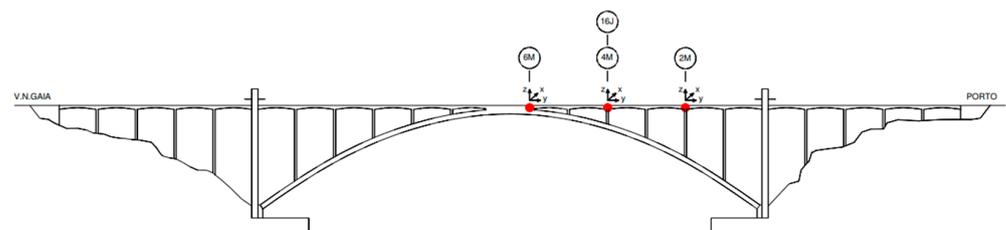
Regarding the accelerometers, all of the sensors were installed in the first phase of instrumentation and placed on the north side of the bridge, and these devices were named as follows: 2M, 4M, 6M and 16J. The devices with a code ending with “M” were placed upstream, while the ones ending with “J” were placed downstream. This configuration was chosen in order to capture the dynamics of the first vibration modes of the structure (see Figure 13). Sensors 4M and 16J were positioned at the same point in the elevation view but on opposite sides of the deck, enabling better identification of the torsional vibration modes of the bridge.

**Figure 13.** Location of the instrumented sections of the bridge.

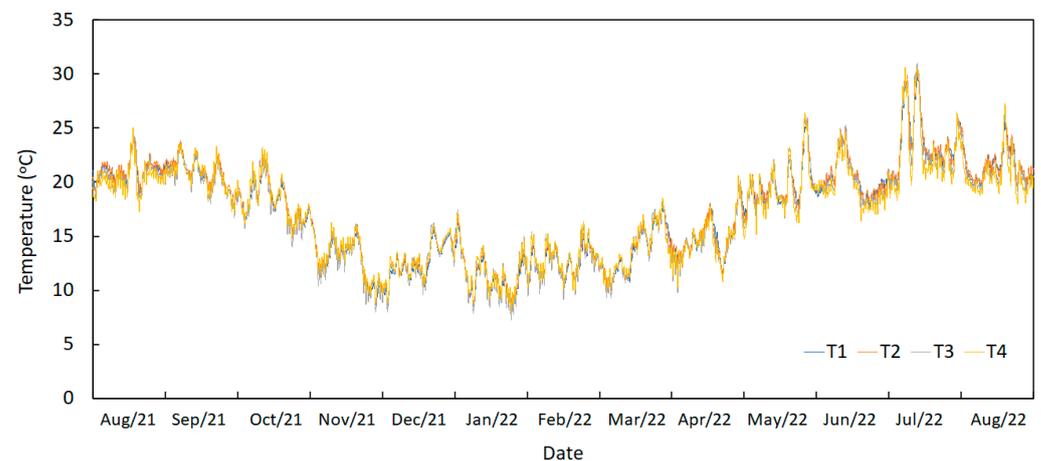
In Figure 16, the annual temperature variation recorded by the sensors installed on the deck (T1 to T4) is visualized.

**Figure 16.** Temperature records from August 2021 to August 2021 measured by sensors T1, T2, T3 and T4.

The analysis of this graph permits the identification of higher temperatures in summer, followed by decreased temperatures in winter. Some extreme temperature events may also be observed during July 2022, despite the limited period shown.

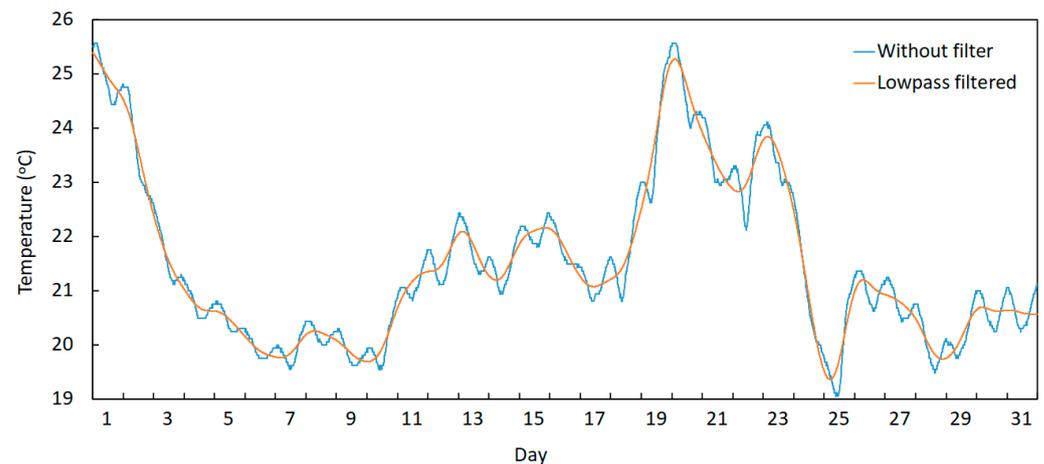
The trend component of the temperature may be obtained by filtering frequencies equal to and higher than the daily component and allowing lower frequencies to pass, which corresponds to the use of a lowpass filter (see Figure 17), while the daily temperature variation may be obtained by using a highpass filter with a cut-off frequency set to a value slightly below the daily frequency (see Figure 18).

**Figure 17.** Temperature variation of sensor T1 during August 2022: obtaining the trend component by applying a lowpass filter.

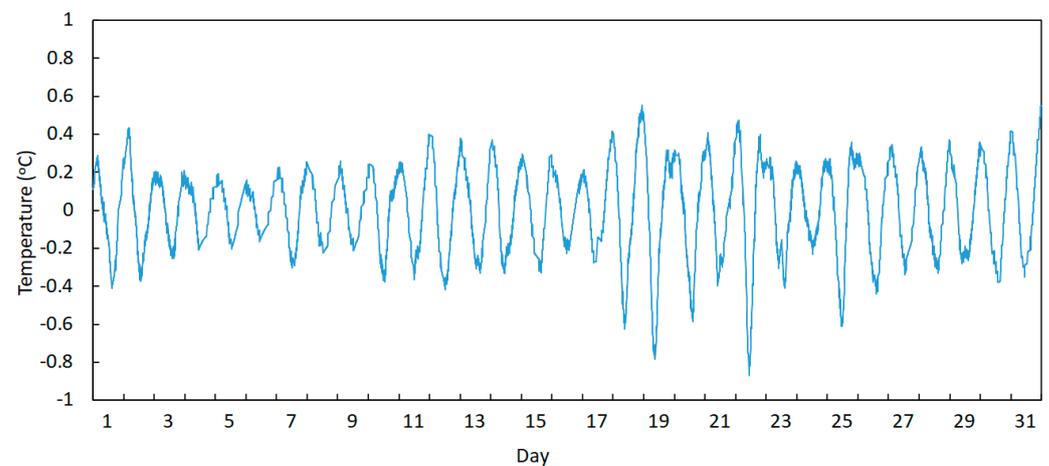
**Figure 18.** Temperature variation of sensor T1 during August 2022: obtaining the daily component by applying a highpass filter.

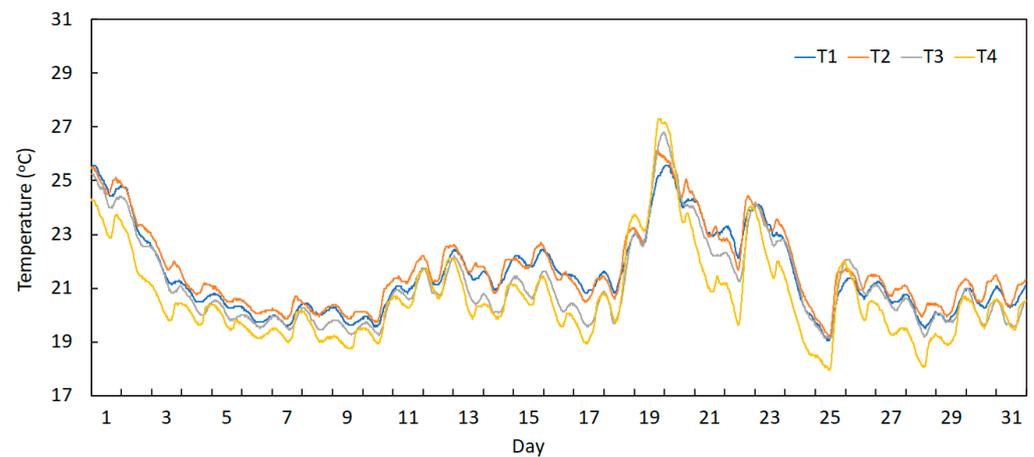
On the other hand, Figures 19 and 20 depict the measured temperatures obtained from the sensors installed on the deck (T1 to T4) and the arch (T5 to T8), respectively, during the month of August 2022. These graphs permit the verification that the devices installed on the deck present lower and smoother daily amplitudes. This is because these devices are installed on the transversal beams below the deck, where the sunlight incidence is not made directly on these sections. By contrast, temperature curves of the sensors placed at the arch show higher daily amplitudes and sharper peaks, as these devices are installed on sections of the arch exposed directly to sunlight incidence.

**Figure 19.** Temperature records during August 2022 measured using the deck sensors (T1 to T4).

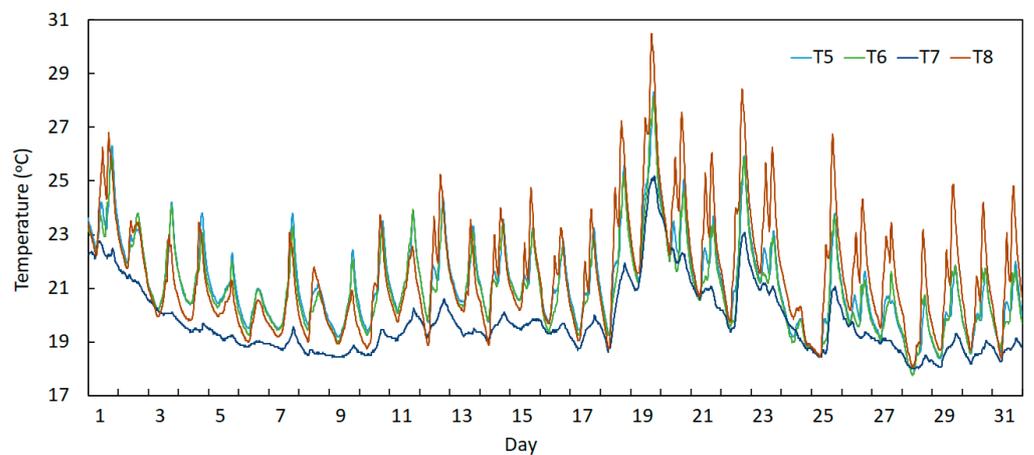
**Figure 20.** Temperature records during August 2022 measured using the arch sensors (T5 to T8).

In addition, Figure 20 permits the verification of the peculiar behaviour of sensor T7, which presented lower daily amplitudes in terms of temperature when compared to the remaining sensors installed on the arch. This difference can be justified by considering the section where this device is installed, which is very near to the mid-span of the bridge, where the vertical distance between the arch and the deck is very small, and consequently, this sensor is under the shadow of the deck, receiving less sunlight incidence than the others.

Moreover, the curves of sensors T5, T6 and T8 regarding the period of August/2022 reveals another important point to be discussed, which is also associated with the higher exposure to the sunlight incidence of these devices. In fact, very often, their daily variation curves present two consecutive peaks in short periods of time. This can be explained as a consequence of the changing position of the sun in relation to the position of these sections of the bridge. The first peak happens when the sunlight falls on the measured section with an angle that causes the initial temperature peak. At that time, the section is not under the shadow of the deck. Then, when the sun is over the deck (close to noon), the section becomes covered by the shadow coming from the deck, and so the temperature decreases. After some time of shadow, the section is again directly exposed to sunlight incidence, presenting with a new peak, which is higher than the first one. It is worth remembering that the temperature sensors are inserted into the concrete at a depth of 15 cm. Therefore, the measured temperature is not superficial.

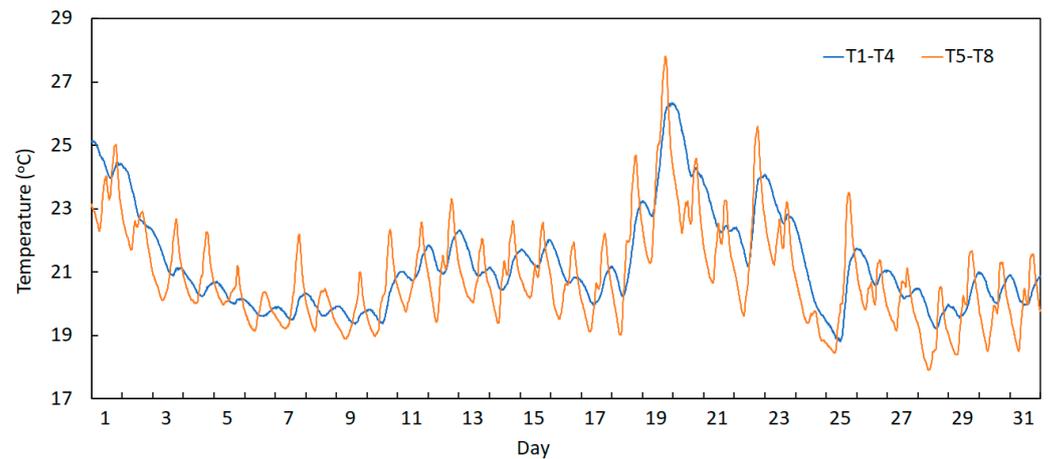
After dividing the recorded temperatures into two groups (deck sensors and arch sensors), the average temperature of each group was calculated, and each curve is represented in Figure 21.

**Figure 21.** Average temperature variation in August 2022 of the two groups of sensors: deck sensors (T1 to T4) and arch sensors (T5 to T8).

This graph permits the visualization of the fact that the two groups present different phase shifts between them, which was evaluated at  $-5.33$  h, meaning that the temperature sensors in the arch group achieve their peak of amplitude 5.33 h before the sensors in the deck group. This happens due to the placement of the sensors in these two different elements of the bridge. The sensors installed on the deck are located on the transversal beams below the top slab, and so they are not directly exposed to sunlight incidence. Once the light falls initially on the superior part of the deck slab, the heat is conducted through the concrete element from the deck to the beam, taking more time for the sections below the deck to reach the peak when compared to the incidence of sunlight on the sensors placed at the arch, which are directly exposed to it, and for this reason, achieve peak temperature sooner.

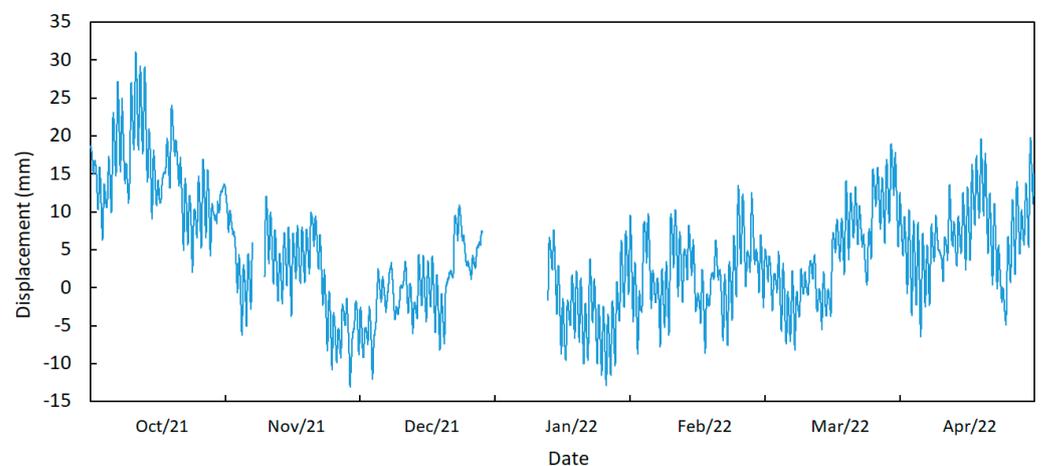
In Figure 22, the measurements of the displacement of the north expansion joint are shown, which were obtained by averaging the signals from the sensors installed on the upstream and downstream sides. During the periods from 6 November 2021 to 9 November 2021 and 27 December 2021 to 11 January 2022, there was a lack of data from both sensors due to a delay in battery replacement, leading to battery failure in the system during those periods.

**Figure 22.** Displacement variations in the north joint during September 2021 to May 2022 (average of sensors D1 m and D2-J).

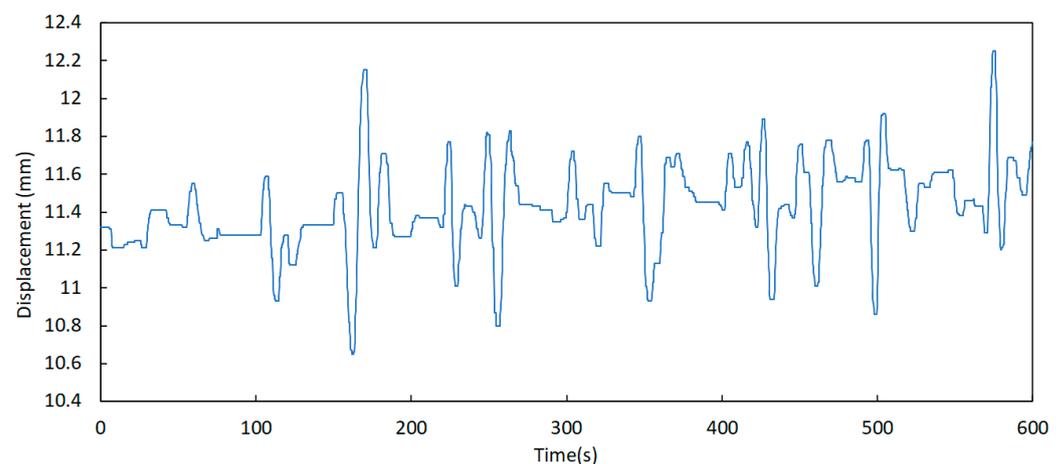
This was possible due to the adoption of a higher sampling frequency in the displacement sensors. While the temperature sensors were programmed to acquire one sample every 10 min, the displacement sensors use a sampling frequency of 5 Hz. Figure 23 shows an example of a displacement signal where dynamics with very small amplitude are clearly visualized (in the order of 1 mm peak-to-peak).

**Figure 23.** Displacement variation in sensor D1 on 22 October 2021 at 14 h 20 min (example of the dynamic component).

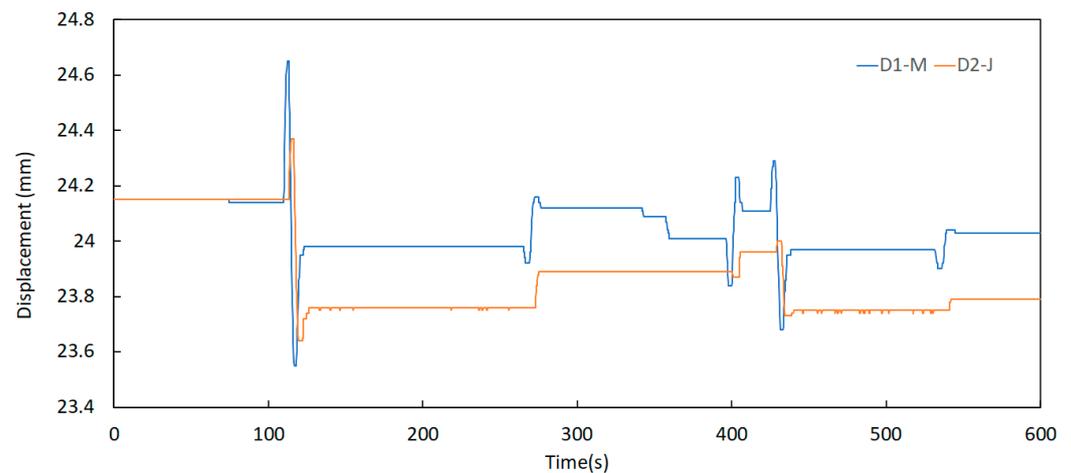
**Figure 24.** Displacement signals of the north joint sensors D1—M and D2—J on 11 October 2021 at 00 h 00 min.

It can be observed that the energy contained in the signals is much higher in the period of 08 h 00 to 08 h 10 min when compared to the period of 00 h 00 min to 00 h 10 min. This is attributed to the intensity of traffic flow, meaning that horizontal displacements in the expansion joints are related to the vertical loads applied by vehicles.

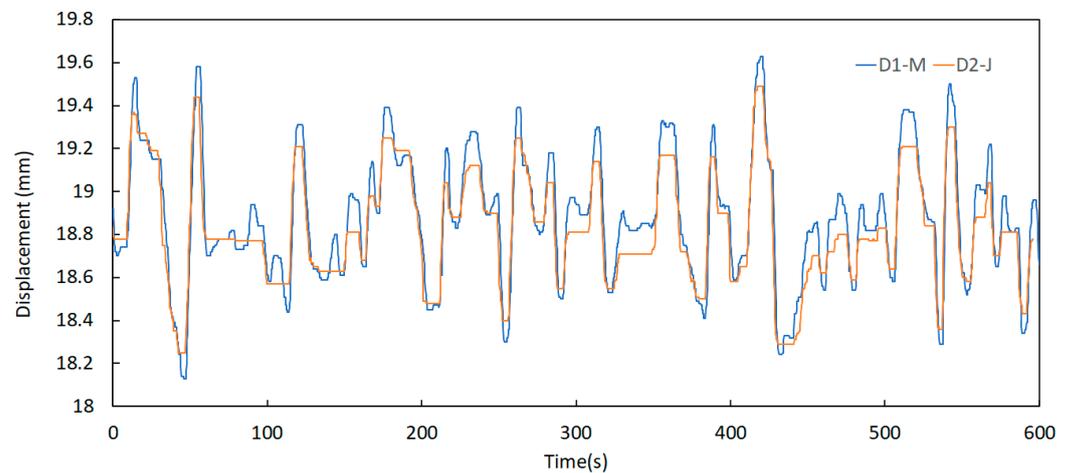
**Figure 25.** Displacement variation of the north joint sensors D1—M and D2—J on 11 October 2021 at 08 h 00 min.

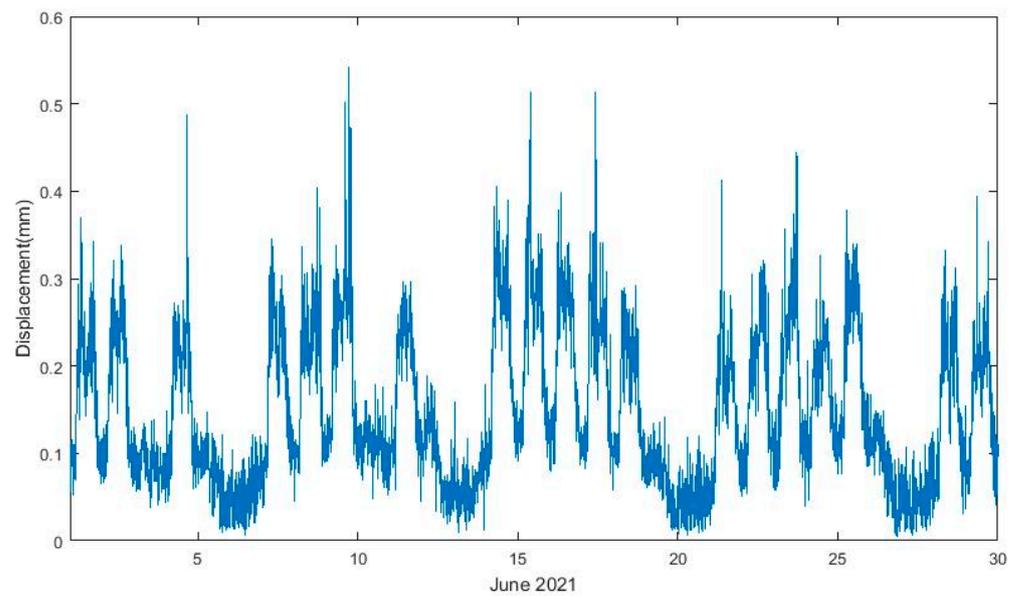
**Figure 26.** RMS values of displacements measured by sensor D1 m during June 2021.

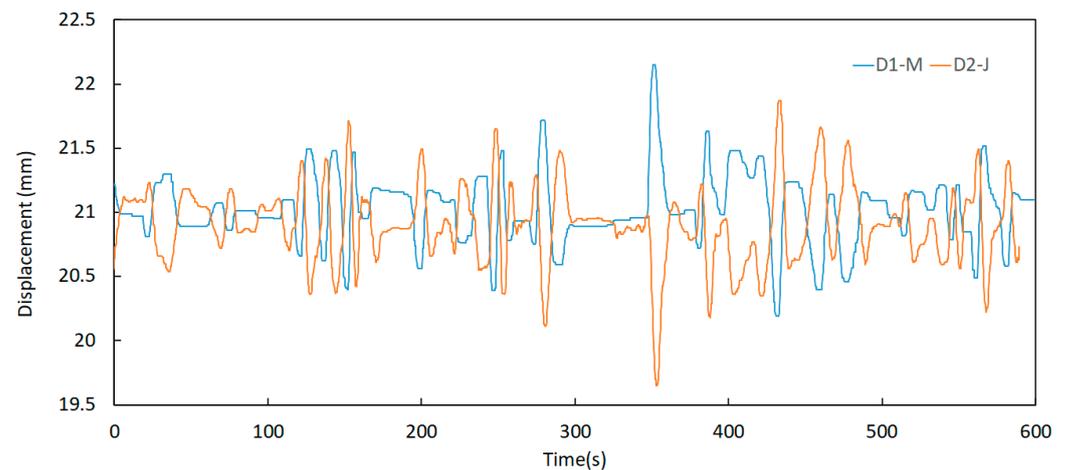
Curiously, when sensor D2 was moved to the south joint, the measurement records yielded the outputs indicated in Figure 27. They have similar amplitudes but opposite directions, meaning that when one joint expands, the other retracts, i.e., the deck is moving longitudinally as a rigid body.

**Figure 27.** Displacement variation of the north and south joint sensors D1b—M and D2b—M on 12 September 2022 at 08 h 00 min.

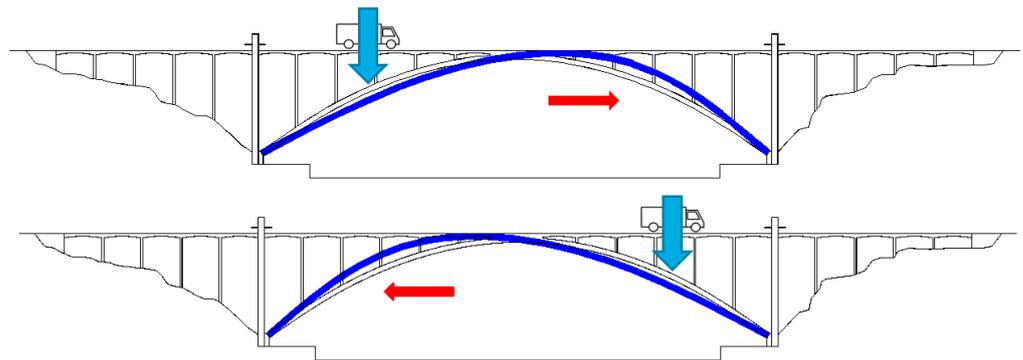
The effect of moving traffic on the displacement of the joints may be seen as suggested in Figure 28. Due to the deformation of the arch, when a certain vertical loading is more concentrated on the first half-span of the arch, the deck moves in the right direction, and after the loading changes to the second half-span, the deck moves in the left direction. That is why the signals of the displacement joints depicted in Figures 24 and 25 are marked by sinusoidal or pseudo-sinusoidal motions, which reflect the continuous motion of the loading from one pilaster to another.

**Figure 28.** Sketch of the deformation of the arch when submitted to a vertical loading in each half-span.

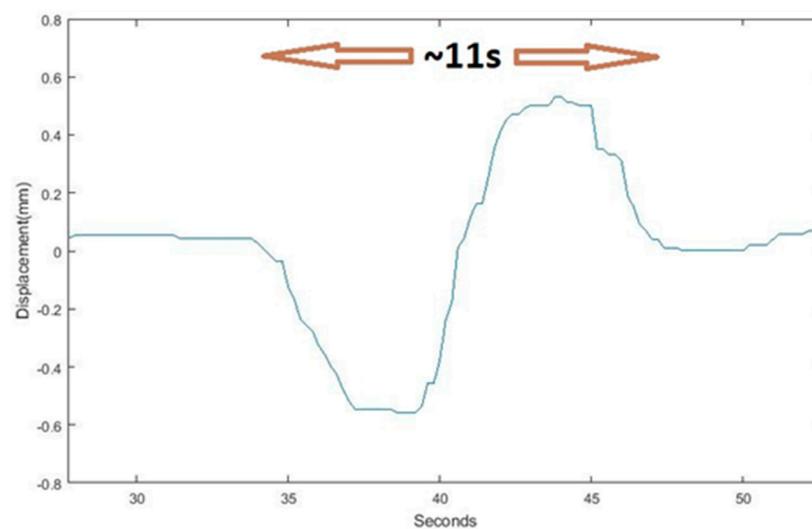
In addition, the frequency identification of these sinusoidal motions may be used to estimate the velocity of the vehicles over the bridge. As an example, Figure 29 shows a zoomed image of one of these sinusoidal signals registered during rush hours, where a period of  $T = 11$  s was estimated. Taking into account that the span of the arch from one pilaster to another is 270 m, the velocity of the vehicle is estimated to be 90 km/h, which is reasonably consistent with the normal velocity of traffic over the bridge during that period (see Figure 30).

**Figure 29.** Example of a sinusoidal motion of the arch in the longitudinal direction.

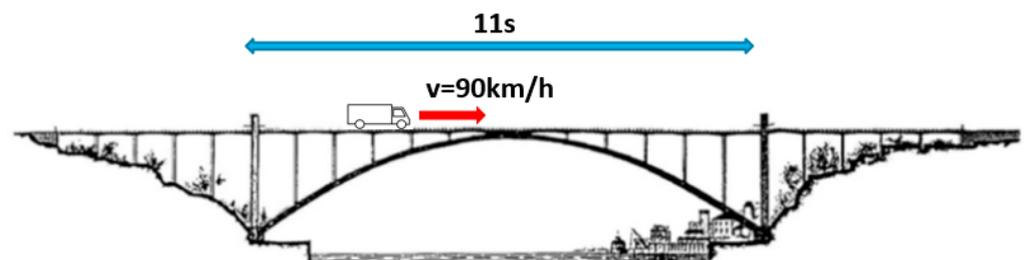
**Figure 30.** Estimation of the velocity of the traffic loads.

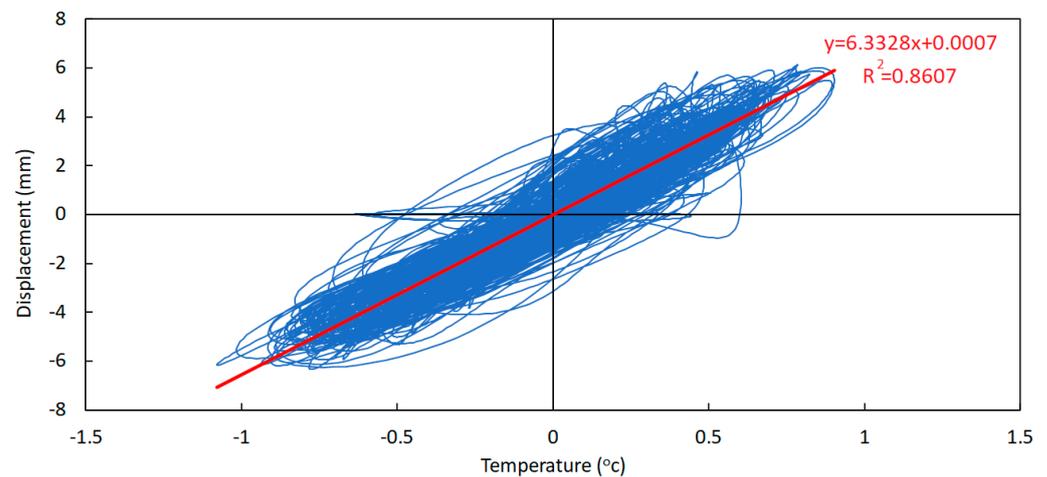
To find the correlation between the daily component of temperature and displacement, first, the temperature signal was aligned in order to be in the same phase as the displacement signal. Then, the temperature-versus-displacement chart was plotted, and its linear correlation line was obtained, as shown in Figure 31.

**Figure 31.** Temperature-versus-displacement chart—daily components (September 2021 to May 2022).

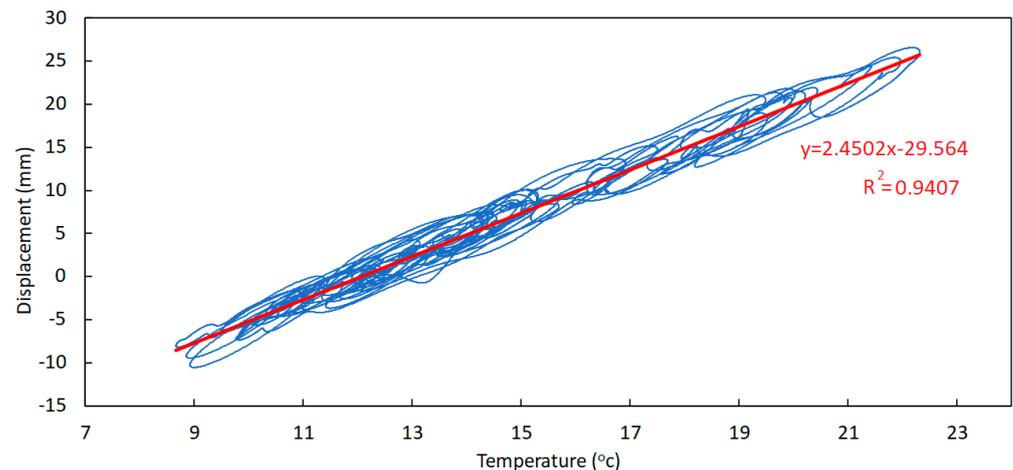
Regarding correlation between the trend component of temperature and displacement, the signal alignment is not necessary as they have the same phase shift. Therefore, in Figure 32 the temperature versus displacement chart is plotted and the linear correlation was found.

**Figure 32.** Temperature-versus-displacement chart—trend components (September 2021 to May 2022).

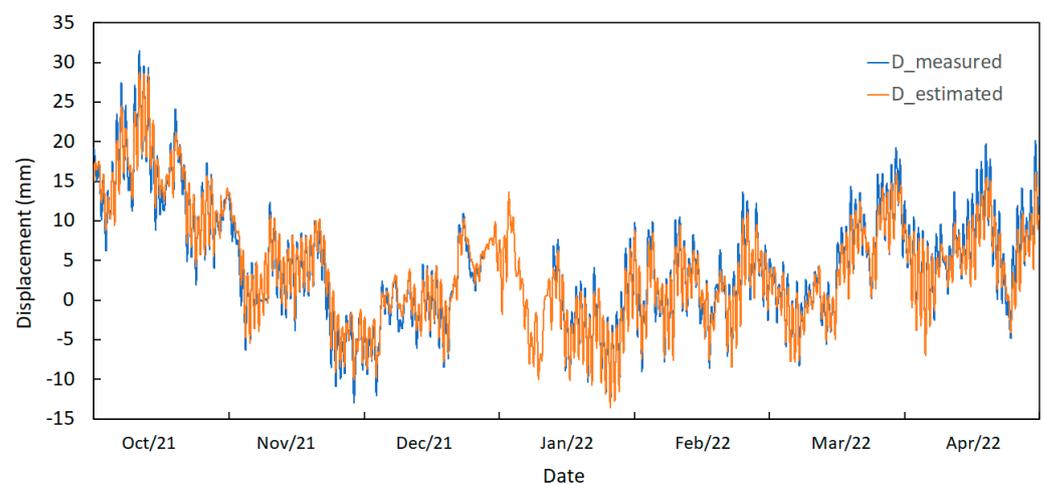
As a result, Figure 33 shows a comparison between the measured displacement ( $D_{\text{measured}}$ ) at the joints and the estimated displacement ( $D_{\text{estimated}}$ ) using the temperature measurements. Despite the previous comments related to correlation factors, the approximation between the two curves is very good. This means that by measuring the temperature in the appropriate sections of the bridge, it will be possible to estimate with good precision the displacements in critical sections of the structure.

**Figure 33.** Displacement curves (obtained and estimated values during September 2021 to May 2022).

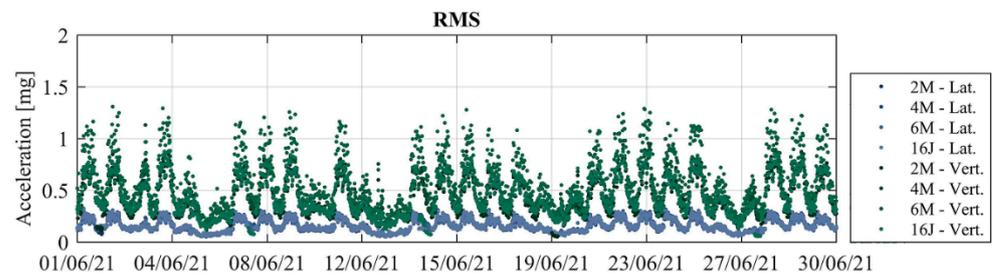
A first check on the signals was performed by calculating the root mean square (RMS) values of the time series of accelerations for periods of 30 min during 1 month, as shown in Figure 34. It can be observed that sensors present a proper functioning since it is possible to note consecutive peaks of acceleration on business days and a decrease in these values on the weekends and holidays (3 June and 10 June). Differences between vertical (green) and lateral (blue) measurements are observable as well.

Figure 34. RMS values of accelerations measured during June 2021.

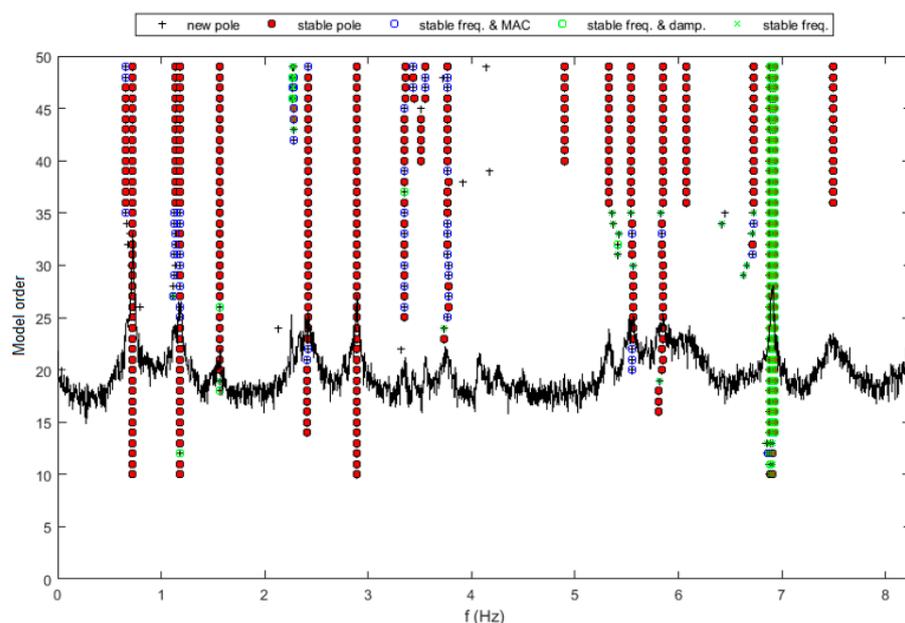
After that, the application of the SSI-Cov method for a specific record of 30 min belonging to that month allowed us to obtain a stabilization diagram. To better distinguish the results obtained in lateral and vertical directions, this diagram was generated for both cases, as shown on Figures 35 and 36. Similar natural frequencies can be found in both diagrams, indicating the occurrence of vibration modes with components in the two directions.

Figure 35. Stabilization diagram obtained using SSI-Cov methodology for lateral accelerations.

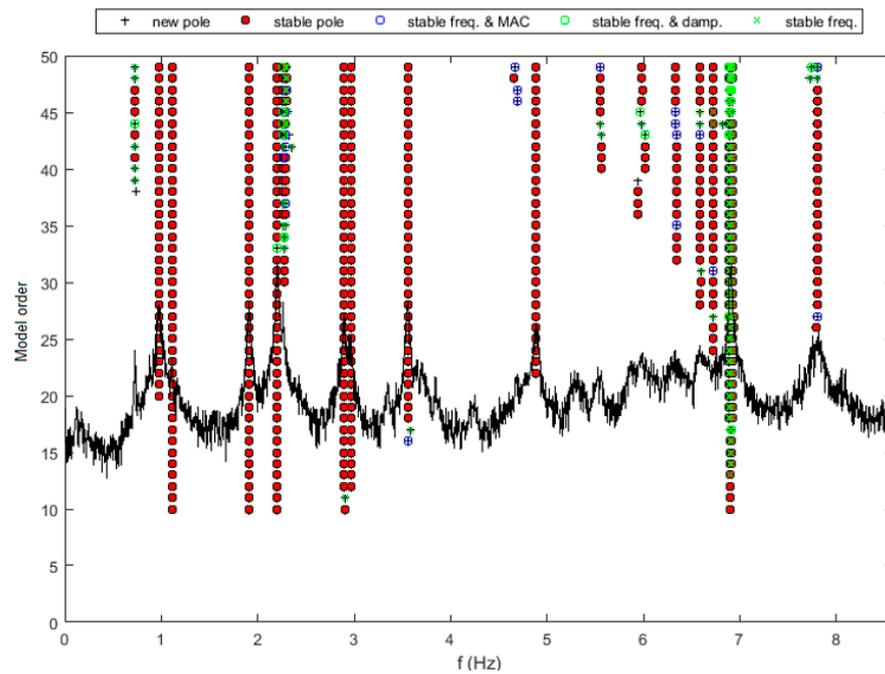
Figure 36. Stabilization diagram obtained using SSI-Cov methodology for vertical accelerations.

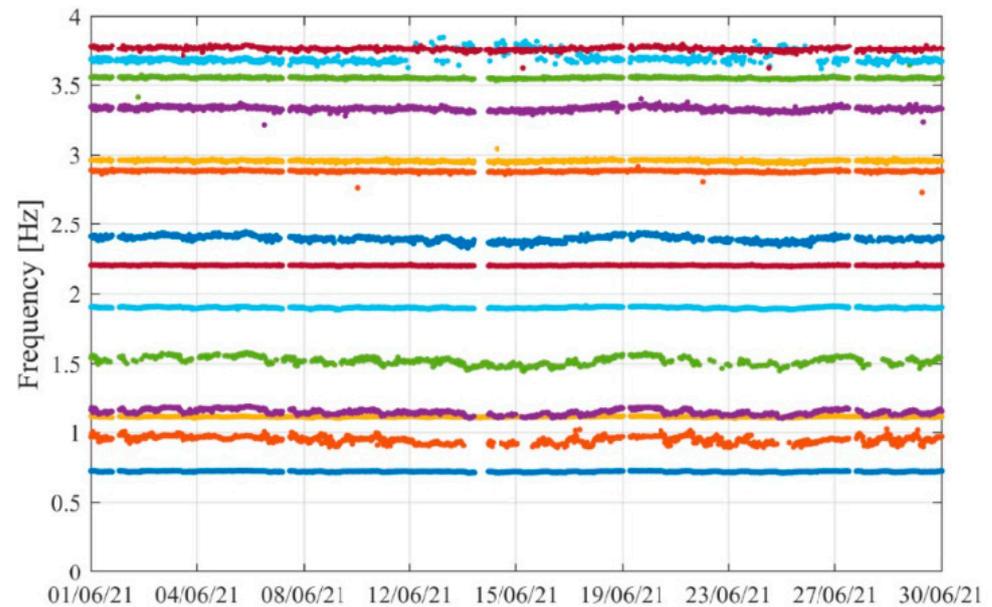
Figure 37. Frequency evolution along time (results obtained during June 2021).

It can be observed that the natural frequencies obtained from the ambient vibration tests are also identified in the continuous monitoring results obtained using the SSI-Cov method. However, there are additional frequencies found when using SSI-Cov (modes 4, 5, 8, 11, 13 and 14) that were not detected in the ambient tests, whose origin has yet to be studied. This may arise from the application of different identification methods to the signals but also from the complexity of the shape of these vibrations modes, which were identified with the SSI-Cov method, but generally present lower identification rates than those already identified with the AVTs.

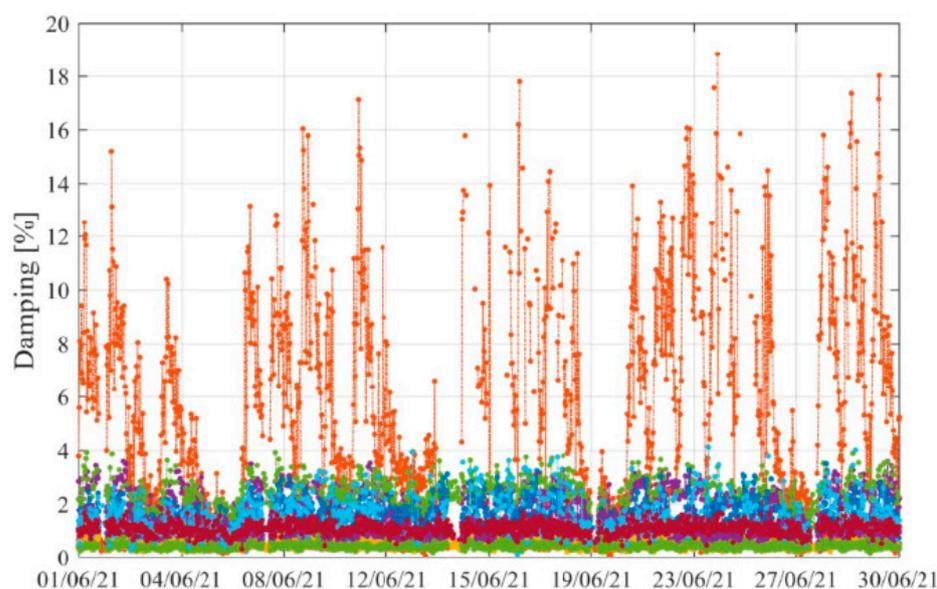
This analysis proceeded to the damping results (see Figure 38), permitting the identification of the significantly increased damping observed during some business days periods. This increase may be attributed to the higher traffic intensity during some periods, which is a phenomenon detected in other case studies, such as with the Infante D. Henrique bridge [29]. However, the sharp increase in damping of the 1st vertical vibration mode (dark orange colored), which has a longitudinal component, may be amplified by the friction present in the expansion joints. This is an important issue to be investigated that will be addressed in future work.

Figure 38. Damping evolution along time (results obtained during June 2021).
