# Health Hazards Associated with Consumption of Roof-Collected Rainwater in Urban Areas in Emergency Situations

**Keywords:** emergency rainwater tanks; earthquake; Wellington; health hazards; drinking-water quality; *E. coli*; lead; zinc

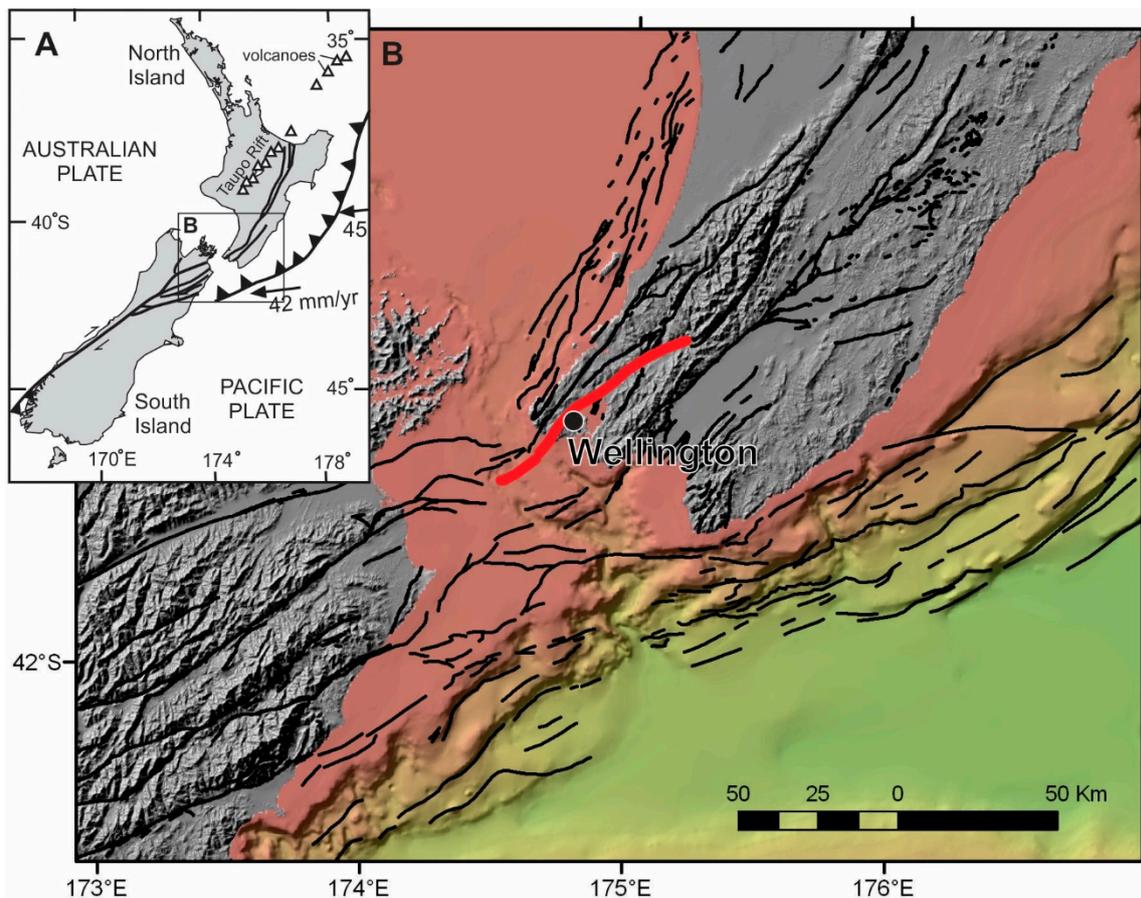
**Figure 1.** (A) Tectonic setting of New Zealand; (B) Known active faults of central New Zealand, with the Wellington Fault shown in red.

Recent studies [1–3] have identified that the greater Wellington region, New Zealand, is highly vulnerable to large earthquakes because it is cut by active faults, both on- and offshore (Figure 1). Wellington City is bisected by the active Wellington Fault (Figure 1), and many engineering lifelines (e.g., bulk water supply pipelines, electricity, road and telecommunications networks) cross this fault. Surface fault rupture with a large earthquake (approximately magnitude 7.5) is regarded as New Zealand's probable maximum earthquake loss event [4,5]. The likelihood of this event happening within the next century is approximately 10% [2].

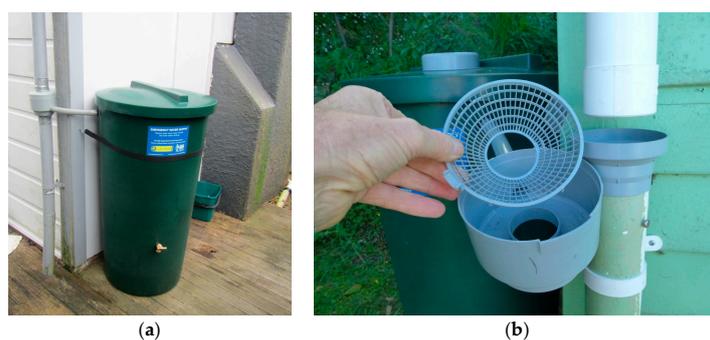
**Figure 2.** (a) WREMO emergency 200-L rainwater tank installed at Site 6; and (b) detail of diverter showing coarse screen (photo credit: Jim Cousins).

Six 200-litre emergency rainwater tanks were purchased in December 2013 and installed at properties across the Wellington region. These tanks (Figure 2) are marketed by the Wellington Regional Emergency Management office (WREMO) as inexpensive options for households wishing to increase their post-earthquake water security.

The cylindrical tanks have a removable lid and are sold with a diverter which enables them to be connected to a downpipe. The diverter contains a coarse screen (Figure 1) to exclude large debris from the tank. The tank fills through a horizontal inlet pipe installed near the top, with inflow ceasing once the water level in the tank reaches this level. Tanks are also supplied with a brass tap and a restraining strap. The tanks are made from Rotathene<sup>®</sup> 6329 linear low density polyethylene resin

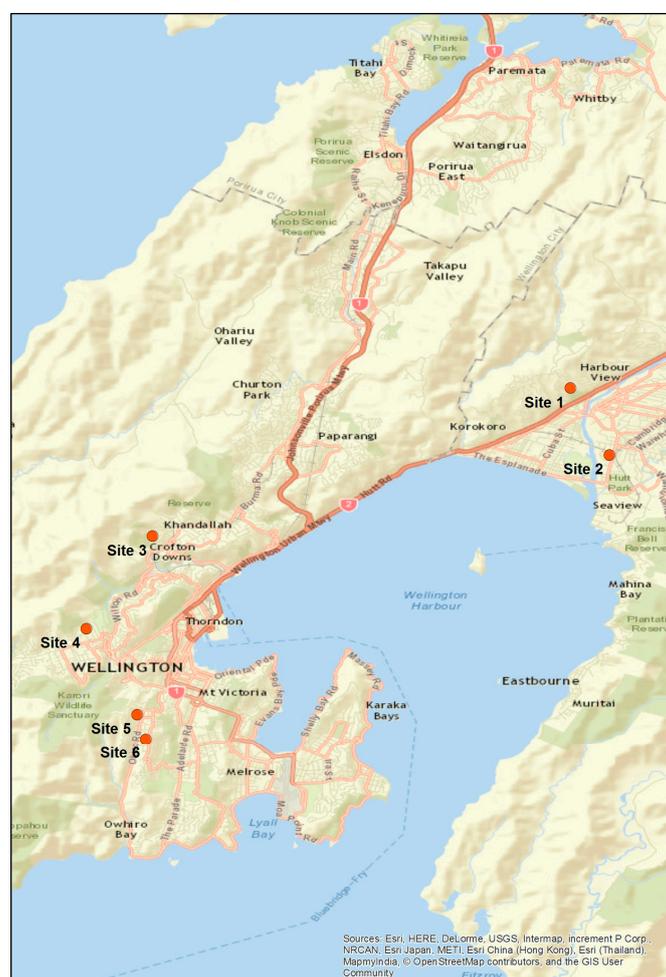
Figure 3. Location of study sites in Wellington region.

The six study sites are shown in Figure 3. The choice of locations was based primarily on access and availability. All sites except Site 2 (Moera) were located in hill suburbs, which are likely to be affected by stronger winds than valley floor suburbs. This may limit exposure to winter air pollution caused by domestic woodburners. All sites were located well away from major roads and thus are expected to have been relatively unaffected by contaminants associated with traffic.

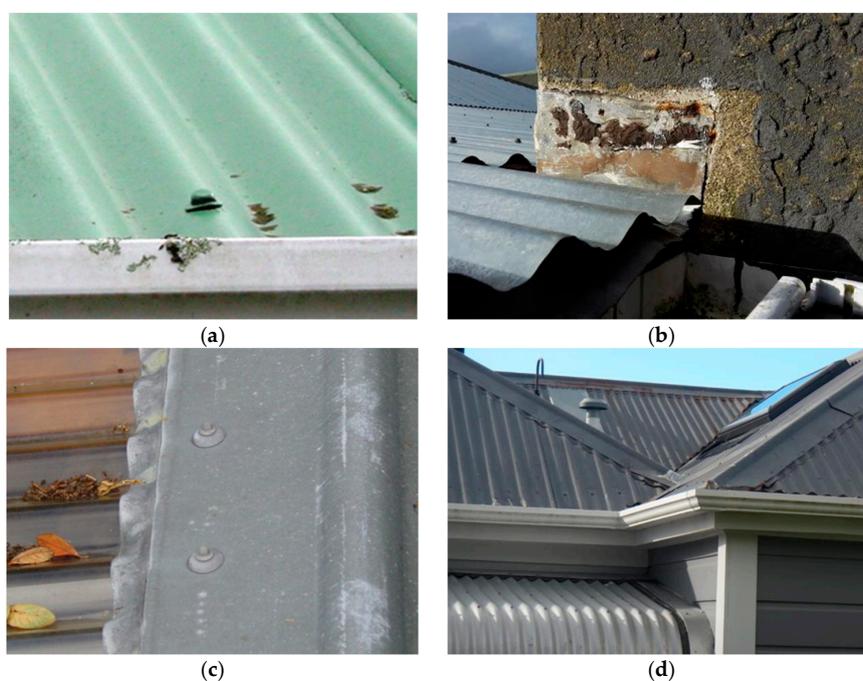
**Figure 4.** (a) Old lead head nail, Site 4; (b) Lead flashing abutting chimney, Site 6; (c) Soft lead edging to ridge cap, Site 1; and (d) Roof at Site 5, showing areas of new roof cladding at lower left (unpainted galvanised steel with modern screw fasteners) and original roof cladding on main roof (painted galvanised steel with lead fixings and flashing).

To characterise materials comprising the roof catchment systems in this study, we commissioned a survey by a registered builder experienced at building inspections. Results are summarised in Table 1 and provided in full elsewhere [36]. Specific attention was paid to the type and condition of the roof cladding, fixings (nails and screws used to fasten cladding), flashings, and guttering materials. Selected features of roof catchment systems are shown in Figure 4. Home heating arrangements for each household are also shown in Table 1.

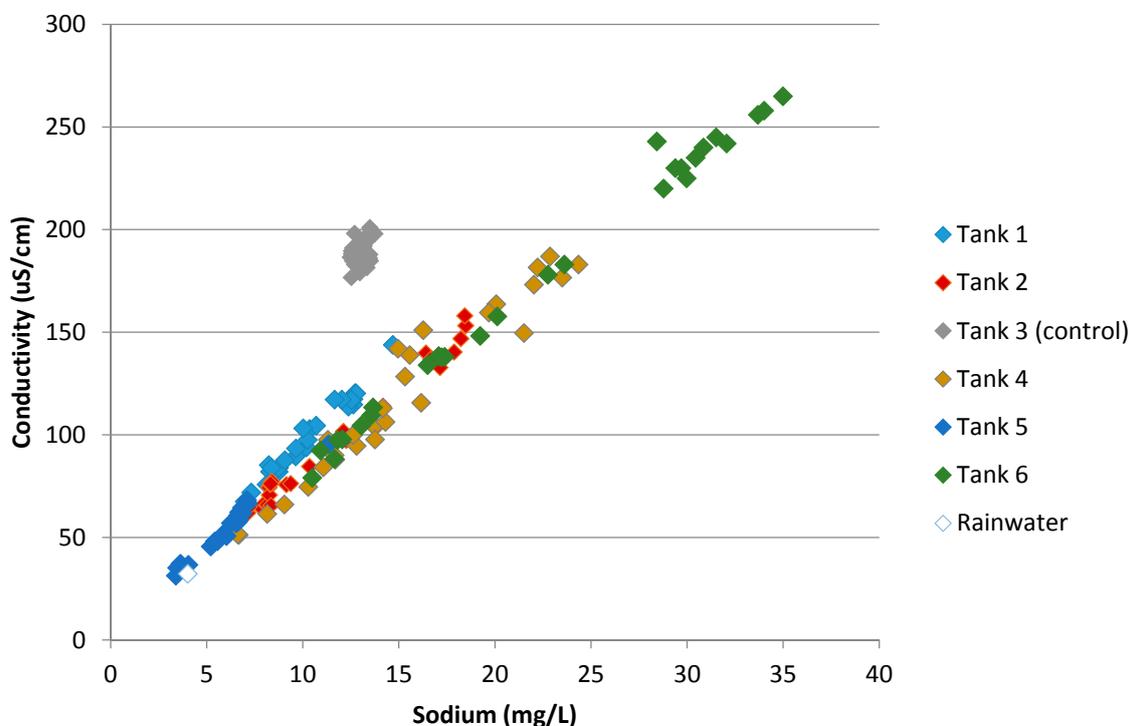
Figure 5. Sodium and conductivity data for all samples.

with major cation concentrations, see Table S6. Considering data from all tanks (Figure 5), a very strong positive relationship was found between conductivity and sodium for the roof catchment tanks ( $r = 0.989, p < 0.0001$ ). Strong positive relationships also were found within each individual roof catchment tank ( $p < 0.0001$  in all cases).

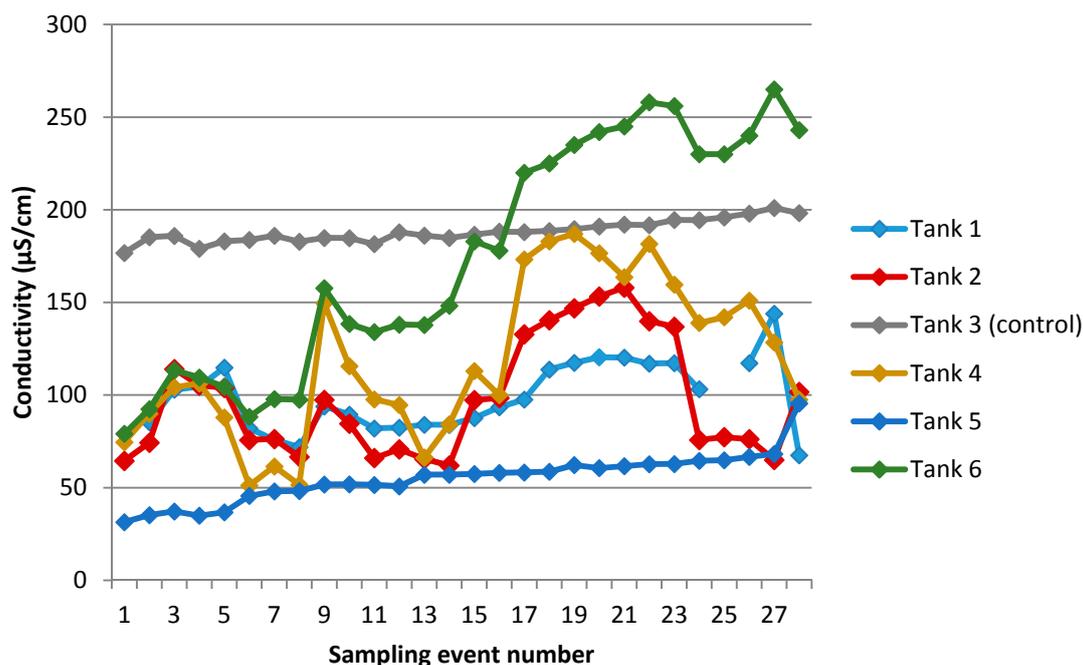
**Figure 6.** Changes in conductivity of water sampled from each tank over 28 sampling events.

Trends in conductivity over time for all six tanks are shown in Figure 6. Sampling events 1–26 are spaced at two-week intervals, but there was a seven-week interval between events 26 and 27, and a 13-week interval between events 27 and 28 (Section 2.5). For the first year of sampling (events 1–26), lines were fitted to the data. Slopes and correlation coefficients are presented in Table 5.

Trends in accumulation differed between tanks. Tank 3 showed a minor but steady increase over time, likely to have been caused by gradual concentration through slow evaporation. Tank 5 showed a very similar trend, which is probably due to the diverter malfunctioning so that the tank was not refilled with rainwater; field notes indicated that the level slowly lowered over the duration of the experiment.

Tanks 1, 2, 4, and 6 all had very similar ionic strength at the outset of the experiment, and remained tightly coupled for the first few sampling events, after which time they began to diverge in magnitude while retaining very similar peaks and troughs. Tank 6 showed the greatest rate of change (Table 5) and accumulated the highest conductivity (Tables 4 and 5) and sodium concentration (Table 4). The peaks in conductivity reached between sampling events 17–22 were progressively lower for Tank 4, then Tank 2, and then Tank 1. We note that this order of accumulation (Tank 6 > Tank 4 > Tank 2 > Tank 1) corresponds to increasing distance of these sites from Wellington’s south coast (Figure 3), thus the decreasing influence of windblown marine aerosol. For further detail on source apportionment calculations to determine the contribution of marine aerosol at each site (see Supplementary Materials Section 3).

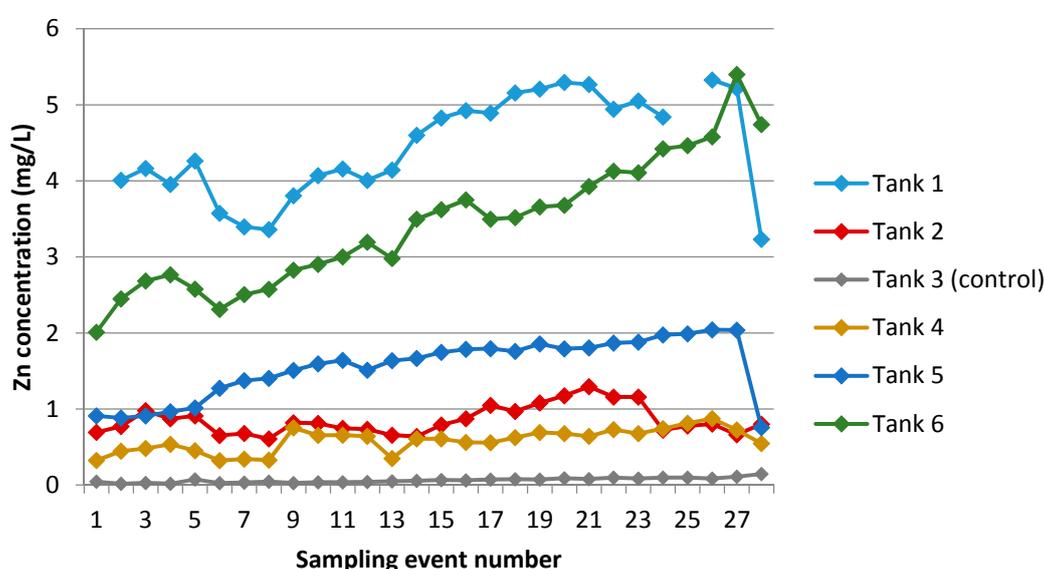
Figure 7. Changes in zinc concentrations in water sampled from each tank over 28 sampling events.

A time-series graph showing changes in Zn concentrations over the sampling period is provided in Figure 7. Relationships between pairs of variables (time/sampling event number, Zn and Na concentrations, pH, and conductivity) are shown in Table 6.

At all sites with rainwater-fed tanks, roof cladding material was galvanised steel, either relatively new and unpainted (Sites 1 and 6), old and painted (Sites 2 and 4), or a combination of both (Site 5). Water in these tanks quickly took on Zn in the mg/L (part per million) range, which is approximately two orders of magnitude greater the Zn concentration in a background rainwater sample (0.027 mg/L). As for Figure 6, increases over time are apparent in Zn concentrations in some tanks (Table 6). Similar peaks around sampling events 4, 9, and 17–22 are also apparent, to varying extents, in the data for Tanks 1, 2 and 6.

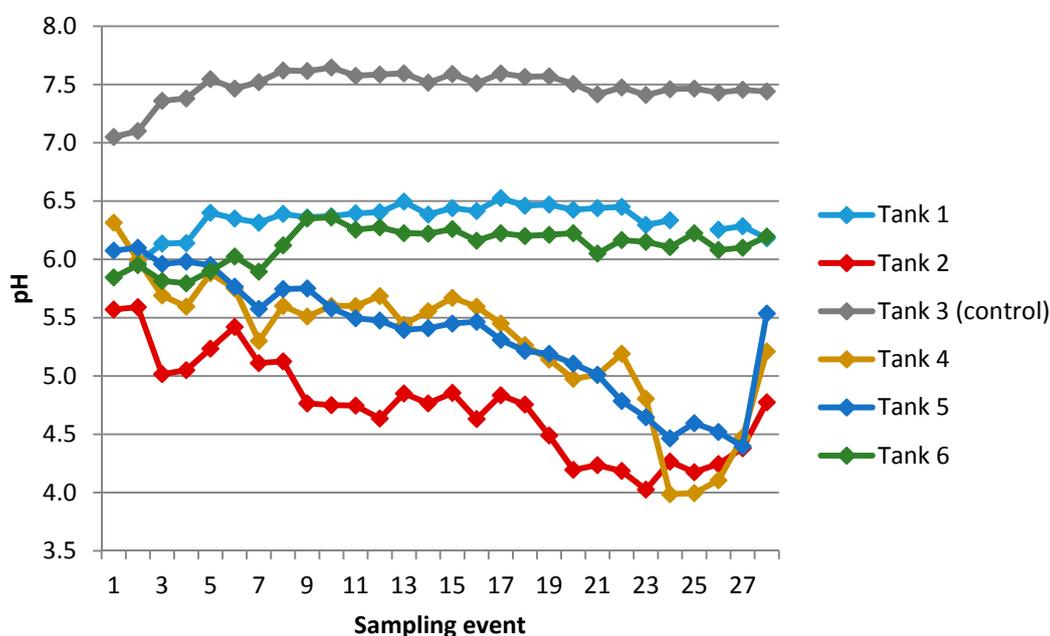
Figure 8. Changes in pH in water sampled from each tank over 28 sampling events.

A time-series graph showing changes in pH over the sampling period is provided in Figure 8. The progressive increases in acidity observed in Tanks 2, 4, and 5 are notable because of the unusually low pH values attained, to just under pH 4.0 in Tank 4. A further 400-L storage tank (draining a catchment comprised of polycarbonate cladding) sampled on two occasions as a supplement to this study reached an even lower pH value of 3.2. This is consistent with the generation of dissolved organic acids in these poorly buffered water systems. Fulvic acids in particular can be very acidic, with an indicative  $\text{pK}_{\text{a}1}$  value of  $2.0 \pm 0.3$  based on four- and five-site models of carboxylate groups [45,46]. Results for non-purgeable organic carbon (NPOC) (Table 4) allowed a check to be run on this possibility by providing an upper limit on the possible concentrations of dissolved organic acids. At or near to the weeks where their lowest pH values had developed, NPOC concentrations in Tank 2 (pH 4.03) and Tank 4 (pH 3.99) were measured at 1.4 mg/L in both tanks. Based on mean molecular weights for Suwannee Stream fulvate (1150 g/mol as a number average, and 1910 g/mol as a weight average, [47]), a NPOC concentration of 1.4 mg/L would translate to molar concentrations of  $\sim 1 \times 10^{-6}$  M, assuming all NPOC in Tanks 2 and 4 was present in a broadly similar form as the stream fulvate. Assuming a  $\text{pK}_{\text{a}1}$  value of 2.0, this concentration of fulvic acid would indeed yield a calculated pH of 4.0 (via the standard equation:  $\text{pH} = 0.5(\text{pK}_{\text{a}} - \log [\text{HA}])$ ).

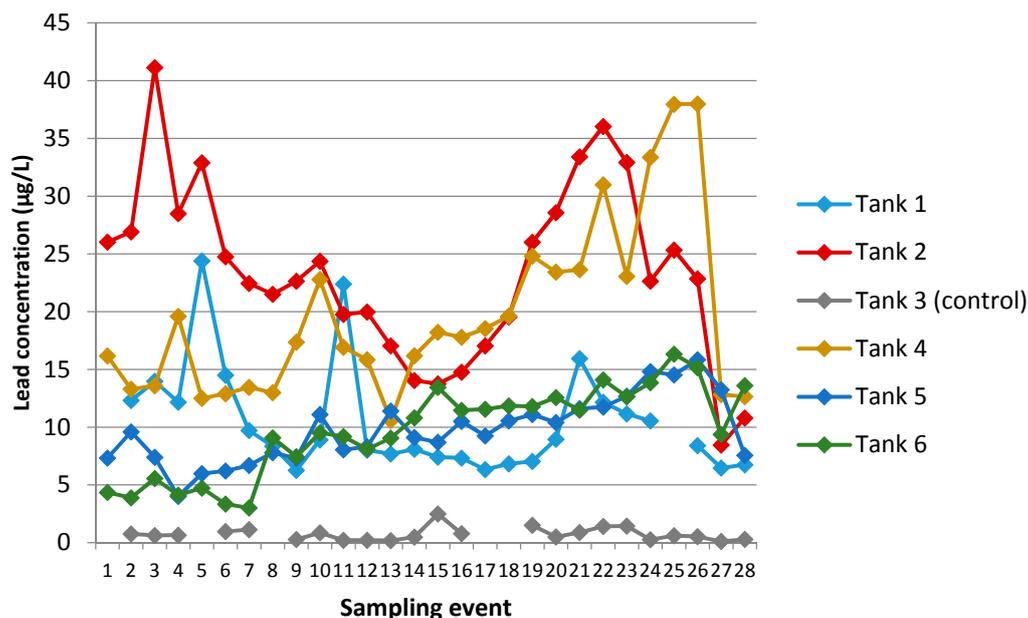
Figure 9. Changes in concentrations of lead over 28 sampling events.

Changes in concentrations of lead over time are shown in Figure 9.

Lead was enriched in all rain-fed tanks (range of 3–41  $\mu\text{g/L}$ ) compared with both a background rainwater sample (0.4  $\mu\text{g/L}$ ) and the tapwater control tank (mean of 0.7  $\mu\text{g/L}$ , Table 4). Its appearance was not gradual, with all rain-fed tanks already showing lead enrichment from the first sampling event (Figure 9). Within each rain-fed tank, lead concentrations showed some ( $\sim$ threefold) variability with time but generally remained within a given order-of-magnitude range. The highest average and peak concentrations were found in Tanks 2 and 4. The roof catchments feeding these tanks were both comprised of old, painted galvanised steel.

In Tanks 4–6, lead concentrations increased ( $p < 0.0001$ ) with time over the first year, but these trends did not persist into the second year (Figure 9). Of these, Tanks 5 and 6 were the two rain-fed tanks with the lowest initial lead readings, and Tank 6 showed the strongest linear correlation with time ( $r = 0.934$ ). Over the first year, lead concentrations in Tank 6 increased by about 1 µg/L per month. We further note that, for the tanks in which lead concentrations increased over time, lead had strong positive linear correlations with zinc, sodium, and conductivity. In Section Trends in Zn Concentrations, we noted the strong linear correlations within all rain-fed tanks for sodium, zinc, and

Observed trends in lead concentration (Figure 9) are likely to reflect the combination of the influence of an external source of lead together with a number of moderating factors such as a variable and possibly seasonal influence of corrosion chemistry [44], in-tank adsorption equilibria, evaporation, and water turnover (leading to an accumulation mechanism). The current data set does not allow us to quantify the relative magnitudes of each of these influences.

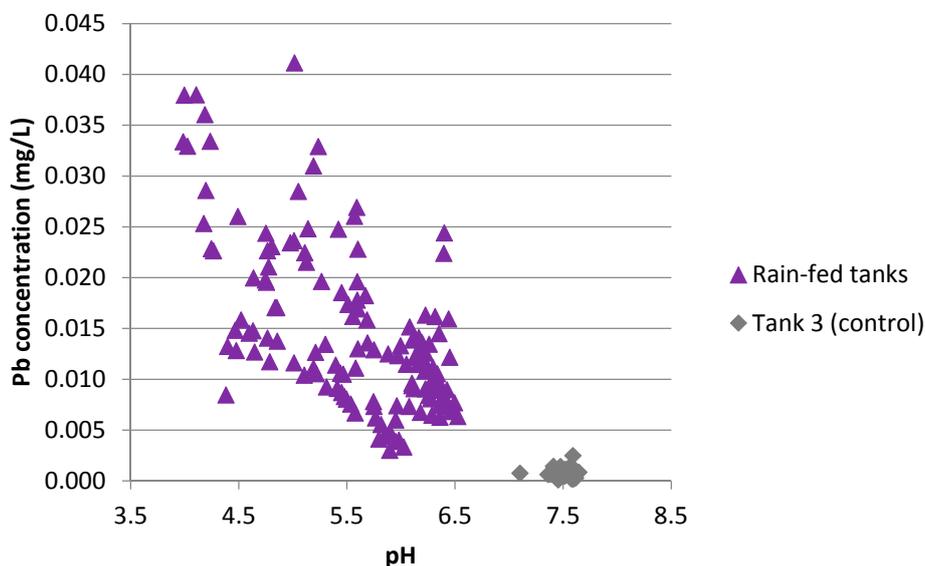
Figure 10. Relationship between pH and lead concentration for all samples.

Samples from all tanks (including the tapwater control) showed a highly significant linear relationship ( $r = -0.760, p < 0.0001$ ) between pH and lead concentration (Figure 10). Omitting the control tank from the correlation yielded a weaker but still highly significant relationship. In individual tanks, linear relationships between pH and lead were found only for Tanks 4 and 5.
