Article

Mechanical Properties and Consolidation Performances of High-Polymer Material in Coal

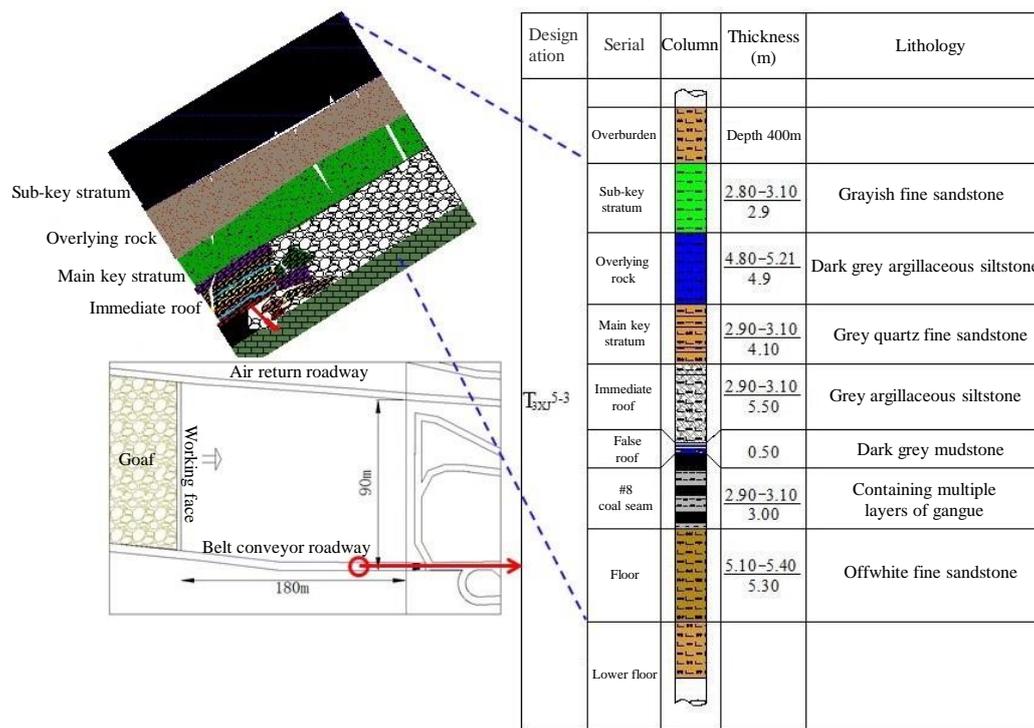
Figure 2. Layout of the eighth coal seam and lithostratigraphic column.

The Tangjiahe coal mine is located in the north of Qingchuan prefecture, Guangyuan city, Sichuan province, China (Figure 1). The detailed stratigraphic column and the layout plan of the roadway are shown in Figure 2. The eight coal layer of this mine is at the bottom of the third sub-segment in Section 5 of the Xujiahe formation of the upper Triassic (T_3xj^{5-3}); this coal seam is the primary mineable coal bed of the Tangjiahe coal mine, and it has a thickness of 1.2–3.2 m and a coal seam dip angle of 45° . The false roof is argillaceous siltstone mixed with coal dust with a thickness ranging from 0.1 to 0.3 m, the immediate roof is argillaceous siltstone with a thickness of 2.0–4.0 m, and the upper roof is fine sandstone with a thickness of 4.0–7.0 m. The immediate floor is argillaceous siltstone with a thickness of 0.2–0.4 m, and the lower floor is argillaceous siltstone or siltstone with an approximate thickness of 5.0 m.

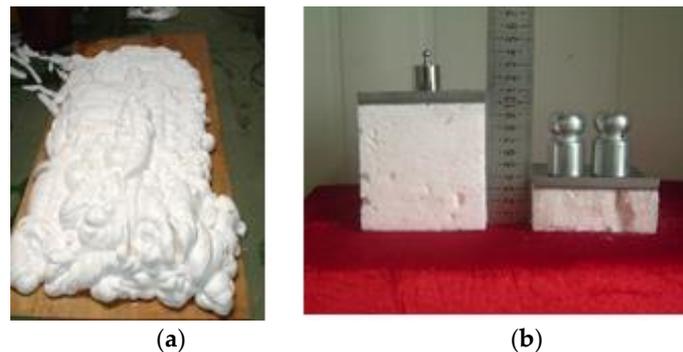
Figure 3. Foaming performance of mixed HASF-2/20 and DN-1. (a) Expansion effect and (b) solidified foam.

The mixed HASF-2/20 and DN-1 have an endothermic reaction after mixing, forming a 30-time hermetic foam that is stable and does not collapse. The foam can quickly fill collapsed openings and discharges accumulated gas. The expansion effect and the solidified foam are shown in Figure 3.

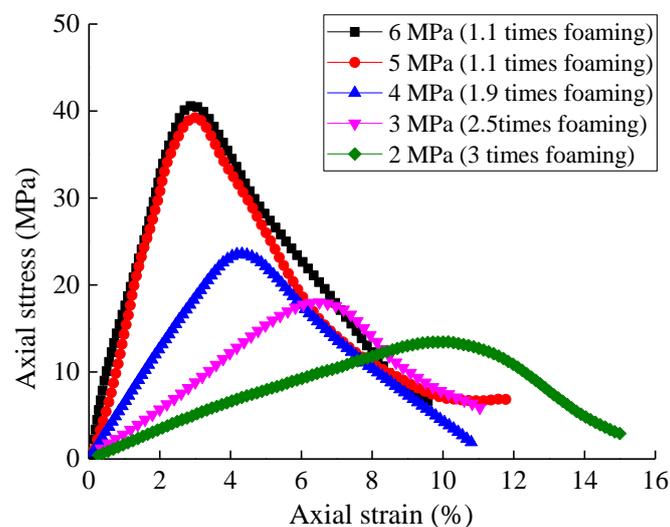
Figure 4. Influence of the grouting pressure on the material strength.

Compressive strength is an important indicator of the performance of the grouting-consolidated material. The grouting pressure exerts a large influence on the reaction speed, the foaming ratio after the HASF-2/20 and DN-1 are mixed, and the final strength. Figure 4 shows the material strength curve for different grouting pressures. In general, as grouting pressure increases, the material foaming ratio decreases and the compressive strength increases. When the grouting pressure surpasses 5 MPa, the material reaction foaming ratio remains at 1.1 and a small increment is observed. The five different grouting pressures lead to four foaming ratios, at which the material with a higher foaming ratio shows a larger axial strain under the same compressive strength. The critical strain value ε_p also increases along with the foaming ratio. Compared with the coal and rock specimens, the consolidation material specimen exhibits no initial compression phase and the elastic stage lasts until the peak. Lastly, the higher the foaming ratio, the smaller the slope of the stress curve is after the peak.

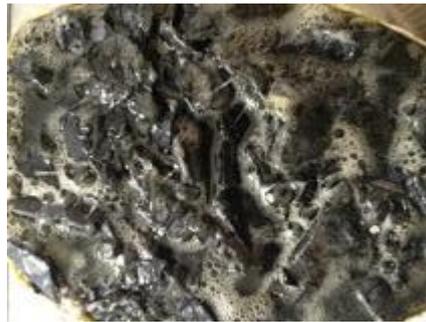
Figure 5. Photo of gangue solidification using a high-polymer material.

Carbon mudstone gangue was selected: It is flaky with angular edges and has low compressive strength and high discreteness. The gangue samples were placed into containers (confining pressure $P_0 = 0$), and the grouting pressure of $p = 2$ MPa was the same as in the field for gangue solidification as shown in Figure 5. Standard specimens of 50 mm diameter and 10 mm height were cored after curing for 1 h under ambient temperature conditions. Figure 6 shows the standard solidified specimens with different grout proportions. Three grouted gangue specimens with grout proportions of 6%, 9%, and 13% were tested to determine the influence of the grout proportion on the mechanical properties of the grouted specimens.

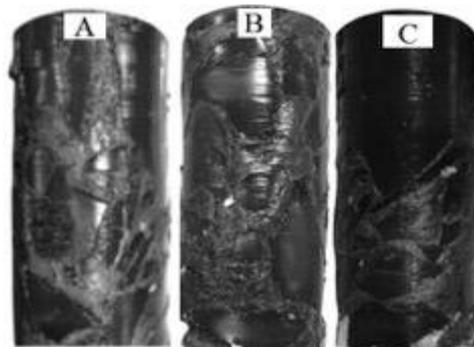
Figure 6. The grouted gangue specimens having grout proportions of (A) 6%, (B) 9%, and (C) 13%.

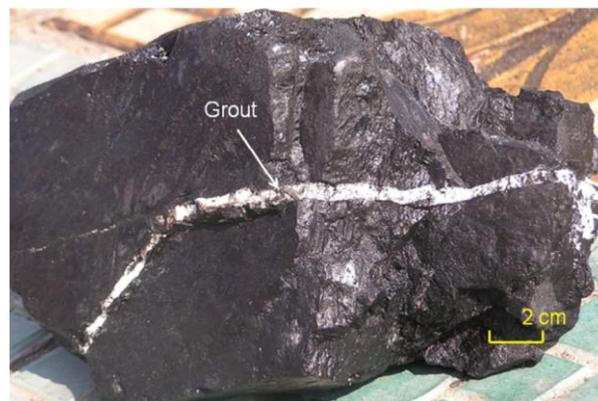
Figure 7. Photo of coal mass after consolidation.

$p = 5$ MPa. Figure 7 shows the fracture filled with the injected high-polymer material to strengthen the fractured coal. After curing for 1 h, the consolidated siltstone masses were cored parallel and perpendicular to the fracture into cylinder specimens of 50 mm diameter and 10 mm height, as shown in Figure 8. The consolidated specimens had vertical and horizontal fractures that were filled with the high-polymer material in the consolidated face of the coal and siltstone specimens. All specimens had the same consolidated face thickness. Therefore, the solidification of a single-fracture was used to understand the grout propagation in the fracture network.

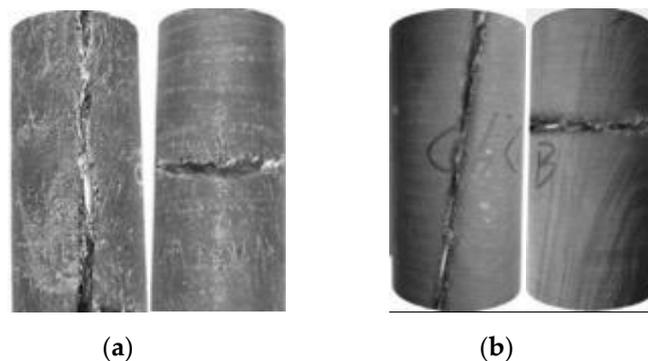
Figure 8. Typical consolidated single-fractured coal and siltstone specimens. (a) Coal and (b) siltstone.

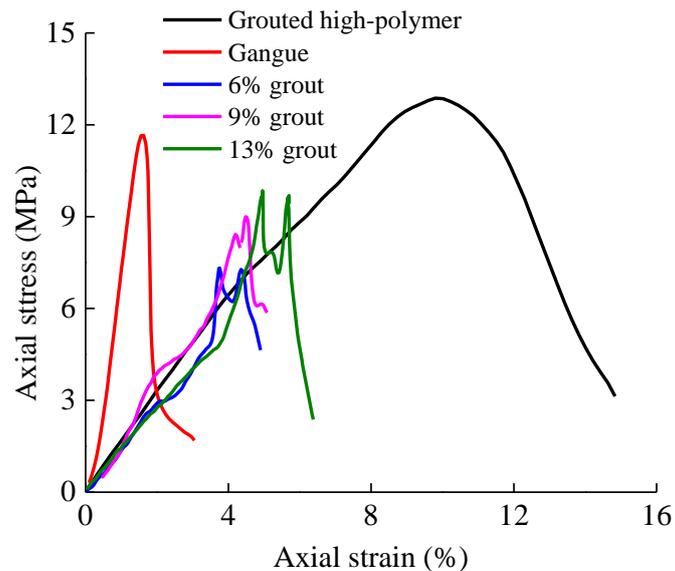
Figure 9. Stress–strain curve of the grouted gangue specimens.

Three grouted gangue specimens, one gangue specimen, and one grouted high-polymer specimen were tested with a uniaxial compression test. According to the stress–strain curves shown in Figure 9, the grouted gangue specimens exhibited non-linear behavior as a result of the interaction between the grout and the gangue in the mechanical process [24]. The compressive mechanical characteristics were manifested as the interaction between the grout material and the gangue and the yield and weakening of the internal defects.

The axial stress–strain curves were divided into four sections based on the interaction between the grout material and the gangue: the elastic stage (grout-dominating stage), the partial yielding stage (gangue-dominating stage), the yielding stage (interaction-dominating stage), and the post-damage stage. In the elastic stage, the grout material dominated the mechanical properties. In the partial yielding stage, during the specimen compression, the gangues came into contact with each other and caused the local stress to become larger than the tensile and shear strength; this pattern led to some microscopic damage, and some shifts occurred among the particles around the fractures, resulting in a reduction in the stress. At this point, a large extrusion force was generated as a result of the interaction of the gangues, leading to an increase in the rate of the stress–strain curve. In the yielding stage, the curve exhibited bimodal behavior. Shear and splitting failure occurred in the area of dense distributions of gangue or in the area of flaky gangues, leading to a rapid release of strain energy and a rapid reduction in the stress. Restricted by the grout material, the gangue rejoined and then the second peak appeared, but it was clearly lower than the first peak. The damage stage followed the second peak; after repeated stress release and mutual shift, the stress declined rapidly.

The gangue specimen had an elasticity modulus of 705 MPa, a Poisson’s ratio of 0.21, and a uniaxial compressive strength of 11.8 MPa. The high-polymer grout material specimen had an elasticity modulus of 135 MPa, a Poisson’s ratio of 0.36, and a uniaxial compressive strength of 13.5 MPa. The compressive strength of the grouted gangue specimen was clearly greater than that of the gangue specimen. The elasticity modulus of the gangue specimen was 5.2 times that of the grout specimen, and the Poisson’s ratio of the gangue specimen was 0.58 times that of the grout specimen; thus, under the same pressure, the axial and radial deformation and expansion volume of the grout were much greater than that of the gangue. Furthermore, the stress–strain curve of the gangue exhibited the typical features of a stress–strain curve of rock under uniaxial compression with a clear void and crack compaction stage and brittle drop after the peak. The stress–strain curve of the uniaxial compression demonstrated no void and crack compaction stage and directly entered the elastic stage after being compressed; additionally, the slope of the stress–strain curve after the peak was relatively gentle. The gangue specimen exhibited brittle fracture, whereas the grout specimen exhibited ductile fracture.

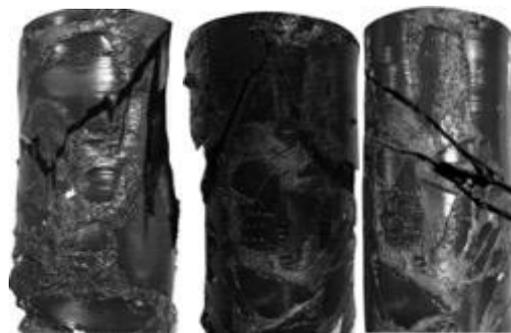
Figure 10. Damage patterns of the consolidated specimens.

The uniform graded aggregate showed no obvious interlocking effect. The openings of the aggregate were filled by the high-polymer material to form a whole unit with the grout as the skeleton and the gangue as the aggregate after the solidification reaction. Figure 10 shows the damage patterns of the three grouted gangue specimens. As the solidification material proportion changed, the damage patterns changed. Due to the influence of the anisotropy of the specimens, through-splitting damage from top to bottom would normally not occur; instead, shear failure typically appeared along a relatively weak cementation face or directly through the flake gangue. Since the strength of a material is usually governed by the weakest portion, the large amount of pre-existing weak cementation face makes the grouted gangue more prone to fragmentation. Turichshev and Hadjigeorgiou [27] demonstrated that an intact veined rock specimen failed along a vein, as shown in Figures 11 and 12, and concluded that the weakest mechanical link in the system determines the overall strength.

Along with the load and deformation of the specimens, the skeleton was first compacted, followed by stress concentration surrounding the gangue. As the gangue shifted during the deformation process, the force chain was developed and fractured over again and again, and a combined shear and tension damage mode gradually occurred. Slippage damage was observed along the contact interface, leading to more significant interior shear zones and splitting zones that exacerbated the degradation of the specimens; hence, the compressive strength of the grouted gangue specimens did not reach the compressive strength of either the high-polymer material specimen or the gangue specimen. The limitation of the high-polymer material, as well as the contact and interlocking of the

The damage patterns of the specimens with different grout proportions varied. As with the loading, the damage pattern of the specimen with a grout proportion of 6% manifested as a flexural crack through most specimens with a local collapse, similar to local tensile splitting damage as a whole unit. The damage plane essentially mimicked the contact interface of the high-polymer material and gangue, whereas the specimens with the grout proportions of 9% and 13% exhibited nearly no local collapses, and a crack developed through part of the gangue and resulted in local shear damage. The mechanical strength and deformation properties of the grouted gangue specimens were hence related to the properties of the gangue and high-polymer material, as well as to the amount of high-polymer material.

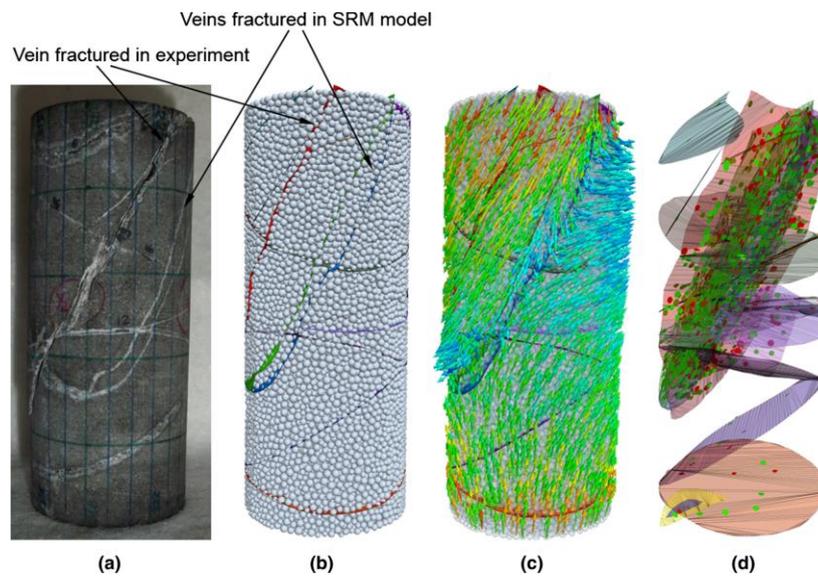
Figure 11. Illustration of a fracture developed in Specimen 1 (a) and in the corresponding synthetic rock mass (SRM) specimen (b), with displacement vectors shown in (c). Smooth joint contacts broken in tension (red disks) and in shear (green disks) are shown in (d) (reprinted with permission from Reference [27]).

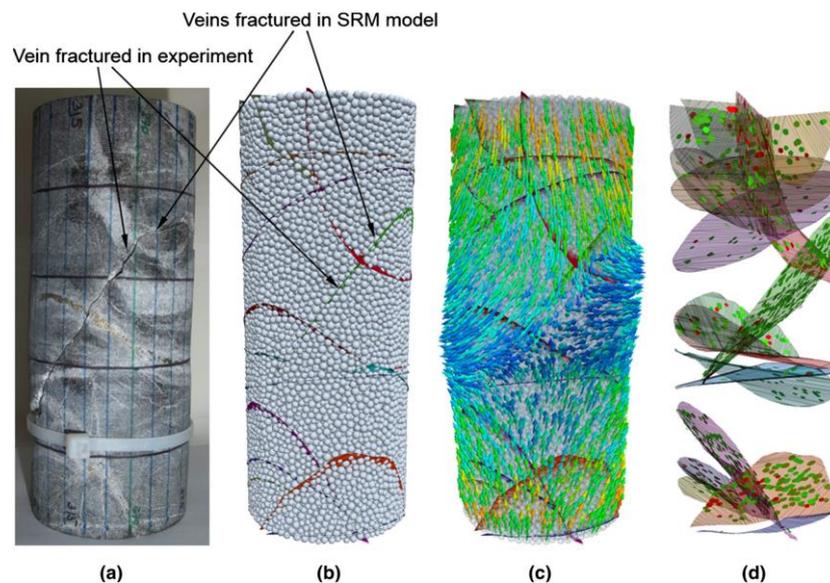
Figure 12. Illustration of a fracture developed in Specimen 5 (a) and in the corresponding synthetic rock mass specimen (b), with displacement vectors shown in (c). Smooth joint contacts broken in tension (red disks) and in shear (green disks) are shown in (d) (reprinted with permission from Reference [27]).

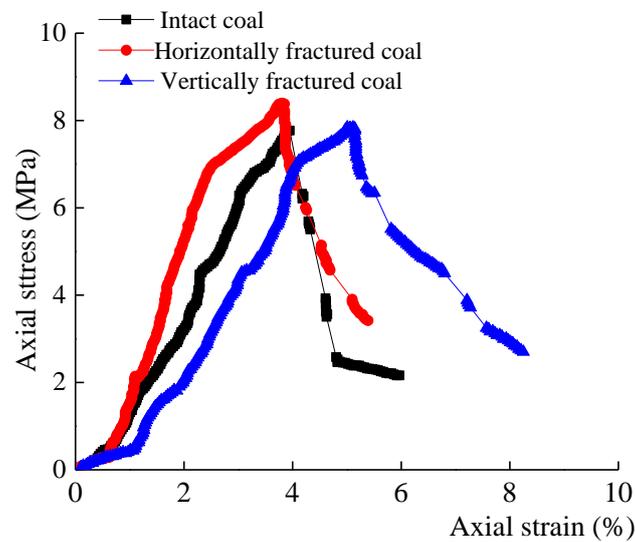
Figure 13. Stress–strain curve of the coal specimens.

Figure 13 presents the stress–strain curves of the three coal specimens with different fracture distributions in the uniaxial tests. The consolidation of the coal and siltstone specimens with the high-polymer material significantly increased the peak strength of the specimens. When reaching the damage stage, the peak strength of the intact coal specimen was 7.9 MPa, that of the horizontally fractured coal was 8.9 MPa, and that of the vertically fractured coal was 8.4 MPa. Due to different consolidated fracture positions, the strengths of the horizontally and vertically fractured coal were increased by 13% and 6%, respectively, as compared to those of the intact coal. Given the increased residual strength after the peak, the axial stress of the coal and siltstone specimen rapidly declined after reaching the peak. The stress drop diminished after the peak for the consolidated fractured specimen due to the solidification effect of the high-polymer material.

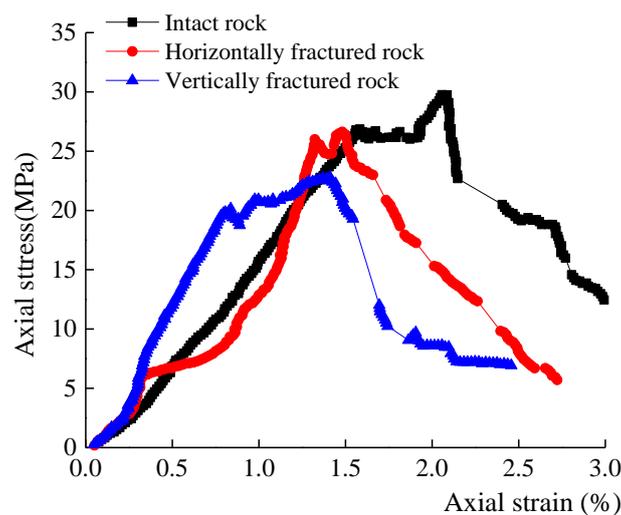
Figure 14. Stress–strain curve of siltstone specimens.

Figure 14 shows the stress–strain curves of the three siltstone specimens with different fracture distributions. The peak strength of the intact siltstone specimen was greater than that of the consolidated specimens; the peak strengths of the specimens with horizontally- and vertically-consolidated fracture were decreased by 13.4% and 26.8%, respectively, as compared to those of the intact siltstone specimen. The siltstone specimen exhibited a dense structure without a discontinuity effect, and the increase in the stress–strain curve was relatively gentle without large fluctuations. Obvious fluctuations occurred

in the increasing stage of the stress–strain curve for the consolidated fractured specimen, along with a deviation from the curve of the siltstone specimen.

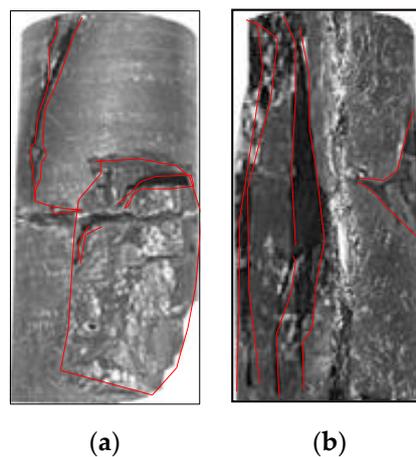
Figure 15. Damage patterns of the consolidated coal specimens. (a) Horizontal consolidation and (b) vertical consolidation.

The bonding effect of the high-polymer material transformed the fractured coal/siltstone mass into a complete system, resulting in a damage process with more complex crack initiation, extension, and cut-through behavior than in the intact coal/siltstone specimens. A comparison of Figure 15a,b indicates that no vertical through-going cracks occurred in the horizontally-consolidated specimens due to the obstruction of the high-polymer material layer. The cracks in the vertically-consolidated specimens showed vertical through-going cracks. For the both horizontally- and vertically-consolidated coal mass under uniaxial compression, cracks of the coal mass developed and extended into the coal mass; after a certain distance, cracking along the boundary of gangue occurred near the high-polymer material layer.

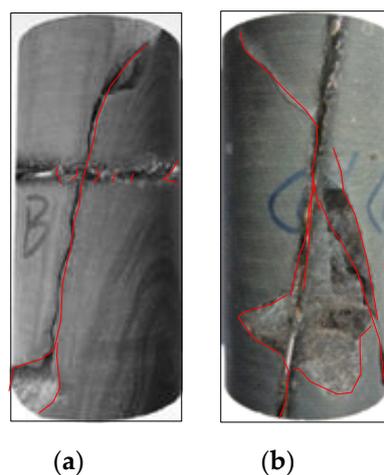
Figure 16. Damage patterns of consolidated siltstone mass specimens. (a) Horizontal consolidation and (b) vertical consolidation.

Figure 16a,b shows that both consolidation types exhibited through-going cracks. The cracks first developed in the high-polymer material layer and then became through-going cracks during the compression process.

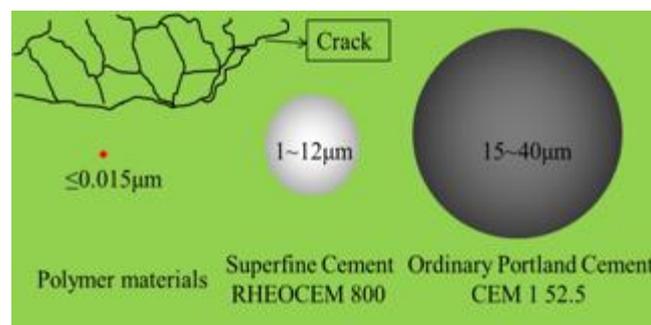
Figure 17. Comparison of the particle size and infiltration capacity of different materials.

As shown in Figure 17, compared to common and fine cement grouts, the grain size was smaller for high-polymer materials. After the high-pressure grouting of the rock mass, this high-polymer material easily diffused, gelatinized, and solidifies in the microcracks and openings, and it integrated the coal/rock mass, reduced the stress concentration from the crack tips, and increased the coal/rock mass strength.

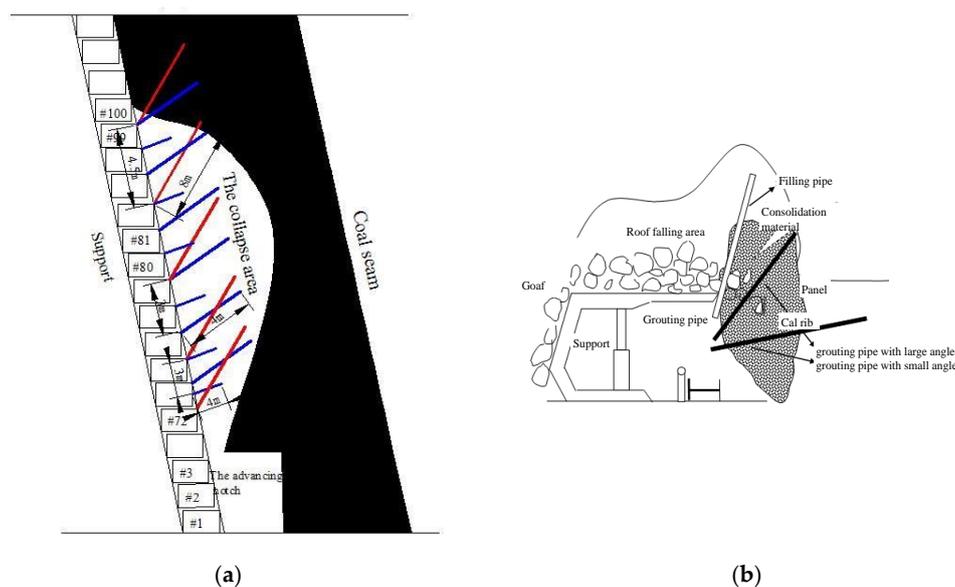
Figure 18. Distribution of the grouting holes. (a) Plane layout of the grouting holes and (b) layout of the grouting holes.

The experimental tests demonstrated the good performance of the high-polymer material regarding the solidification and consolidation of the coal mass and rock mass; actual field applications were conducted thereafter in the Tangjiahe coal mine. The distribution of the grouting holes is shown in Figure 18.

The construction sequence for creating the grouting holes proceeded from low to high; one filling hole was created for every three supports (4.5 m), the hole was located on the roof of the junction of the forepoling, and the face guard and was inclined at 70° against the wall. The end of the hole was at the top of the roof fall area, and the grouting pipe was 500 mm below the top. If the roof fall area was more than 8 m, this hole was considered a deep filling hole, and the setting depth of the grouting pipe was at least 6 m. The grout quantity was adjusted according to the field grout leakage. If the grout leakage was directly proportional to the injection quantity or reached the designed grouting pressure, the grouting was completed for this hole; at this point, we moved to the next hole until all grouting work was completed.

The grouting holes for the gangue solidification included two types: large-angle (45°) grouting holes and small-angle (10°) grouting holes. The large-angle grouting holes were 500 mm below the roof and 4 m deep, and the grouting pipe was 3 m long. The hole of the small-angle grouting holes was under the face guard with a depth of 4 m, and the grouting pipe was 3 m long. For both large and small-angle grouting holes, one grouting hole was drilled per every two supports (3 m), resulting in six grouting holes for 10 supports. These consolidation grouting holes were distributed in a staggered arrangement so that the small-angle grouting hole was in the middle of large-angle grouting holes to facilitate a supplementary effect of the grout. The grouting holes were slightly adjusted depending on conditions to achieve a good consolidation effect. This construction scheme consisted of two cycles: after the initial grouting work, the working plane moved forward by 2 m, and the secondary grouting work began. If any leakage of the gangue occurred during the forwarding process, the supplementary grouting was completed in time.

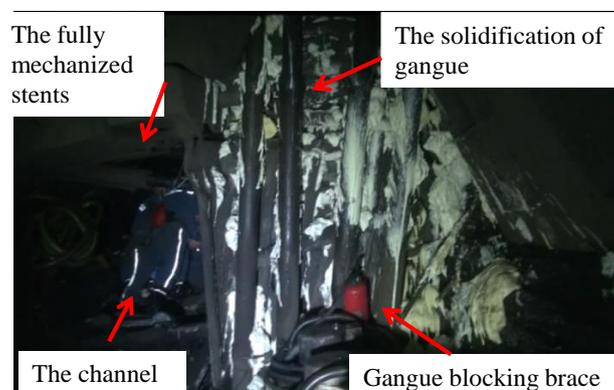
Figure 19. Gangue consolidation.

Figures 19 and 20 show photos of the field application of the grouting consolidation and solidification. It can be seen that the coal wall and the roof in front of the working face had good integrity. The coal wall was neat after cutting. Having been grouted, the stratum settlement was significantly mitigated and the stress state was leveled off. Consequently, the stope stability was greatly improved and the roof fall was effectively controlled. A good grouting effect had been achieved.

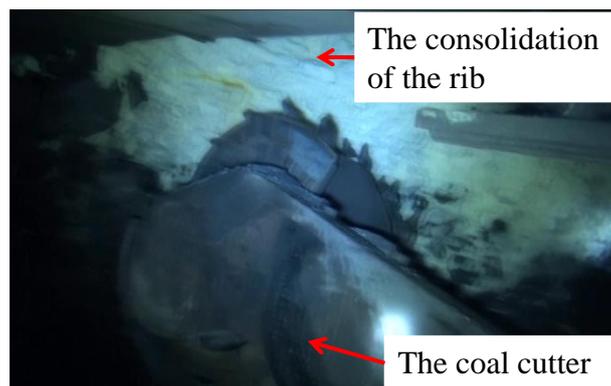
Figure 20. Coal wall and roof consolidation.
