# Experimental Study on the Compressive and Shear Mechanical Properties of Cement–Formation Interface Considering Surface Roughness and Drilling Mud Contamination

**Abstract:** In a casing-cement sheath-formation system, the cement–formation interface is usually weakly cemented for the residual of drilling mud, in which a leakage path would easily form, threatening the safe operation of underground energy exploitation and storage. To evaluate the compressive and shear mechanical behavior of the cement–formation interface, cement–rock composite cylindrical specimens were prepared. Uniaxial and triaxial compression and direct shear tests were implemented. The flushing efficiency of the rock surface, compressive strength, interface incompatible deformation, parameters of shear strength, and morphology of shear failure surface were acquired and analyzed. Results show that the flushing efficiency of shale surface decreases from 76.7% to 64.2% with the surface roughness increasing from 0 to 2 mm. The flushing efficiency of sandstone is only 44.7%, remarkably lower than that of shale. With the stress condition transforming from uniaxial to triaxial compression, the feature of the stress–

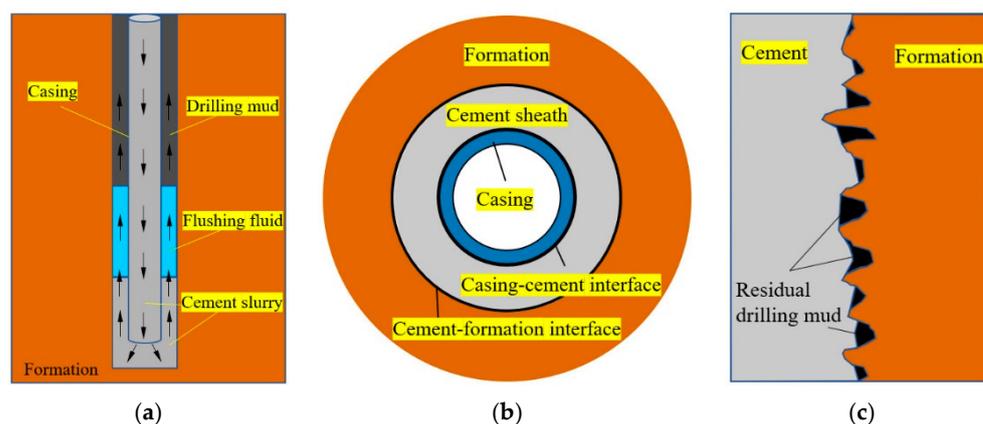
**Figure 1.** Primary cementing and casing–cement–formation system. (a) Primary cementing, (b) Casing–cement–formation structure, (c) Cement–formation interface.

A wellbore is an artificial established channel connecting the surface and deep formations in underground energy exploitation [1–5] and storage [6–10]. The cementing operation is implemented after drilling. As shown in Figure 1a, before injecting cement slurry, flushing fluid is pumped into the well to clean the hole and separate mud from cement [11]. Then, the cement slurry is pumped in and placed around the lower part of the casing. After the setting and hardening of the cement, a robust and tight casing–cement–formation sealing system is formed (Figure 1b).

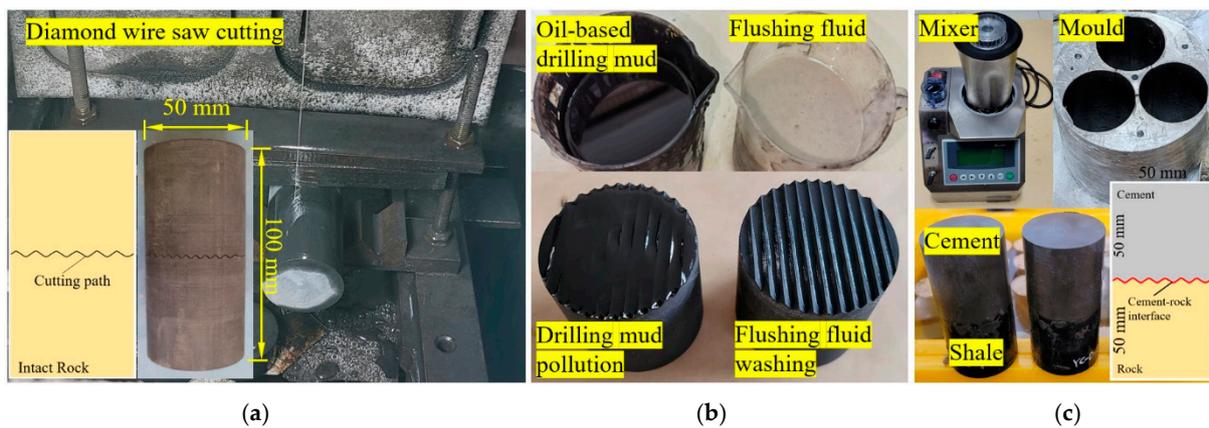
**Figure 2.** Preparation steps of rock–cement composite specimens. (a) Cutting rock with diamond wire saw, (b) Rock surface pollution and flushing, (c) Cement pouring and curing.

The preparation procedure is presented in Figure 2. Firstly, the standard rock cylinder (height of 100 mm and diameter of 50 mm) was cut along its central section with diamond wire saw (Figure 2a). The setting of cutting path is specially introduced in the following part. Three types of surface roughness were designed (Figure 3): (1) flat surface (roughness 0 mm), which simulated the ideal smooth state of the wellbore wall; (2) small undulating surface (roughness 1 mm) (Figure 3a), in which the cutting path was a zigzag line with amplitude of 1 mm, which was a simplified simulation of the roughness condition of real wellbore wall; and (3) large undulating surface (roughness 2 mm) (Figure 3b), which was prefabricated by a zigzag cutting path with amplitude of 2 mm; the wall of the broken formation exhibited greater roughness.

Then, as shown in Figure 2b, oil-based drilling mud, with volume of 15 mL, was poured on the cutting surface of the rock. After precipitation of 6 h, the drilling mud was poured out. Immediately, the polluted surface was immersed into the flushing fluid (15 mL). The residual drilling mud was dissolved and washed away. The drilling mud and flushing fluid were taken from the site. During the mud pollution and flushing process, the mass variation of the rock specimens was recorded, to acquire the flushing efficiency, which was calculated using

Finally, the rock was placed into the mould, with the treated face up. Mixed cement slurry was poured into it. Demolding occurred after curing of 72 h and continue curing for 28 days. After cutting and polishing of the cement surface, the rock–cement composite specimens (standard cylinder  $\phi 50 \times 100$  mm) were ready to test (Figure 2c).

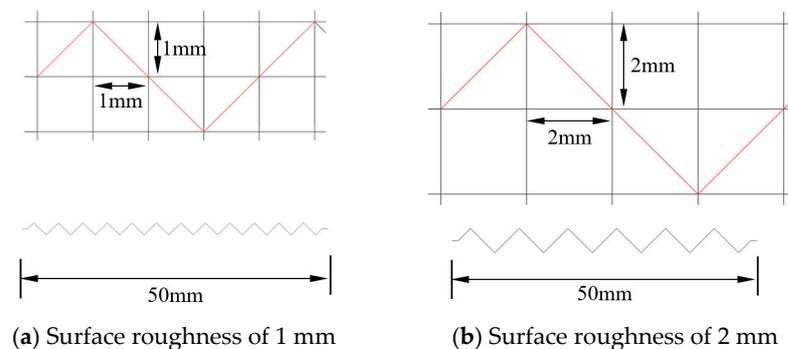
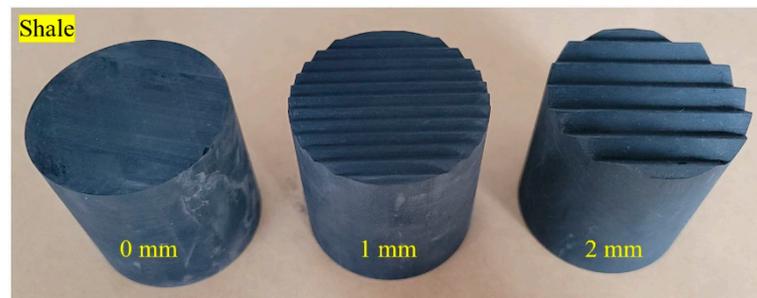
(a) Surface roughness of 1 mm

(b) Surface roughness of 2 mm

(c) Prepared shale with different roughness

**Figure 3.** Roughness setting of rock surface.

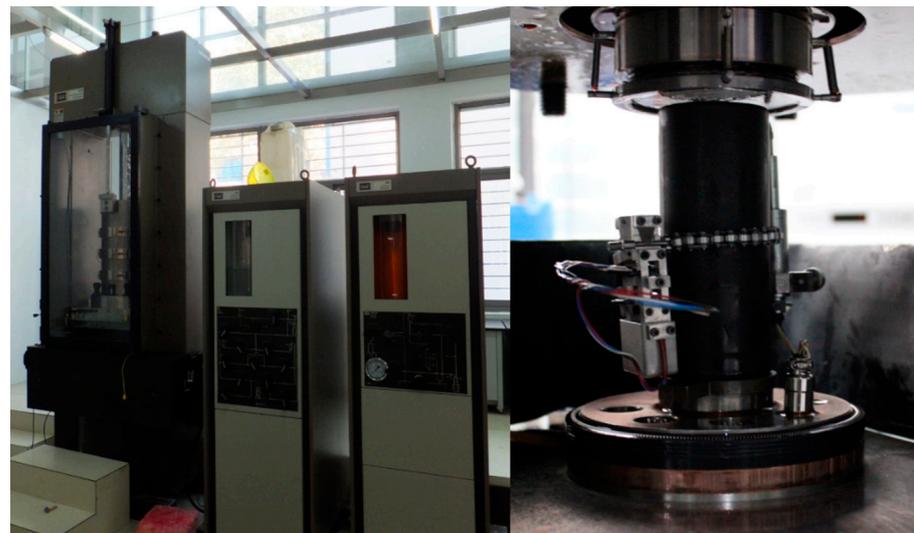
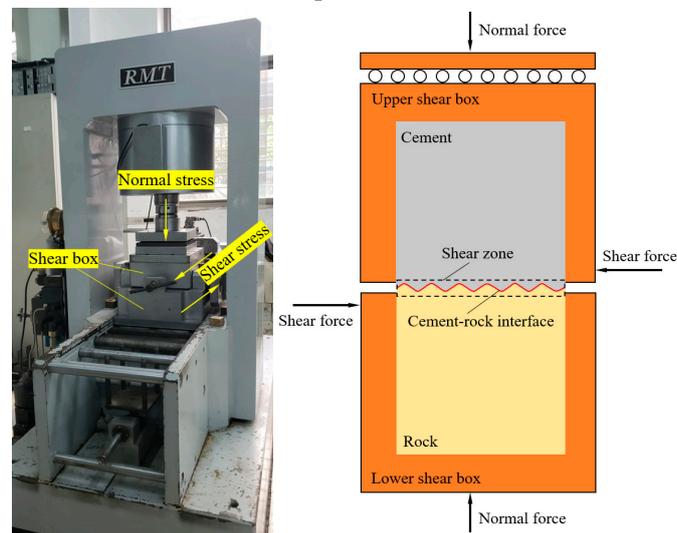
(a) MTS815 for compression tests

(b) RMT-150C for direct shear tests

**Figure 4.** Test system for compression and direct shear experiments.

The uniaxial and triaxial compression experiments were performed on an MTS 815 test system [28]. It provided a maximum axial force of 4600 kN and confining pressure of 140 MPa, with excellent rigidity of  $11.0 \times 10^9$  N/m (Figure 4a). The direct shear tests were conducted on a RMT-150C rock mechanics testing system [26] (Figure 4b), which was self-developed by the Wuhan Institute of Rock and Soil Mechanics, Chinese Academy of Sciences (WHRSM, CAS). The maximum horizontal shear and vertical compressive forces reach 400.0 and 1000.0 kN, respectively. The control rate of displacement could be set between 0.0001 and 1.0 mm. The rigidity of the whole frame is  $5.0 \times 10^9$  N/m.

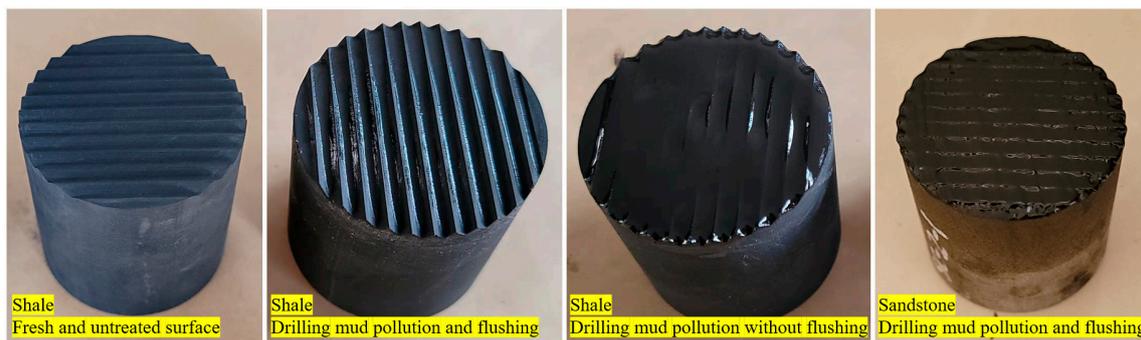
Figure 5. Rock surface state with different treatment method.

As shown in Figure 5, after drilling mud pollution and deposition, the grooves of the rock surface are filled with drilling mud. With the treatment of flushing fluid washing, most of the attached mud on the shale surface is removed. The buried undulating surface reappears. However, after careful observation, we could still see a little mud and flushing fluid remaining in the bottom of the grooves. In comparison, the residual drilling mud on the sandstone surface is quite difficult to clean. After the same flushing treatment of shale, there is still much drilling mud left and filling the grooves. We could hardly see the clean sandstone surface reappear.

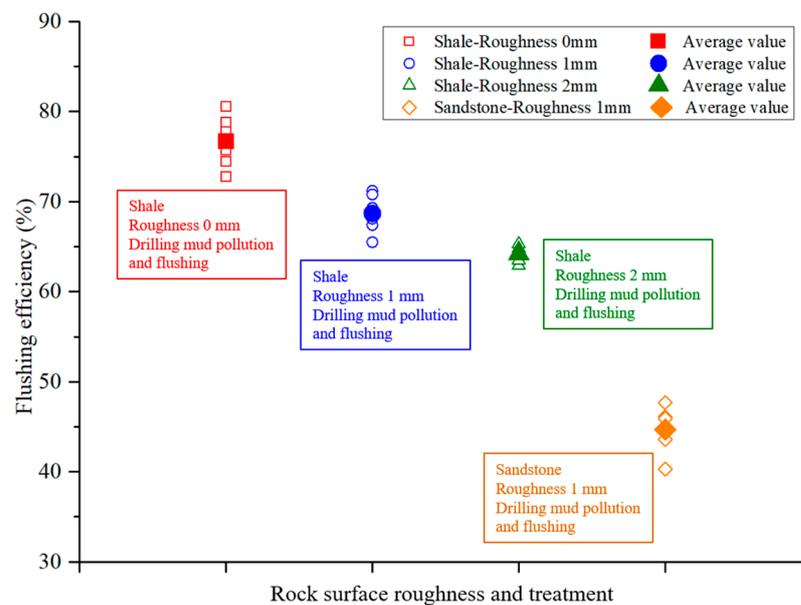
Figure 6. Flushing efficiency of rock surface with difference roughness and lithology.

The flushing efficiency could be used to quantitatively evaluate the washing effect. As shown in Figure 6, the flushing efficiency decreases from 76.7% to 64.2%, with the surface roughness increasing from 0 mm to 2 mm. As it is difficult to wash away the drilling mud hiding in the depths of the rock grooves, under the same cleaning procedure, the flushing efficiency of sandstone is only 44.7%, remarkably lower than that of shale (68.7%).

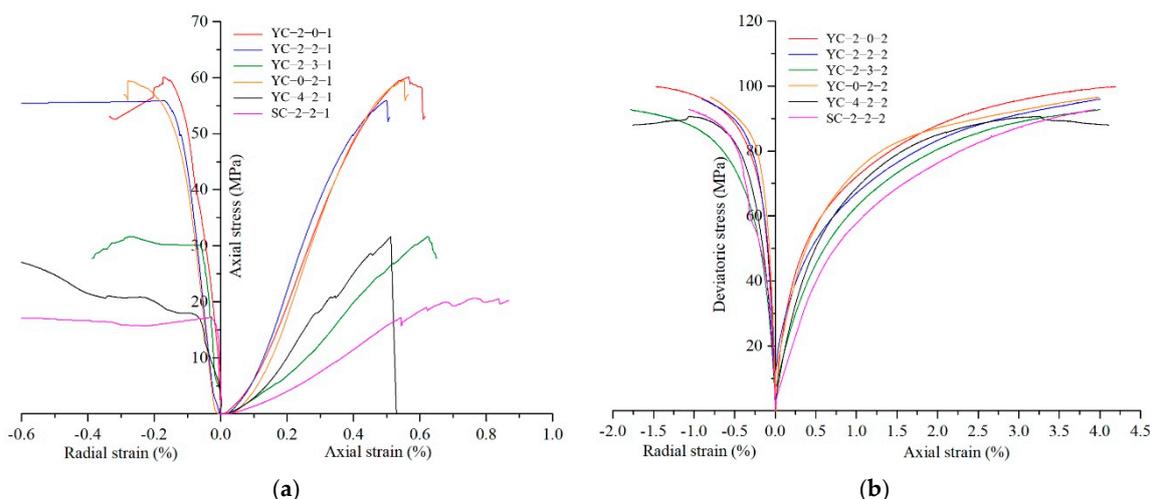
**Figure 7.** Stress–strain curves of composite rock–cement specimens under uniaxial and triaxial compression. (a) Stress–strain curves under uniaxial compression, (b) Stress–strain curves under triaxial compression.

In the uniaxial compression state, the values of compressive strength vary in a wide range, influenced jointly by interface cleanliness, roughness, and lithology. As depicted in Figure 7a, shale–cement specimens with good interface cleanliness and small roughness (YC-2-0-1, YC-0-2-1, YC-2-2-1) show relatively high strength (55.9~60.1 MPa). The reason is that good interface cleanliness brings strong interface bonding, and small roughness does not induce excessive stress concentration at the interface. Therefore, the shale–cement specimen, as a solid whole, can bear a relatively high compressive stress. Under the condition of drilling mud pollution without flushing, the shale–cement interface is poorly cemented for the large amount of residual drilling mud. Therefore, relatively free lateral slippage can happen between cement and shale at the interface. The overall stiffness of the shale–cement specimen declines and the corresponding compressive strength decreases. Specifically, the compressive strength of specimen YC-2-3-1 is only 31.7 MPa. For the specimen with the interface roughness of 2 mm (YC-4-2-1), the value of compressive strength is only 31.6 MPa. The high level of roughness inducing excessive stress concentration at the interface is the main reason. The compressive strength of the sandstone–cement specimen (SC-2-2-1) is the weakest, which is only 20.6 MPa. Poor interface cementation and low strength of sandstone contributes to the low bearing capacity of the composite specimen.

The situation is quite different for specimens under triaxial compression. At the confining pressure of 20 MPa, all stress–strain curves exhibit remarkable elastoplastic characteristics (Figure 7b), which is different from the elastic–brittle feature under uniaxial compression. The values of the compressive strengths are very close, and focus on the range of 110~120 MPa (Table 4). The existence of confining pressure inhibits the adverse effects of poor interface cementation and roughness on compressive strength.

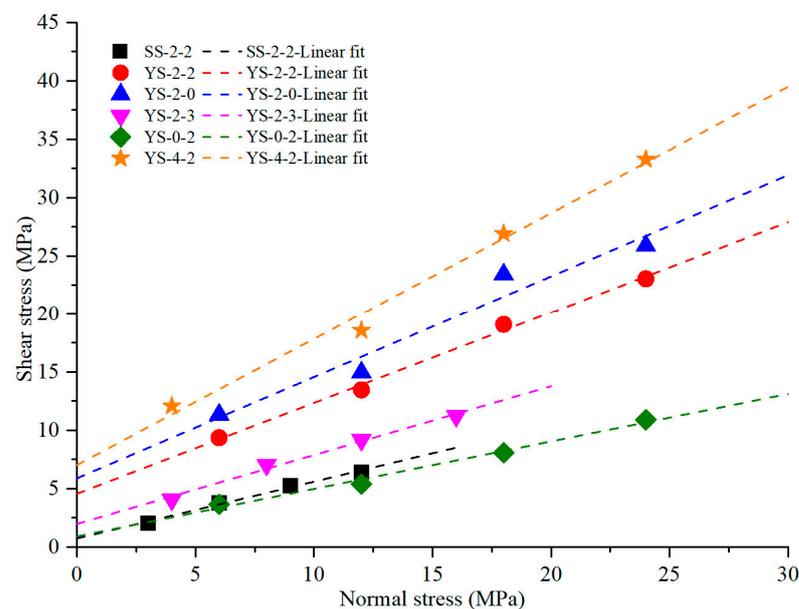
**Figure 9.** Scatters of shear and normal stresses and corresponding linear fit curves.

The scatters of shear and normal stress are plotted in Figure 9. For each type of composite specimens, shear stress keeps growing with the increase in normal stress. Based on the Mohr–Coulomb criterion, the linear fit was implemented, and parameters of shear strength (internal friction angle and cohesive strength) acquired are shown in Table 5.

The tangent value of the internal friction angle ( $\tan\phi$ ) is the slope of the fitted line, which reflects the sliding friction property of the shear plane, and is determined by surface roughness and material stiffness. As shown in Figure 10a, the values of internal friction angle decrease with the increase in drilling mud pollution for shale–cement specimens with the same surface roughness of 1 mm. For specimens with fresh and untreated surfaces, the internal friction angle is  $40.9^\circ$ , while it decreases to  $37.9^\circ$  for surface treated with drilling mud pollution and flushing fluid washing. If the step of flushing is further removed, the value continues to decline to  $30.6^\circ$ . Under the same condition of surface cleanliness, the internal friction angle grows from  $22.2^\circ$  to  $47.3^\circ$ , as the roughness increases from 0 mm to 2 mm. Owing to the incomplete drilling mud cleaning and relative low stiffness of sandstone, the internal friction angle of the sandstone–cement interface ( $25.9^\circ$ ) is much smaller than that of the shale–cement interface ( $37.9^\circ$ ).

Cohesive strength ( $c$ ) is the intercept of the fitted line, which represents the initial shear strength without the action of normal stress, and could be used to evaluate the initial bond strength of the rock–cement interface. As provided in Figure 10b, the cohesive strength shows a similar trend to the internal friction angle, but its change in range is relatively wider. Specifically, the values of cohesive strength decline from 5.87 MPa to 1.96 MPa, a drop of about 66.6%, as the surface cleanliness changes from fresh and untreated to drilling mud pollution without flushing, while it drops dramatically from 7.01 MPa to 0.89 MPa,

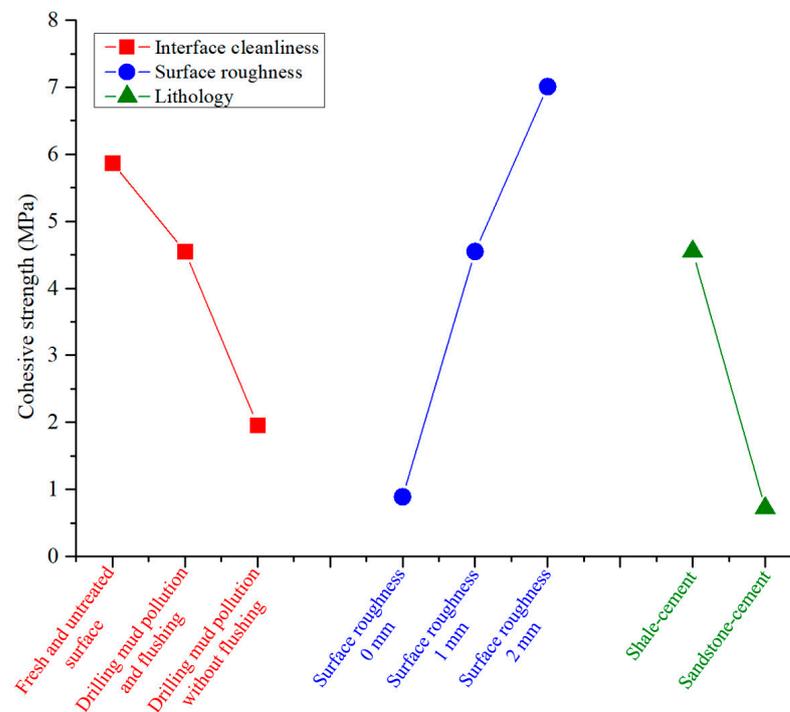
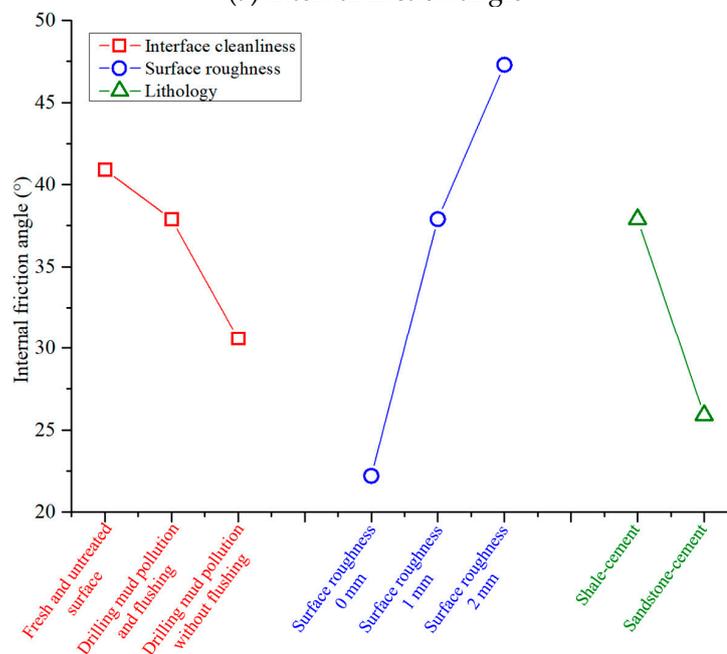
(a) Internal friction angle

(b) Cohesive strength

Figure 10. Variation of parameters of shear strength with different factors.

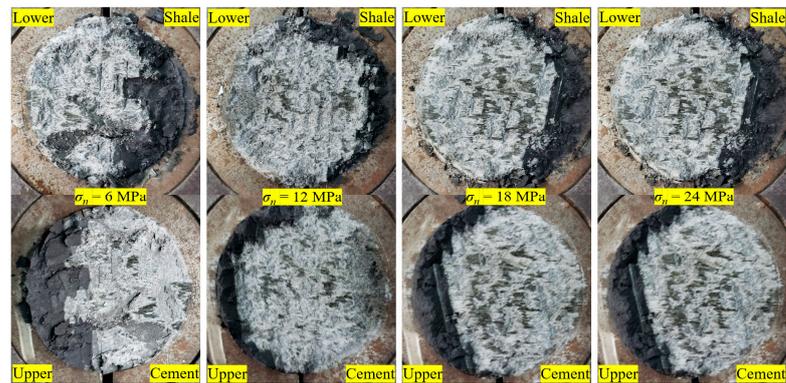
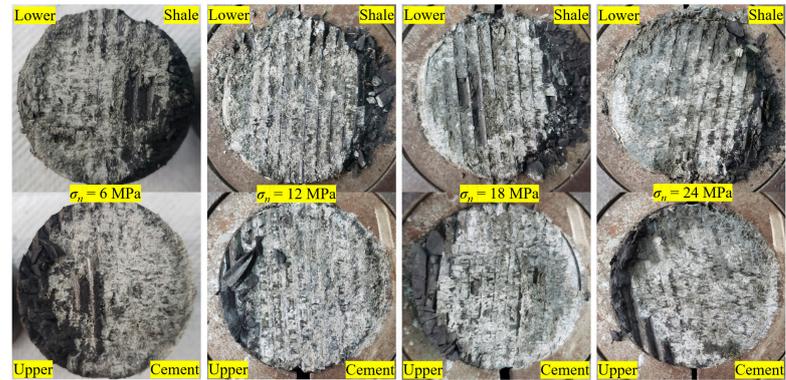
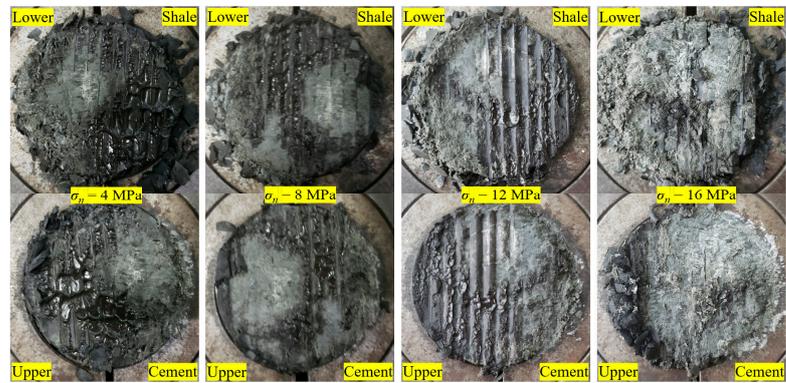
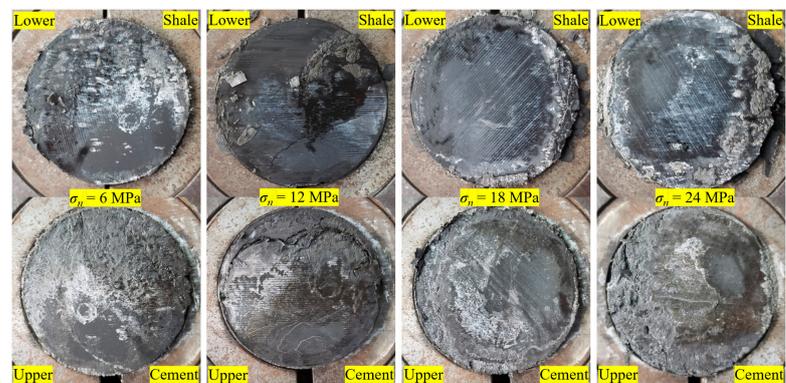
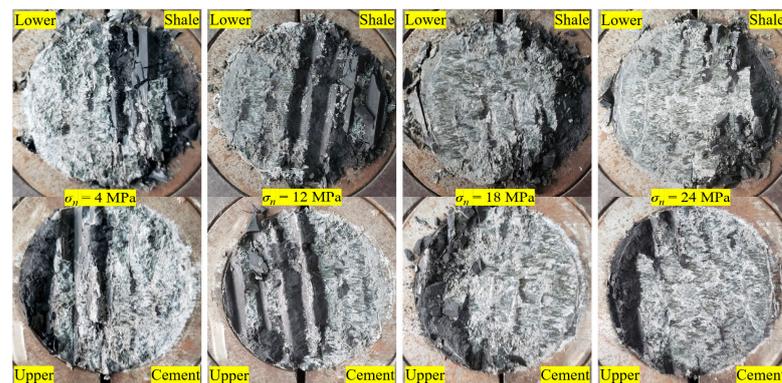
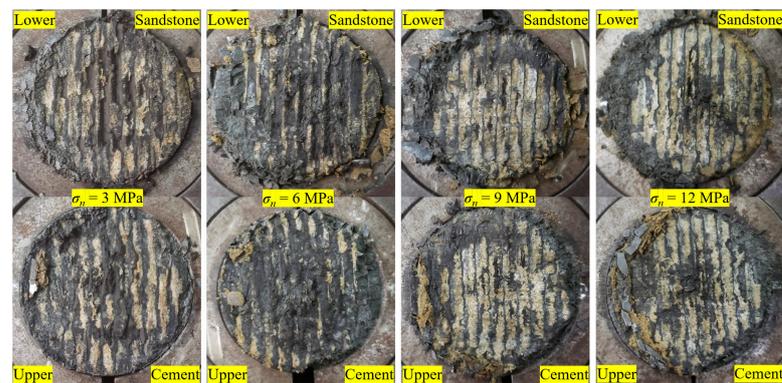
**Figure 11.** Morphology of shear fracture surfaces.

The analysis of shear fracture surface could provide detailed information about the failure mechanism. As shown in Figure 11, the shear fracture surface is not always exactly the rock–cement interface. It usually manifests as a shear zone, in which the rock, cement, and interface all contribute to the final shear failure. The morphology of fracture surface also shows diversity for different types of rock–cement specimens.

As shown in Figure 11a, the interface of composite specimens is fresh and uncontaminated with a roughness of 1 mm. The surfaces of the shear fractures are flat and exhibit gray friction trace, and we could not see the bumpy shale–cement interface, which are filled up and made even by the broken cement. All these indicate that shear failure mainly occurs in the cement part next to the interface. The reason is that when the shale and cement at the interface are firmly cemented, shear failure initiates and propagates along the relatively weak cement part. In addition, with the increase in normal stress, the friction trace becomes more significant.

For specimens with interface treatment of drilling mud contamination and flushing fluid washing, shear failure still mainly happens in the cement part (Figure 11b). However, the surface of the shear fracture is no longer flat and shows certain roughness. As the residual drilling mud is not completely removed by flushing, and so the shale–cement interface is not cemented as firmly as that in the fresh state. During shear sliding, some cement, imbedded into the shale grooves, delaminates, so the surface becomes uneven.

As shown in Figure 11c, the interface is treated with drilling mud pollution without flushing. The surfaces of shear fractures are filled with residual drilling mud, and the

When the interface is flat, shear failure occurs exactly on the shale–cement interface (Figure 11d). A small amount of cement is still glued to the shale. Due to the flat surface and a little drilling mud residue, it is easy to start shear sliding, and the cohesive strength of the interface is relatively low.

Under the condition of large surface roughness (2 mm), the initiation and propagation of shale failure becomes more difficult. As shown in Figure 11e, because of the relatively large roughness, not only cement but also shale, participates in the formation of shear fractures. Consequently, the cohesive strength of this kind of interface is high and reaches 7.01 MPa.

As shown in Figure 11f, the shear fracture surface of sandstone–cement is mainly along the interface. Due to the poor flushing effect and low strength of the sandstone, residual drilling mud and fragments of sandstone and cement are seen on fracture surfaces.
