# Monitoring and Preventing Failures of Transmission Pipelines at Oil and Natural Gas Plants

**Citation:** Beben, D.; Steliga, T. Monitoring and Preventing Failures of Transmission Pipelines at Oil and Natural Gas Plants. *Energies* **2023**, *16*, 6640. <https://doi.org/10.3390/en16186640>

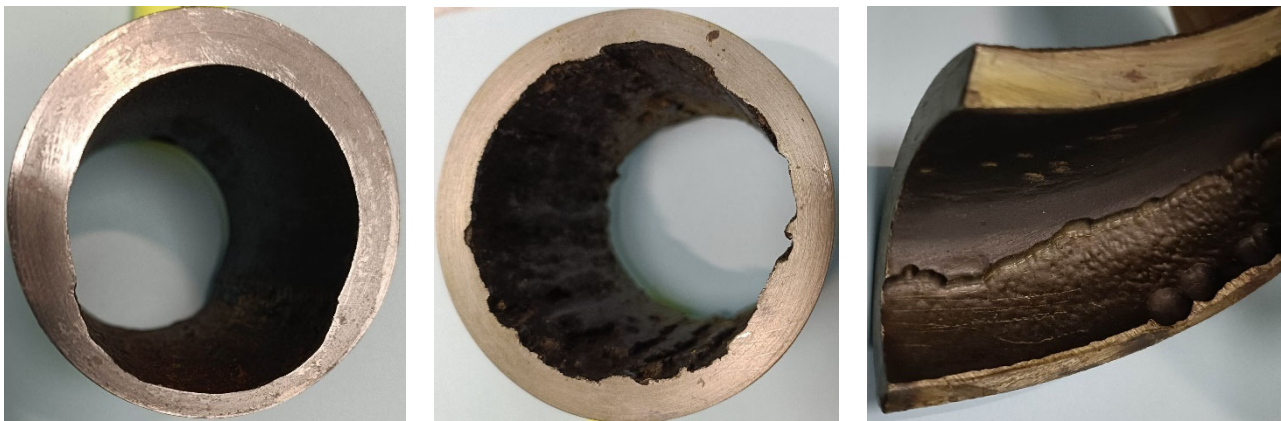
Currently, several corrosion monitoring methods are available, primarily focused on monitoring the progress of general corrosion. Such corrosion occurs when the construction material undergoes uniform degradation throughout the area in contact with the aggressive corrosive medium. Figure 1 illustrates several examples of general corrosion.

**Figure 1.** Pipe fragments illustrating general and pitting corrosion.

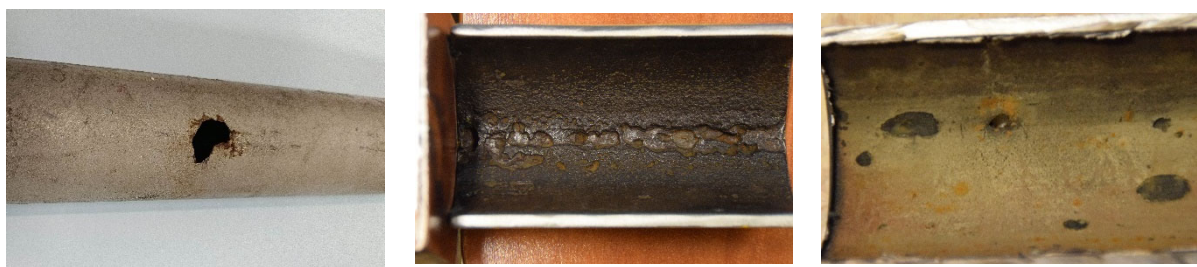
Various methods and measurement techniques for corrosion are advanced enough that monitoring general corrosion is considered solved. Greater difficulties are encountered in monitoring pitting corrosion, which, due to the random nature of material damage location using conventional corrosion rate measurement methods, is challenging to locate, let alone monitor. Figure 2 shows an example of pitting corrosion.

**Figure 2.** Pipeline fragment illustrating pitting corrosion.

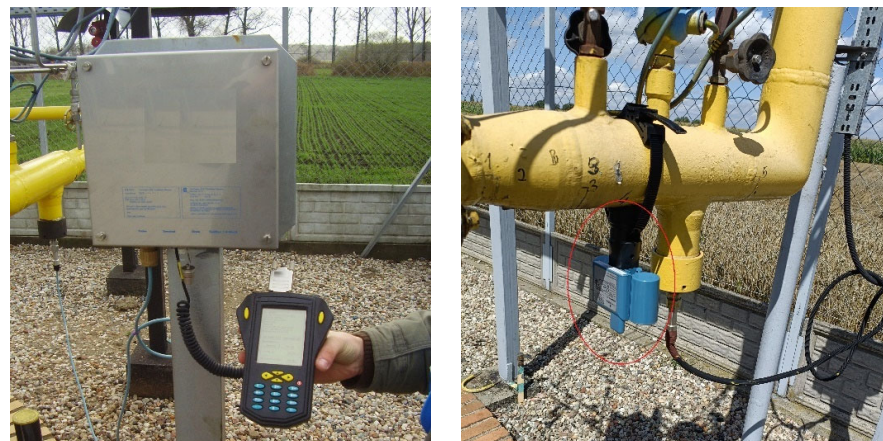
Special attention should be paid to corrosion protection techniques from the very beginning of pipeline construction, starting with the selection of steel, the chemical treatment of the steel used, the coating that protects the pipe, and the use of monitoring and application of corrosion protection [49]. A corrosion monitoring system using a probe and ultrasonic waves is illustrated in Figure 3.

**Figure 3.** Corrosion monitoring system using a probe and ultrasonic waves.
