Article

Self-Healing Concrete by Biological Substrate

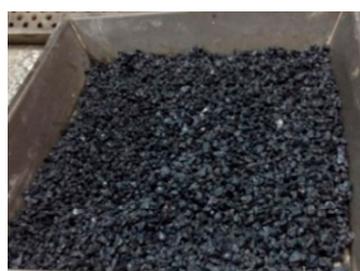
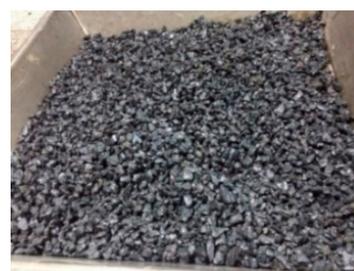
Figure 2. Lightweight aggregate containing biological species: (a) soaked once; (b) soaked twice.

After the strains were implanted into the lightweight aggregate (as shown in Figure 2), concrete mixing was carried out. The water-to-cement ratio of the mixed concrete was 0.60, and the detailed proportioning design is shown in Table 2. After the concrete was mixed, 48 cylindrical specimens (100 mm in diameter × 200 mm in height) and 48 beam specimens (3600 mm in length × 100 mm in width × 100 mm in thickness) were cast and compacted using an external vibrator. After casting, all the specimens were covered overnight with wet hessian and polyethylene sheets for a period of 24 hours. After 24 hours, the specimens were demolded.

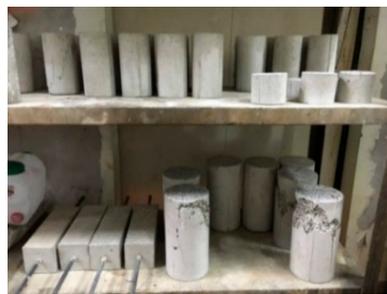
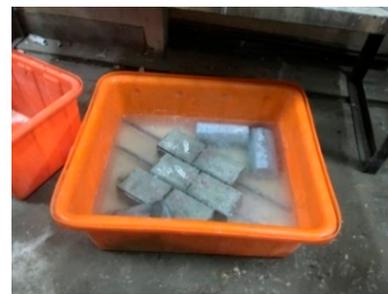
Figure 3. Curing situation of specimens: (a) control group and experimental group I; (b) experimental group II.

The specimens of the control group were lightweight aggregate concrete without implanted bacteria or a nutrient source. The curing method involved placing the test specimens directly in the curing room for air curing, as shown in Figure 3a. The temperature of the curing room was maintained at 23 ± 1.5 °C, and the humidity was 100%. The specimens of experimental group I were implanted with bacteria and a nutrient source. The curing method was the same as that of the control group. The specimens from experimental group II were immersed in a mixed aqueous solution of urea and calcium acetate (see Figure 3b), wherein the mixed aqueous solution contained urea at a concentration of 1 mole and calcium acetate at a concentration of 0.5 moles. The specimens were alternated between curing in a mixed aqueous solution and air. That is to say, the specimens were immersed in an aqueous solution for 1 day, and then the specimens were taken out and placed in the air for 1 day, and the cycle number was 2 days until the required age, and then they were taken out and observed.

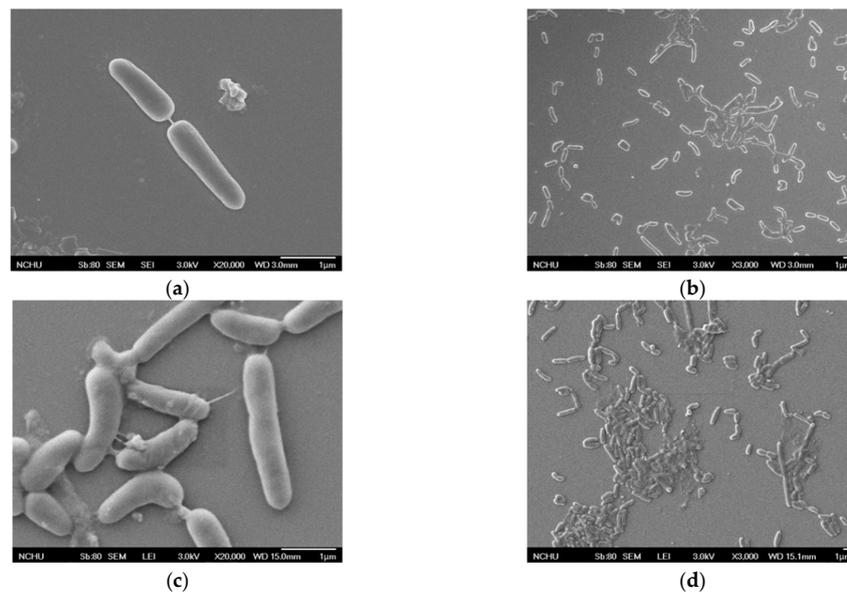
Figure 4. Unheated *Bacillus pasteurii* images: (a) SEI (upper detector image, 20,000 times magnification); (b) SEI (3000 times magnification); (c) LEI (lower detector image, 20,000 times magnification); (d) LEI (3000 times magnification).

From the results of the photographs shown in Figures 4 and 5 of the unheated *Bacillus pasteurii* in the SEI or LEI shooting mode, the surrounding environment shows that there was no other impurity in the *Bacillus* and that the surface of the *Bacillus* was smooth and there was no adhesion phenomenon. After heating, there were many white spots (SEI) and particles (LEI) in addition to the *Bacillus* itself around the *Bacillus pasteurii* image. Moreover, the appearance of the *Bacillus* became more and more uneven, and in some cases, the *Bacillus* was observed to have protrusions and particle adhesion on the surface.

It can be seen from the image results that the unheated *Bacillus pasteurii* was flat and clean under the conditions of SEI or LEI, and the appearance of the *Bacillus* was also different. After heating, the appearance of the *Bacillus* was broken and there were more impurities in the image. In a high-temperature environment, in order to cope with the severe environment, *Bacillus pasteurii* will produce spores to continue life. It can be speculated that the white spots (SEI), particles, and protrusions (LEI) in the image after heating may be spores, because the spores of *Bacillus* will be released from the broken sporangia when they mature. The image obtained by the FE-SEM observation was the only appearance of a living thing. In order to confirm that the observed image was a spore of *Bacillus pasteurii*, the spore staining method was used for observation. The spore staining method mainly uses malachite green solution to stain the spores, and safranin solution is used to infect the cell wall of the *Bacillus*, and this is then observed by an optical electron microscope at 800 times magnification.

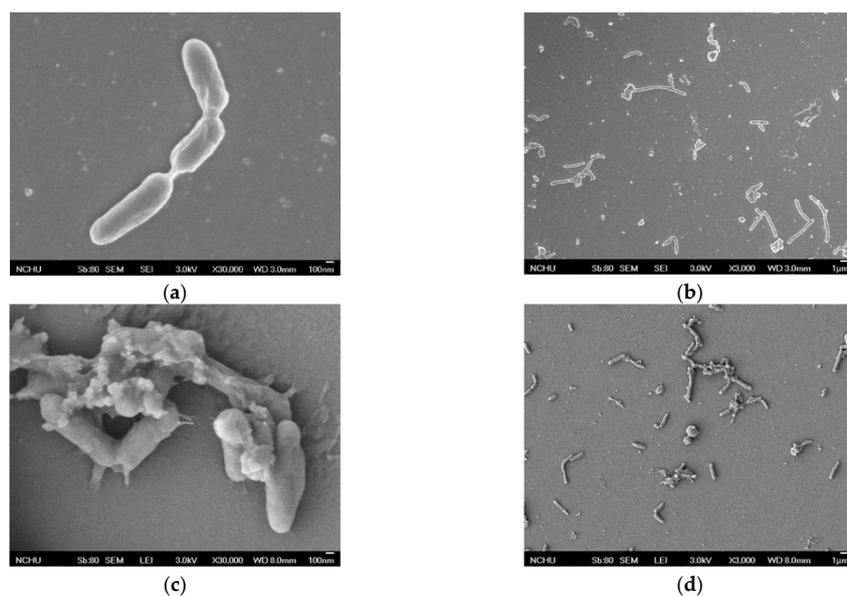
Figure 5. Heated *Bacillus pasteurii* images: (a) SEI (20,000 times magnification); (b) SEI (3000 times magnification); (c) LEI (20,000 times magnification); (d) LEI (3000 times magnification).

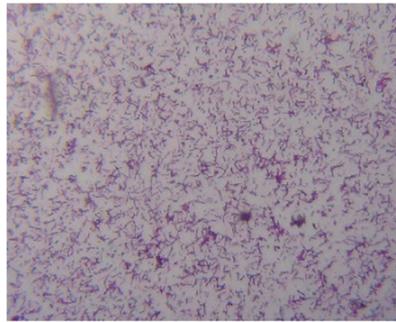
Figure 6. Unheated *Bacillus pasteurii* image (stained).

The image results of Figures 6 and 7 show that the unheated *Bacillus pasteurii* was densely distributed under microscope observation, and the *Bacillus* body was red, while the heated *Bacillus pasteurii* was loosely distributed and exhibited a green, non-rod shaped cell. From the experimental results, it was found that the number of cells of the *Bacillus* was less after heating than when the *Bacillus* was not heated. It is speculated that when the bacteria respond to the harsh environment, after depositing their own DNA into the spore, they will die by themselves to continue life. The green spots observed in Figure 7 can be presumed to be spores released by the *Bacillus*.

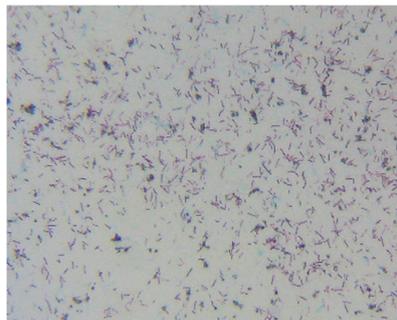
Figure 7. Heated *Bacillus pasteurii* image (stained).

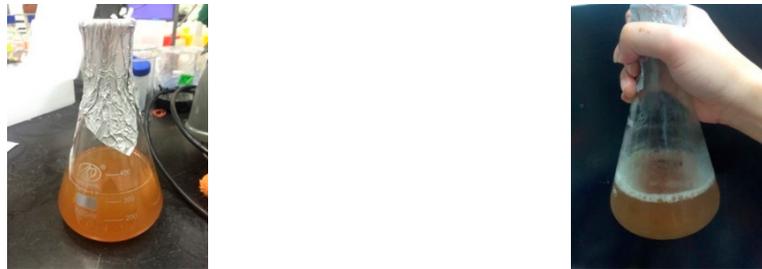
Figure 8. Confirmation of activity after sporulation of the strain (replanting of bacterial solution).

The reactivation test was carried out to verify whether the spores were germinated into *bacilli* by re-cultivation after the *Bacillus pasteurii* was heated to form spores. The test results are shown in Figure 8. It was observed that the spore culture solution after the culture showed a turbid state, and the optical density (OD) value was found to be about 1.0. The OD values of the freshly cultured bacterial liquid, the spore-formed bacterial liquid, and the bacterial culture cultured after sporulation were

1.2, 0.7, and 1.0, respectively. It is considered that the bacterial liquid after sporulation is active from the change in the OD value, and the turbidity of the medium solution indicates the activity trace of the organism.

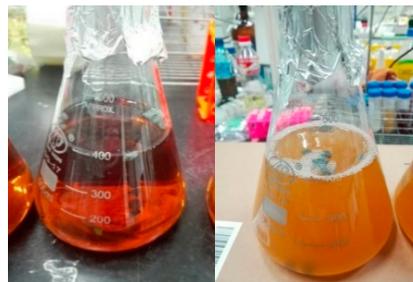
Figure 9. Confirmation of activity after sporulation of the strain (replanting of aggregate containing biological species).

After the spore-formed *Bacillus pasteurii* was planted into the aggregate as a biological strain, it was necessary to further understand whether the nutrient source could still be provided to restore the activity again. The test results are shown in Figure 9. It was observed that the medium solution containing the biological strains showed a turbid state, and the OD value was about 1.0, while the OD value of the original culture solution was 0 (control group). According to the test results, the *Bacillus pasteurii* spores can be re-germinated after being stored in the lightweight aggregate.

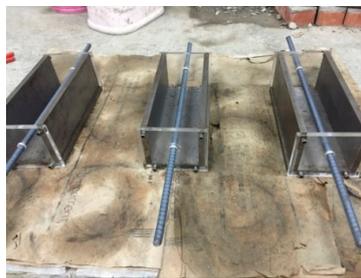
Figure 11. Mold of the beam specimen.

In the crack repair test of lightweight aggregate concrete, two different specimen types were planned. One was a cylindrical specimen, and the other was a beam specimen (the center is placed with #4 steel bars to prevent breakage, as shown in Figure 11). For these two different types of concrete specimens, the crack had a design width of about 0.1–2.0 mm. After the concrete specimens to be observed were cured in different ways, at the ages of 1, 3, 7, 14, 21, 28, 56, and 91 days, they were taken out for microscopic observation.

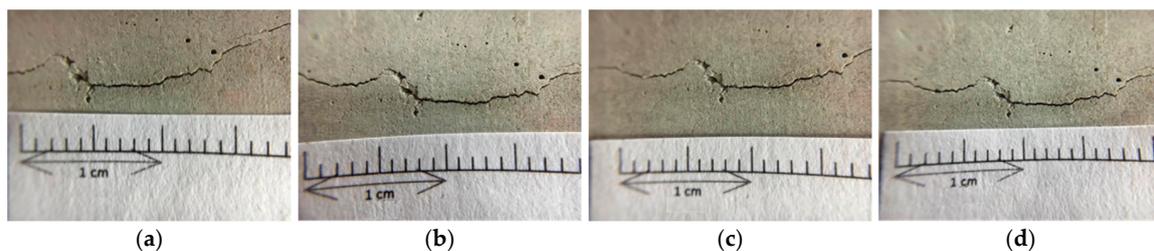
Figure 13. Images of the pre-cracked concrete cylindrical specimen (Control group): (a) Day 1; (b) Day 28; (c) Day 56; (d) Day 91.

This study used a splitting method (as shown in Figure 12) to create deep and wide cracks in cylindrical specimens. The width of the produced crack was 0.1–2.0 mm, as shown in Figures 13–15. It can be seen from the test results that the control group and experimental group I had no repair phenomenon, regardless of the width of the crack in the sample. In contrast, in experimental group II, with the increase in the curing age, the crack of the sample began to show obvious repair on the 28th day of curing (as shown in Figure 15).

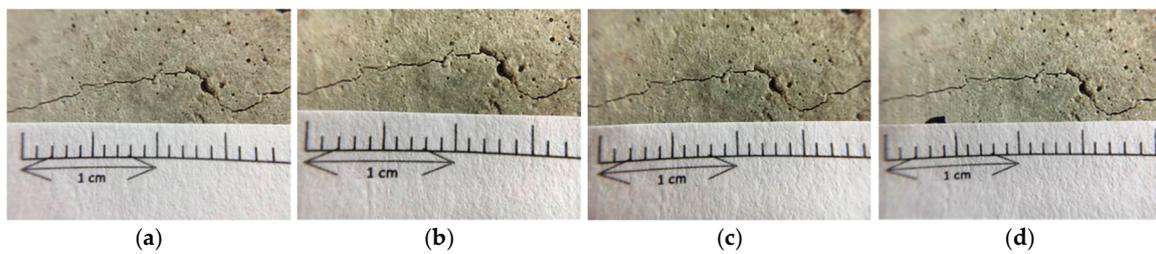
Figure 14. Images of the pre-cracked concrete cylindrical specimen (Experimental group I): (a) Day 1; (b) Day 28; (c) Day 56; (d) Day 91.

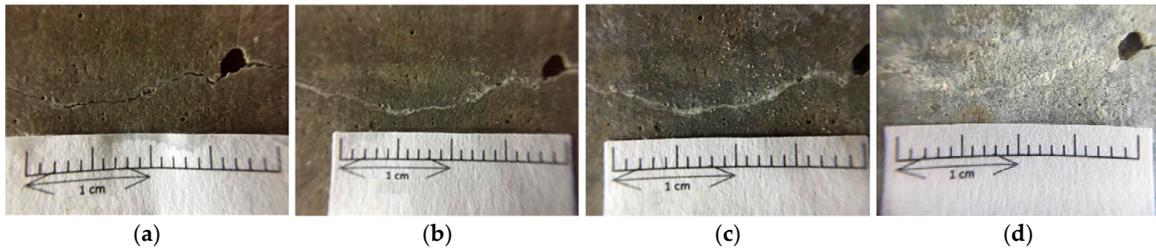
Figure 15. Images of the pre-cracked concrete cylindrical specimen (Experimental group II): (a) Day 1; (b) Day 28; (c) Day 56; (d) Day 91.

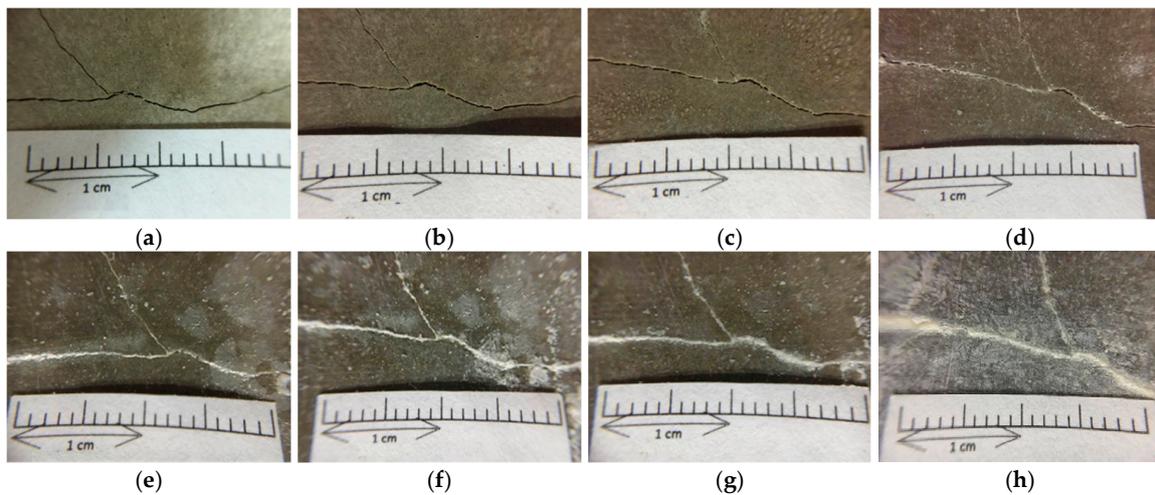
Figure 17. Images of the pre-cracked concrete beam specimen with small cracks (Experimental group II): (a) Day 1; (b) Day 3; (c) Day 7; (d) Day 14; (e) Day 21; (f) Day 28; (g) Day 56; (h) Day 91.

Under a controlled load, the beam specimens produced flexural cracks (as shown in Figure 16). The width of the cracks ranged from 0.1 to 2.0 mm, as shown in Figures 17 and 18. Careful observation revealed that the resulting cracks were wider near the surfaces of the specimens and thinner near the middle of the specimens. As with the test results of the cylindrical specimens, the control group and experimental group I did not show a self-healing phenomenon regardless of the crack width of the specimens. In contrast, in experimental group II, the cracks in the specimen began to show significant self-healing on the third day of curing. As the number of curing days increased, the crack self-healing effect was better, regardless of the crack width.

As can be seen from Figure 16, for a relatively small deflection crack, for example, less than 0.1 mm, the crack can be completely repaired after about the 14th day. In addition, the inclusion of steel in the specimen allowed it to not crack too much when cracks were formed. Also, because there was a steel strip to pull the cracked sample, *Bacillus pasteurii* was less susceptible to disturbance when it produced calcium carbonate precipitate for crystal stack repair. If the flexural crack width reached about 1.2 mm (Figure 17), the calcium carbonate crystal completely filled the crack when the curing age reached 91 days. As with the splitting crack observation of the cylindrical specimen, when the flexural crack was wider, the crack initiation time and the crack repair time were longer.

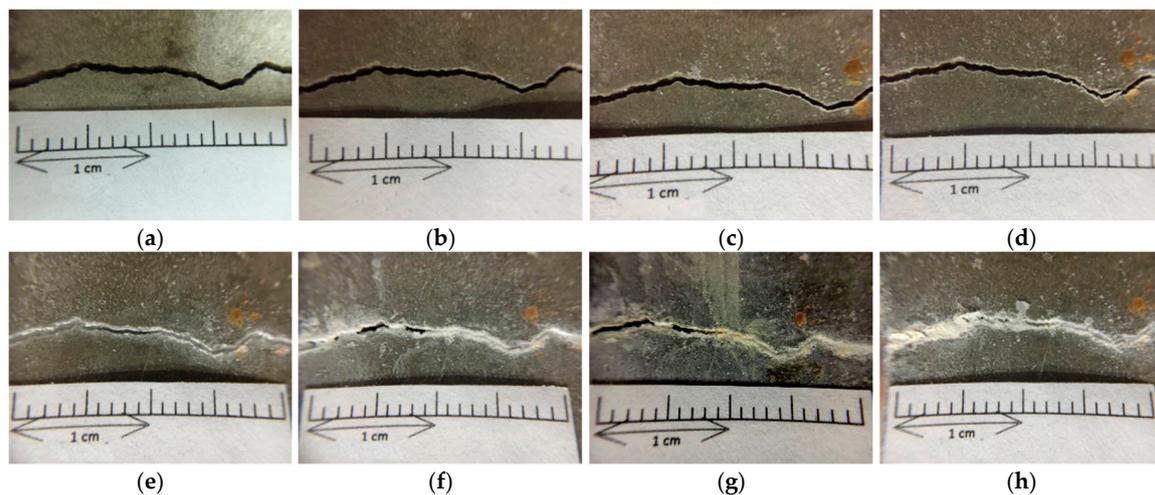
Figure 18. Images of the pre-cracked concrete beam specimen with large cracks (Experimental group II): (a) Day 1; (b) Day 3; (c) Day 7; (d) Day 14; (e) Day 21; (f) Day 28; (g) Day 56; (h) Day 91.

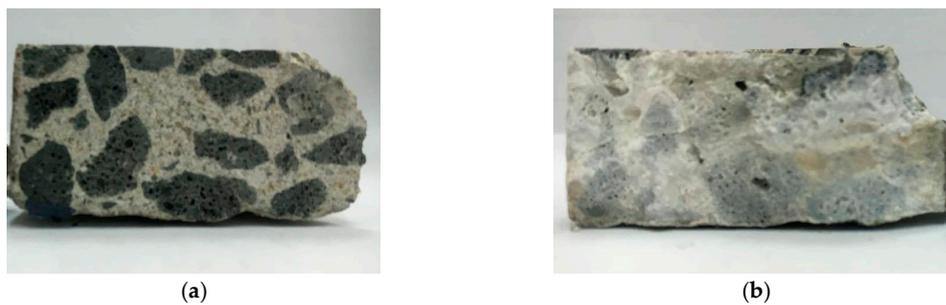
Figure 19. Comparison of cross-section observations between the control group and experimental group II: (a) control group; (b) experimental group II.

To further understand the effectiveness of biobacterial mineralization and accumulation, this study compared the crack profiles of the specimens. As is clear from Figure 19, the experimental group II specimen-implanted biological strains were covered with calcium carbonate crystals in contrast to the control group specimen. Further, the cross-section of the experimental group II specimen was observed with a portable microscope. As can be seen in Figure 20, calcium carbonate crystals were formed outward from the surface of the aggregate. This result indicates that calcium carbonate crystals were produced by biological species implanted in the aggregate.

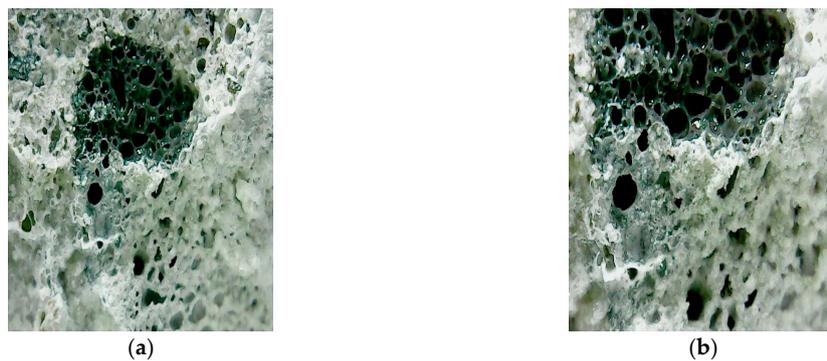
Figure 20. Sectional observation of experimental group II under a portable microscope: (a) 100 times magnification; (b) 200 times magnification.

According to the test results of the crack self-healing of the concrete cylindrical specimens and beam specimens, it is known that experimental group II of the circulating curing method can use the biological strains to repair the cracks in the concrete. In order to further understand the repairable depth of the crack after the action of the biological strains, the experimental group II concrete specimen was cut along the vertical plane of the crack, and the vertical section was observed. The observed crack width was approximately 0.5 mm (as shown in Figure 21). The vertical section observation results are shown in Figures 22 and 23 after 91 days of crack self-healing. The repaired depth of the crack was about 1.2 mm from the surface of the specimen, as shown in Figure 22. As can be seen from Figure 23, the calcium carbonate crystals produced by the biological species were very fine and compact, and the cracks were repaired perfectly, preventing the concrete from being damaged by external foreign matter invasion. It is worth noting that, as can be seen from the figure, when *Bacillus pasteurii* was repaired with calcium carbonate crystals, a large amount of calcium carbonate precipitate formed from the outer edge of the crack. After sealing the outer edge of the crack, it extended to the inside and continued to slowly deposit calcium carbonate crystals for repair.

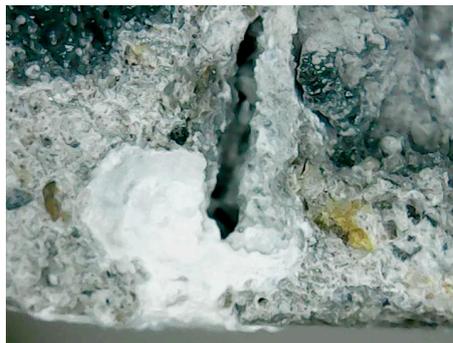
Figure 23. Thickness observation of the vertical section crack repair under a portable microscope (100 times magnification).

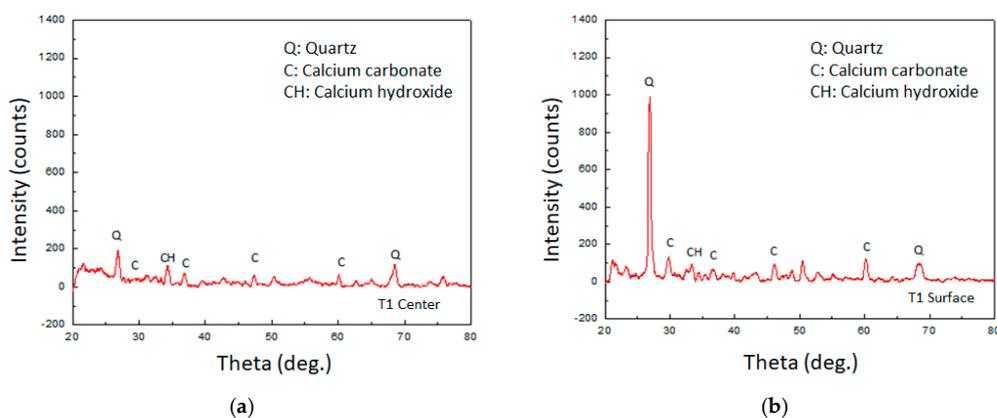
Figure 24. XRD test results of crack repair powder (experimental group I): (a) result at the sample center; (b) result at the sample surface.

It can be seen from Figures 24 and 25 that the lightweight aggregate concrete containing biological species had calcium carbonate crystals at the center or near the surface. Because the concrete was mixed with fine sand, the X-ray reflection value of quartz is also shown in the figure. Basically, the intensity of the X-ray reflection can indicate the amount of crystal present. It can be seen from the figure that the experimental group I samples of air curing or the experimental group II samples of circulating curing had peaks of calcium carbonate crystals on the surface that were larger than the center. Therefore, it is foreseeable that the calcium carbonate crystal content measured at the center of the sample was not high. The reason for this may be that under long-term curing, the cement hydration reaction tended to be complete so that the interior of the concrete became denser. As a result, the MICP reaction of the strain was limited, and the amount of calcium carbonate was less.

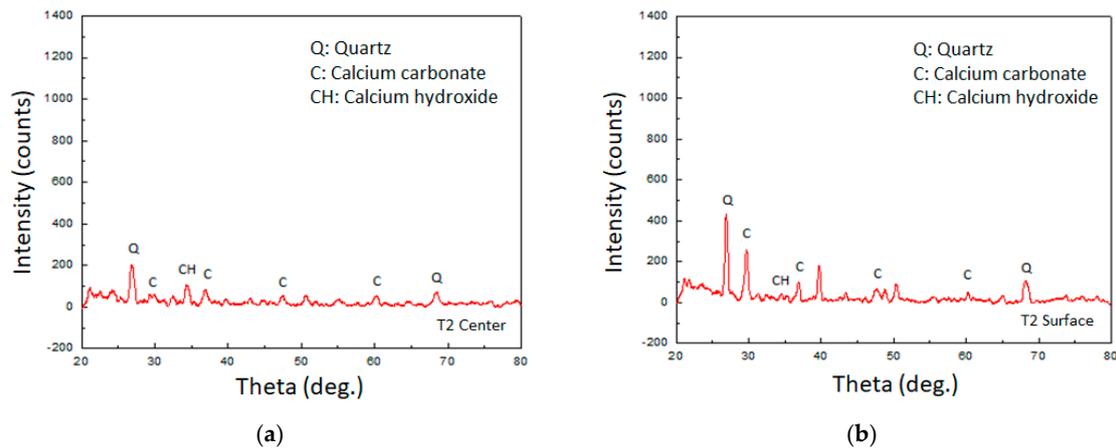
Figure 25. XRD test results of the crack repair powder (experimental group II): (a) result at the sample center; (b) result at the sample surface.

Moreover, in the experimental group II samples, *Bacillus pasteurii* also provided additional calcium carbonate formation on the crack surface. The concrete specimen did nothing more than form a protective layer, which made it difficult for oxygen to enter the sample, thus causing the internal *Bacillus pasteurii* activity to be reduced, and it was difficult to form calcium carbonate crystals. Therefore, the calcium carbonate crystal formed at the center of the sample was smaller than the crystal on the surface of the sample. It can also be seen from the figure that the peak of the calcium carbonate crystal of the experimental group II samples at both the center and the surface was higher than that of the experimental group I samples. This result is consistent with the previous observations, which means that experimental group II specimens can produce significant calcium carbonate precipitation for crack repair.
