# Experimental Investigations of Timber Beams with Stop-Splayed Scarf Carpentry Joints

**Abstract:** The paper presents the results of an experimental investigation of stop-splayed scarf joints, which was carried out as part of a research programme at the Wrocław University of Science and Technology. A brief description and the characteristics of scarf and splice joints appearing in historical buildings are provided, with special reference to stop-splayed scarf joints (so-called ‘Bolt of lightning’) which were widely used, for example, in Italian renaissance architecture. Analyses and studies of scarf and splice joints in bent elements presented in the literature are reviewed, along with selected examples of analyses and research on tensile joints. It is worth noting that the authors in practically all the cited literature draw attention to the need for further research in this area. Next, the results of the authors’ own research on beams with stop-splayed scarf joints, strengthened using various methods, e.g., by means of drawbolts (metal screws), steel clamps and steel clamps with wooden pegs, which were subjected to four-point bending tests are presented. Load-deflection plots

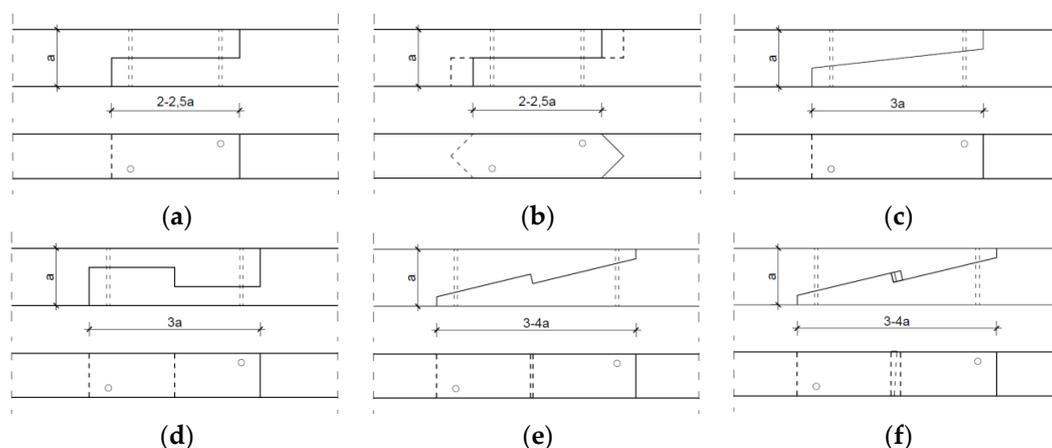
**Figure 1.** Various forms of scarf and splice joints: (a) splice joint, (b) nibbed splice joint, (c) nibbed scarf joint, (d) tabled splice joint, (e) stop-splayed scarf joint ('Bolt of lightning'), (f) stop-splayed and tabled scarf joint with key.

Researchers distinguish many different types of carpentry joints in historic buildings, depending on their function and form (inter alia [7]). One group includes scarf joints and splice joints which enable a connection along the length of two elements. These were applied when the available material could not cover the whole beam length. Typically, whenever possible, the joints were applied in the least stressed sections, as the connecting elements at the point of contact could not bear a load greater than that in continuous sections [8]. Aside from extending foundation beams and capping beams in the building frames of historical structures, scarf and splice joints were used to extend roof frame elements, such as purlins or rafter beams. Until the introduction of glulam wood, this was a universal method for extending wood elements [9]. Scarf and splice carpentry joints are used today to restore historical joints or replenish material in historical elements of special value [10]. Examples of scarf and splice joints found in historical structures are presented in Figure 1.

The type of joint applied in a given connection is related to the function to be performed or the type of loading to be transferred. For example, a nibbed scarf joint (Figure 1c) would be used where the connection is stressed vertically and located near a support. In such a situation, the joint is responsible for transferring shear stress. In situations where tensile elements are connected, such as rafter beams, a different type of joint needs to be applied. For tensile elements, stop-splayed and tabled scarf joints with a key (Figure 1f) were used.

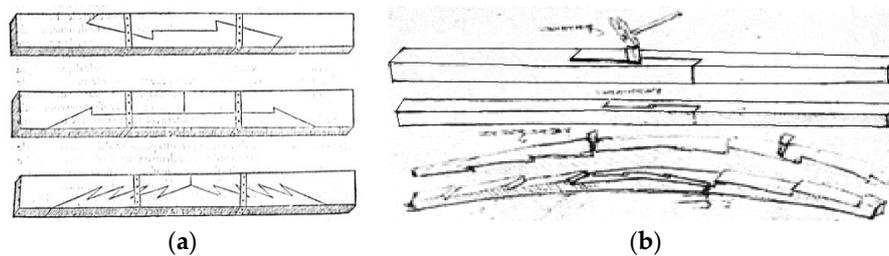
**Figure 2.** Sketches presenting scarf and splice joints in wooden beams (a) according to Leon Battista Alberti, (b) according to Leonardo da Vinci.

Stop-splayed scarf joints ('Bolt of lightning') were used in ancient times, for example, in the Roman construction of bridges, and later, in roof beam constructions and wooden ceiling construction elements right up to the end of the 19th century. A special period of development for this method of joining beam elements was that of the Italian Renaissance, which was the time of such masters as Leon Battista Alberti (Figure 2a) [19] and Leonardo da Vinci (Figure 2b) [16]. This method of connecting elements along their length was applied especially in elements subjected to tensile and bending forces. Typically, the joints were wedged, which was supposed to help in transferring loading and to ensure a tight fitting joint. Today, they are used mainly to strengthen and repair historical structures. Examples of stop-splayed scarf joints ('Bolt of lightning') and so-called composite beams are presented below (Figures 2–4).

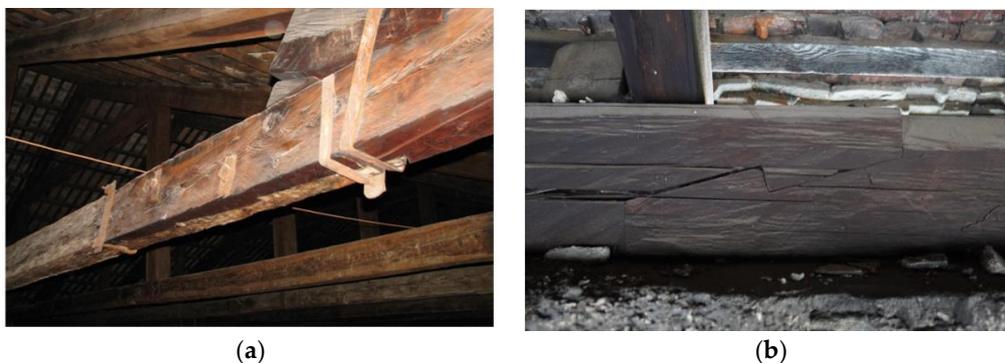
**Figure 4.** Examples of scarf and splice joining of wooden beams in existing buildings: (a) building in Italy, (b) building in Poland—13th century Czocho Castle in Sucha.

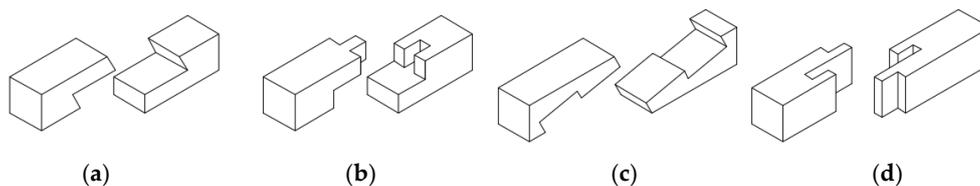
**Figure 6.** Scarf joints analysed in research: (a) under-squinted butt in halved scarf with two pegs, (b) side-halved and bridled with two pegs, (c) stop-splayed and tabled scarf with key and four pegs, (d) and face-halved and bridled scarf with four pegs.

The results of research carried out at the University of Bath in the UK by a team consisting of Walker, Harris, Hirst and others on the static behaviour of scarf joints, inter alia stop-splayed scarf joints, which are universally found in historical buildings across England, are presented in [21]. The joints studied were under-squinted butt in halved scarf with two pegs, side-halved and bridled with two pegs, stop-splayed and tabled scarf with key and four pegs, and face-halved and bridled scarf with four pegs (Figure 6) (drawing based on data from [21]).

Experimental testing [21] was carried out on model beams of 2.5 m in length joined by means of the joints listed above and 1.5 m continuous beams in order to compare results. The elements were subjected to a four-point vertical bending test and lateral bending test to provide for pure bending. Load-deflection plots were determined, and on the basis of a comparison of results for the different joint types and also the parameters for the continuous element, it was possible to determine the performance factor describing the relationship of loading and stiffness of the composite beam to that of the continuous beam. The stop-splayed scarf joint ('Bolt of lightning') displayed the greatest stiffness and load-bearing (28% in relation to the continuous beam) with bending in the vertical plane.

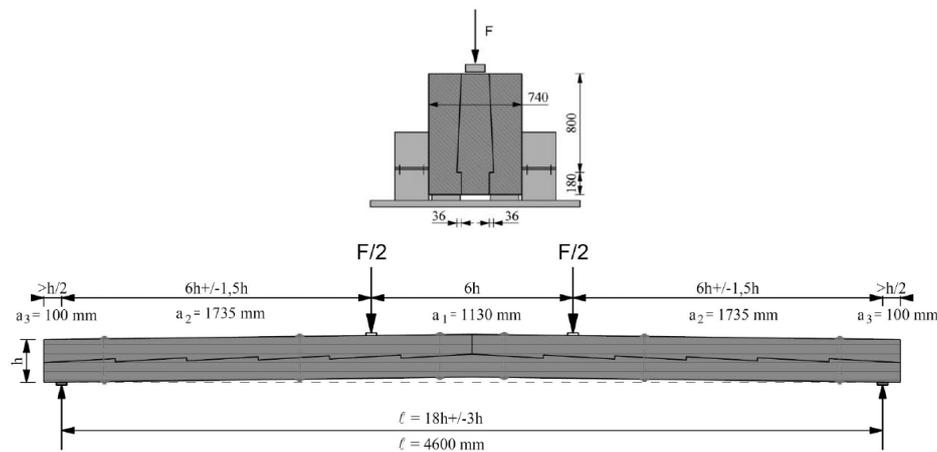
**Figure 7.** Model of a composite beam connected with a stop-splayed scarf joint and models used for testing of the joint itself and the element as a whole, image adapted from [17] with permission.

(the dimensions adopted were the same as those in an existing rafter beam roof in a tower of a German church) and also on 1:2 scale models (Figure 7). Bending tests were carried out (in accordance with EN408), achieving an average loading at the level of approximately 57 kN; the deflection plot and flexibility modulus of the joint in the technical scale were determined in accordance with EN26891.

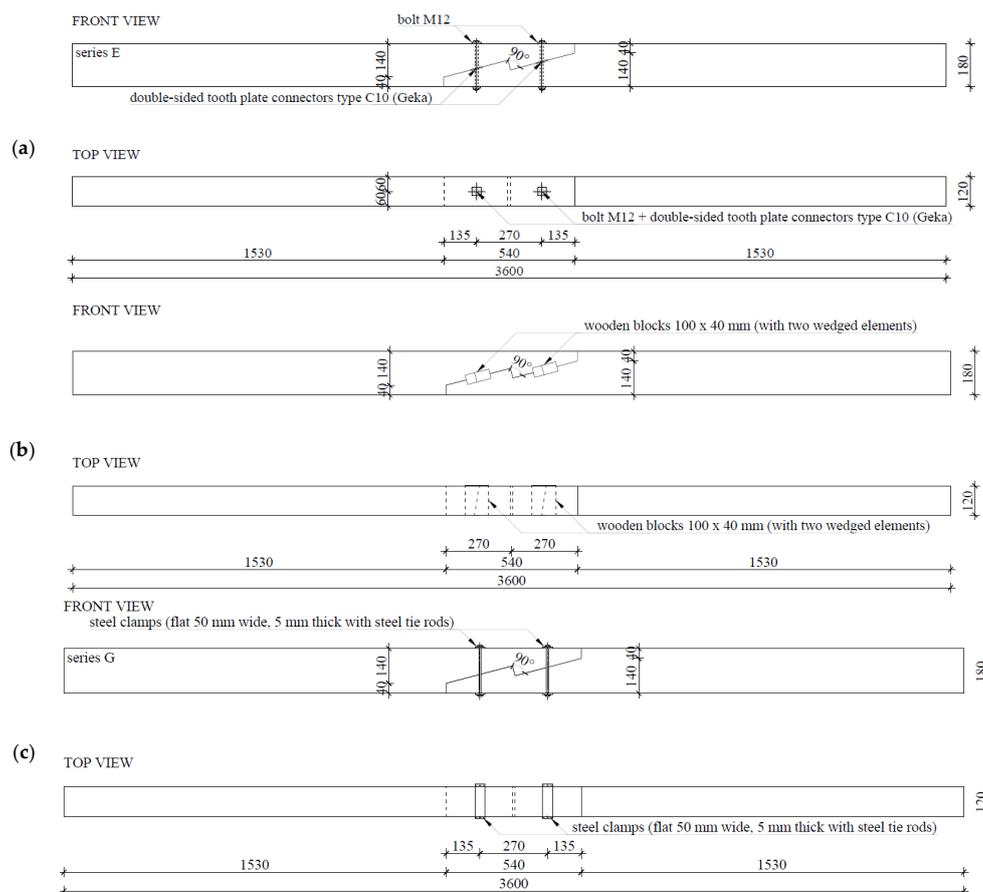
**Figure 9.** Schemes of the experimental testing models: (a) series E—with 2 drawbolts (double-sided tooth plate connectors type C10 + M10 screws), (b) series F—with wood inserts (and additional steel clamps), (c) series G—with steel clamps.

For the purposes of experimental testing, technical scale beam models were made from pine wood (*Pinus sylvestris* L.) of 360 cm in length and with a cross-section measuring 12 cm × 18 cm. Testing involved four series, each with three models. Series A included continuous beams as references, whereas series E, F, and G included beams with stop-splayed scarf joints in the horizontal plane. The series with joints differed from one another in terms of the methods used to strengthen the joint, i.e.:

- series E—beams with stop-splayed scarf joints and two drawbolts (double-sided tooth plate connectors type C10 (Geka) + M12 screws);
- series F—beams with stop-splayed scarf joints and wooden keys made from oak wood and additional steel clamps;
- series G—beams with stop-splayed scarf joints and flat steel clamps and steel tie-rods.

With respect to the geometry of the joints, these were based on data obtained for real structures and on data from the literature. The schematics and views of the various models used for testing are presented in Figures 9–11.

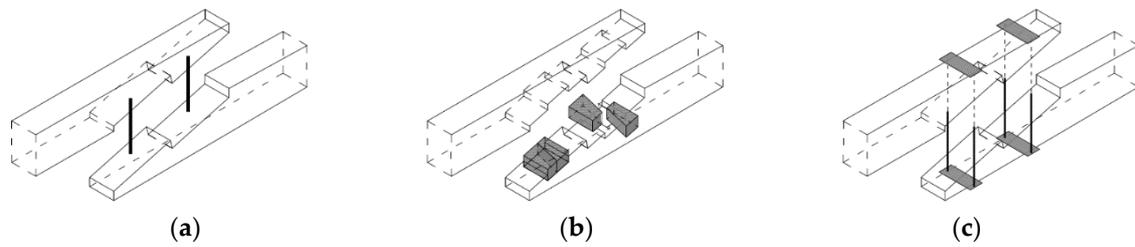
**Figure 10.** Aximetric schematics of joints used in the experimental models: (a) series E—with 2 drawbolts (double-sided tooth plate connectors type C10 + M10 screws), (b) series F—with wood inserts (and additional steel clamps), (c) series G—with steel clamps.

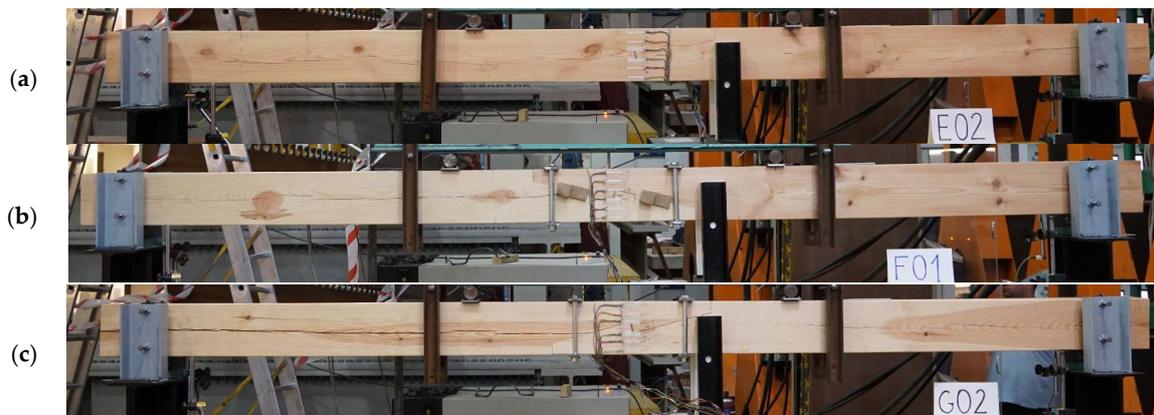
**Figure 11.** View of an example beam in each series: (a) series E—with 2 drawbolts (double-sided tooth plate connectors type C10 + M10 screws), (b) series F—with wood inserts (and additional steel clamps), (c) series G—with steel clamps.

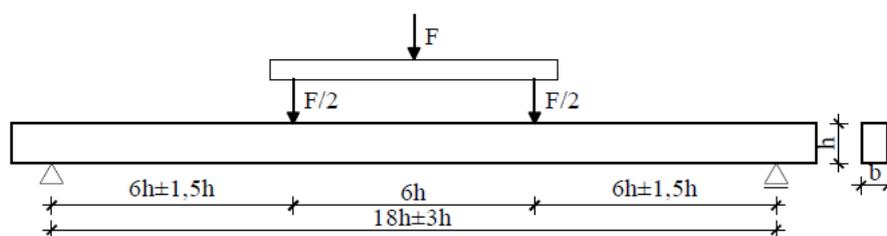
**Figure 12.** Scheme of the four-point bending test in accordance with standard procedure.

In order to determine the load-bearing and the load-deflection plot, the beam was subjected to four-point bending tests, in accordance with the standard procedure described in [36]. A schematic of the experimental testing is provided in Figure 12 (drawing based on data from [36]).

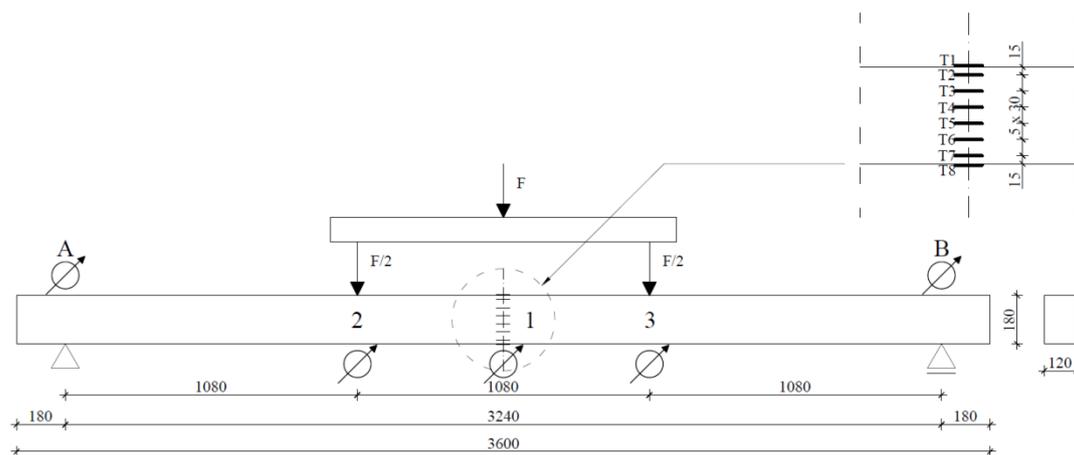
**Figure 13.** Scheme of the experimental testing site showing locations of the strain gauges.

The beams were freely supported at both ends. The span between the axes of the supports was 3.24 m. The supports included a fork support, which ensured that there was no loss in flexural static (lateral buckling). The beams were loaded symmetrically with a loading force applied at two points, thanks to which pure bending was obtained in the central part of the element. The speed of application of the loading was 5 mm/min. A schematic and view of the testing stand is presented in Figures 13 and 14. Registration of the strains observed in the materials was carried out by means of a series of RL 300/50 strain gauge.

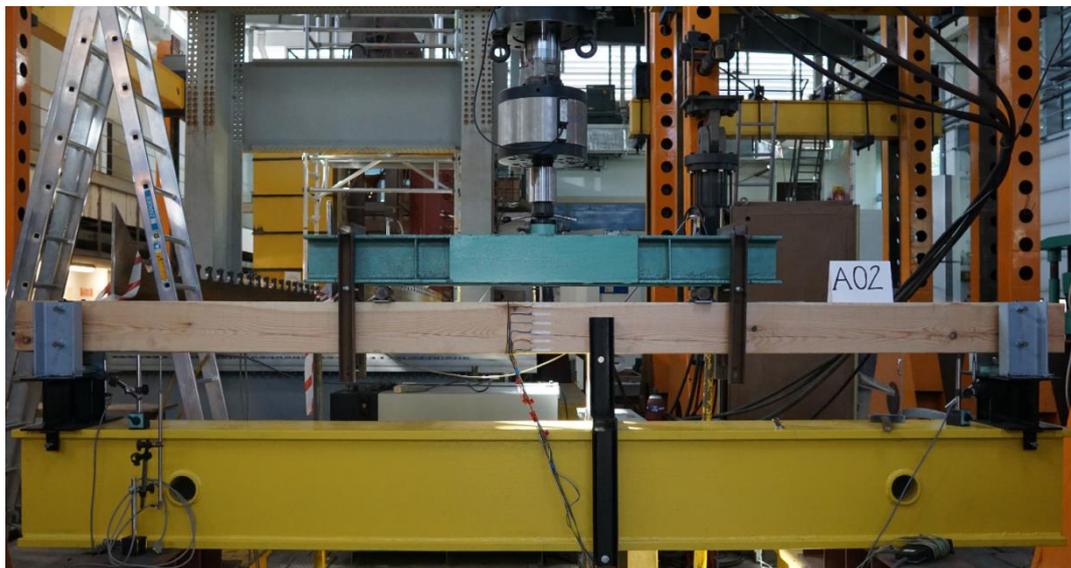
**Figure 14.** View of experimental stand for testing with an example beam.

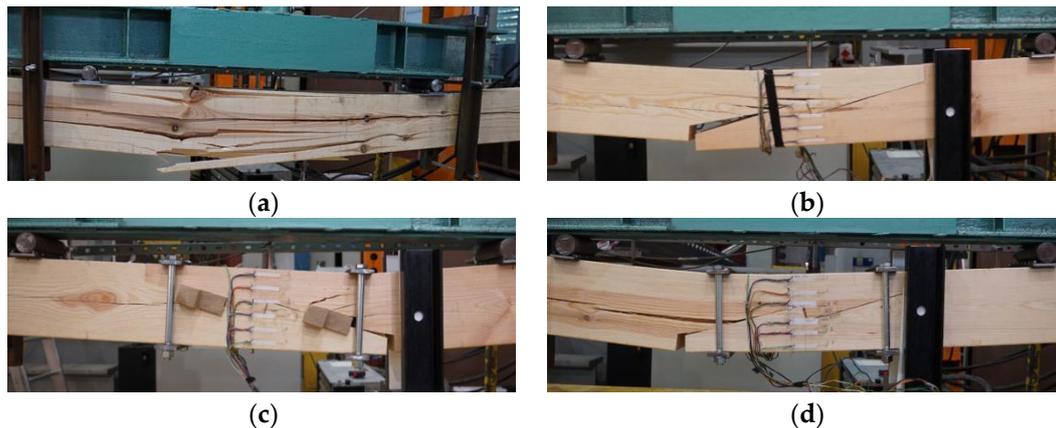
Figure 15. Failure views for selected beams (a) A01, (b) E03, (c) F01, (d) G02.

All the beam models (altogether 12 elements) were loaded at a constant speed right up to their failure. The failure of beams in series A resulted from the shearing of fibres in the bottom part of the central area of the beam where earlier there were no visible cracks (except for cracks in the vicinity of knots in the beams). Sudden failure with no prior signs occurred. Generally, the failure of beams in

series E, F, and G involved a loosening of the joint in the lower zone of the central part of the beam and the appearance of cracks and fractures on the edges of the joint and in points weakened as a result of earlier flaws (such as knots or primary cracks of the beam). The tested joint was unsymmetrical. In the right part of the joint, the beam elements were bent and pressed to each other. In the left part of the joint, the elements were also bent, but the bottom element was not pressed and the joint was loosened. Destruction occurred in the left part of the joint by breaking the upper element (visible cracks above the edge of the joint). The cross-section of the destruction was in the joint area. Failure resulted from delamination due to stretching across the fibres. The failure views of selected experimental models are presented in Figure 15.

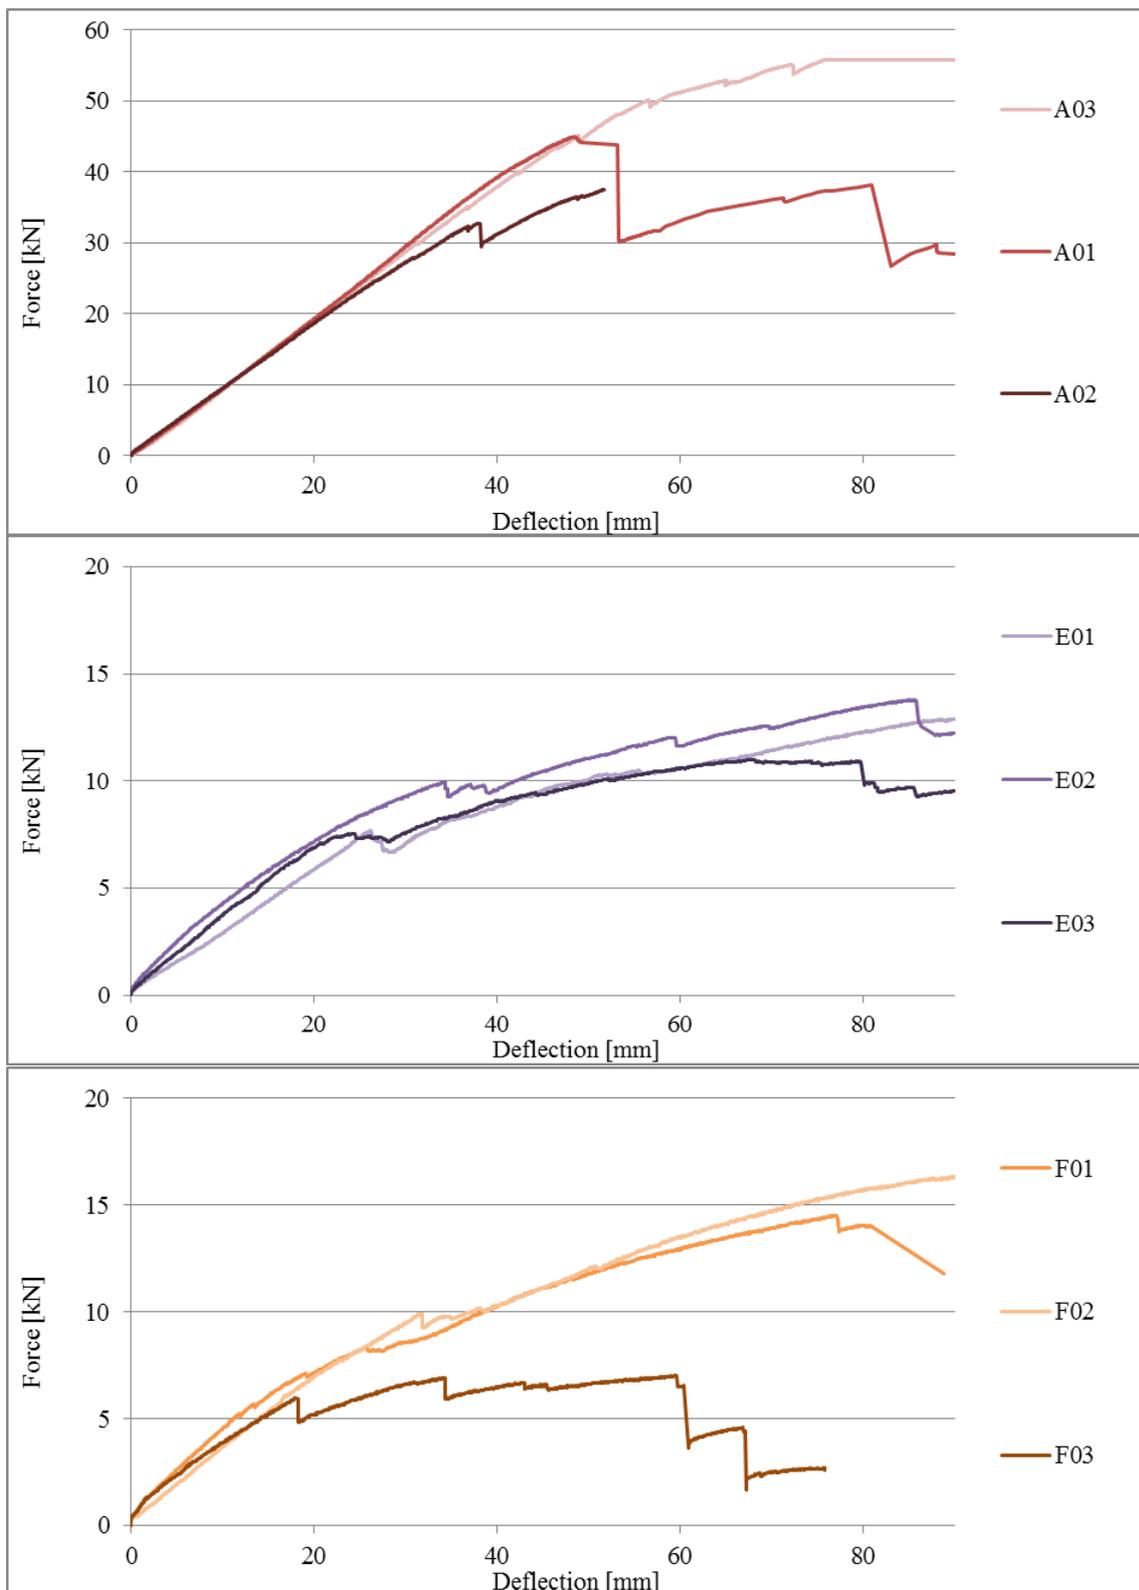
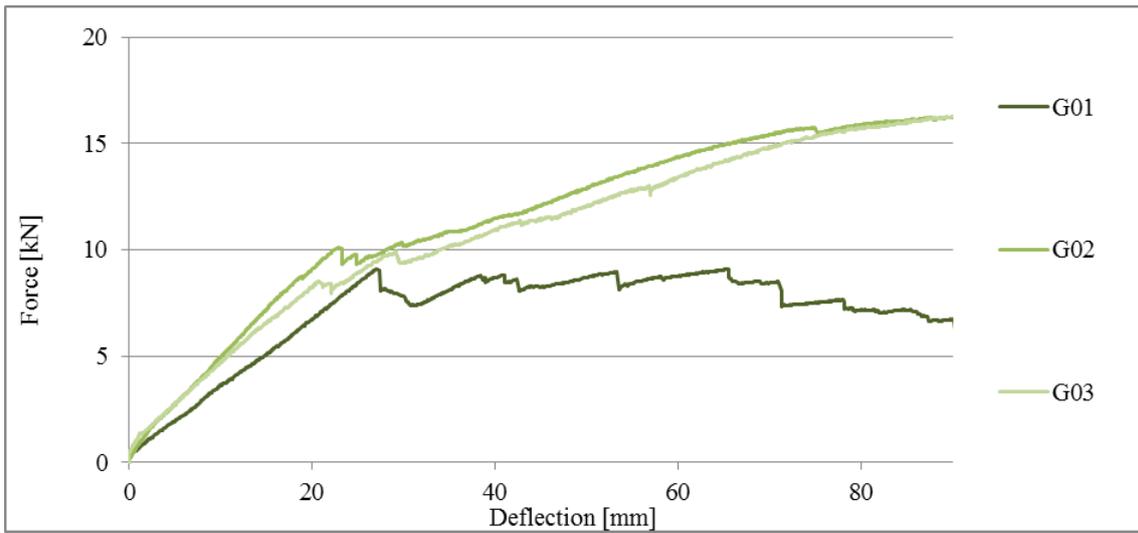
Figure 16. Load-deflection plots for beams in series A, E, F, and G.

Load-deflection plots (in the central part of the beam span, i.e., in point 1) for beams in the various series are presented in Figure 16.

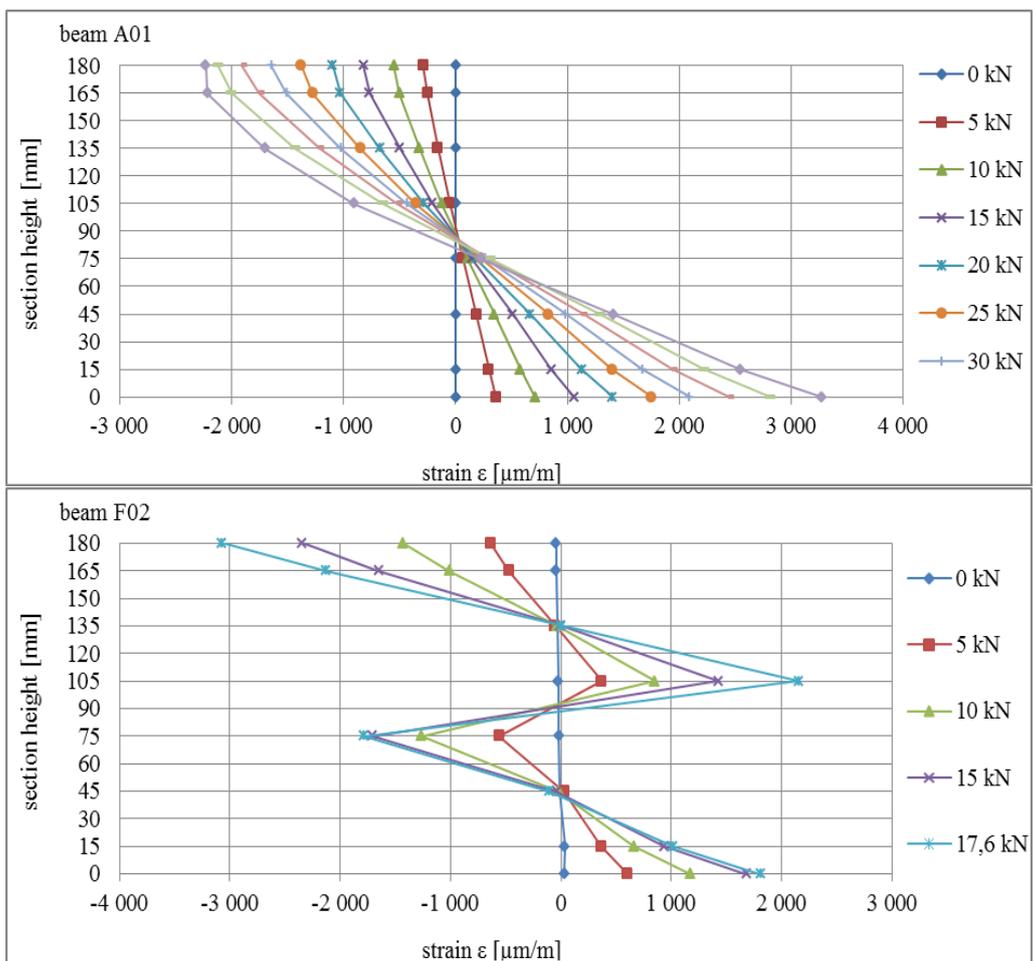
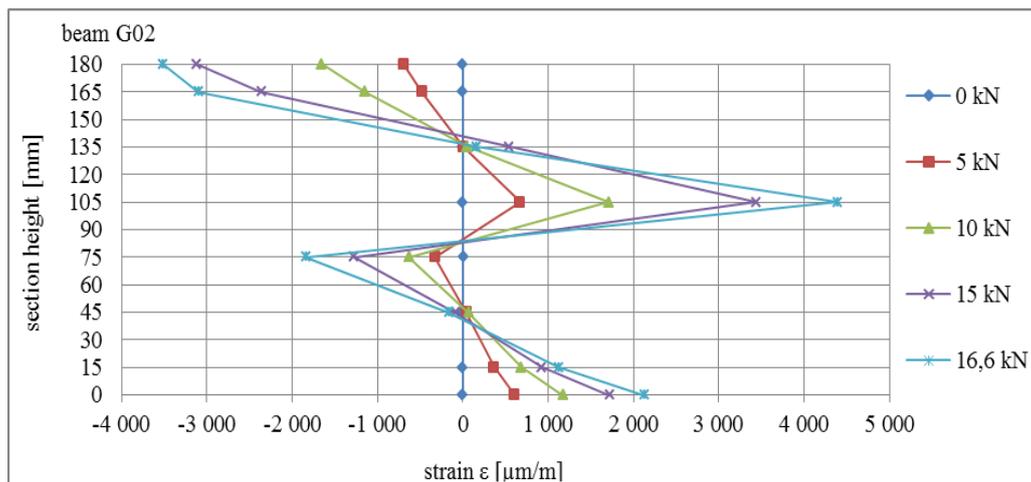
Figure 17. Strain profile in the cross-section for selected beams subjected to bending.

Deformations in the area of point 1 in the central part of the beams are presented in Figure 17. The deformation profiles are consistent with expected curves: for beam A01, the standard image of deformation in the cross-section for the continuous beam was obtained, whereas for beams E02, F02, and G02, it was noted that the typical curve shape for the composite cross-section was as presented inter alia in [18].

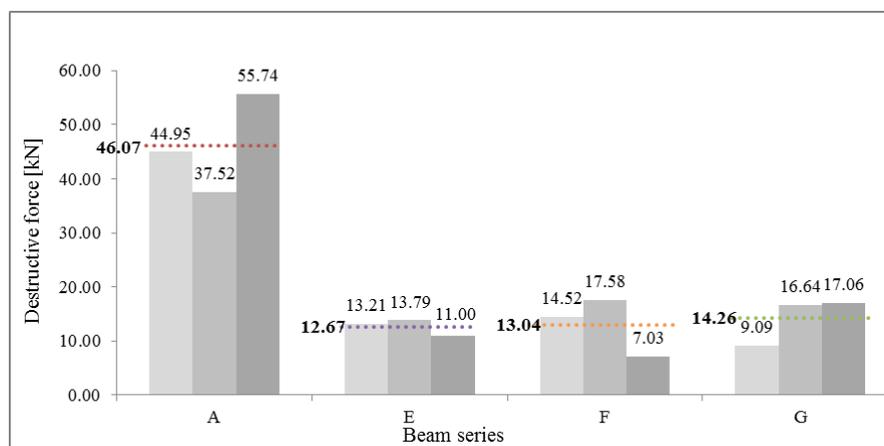
Figure 18. Comparison of values obtained for ultimate force values for beams of series A, E, F, and G.

The mean ultimate force value for beams in series A (continuous beams) was 46.07 kN. The value of the mean load bearing for bending for this series was 24.88 kNm. Compared to the reference beams, beams joined with stop-splayed scarf joints, i.e., beams in series E, F and G, achieved lower load-bearing levels, which were comparable to one another. The highest values were obtained for series G beams with a mean ultimate force of 14.26 kN (load-bearing for bending of 7.70 kNm), which constituted 31.0% load-bearing in relation to reference beams. The largest variation in results was obtained for this series (variation coefficient exceeds 30%). Beams of series E and F obtained lower ultimate force values: series E—12.67 kN (load-bearing for bending 6.86 kNm), series F—13.04 kN (load bearing for bending 7.04 kNm) which constitutes respectively 27.5% and 28.3% load-bearing in relation to the reference beam. The results of series E were characterised by the smallest variation with an indicator of not much more than 10%. A comparison of the values of ultimate force values for beams in series A, E, F, and G is presented in Table 2 and in the curve in Figure 18.

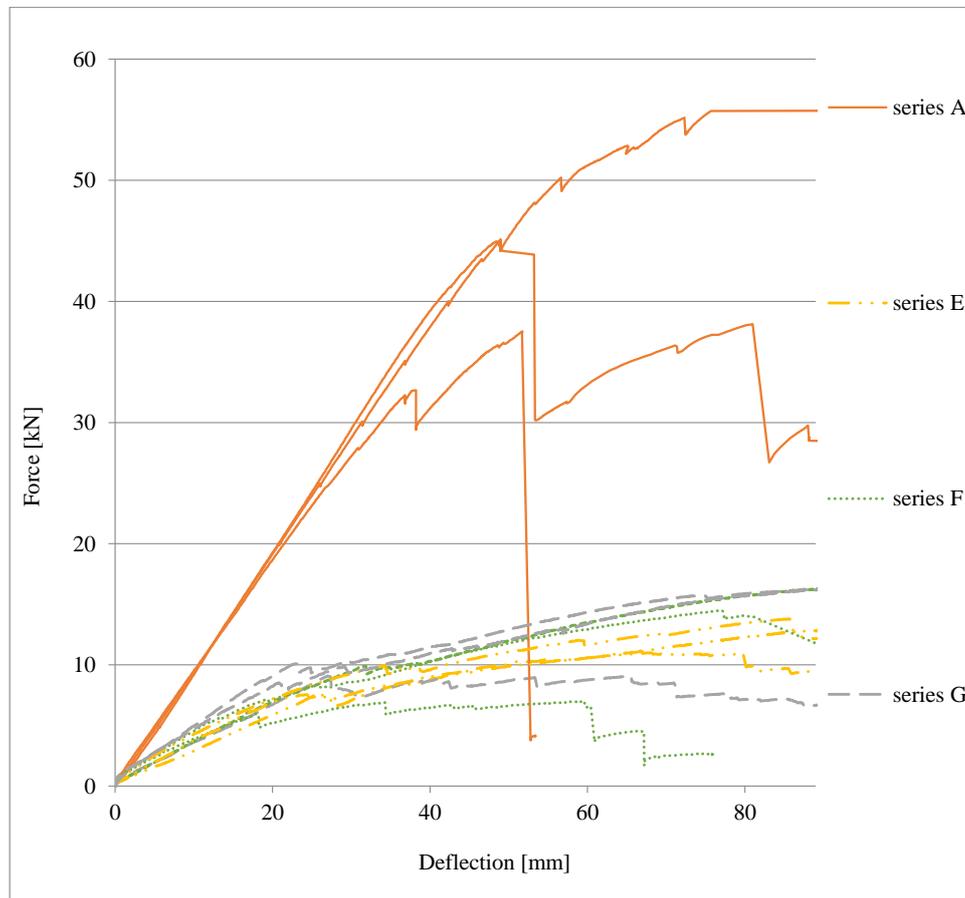
**Figure 19.** Comparison of load-deflection plots of beams of series E, F, G to the reference beam of series A.

As part of the comparative analysis, in Figure 19, a comparison of the load-deflection plots of the beams of series E, F, and G to the reference beams of series A is presented. It should be noted that the tested beam series attained similar values for final deflection, but with different levels of force, which are several times higher for series A, whereas the values for beams of series E, F, and G were similar to one another.

An analysis of the graph (curves for series E, F, and G) shows a change in the nature of the static behaviour of the joint when strain  $\eta$  is equal to approximately 60% of the elastic to ductile state. Estimations on the basis of the load-deflection plots of the ‘stiffness parameter’ in the elastic state, calculated as the ratio of loading force value to deflection (1) for the beams representing series A, E, F, and G, are as follows: for A01—0.94 kN/mm, for E01—0.31 kN/mm, for F01—0.32 kN/mm, and for G02—0.45 kN/mm.

It should be noted that the parameters for beam E01 and F01 are close to one another and amount to approximately 30% of the stiffness parameter for the continuous beam A01, whereas in the case of beam G02, the parameter amounts to approximately 50% of the reference value. The most important test results obtained for the beams from the specified series in relation to the reference beam (continuous beam) are presented in Table 3.
