Indirect Determination of Residual Prestressing Force in Post-Tensioned Concrete Beam

Abstract: A diagnostic survey on the precast prestressed bridge Nižná confirmed significant deterioration due to environmental distress. Evidently, decisive failures of the structure have a similar character as in the previous precast prestressed bridge in Podbiel in the northern part of Slovakia. These failures result from the unsuitable concept of the first generation of precast prestressed concrete beams, which was used in the former Czechoslovakia in the second half of the 20th century. Subsequently, experimental verification using the proof-load test was also executed. This bridge was built in 1956, so at the time of testing, it was 60 years old. The paper presents the indirect determination of prestressing level in one precast post-tensioned concrete beam using the saw-cut method. Experimental measurement was executed during the bridge demolition. Subsequently, a 2D numerical model in ATENA 2D Software, with the assumption of nonlinear material behavior for verification of experimental results, was performed. Finally, the residual prestressing force was evaluated and compared with the expec

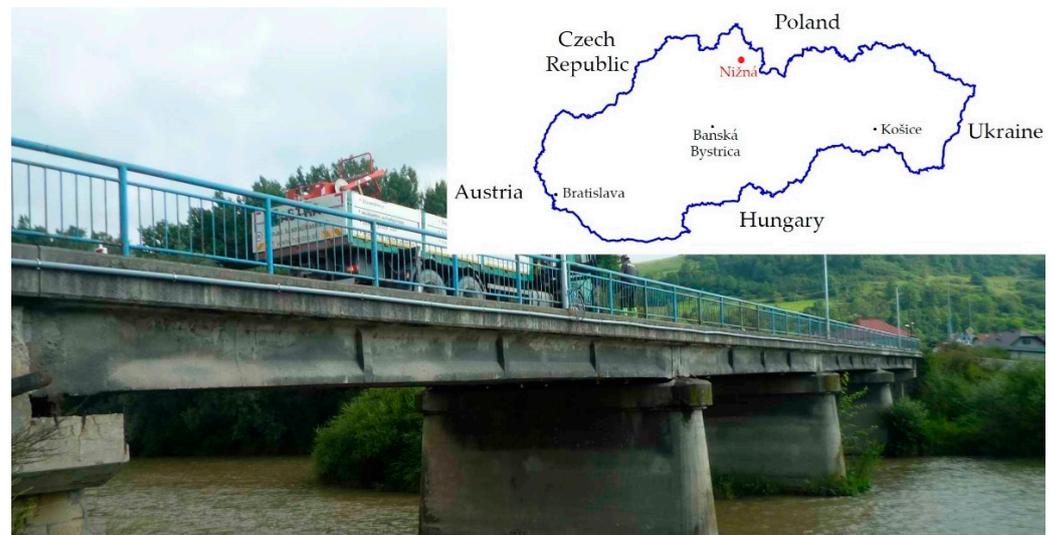
Figure 1. View of Bridge Nižná in service.

The bridge structure consisted of four simply supported spans with an effective length of 17.18 m; the total length of beams was 17.88 m, see Figure 1. Longitudinal unfilled gaps between the beams were approximately 40 mm wide. The width of the structure was 9.67 m. Transversally, a total of ten beams with a spacing of 0.97 m and a height of 1.05 m were designed. After demolition, only four rebars of conventional reinforcement with a diameter of 6.0 mm were detected, along with stirrups of the same diameter and a spacing of 0.25 m. At the time of construction of the bridge, the rebar type R (Roxor) with a mean yield strength f_y of 380.0 MPa was used as a conventional reinforcement.

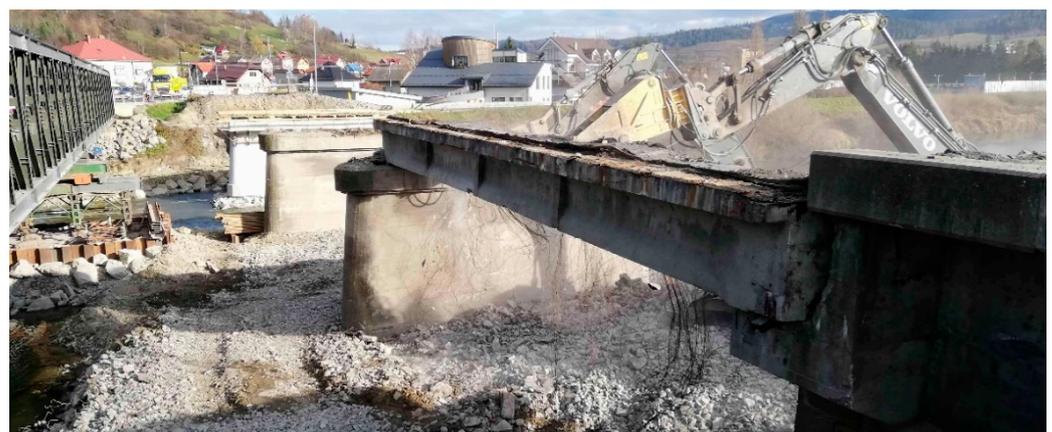
Figure 2. Investigated post-tensioned concrete beam.

The precast post-tensioned concrete beam in a visually good condition was selected. This beam seemed to be the least degraded and had a favorable approach from the underside, which was necessary to perform the experimental measurements. Specifically, it was the edge beam in the first span of the bridge, which was already out of order at that time. The beam under investigation is shown in Figure 2. Contrasted to the beams in the other spans of the bridge, it visually exhibited almost no damage, and therefore, it was reasonable to expect a relatively good condition of the prestressing steel as well. Prior to the experiment, the post-tensioned concrete beam was carefully separated from the others, which had already been demolished at the time of the test, and thus, the transverse connection in the form of prestressing was interrupted. For this reason, the selected beam acted independently as a simply supported beam, embedded on the original supports located on the abutment and pier.

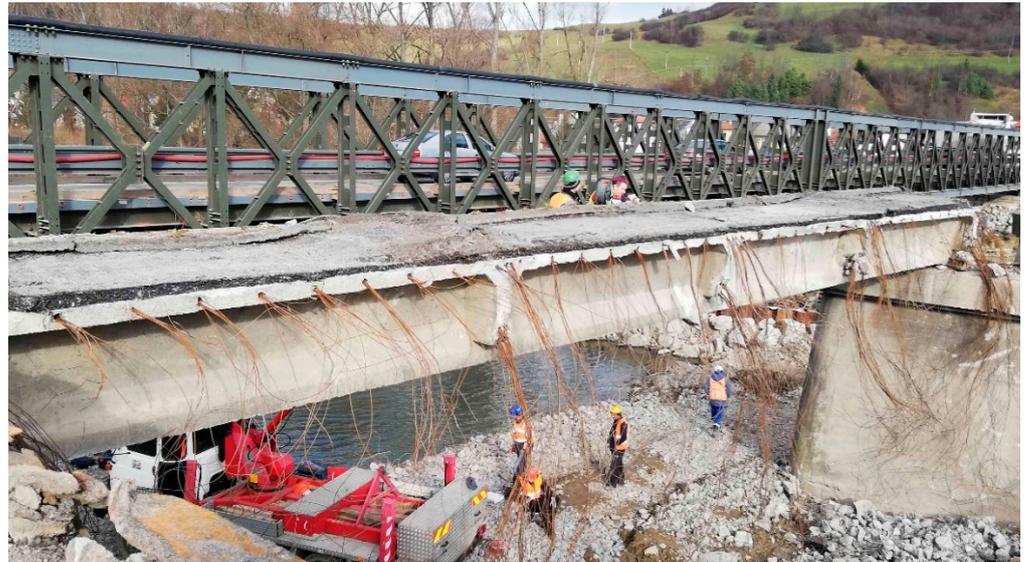
Figure 3. Material on the upper flange of the investigated post-tensioned concrete beam.

During demolition, the remaining material on the upper flange of the beam could not be completely removed. Therefore, in the analysis, it was necessary to consider the load resulting from the material that remained on the beam. Namely, this consisted of a concrete layer with an average thickness of approximately 50 mm. This layer can be seen in Figure 3.

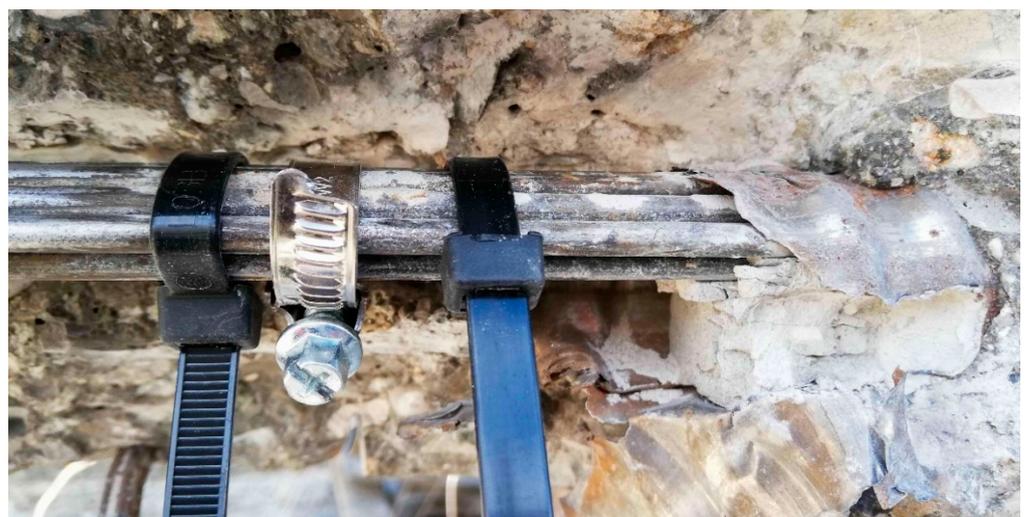
Figure 4. Prestressing wires after exposure (no signs of corrosion).

The longitudinal prestressing of the beam was unbonded, and therefore, transfer was provided only in the anchorage area. Very rarely was the cement grout endoscopically discovered, and in such cases this was only locally at the lower surface of the cable duct; even in these areas the grout fell off the prestressing wires after a gentle tapping with a hammer. Hence, it was reasonable to assume that the bond between the cement grout and the prestressing wires was not ensured. From the photographs provided by the endoscope—which was inserted into the cable ducts—it can be seen that the prestressing wires of the selected beam were in good condition almost without any sign of corrosion. This fact confirmed the primary assumption of the good state of the selected post-tensioned concrete beam, determined by visual assessment. Following the experimental measurements, some prestressing wires were also inspected destructively. Once again, it was possible to visually confirm the good condition of the prestressing wires without corrosion. Prestressing wires after exposure are shown in Figures 4 and 5a.

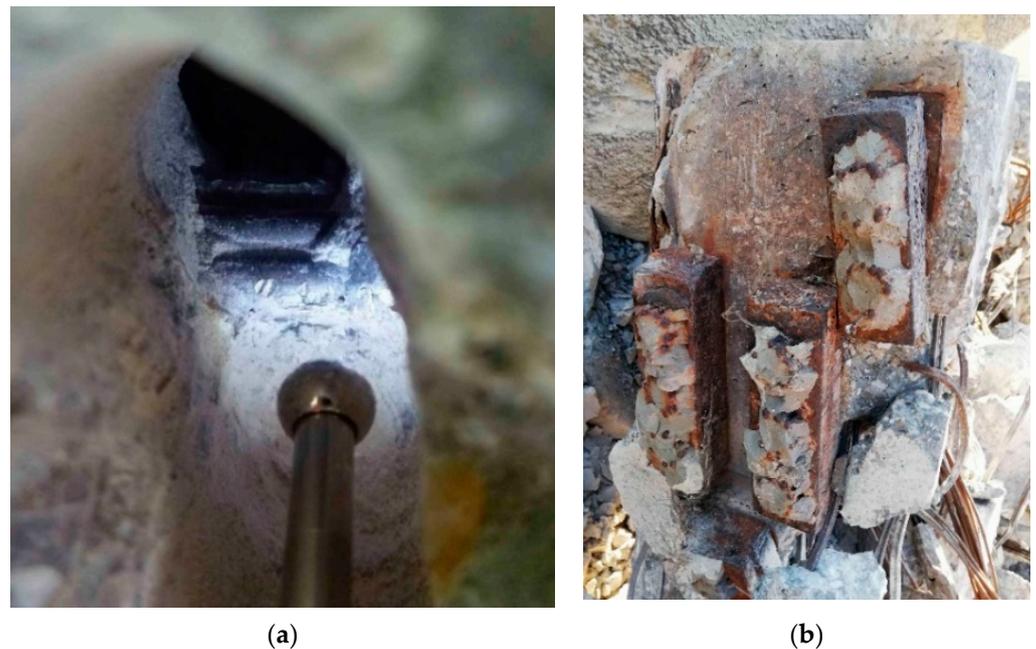
Figure 5. Endoscopic method (a); corroded anchorage area after demolition (b).

After exposing the anchorage area, considerable corrosion of anchorages was observable. This corrosion can be credited to insufficient protection of the anchorages by the concrete, and thus, to the easy access of water to this area. The anchorage area is shown in Figure 5b.

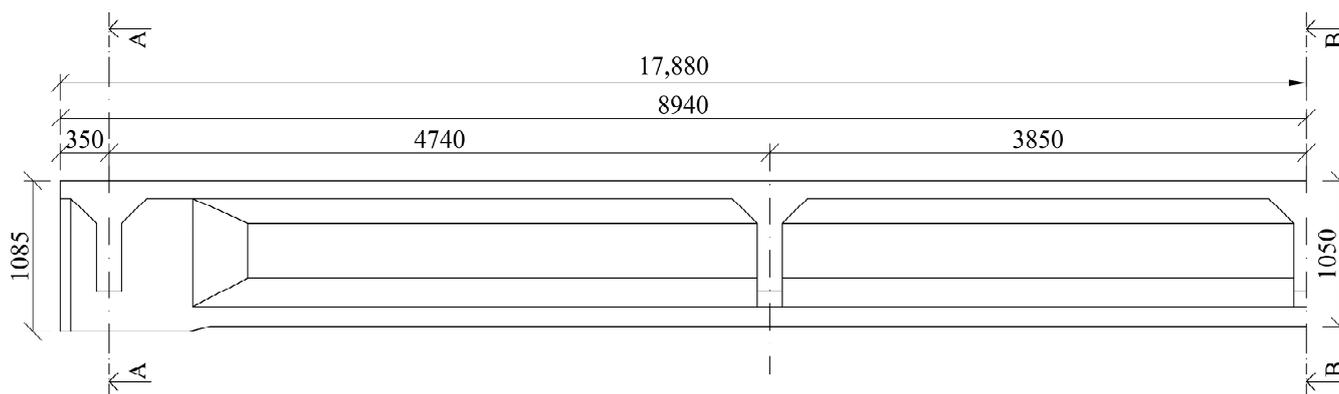
Figure 6. Longitudinal layout of the precast post-tensioned beam.

The saw-cut method was applied to determine the residual prestressing force. The scheme of a selected post-tensioned precast concrete beam is illustrated in Figures 6 and 7. Thirteen prestressing tendons, consisting of nine patented wires with a diameter of 4.5 mm, were placed in a cable duct with a diameter of 30 mm, see Figure 7c. Cable ducts were identified as metal tubes.

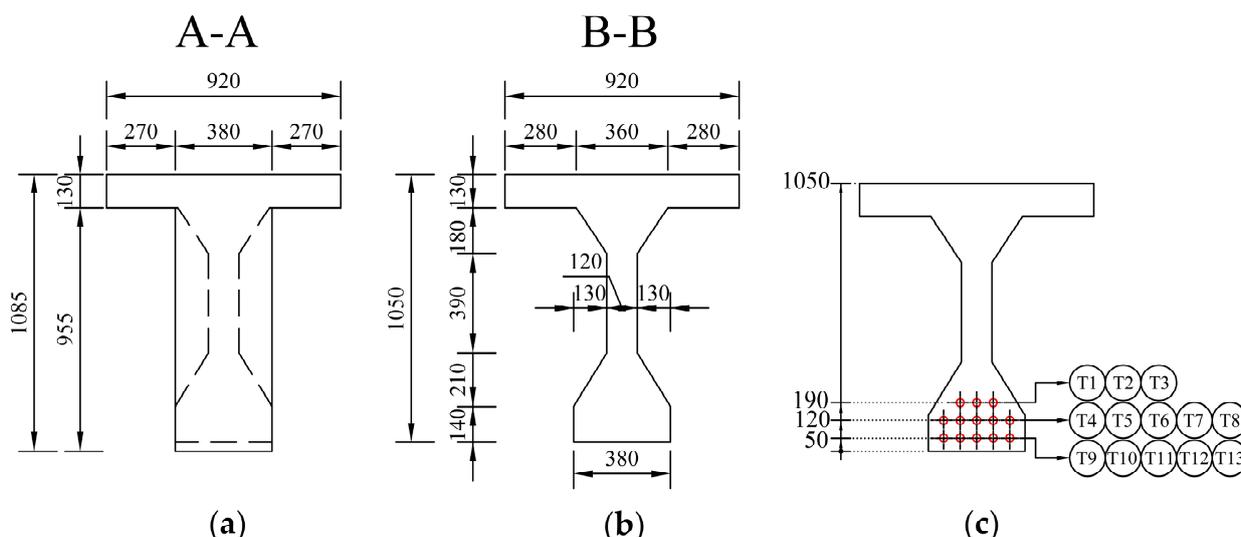
Figure 7. Cross-section of the selected beam: (a) at the end; (b) mid-span; (c) arrangement of tendons.

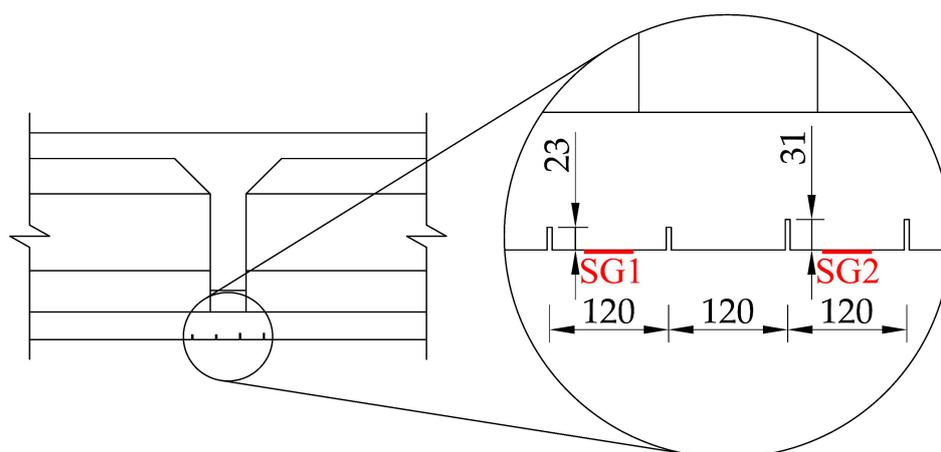
Figure 8. Parameters of performed saw-cuts.

Two pairs of saw-cuts with an identical axial distance of 120 mm were performed in the beam, see Figure 8. The pair of saw-cuts SC1 had a depth of 23 mm and the pair of saw-cuts SC2 were 31 mm deep. The applied saw-cuts are shown in Figure 9. These parameters were determined by the measurement of the saw-cuts' depth and axial distance after the actual sawing of the beam and were the necessary basis for further analysis. Our intention was to avoid cutting the beam's reinforcement. Linear foil strain gauges HBM LY41-50/120 made of ferritic steel (temperature matching code "1": $10.8 \times 10^{-6}/\text{K}$) with a measuring grid length of 50.0 mm and a total length of 63.6 mm were used to record the strain. The linear foil strain gauges were installed in the middle of the axial distance between the saw-cuts. Transversely, they were applied to the center of the lower flange of the beam. The measurement was finalized after stabilization of the recorded values on both used linear foil strain gauges. The maximum value of the change in stress $\Delta\sigma$, measured by the strain gauge SG1 (related to the pair of saw-cuts SC1), was 3.13 MPa and the strain gauge SG2 (related to the pair of saw-cuts SC2) was 4.21 MPa.

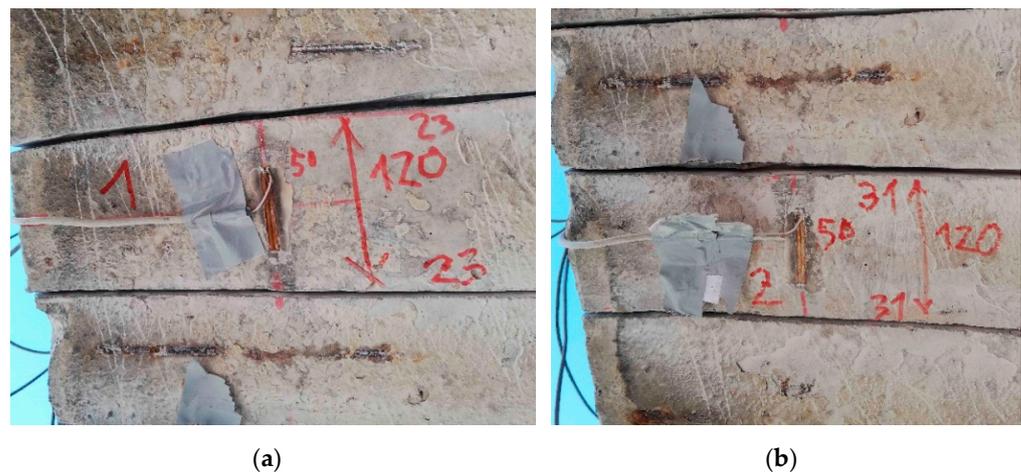
Figure 9. Applied saw-cuts (SC1—(a); SC2—(b)).

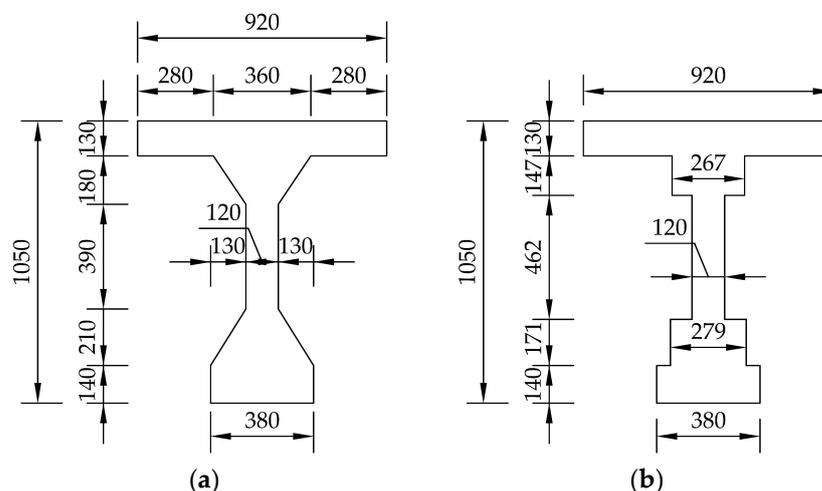
Figure 11. Real cross-section (a); equivalent cross-section used in numerical analysis (b).

The post-tensioned precast prestressed concrete beam was modelled as a 2D finite element, which is shown in Figure 10, while the individual parts of the beam (macro-elements) were assigned the dimensions according to the equivalent cross-section presented in Figure 11. The equivalent cross-section has the same area and second moment of inertia as the real cross-section. The load from the unremoved material with an average thickness of 50 mm on the upper flange of the beam was considered by a uniformly distributed load with a value of 1.15 kN/m. The supports were modelled at a distance of 350 mm from the ends of the beam, and thus, the effective length of the beam in question was 17,180 mm. Based on the results of the bridge survey, the prestressing tendons were considered unbonded. In the middle area of the beam, at a width of 765 mm (the area adjacent to the saw-cuts), the mesh was smoothed into quadrilateral CCQ10SBeta elements with a size of 10 mm. The rest of the modelled beam was composed of quadrilateral CCQ10SBeta elements with a uniform size of 100 mm. The application of the saw-cuts was modelled in the 2D numerical analysis using “construction stages”. First, all macro-elements had the properties of the beam’s concrete. In the next phase, the modulus of elasticity of the macro-elements that represented the saw-cuts was rapidly reduced, thus taking into account the sawing.

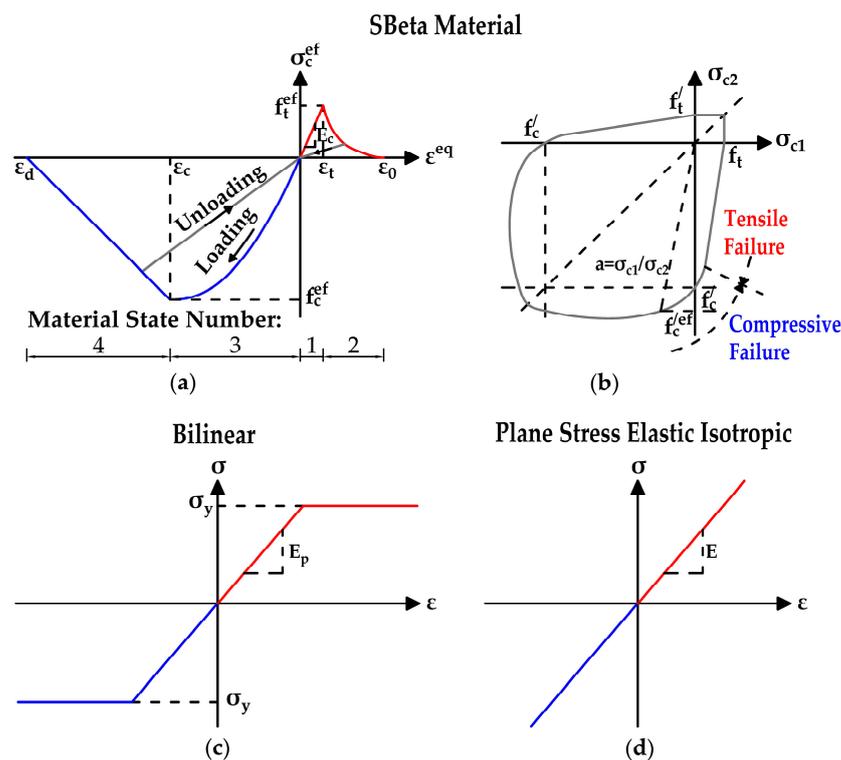
Figure 12. (a) Stress–strain curve for concrete; (b) Biaxial failure function for concrete; (c) Stress–strain curve for prestressing steel; (d) Stress–strain curve for saw-cuts [28].

The stress–strain curves that were used are presented in Figure 12. The SBeta constitutive model of concrete includes 20 material parameters. Whereas simulations of real behavior were performed, known parameters were chosen based on material testing. Other parameters were based on guidelines for Finite Element (FE) analysis of concrete structures in ATENA Software. The formulation of constitutive relations is considered in the plane stress state. The concept of the material model SBeta includes, for example: the non-linear behavior in compression (including hardening and softening); the fracture of concrete under tension, based on the non-linear fracture mechanics biaxial strength failure criterion; a reduction in compressive strength after cracking; the tension stiffening effect; a reduction in the shear stiffness after cracking; and two crack models—the fixed crack direction and rotated crack direction. More information can be found in [28–30].

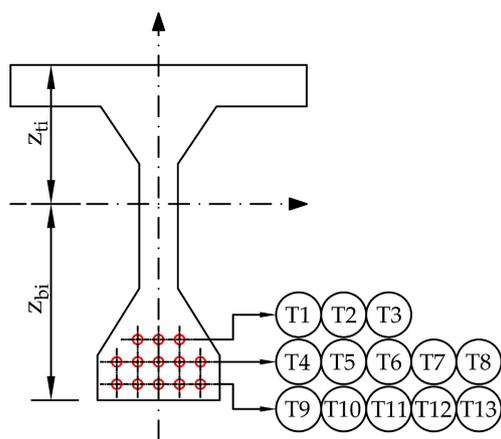
Figure 13. Ideal cross-section of the investigated beam.

The values of stress before ($\sigma_{c,0}$) and after the application of saw-cuts on the beam ($\sigma_{c,1}$), and the difference between these two values ($\Delta\sigma_c$) are presented in Table 5. The numerical analysis showed that the used parameters of the saw-cuts partially isolated the concrete block from the acting forces. In the case of the pair of saw-cuts SC1, the stress change was less than 63%, while the pair of saw-cuts SC2 initiated a stress relief of almost 87%. For this reason, the initial stress value in the bottom of the precast post-tensioned concrete beam was determined analytically. Subsequently, the ideal cross-sectional characteristics were calculated and the value of the residual prestressing force in the investigated beam ($P_{m60,actual}$), as a result, was determined using Equation (2). The ideal cross-sectional characteristics of the beam (see Figure 13) are listed in Table 6.

A_i (mm ²)	I_{yi} (mm ⁴)	z_{bi} (mm)	z_{ti} (mm)	e_{pi} (mm)
318532.396	4.4532×10^{10}	614.662	435.338	505.432

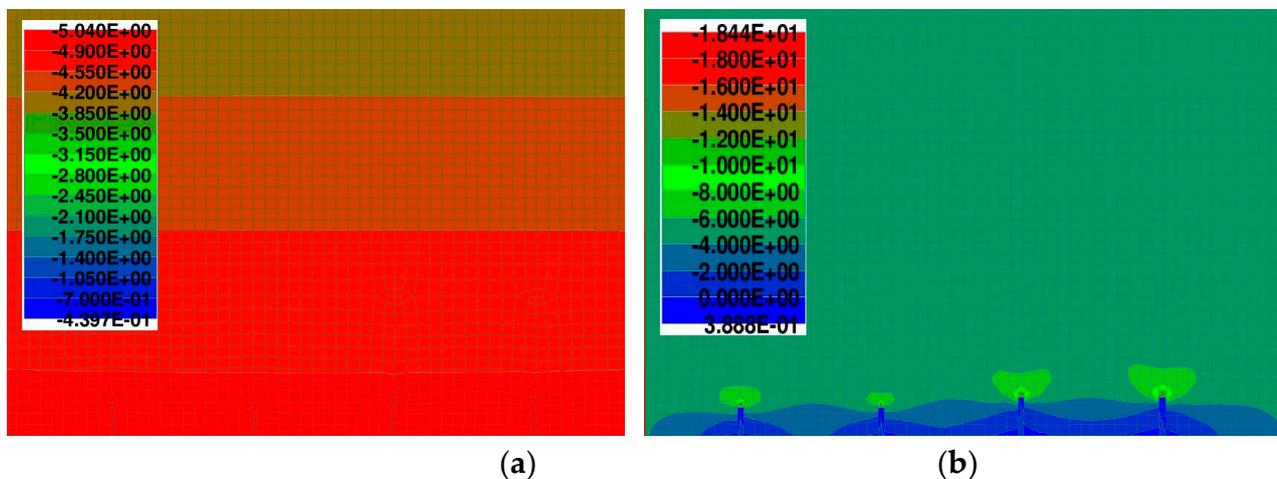
Figure 14. Stress before (a) and after (b) application of saw-cuts.

The stress before and after application of saw-cuts is shown in Figure 14. Based on the numerical analysis, the initial stress value in the monitored area ($\sigma_{c,0}$) was -5.04 MPa.

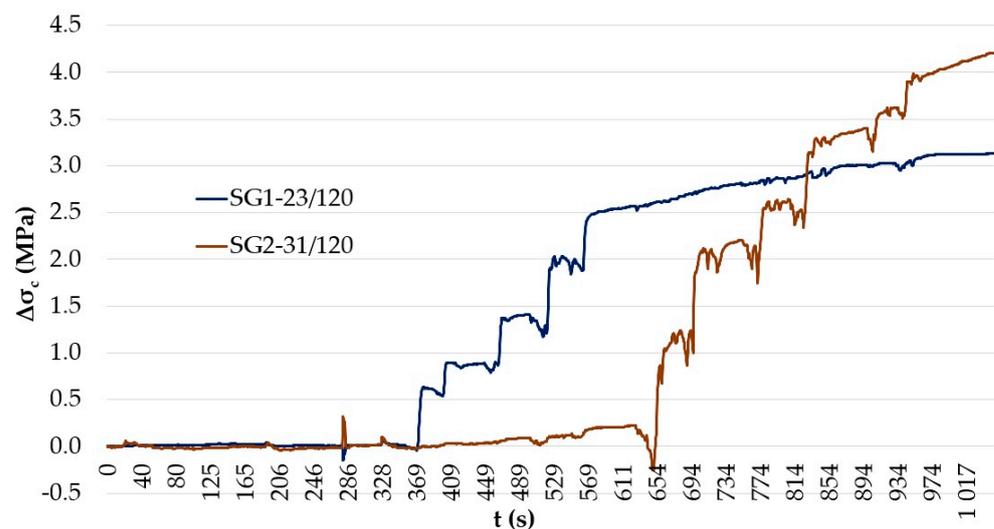
Figure 15. Recorded stress in the bottom edge of the post-tensioned concrete beam.

The expected value of the prestressing force based on the expected stress in individual tendons after 60 years of operation ($P_{m60,theoretical}$) in the precast post-tensioned prestressed concrete beam—determined according to Eurocode 2 [27]—was 1090.30 kN. Comparing the value obtained by the standard procedure ($P_{m60,theoretical}$) in compliance with Eurocode 2 [27] and value of residual prestressing force obtained based on experimental measurements ($P_{m60,actual}$) and subsequent nonlinear numerical analysis in ATENA 2D Software, there is a difference of 13.32% (ΔP). The values of the change in stress after application of the saw-cuts, which were recorded during the measurement, are presented in Figure 15. This quite low value of additional prestressing losses after 60 years proves the good technical state of the selected and subsequently analyzed post-tensioned prestressed concrete beam. Endoscopically and later destructively examined prestressing wires showed no notable corrosion, so the prestressing losses can be mainly attributed to the relatively poor state of prestressing anchorages in the ends of the investigated beam. Considering the results, future experiments should be performed using modified parameters of saw-cuts regarding validation of partial and full isolation of concrete block from acting forces.

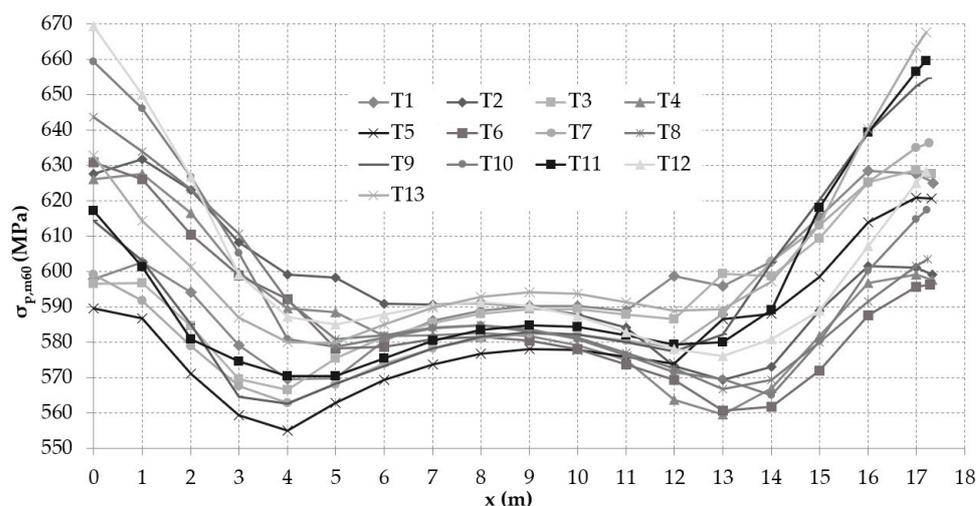
Figure 16. Stress in prestressing tendons after 60 years of service according to Eurocode 2 [27].

The expected stress in the individual tendons of the investigated bridge in compliance with Eurocode 2 [27] after 60 years of service is presented in Figure 16. The assumption of the relationship between the value of prestressing force and time is shown in Figure 17.

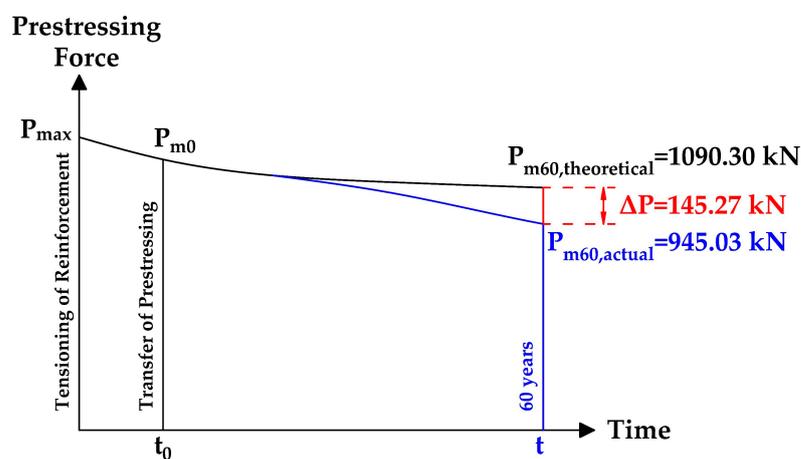
Figure 17. Relation between the value of prestressing force and time.
