# New Ceramic Tiles Produced Using Old Technology Applied on Historic Roofs—Possibilities and Challenges

**Abstract:** In the case of historic buildings, especially those under protection, it is important to replace elements of the roof covering, while maintaining current technical standards, to meet the requirements of the conservator. The authors of the article present alternatives to commonly used solutions, based on their experience with replacing historic building roofing with ceramic tiles made according to the production and firing technology of the nineteenth century. They emphasize that the correct/specialized restoration of existing tiles in a building makes it possible to preserve and reuse them, which is in line with the principles of historic preservation. However, due to the preservation of the roof tiles, it is not always possible to revitalize them. As a solution to the problem, the use of clay roof tiles manufactured according to 19th-century firing technology, including handmade methods, is presented, which preserves the geometry of the historic roof tiles. The approach presented by the authors meets both the requirements of conservation theory and the building s

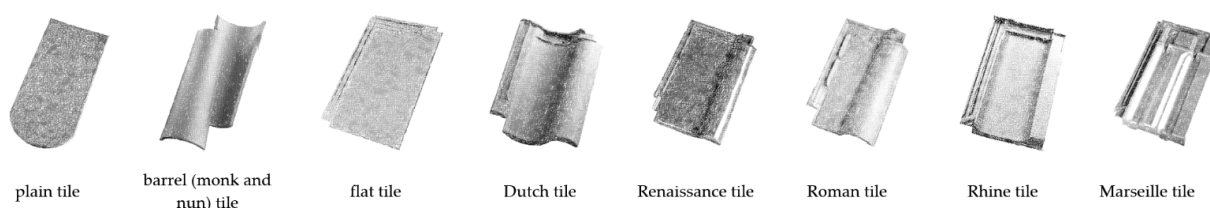
**Figure 1.** Examples of different roof tiles.

Of today's clay roof tiles, the most common shapes used are the Dutch (also known as S-shaped), overlapping, Marseille, or plain tile (Figure 1). Flat roof tiles are available as clay and cement tiles. A modern solution is the photovoltaic tile, which makes it possible to produce electricity. This type of tile is a novelty on the construction market, but is not recognized by the conservation community.

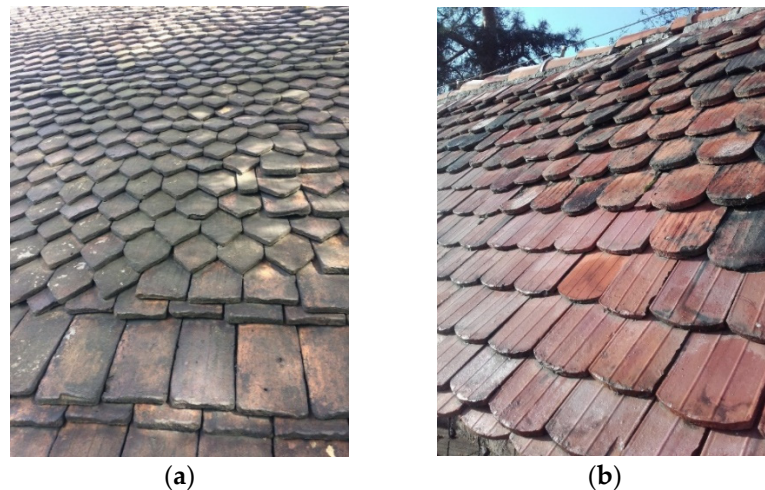
**Figure 2.** Examples of historic roof coverings after many years of use: (a) handmade late medieval and Renaissance roofing tile; (b) machine-made tiles approximately 100 years old.

Over the years, as a result of UV radiation, rain, and other atmospheric conditions, tiles can become stained, lose color, and thus start to look unattractive (Figure 2a,b). To renovate the tiles, it is not necessary to replace the entire roof immediately. It is also possible to renovate them, waterproof the surface, and strengthen the structure with suitable chemicals based on silane and silicate particles.

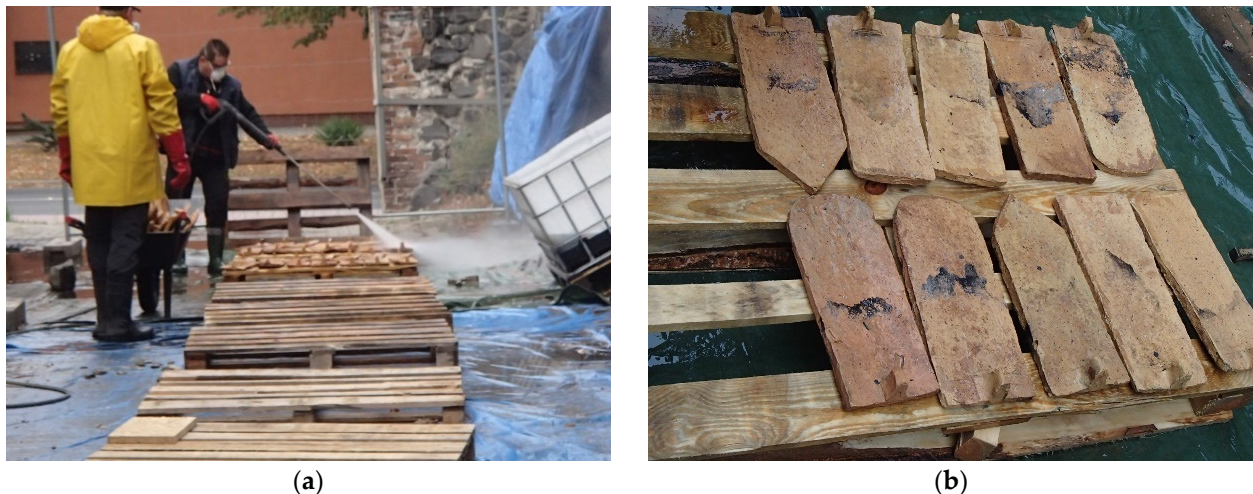
**Figure 3.** Revitalization of historic roof tiles: (a) cleaning; (b) maintenance.

The most effective method is to clean the tiles using a pressure washer (Figure 3a) with a rotary nozzle at a pressure of min. 220 bar. Using this method, loose dirt, moss, and old, poorly adhering coatings can be removed. Particular care should be taken to thoroughly remove moss from the tiles.

The most common means of restoring historic roof tiles after cleaning are silicate-based agents (Figure 3b), which do not add a new color to the ceramics (they are colorless), thus achieving colorless protection while at the same time impregnating and closing the pores in the old tiles. This action also protects them from moisture. This is particularly important under the influence of changing weather conditions. By closing the pores in the ceramics, the silicates create a smoother finish and thus inhibit moss growth on the roof. Tile waterproofing treatments are available in gloss, satin, and matt finishes. Unfortunately, not all roof tiles can be revitalized, especially if their structure and mechanical properties disqualify them.

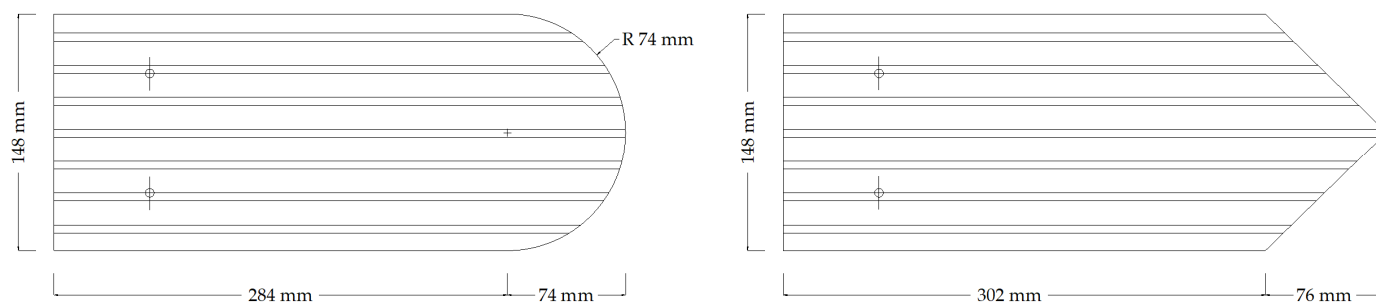
**Figure 4.** Geometry of historic roof tiles.

For roof coverings of historic buildings, it is important to produce adequate documentation that includes measurements of the geometry of the existing tiles and, if necessary, their layout on the slope of the roof. An example of such measurements of the geometry of historic roof tiles to help produce replacements is shown in Figure 4.

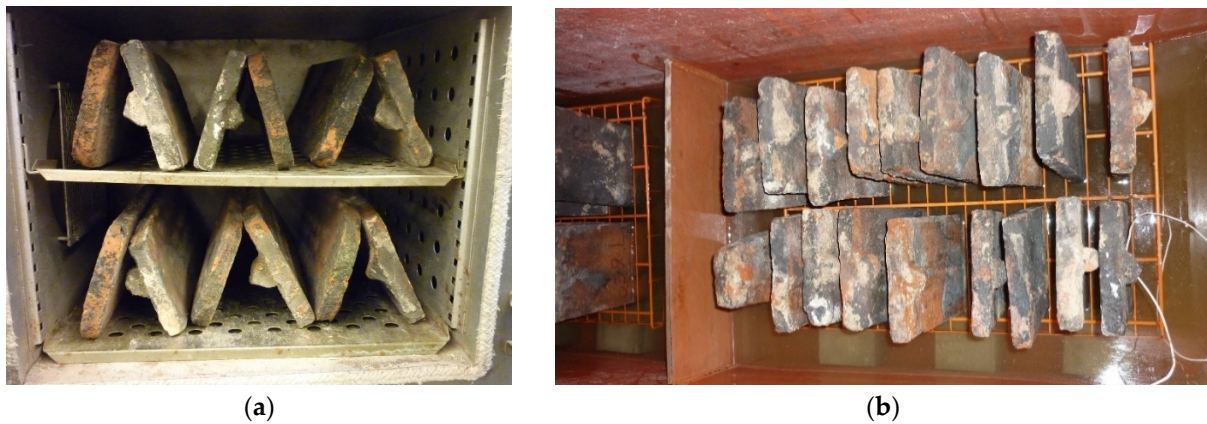
**Figure 5.** Absorption test: (a) drying of tiles to constant weight at a temperature of  $110\text{ }^{\circ}\text{C} \pm 5\text{ }^{\circ}\text{C}$ ; (b) roof tiles in a chamber with 100% humidity.

A total of 30 samples of the dismantled clay tiles (No. 021 to No. 046, No. 048 to No. 050, and No. 052) were selected from the tiles supplied for the test, dried for 24 h in an oven at  $110\text{ }^{\circ}\text{C} \pm 5\text{ }^{\circ}\text{C}$  (Figure 5a), and weighed to the nearest 1 g. Then, they were subjected to a water absorption test (Figure 5b) according to the procedure in Appendix A of the current standard in [7]. The results of the  $n_m$  mass absorption were between

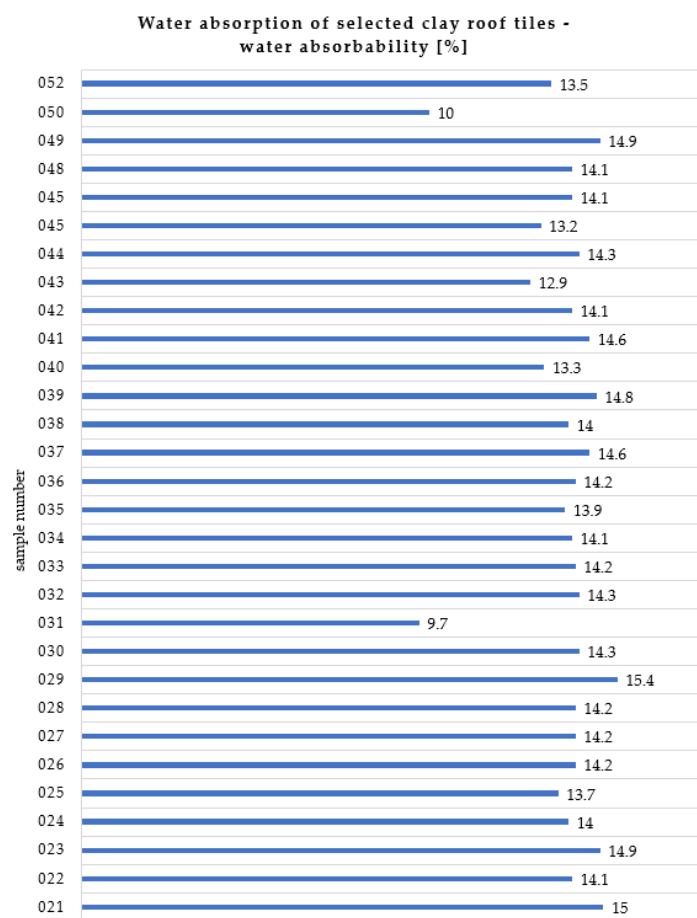
**Figure 6.** Water absorption of selected historical clay roof tiles.

$n_{m \min} = 9.7\%$  (sample No. 031) and  $n_{m \max} = 15.4\%$  (sample No. 029), as shown in Figure 6. The average absorption for all 30 tiles was 13.9%.

Unfortunately, there are no standards for the maximum water absorption values of clay plain tiles. According to the world's operating major tile manufacturers, the maximum water absorption of approved clay roof tiles should not exceed 10%. This water absorption condition was not met by 28 of the 30 samples.

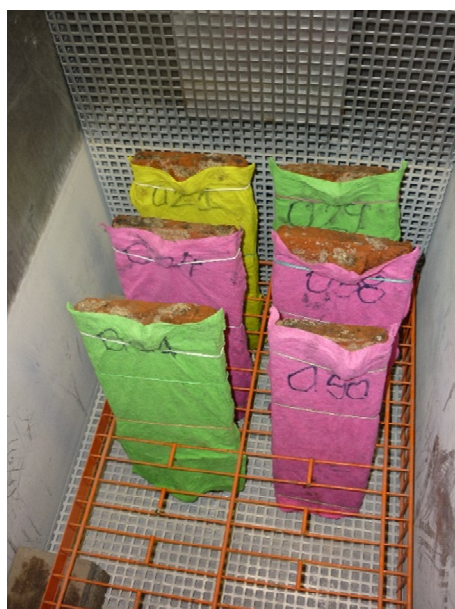
**Figure 7.** Roof tiles in a climate chamber.

The frost resistance test was performed according to the current standard in [8]. Before the frost resistance test, 6 tiles (Nos. 021, 024, 029, 031, 038, and 050) were selected from the 30 tiles (No. 021 to No. 046, No. 048 to No. 050, and No. 052; tile No. 047 was a broken tile) on which the tile water absorption test was performed. Tiles that were free from unacceptable damage in the test and characterized by their minimum, maximum, and average water absorption (2 pieces each) were selected and subjected to frost resistance tests according to the procedure presented in the standard in [8] (Figure 7). Table 1 summarizes and compares the tiles before and after the frost resistance test.

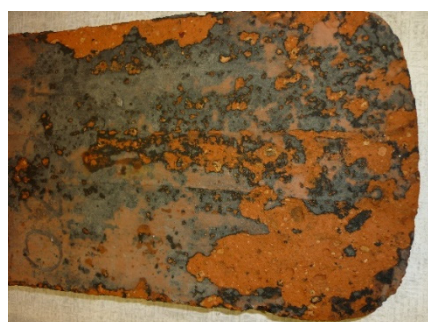
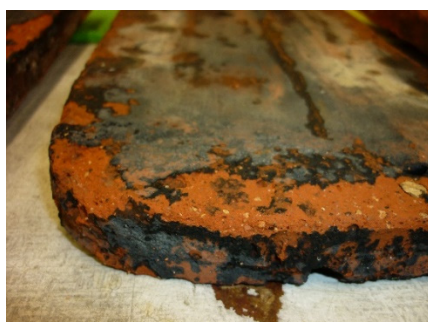
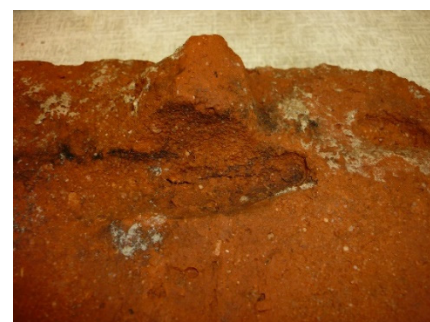
**Figure 8.** Frost resistance test: (a) surface damage observed after the test; (b) edge damage observed after the test; and (c) damage observed after the test.

The following were observed on tiles subjected to the frost resistance test after the test: surface scratches, peeling, delamination, and spalling, examples of which are shown in Figure 8a–c.

According to the standard in [9], the clay roof tiles used in Central Europe should be Class 1; that is, they should not show any of the types of damage specified in Table 1 of the standard in [8] after 150 freeze/thaw cycles. The condition of resistance to frost was not fulfilled.

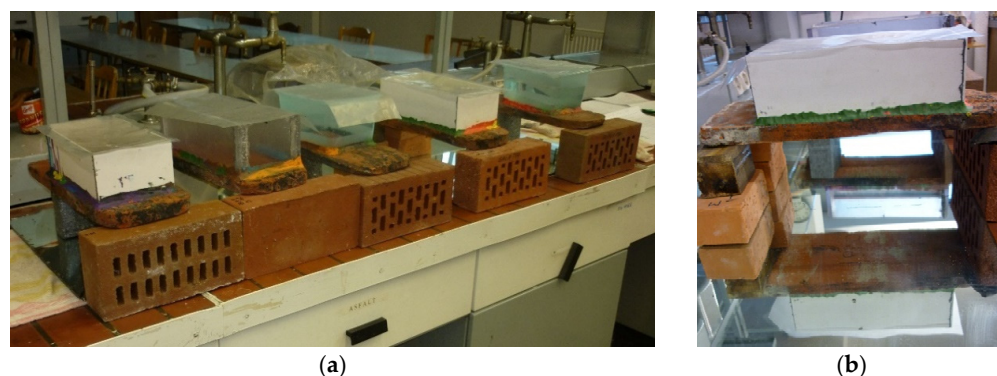
**Figure 9.** Roof tiles during the impermeability test: (a) general view; (b) view of the underside of tile.

The permeability test was performed according to the current standard in [10]. After selecting 10 samples (No. 011 to No. 020) of tiles, the tests were carried out according to the procedure described in the standard in [10] (Figure 9). The tile permeability test consisted of determining the time that elapsed until the first drop of water fell under the pressure of the water column exerted on the upper surface of the tile, under normal atmospheric conditions. The test consisted of lying the tile samples in tap water at room temperature for  $48 \text{ h} \pm 4 \text{ h}$ . The samples were then dried at  $110 \text{ }^{\circ}\text{C} \pm 5 \text{ }^{\circ}\text{C}$  to a constant weight. The final step was to cool for 4 h at room temperature. The test lasted no longer than 20 h. The permeation coefficient (IC) was calculated using the relevant formulae.

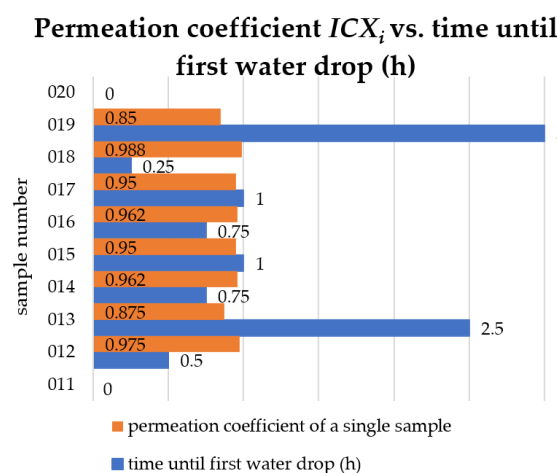
**Figure 10.** Permeation coefficient.

The test results for the individual tiles and the time to the first drop of water (h) are shown in Figure 10. The average time to the first drop of water for the entire test series was  $X_{i\text{av}} = 4.98$  h. The highest value of the single water absorption coefficient was  $ICX_{i\text{av}} = 0.751$ . The mean permeation coefficient was  $ICX_{i\text{av}} = 0.751$ . The value of the largest single-sample permeation coefficient was  $ICX_i = 0.988$ .

According to the standard in [9], for standard clay tiles approved for Category 1, the average permeability coefficient of  $ICX_{i\text{av}}$  should be 0.8 or less, and all values of the permeability coefficient of  $ICX_i$  for individual samples should be 0.85 or less. The condition for the average permeation coefficient  $ICX_{i\text{av}}$  was met. The condition for the values of the permeation coefficients for individual  $ICX_i$  samples was not met by seven out of ten samples.

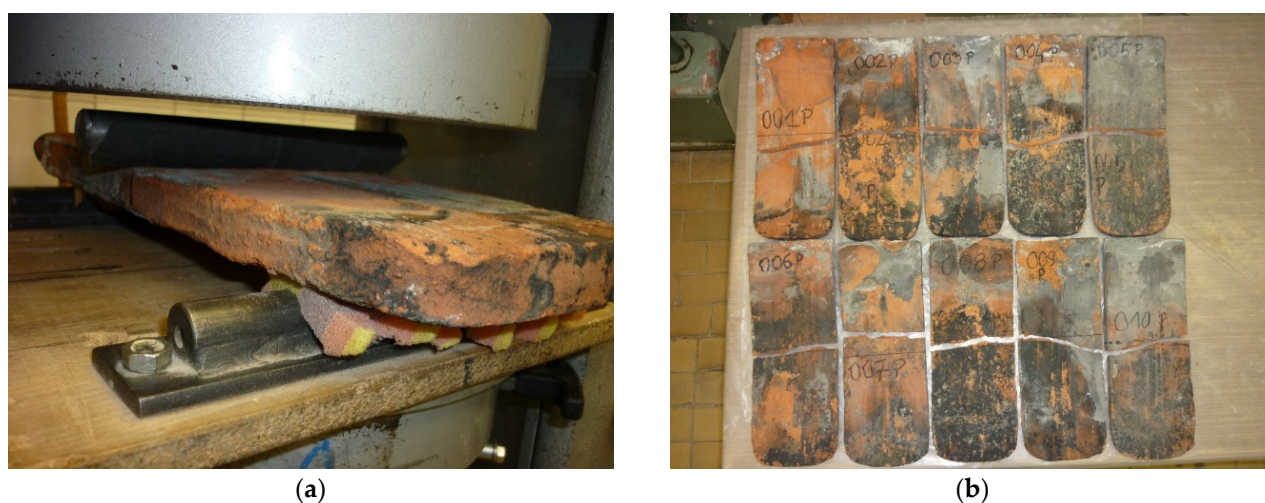
**Figure 11.** Flexural load capacity test: (a) tile in the testing machine during flexural capacity tests; (b) tiles (Nos. 001–010) after flexural strength tests.

The bending resistance test was carried out according to the current standard in [7]. After selecting 10 clay tile specimens (No. 001 to No. 010), the tests were carried out according to the procedure described in the standard in [7] (Figure 11a,b). Figure 12 summarizes the load-bearing results obtained on the selected clay roof tiles tested. The average failure load of  $F_{\text{av}}$  was 0.24 kN.

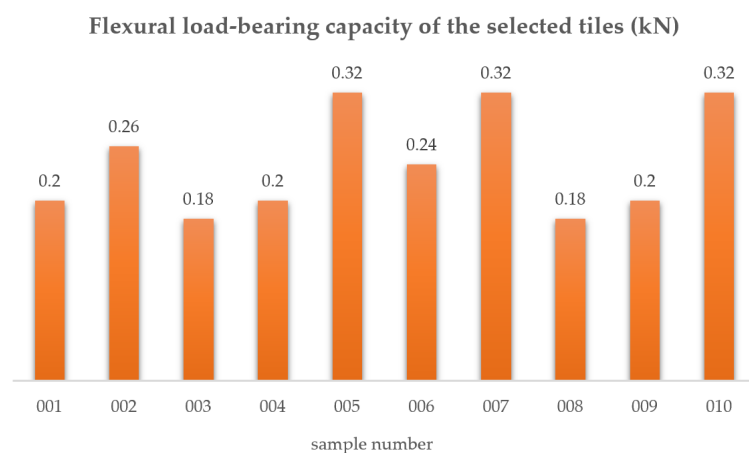
**Figure 12.** Flexural load-bearing capacity of the selected tiles.

According to [9], for approved plain clay tiles, the bending strength should take a value of min. 600 N (0.60 kN). The bending strength condition was not met in all 10 samples.

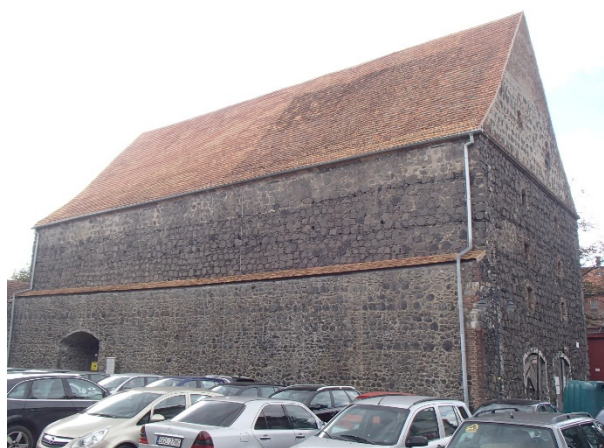
**Figure 13.** The Salt House elevation view.

To illustrate the applicability of new ceramic tiles produced with old technology, a short case study of the application of this type of tile in a historic building is presented below. The reference object is the Salt House (Figure 13) of 1539, located in southern Poland [11]. It is located in a space between two rows of medieval defense walls erected before 1220. In 1566, there was a fire in the town, but the building was not damaged besides a few wooden elements. Extended in 1698, the building was used as a storage house for salt and grain until the end of the 18th century. In the 19th century, it was partly converted for use as a prison and the headquarters of the town's fire brigade. The building served as the firemen's headquarters up to the 1990s of the twentieth century.

The Salt House is situated on a hill within the chamber of the ramparts, i.e., between the higher and lower lines of the ramparts. This location was due to fire safety considerations, since the high walls effectively separated the building from the flammable buildings of the city, mostly wooden, and also protected it from flooding in the event of rainfall and floods.

The project documentation created for the renovation envisaged the removal of the existing 19th-century machine-made tiles of no historical or technical value and their replacement with new clay roof tiles, with the application of contemporary layers used in the laying of the new roof, including vapor-permeable foil, which is a commonly used solution [15], but not always correct.

Once the work had started, it was found that on the roof, in addition to tiles dating back to the nineteenth century produced by machine in an amount of approximately 25%, the majority of the remaining were handmade tiles, including some from the period of the building's construction, with four different modes of shaping (flat, segmental, semicircular, and angular) (Figure 14a).

It was also found that on the south slope, the tiles were laid in a scalloped pattern (on the north slope in a lace pattern) with lime mortar fixings with fur and the joints sealed with wooden shackles.

Following the intervention of the building inspector after the renovation work had already begun, the voivodeship conservator of monuments changed his earlier decision to remove the tiles in their entirety and replace them with new ones. He ordered the careful removal, under the additional supervision of a conservator of works of art, of about half of the tiles on the southern slope, ordering that the tiles fixed with original mortar be left on the roof. After analyzing the problem, it was decided to undertake the conservation of the original roofing elements in situ using a hoist and climbing methods (on ropes), while reinforcing the slope by introducing additional battens supporting the original ones. This allowed the original patches and mortar to be preserved and prevented possible damage to the original tiles during their removal and reinstallation after conservation. Only selected roof tiles in poor condition were replaced (Figure 14b). These measures were taken after taking into account all the conservation principles of this type of historic structure [16], while monitoring the static condition of the structure. Some of the procedures proposed in [17] were implemented.

The original decision of the preservation office was also modified, ordering that the original existing roof tiles be cleaned, preserved, and incorporated using traditional mortar fixing. Not all tiles were suitable to undergo this process due to their technical condition.

Instead of the heavily damaged original and 19th-century machine-made tiles, custom handmade tiles resembling the original in appearance, but with much better physical and mechanical properties and with a detailed arrangement of tiles of different shapes on the roof slope reflecting its historic character, were installed (Figure 15).

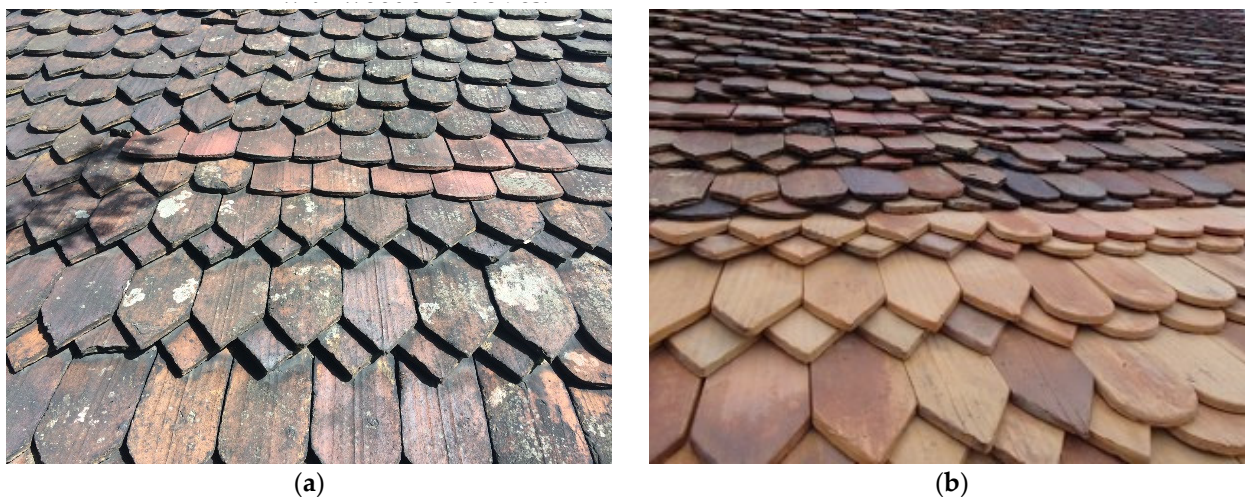
**Figure 14.** Different types of roof tiles: (a) historical; (b) new roof tiles in historic dimensions.
