Article

The Construction of a Footbridge Prototype with Biological Self-Healing Concrete: A Field Study in a Humid Continental Climate Region

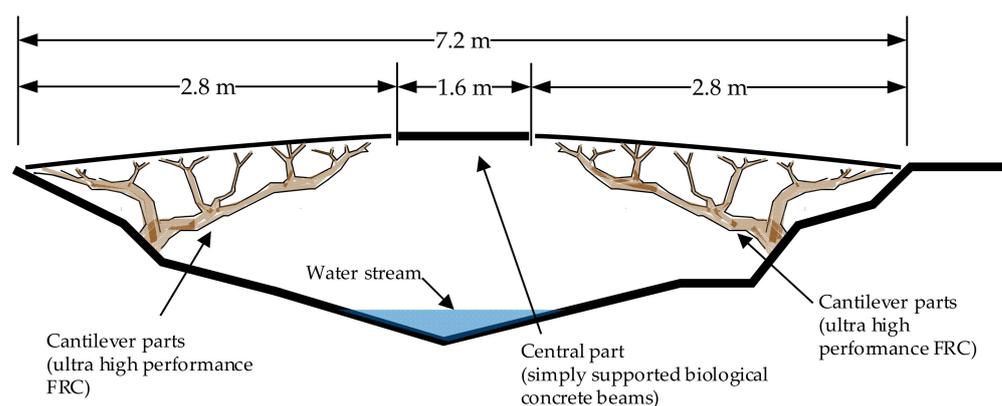
The total span of the bridge prototype was 7.2 m (2.8 + 1.6 + 2.8 m), sufficient to pass a small water stream in the Botanical Gardens of Vilnius University (Figure 1). The location of the footbridge inspired the application of biomimetic architectural principles. The shape of the bridge mimics the natural branch growth of *Pinus sylvestris*, the most common tree species in Lithuania. Four tree-like cantilever trusses (two from each side) were designed as the main load-bearing elements of the bridge, while the central part acts as a simply supported beam. This bridge design presents benefits with regard to the installation and replacement of the central bridge part. The bridge having replaceable beams allows us to perform several consecutive studies of healing performance under real environmental conditions, as beams may easily be dismantled and replaced after the study is finished. Moreover, this design enables cracks to be induced in the beams under laboratory conditions before installation on the bridge.

Figure 1. Design of bridge prototype.

The bridge prototype was designed for normal pedestrian use. Consequently, the characteristic value of a uniformly distributed load of 5 kN/m^2 was assumed according to [18]. The most unfavorable situation was obtained by applying this load on the whole bridge surface (7.2 m length and 1.5 m width). Concentrated loads were not taken into account as service vehicles are not carried on the footbridge.

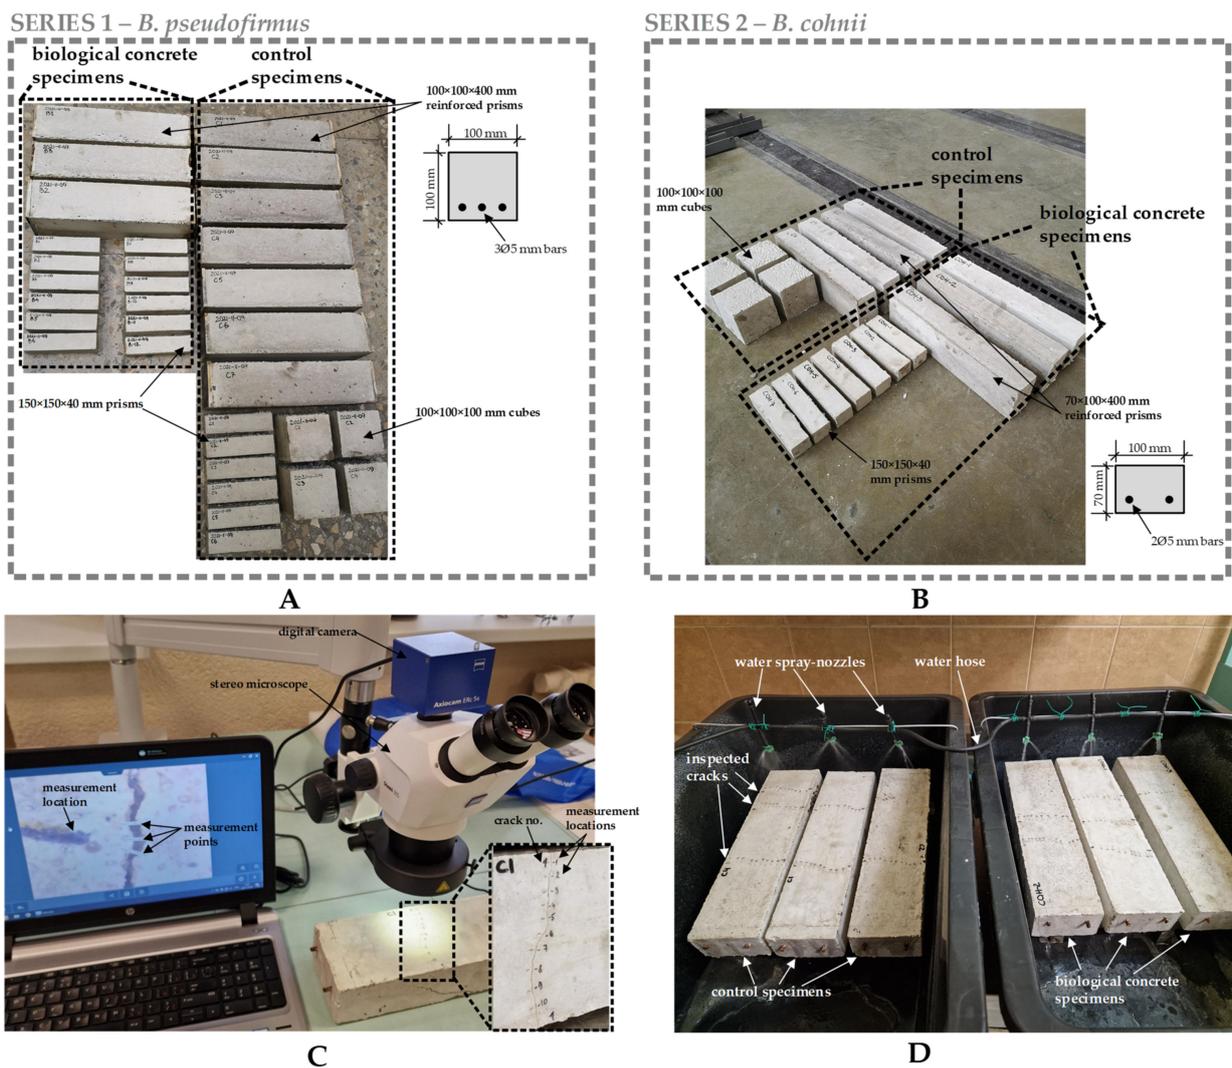
Laboratory tests on BSHC specimens were conducted in two stages. At the first stage (Series 1), the *B. pseudofirmus* bacteria strain (DSM 8715, the German Collection of Microorganisms and Cell Cultures, Braunschweig, Germany) was used (Figure 2A). At the second stage (Series 2), tests with *B. Cohnii* bacteria (DSM 6307, the German Collection of

Microorganisms and Cell Cultures, Braunschweig, Germany) were performed (Figure 2B). These bacteria strains were selected due to their high sporulation yields and their ability to survive in the concrete matrix [19]. The concrete mix listed in Table 1 was used for both test series. This mix design is based on several of our previous studies where healing performance was examined with respect to the chemical composition of cement, bacteria strain, concrete curing temperature and the impact of negative temperatures and protective coatings on bacteria [11,13,20]. A comprehensive study of bacterial viability in concrete indicated that the best bacterial survivability and, consequently, healing ability of BSHC may be obtained by using cements with minimal amounts of zinc and copper oxides [11]. Bacterial survivability may be further increased by using protective coatings from magnesium oxide or styrene-acrylate emulsion [20].

Figure 2. Laboratory tests on BSHC: (A) specimens of test Series 1; (B) specimens of test Series 2; (C) crack measurement scheme; (D) healing conditions.

Reinforced BSHC prisms were used to measure the crack healing process, whereas plain concrete specimens were employed for bacteria viability tests. Here, we report only the results of crack healing in reinforced specimens. As shown in Figure 2A,B, control specimens of the same dimensions were also produced for laboratory tests. For control specimens, the concrete mix as listed in Table 1 was used, but without bacterial spores. After 28 days of water-immersed curing, cracks in reinforced specimens were induced under a three-point loading scheme. Bottom cracks wider than 50 μm were selected for further inspection. Initial crack widths were measured using a stereo microscope (Stemi 305, Zeiss, Oberkochen, Germany) equipped with 5.0-megapixel digital camera (AxioCam ERc 5s, Zeiss, Oberkochen, Germany). For each crack, 8–10 measuring locations were marked, avoiding parallel cracks, missing aggregates and other irregularities. In each location, crack width was measured at three points (Figure 2C), resulting in around 24–30 measurement points in each crack.

Next, specimens were moved for a healing period of 28 or 98 days to specifically designed rain-simulating basins (Figure 2D). Water was automatically sprayed on the specimens for 30 min two times per day. Water slowly flowed and evaporated from the bottom face of the specimens after each dry cycle. For the rest of the time, specimens were kept in air with an RH varying between 40% and 50%. Such healing conditions were considered to be more realistic in comparison to common healing under water immersion or in 100% RH rooms.

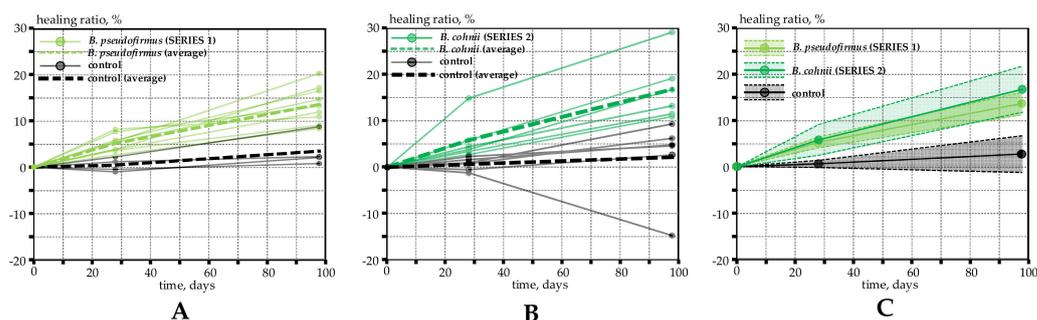
Crack widths in the reinforced specimens were repeatedly measured after 28 and 98 days of healing. The obtained variation of healing ratio over time for Series 1 and Series 2 specimens is shown in Figure 3A,B, respectively. Here, continuous lines represent the calculated healing ratio of each separate crack, whereas dotted lines show the average values. An average healing ratio of 14% was obtained for Series 1 specimens (with *B. pseudofirmus* bacteria) after 98 days of regular water spray. Control specimens also exhibited marginal crack closure, with a 3% healing ratio over 98 days. The autogenous healing of plain concrete is a well-known phenomenon and is mostly related to the swelling of concrete, continued hydration of cement and mechanical blocking of cracks by fine particles [3]. It should be noted that the latter component of autogenous healing may have a minor contribution in rain-simulated healing conditions as some cracks in control specimens even exhibited negative healing ratios. Most likely, loose aggregates were washed out from the crack surface, increasing the measured crack width. A similar effect was reported in [17], where biological concrete was in contact with saturated soil. Due to the water pressure, a large amount of white precipitate flowed from the crack. It was concluded that crack healing efficiency may be related to the flow rate of water through the crack.

Figure 3. Variation in healing ratio over time: (A) results of test Series 1; (B) results of test Series 2; (C) comparison of healing ratio between test Series 1 and Series 2—continuous lines represent the average values of the calculated healing ratio, whereas shaded areas show 95% confidence intervals.

Similar healing ratios were obtained for Series 2 specimens (with *B. cohnii* bacteria), where healing ratios of 17% and 2% were observed for biological and control specimens, respectively. The healing ratios of Series 1 and Series 2 are compared in Figure 3C. Crack closure in both Series was considerably lower in comparison to our previous study [20], where healing ratios up to 80% were reported. As discussed previously, such differences are mostly related to the different healing conditions: water immersion results in higher healing ratios in comparison to the regular spraying technique that was used in the present study. Nevertheless, surface water spraying was considered to be a more realistic healing condition for an open-air structure such as the bridge prototype discussed here. On the other hand, direct water spraying onto the crack may hinder the microbial-induced calcium carbonate precipitation, underestimating the healing ratio. To obtain representative results, bacterial healing must be examined in field conditions under the normal service of structures. In the next section, the production and testing of the structural biological concrete bridge beams are discussed.

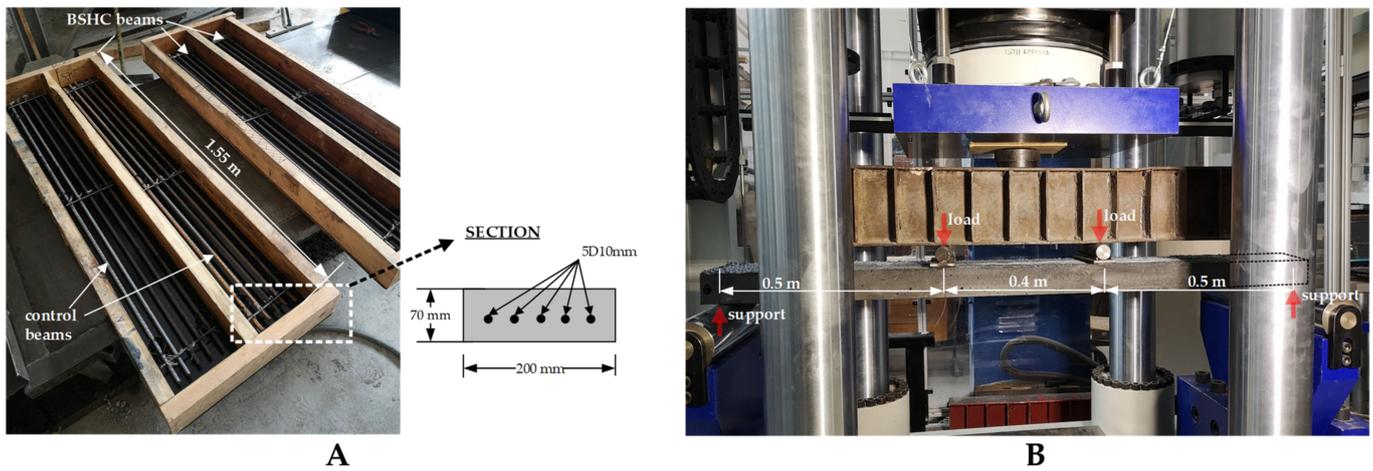
The shape and number of reinforcing bars for the beams were selected based on two requirements: (i) sufficient strength to withstand the design loads; and (ii) the formation of 10–15 cracks in the central part of the beam. After several numerical simulations using the ATENA nonlinear finite element software [22], the final height and number of reinforcing bars was selected (Figure 4A). Before installation on the bridge, the beams were tested in the laboratory via a four-point bending test (Figure 4B). Laboratory conditions allowed the load, number of cracks, and crack widths to be controlled during testing. Moreover, the position of cracks and measuring points were precisely marked before installation.

Figure 4. Production and testing of central simply supported beams: (A) formwork for biological and control beams; (B) load arrangement in four-point bending test.

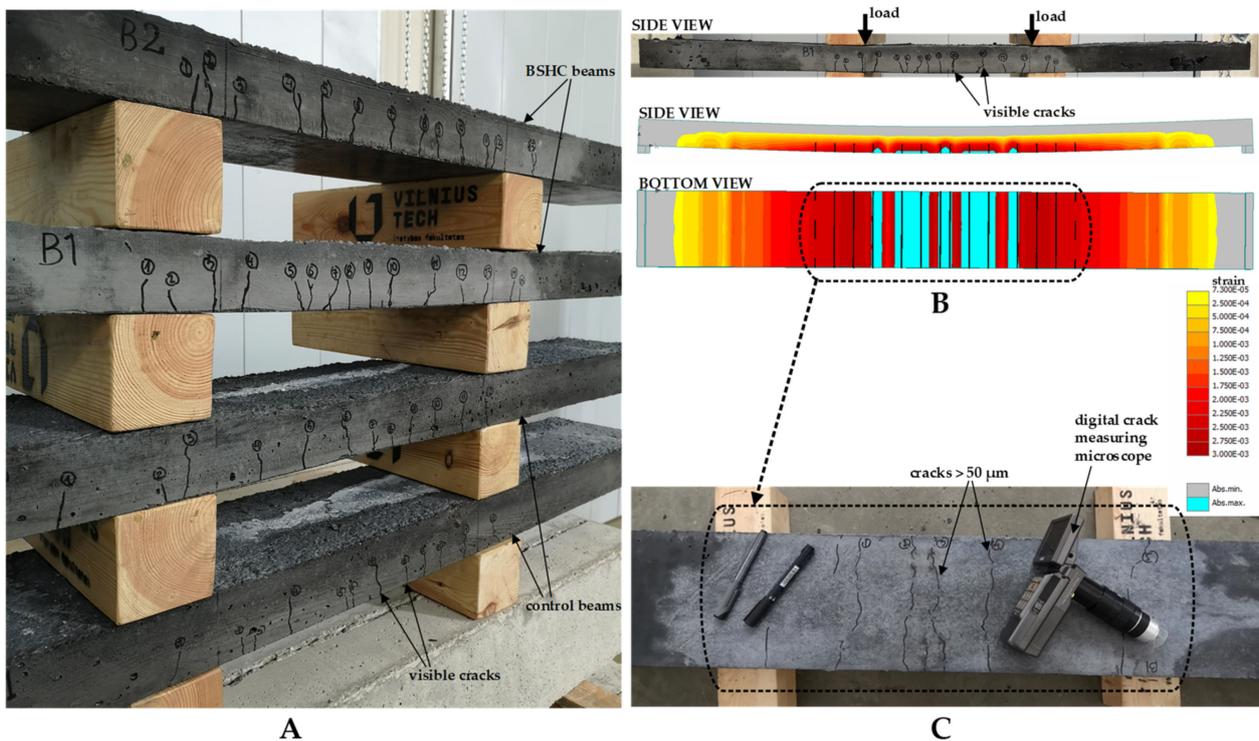
As predicted by the numerical simulation, 12–15 visible cracks formed in the side profiles of the beams (Figure 5A,B). For long-term examination of healing performance, only cracks wider than 50 μm were marked on the bottom surface of the beams and selected for further inspection (Figure 5C). A digital crack microscope was used to measure the initial crack widths. The tested beams were transported to the construction site and installed on the bridge (Figure 6). Crack monitoring began in September 2022.

Figure 5. Crack analysis of central beams: (A) crack patterns of all tested beams; (B) comparison between predicted and experimental crack positions; (C) bottom cracks selected for long-term inspection.

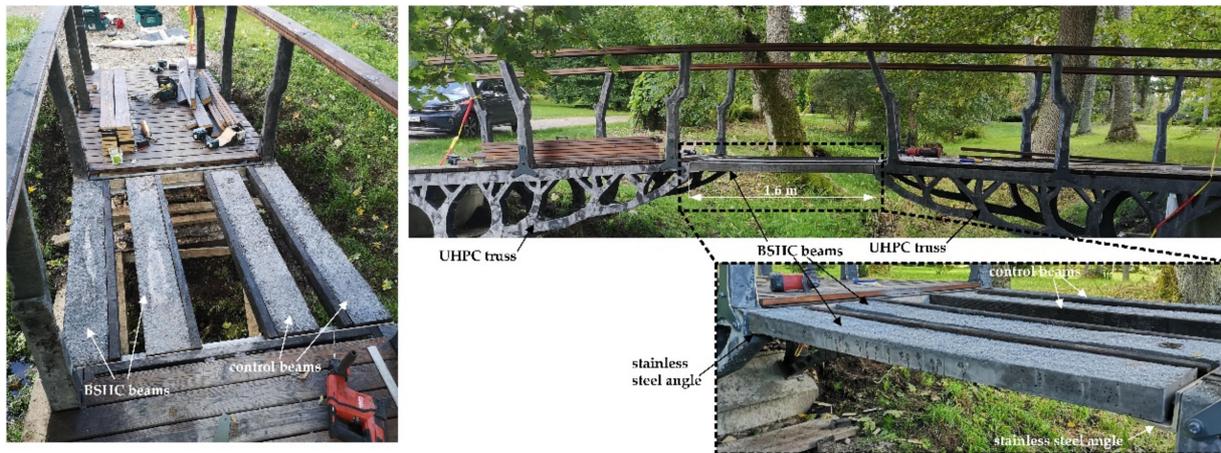
Figure 6. Biological and control beams installed in the bridge for long-term inspection of crack healing.

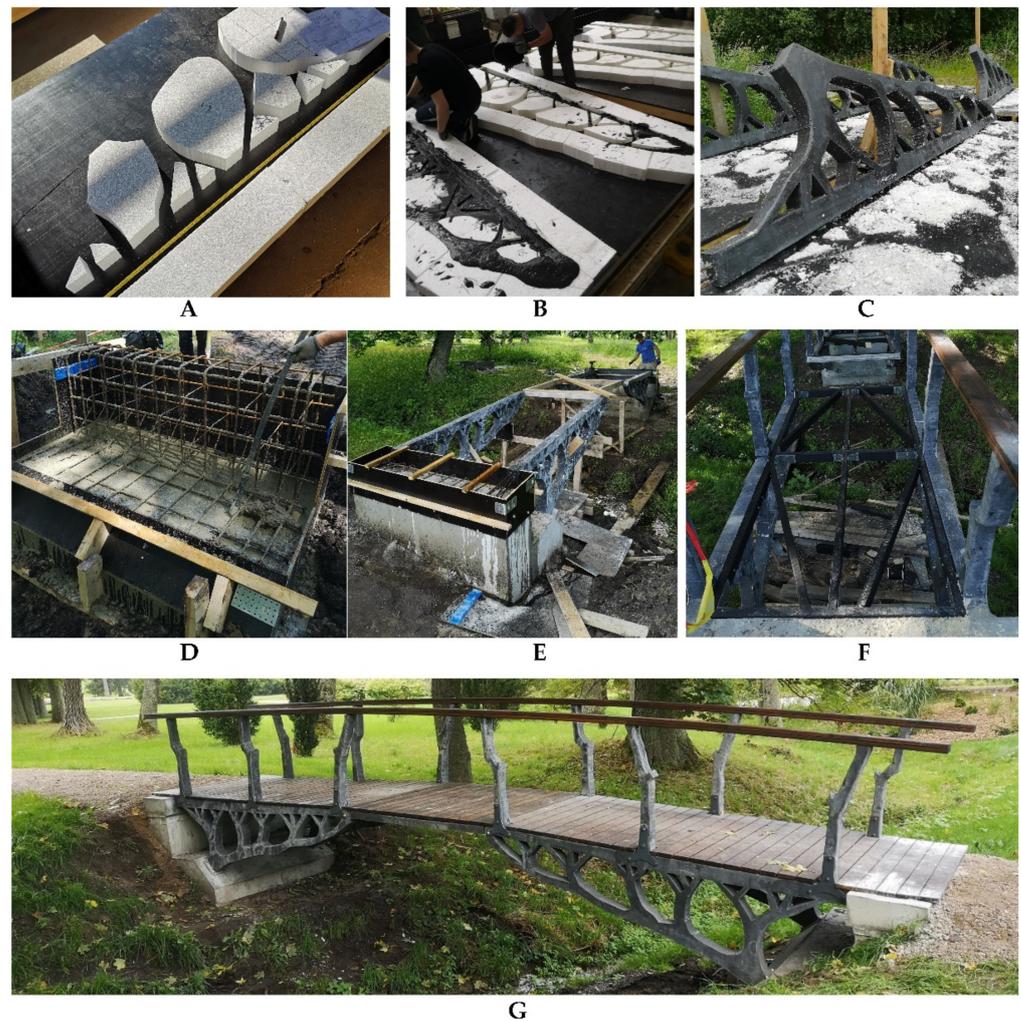
The cantilever design of the bridge required a relatively massive foundation. The bridge abutment was placed on four piles with a diameter of 0.4 m and a depth of 1.8 m, sufficient to resist uplifting forces from the cantilever action (Figure 7D). The compressive chord of the truss was joined to the abutment using a stainless-steel base plate, and a tensile chord was connected using the anchorage bars (Figure 7E). The trusses were joined and stiffened by a braced timber frame (45 × 95 mm) that also served as a support for the bridge decking (Figure 7F). Finally, the central biological concrete beams were installed on stainless steel angles and covered with wooden decking boards (Figure 7G). The gaps between the boards ensured that the water would easily flow from the deck, reaching the cracks in the BSHC beams. Such exposure conditions are considered to be close to the normal service conditions of footbridges. Moreover, horizontally placed beams in open air healing conditions will serve as a supplement to existing field studies on BSHC structures [7–10,15–17]. The bridge railings were produced from the same UHPC concrete mix, mimicking the growth of tree branches. The final bridge design perfectly suited the environment of the Botanical Gardens by visually blending with the growth of old trees.

Figure 7. The construction of a prototype footbridge: (A) preparation of formwork; (B) pouring UHPC mix; (C) demolding UHPC trusses; (D) construction of foundation; (E) installation of UHPC trusses; (F) trusses connected with braced timber frame; (G) finished prototype bridge.

The most challenging process in the construction of the prototype footbridge was the production of the tree-like trusses. The idea of 3D-printing the trusses was excluded due to existing challenges in printing fiber-reinforced concretes. Often, 3D-printed structures suffer from difficult buildability and exhibit a high degree of anisotropy. Moreover, constitutive models for such materials have not yet been developed [24]. Consequently, it was decided to produce four custom-made formworks. Due to the complex and irregular shape of the web elements, four custom-made formworks were produced. The formworks consisted of stiffened plywood sheets and expanded polystyrene EPS80 (100 mm thickness). Polystyrene sheets were cut with a hot wire according to the final shape of the truss and were glued to the plywood with epoxy resin (Figure 7A). After assembly, the formworks were placed on a shaking table. Concrete was poured in two layers and shaken for 60 s each time (Figure 7B). Fresh concrete was covered with plastic film and left for a 14-day curing period. Next, the trusses were transported to the construction site and demolded from the expanded polystyrene (Figure 7C). Good workability and proper compaction of concrete ensured a smooth and aesthetically attractive surface even in the thinner elements of the truss.
