Article

Experimental Research on Seismic Behavior of Seismic-Damaged Double-Deck Viaduct Frame Pier Strengthened with CFRP and Enveloped Steel

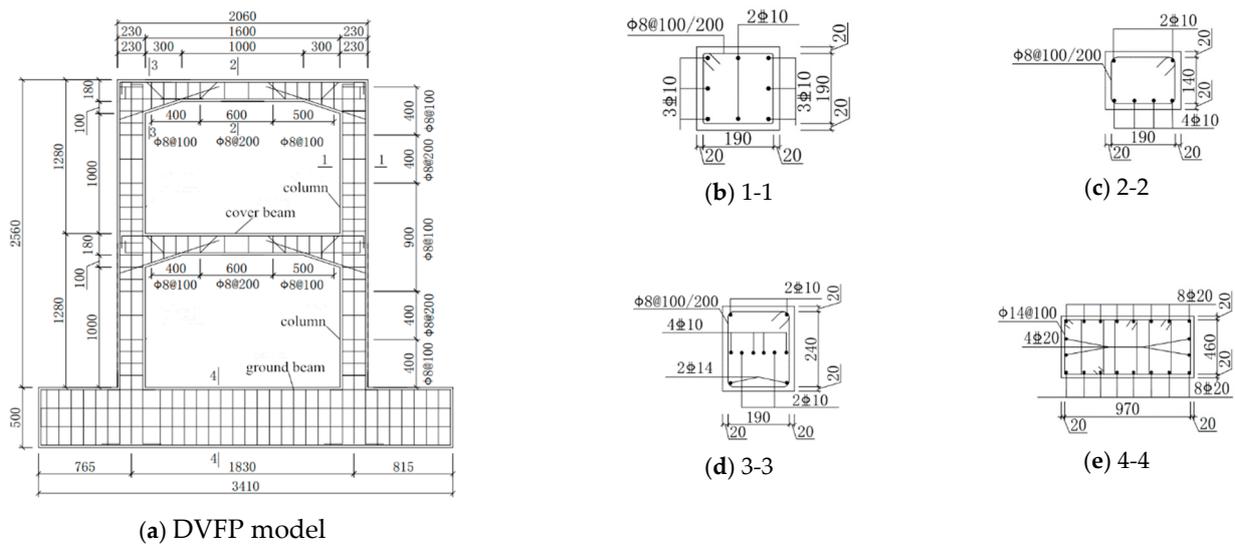
Figure 1. Details of DVFP specimen.

Four DVFP specimens with the same dimensions and reinforcement at 1:5.5 scale were designed and cast, and pre-damaged by static testing to simulate varying degrees of seismic damage, numbered from KJD-0 to KJD-3. The size and reinforcement condition of the specimens are shown in Figure 1. The longitudinal reinforcement ratio of column and cover beam are 1.19% and 1.14%, respectively, and the details of reinforcement are shown in Figure 1. The concrete strength of the specimen was C40 and the average tested compressive strength of the concrete cube at 28 days was 33.8 MPa (cube size: 150 mm × 150 mm × 150 mm). The mechanical properties of steel are shown in Table 1. The mechanical properties of CFRP, CFRP sheets mucilage and mucilage are shown in Table 2.

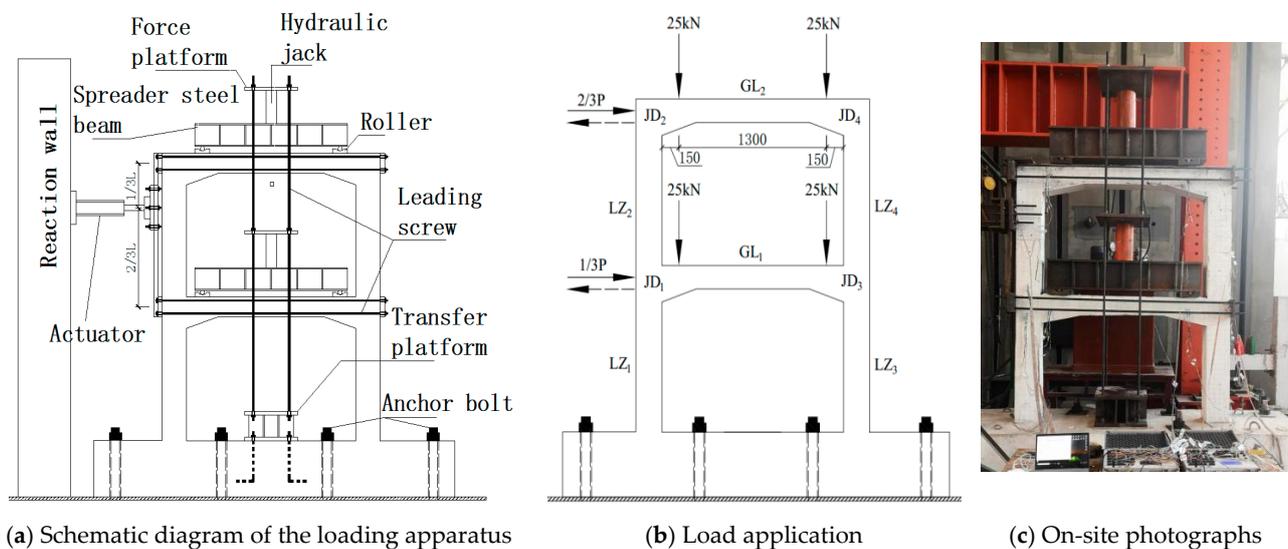
Figure 2. Loading device and scene.

The DVFP model was attached to the strong floor using 8 high-strength bolts. The vertical load adopted the self-reaction system, which is composed of oil jack, reaction platform, leading screw and spreader steel beam, the loading device. The test site is shown in Figure 2. The vertical loads were applied to the first and second floor cover beams, respectively. The horizontal cyclic load was applied by the actuator at the ends of the upper and lower cover beam in the proportion of 2:1 through the spreader device on the column side.

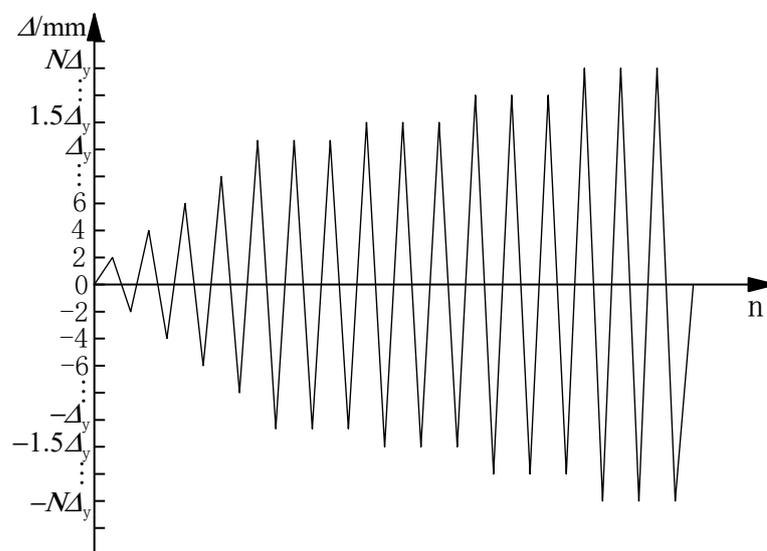
Figure 3. Loading history.

During the test, a constant axial load was applied at the cover beam on the first and second floors and the horizontal force was cycled under a lateral displacement control mode. Before the yield, one cycle was imposed with 2 mm and 1 time step for each loading step. After the specimen entered the yield stage, the lateral load repeated three cycles at the displacement levels of $0.5\Delta_y$, $1\Delta_y$, $1.5\Delta_y$, . . . , until the load decreased to less than 85% of the peak load or it failed. The loading system is shown in Figure 3.

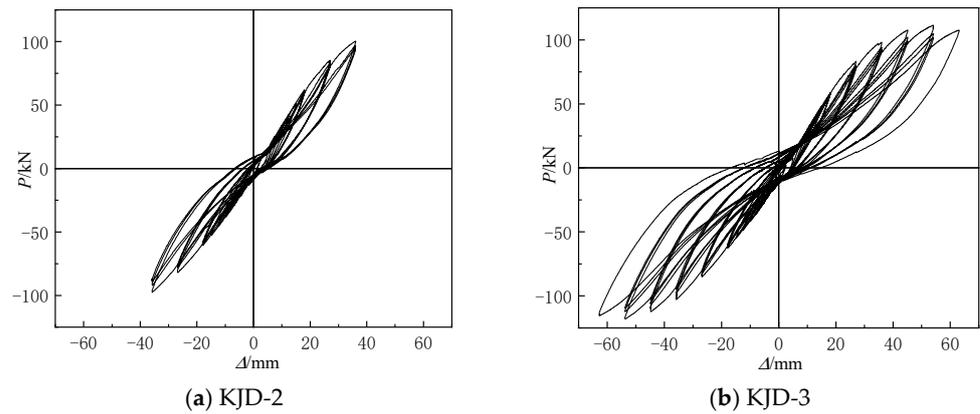
Figure 4. Hysteretic loops of pre-damage specimens.

The pre-damage parameters and reinforcement methods of the specimens are shown in Table 3. The specimen KJD-0 was not strengthened and specimen KJD-1 was reinforced directly without pre-damage. Specimens KJD-2 and KJD-3 were pre-damaged by quasi-static test to achieve a moderate damage and a severe damage of the reinforced concrete pier grade 5 performance class, respectively [20]. When the horizontal displacement reached 36 mm in the third cycle, cracks appeared at the column and joint of KJD-2, which was designated as moderate damage. When the specimen KJD-3 was loaded to ± 63 mm in the first cycle, and the original cracks of joints and column foot extended, the concrete cover of the bottom column foot began to fall off, and the horizontal bearing capacity reached the peak load, which was designated as a severe damage. The hysteretic curves of pre-damage specimens are shown in Figure 4.

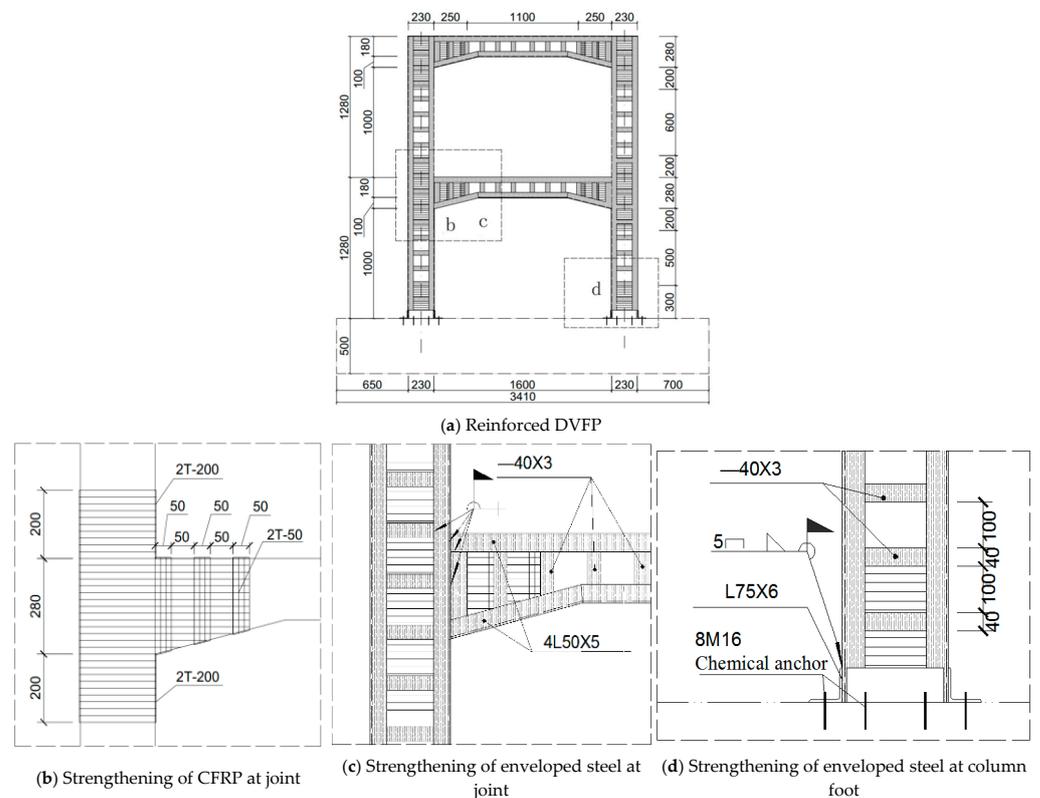
Figure 5. Reinforcement design of specimens.

The reinforcement method of the specimens was based on references [20], specimens KJD-1, KJD-2 and KJD-3 were reinforced by the same measures, and two layers of CFRP were pasted at the column foot and joints in order to avoid premature failure of the plastic hinge area of the specimen. The column and cover beam were reinforced by enveloped steel, and the enveloped steel at the column foot was fixed on the base by a chemical anchor. The reinforcement design of specimens and on-site photographs are illustrated in Figures 5 and 6, respectively. The enveloped steel ratio of column and cover beam is 2.33% and 3.11%, respectively, while the batten plate stirrup ratio is 0.77% and 0.79%, respectively, and the volume ratio of CFRP circumferential girth is 0.58%. As the first reinforcement step, the polymer cement mortar was used to repair the defective part after removing the surface of the loose concrete, and the second step was to inject mucilage to the cracks. Finally, CFRP and enveloped steel reinforcement construction were carried out after polymer cement mortar and mucilage solidification.

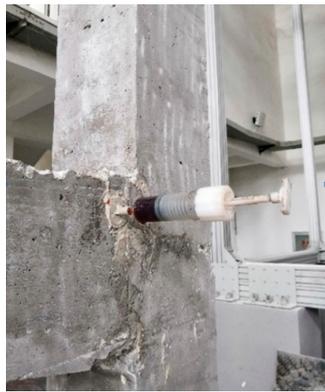
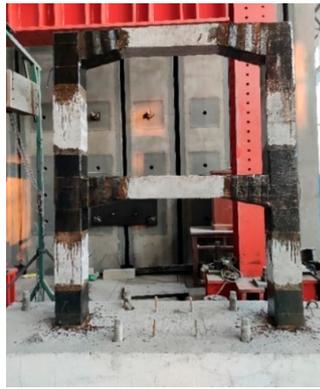
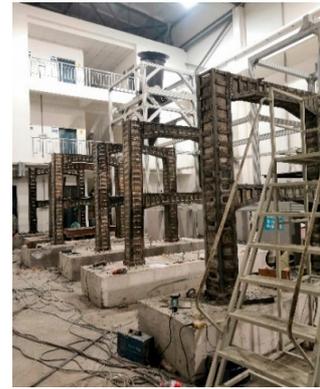
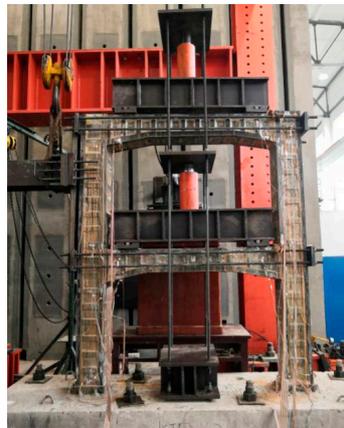
Figure 6. On-site photographs.

(a) Glue injection

(b) Strengthening with CFRP

(c) Strengthening with Enveloped Steel

(d) Experimental setup

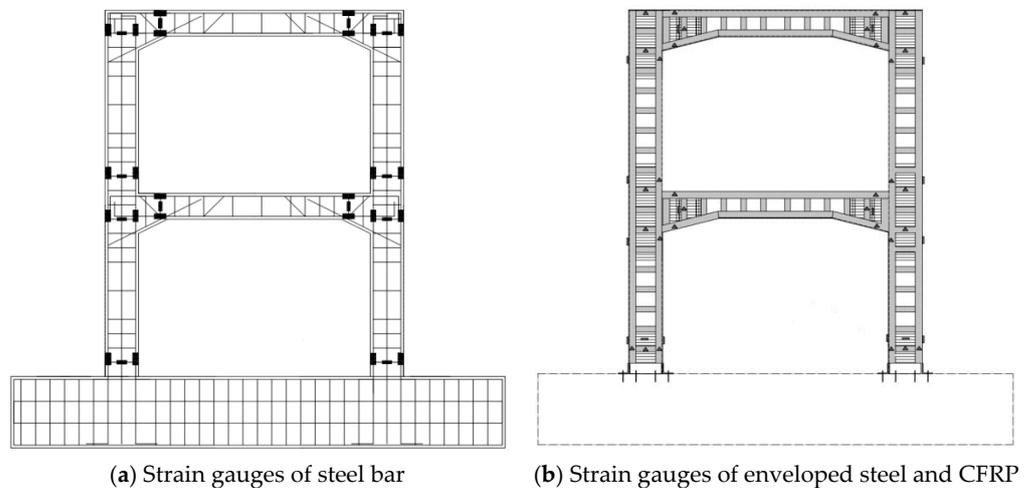
Figure 7. Layout of strain gauge.

The horizontal load and horizontal displacement were recorded by the actuator. The strain of longitudinal reinforcement and stirrup in the potential plastic hinge area of column, the strain of section steel and batten as well as the strain of the CFRP at the cover beam and column were measured and recorded by strain gauges. The obtained layout of the strains is illustrated in Figure 7.

(a) Strain gauges of steel bar

(b) Strain gauges of enveloped steel and CFRP

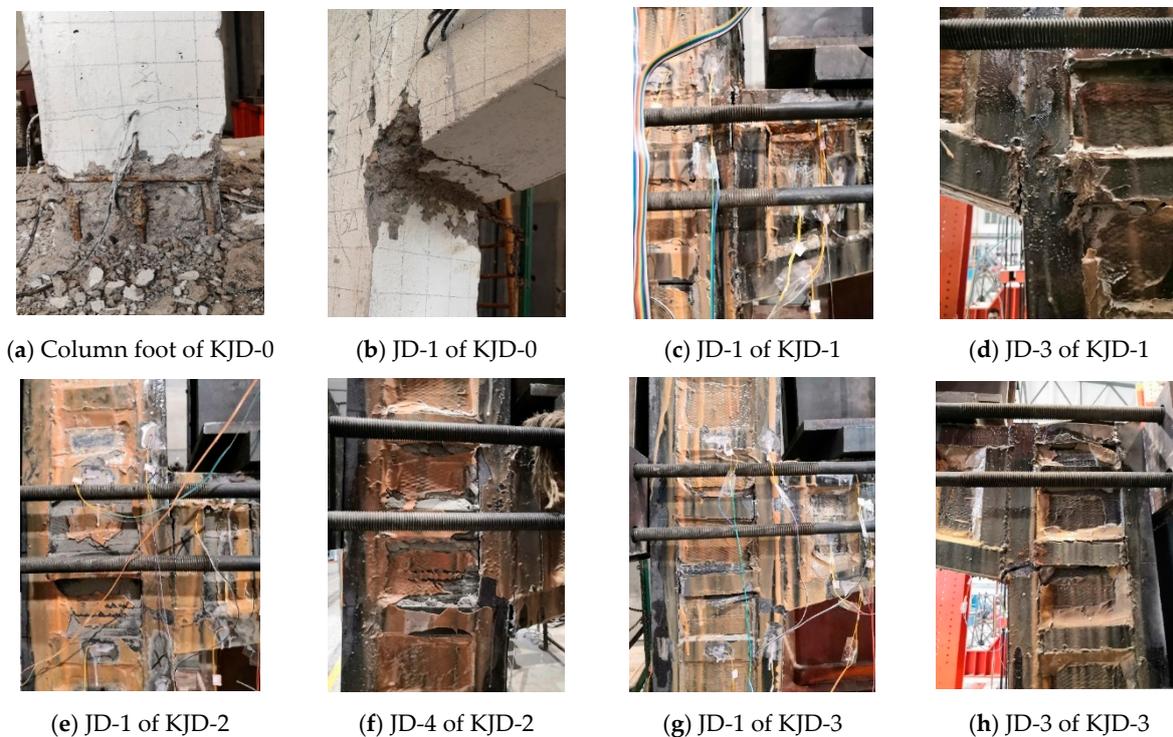
Figure 8. Typical failure phenomenon of specimens.

When the horizontal displacement reached 12 mm in the first cycle, micro-cracks appeared at the foot of the column marked as LZ1 and LZ3. The original cracks extended and penetrated, while new cracks appeared in the first cycle of 16 mm. The strain monitoring system indicated that the strain of the longitudinal bars at the foot of LZ1 and LZ3 columns exceeded the yield strain. As the loading continued, the concrete cover of column foot began to fall off, the longitudinal reinforcement basically yielded, and two fine cracks appeared at the bottom of beam GL1. When the horizontal displacement reached 63 mm, the horizontal bearing capacity reached the peak load, the concrete cover of the column foot spalled off seriously, and many longitudinal bars were exposed. At a horizontal displacement of 90 mm, the bearing capacity decreased to less than 85% of the peak load, and the test stopped. Figure 8a,b illustrate the failure mode.

At the first cycle of displacement of ± 18 mm, the strain of angle steel at the foot of column LZ1 exceed the yield strain; the weld of enveloped steel of joint JD1 was pulled off, accompanied by cracking sounds. At 99 mm, the concrete of JD1 and JD3 was seriously crushed, CFRP was obviously bulged, the CFRP at the foot of column was fractured, and a small amount of concrete debris was spalled. Figure 8g,h illustrate the failure mode.

In the later failure stage of KJ-0, the concrete cover of the column foot spalled off seriously, and many longitudinal bars were exposed. Specimens KJD-1, KJD-2 and KJD-3 present similar failure mode, longitudinal bars and enveloped steel partially reach yield, but there was no obvious deformation or failure at the foot column. It can be seen that the CFRP and steel jackets can effectively prevent the concrete crushing. However, the enveloped steel fractured and CFRP bulged seriously at the joints. Compared with KJD-0, the ultimate displacement and the peak capacity of specimens KJD-1, KJD-2 and KJD-3 have significantly increased. The damage degree of reinforced specimens increases with the increasing pre-damage degree, and the damage of KJD-3 is largest.

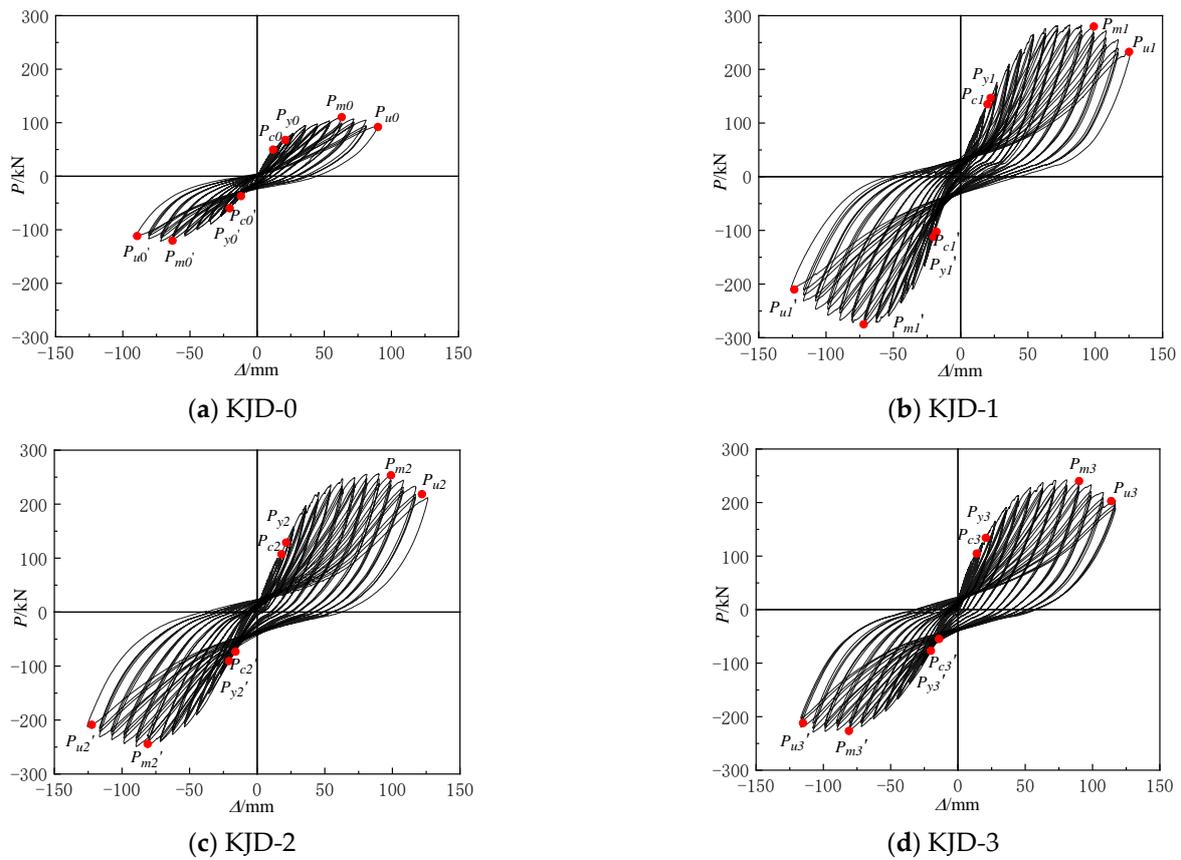
The recorded P- Δ curves of the four specimens are shown in Figure 9. At the beginning of the test, the lateral load is approximately in line with displacement. The hysteresis curve gradually tilts to the X-axis direction and exhibits an inverse s-shape, and the enclosed area gradually increased. In the yielding stage, the maximum load and hysteresis loop area are similar, and the degradation of stiffness and energy dissipation capacity is not significant under the same level of displacement loading, indicating that there is no obvious cumulative damage under the low circumferential reciprocal loading of the specimen. Compared with the prototype contrast specimen KJD-0, both the ultimate displacement and bearing capacity of the specimen KJD-3 have a great improvement, and the hysteresis loop increases significantly increased, which indicates that the seismic performance of the severely damaged specimen can still be effectively recovered after the composite reinforcement by CFRP and enveloped steel. The peak point and the slope of curve of the last two cycles are smaller than those of the first one, and the hysteresis loop area of the last two cycles also reduced to different degrees, indicating that the stiffness and energy dissipation capacity of the specimens are degraded. The degradations of KJD-2 and KJD-3 are greater than that of KJD-1, reflecting the effect of accumulated damage of the specimen under the low circumferential reciprocal loading.

There is no obvious inflection point on the skeleton curve of each specimen. The stiffness of each reinforced specimen is similar at the early stage of loading, and the initial stiffness of the comparison specimen is slightly lower. The reinforcement method of CFRP and enveloped steel exhibits a superior reinforcement effect in the early stage.

Figure 9. Hysteretic loops of specimens. (a–d). Note: For KJD-0, P_c represents the cracking point of concrete; For KJD-1~KJD-3, P_c represents the cracking point of surface glue; P_y , P_m and P_u represent the yield point, peak point and limit point, respectively.

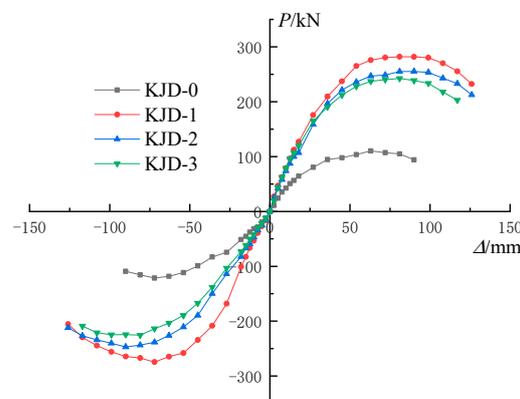
Figure 10. Skeleton curves of each specimen.

As is can be seen from Figure 10, compared with KJD-0, the ultimate displacement of reinforced specimens KJD-1, KJD-2 and KJD-3 has significantly increased. After the bearing capacity reached the peak load, CFRP and enveloped steel can effectively restrain the development of concrete cracks. The descending section of the skeleton curve is relatively gentle and exhibits a good ductility. The bearing capacity of specimens decreases faster with the increasing pre-damage degree. The ranking of the bearing capacity of the reinforcement specimens during forward loading is $KJD-1 > KJD-2 > KJD-3$, and significantly larger than KJD-0.

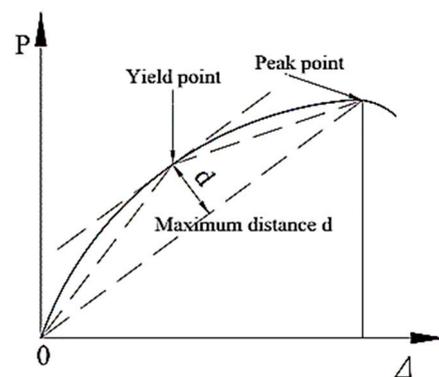
Figure 11. The farthest point method.

The displacement ductility coefficient is commonly used to express the plastic deformation performance of the specimen. Since there is no obvious yield point in the skeleton curve, the farthest point method proposed in the literature [21] is used to calculate the yield displacement, which is simple and feasible, and the calculation results are close to those of the graphical method and the equal energy method, and the schematic diagram of the farthest point method is shown in Figure 11. The displacement corresponding to the load dropping to 85% of the peak load is taken as the ultimate displacement. The displacement ductility factor μ is defined as the ratio of the ultimate displacement Δ_u to the yield displacement Δ_y [22]; it is calculated as follows:

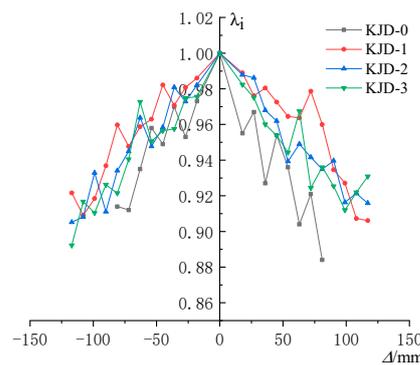
Figure 12. Strength degradation curves.

$P_{i,1}$ and $P_{i,3}$ represent the peak load of the first cycle and the third cycle at the i th drift level, respectively [23]. The relationships between λ and Δ are plotted in Figure 12. The stiffness degradation coefficient K_i can be defined as

As is can be seen from Figure 12, the strength degradation of the specimen after yielding is accelerated significantly due to the continuous damage accumulation. The strength degradation of the specimen KJD-0 was the most significant, and the ranking

of the strength degradation of the reinforcement specimens during forward loading was $KJD-3 > KJD-2 > KJD-1$, which shows that the strength degradation is related to the degree of damage. The more serious the damage is, the faster the strength degradation is. The strength degradation coefficients are above 0.9, indicating that the reinforcement method is effective. The specimens maintain a more stable bearing capacity under large deformation and show good seismic performance.

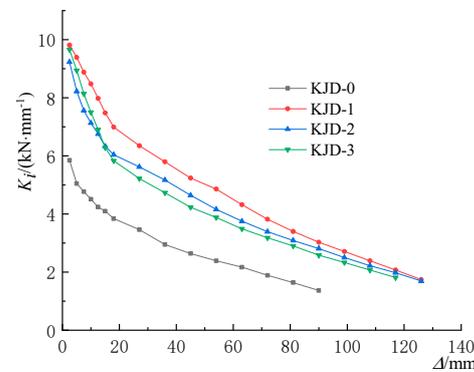
Figure 13. Stiffness degradation curves.

$P_{m,i}$ represents the peak load of the i th drift level in the half cycle; $\Delta_{m,i}$ represents the peak displacement of the i th drift level in the half cycle level [24]. The relationships between K and Δ are plotted in Figure 13.

The stiffness degradation curves are shown in Figure 13, and it is seen that the stiffness degradation coefficient λ of KJD-2 and KJD-3 is greater than that of KJD-0, but slightly lower than that of KJD-1; The stiffness degradation trends of all specimens are similar. At the beginning of the test, the bearing capacity and secant stiffness decreased gradually. As the loading continued, the secant stiffness decreased slowly. The stiffness degradation rate of KJD-2 was close to that of KJD-1 at the late loading stage, and that of KJD-0 was faster than that of KJD-3. This indicates that the composite reinforcement of CFRP and outer clad steel can improve the stiffness of the specimen and delay its stiffness degradation after the pier enters the nonlinear phase.

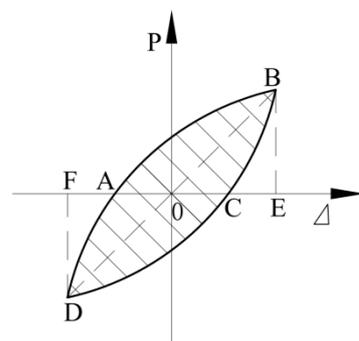
Figure 14. Energy dissipation index calculation.

The energy dissipation capacity of the specimens was evaluated using the cumulative hysteretic energy dissipation E_u and the energy dissipation coefficient E . The calculation method of energy dissipation coefficient was shown in Figure 14 and its expression in Equation (4). The relationship between the cumulative hysteretic energy dissipation and the displacement ductility ratio $\mu\Delta$ (the ratio of loading displacement to yield displacement) of each specimen is shown in Figure 15.

$$E = \frac{S_{(ABC+CDA)}}{S_{(OBE+ODF)}} \quad (4)$$

S_{ABC} is the area within the hysteretic loop; S_{OBE} is the corresponding triangle area [25].

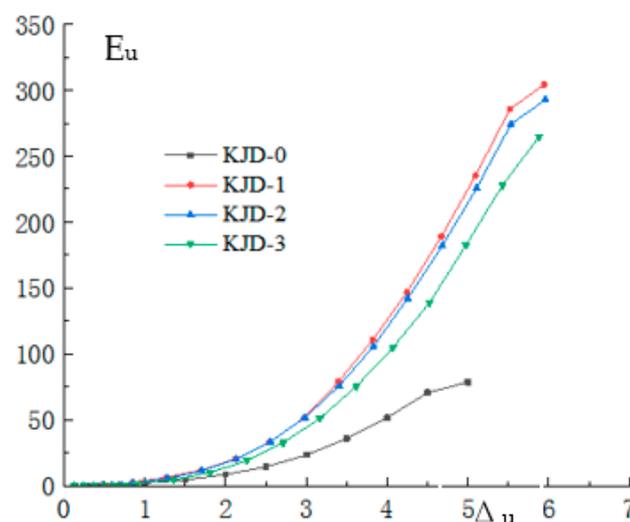
Figure 15. Cumulative energy dissipation curves.

It is seen that: The varying trend of cumulative hysteretic energy consumption of each specimen is close to that of the displacement ductility ratio. In the elastic working stage, the displacement-ductility ratio is less than 1, and the accumulated hysteretic energy dissipation is close to 0. When the displacement ductility ratio is greater than 1, the cumulative hysteresis energy increases steadily with the increase in displacement ductility ratio, and the cumulative hysteresis energy of reinforcement specimens KJD-1, KJD-2 and KJD-3 is significantly higher than that of contrast specimen KJD-0 due to the participation of CFRP and outsourced steel. At the same level of displacement ductility ratio, the cumulative hysteresis energy of reinforcement specimens KJD-1, KJD-2 and KJD-3 decreases with the increase in pre-damage degree.

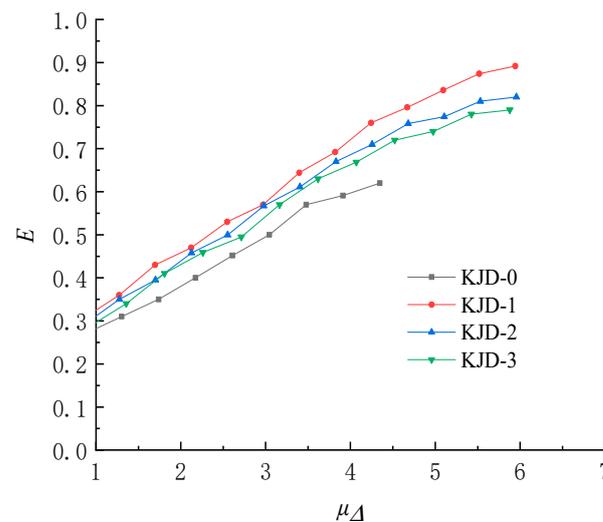
Figure 16. Energy dissipation coefficient curves.

The energy dissipation coefficient curve of each specimen is shown in Figure 16. When the displacement ductility coefficient is less than 1, the specimen is in the elastic working stage, and the coefficient is not significant to study. Therefore, only the energy dissipation coefficient after yielding is calculated. It is seen that, at yielding, the energy dissipation coefficients of all specimen are similar. With the increasing loading, E grows smoothly, and the growth rate of the comparison specimen KJD-0 is smaller than that of the reinforced specimens.

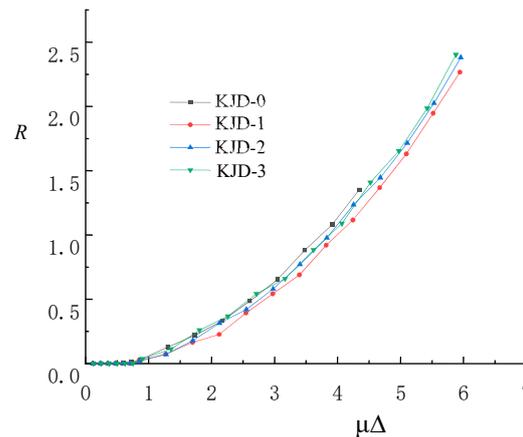
Figure 17. Residual displacement coefficient curves.

The residual displacement coefficient curve is shown in Figure 17. It is seen that the residual displacement coefficient of each specimen varies basically with the displacement

ductility ratio. When the displacement ductility ratio is less than 1, the residual displacement coefficient is equal to 0. When the displacement ductility ratio is greater than 1, the residual displacement coefficient changes linearly with the displacement ductility ratio. Under the same displacement ductility ratio, the residual displacement coefficient of KJD-1 is lower than that of the prototype contrast specimen KJD-0, and the residual displacement coefficients of KJD-2 and KJD-3 are also slightly lower than that of the prototype contrast specimen KJD-0. It is shown that the composite reinforcement of CFRP and enveloped steel can slow down the growth of residual displacement coefficient.

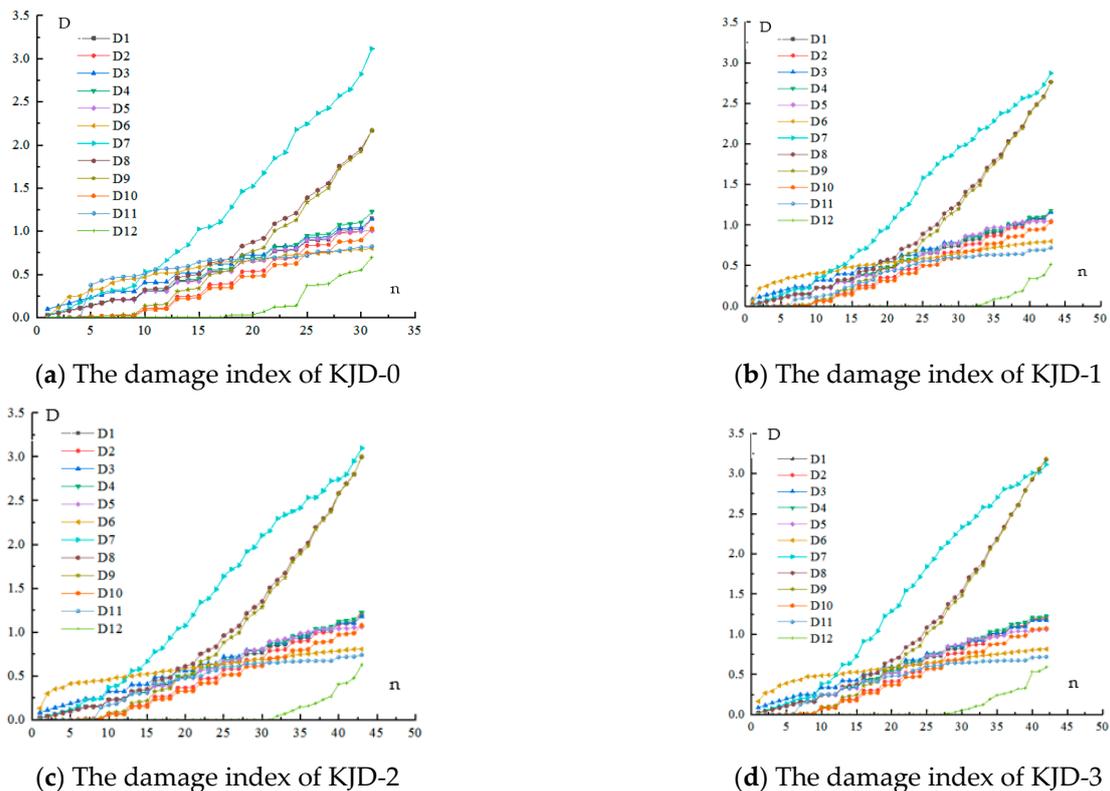
Figure 18. The damage index of KJD-0~KJD-3.

As shown in Figure 18, the damage index of the four specimens calculated with different damage models and the damage index development curve of each specimen was obtained. The analysis of the damage curves of four specimens shows that the damage index calculated by different models is more discrete under the same damage state, mainly because each damage model is based on limited parameters of different components or structural test data. Another reason may be that the structural design, test conditions, and loading methods will affect the calculation results.

As is shown in Figure 18, except for D6 [32], the development trends of damage indexes of all specimens calculated by different damage models are roughly similar, and the growth rate is slow in the early stage. With the progress of cyclic loading, the exponential growth accelerates after the specimen enters the yield stage, which can effectively reflect the cumulative damage of specimens during the loading process.

D6 increases rapidly in the early stage, but tends to be flat in the later stage, which is inconsistent with the actual damage process of the specimen. D2 [28] and D9~D12 [35–38] have less damage before yielding, which is consistent with the actual situation in the early stage. The damage index of D7~D9 [33–35] in the later stage exceeds 1, which overestimates the damage degree of the specimen during the loading process. When the specimen reaches moderate damage, the damage index of D12 [38] is still small, which does not conform to the actual situation. The damage index calculated by D5 [31], D10 [36], and D11 [37] is small in the early stage, and gradually increases during the loading process.

The damage phenomenon and the measured data of the specimen during the loading process can provide a lot of evidence for seismic-damage research of DVFP. Whether the earthquake damage model can better evaluate the damage degree of the specimen during the loading process mainly depends on the damage index calculated by the model and the test results. Objective and accurate damage evaluation criteria are the premise for quantitatively evaluating the damage degree of bridge piers. It is seen from Figure 18 that the Kumar model [36] can better reflect the damage evolution of DVFP during the test
