Article

Characteristic Parameters of Magnetostrictive Guided Wave Testing for Fatigue Damage of Steel Strands

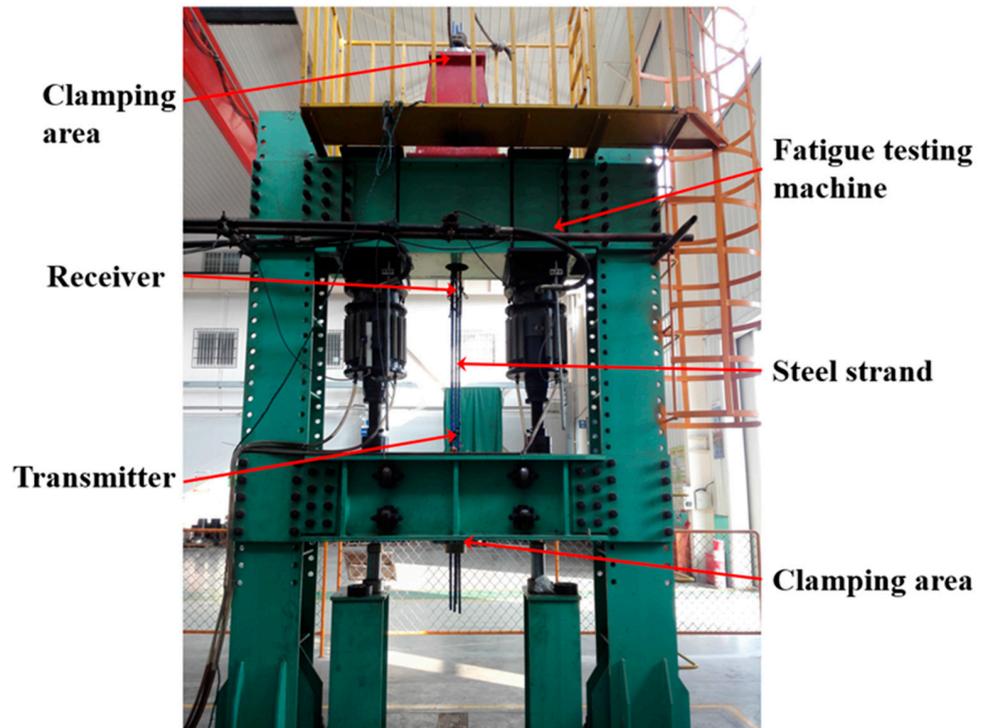
Figure 2. Photo of the steel wire loading experiment installation.

A 1000 kN electro-hydraulic pulsating fatigue testing machine was employed to cyclically load the steel strands. The specimens consisted of three strands with seven epoxy-coated ASTMA416-270 grade low-relaxation wires each from the same batch, with a nominal diameter of 15.2 mm, each having a length of 4 m and a nominal tensile strength of 1860 MPa. The installation of the steel strands on the fatigue testing machine is shown in Figure 2, with the upper and lower ends clamped securely. Prior to installation, the solenoids of the transmitter and the receivers were mounted on the steel strands using single-layer 40-turn 0.5 mm enameled wire.

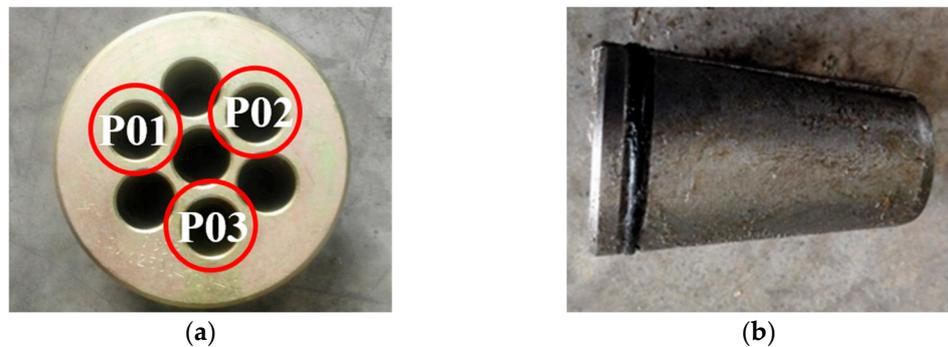
Figure 3. Photo of the steel strand fixture and the numbers of steel strands: (a) anchor plate; (b) clips.

For distinction, the three steel strands were labeled as P01, P02, and P03, as shown in Figure 3, which depicts the fixture composed of clips and anchor plates. To ensure that the steel strands did not slip during stretching, the clamp blocks were designed with a tapered shape. The steel strands were first placed in the clamp blocks and then inserted into the sleeves. During the test, the clamps with the baffle were fixed onto the fatigue testing machine, as depicted in Figure 4. In order to prevent slippage of the steel strands during the loading process, preloading was applied using the fatigue testing machine. The tensile force was gradually increased to the upper limit stress and held for approximately half an hour. If no slip or abnormal behavior was observed, the tensile force was then unloaded to zero. If slippage occurred, the installation of the clamp was checked for correction. After the preloading process was completed, the cyclic loading started. Sinusoidal loading was employed as the loading mode with a frequency of 4 Hz. The ultimate stress applied on the strands during the experiment was set at 45% of the nominal tensile strength, corresponding to 837 MPa (117 kN), with a stress amplitude of 250 MPa (35 kN).

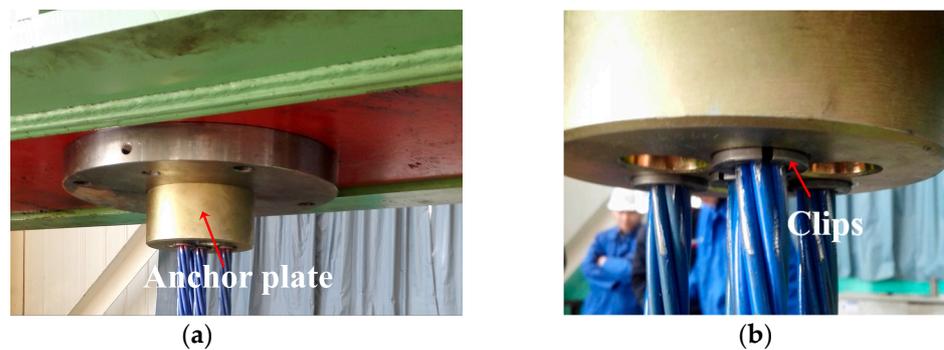
Figure 4. Photo of the installation of the steel strand fixture: (a) anchor plate; (b) clips.

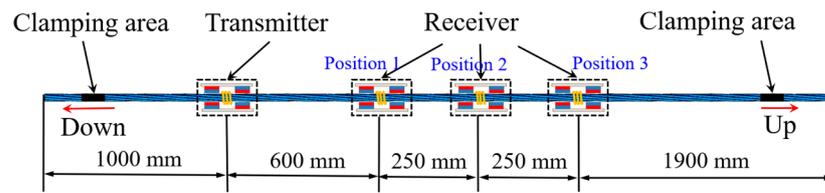
Figure 5. Schematic diagram of the installation position of the sensor in the cyclic loading experiment.

The installation position of the sensors on the steel strands is presented in Figure 5, with the clamping areas on both sides. The transmitter and the receivers were positioned 1000 mm apart from the left end, with distances of 600 mm, 850 mm, and 1100 mm between them, which were recorded as positions 1 to 3, respectively. Prior to conducting the cyclic loading experiment, a guided wave experiment was performed on the stranded wires, collecting data at positions 1, 2, and 3, respectively. The excitation signal used in the experiment was 5 cycles of an 80 kHz sinusoidal signal modulated by a Hanning window. Guided wave testing was conducted on the steel strands when the cyclic loading times reached 0.27 M, 0.58 M, 0.88M, 1.61 M, and 1.85 M, with a tensile stress of 78 kN applied during the detection. To accurately capture the change in the guided wave detection signal, the data were collected every 0.05 M times until a total of 39 sets of data were obtained at

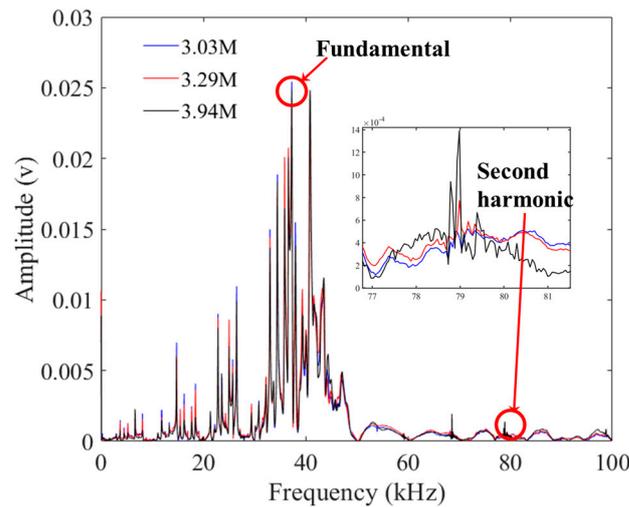
Figure 6. The frequency domain signals of three cyclic loading stages.

The detection signals from three different loading stages of the unbroken P01 chain were taken as examples. The passing signal underwent a fast Fourier transform, and Figure 6 illustrates the frequency domain signals of the three cyclic loading stages. The second harmonic amplitude and fundamental amplitude of the three loading times were obtained and then substituted into Equation (1) to derive the nonlinear coefficients corresponding to different levels of fatigue. The relationship between the cyclic loading times and the nonlinear coefficients is depicted in Figure 7.

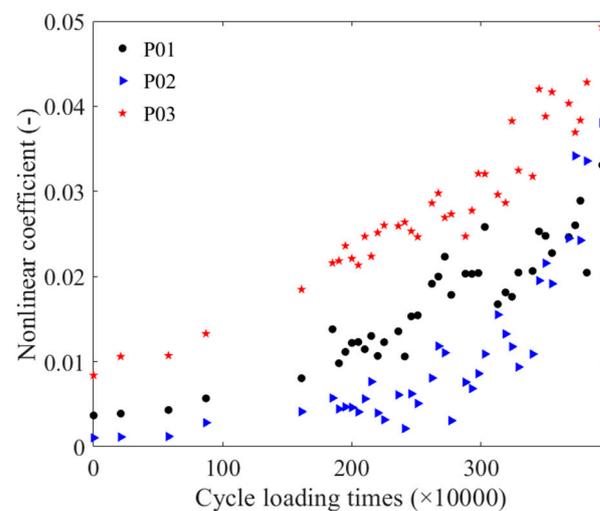
Figure 7. The relation between the cyclic loading times and the nonlinear coefficients.

The relationship could be divided into two segments: 0–0.88 M times and 1.61 M–3.94 M times. The change in the nonlinear coefficient of the three steel strands from 0 times–0.88 M times was relatively smooth, with an overall increasing trend with the number of cyclic loading. Similarly, between 1.61 M times and 3.94 M times, the nonlinear coefficient of the P01 steel strand showed an increasing trend, with two segments from 1.61 M times to 3.03 M times, and from 3.13 M–3.94 M times. The change in the P02 steel strand between 1.61 M times and 3.00 M times was relatively smooth, followed by an increasing trend in the relative nonlinearity after 3.00 M times, with a faster rate of change. The nonlinear coefficient of the P03 steel strand also increased with the number of cyclic loading times.

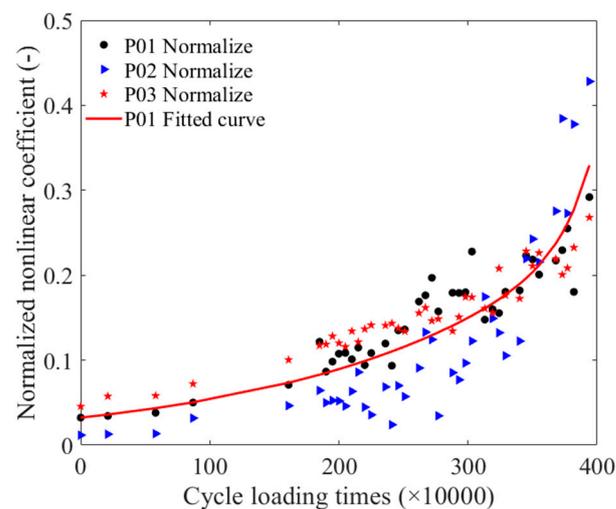
Figure 8. The normalized cyclic loading time and nonlinear coefficients fitting curve.

To quantitatively assess the fatigue damage of the strand, the relationships between the cyclic loading times and the nonlinear coefficients of the P01 steel strands were normalized and then subjected to exponential fitting. The normalization process was also applied to the P02 and P03 steel strands. The normalized cyclic loading time and nonlinear coefficients fitting curve is presented in Figure 8, showing that the trend of the detected data distribution for the P02 and P03 strands was approximately consistent with the fitted curves. The equation for the normalized cyclic loading time and nonlinear coefficient fitting is represented as Equation (3).

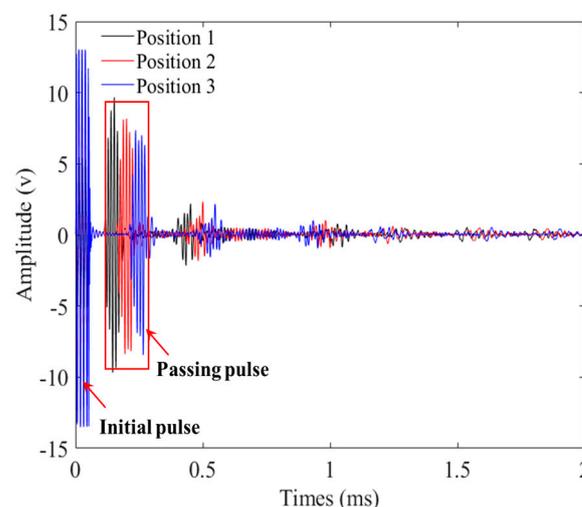
Figure 9. Time-domain waveform obtained from three positions of an unfatigued steel strand.

Taking the detection signals of three positions of the unfatigued P01 strand as an example, Figure 9 illustrates the time-domain signals of three positions. When calculating the attenuation coefficient, Equation (2) was combined with the pass signals at three positions, and the peak-to-peak value of the pass signals at these positions was fitted using an exponential function. Figure 10 presents the attenuation coefficient of the steel strand under different cyclic loading times. Figure 11 displays the normalized cyclic loading times and attenuation coefficient curves for P01, P02, and P03, as well as the fitting curve

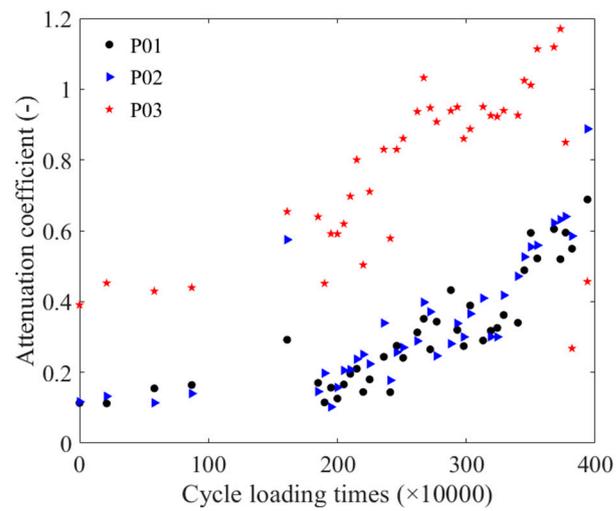
Figure 10. Relationship between the number of cyclic loading times and the attenuation coefficient.

for the P01 strand. Equation (4) presents the fitting equation for the normalized cyclic loading times and attenuation coefficients. The relationship could also be divided into two stages: 0–1.61 M times and 1.85 M–3.94 M times. Between zero times and 1.61 M times, the P01 steel strands exhibited an increasing trend. While the P02 steel strand showed an increasing trend from 0–0.88 M times, the change was relatively flat at 1.61 M times, with a large value at this point. Between 1.85 M times and 3.94 M times, the attenuation coefficients of the P01 and P02 steel strands increased with the cyclic loading times, and the attenuation coefficients of the two steel strands were relatively close. However, the attenuation coefficient fluctuations of the P03 steel strand were larger than those of the P01 and P02 steel strands, reaching a maximum value at 2.67 M times, and then decreasing to a minimum value at 3.82 M after 3.73 M times. It may be that as the cyclic loading times increased, the notch frequency of the guided wave in the strand changed. From the overall trend, the attenuation coefficient of the three steel strands increased with the number of cyclic loading times.

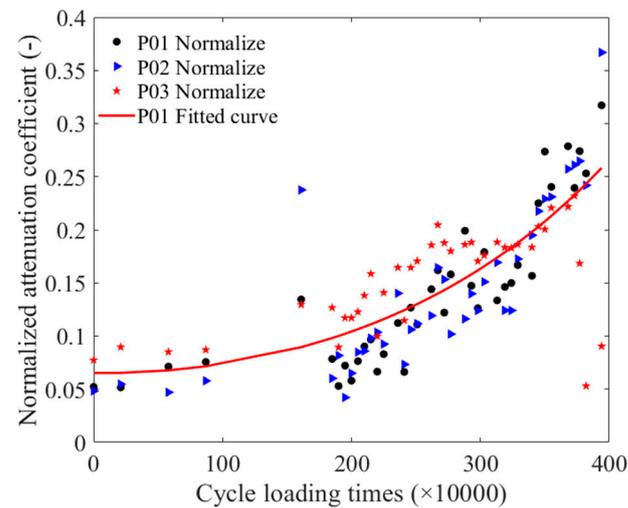
Figure 11. The normalized cyclic loading time and attenuation coefficient fitting curve.

where the y_A is the normalized attenuation coefficient and the unit of x is ten thousand times. The results in Figure 11 indicate that the overall trend of the wave attenuation coefficient in the three steel strands increased with the number of cyclic loading times. This finding suggested that fatigue damage in the steel strand due to the generation of microcracks led to an increase in wave attenuation during propagation, resulting in an increase in the attenuation coefficient. Therefore, the attenuation coefficient can serve as a characteristic parameter for the detection of magnetostrictive guided waves in steel wire fatigue damage after avoiding the notch frequency in the excitation parameter. Furthermore, although the overall trend of the three curves in Figure 11 is increasing, some exhibit significant fluctuations, such as the attenuation coefficient after 3.73 M cycles of loading of the P03 steel strand. For the occurrence of abnormal results, the influence of the notch frequency should be considered again to correct the results.

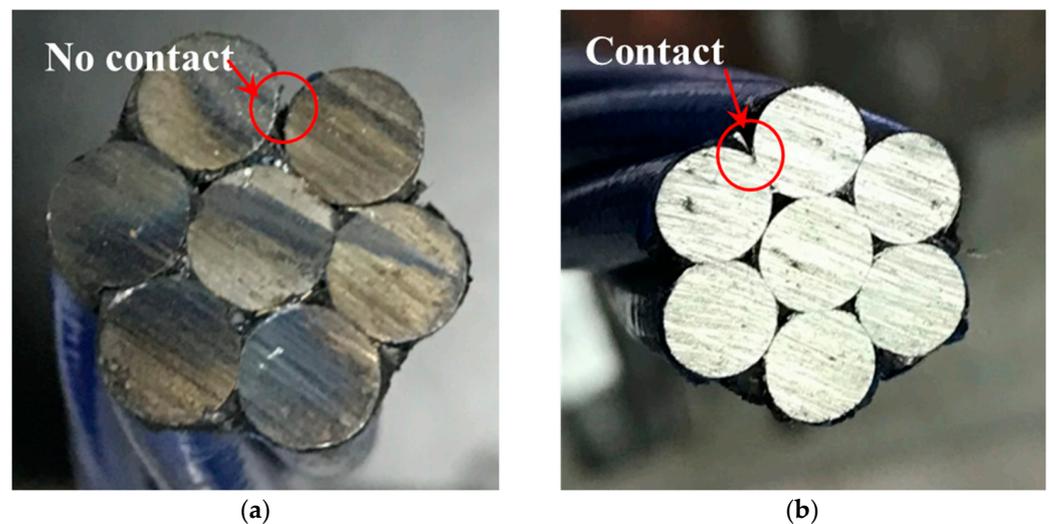
Figure 12. The cross-sections: (a) un-fatigued; (b) fatigued after 3.94 M cycles.

Figure 12a shows the cross-sections of an unfatigued strand with no contact between peripheral wires. And Figure 12b shows the cross-sections of the same strand after 3.94 M cycles of loading, with contact between peripheral steel wires and deformation at the contact area.

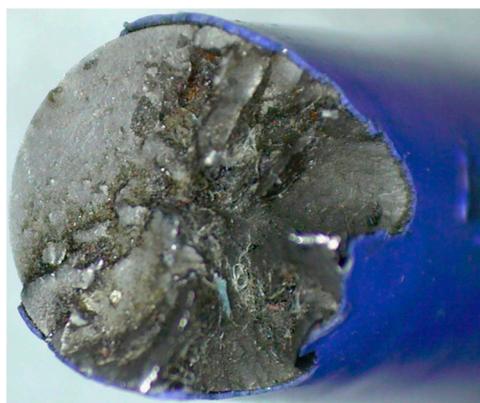
Figure 13. Photo of a fatigued wire fracture.

We continued to apply cyclic loads to the strand until one of the wires fractured, and its fracture cross-section is shown in Figure 13.

Combining the guided wave detection results with Figure 13, it is evident that when the strand was subjected to a certain level of cyclic load, small cracks were generated inside its steel wire. If the cyclic load continued to be applied, these small cracks were enlarged until a material fracture occurred.
