Article

Analysis of the Vehicle Chassis Axle Fractures

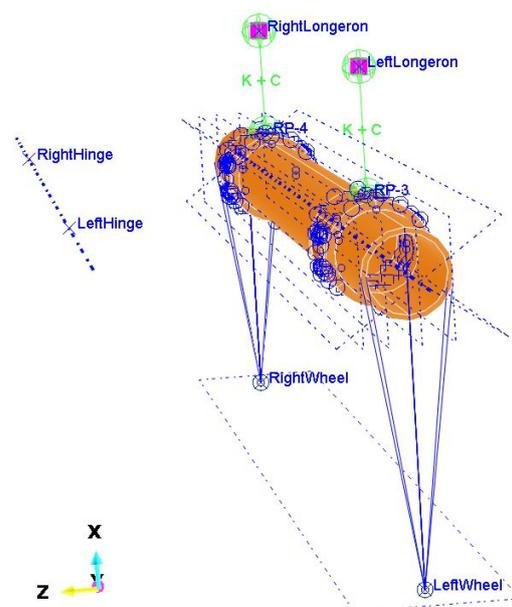
Simulations of the operation of the semi-trailer's non-driven axle were carried out using the Abaqus Explicit module. The model (Figure 1), apart from the axle itself, included two hinges, two bushings, two spring-damping elements and two points reflecting the contact points of the wheels with the road. The distribution of forces adopted for the simulation assumed an even position of the nominal load over the entire space of the platform.

Figure 1. Complete model of the axle for simulations (front in Z direction).

The prepared model contains simplifications compared to the actual structure [29,30], i.e., the possibility of deformation of the wishbones, which were modeled with Rigid Body elements, was omitted. All degrees of freedom were fixed but with rotation around the Y axis. Each of the wishbones is coupled with a bushing that is mounted on the axle. This coupling also does not take into account the possibility of deformation of these two parts (rocker arm and bush) relative to each other. The bushings are connected to the side members by means of integrated spring/dashpot elements, while in reality the shock absorber works between the swingarm and the front side member, and the air bellows between the swing arm and the side member behind the axle. The model does not take into account the stiffness and damping of the road wheels. The contact points of the wheels with the road have been connected with Coupling elements to the ends of the axles.

In the presented model, the connection of the bushing with the axle tube was modeled using welds with a shape and location similar to the real structure. In addition, contact was modeled between the inner surfaces of the bushing and the outer cylindrical surface of the axle with a friction coefficient of 1.0. It was assumed that the spring elements of the suspension have a stiffness of 4.5 kN/mm and the damping coefficient of each shock absorber is 10 N s/mm. These parameters were selected in such a way that the wheel does not lose its grip with the ground and that the deflection of the suspension after its load corresponding to the permissible axle load is in the range of 15–20 mm.

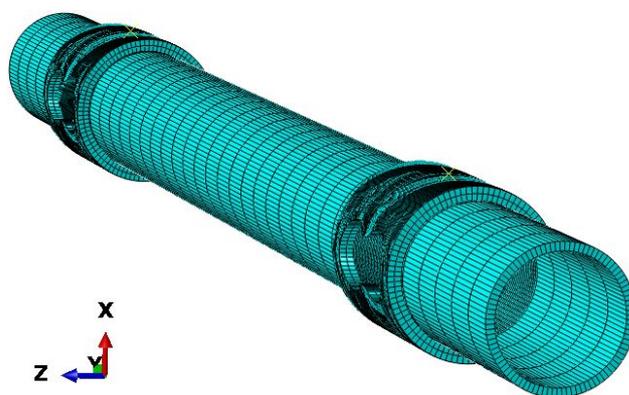
The mesh for the axles and bushing was created using linear elements of the C3D8R type, which are bricks with an integration point reduced to its center. In the area of contact between these two parts, the mesh of elements was densified (Figure 2). The bushing has 11,496 elements and 17,943 nodes, while the axle has 10,120 elements and 20,424 nodes.

Figure 2. Axle meshed for simulations (front in Z direction).

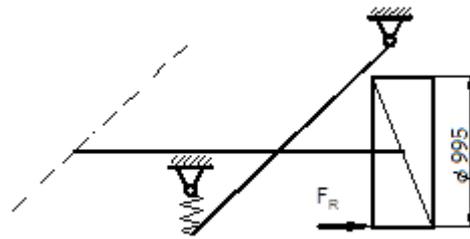
The reaction force of the wheel (Figure 3) is derivable from the equation of equilibrium. The additional bending moment acting around the horizontal axis is shown in (Figure 4).

Figure 4. Reaction force.

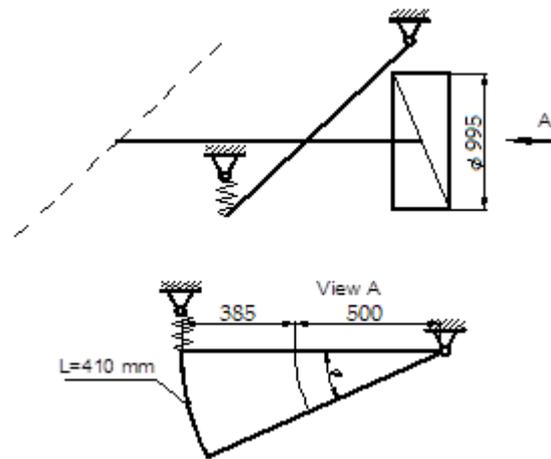
When one wheel is in the background and another is in the pothole, this results in torsion of the axle (Figure 5). The angle of twist is:

Figure 5. Air cushion throw, ($L \leq 300$ mm [35]).

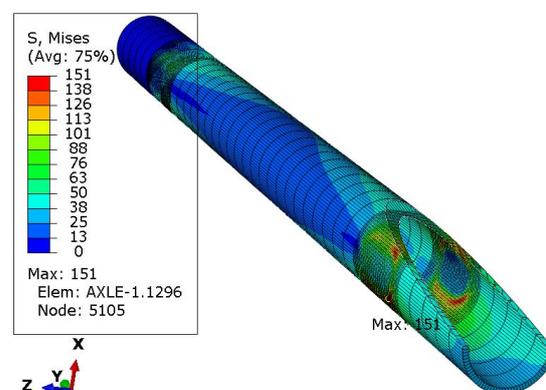
One of the ways of loading (Figure 6) concerned only the left wheel, i.e., as if the right wheel fell into a hole in the road. Four subsequent cases concerned the vertical load on both wheels (Figure 7), followed by braking the left wheel (Figure 8), braking both wheels (Figure 9), side load on the left wheel (Figure 10), and side load on both wheels (Figure 11). The adopted values of forces ($F_{\text{side}} = 44.1 \text{ kN}$ for each wheel) reflect the situation as if the coefficient of friction between the tires and the road surface was 1.0, both when braking and when cornering. One-wheel braking and lateral force on only one wheel can occur when the other wheel loses grip with the road surface.

Figure 6. HMH stress distribution in the axle while only left wheel loaded with F_{side} force. Trail front in Z direction.

The analysis of the distribution of stress in Figures 6–11 demonstrates that the max values in bushing were always near the welding. For the max strengthened node, the lowest value 136 MPa was observed for the symmetrical loading of two wheels (Figure 7). A slightly larger value (151 MPa) was found for the load on one (left) axle wheel. After that,

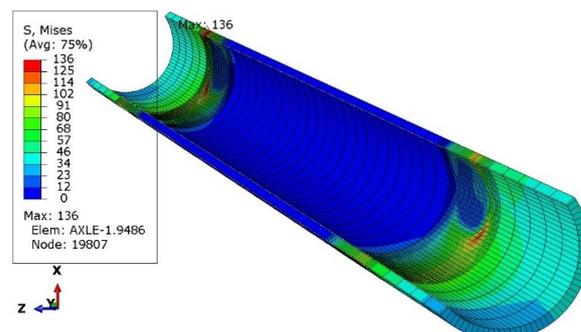
Figure 7. Stress distribution in the axle while both wheels loaded with F_{side} force.

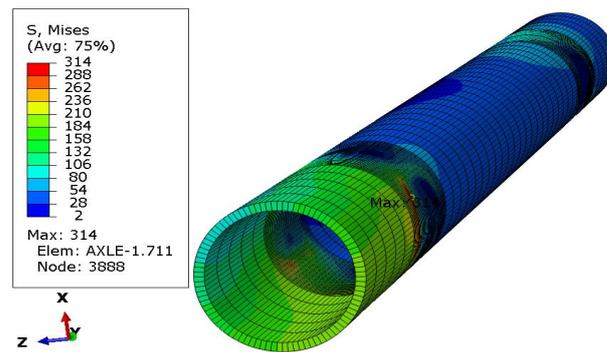
Figure 8. Stress distribution in the axle while only left wheel break is active.

when side (Figures 8 and 9) or brake (Figures 10 and 11) force was added to the simulations, for the most loaded nodes, HMH stress was found to be at least twice as big (312 MPa).

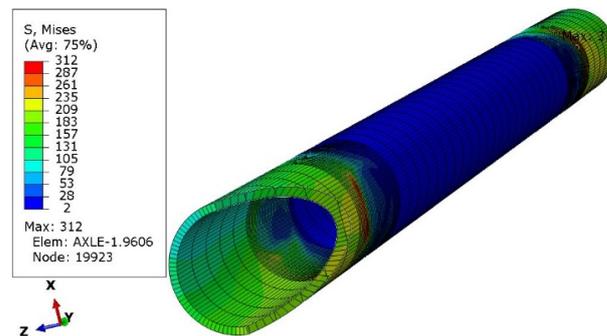
Figure 9. Stress distribution in the axle while only both wheels break.

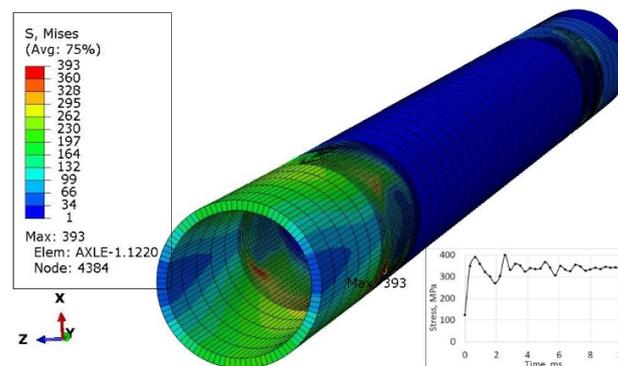
Figure 10. Stress distribution in the axle and max strengthen node 4384 while side force during turning acts to the left wheel.

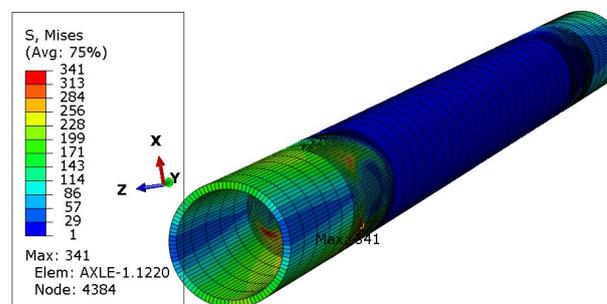
Figure 11. Stress distribution in the axle while side force during turning acts to both wheels.

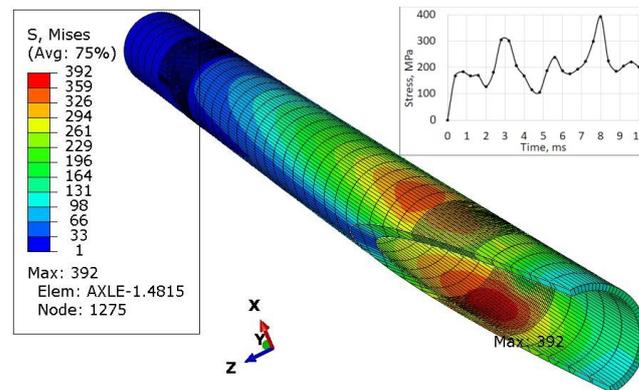
The last simulations concerned the case where the left wheel overruns a small trough (Figure 12) of a triangle shape with a height of 30 mm, and then both wheels simultaneously overcome such an obstacle (Figure 13). Each of these cases was simulated as a kinematic excitation occurring in 8 ms.

Figure 12. Stress distribution in the axle and max strengthened node 1275 while left wheel passes the triangular road deformation.

When forcing the vertical displacement of the left wheel, the maximum stresses occur at the point of contact between the sleeve and the axle in the lower part of the axle (Figure 12). It can be seen from the graph that apart from the average stresses in the range of 100–200 MPa, there are sudden jumps in their values (peaks) by about 200 units to over 300 MPa and many load cycles.

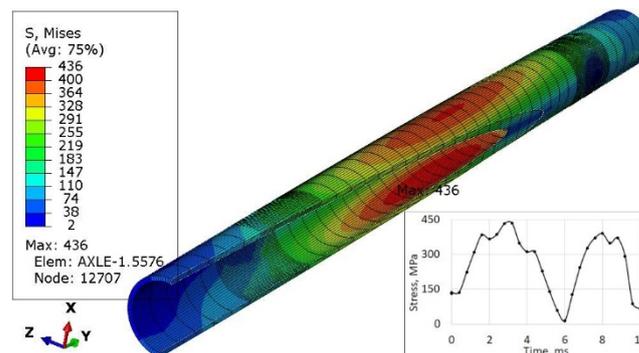
Figure 13. Stress distribution in the axle and max strengthened node 12,707 while both wheels pass the triangular road deformation.

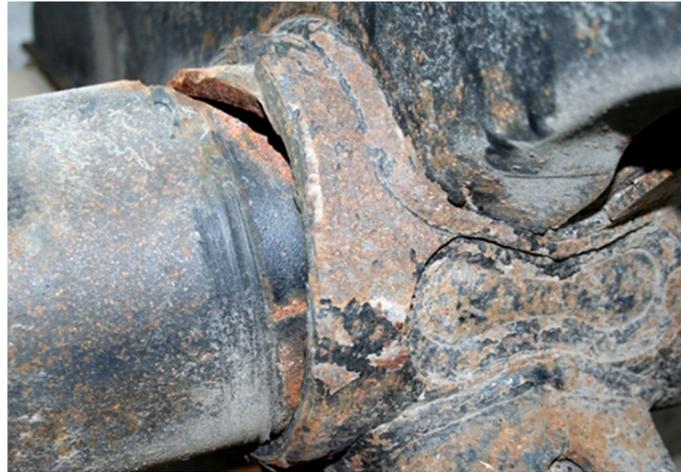
The test object is a broken axle of a semi-trailer chassis. The axle broke in February 2016. The total mileage of the axle is 326,516 km. The axle breaks near the weld (near the mounting location). The broken axle is analyzed in the condition in which it was delivered

for service under warranty. After inspecting the axle, a fracture of the axle is visible near the coupling joint in which the axle is fastened with the bracket. Non-destructive methods show only part of the fracture (Figure 14). Fractographic analysis of the fracture surface was performed using the MBS-2 stereo microscope and an Optikam Microscopy digital USB camera.

Figure 14. Axis fracture location.

The axis in this place puts the difficult working conditions of the surface in contact with the sleeve. This can cause corrosion of the axle surface (compare Figures 14 and 15) and fretting. In addition, the end of the axle is located near the wheel, from which sand and gravel can be thrown onto the surface of the material and damage the paint coating. Corrosion pits cause additional weakening of the material and surface notches, which are dangerous, especially when the material is subjected to fatigue, i.e., in the conditions of axle operation. The safety factor related to the min yield stress value obtained from strength tests is $567/392 = 1.45$. It should be noted that the result of 567 MPa was obtained for a standardly prepared tensile sample (Figure 22c). On the surface of the axis, near the fracture (Figure 14), corrosion pits are clearly visible, reducing the strength of the material, and causing geometrical and structural stress concentrations.

In any case, this result has shown that about 60% ($335/567$) of elastic behavior of steel is used. Note that the analysis Equation (18) did not evaluate possible stress concentration factors due to welding impact on an axle and damage to its surface by corrosion (compare Figure 14).

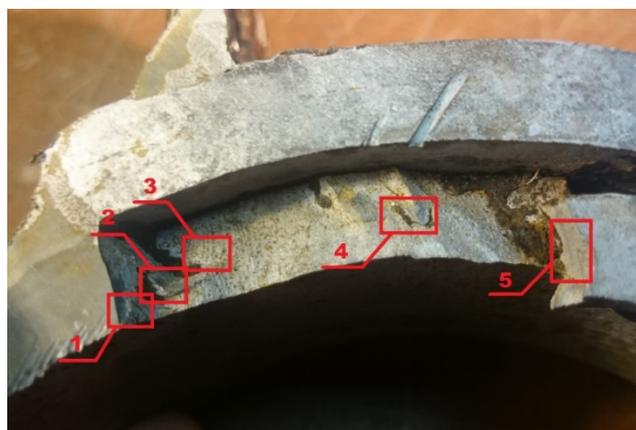
Fractures of a complex nature predominate in the fracture as the structural material is subjected to environmental influences and various deformations (Figure 15). In the manufacturing process, for example in the welded joints, areas of different mechanical properties are formed. Where there is a decrease in the plasticity of the material or in the area of higher stresses, individual voids may appear and a process of long-term plastic deformation may begin. By inspecting the fracture surface, three areas of fracture can be distinguished: fatigue before fracture, the onset of fracture, and major fracture.

Figure 15. Fracture surface: Areas 1 to 5 are used for fractographic analysis.

Figures 16–20 show the results of fractographic studies of individual fracture areas (Figure 15). Fracture surfaces: Figure 16—an area no. 1; Figure 17—an area no. 2; Figure 18—an area no. 3; Figure 19—an area no. 4; Figure 20—an area no. 5.

Fractographic analysis shows that it is a fatigue fracture characterized by three fracture areas and the fracture surface oriented perpendicular to the direction of maximum stresses. It can be assumed that the fracture may have been initiated by a long-term load.

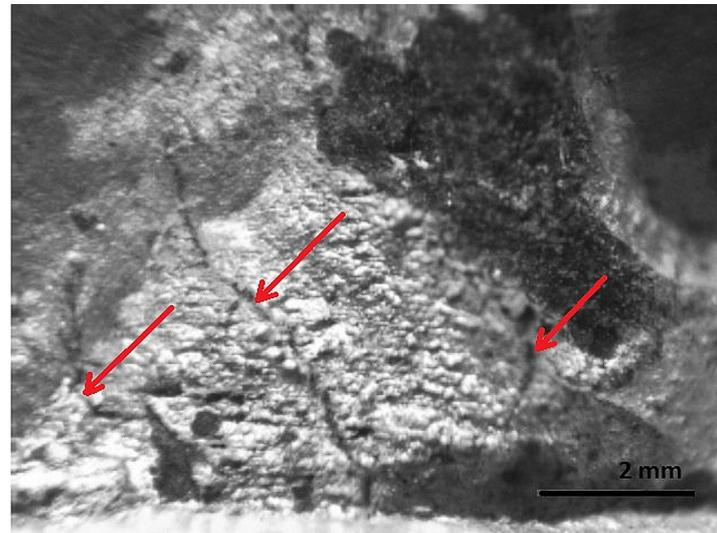
The first is the area of fatigue before fracture or decay; it has a wavy relief (Figures 16 and 17).

Figure 16. Fracture area: the area of the focal point of decay.

In the area of fatigue before the fracture, in the base and at the weld metal, near the weld where the highest stresses are applied, cracks are observed and a fragile fine-grained structure is visible. The formation and propagation of a crack depending on the type of deformation, the structure of the material, the level of the load, the shape of the part, and many other factors. The fracture is thought to have been initiated by long-term loading, as cracks and ribbed fracture morphology are characteristic of the effects of long-term loading.

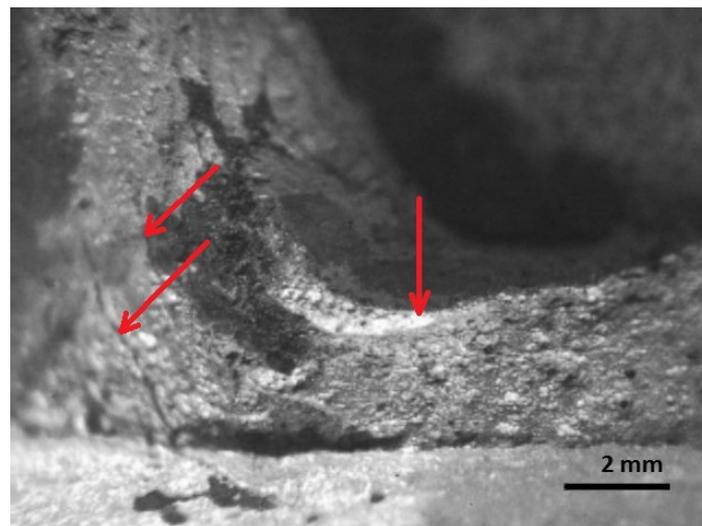
Figure 17. Fracture area: wider view of the area of the focal point of decay.

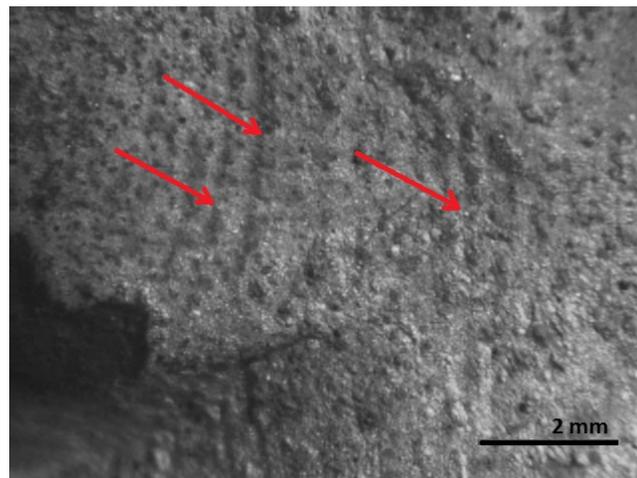
Figure 18. Fracture area: the area of gradual crack growth.

The second is the area at the beginning of the fracture. Grooves and fatigue thresholds are observed, which are characteristic of low-cycle fatigue fractures (Figure 18). Fatigue thresholds and grooves are among the signs of macroscopic decay. These signs indicate the direction of crack propagation, which is associated with plastic deformations, a decrease or increase in the rate of crack propagation, depending on the effects of the environment.

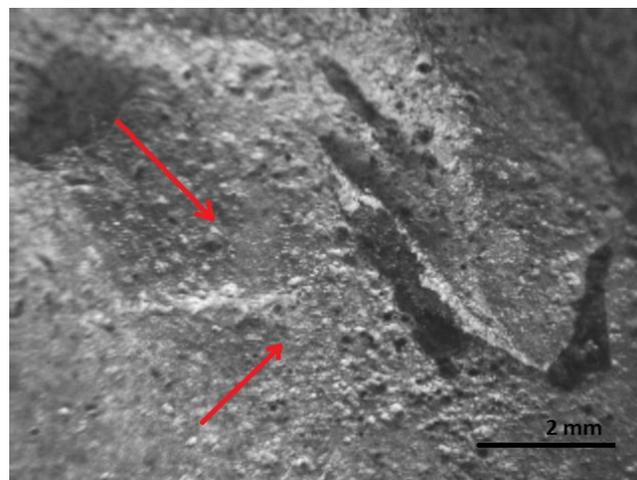
Figure 19. Fracture area: The area of the final fracture.

The relief of the main or final fracture area is crystalline in structure, brittle, and the surface is rough and porous (Figure 19).

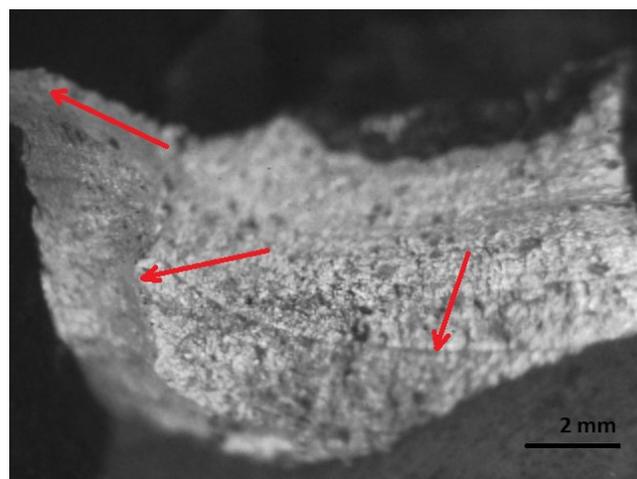
Figure 20. Fracture area: area of plastic deformation.

At the edges of the fracture, the shear characteristic of plastic deformation is seen, as well as grooves and fatigue thresholds characteristic of fatigue fracture (Figure 20).

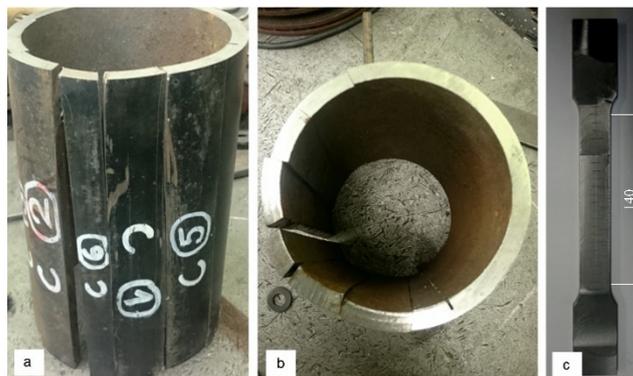
The blanks for specimens were cut from the middle. It was important to know the numbers of blanks and their position in the axle (Figure 22a,b). The specimen for the tension test was produced by the milling process (Figure 22c).

Figure 22. The blanks for specimens: (a) number of blanks; (b) orientations of blanks (c) specimen.

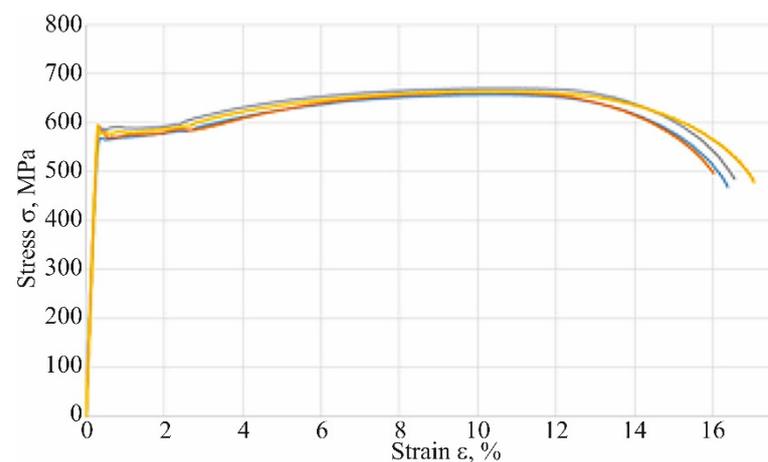
After tensions, tests of the specimens were measured and machine diagrams force F - displacement L were transformed to stress σ -strain ϵ diagrams. Finally, the behavior of the steel used for the axle is described by the non-linear stress σ -strain ϵ diagram (Figure 23), which is an average of results.

Figure 23. Experimental stress–strain diagrams.
