Article

Possibilities of Using UAV for Estimating Earthwork Volumes during Process of Repairing a Small-Scale Forest Road, Case Study from Kyoto Prefecture, Japan

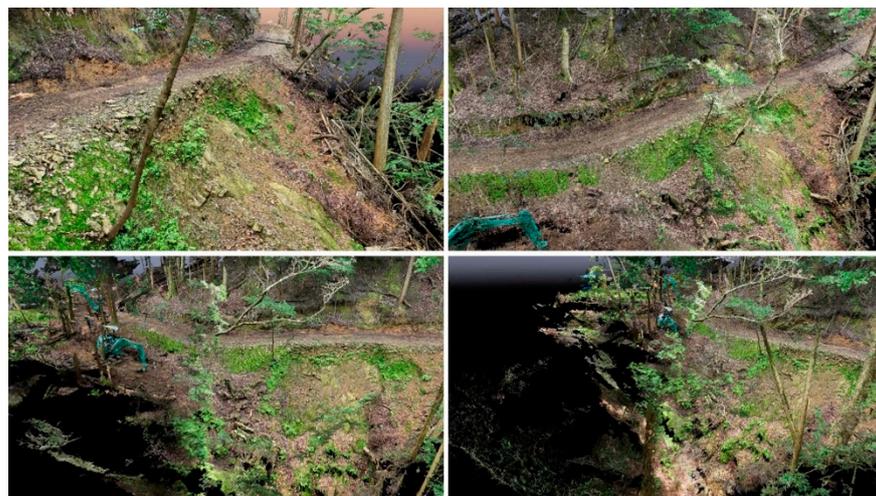
Figure 1. A 3D model generated by SfM analysis before the repair work started.

The 3D models of each phase were successfully constructed using SfM analysis. The resolution of the generated models ranged from 1.1 cm to 1.4 cm. For example, the 3D models generated from the data taken before, during, and after the work was completed and viewed from various angles are shown in Figures 1–3.

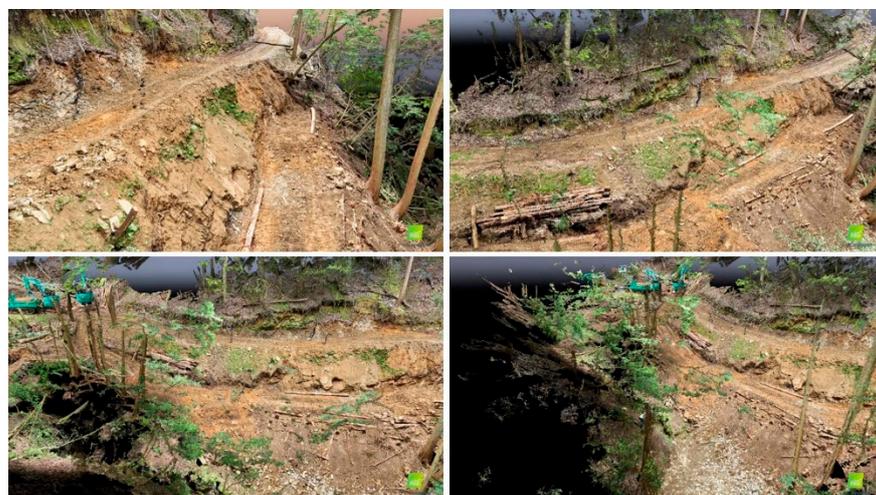
Figure 2. A 3D model generated by SfM analysis during the repair work.

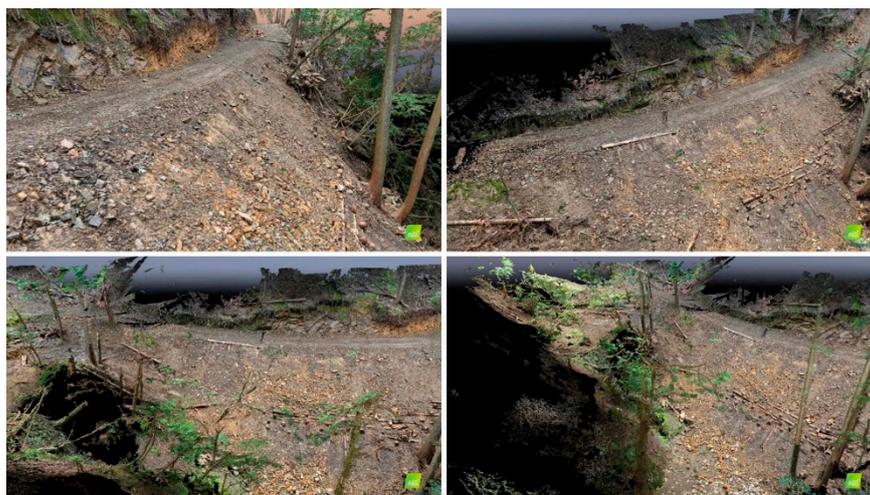
Figure 3. A 3D model generated by SfM analysis after the repair work completed.

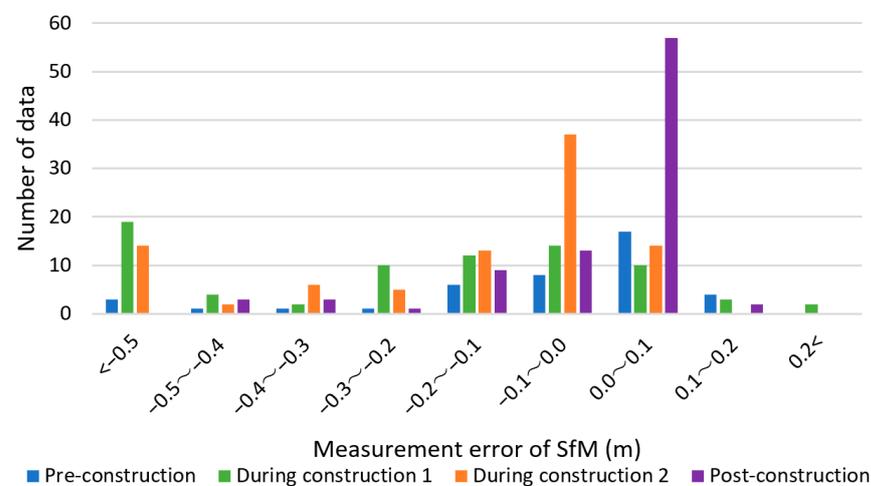
Figure 4. Frequency distributions of height measurement error in SfM analysis.

The elevation values obtained at each point of the 3D model were compared with those measured by the TS. However, measurement by the TS takes time, which causes a significant time lag between drone photography and TS surveying. Therefore, verification of measurement accuracy was limited to four times: the morning of 22 August before the repair work, the morning of 23 August and 24 August during the repair work, and 13 September after the repair work. The results are shown in Table 1 and Figure 4.

The overall measurement error averaged -0.146 m, leading to a general tendency toward underestimation. The RMSE was 0.098 m, indicating that elevation values could be obtained with an accuracy of about 10 cm. However, the average error varied greatly from one measurement session to the next. It was -0.102 m before the repair work, and -0.259 m and 0.198 m during the repair work, whereas it was -0.017 m after the repair work, a significant improvement. Lee and Lee [28] reported an RMSE error of 0.11 m in the vertical direction for the SfM analysis using vertical and 45-degree photographs from 50 m altitude at a construction earthwork site. The error in this study was similar, but the accuracy in this study was slightly less at closer distances to the ground surface and in forest areas.

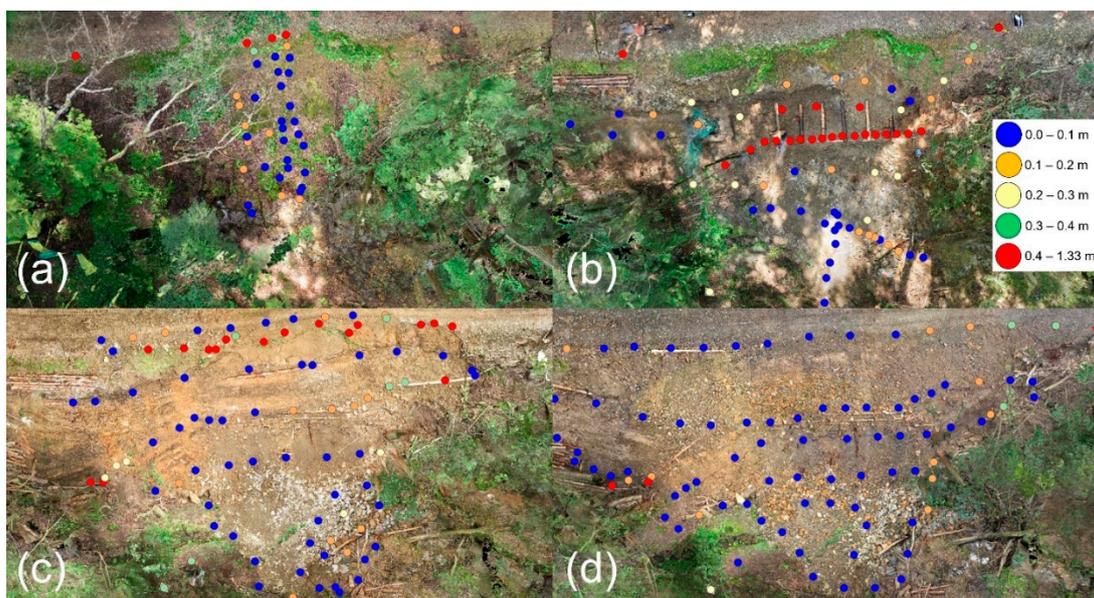
Figure 5. Absolute values of the error at each process of the repair work. (a) before the repair work, (b,c) during the repair work, (d) after the repair work.

With this in mind, we discuss the accuracy of the measurements at each stage. The absolute value of the error at the TS measurement points before the repair work is shown in Figure 5a. It is shown in the figure that the error is small on slopes where the soil is visible, and slightly larger errors are observed in vegetated areas and on the shoulders of embankment slopes.

Similarly, the situation during the repair work is shown in Figure 5b,c, and the situation after the repair work is shown in Figure 5d. It is shown in Figure 5b,c that errors were minor,

even during the repair work, in areas where the soil was visible. However, substantial errors occurred in areas where work was being done, such as in areas where wood framing was being installed. A significant error at the shoulder of the embankment is shown in Figure 5c. Still, further verification was needed to determine whether the accuracy of edge detection in the SfM analysis was reduced by this problem or whether the soil tended to move easily at the shoulder of the embankment.

On the other hand, Figure 5d shows that the accuracy was generally good after the repair work, including the shoulders of the embankment. Even on the shoulders of the embankment, most of the errors were lower than 0.1 m. Slightly larger errors were observed in the upper right and lower left parts of the figure, which are close to the vegetation. Together with the edge mentioned above, a more precise analysis of the accuracy in areas easily shaded by vegetation is considered necessary.

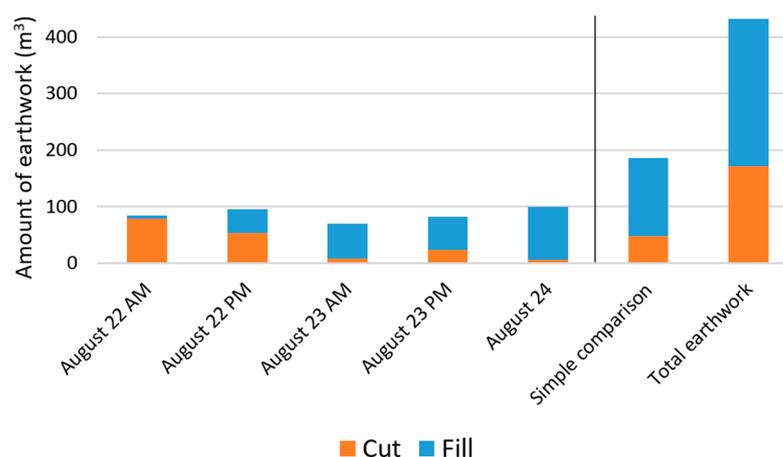
Figure 6. Amount of earthwork for cut and fill at each stage.

It was suggested by these results that SfM analysis is sufficiently accurate for soil volume calculations in units of cubic meters. However, there was room for further study on the accuracy of measurements under subsoil vegetation and at sharp slope conversion points. Therefore, we calculated the amount of earthwork for cut and fill at each stage. The results are shown in Figure 6.

It was estimated that 78.6 m³ of cut soil was generated on the morning of the first day of work (22 August), and another 5.49 m³ was used as fill. In the early stage of the repair work, it was assumed that much of the cut soil was generated to shape collapsed areas and construct an access road to the lower part of the embankment. In the afternoon of 22 August, the cut, and fill volumes were 54.1 m³ and 41.4 m³, respectively. This was consistent with the fact that much soil was used during the formation of the log structure at the base of the fill. On the morning of 23 August, the cut decreased to 8.8 m³ and the fill increased to 60.9 m³ when the log structure continued to be installed. The cut soil increased again to 23.6 m³ and the fill to 58.9 m³ when the upper portion of the embankment was re-excavated simultaneously with the formation of the fill in the afternoon of 23 August. On 24 August, the last day of the repair work, the cut was 6.2 m³ and the fill was 93.9 m³.

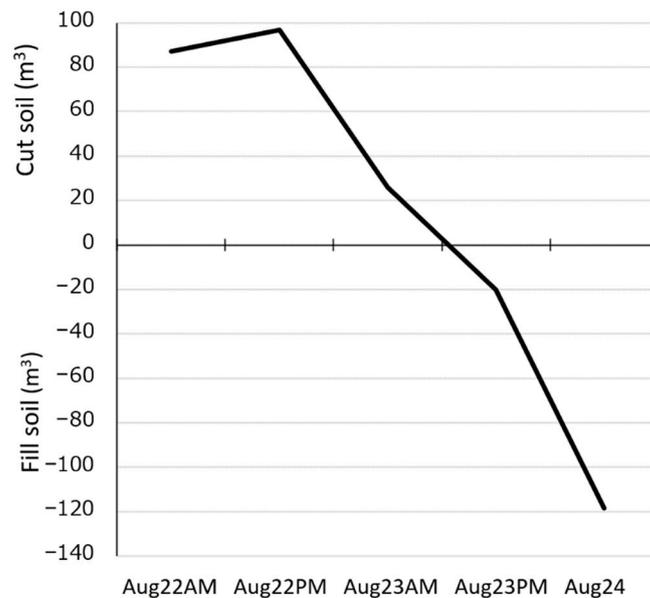
Figure 7. Cumulative amount of earthwork at each stage.

The cumulative earthwork volume at each stage is shown in Figure 7. The rate of change in the volume of loosened soil, the change in the volume of soil in the excavation of the ground soil volume (L), was calculated as 1.2 in calculating the amount of earthwork. The rate of change in the volume of compacted soil and the difference in soil volume in forming the ground soil volume into fill (C) was 0.9. The volume of the log structure embedded in the fill was not considered.

According to this figure, it can be seen that in the early stage of the repair work, when there was much cut soil, there was a maximum of about 100 m³ of cut soil. Securing a temporary storage place for this cut soil around the work site is necessary. On the other hand, the cut soil forms the embankment, and at some point, the soil for the embankment becomes insufficient. Therefore, it is necessary to secure soil from another location. This amount of fill was considered to be about 120 m³.

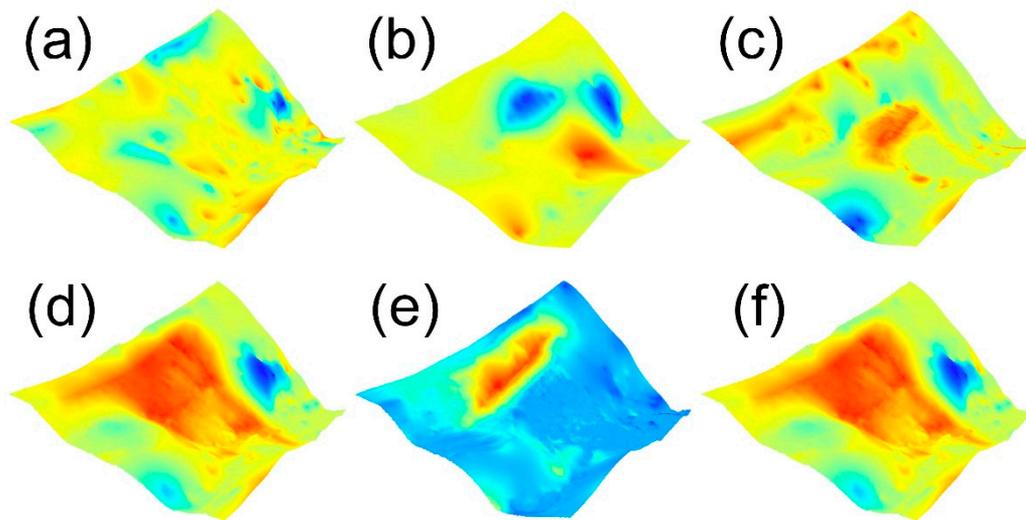
Figure 8. 3D model of the earthwork sections at each stage. (a) constructing an access road to the lower part of the embankment and the formation of the base, (b) forming the embankment base by earthwork and logs, (c) forming the lower part of the embankment by earthwork and logs, (d) forming the upper part of the embankment by earthwork and logs, (e) shaping the entire embankment, (f) overall earthwork.

Figure 8 shows a 3D model of the earthwork sections at each stage. The cut and fill areas are shown in blue and red, respectively. In Figure 8f, showing the overall earthwork volume in the lower right corner, almost the entire missing fill area was covered with fill. The cut and fill areas were indicated in each step, making the procedure easy to understand. The entire fill was shown in blue, except for some parts, in Figure 8e. This is because the photographs after the repair work were not taken until three weeks after the completion of the repair work, and it is presumed that the entire fill has tightened and settled.
