Article

Energy and Seismic Recovering of Ancient Hamlets: the Case of Baia e Latina

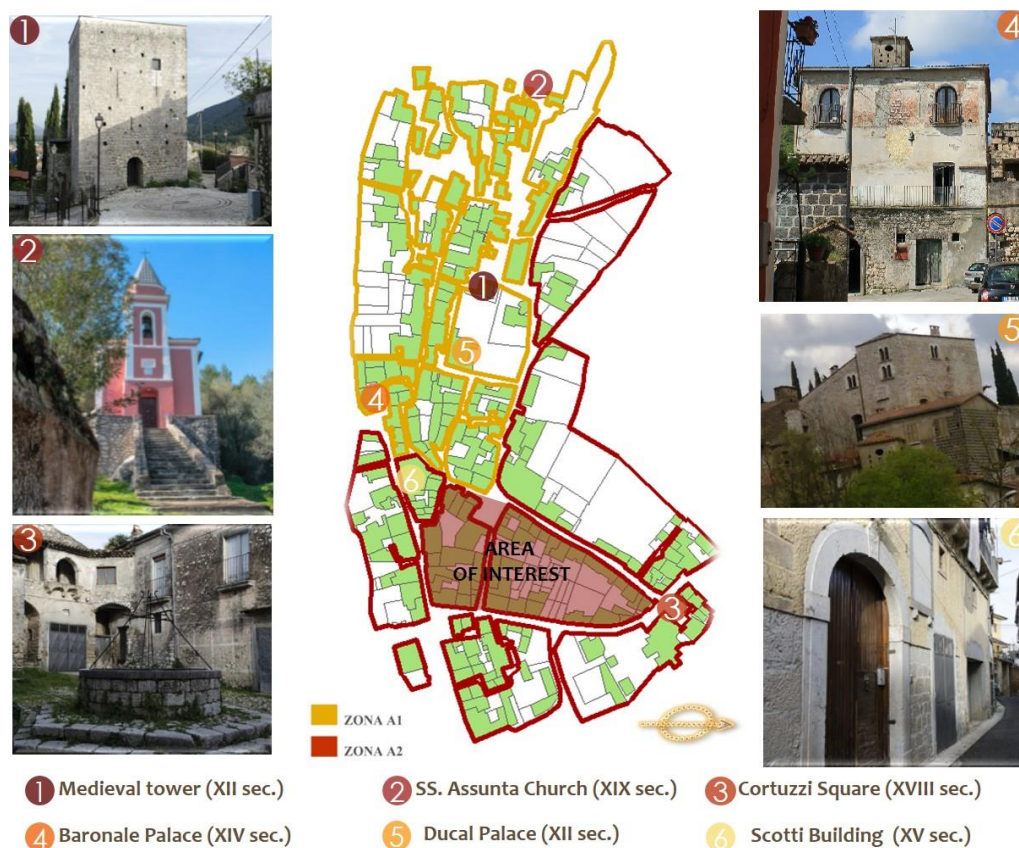
Figure 1. The zoning of the municipality of Baia and Latina.

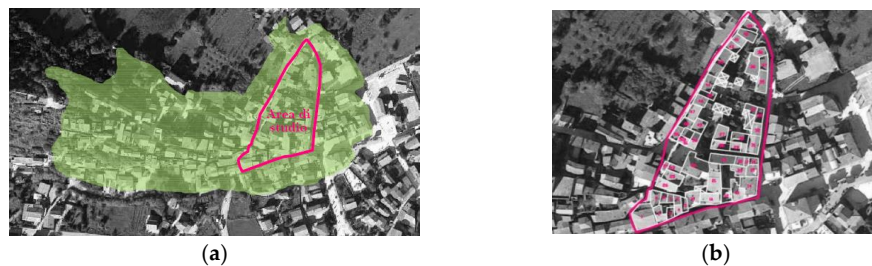
Figure 8. Baia: (a) recognition of study area, (b) recognition of structural units.

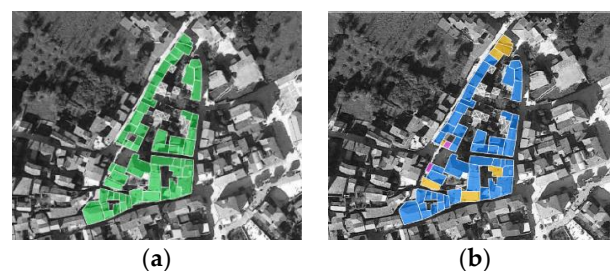
Figure 12. Damage maps: (a) E.D. = 20 km and M = 4 and 5; (b) E.D. = 20 km and M = 6.

Figures 10–13 show some of the 18 damage maps. It is highlighted that increasing magnitude, at the same epicentre distance, corresponds to an increase in buildings that suffer serious damage, just as the increase in epicentre distance reduces the number of extremely damaged buildings. The buildings that develop the most damage are especially those that have a poorer planimetric interaction and a more irregular distribution of in-plan resistant elements. From the maps, it is apparent that the most damaged buildings, which are located in the lower part of the study area, are the most ancient ones, and have not been subjected to retrofitting interventions to improve their seismic behaviour.

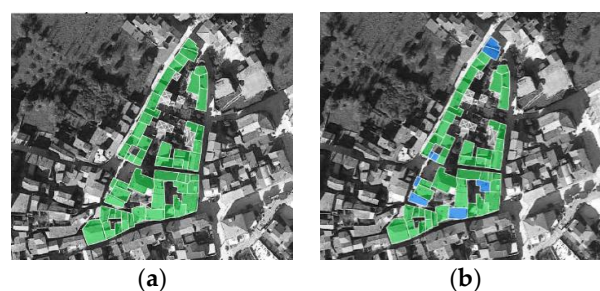
Figure 13. Damage maps: (a) E.D. = 30 km and M = 4 and 5; (b) E.D. = 30 km and M = 6.
